**Pacific Northwest
National Laboratory**

**Ultrasonic Examination of Double-Shell
Tank 241-AW-103 Examination
Completed September 2006**

April 2007

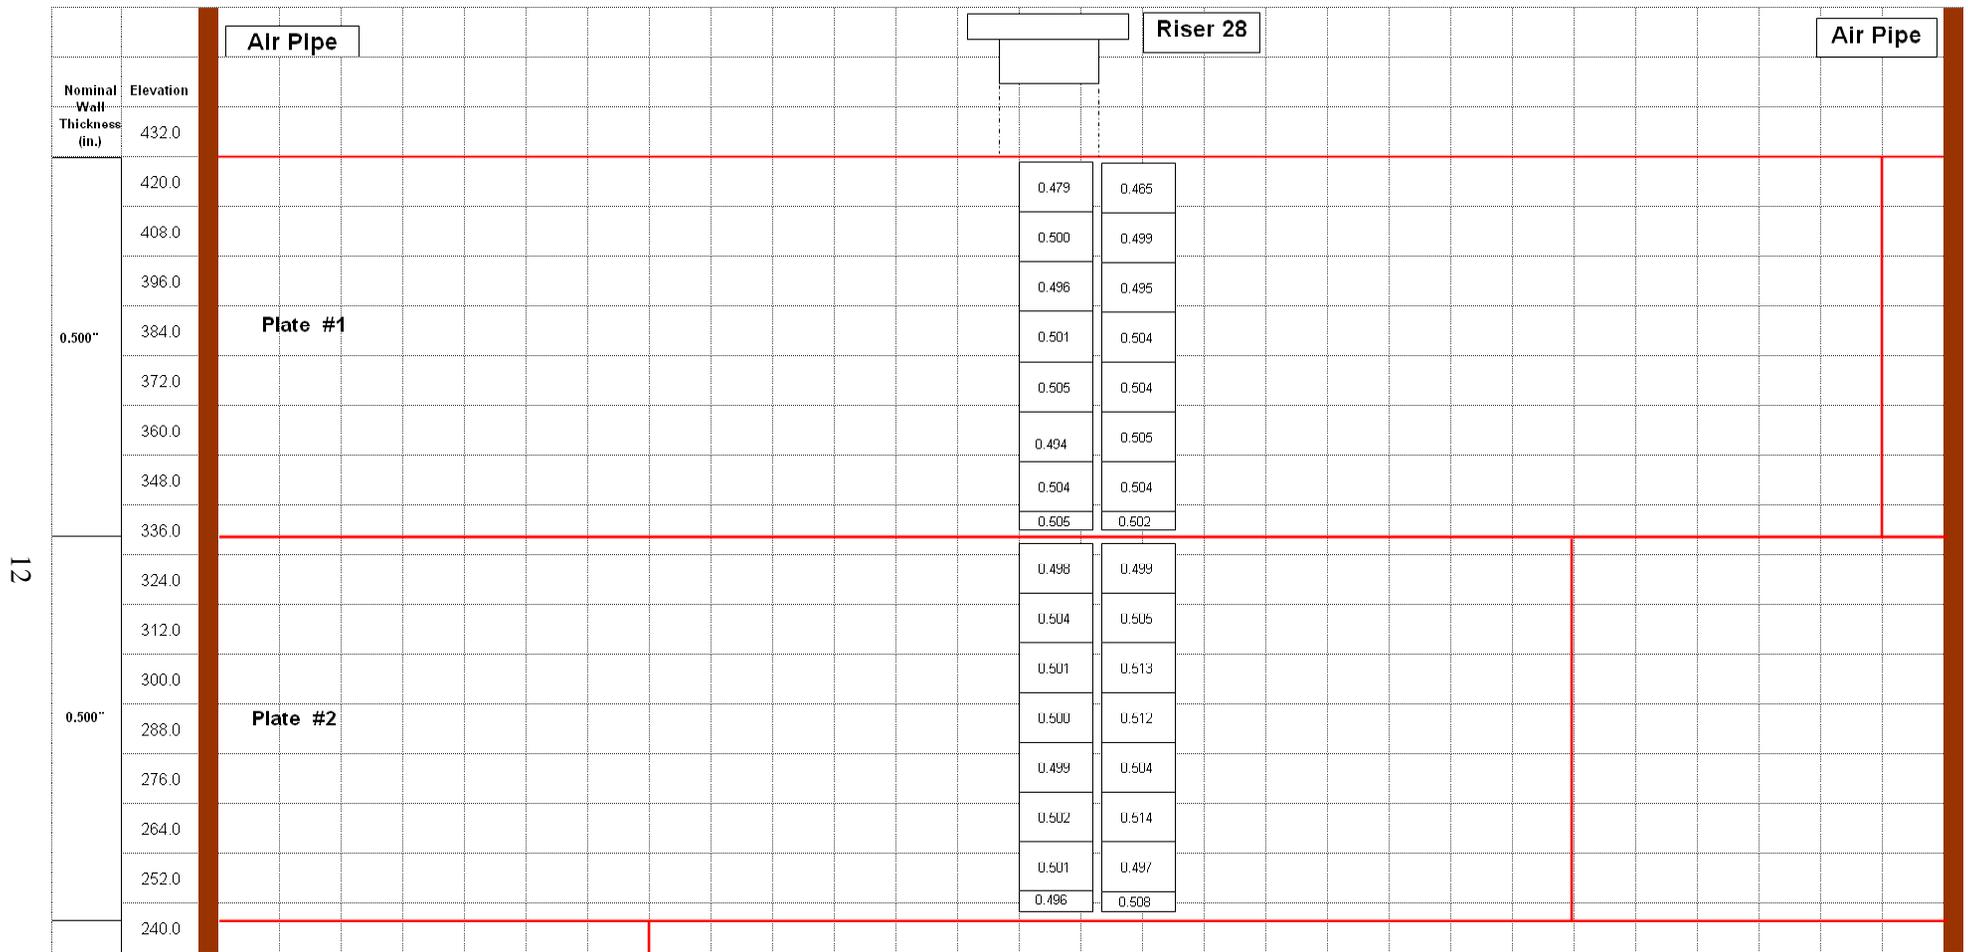
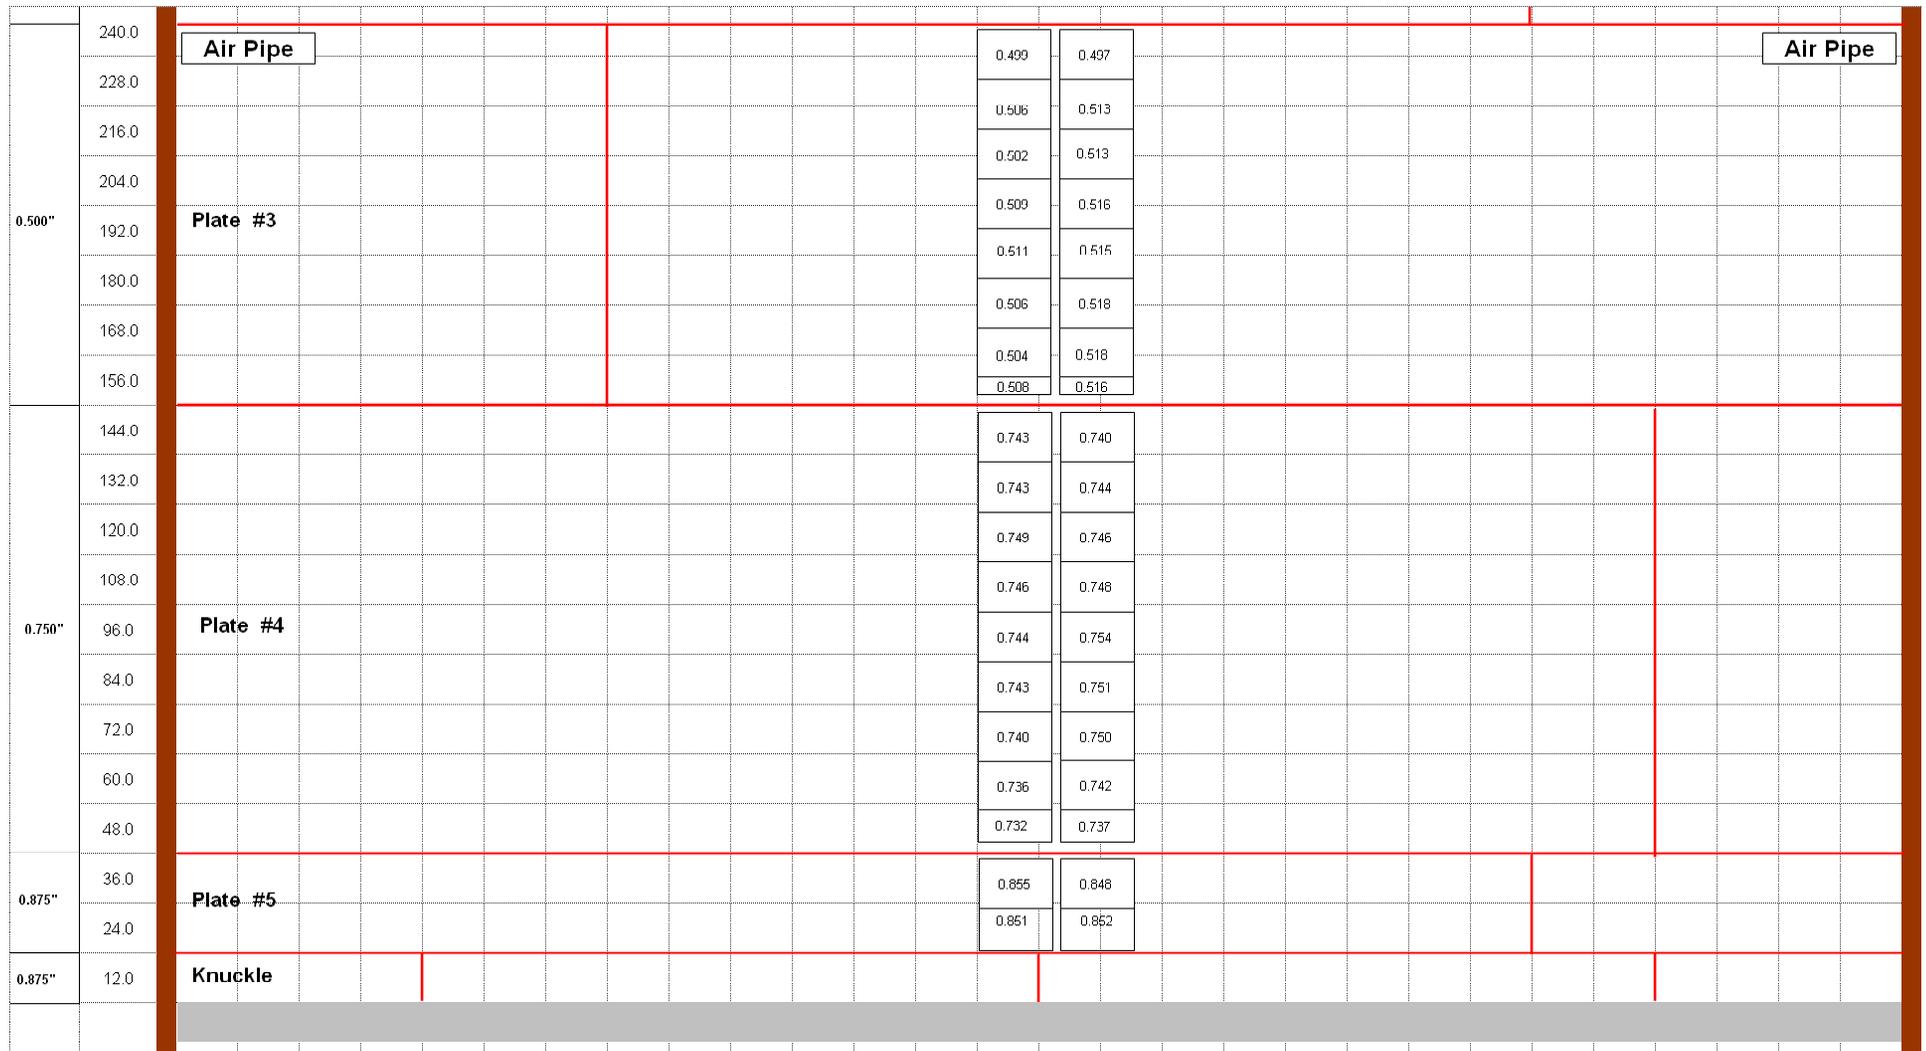
Figures 5.1 and 5.2 show the wall thickness examination results for the primary tank wall from Riser 28. The examination consisted of two vertical paths beneath the 24-in. diameter riser. Vertical scan #1 was 15-in.-wide on Plates #1, #2, #3, #4, and #5 near the centerline of the 24-in. riser. Vertical scan #2 was adjacent to vertical scan #1 and was also 15-in.-wide on Plates #1, #2, #3, #4, and #5. Vertical scans were conducted in the downward direction. Figures 5.1 and 5.2 display the minimum readings taken in each 15-in.-wide by 12-in.-long area of the scan.

Figure 5.1. UT Data from Tank 241-AW-103 Primary Tank Riser 28

Figure 5.2. UT Data from Tank 241-AW-103 Primary Tank Riser 28 cont.

Two 15-in.-wide vertical scan paths were performed on Plates #1, #2, #3, #4, and #5 from Riser 28. The plates were examined for wall thinning, pitting, and cracks oriented vertically on the primary tank wall. The results indicated that the minimum thicknesses in the areas that were scanned with nominal thickness of 0.500-in. are as follows; Plate #1 was 0.465-in., Plate #2 was 0.496-in., and Plate #3 was 0.497-in. The nominal thickness in Plate #4 is 0.750-in. and the minimum thickness in this area was 0.732-in. The nominal thickness in Plate #5 is 0.875-in. and the minimum thickness in this area was 0.848-in. There were no areas of wall thinning that exceeded the reportable level of 10% of the nominal thickness. No pitting or vertical crack-like indications were detected in Plates #1, #2, #3, #4, or #5.

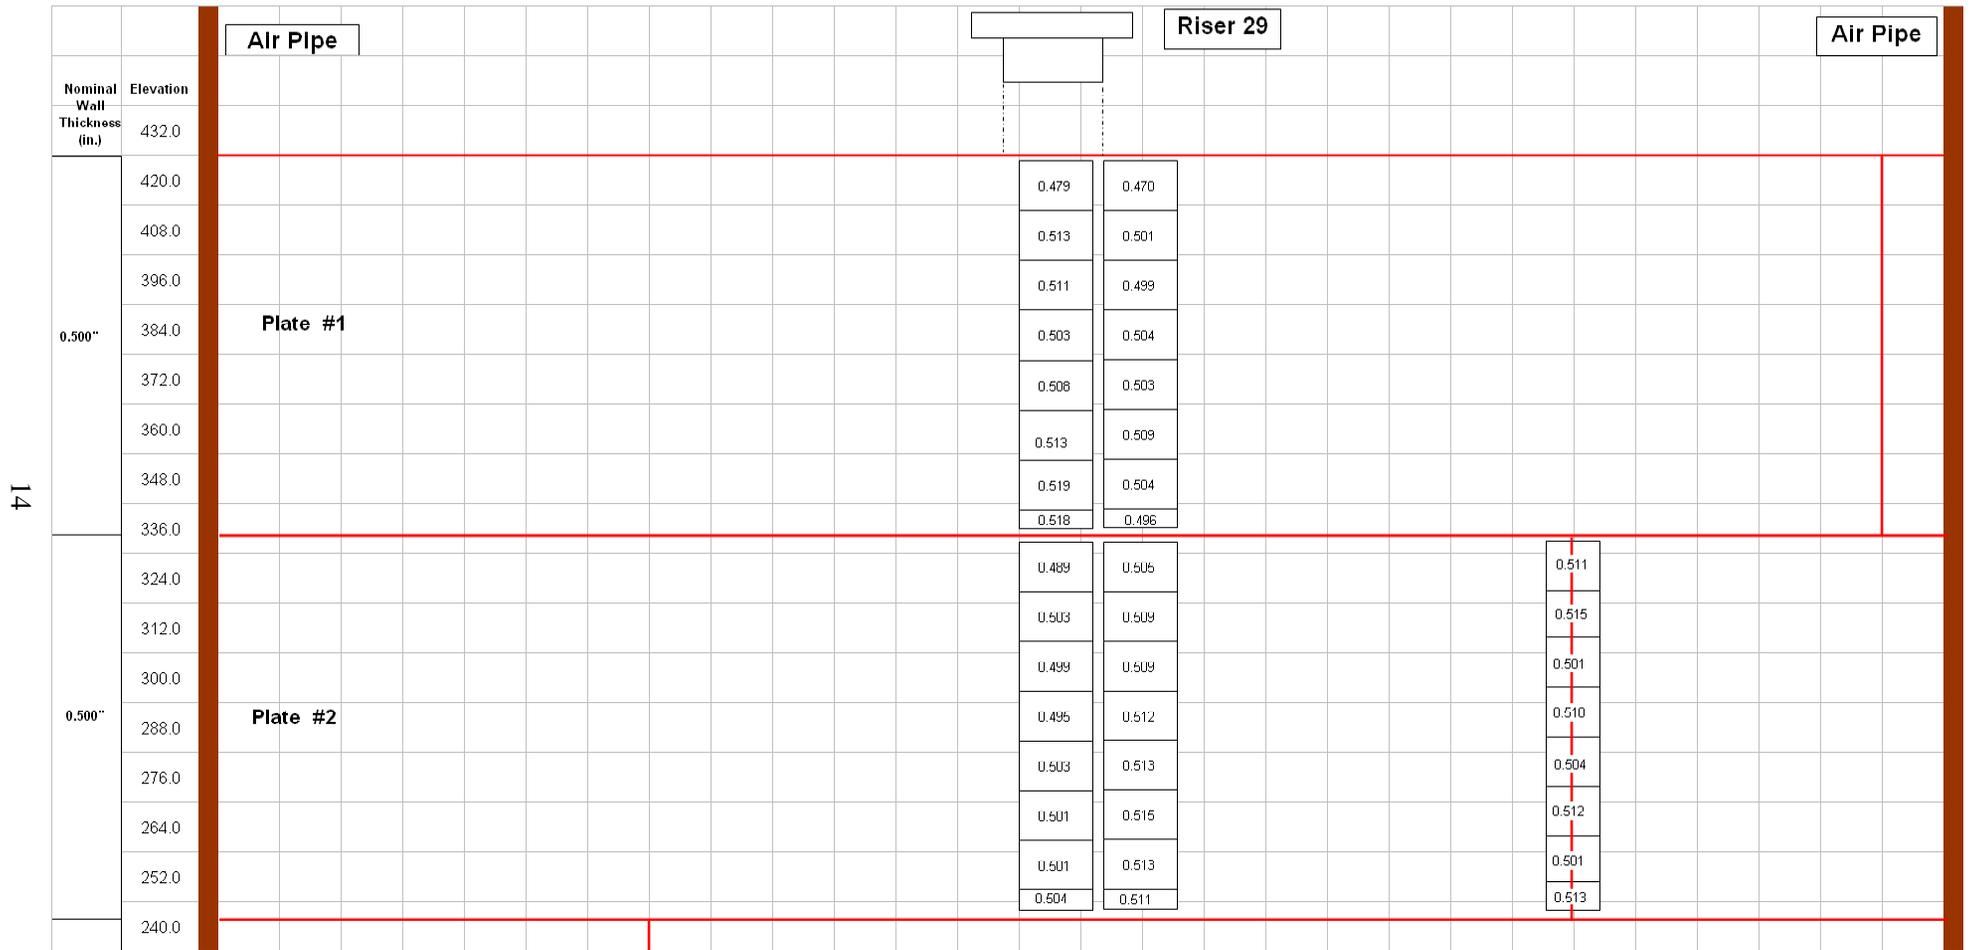
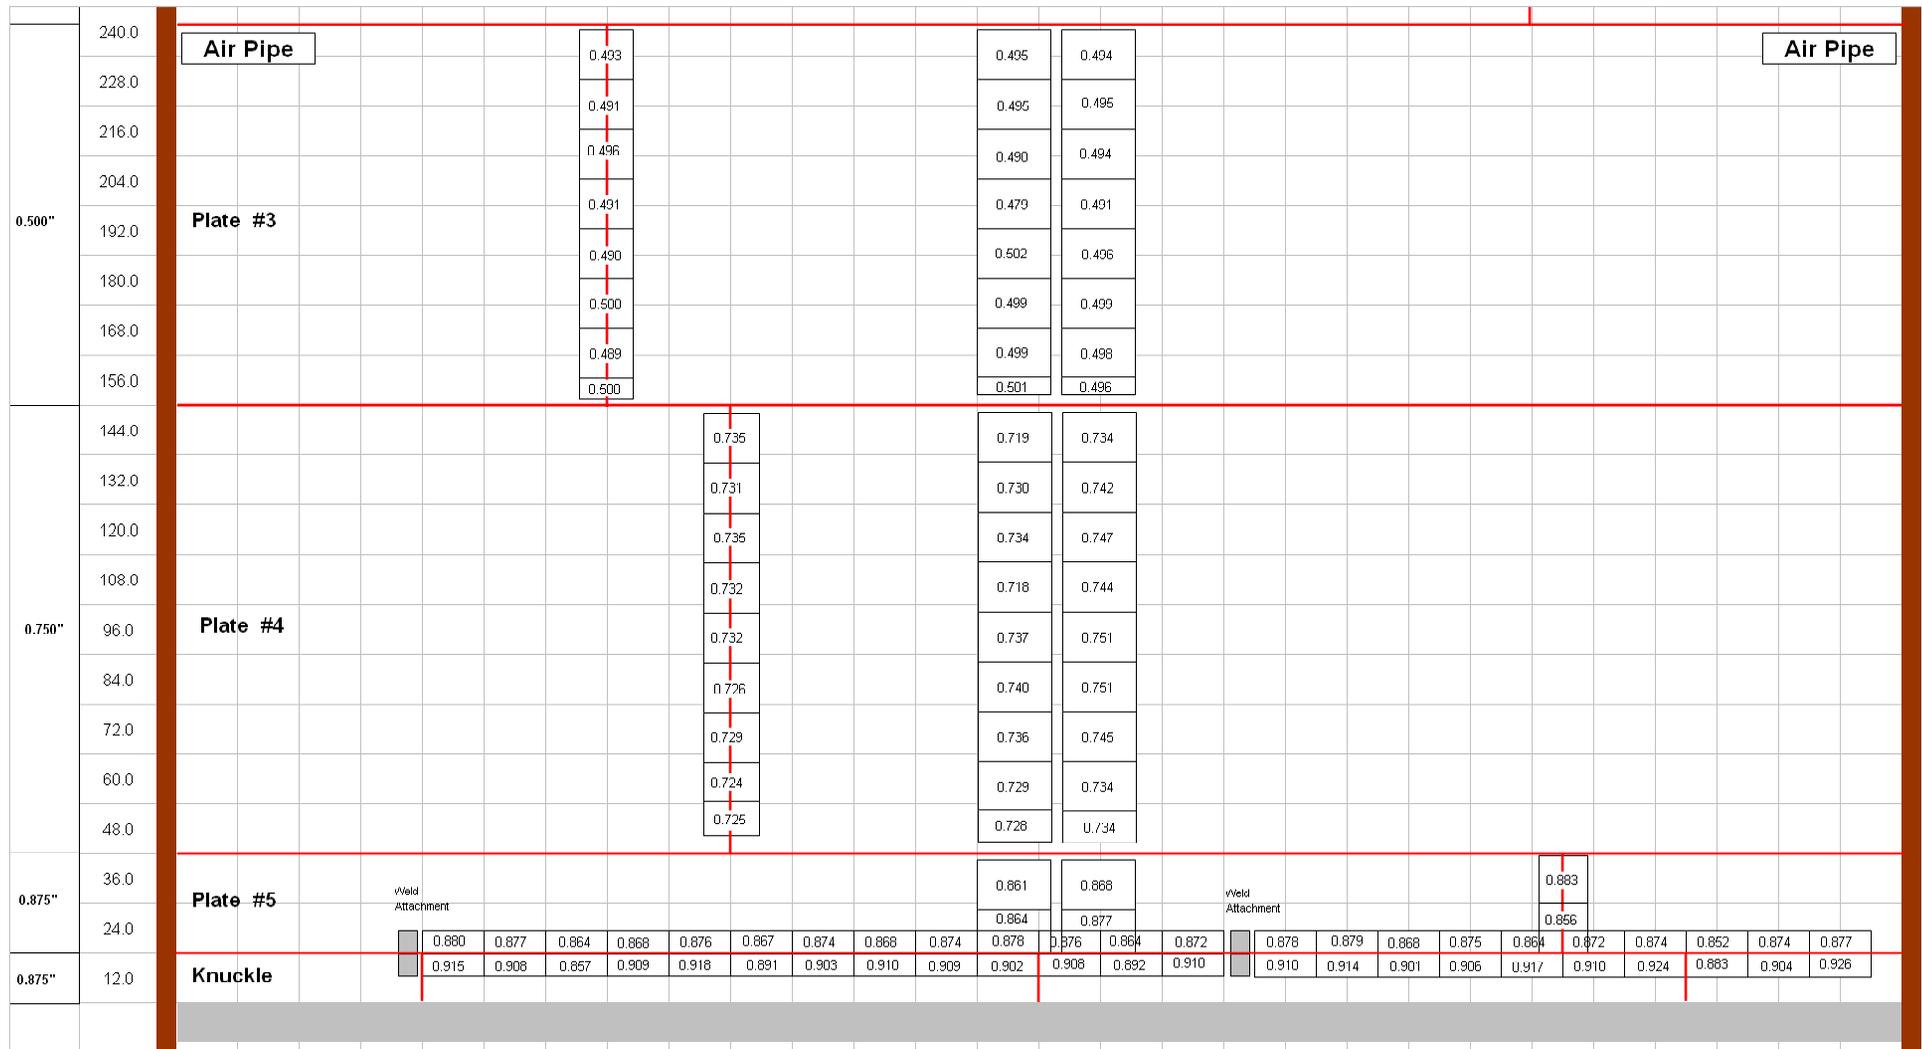
Figures 5.3 and 5.4 show the wall thickness examination results for the primary tank wall and the HAZs of both vertical and horizontal welds from Riser 29. The examination consisted of two vertical paths beneath the 24-in. diameter riser. Vertical scan #1 was 15-in.-wide on Plate #1, #2, #3, #4, and #5 near the centerline of the 24-in. riser. Vertical scan #2 was adjacent to vertical scan #1 and was also 15-in.-wide on Plates #1, #2, #3, #4, and #5. Vertical scans were conducted in the downward direction. The HAZs of vertical welds in Plates #2, #3, #4, and #5 were examined and the HAZ in the horizontal weld between Plate #5 and the knuckle section was also examined. Weld area exams include approximately 5-in. on each side of the weld. Areas in the figures that show two measurements in the same box are the result of the vertical scan paths overlapping the horizontal scan paths. Figures 5.3 and 5.4 display the minimum readings taken in each 15-in.-wide by 12-in.-long area of the scan. In the overlapping areas, both minimum readings from each vertical and horizontal scan paths are given.

Figure 5.3. UT Data from Tank 241-AW-103 Primary Tank Riser 29

Figure 5.4. UT Data from Tank 241-AW-103 Primary Tank Riser 29 cont.

Two 15-in.-wide vertical scan paths were performed on Plates #1, #2, #3, #4, and #5 from Riser 29. The plates were examined for wall thinning, pitting, and cracks oriented vertically on the primary tank wall. The results indicated that the minimum thicknesses in the areas that were scanned with nominal thickness of 0.500-in. are as follows; Plate #1 was 0.470-in., Plate #2 was 0.489-in., and Plate #3 was 0.479-in. The nominal thickness in Plate #4 is 0.750-in. and the minimum thickness in this area was 0.718-in. The nominal thickness in Plate #5 is 0.875-in. and the minimum thickness in this area was 0.861-in. There were no areas of wall thinning that exceeded the reportable level of 10% of the nominal thickness. No pitting or vertical crack-like indications were detected in Plates #1, #2, #3, #4, or #5.

The HAZ of vertical welds in Plates #2, #3, #4, and #5 from Riser 29 were examined for wall thinning, pitting and cracks oriented either perpendicular or parallel to the weld. The results indicated that the minimum thicknesses in the weld areas that were scanned are as follows: The nominal thickness of Plate #2 is 0.500-in. and the minimum thickness in this weld area was 0.501-in. The nominal thickness in Plate #3 is 0.500-in. and the minimum thickness in this weld area was 0.491-in. The nominal thickness in Plate #4 is 0.750-in. and the minimum thickness in this weld area was 0.724-in. The nominal thickness in Plate #5 is 0.875-in. and the minimum thickness in this weld area was 0.856-in. There were no areas of wall thinning that exceeded the reportable level of 10% of the nominal thickness. No pitting or crack-like indications were detected in the weld areas in Plates #2, #3, #4, and #5.

The HAZ of the horizontal weld between Plate #5 and the tank knuckle from Riser 29 was examined for wall thinning, pitting and cracks oriented either perpendicular or parallel to the weld. The results indicated that the minimum thickness in the weld area with nominal thickness of 0.875-in. on Plate #5 was 0.852-in. The minimum thickness in the weld area with nominal thickness of 0.875-in. on the knuckle was 0.857-in. There were no areas of wall thinning that exceeded the reportable level of 10% of the nominal thickness. No pitting or crack-like indications were detected in the weld areas on Plate #5 side or on the knuckle side of the horizontal weld.

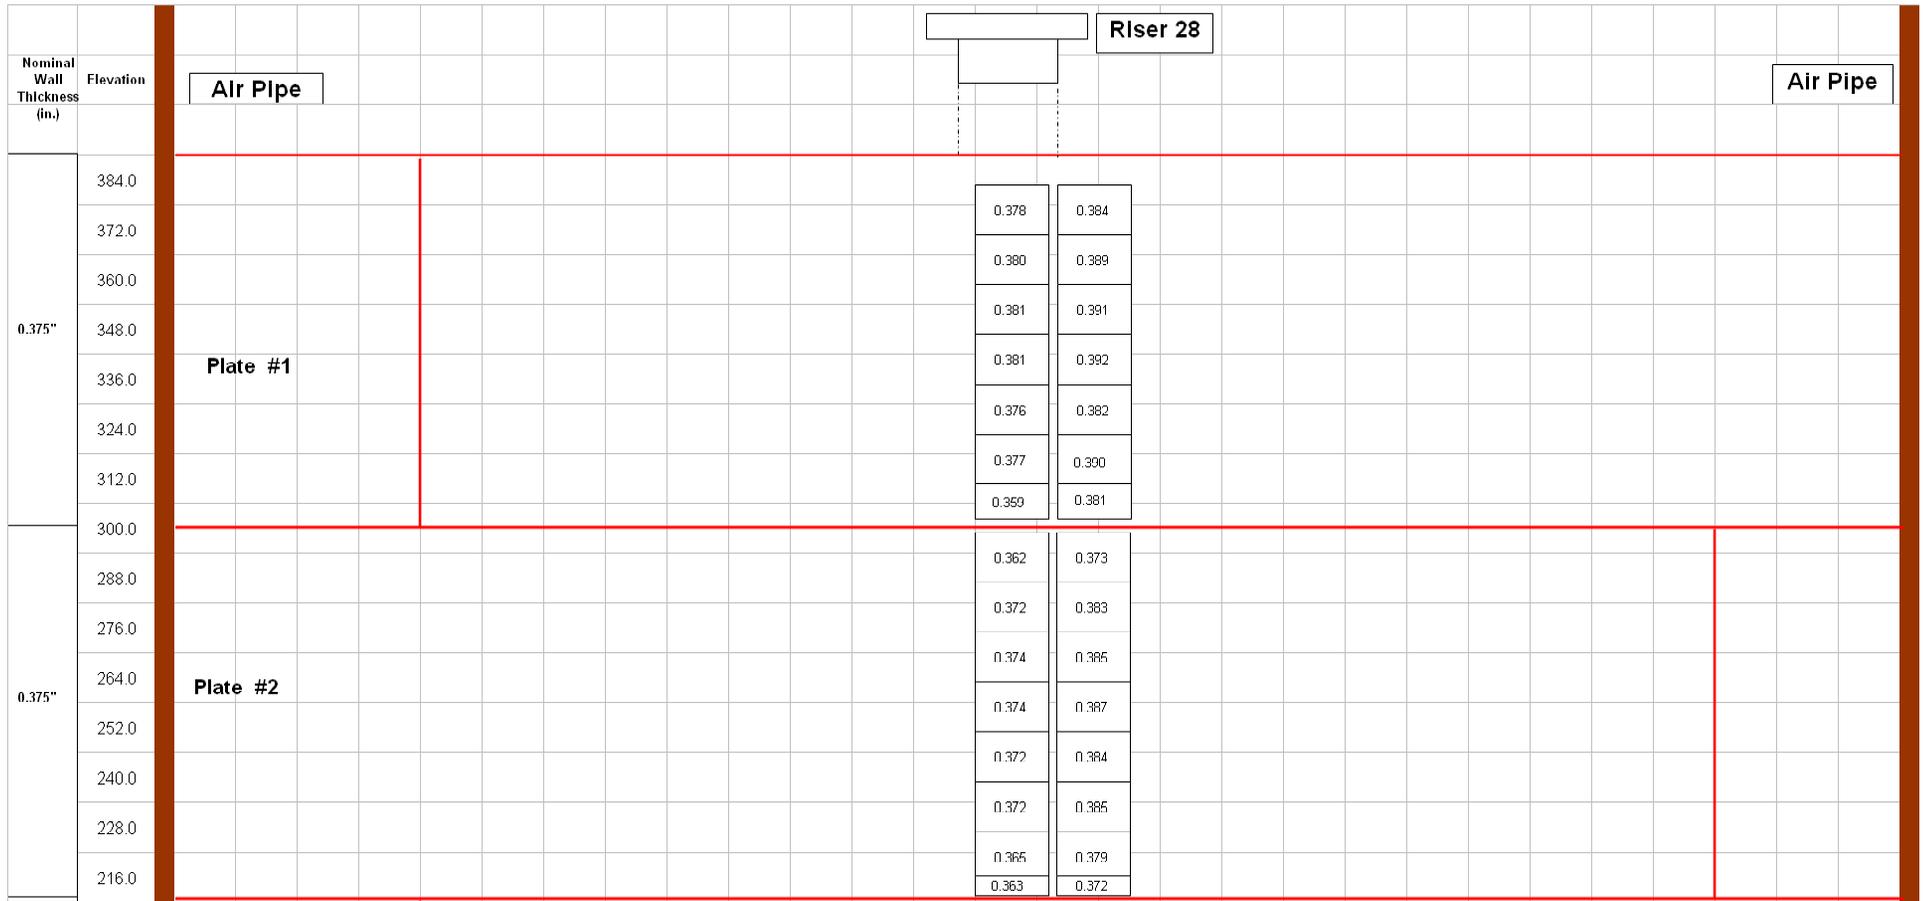
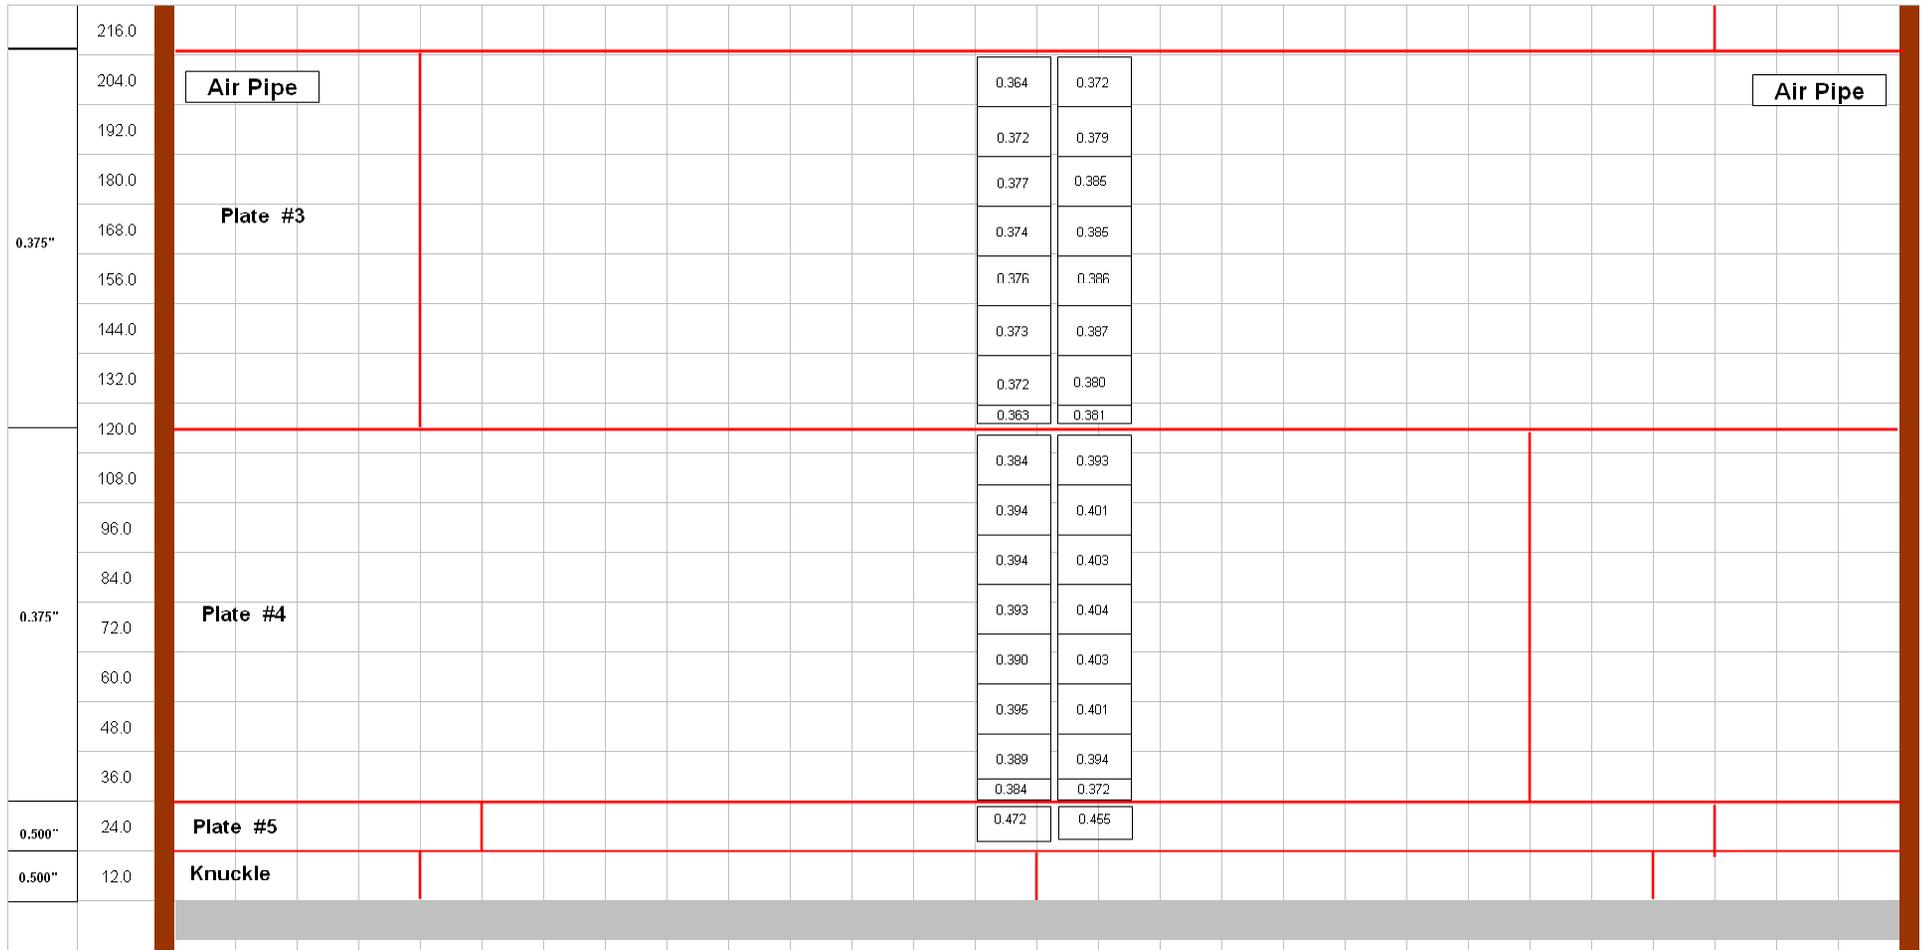
Figures 5.5 and 5.6 show the wall thickness examination results for the secondary tank wall from Riser 28. The examination consisted of two vertical paths beneath the 24-in. diameter riser. Vertical scan #1 was 15-in.-wide on Plates #1, #2, #3, #4, and #5 near the centerline of the 24-in. riser. Vertical scan #2 was adjacent to vertical scan #1 and was also 15-in.-wide on Plates #1, #2, #3, #4, and #5. Vertical scans were conducted in the downward direction. Figures 5.1 and 5.2 display the minimum readings taken in each 15-in.-wide by 12-in.-long area of the scan.

Figure 5.5. UT Data from Tank 241-AW-103 Secondary Tank Riser 28

Figure 5.6. UT Data from Tank 241-AW-103 Secondary Tank Riser 28 cont.

Two 15-in.-wide vertical scan paths were performed on the secondary tank wall on Plates #1, #2, #3, #4, and #5 from Riser 28. The plates were examined for wall thinning, pitting, and cracks oriented vertically on the secondary tank wall. The results indicated that the minimum thicknesses in the areas that were scanned with nominal thickness of 0.375-in. are as follows; Plate #1 was 0.359-in., Plate #2 was 0.362-in., Plate #3 was 0.363-in., and Plate #4 was 0.372-in. The nominal thickness in Plate #5 is 0.500-in. and the minimum thickness in this area was 0.455-in. There were no areas of wall thinning that exceeded the reportable level of 10% of the nominal thickness. No pitting or vertical crack-like indications were detected in Plates #1, #2, #3, #4, or #5.

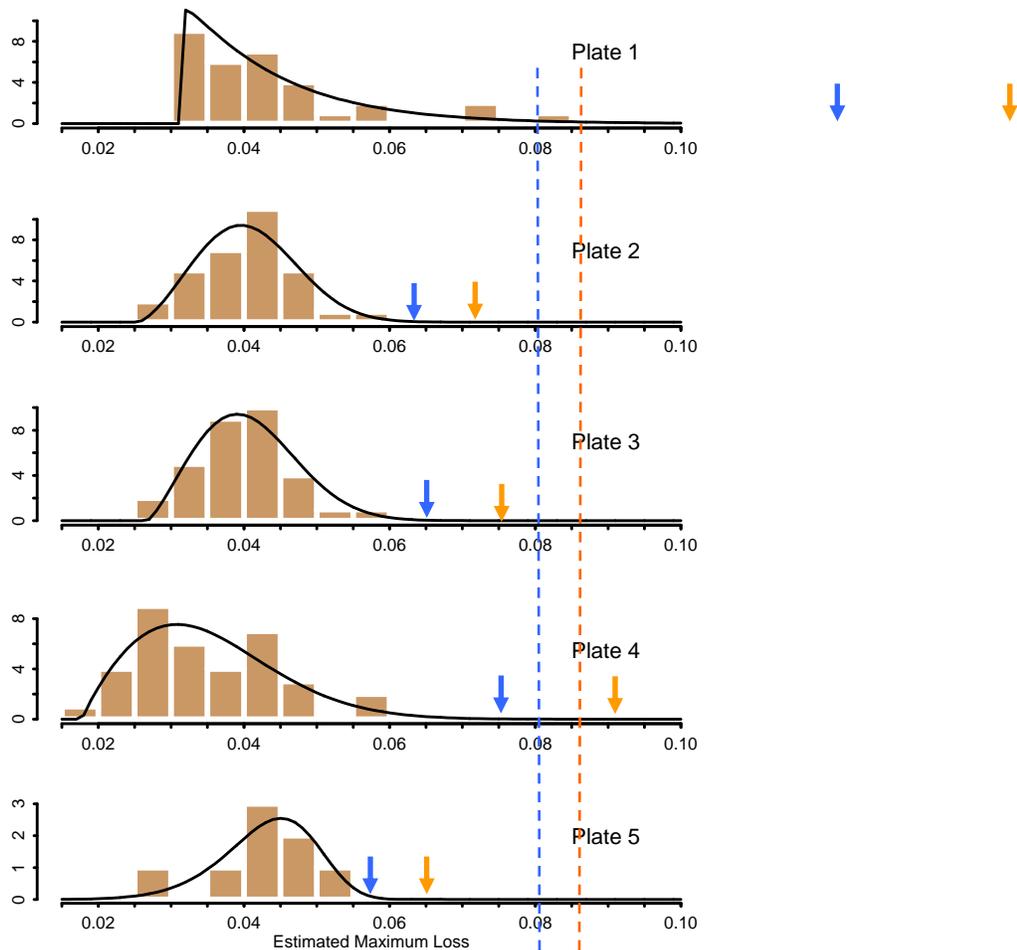
Figure 6.2. Weibull Distribution Fits to UT Maximum Wall Thickness Loss by Plate Course

The histograms in Figure 6.2 show such wall thickness loss data grouped by plate course. That is, the UT image maximum losses from the four paths, two per riser, within each plate course are combined. Three parameter Weibull distributions are fit to these histograms and are shown as the smooth curves. The total surface area of a plate course, and thus the number of 15-in. by 12-in. UT images needed to 100% inspect the plate course, is computed. The percentile of the distribution that then corresponds to the greatest expected loss among this many UT images, based on the distribution fit to the histogram, is

The values indicated by the arrows on the histograms are the estimated worst case losses per plate course (blue) and their associated 95% confidence bounds (orange). The corresponding values are given in the table shown in Figure 6.3. Included in the table are: 1) the number of measurements, 2) the estimated extreme value loss expected for the plate course around the entire circumference of the tank, and 3) the 95% confidence bound for the extreme loss for each plate and for a combination of the plate data. This combination is represented in Figure 6.2 by the blue and gold vertical dotted lines.

The Plate #5 estimate and bound are rather small relative to the largest measured values, since the distribution that was fit actually tails more to small values than to large values. This is likely due more to the modest number of measurements for this plate and not to differences in the actual wall thickness loss mechanism for this plate.

Note that the Plate #1 distribution fit is considerably influenced by the “pile-up” of measurements at the low end of the histogram and then the set of rather large outlying loss values larger than 0.070-in. In fact the usual convergence criteria for fitting the three-parameter Weibull could not be met in this case, and a “shift” parameter had to be specified rather than estimated. The magnitude of this shift parameter value, which actually addresses the left end of the distribution, has considerable impact on the length of the right-hand tail. This is unfortunate since the left-tail values then dramatically affect the extreme value estimates. In other words, the Plate #1 results are not well-modeled using the three-parameter Weibull, and the resulting quite large estimates are somewhat suspect.

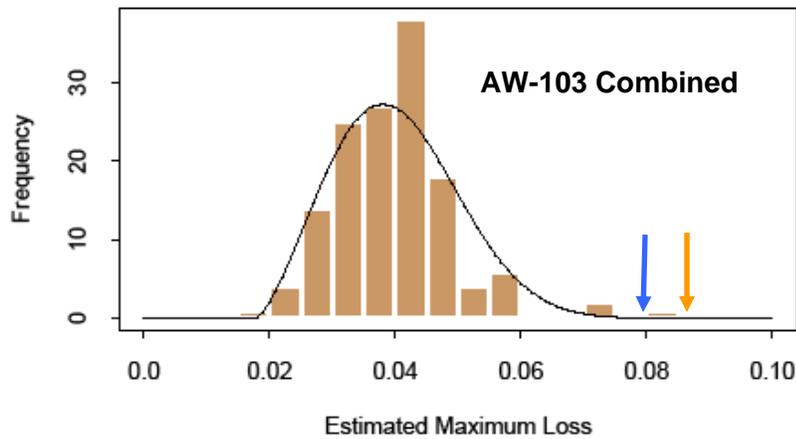
Figure 6.4. Weibull Distribution Fit to Maximum Wall Thickness Loss Combined over Plate Courses

If the three outlying values had not been obtained for Plate #1, there would be little reason to think the wall thickness losses are different from plate to plate, especially in the upper tail of the distributions which is the area of most interest in this extreme value estimation. Under the assumptions that the large outlying values are legitimate values, and not due to some special measurement problem, and that the large values could have just as well been obtained from the other plates, the wall thickness losses are combined across all five plate courses for Tank 241-AW-103 and shown both in the table in Figure 6.3 above and in the histogram in Figure 6.4.

The extrapolation out to a tail percentile for the combined data has to accommodate the entire surface area of the tank across all five courses and therefore goes out to a higher percentile of the distribution. The estimate and bound in this combined case are shown by the arrows in Figure 6.4 and by the vertical dotted lines in Figure 6.2. These values are proposed as the most reasonable extreme value wall thickness loss estimates for Tank 241-AW-103.

In this manner 0.080-in. is proposed as a worse case measured wall thickness loss if the entire surface of the tank walls were UT measured. But the uncertainty on this estimate results in a 95% confidence bound on the true worse case measured loss as 0.086-in. It is important to note that if these loss values were applied to determine a worse case remaining thickness, drawing nominal thicknesses would not be used as the original tank wall thickness, but rather the estimated wall thicknesses given in the table in Figure 6.1. And recall that for Tank 241-AW-103 these estimated nominal thicknesses from the UT maxima were about 0.030-in. to 0.040-in. greater than drawing nominal.

The Plate #1 results are somewhat disconcerting since the largest loss observed in these data does exceed the estimated extreme value, but at least it does not exceed the 95% confidence bound. If it is truly believed that a different corrosion mechanism could be affecting Plate #1 than affects the other plates, then the suitability of grouping the results across all five plates could be questionable. Insufficient data are available to defend a determination either way. As has been shown, if Plate #1 were treated separately, the poor Weibull fit results in much larger extreme value estimates.
