PNNL-22312

Targeted Energy Efficiency Expert Evaluation (E4) Report: Bannister Federal Complex Kansas City, MO

March 2013

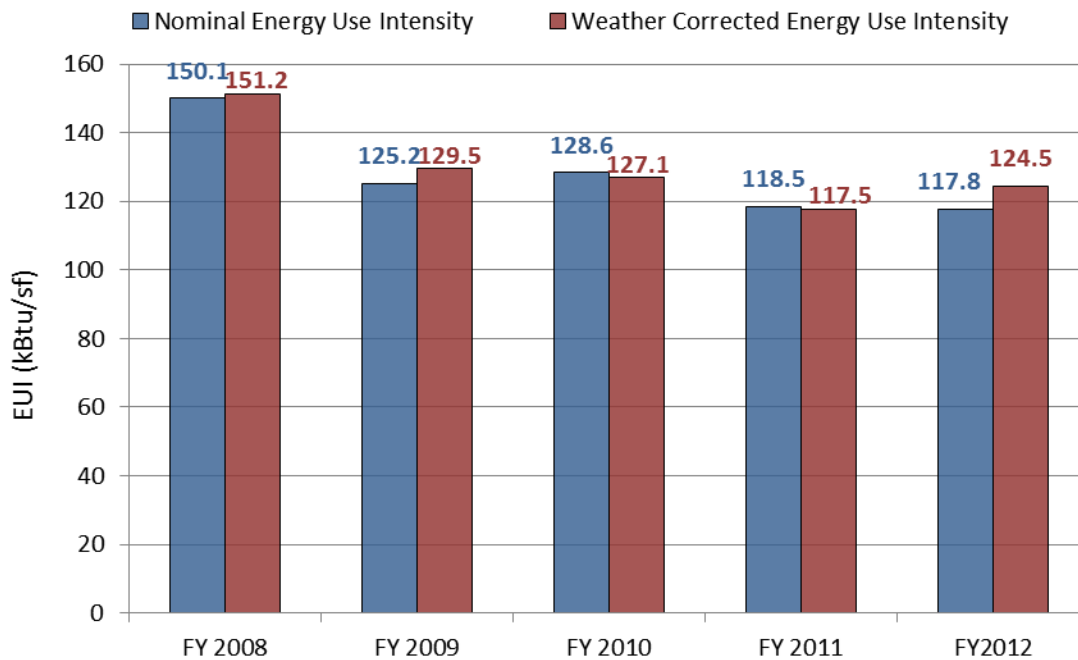
Figure 1. EUI History and Projections for Bannister Complex

Figure 1 shows a history of energy consumption at Bannister, using energy use intensity (EUI) as the metric for comparison. The chart shows the actual energy use intensity in blue, as well as the weather-corrected EUI in red. Since FY08, there has been a sharp reduction in energy consumption (22.3 percent in absolute terms, and 24.5 percent after correcting for weather). Toward the end of FY11, significant vacancies took place at Bannister. These vacancies affected the last three months of FY11, and from October-December 2011 they were responsible for 2.2 percent of the overall 9.0 percent savings compared to FY11. FY12 is the first full year after these vacancies occurred, and continued reductions in energy consumption were expected as a result. On top of reduced energy use due to vacancies, PNNL estimated 3-4 percent additional total building energy savings from the implemented Targeted E4 measures. The vacancies and energy measures, unfortunately, did not result in a complex-wide reduction in utility-metered energy consumption in FY12. Based on differences in weather alone, energy consumption should have dropped 6 percent (estimated) from FY11 to FY12, but instead it dropped only 0.6 percent. Thus, there are unknown factors that have been responsible for negating the otherwise positive impacts of vacancies, energy conservation measures and more favorable weather in FY12.

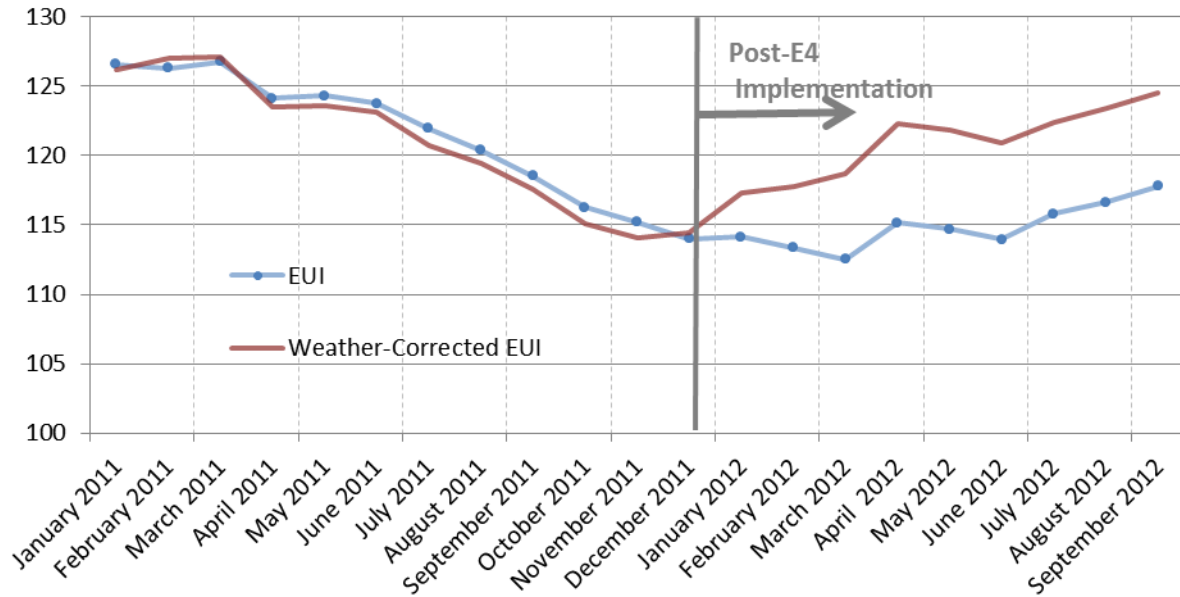
Figure 2. EUAS (Utility Bill) Analysis- Rolling 12-month EUI since January 2011

Figure 2 shows that rather than an energy savings being evident from utility billing data, the site appears to have increased its energy consumption significantly. Energy consumption trends, especially in steam and chilled water, metered at the nearby DOE facility have been unreliable for the last several years, and this year was no exception. It was expected that even without the Targeted E4 improvements, the energy consumption would continue to decline in FY2012 as the effects of recent office vacancies from July 2011 manifested in each month of FY2012 up to July. This was not the case. Steam consumption has increased 8.5 percent relative to FY2011 since the Targeted-E4 December visit (28.4 percent weather-corrected), and chilled water has increased 22.9 percent relative to FY2011 (1.1 percent weather-corrected). However, electricity use decreased by 10.9 percent (13.6 percent weather-corrected). But electricity, accounts for only 25 percent of Bannister’s site energy consumption. The implemented Targeted-E4 measures were expected to result in a modest 3-4 percent site energy savings. The much wilder swings in the three utility meters indicate that the “signal-to-noise” ratio is far too low to make any useful conclusions about Targeted E4 effectiveness. The Continuous Monitoring Plan may serve as a better tool to gauge the effectiveness of the measures, even if their energy savings cannot be verified quantitatively.
