PNNL-22553

Final Assessment of Manual Ultrasonic Examinations Applied to Detect Flaws in Primary System Dissimilar Metal Welds at North Anna Power Station

March 2014

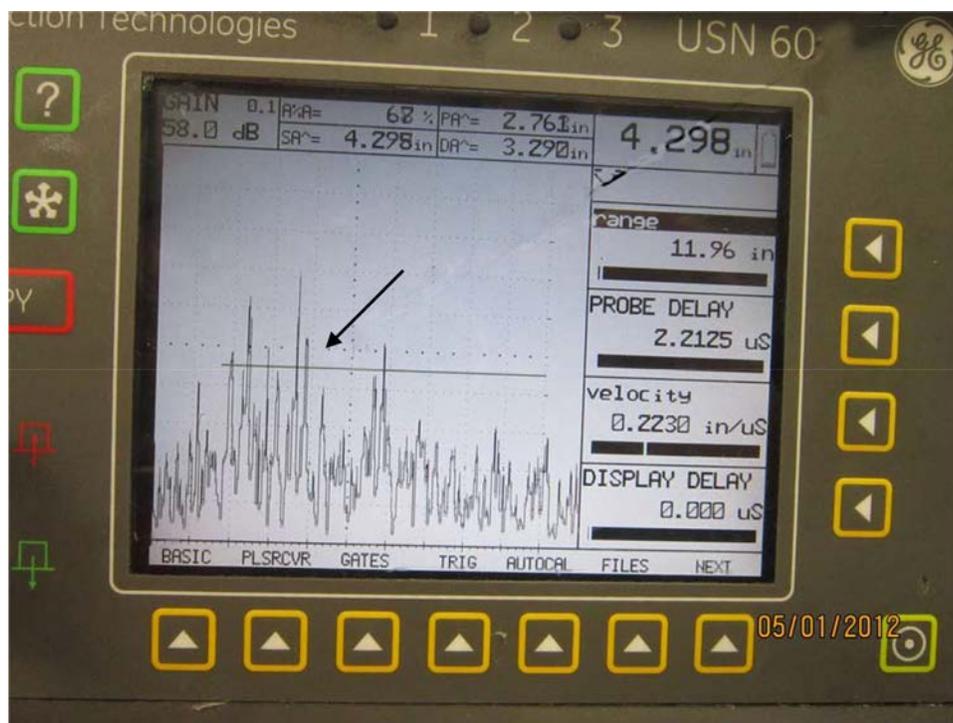
Figure 4.2. Mid-wall Fabrication Flaws or Implantation Artifacts Detected in NAPS-1 Mock-ups (as indicated by the arrow)

As a general observation, one would expect fewer inadvertent fabrication flaw, or implantation artifact, signal responses to be present. The UT responses from these imperfections impede detection and characterization of the axial flaws as cracks. Based on the site observations using the tandem probe configurations, there are many transient indications detected on the NAPS-1 mock-ups that interfere with targeted flaws; this makes it especially difficult for one to unequivocally determine the effectiveness of the inspection system to detect cracks. The placement of the axial flaws, in relative proximity to the locations of the circumferential flaws in these mock-ups results in challenging detection conditions because of implantation or fabrication artifacts.

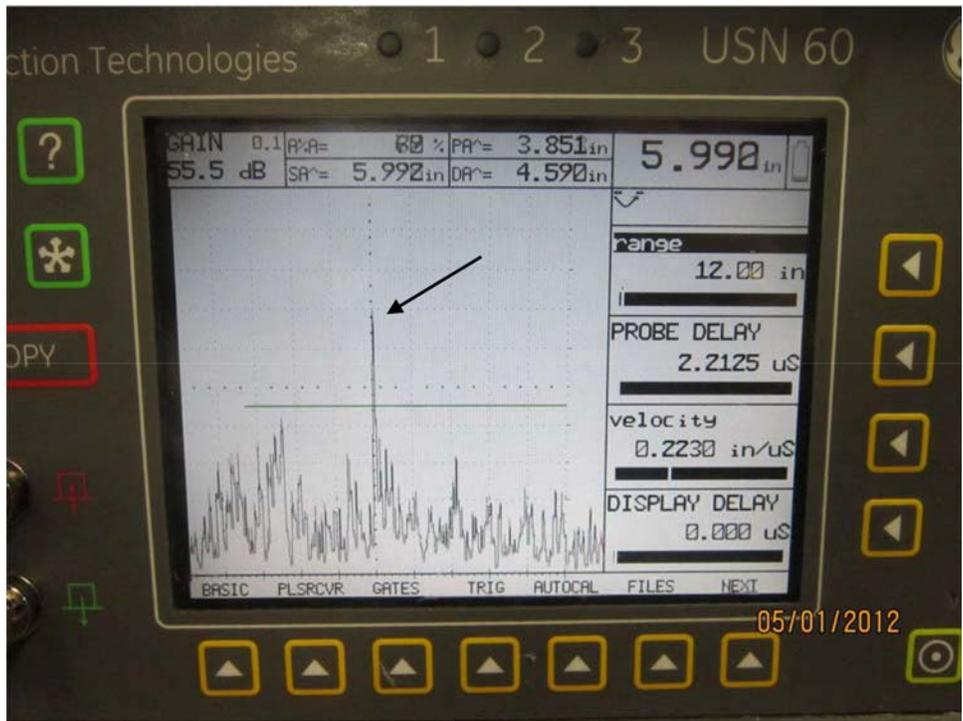
This mock-up has one axial flaw that is reported to be approximately 32% in through-wall depth. The flaw was ultrasonically located in near proximity to the side-drilled holes (SDHs) with the “LR” probe at a 2:1 signal-to-noise ratio (SNR). This flaw was also detected in the opposite scan direction with the “RR” probe, but with much less than a 2:1 SNR. Several other mid-to-upper wall ultrasonic responses were observed along the weld length; these are potentially welding fabrication or, based on the location detected, implantation artifacts from circumferentially oriented flaws in the mock-up. The presence of these “spurious indications” in near vicinity to axial flaws is somewhat unusual for a demonstration mock-up and makes manual UT detection more challenging, even when the locations of the targeted axial flaws are known. Figure 4.2 provides an example of the A-scan results showing typical mid-wall indications. Figures 4.3 through 4.6 provide additional pictorial support of the discussion in this section.

Figure 4.3. DM-05 32% Through-Wall Axial Flaw with LR Probe

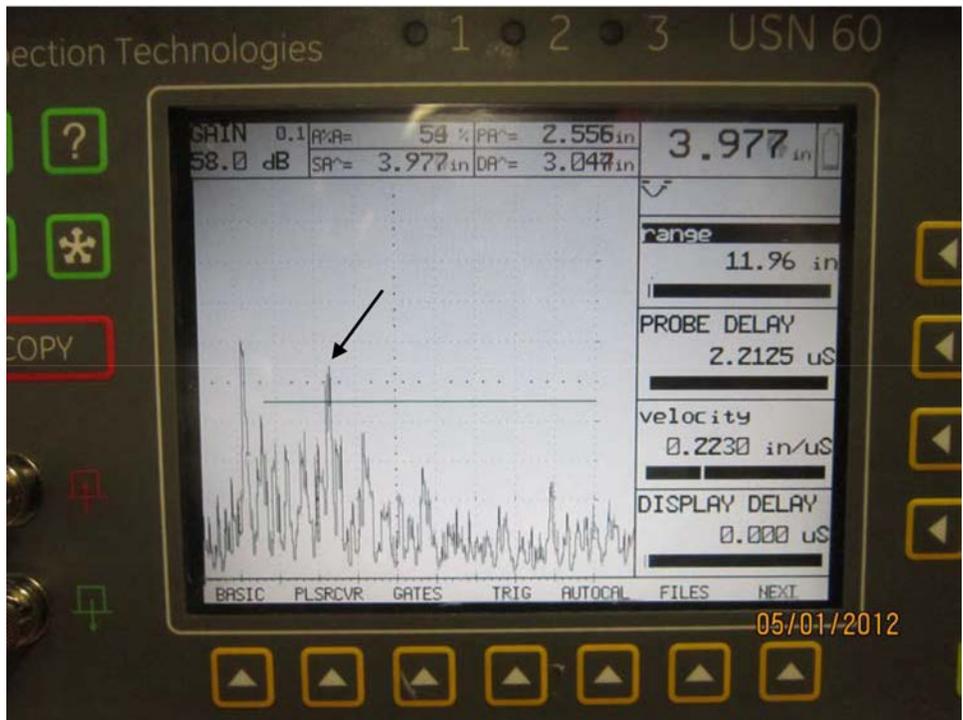
Figure 4.4. DM-05 Fabrication/Implantation Flaws

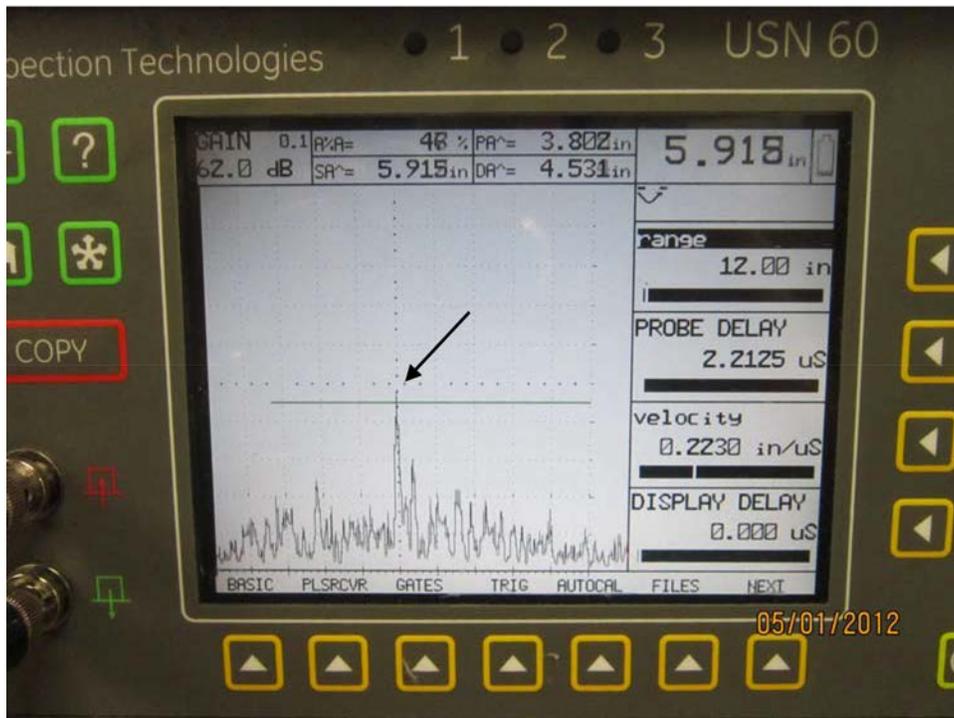
Figure 4.6. DM-05 End-of-Block through Weld

The end-of-block response from the mock-up, which represents a 100% through-wall smooth reflecting surface, was very easy to detect when scanning from the wrought safe end, but exhibited a significantly lower response when scanning through the weld material. In addition, the UT response from the end-of-block appeared to be slightly shifted out in time, indicating that the weld microstructure may be re-directing the primary sound beam “upward” or at a higher inspection angle. There was a noticeable difference in sensitivity between the LR and RR tandem probes—this was on the order of 4 to 6 dB—and each set of probes exhibited a high-pitched “whining” sound. It should be noted that this repetitive “whining” noise occurred while exciting the probes with the USN60 in the “High” square-wave mode setting (while at North Anna and during assessments at PNNL). The USN60 contains two square wave mode pulser voltage settings – high and low. The USN60 low voltage setting was not applied, as this evaluation was aimed at assessing the field operation at NAPS-1. However, when lower voltage settings were subsequently applied to the tandem probes using instrumentation at PNNL, no audible “whine” was observed.

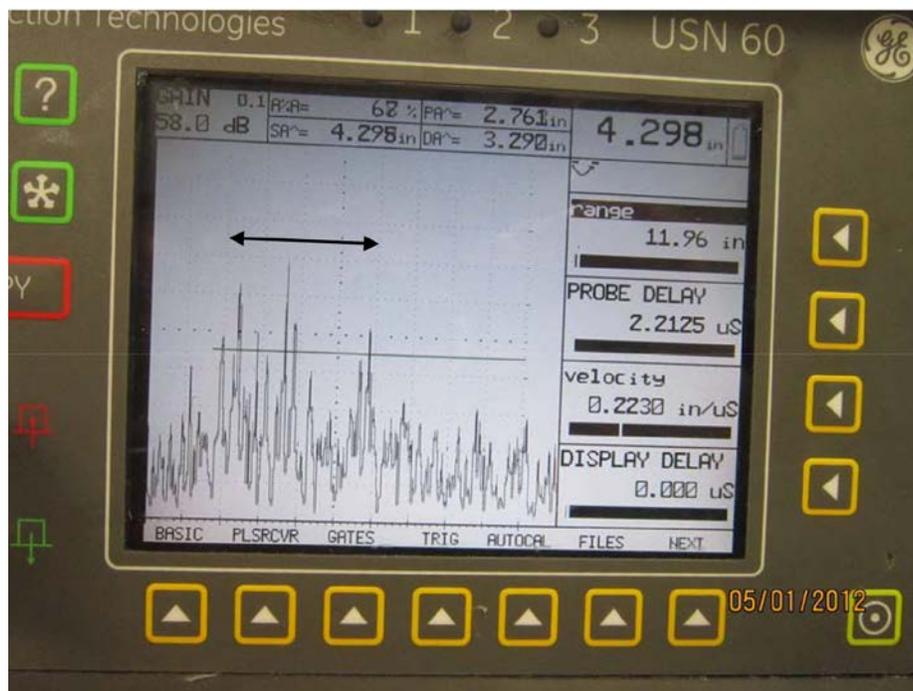
Two axial flaws were detectable with the LR probe (less so with RR), and the SNRs were poor. Each pair of tandem probes required careful manipulation (skewing) to approach a SNR of 2:1. Many larger fabrication/ implantation artifact responses were observed in DM-10 in contrast to those observed in DM-05; these were also found in the near vicinity of the axial flaw locations. The end-of-block response appeared somewhat higher in amplitude through the weld, which could indicate that the weld microstructure varies between DM-05 and DM-10. Figures 4.7 through 4.9 provide additional pictorial support of the discussion in this section.

Figure 4.7. Assumed DM-10 Fabrication/Implantation Flaws (shown within time base depicted by arrows)

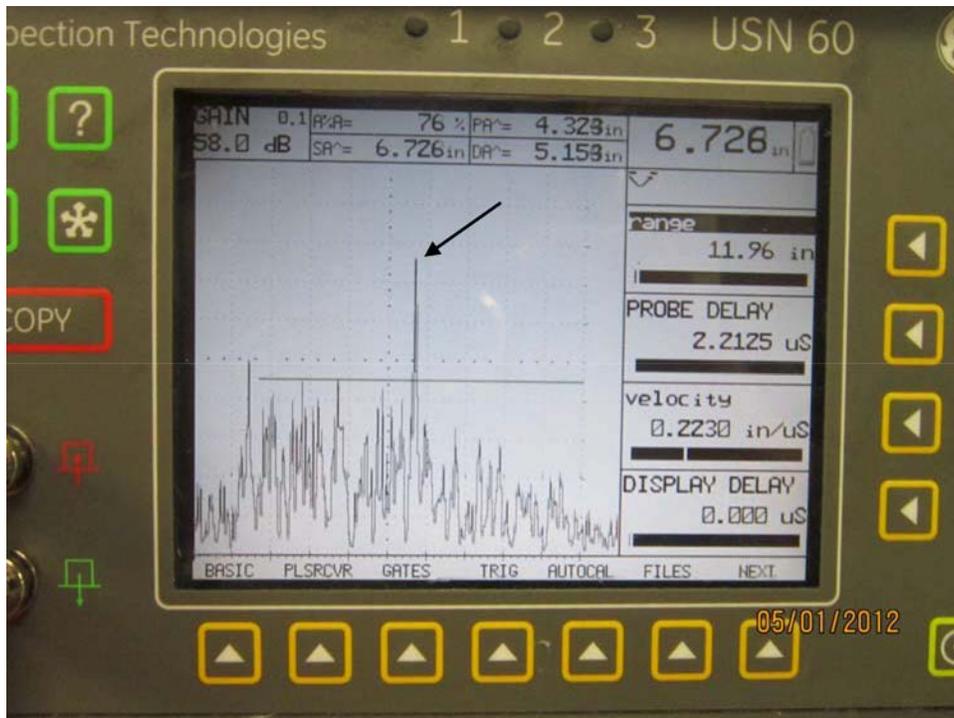
Figure 4.9. Assumed DM-10 51% Through-Wall Axial Flaw with LR Probe

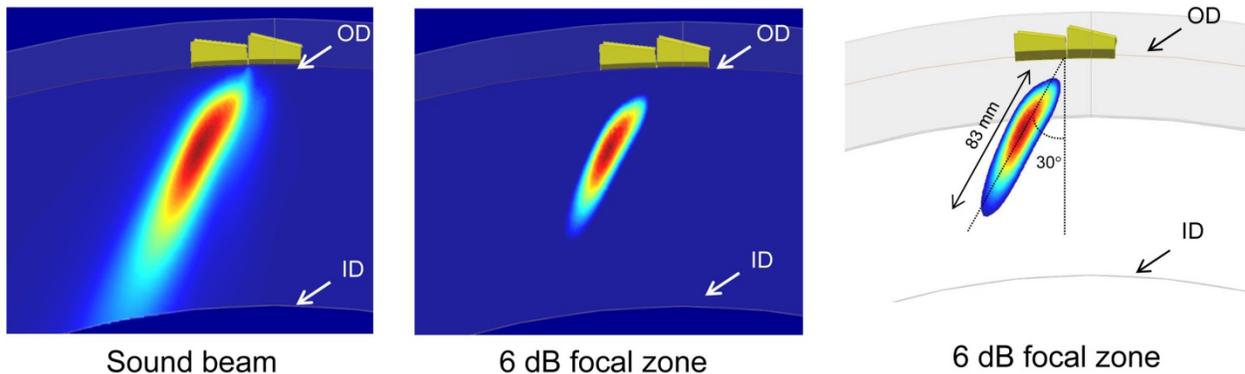
Sound field simulations showing the acoustic beam density generated by the tandem probe as modeled with the CIVA 10.1 software suite are displayed in Figure 5.5. CIVA was chosen for these simulations as this software platform supports a tandem probe configuration whereas UltraVision 3 [the software chosen to depict theoretical PA transmit-receive (TR) probe sound fields] does not as yet have this capability (see Section 6.0 of this report). As depicted, simulated sound field energy increases from blue to red. The left image shows an unfiltered sound beam in the specimen; OD and ID surface locations are indicated. The middle image has a -6 dB filter (50% amplitude threshold) applied that highlights a -6 dB focal zone. The right-most image in Figure 5.5 has the same -6 dB filter applied, but without the full computational zone visible, emphasizing the insufficient extent of the -6 dB focal zone (or high intensity sound field expected to produce 2:1 signal-to-noise ratios) to reach the desired specimen ID surface region. The model indicates that this probe configuration produces refracted longitudinal mode ultrasonic energy at a transmitted angle of $30(41)$ degrees, with the maximum value of sound field intensity located at 44 mm (1.73 in.) from the OD along the metal path. The -6 dB focal zone length along the metal path is 83 mm (3.27 in.) or only 56% of the entire through-wall metal path. The required metal path at $30(41)$ degrees to reach the ID is approximately 148 mm (5.83 in.).

Figure 5.5. Sound Field Simulations and -6 dB Filter

By applying a -12 dB filter, the simulated sound field was projected to the specimen ID, and indicates the sound field energy to be substantially diminished in strength. A drop of 12 dB from the maximum sound intensity is a ratio of approximately 4:1. Therefore, only about 25% of the maximum beam intensity is predicted at the ID surface; this is optimistic, given the anisotropic nature of the weld microstructure. This reduced field intensity also predicts a poor signal-to-noise level for detection of ID surface-connected flaws via corner-trapped responses. These results suggest the tandem probe may potentially be suited for detection of specular or tip responses from flaws in the outer 60% of the material (which has only been modeled as a simple isotropic media), but is extremely limited for detection of ID-connected flaws in this specimen configuration.

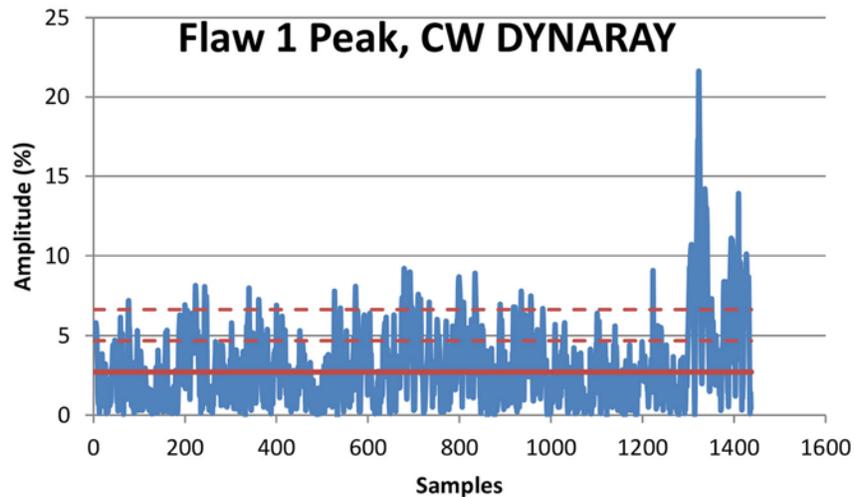
Figure 5.13. DM-05 Axial Flaw 1 Peak Response with the Tandem CW Probe. The average noise level is noted by the solid red line and the average +1 σ and average +2 σ noise levels are noted by the dashed lines.

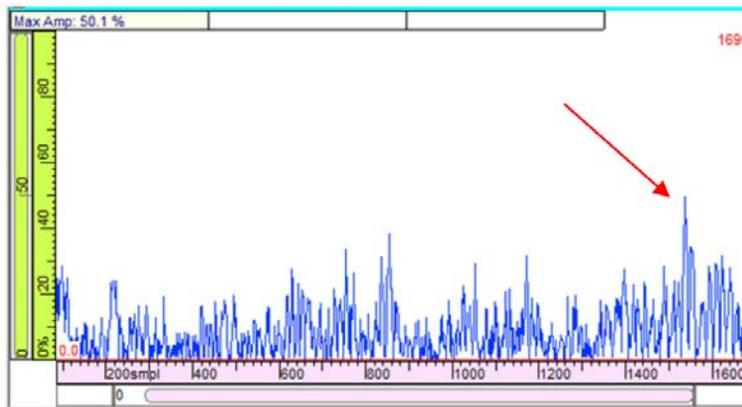
In a manual non-encoded examination, the operator observes the UT instrument screen and, in real time, assesses transient reflections while assuring the transducer is being properly manipulated; thus, a peaked reflector response may not be observed during successive manual scan paths. There can also be significant changes in the A-scans over small changes in probe position. For example, Figure 5.14 shows the data from flaw 1 at a scan position that was incremented by two samples [or 2 mm (0.08 in.)]. This response has a peak-to-mean SNR of 15.5 dB and a peak-to-peak SNR of only 2.1 dB. This response was more typical of the manual data presented in Section 4.0 where SNRs were reported to be at best 2:1 or 6 dB. Figure 5.15 shows the A-scan data with added horizontal lines for the mean, mean +1 σ and +2 σ . The SNR at the mean +2 σ level was 3.3 dB.

Figure 5.14. DM-05 CW Tandem Probe, Axial Flaw 1 Response at a Scan Position 2 mm (0.08 in.) from the Image Peak Response. The arrow marks the flaw response in the A-scan.

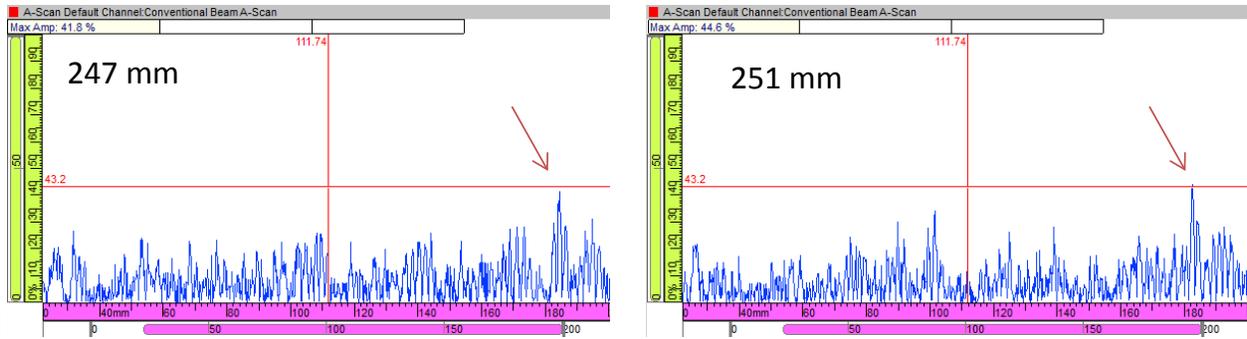
If the signal persistence is instead measured at a relatively higher amplitude level [-3 dB, or about 70% (43% FSH) of the peak flaw response] as displayed in Figure 5.18, the flaw end points are 247 and 251 mm (9.72 and 9.88 in.) for a 4-mm (0.16-in.) scan persistence. At this level, the flaw signal is detectable above the peak noise. However, at this persistence value, the flaw response is highly transient. Regardless of the amplitude one chooses for assessing flaw detection, at any value above the 50% (-6 dB) points, the flaw persistence, as measured in scanning time, is noted to be only a fraction of a second. As shown by laboratory measurements, and assuming a typical manual scan rate of 50.8 mm/sec (2.0 in./sec), flaw persistence for Axial Flaw 1 only equates to approximately 0.51 or 0.08 seconds, based on a 50% or 70% amplitude threshold level, respectively. This extremely short time window (persistence) for a flaw response to be observed during a manual scanning operation would not be expected to afford adequate or reliable detection.

Figure 5.18. Responses at 71% Amplitude Level (-3 dB)

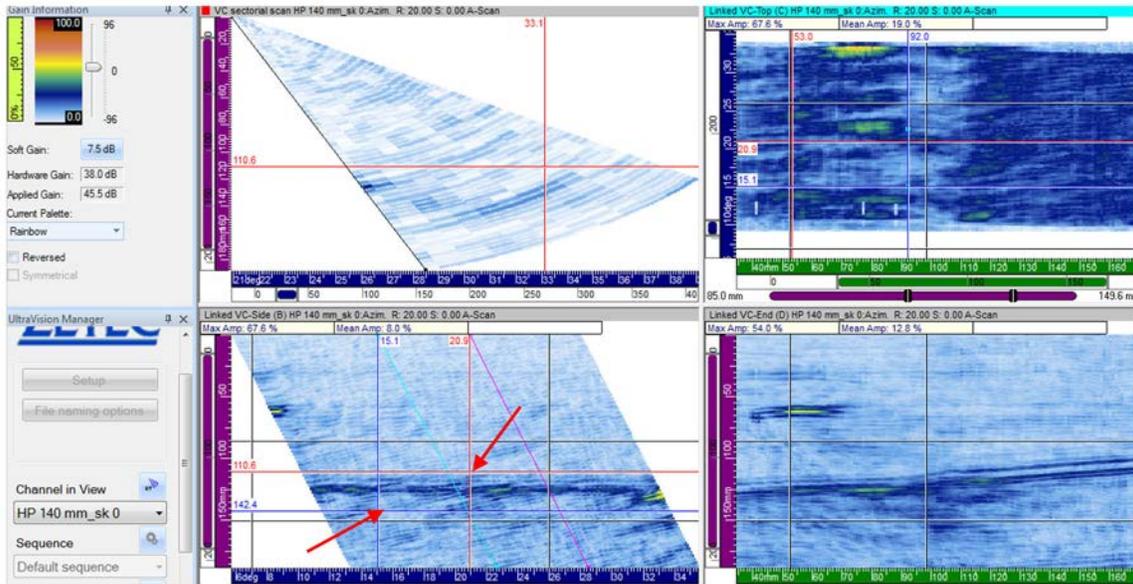
Figure 6.12. DM-05 B-scan Side View (bottom left) Outlines a Region for Circumferential Flaw 3. The response levels in this region are comparable to the baseline noise levels indicating no observed artifacts from the flaw implantation. Red arrows point to corners of the subject region.

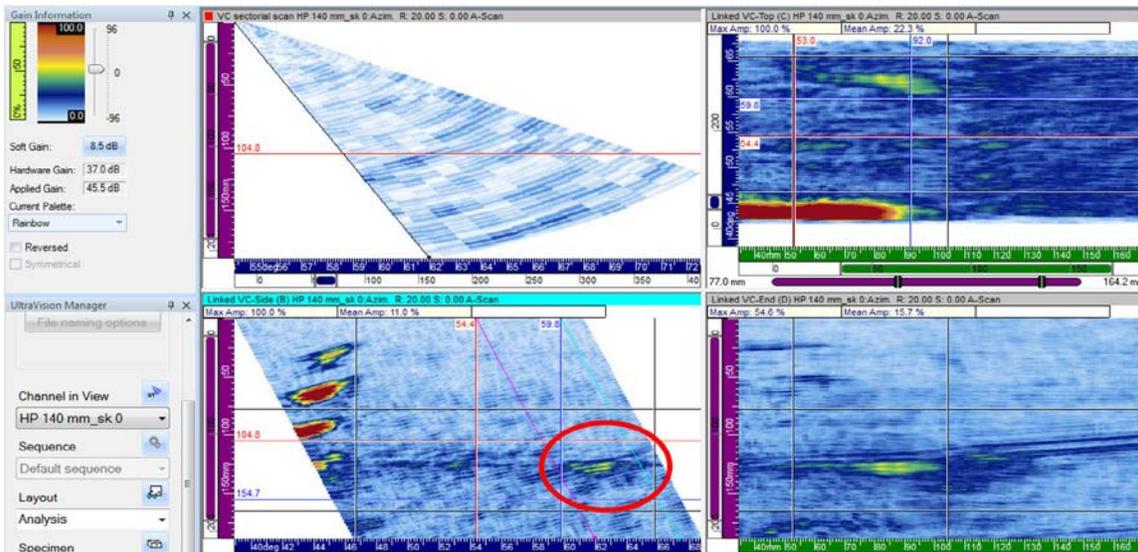
An artifact, however, was detected at approximately 62 degrees and is shown within the red circle in Figure 6.13. The peak response from this signal is 32.5%, which is approximately 20% above the baseline noise level and the signal also displays a broader response (in depth or time; i.e., more cycles in the reflected A-scan) than the noise seen in Figure 6.12. Circumferential flaw 4 is located at 54 to 60 degrees so this artifact is only 19 mm outside of the reported flaw region which is less than 1% circumferentially. While the characterization of this artifact is unclear using the 0.5-MHz data, the closer proximity of implantation artifact-to-flaw distances seen around other flaws would indicate that this may be a coincident welding fabrication flaw, but is more likely an unintended flaw from the circumferential flaw implantation process.

Figure 6.13. DM-05 B-scan Side View (bottom left) Displays an Artifact (circled) at Approximately 62 Degrees, Circumferential Flaw 4

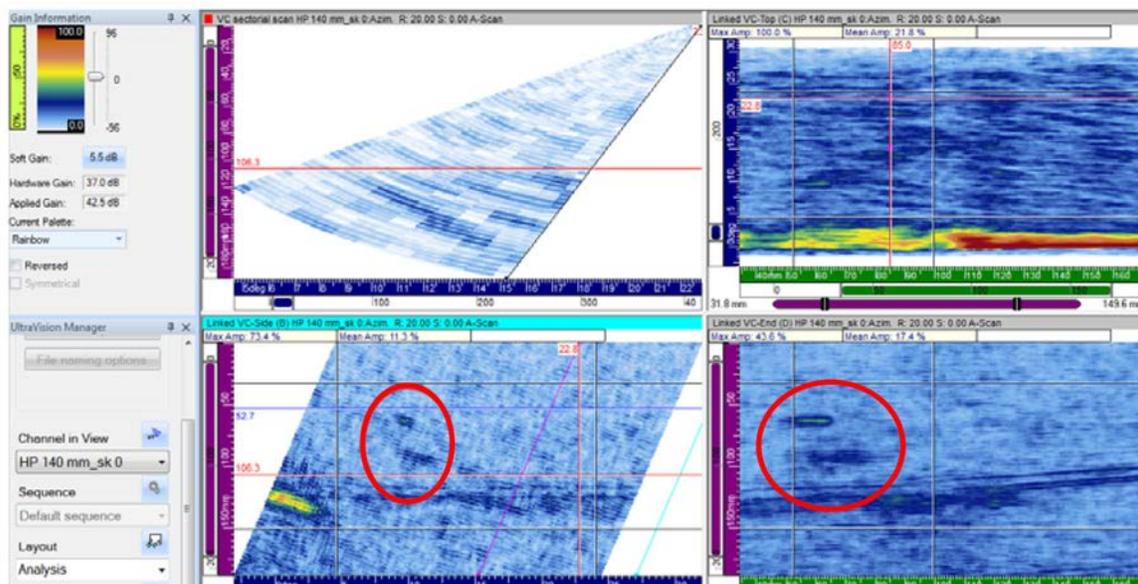
Figure 6.17. DM-05 CCW B-scan Side View (bottom left) and D-scan End View (bottom right) Show an Implantation Artifact at 10 Degrees (circled), Likely from Circumferential Flow 3

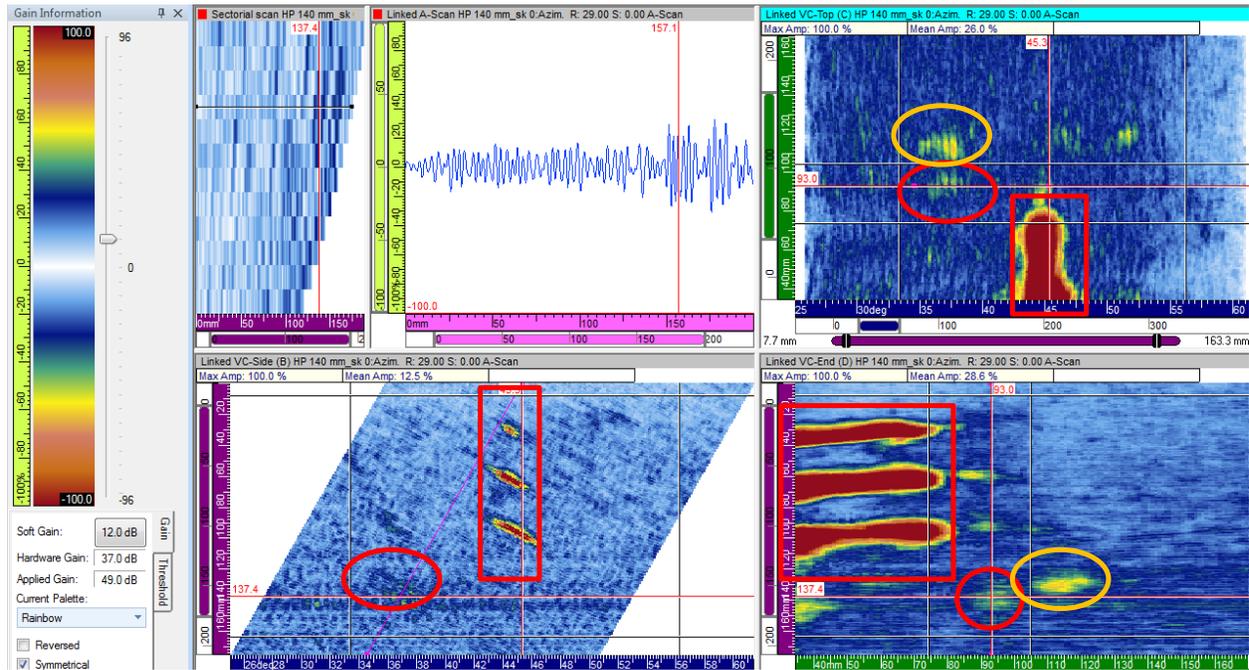
Figure 6.26. Mock-up DM-05 Axial Flaw 1 (circled in red), Three SDHs (boxed), and Artifact (circled in orange) that Extends into the Safe End Region. The scan is in the CCW direction with a 0-degree skew and half-path focusing at 140 mm (5.51 in.).

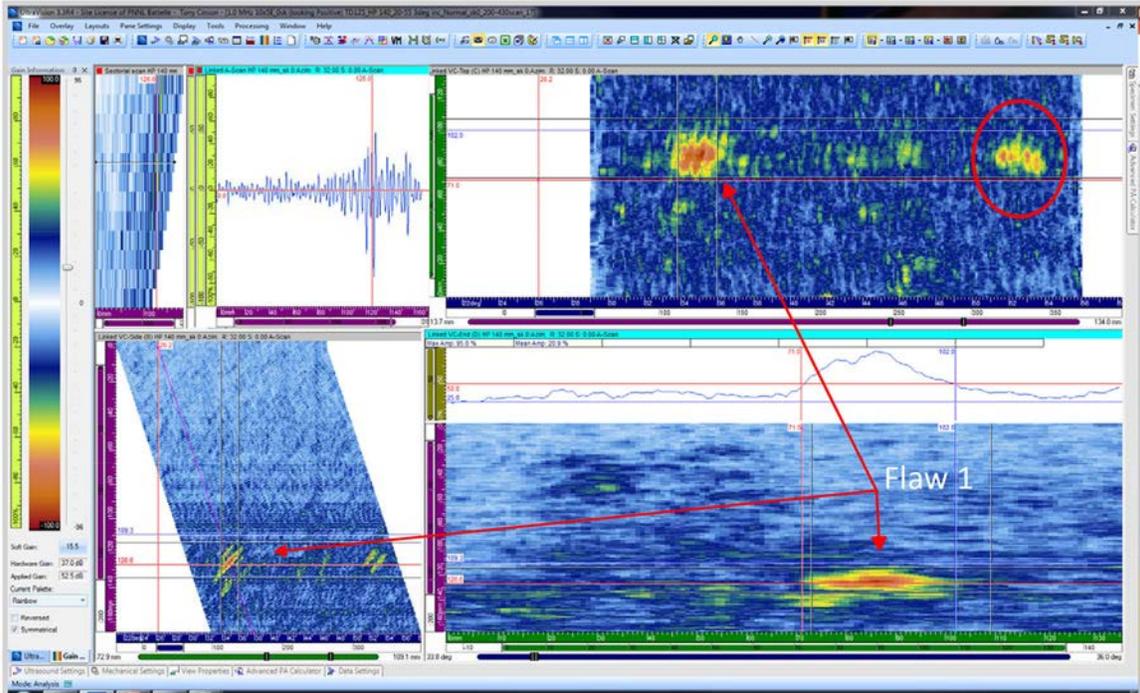
Figure 6.27. DM-05 CW Skew 0 View of Axial Flaw 1 Region with Implantation Artifact from Circumferential Flaw 4 Circled in Red

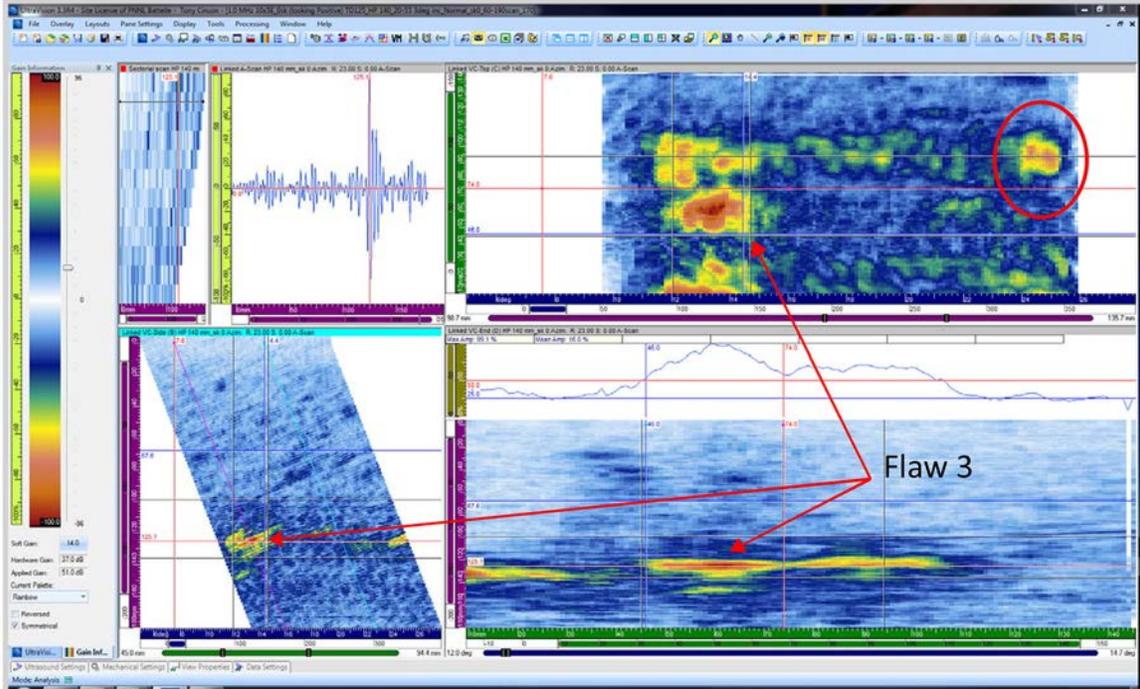
Figure 6.28. DM-10 CW Skew 0 View of Axial Flaw 3 Region with Bonus Indication Circled in Red

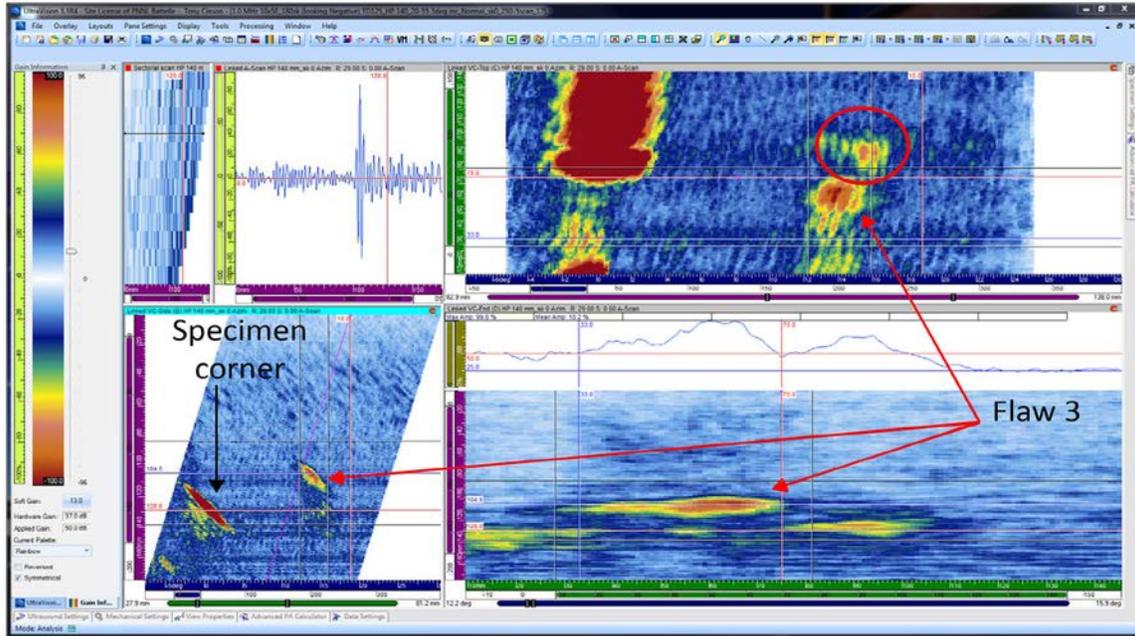
Figure 6.29. DM-10 CCW Skew 0 View of Axial Flaw 3 with Artifact Circled in Red

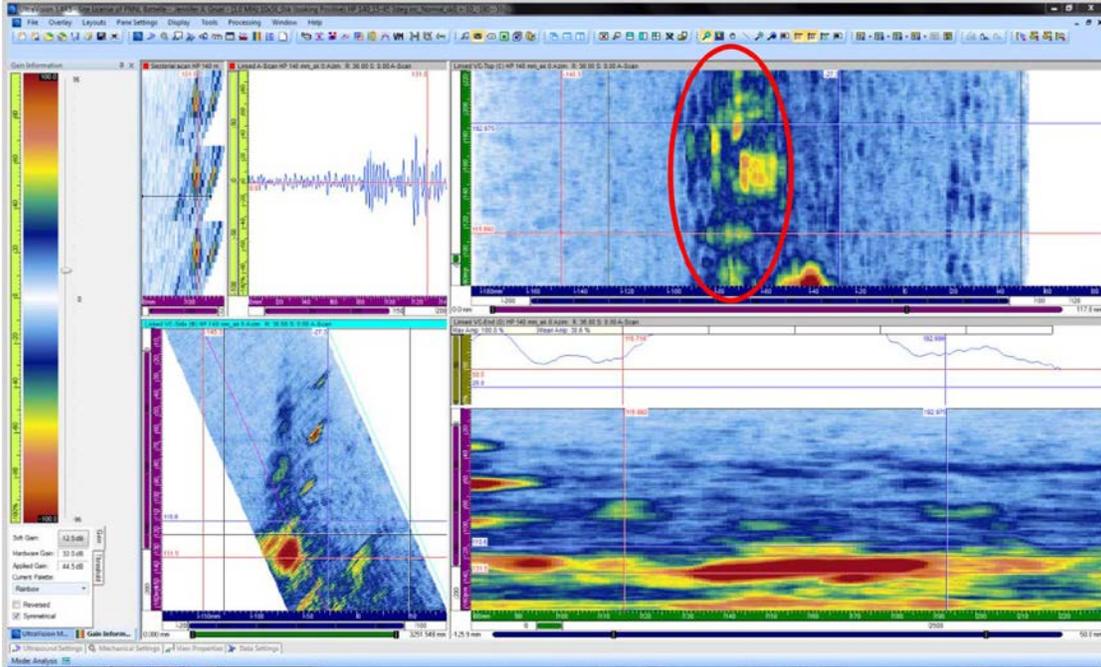
Figure 6.30. Skew 0 View of DM-05Weld Region Indications Adjacent to Circumferential Flaw 3 (all circled in red)

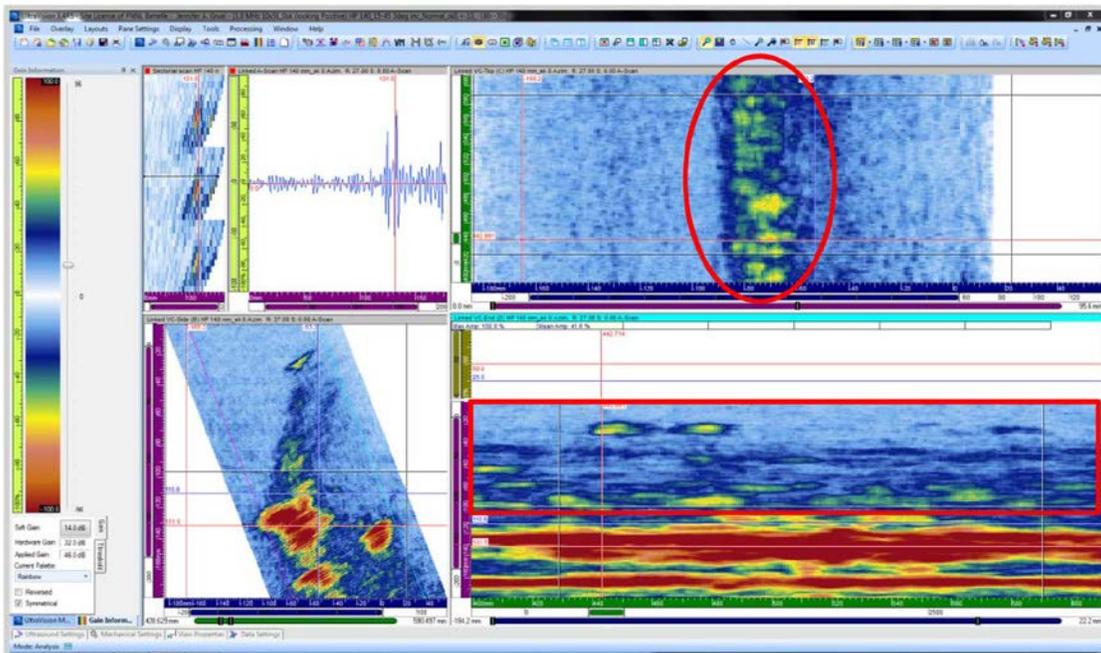
Figure 6.31. Skew 0 View of DM-05 Weld Region Indications Adjacent to Circumferential Flaw 4 (all circled/boxed in red)

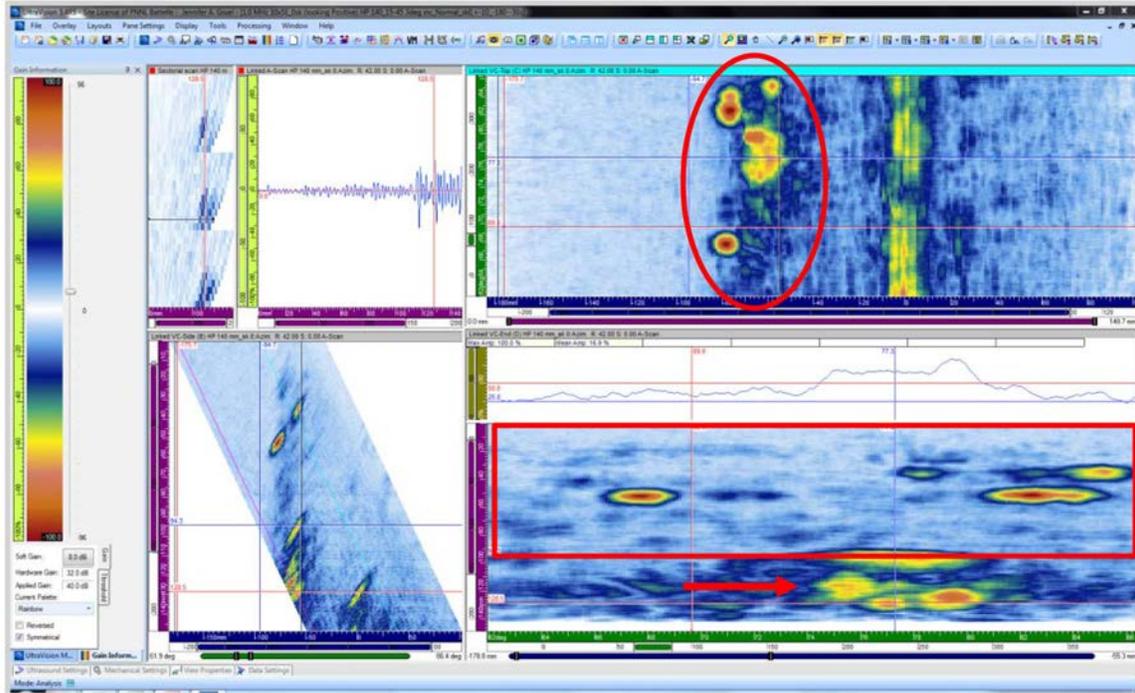
Figure 6.32. Skew 0 View of Axial Flaw 4 DM-10 (red arrow) with Weld Region Indications Circled/Boxed in Red

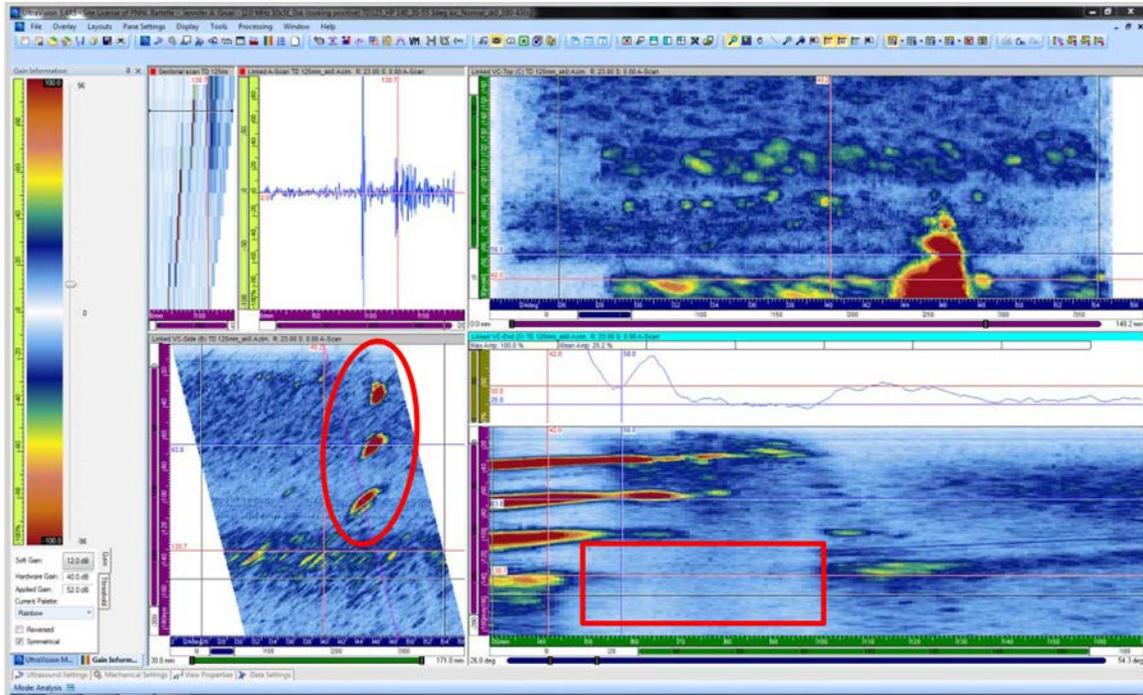
Figure 6.34. Mock-up DM-05 Axial Flaw 1 Region (flaw not detected) and Three SDHs Circled in Red with a TD Focus at 125 mm (4.92 in.). The scan is in the CW direction with a 0-degree skew. ID weld region is boxed in red.

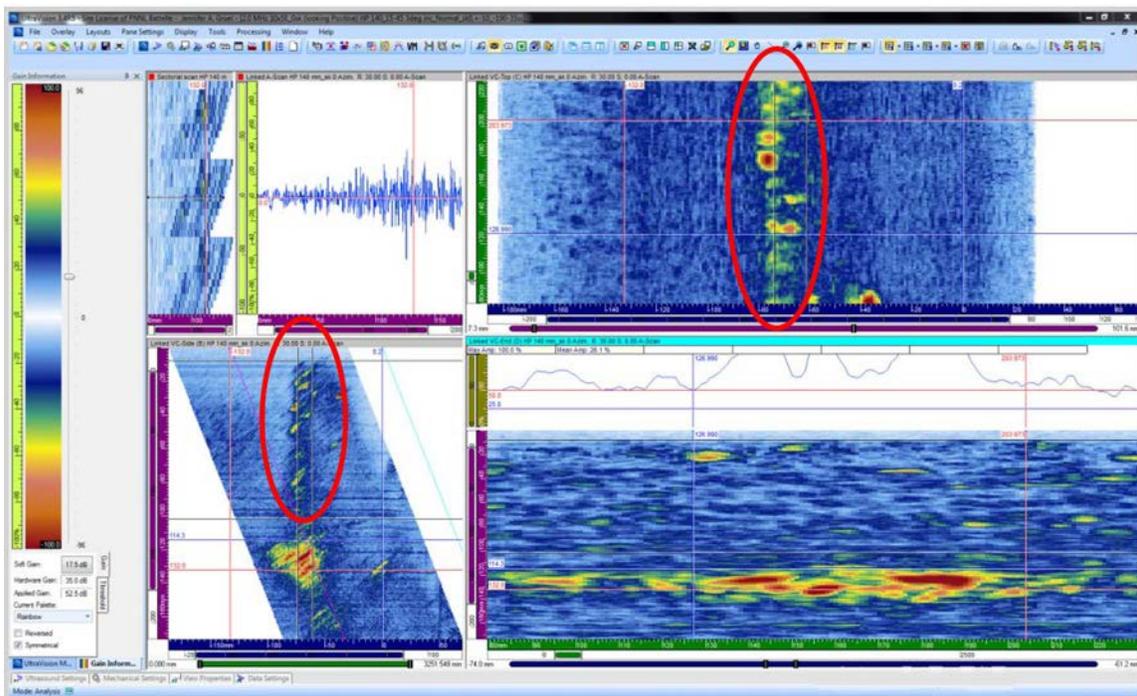
Figure 6.37. Looking Positive Skew 0 View of Circumferential Flaw 3 DM-05 (indicated by red arrow) with Weld Fabrication Flaws Circled in Red

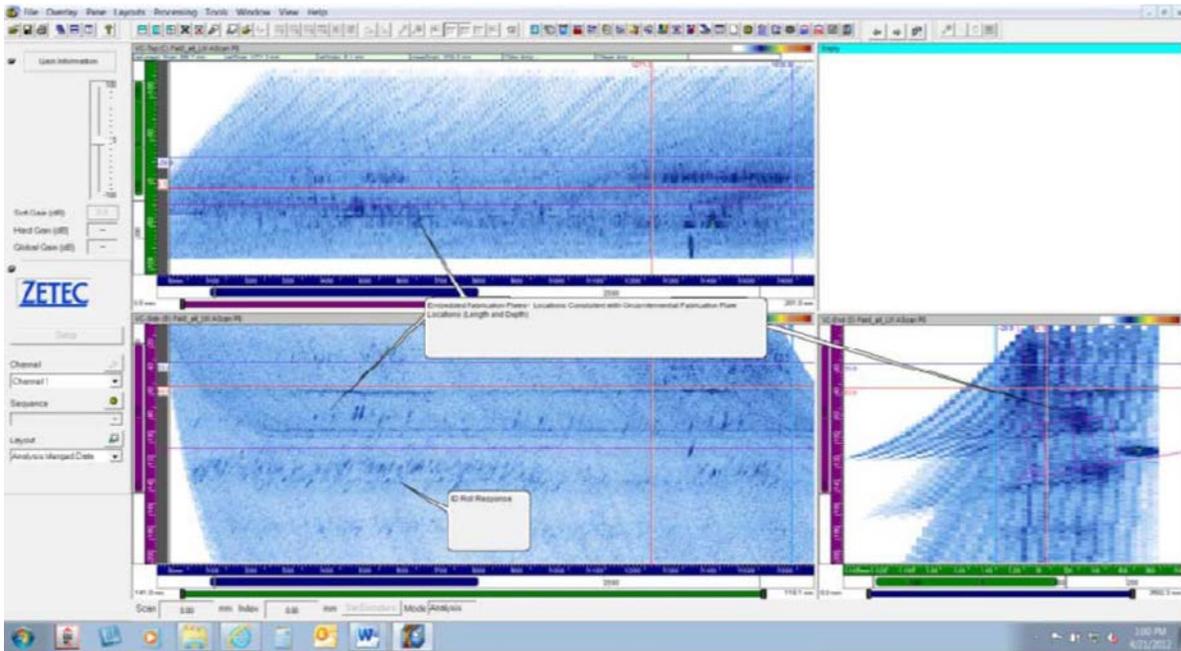
Figure 6.43. Circumferential Scan Data from a Field Weld – “Weld Noise” Noted

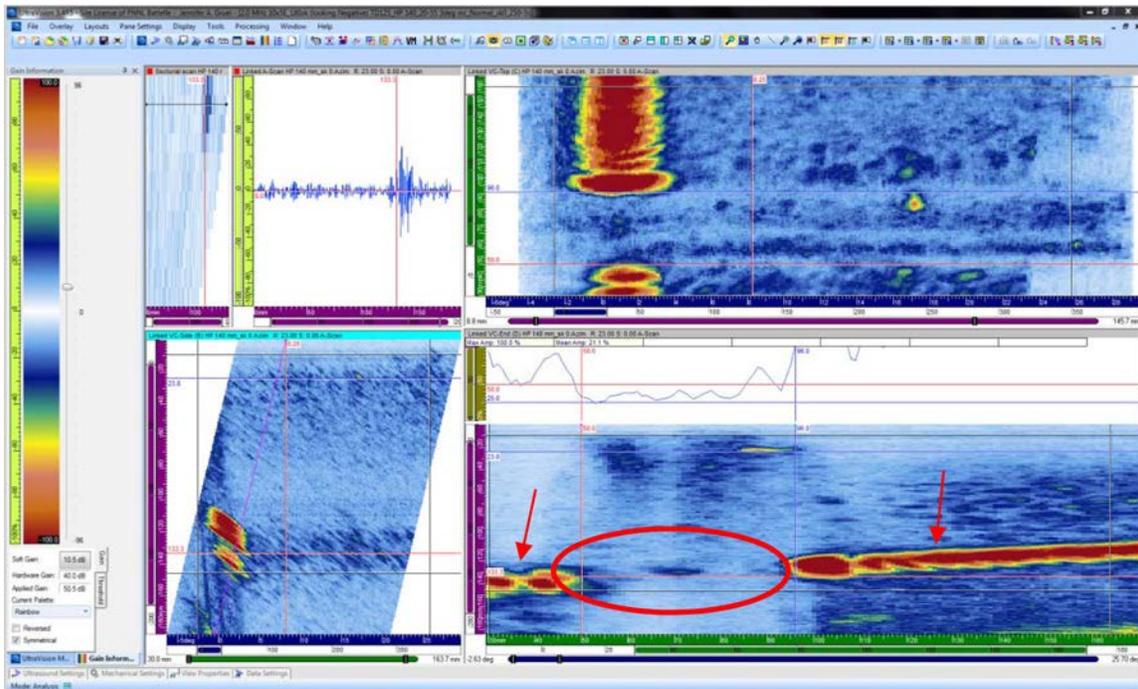
Figure 7.1. DM-10 CCW, Skew 0, Half-path Focus. End-of-specimen is visible in the axial Flaw 3 region and is noted by red arrows. Lack of specimen corner response in the weld is circled in red.
