**Pacific Northwest
National Laboratory**

Independent Review of Tank 241-AY-101 Fitness for Service

February 2003

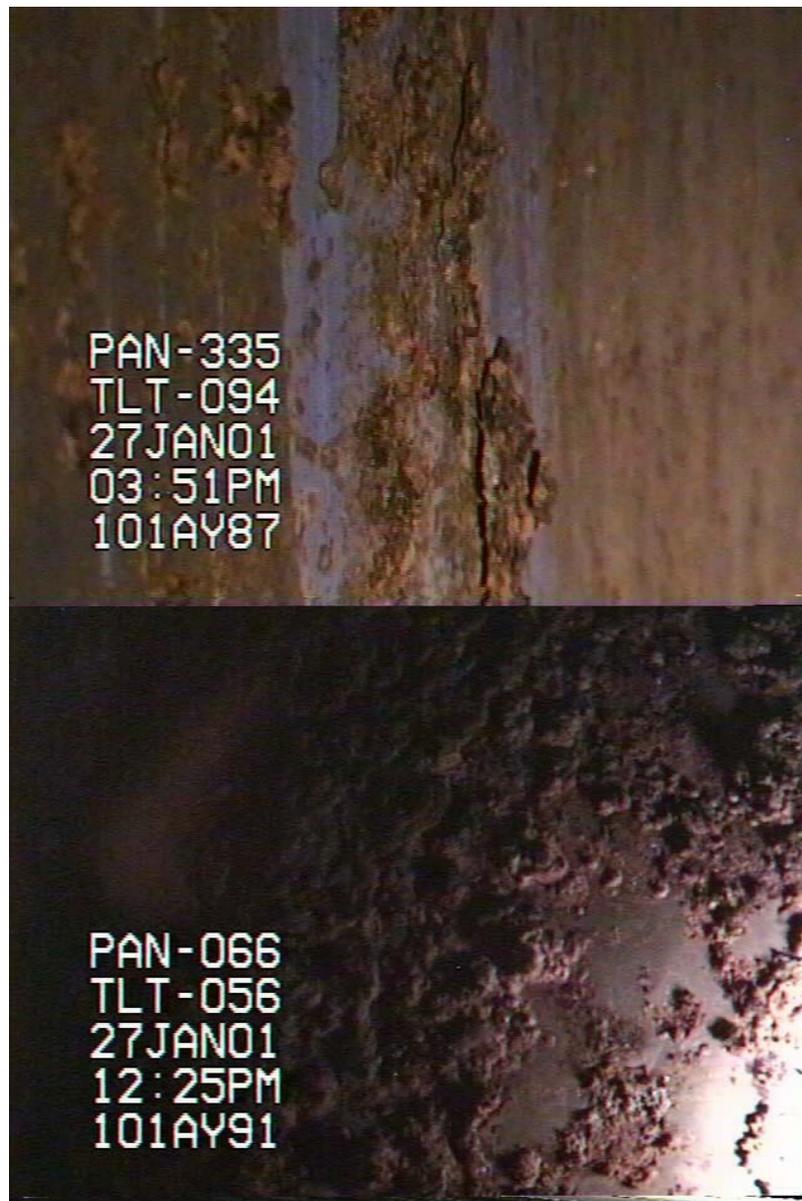
Figure 2.1. Examples of Annulus-Side Corrosion Appearance

This prompted further video inspections in January and February 2001 that revealed extensive and visually severe annulus-side corrosion on both the primary and secondary walls. Examples of this corrosion are shown in Figure 2.1. Corrosion was also observed on the interior of the primary tank, particularly in the historic "waterline" region between the 320- and 360-inch elevations where the waste level had remained for most of the tank's 30-year history (Appendix A, Section A.4 identifies the waterline bands). Figure 2.2 shows primary side corrosion.

Observations and analyses indicated that corrosion on the annulus walls was the result of a water intrusion occurring when annulus ventilation was not available to remove it. The annulus ventilation system was shut down with the inlet dampers closed for about 10 years, from 1992 to 2001. When operating, this system is capable of evaporating water at a relatively high rate and should have kept the annulus dry, even with a sizeable intrusion (Anantamula et al. 2001; Berman 2002). After the annulus ventilation system was restored in April 2001, a psychrometric analysis showed that more water was exiting in the annulus exhaust than was pulled in with the outside air. This led to the conclusion that there was a water intrusion into the annulus area from a service water system leak or precipitation runoff. Besides wetting the walls directly, the intruding water may have promoted a reflux cycle where water evaporated in the warmer area near the tank bottom, condensed near the top, and flowed down the walls. The corrosion product composition was consistent with free corrosion of steel exposed to moisture (Aftanas 2001).

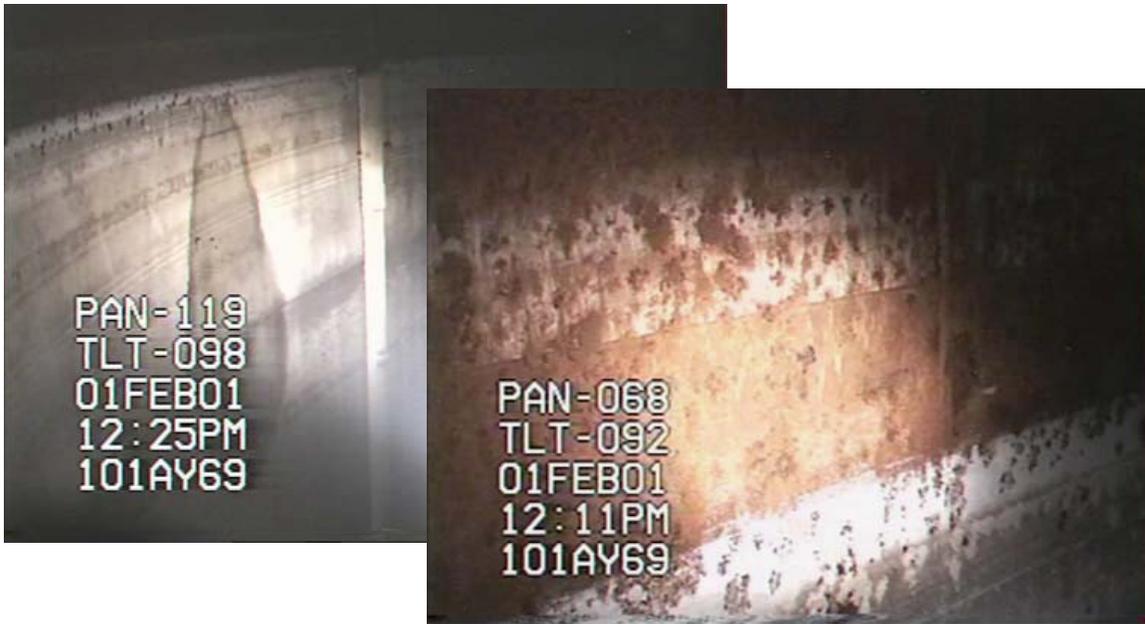
Figure 2.2. Examples of Primary-Side Corrosion Appearance

Figure 2.2 also shows a stain pattern that was initially believed to indicate a leak in the primary tank wall. If the primary tank was indeed perforated, a water film causing corrosion on the annulus side could have been pulled through the wall by the ventilation-induced vacuum in the primary tank, especially with the annulus ventilation system shut down. This was the principal concern that led CH2M HILL to issue an occurrence report to DOE and to restrict the maximum waste level to 80 inches to keep the waste far below the apparent leak site until further studies could confirm the tank's fitness for service.

Finally, the suspect stain area on the inner wall of the primary liner was also later identified as an area that was sprayed by liquid waste when waste was being transferred into the tank. Similar stains were noted at 90° intervals around the inside of the tank at about the same elevation. These corresponded to the four-jet configuration of the waste distributor that had sprayed the tank wall for some period of time. It was therefore concluded that the stains were not associated with perforations of the tank wall.

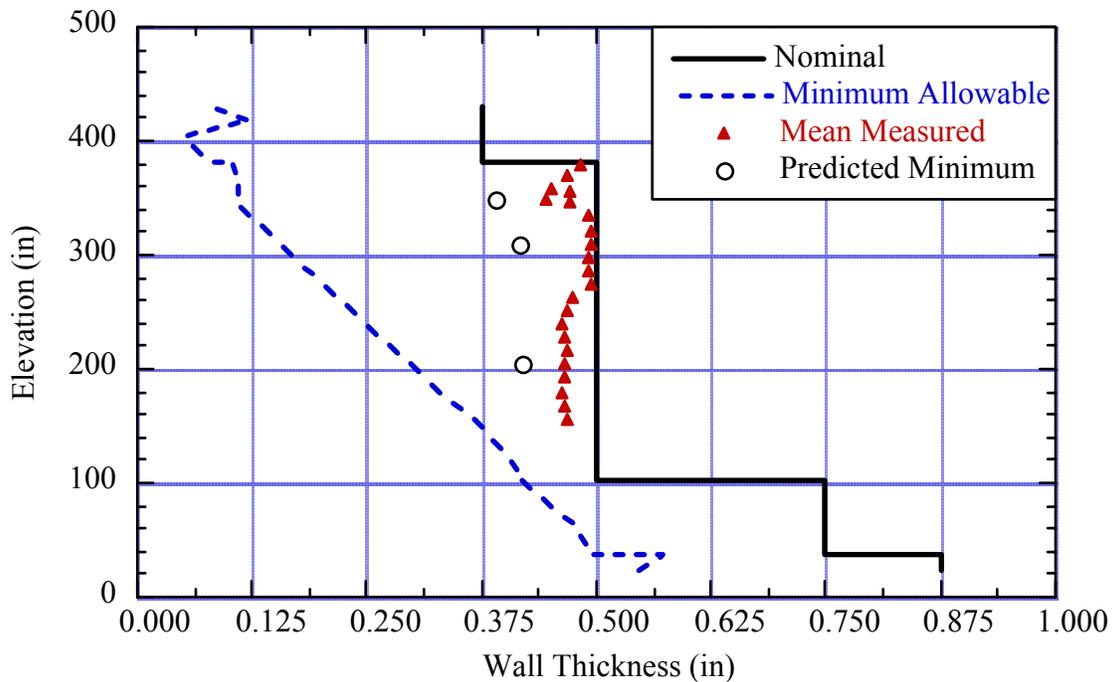
Figure 2.3. Minimum and Measured Wall Thickness in AY-101

The measured wall thickness and the minimum required thickness are plotted versus elevation in Figure 2.3. The minimum wall thickness generally decreases with elevation and is shown by the dashed line. The nominal design wall thickness is shown as the solid line. Note that the minimum wall thickness margin occurs at the 100-inch elevation, where the plate thickness decreases from 3/4 to 1/2 inch. The mean wall thickness measured by UT and the minimum thickness predicted by the extreme-value statistical analysis are shown as triangles and circles, respectively. It is clear that even the minimum predictions provide a very comfortable margin above the allowable thickness (note that the abrupt decrease in measured wall thickness below 262 inches probably represents installation of a thinner-than-nominal plate).
