**Pacific Northwest
National Laboratory**

**Ultrasonic Examination of Double-Shell
Tank 241-AP-101 Examination
Completed March 2003**

AF Pardini
GJ Posakony

April 2003

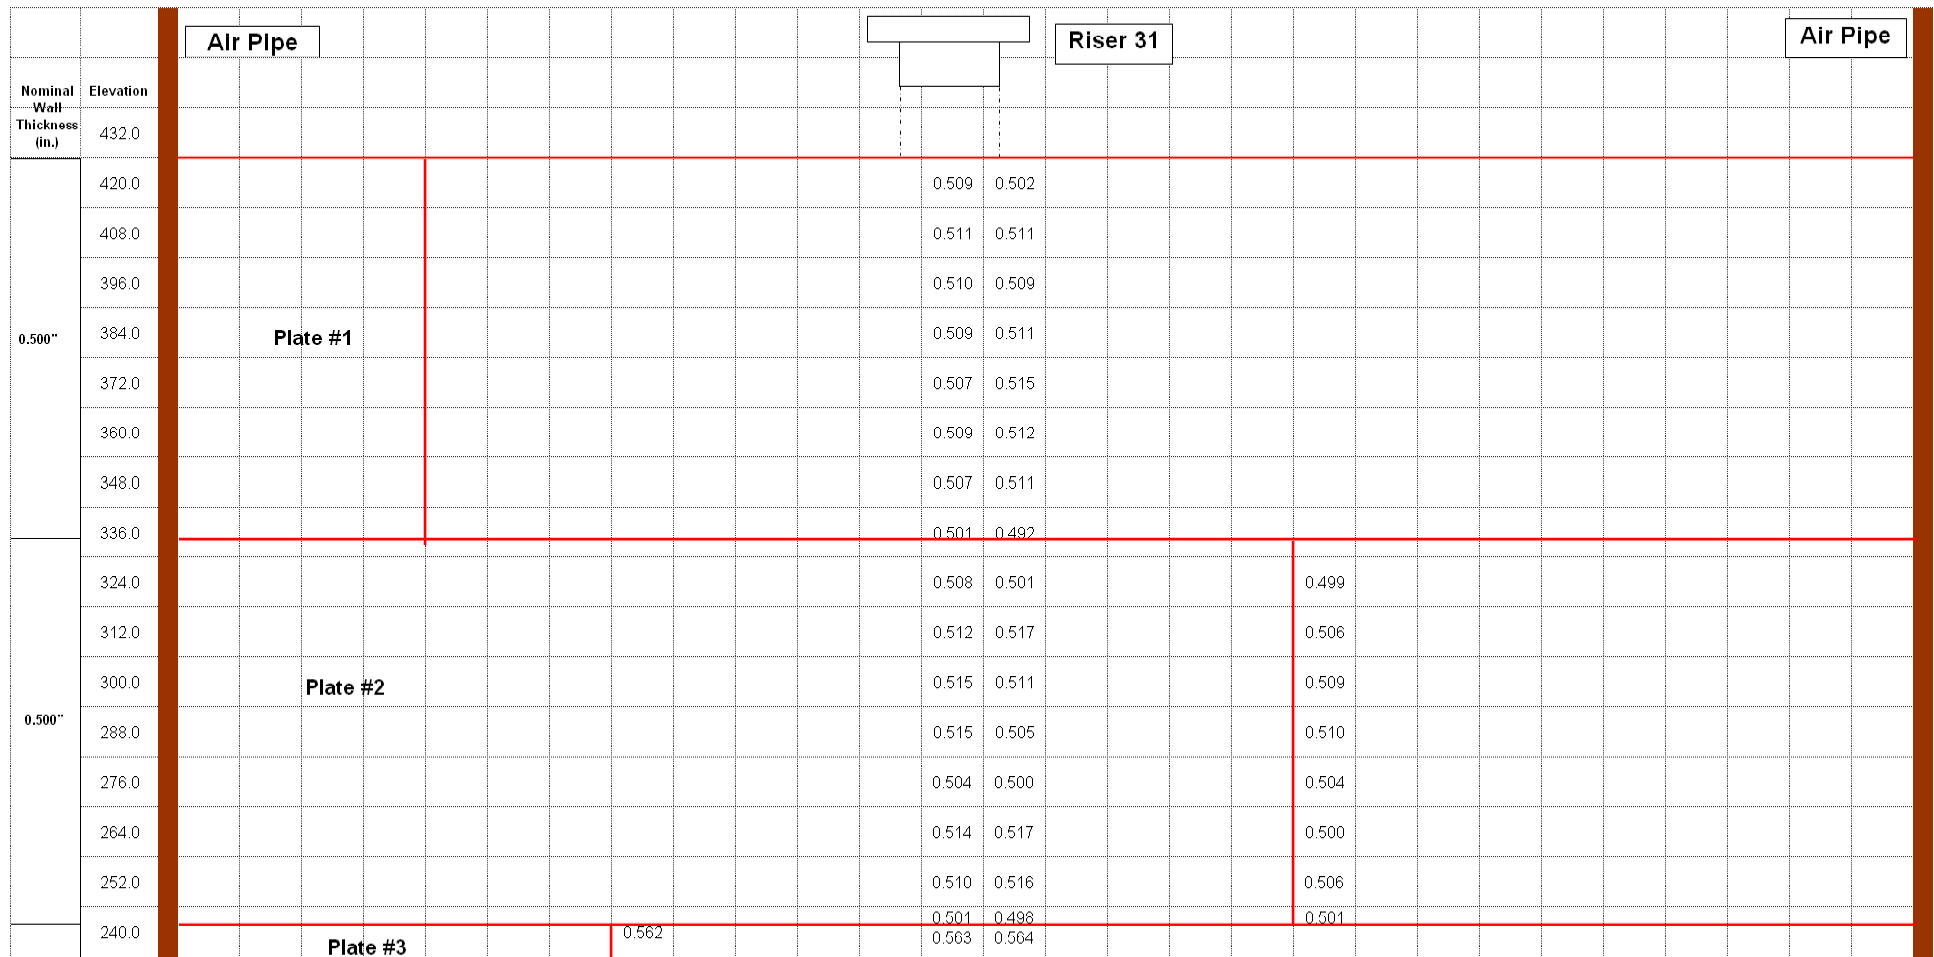
Figure 5.1. UT Data from Tank 241-AP-101

Figures 5.1 and 5.2 show the examination of the primary tank wall and the HAZs of both vertical and horizontal welds. The examination consisted of two vertical paths beneath the 24-in. diameter riser. Vertical scan #1 was 15-in. wide on Plates #1, #2, #3, #4, and #5 and was directly below the 24-in riser. Vertical scan #2 was adjacent to vertical scan #1 and was also 15-in. wide on Plates #1, #2, #3, #4, and #5. The HAZs of vertical welds in Plates #2, #3, #4, and #5 were examined and the HAZ in the horizontal weld between Plate #5 and the Knuckle section were also examined. Areas in the figures that show two measurements in the same box are the result of the vertical scan paths overlapping the horizontal HAZ scan paths or where the inspectors started a new scan and overlapped a previous scan. Figures 5.1 and 5.2 display the minimum reading taken in each 15-in. wide by 12-in. long portion of the scan. In the overlapping areas, both minimum readings from each of vertical and horizontal scan paths are given.

Two 15-in.-wide scan paths were performed on Plates #1, #2, #3, #4, and #5. The plates were examined for wall thinning, pitting, and cracks oriented vertically on the primary tank wall. The results indicated that the minimum thicknesses in the areas scanned with nominal thickness of 0.500-in. were as follows; Plate #1 was 0.492-in. and Plate #2 was 0.498-in. The nominal thickness in Plate #3 is 0.5625-in. and the minimum thickness in this area was 0.539-in. The nominal thickness in Plate #4 is 0.750-in. and the minimum thickness in this area was 0.741-in. The nominal thickness in Plate #5 is 0.875-in. and the minimum thickness in this area was 0.860-in. There were no areas that exceeded the reportable level of 10% of the nominal thickness. No pitting or vertical crack-like indications were detected in Plate #1, #2, #3, #4, or #5.

The HAZs of vertical welds in Plates #2, #3, #4, and #5 were examined for wall thinning, pitting and cracks oriented either perpendicular or parallel to the weld. The results indicated that the minimum thicknesses in the weld areas scanned were as follows: The nominal thickness of Plate #2 is 0.500-in. and the minimum thickness in this weld area was 0.499-in. The nominal thickness in Plate #3 is 0.5625-in. and the minimum thickness in this weld area was 0.562-in. The nominal thickness in Plate #4 is 0.750-in. and the minimum thickness in this weld area was 0.719-in. The nominal thickness in Plate #5 is 0.875-in. and the minimum thickness in this weld area was 0.852-in. There were no areas that exceeded the reportable level of 10% of the nominal thickness. No pitting or crack-like indications were detected in the weld areas in Plate #2, #3, #4, or #5.

The HAZ of the horizontal weld between Plate #5 and the tank knuckle was examined for wall thinning, pitting and cracks oriented either perpendicular or parallel to the weld. The results indicated that the minimum thickness in the weld area with nominal thickness of 0.875-in. on Plate #5 was 0.854-in. The minimum thickness in the weld area with nominal thickness of 0.9375-in. on the knuckle was 0.884-in. There were no areas that exceeded the reportable level of 10% of the nominal thickness. No pitting or crack-like indications were detected in the weld areas on Plate #5 side or on the knuckle side of the horizontal weld.
