**Pacific Northwest  
National Laboratory**

# **RONDE Ultrasonic Examination of Double-Shell Tank 241-AP-101 Knuckle Region Examination Completed April 2003**

AF Pardini  
GJ Posakony

May 2003

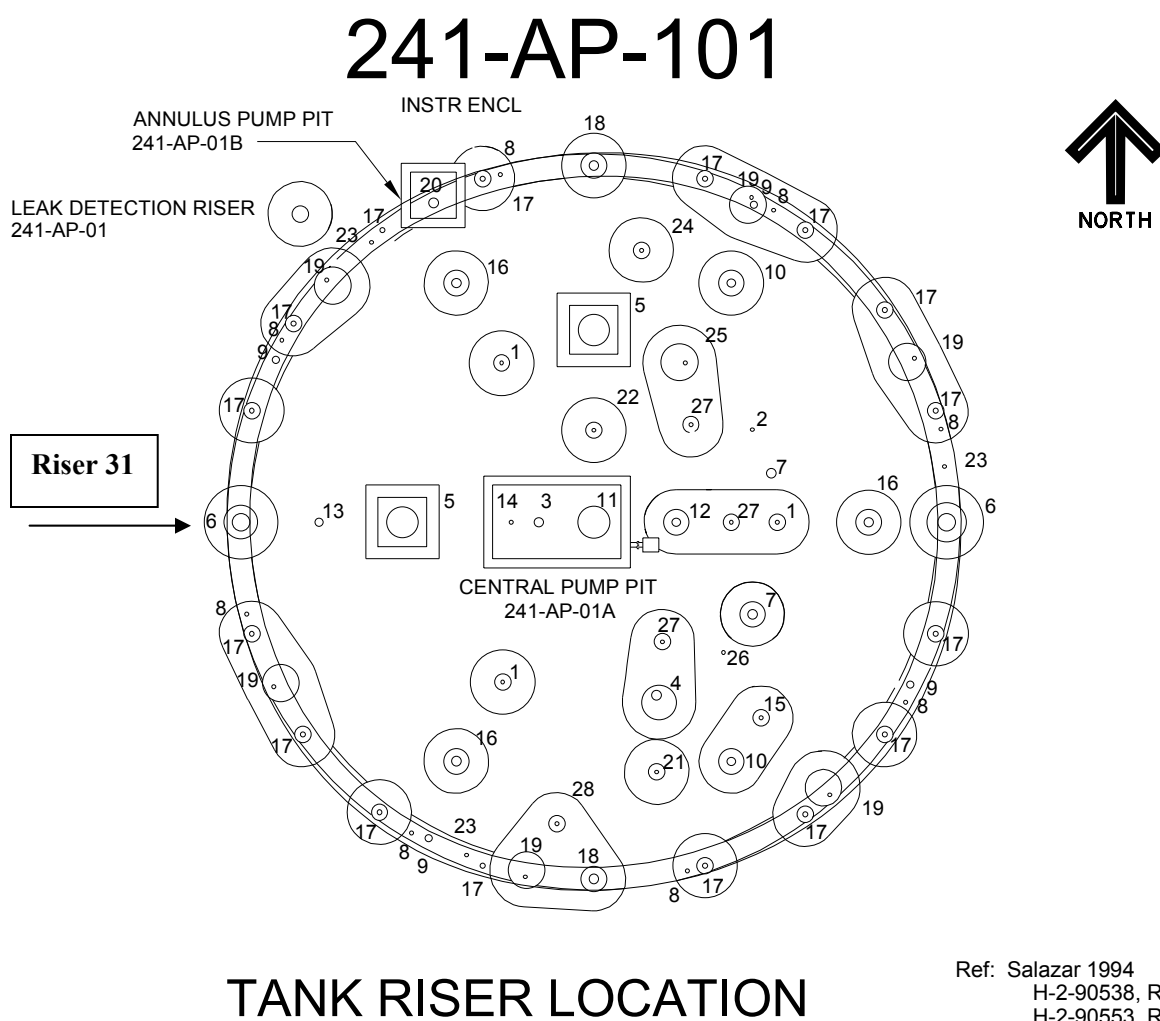
**Figure 4.1 UT of Tank 241-AP-101 from Riser 31**

Tank 241-AP-101 is located in the Hanford 200 East area in AP Tank Farm. The crawler and associated RONDE scanner were lowered into the 24-in. riser located on the west side of 241-AP-101 and designated as Riser 31. Riser 31 was originally called out as Riser 6 West. Figure 4.1 provides a graphic of the location of this riser. Figure 4.2 describes the area on the primary tank wall knuckle of Tank 241-AP-101 that was ultrasonically examined.

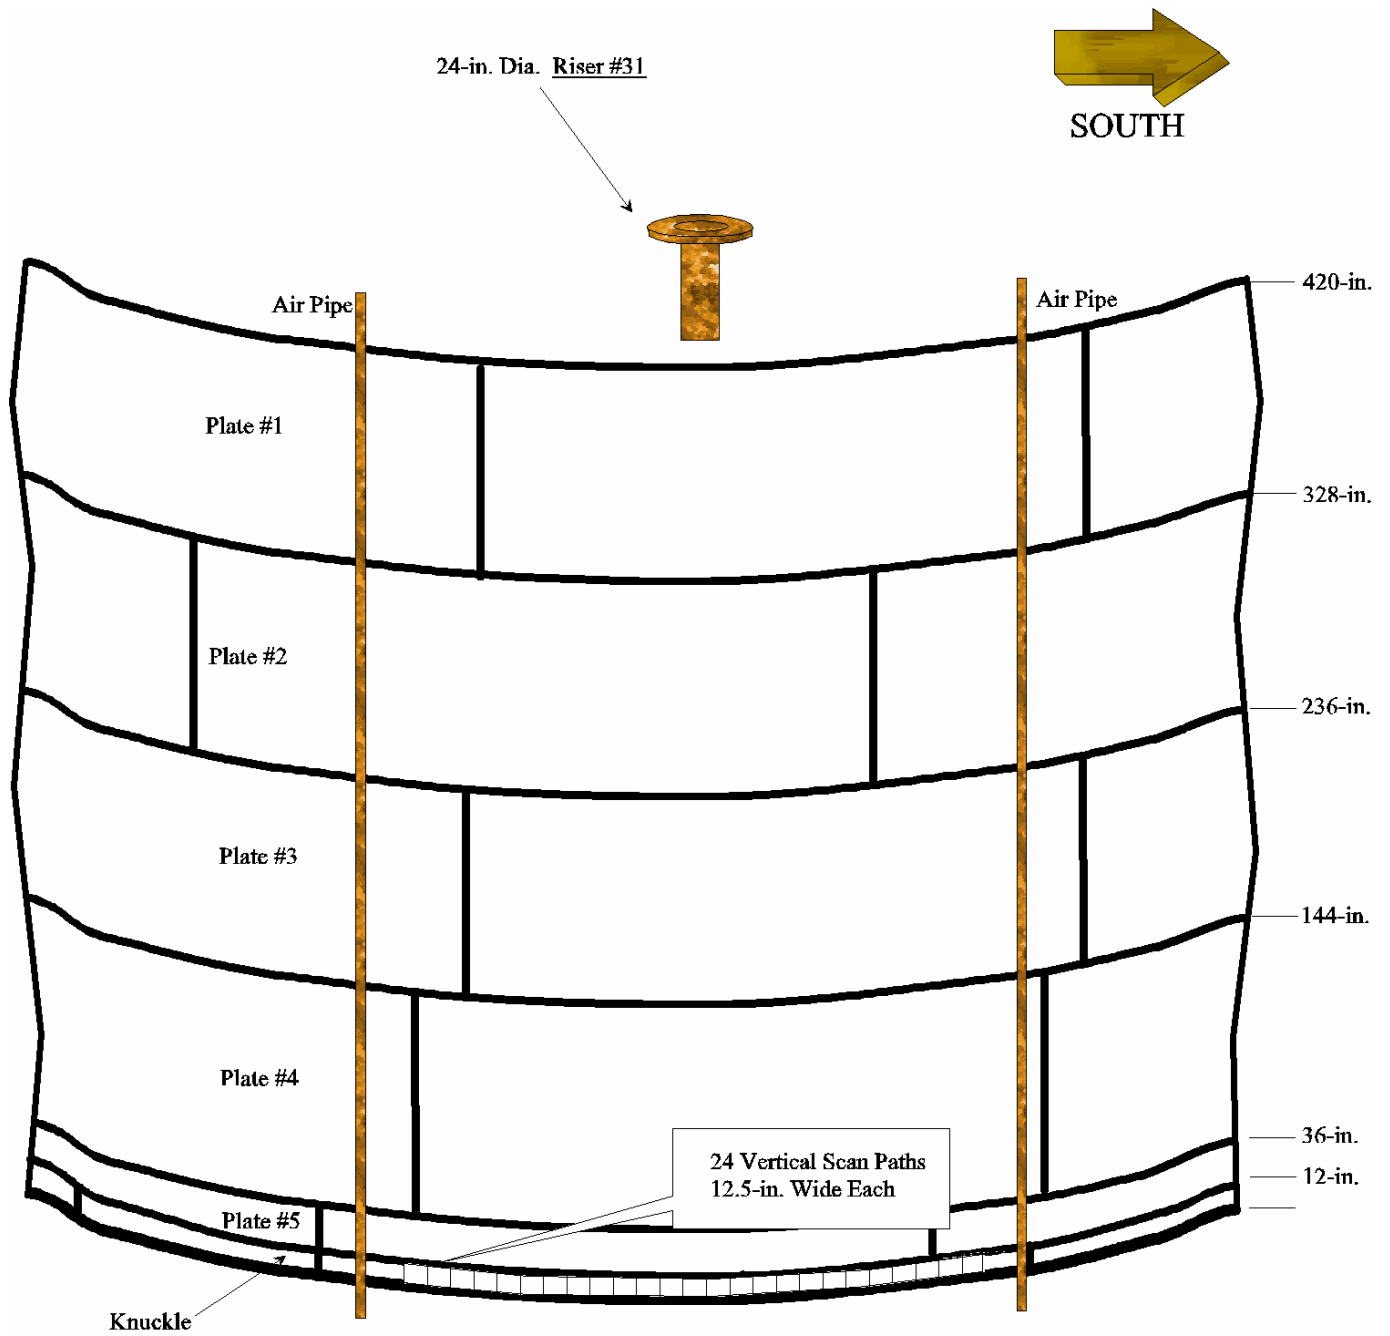
Figure 4.2 Sketch of Scan Paths on Tank 241-AP-101

The examination consisted of 24 individual scans, each being 12.5 in. in width (circumferential direction). The crawler was moved around the circumference in 10-in. increments, thereby providing for a 2.5-in overlap during data acquisition. The total amount of knuckle scanned was approximately 240 in. measured circumferentially around the tank. The data was displayed in a C-scan (plan) view and provided an image of the entire knuckle, from upper knuckle weld to lower knuckle weld (approximately 19 in. measured on the inside diameter), inclusive of the predicted high-stress region. Further analysis was performed on selected data files by PNNL using the SAFT analysis algorithm to verify position of the lower knuckle weld.

The results of the examination of Tank 241-AP-101 indicated no circumferential cracking was present anywhere in the knuckle region between the upper knuckle weld and the lower knuckle weld over the approximately 240 circumferential inches scanned.
