**Pacific Northwest
National Laboratory**

**Ultrasonic Examination of Double-Shell Tank 241-AP-105
Examination Completed April 2003**

AF Pardini
GJ Posakony

May 2003

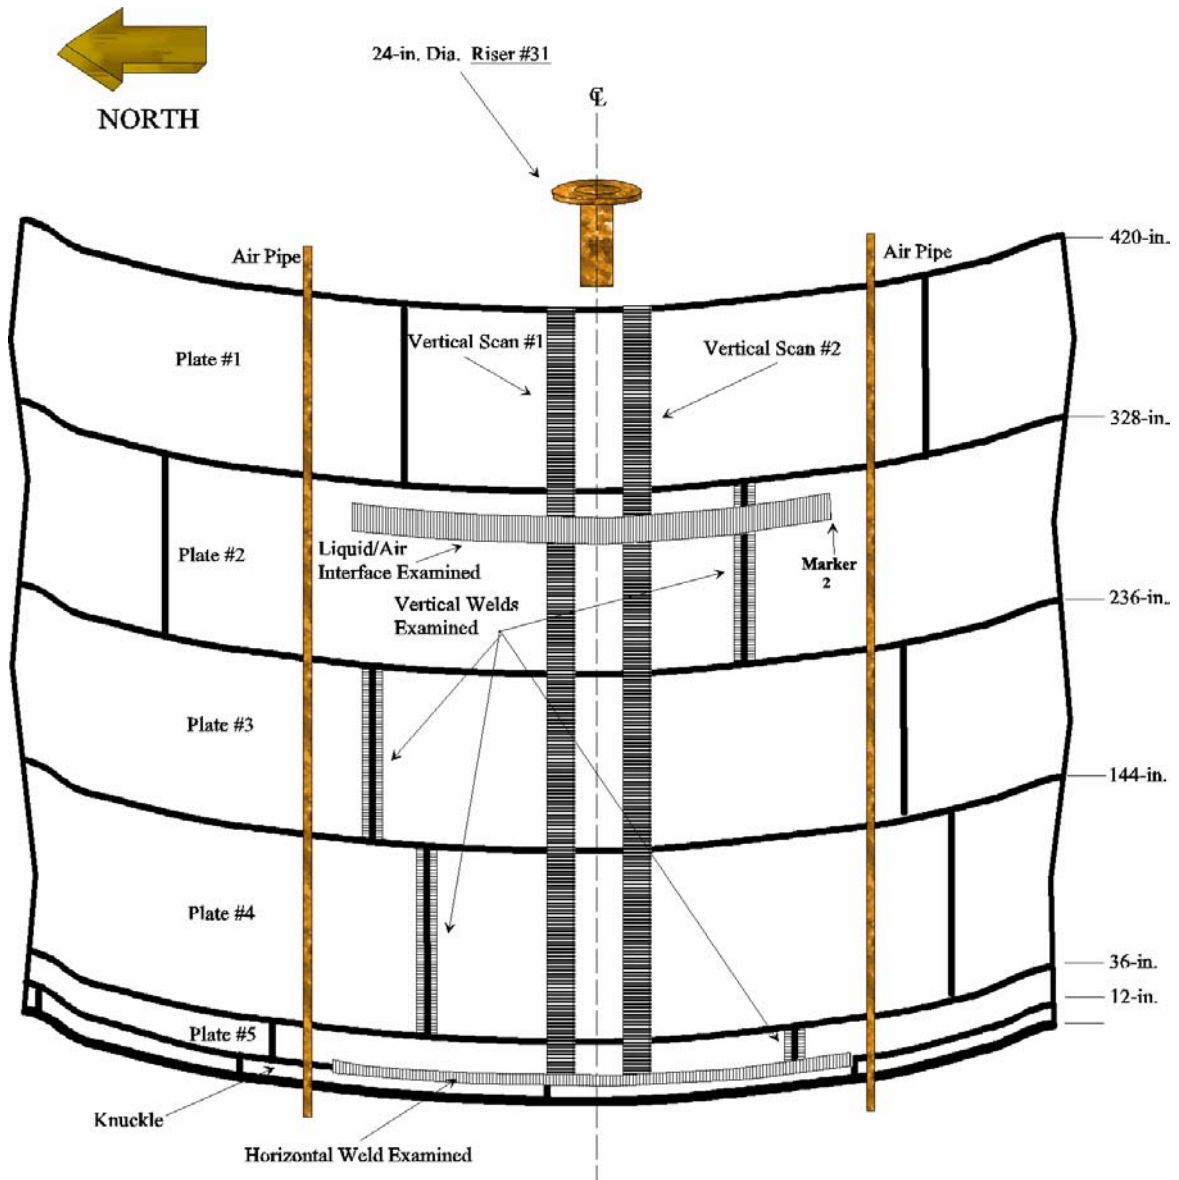
Figure 4.2. Sketch of Scan Paths on Tank 241-AP-105

Figure 4.2 describes the areas on the primary wall of Tank 241-AP-105 that were ultrasonically examined. Two 15-in.-wide vertical scan paths were performed on Plates #1, #2, #3, #4, and #5 below the entrance to Riser 31 at approximately 24-in. from the center of each scan to the center of the riser. Vertical weld HAZ examinations were done on Plates #2, #3, #4, and #5, and the horizontal weld HAZ examination was done on the transition Plate #5 to knuckle weld. A single 15-in. wide scan was performed in the liquid/air region on Plate #2.

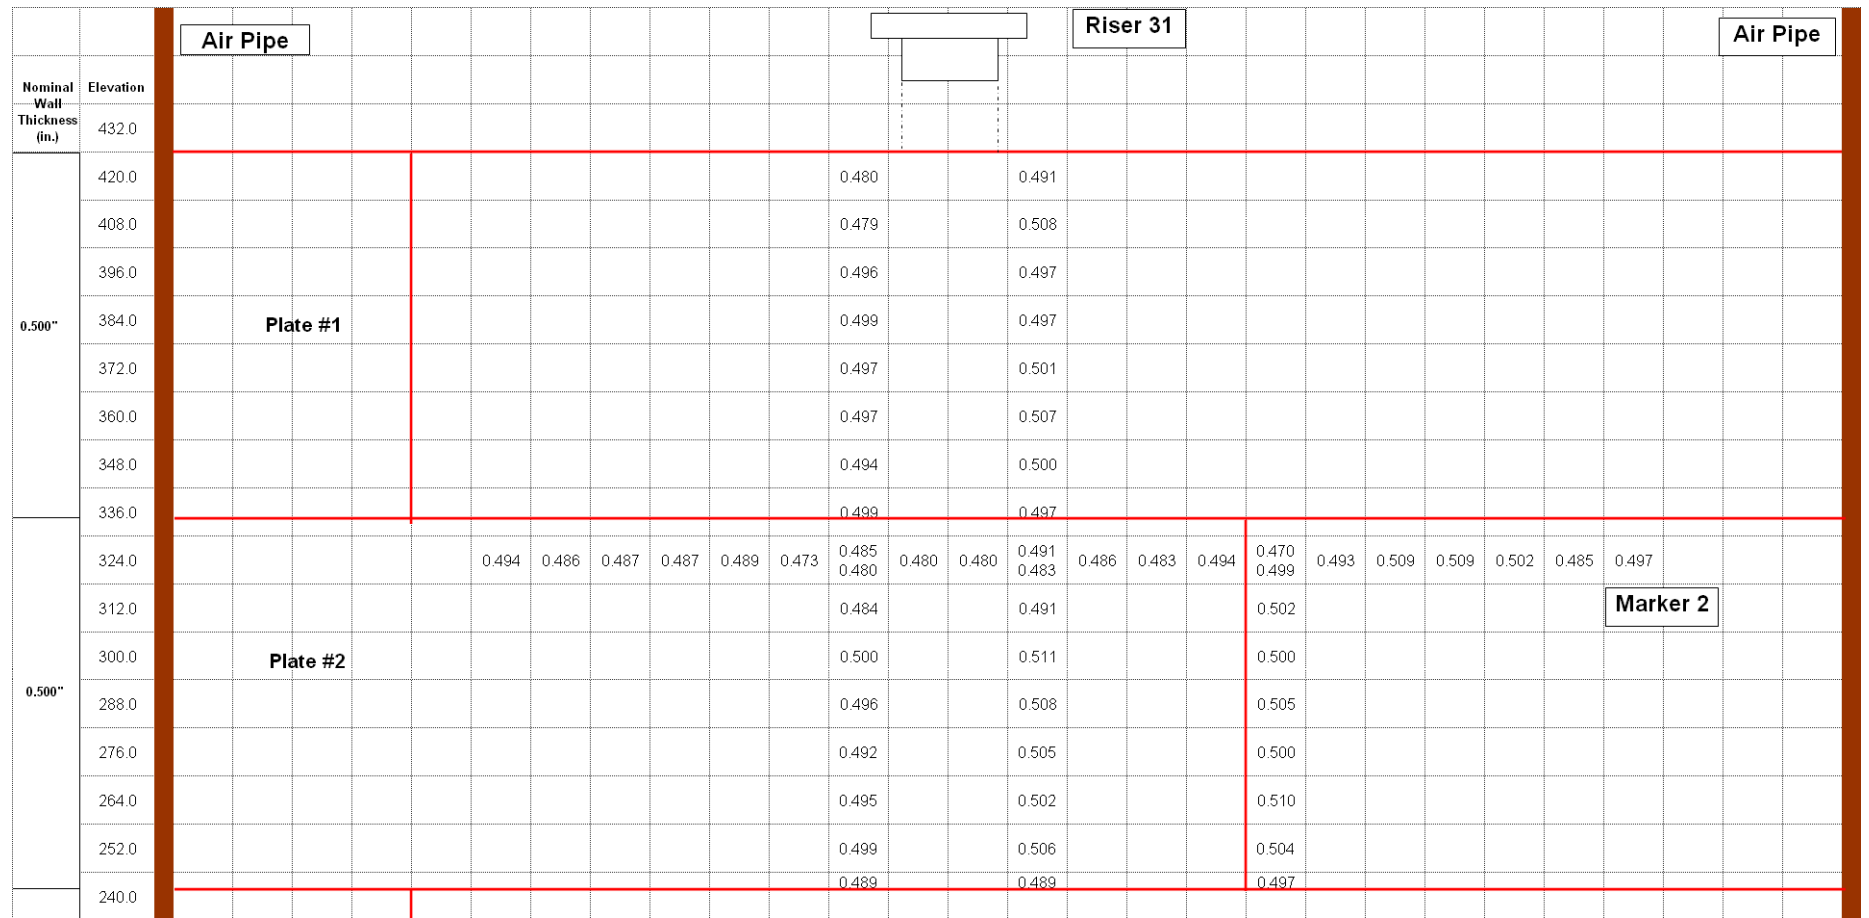
Figure 5.1. UT Data from Tank 241-AP-105

Figures 5.1 and 5.2 show the wall thickness examination results for the primary tank wall and the HAZs of both vertical and horizontal welds. The examination consisted of two vertical paths beneath the 24-in. diameter riser. Vertical scan #1 was 15-in. wide on Plates #1, #2, #3, #4, and #5 and started approximately 30-in. north of the centerline of the 24-in. riser. Vertical scan #2 was also 15-in. wide on Plates #1, #2, #3, #4, and #5 and ended 30-in. south of the centerline of the 24-in. riser. The HAZs of vertical welds in Plates #2, #3, #4, and #5 were examined and the HAZ in the horizontal weld between Plate #5 and the knuckle section was also examined. A 15-in. wide scan was performed in the liquid/air interface region on Plate #2, beginning at marker 2 located just north of the south air pipe. Areas in the figures that show two measurements in the same box are the result of the vertical scan paths overlapping the horizontal HAZ scan paths. Figures 5.1 and 5.2 display the minimum readings taken in each 15-in. wide by 12-in. long area of the scan. In the overlapping areas, both minimum readings from each of vertical and horizontal scan paths are given.

Two 15-in.-wide scan paths were performed on Plates #1, #2, #3, #4, and #5. The plates were examined for wall thinning, pitting, and cracks oriented vertically on the primary tank wall. The results indicated that the minimum thicknesses in the areas scanned with nominal thickness of 0.500-in. were as follows; Plate #1 was 0.479-in. and Plate #2 was 0.484-in. The nominal thickness in Plate #3 is 0.5625-in. and the minimum thickness in this area was 0.554-in. The nominal thickness in Plate #4 is 0.750-in. and the minimum thickness in this area was 0.724-in. The nominal thickness in Plate #5 is 0.875-in. and the minimum thickness in this area was 0.856-in. There were no areas that exceeded the reportable level of 10% of the nominal thickness. No pitting or vertical crack-like indications were detected in Plates #1, #2, #3, #4, or #5.

The HAZs of vertical welds in Plates #2, #3, #4, and #5 were examined for wall thinning, pitting and cracks oriented either perpendicular or parallel to the weld. The results indicated that the minimum thicknesses in the weld areas scanned were as follows: The nominal thickness of Plate #2 is 0.500-in. and the minimum thickness in this weld area was 0.470-in. The nominal thickness in Plate #3 is 0.5625-in. and the minimum thickness in this weld area was 0.547-in. The nominal thickness in Plate #4 is 0.750-in. and the minimum thickness in this weld area was 0.717-in. The nominal thickness in Plate #5 is 0.875-in. and the minimum thickness in this weld area was 0.843-in. There were no areas that exceeded the reportable level of 10% of the nominal thickness. No pitting or crack-like indications were detected in the weld areas in Plates #2, #3, #4, or #5.

The HAZ of the horizontal weld between Plate #5 and the tank knuckle was examined for wall thinning, pitting and cracks oriented either perpendicular or parallel to the weld. The results indicated that the minimum thickness in the weld area with nominal thickness of 0.875-in. on Plate #5 was 0.863-in. The minimum thickness in the weld area with nominal thickness of 0.9375-in. on the knuckle was 0.899-in. There were no areas that exceeded the reportable level of 10% of the nominal thickness. No pitting or crack-like indications were detected in the weld areas on Plate #5 side or on the knuckle side of the horizontal weld.

A 15-in.-wide horizontal scan path was performed on Plate #2 in an area considered a liquid/air interface region. The liquid/air interface region was examined for wall thinning, pitting, and cracks oriented in a circumferential direction on the primary tank wall. The results indicated that the minimum thickness in the areas scanned in Plate #2 with nominal thickness of 0.500-in. was 0.473-in. There were no areas that exceeded the reportable level of 10% of the nominal thickness. No pitting or circumferentially oriented crack-like indications were detected in the liquid/air interface region on Plate #2.
