Ultrasonic Examination of Double-Shell Tank 241-AZ-102 Examination Completed August 2003

AF Pardini
GJ Posakony

August 2003

Pacific Northwest National Laboratory
Richland, Washington 99352

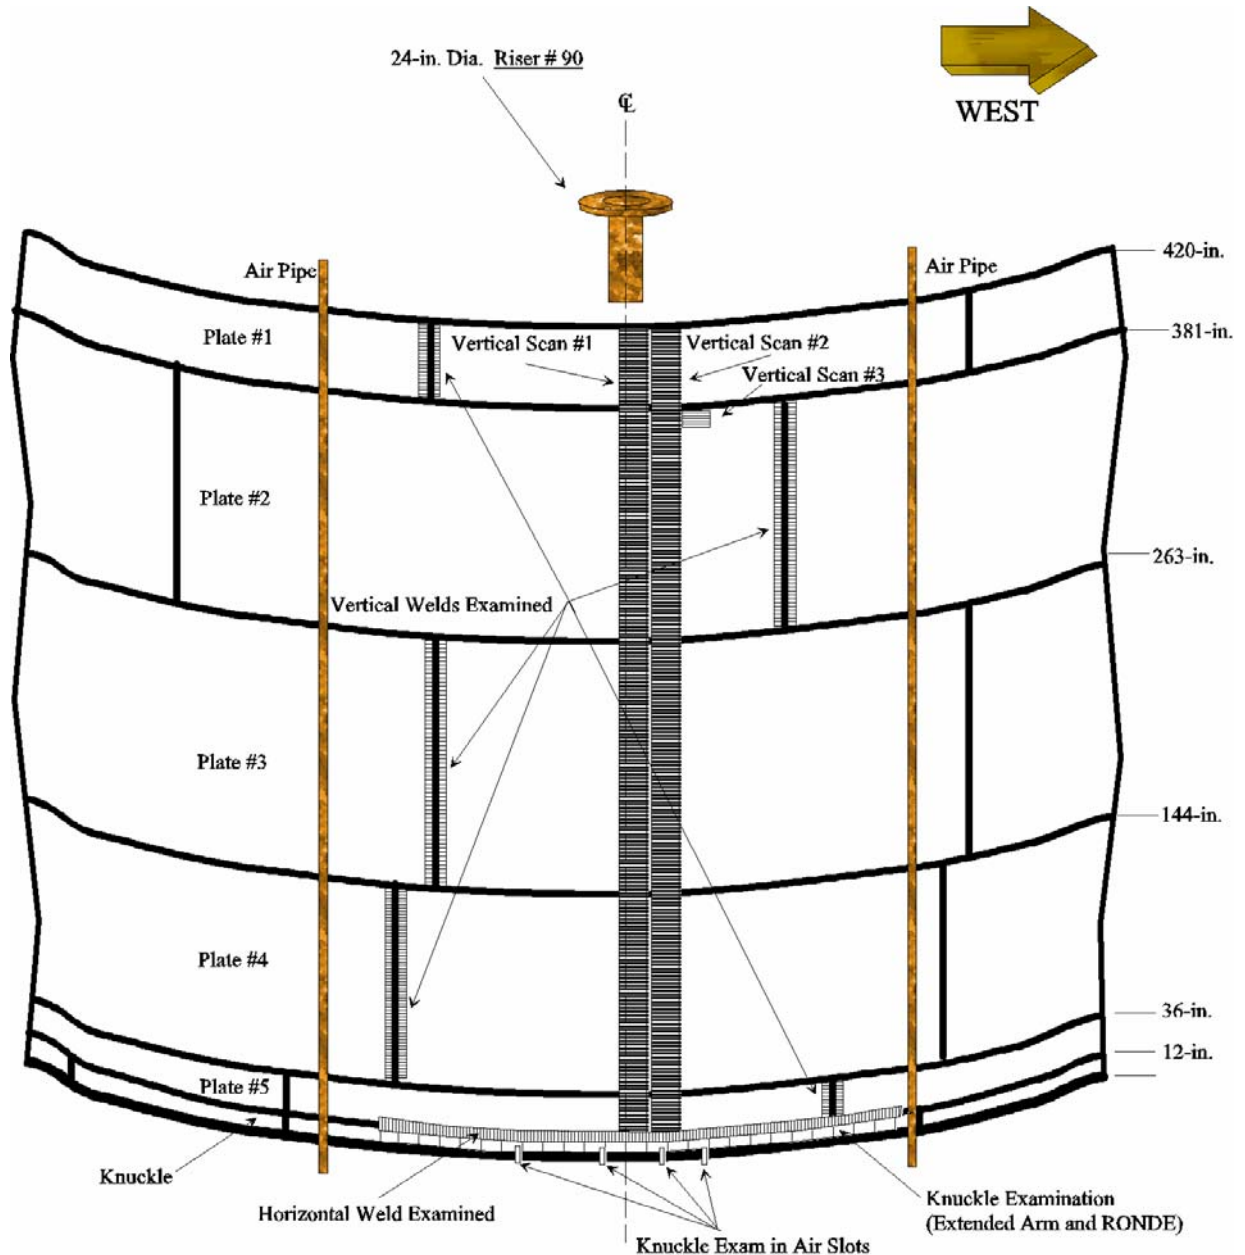
Figure 4.2. Sketch of Scan Paths on Tank 241-AZ-102

Figure 4.2 describes the areas on the primary wall of Tank 241-AZ-102 that were ultrasonically examined. Two 15-in.-wide vertical scan paths were performed on Plates #1, #2, #3, #4, and #5 below the entrance to Riser 90. A short third vertical scan was performed just west of Vertical Scan #2. Vertical weld HAZ examinations were done on Plates #1, #2, #3, #4, and #5, and the horizontal weld HAZ examination was done on the transition Plate #5 to knuckle weld. Approximately 270 circumferential inches of the knuckle region was also scanned.

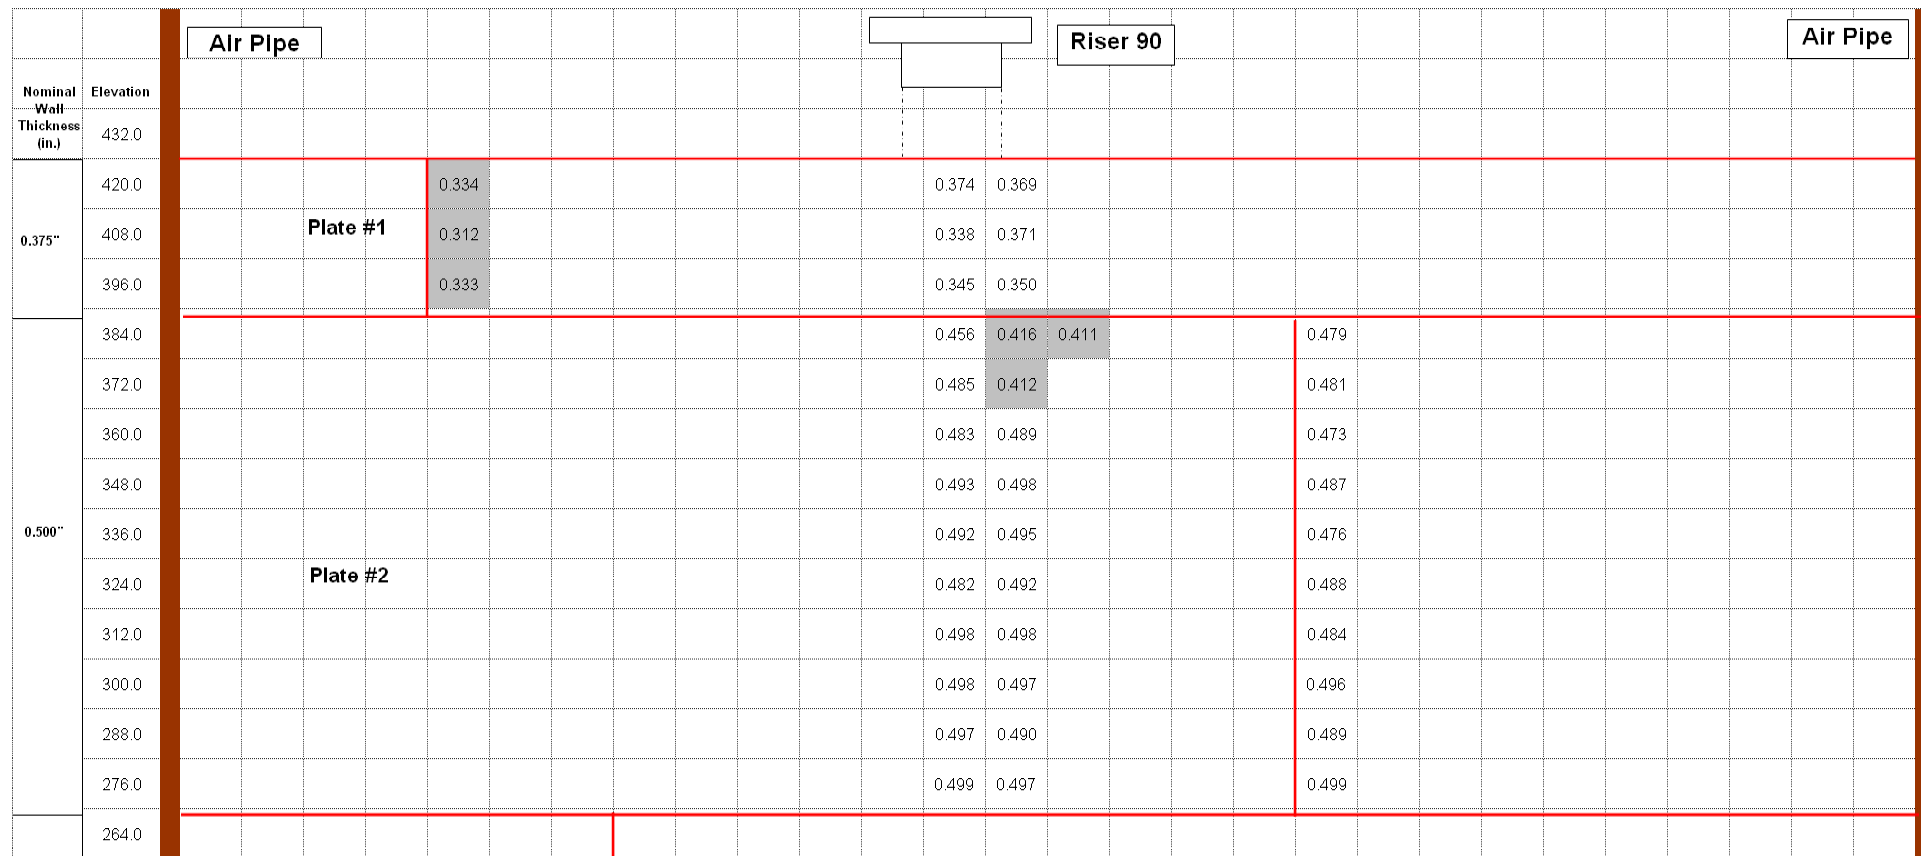
Figure 5.1. UT Data from Tank 241-AZ-102

Figures 5.1 and 5.2 show the wall thickness examination results for the primary tank wall and the HAZs of both vertical and horizontal welds. The examination consisted of two vertical paths beneath the 24-in. diameter riser and one short vertical path adjacent to Vertical scan #2. Vertical scan #1 was 15-in. wide on Plates #1, #2, #3, #4, and #5 and started directly below the centerline of the 24-in. riser. Vertical scan #2 was adjacent to vertical scan #1 and was also 15-in. wide on Plates #1, #2, #3, #4, and #5. Vertical scan #3 was adjacent to vertical scan #2 and was also 15-in. wide but only extends approximately 10-in. on the top of Plate #2. The HAZs of vertical welds in Plates #1, #2, #3, #4, and #5 were examined and the HAZ in the horizontal weld between Plate #5 and the knuckle section was also examined. Areas in the figures that show two measurements in the same box are the result of the vertical scan paths overlapping the horizontal HAZ scan paths. Figures 5.1 and 5.2 display the minimum readings taken in each 15-in. wide by 12-in. long area of the scan. In the overlapping areas, both minimum readings from each of vertical and horizontal scan paths are given. Highlighted areas in Plate #1 and Plate #2 show minimum wall thickness exceeded the reportable level of 10% of the nominal thickness. The three areas in Plate #1 are in the HAZ of the vertical weld. The three areas in Plate #2 are near the end of the plate in the base metal.

Figure 5.3 shows the examination performed on the knuckle of the primary tank wall. The readings distributed around the circumference of the tank knuckle represent the minimum reading in each 12-in. long by 12-in. wide portion extending down around the knuckle. The four areas denoted as Slot 4, Slot A, Slot B, and Slot C, represent small areas that were scanned extending down to the lower knuckle weld in the air slots. These scan areas are approximately 1-in. long (increment direction around the circumference of the tank), and 7-in wide (scan direction is down around the knuckle and into the air slot) as shown previously in Section 3 of this report.

Figure 5.2 UT Data from Tank 241-AZ-102 cont.

Figure 5.3 UT Data from Tank 241-AZ-102 Knuckle Region
