**Ultrasonic Examination of Double-Shell Tank 241-AY-101
Examination Completed August 2003**

December 30, 2003

Pacific Northwest National Laboratory
Richland, Washington 99352

Summary

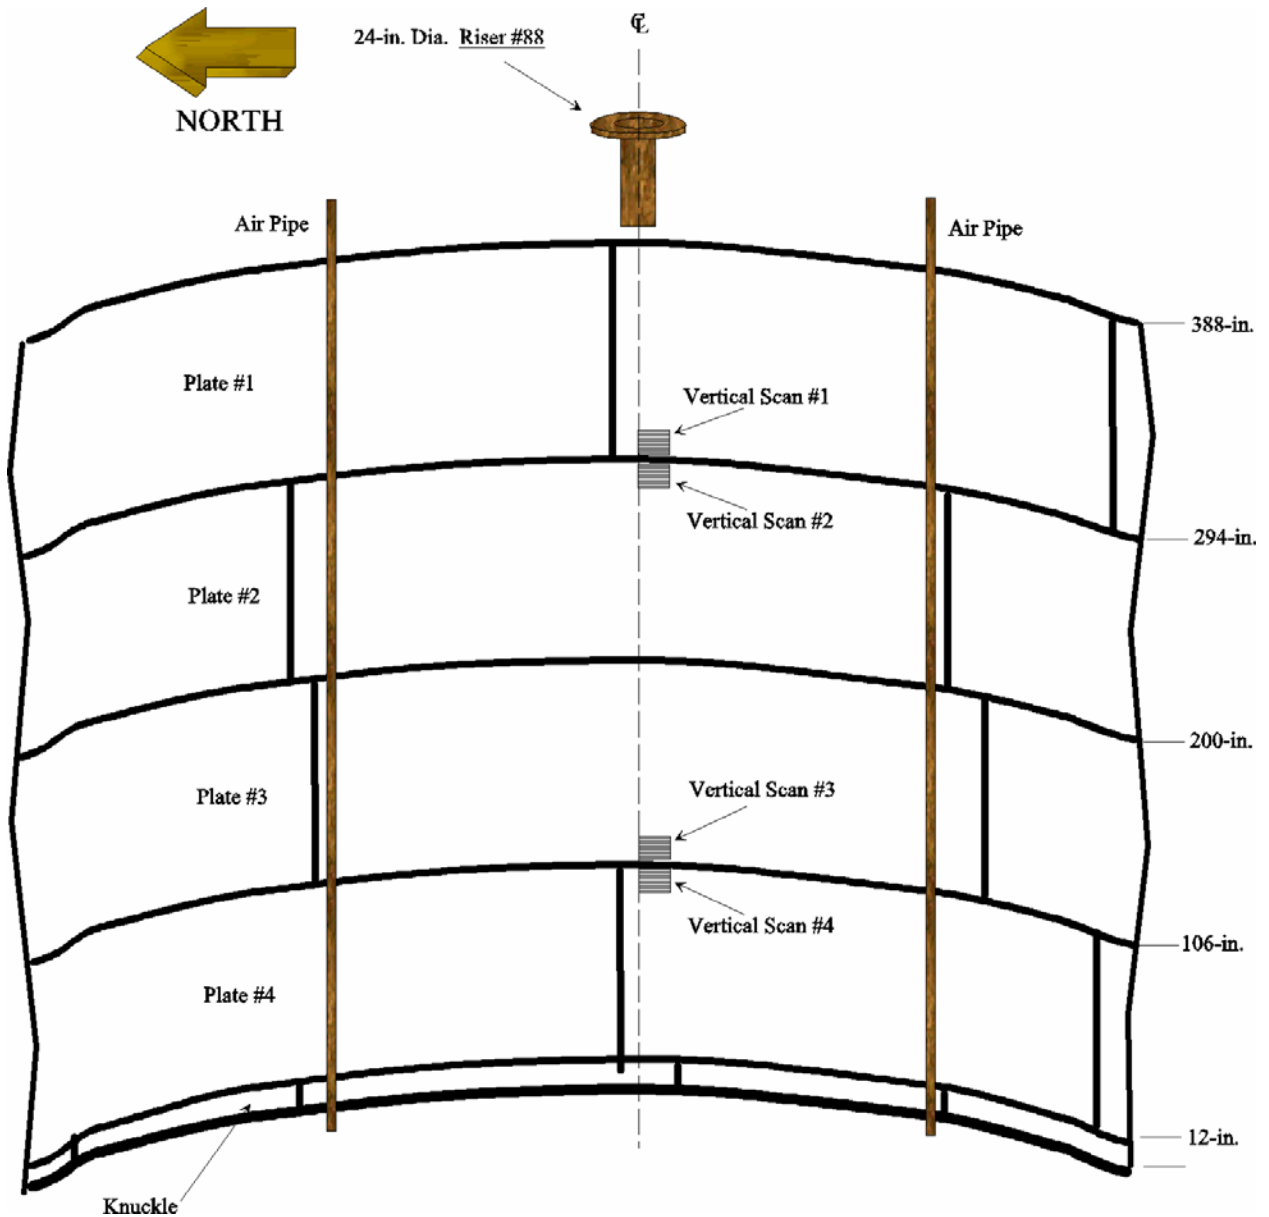
Figure 4.2. Sketch of Areas Scanned on Secondary Wall of Tank 241-AY-101

Figure 4.2 describes the areas on the secondary wall of Tank 241-AY-101 that were ultrasonically examined. Short 15-in.-wide by 12-in.-long vertical scan paths were performed on Plates #1, #2, #3, and #4 below the entrance to Riser 88.

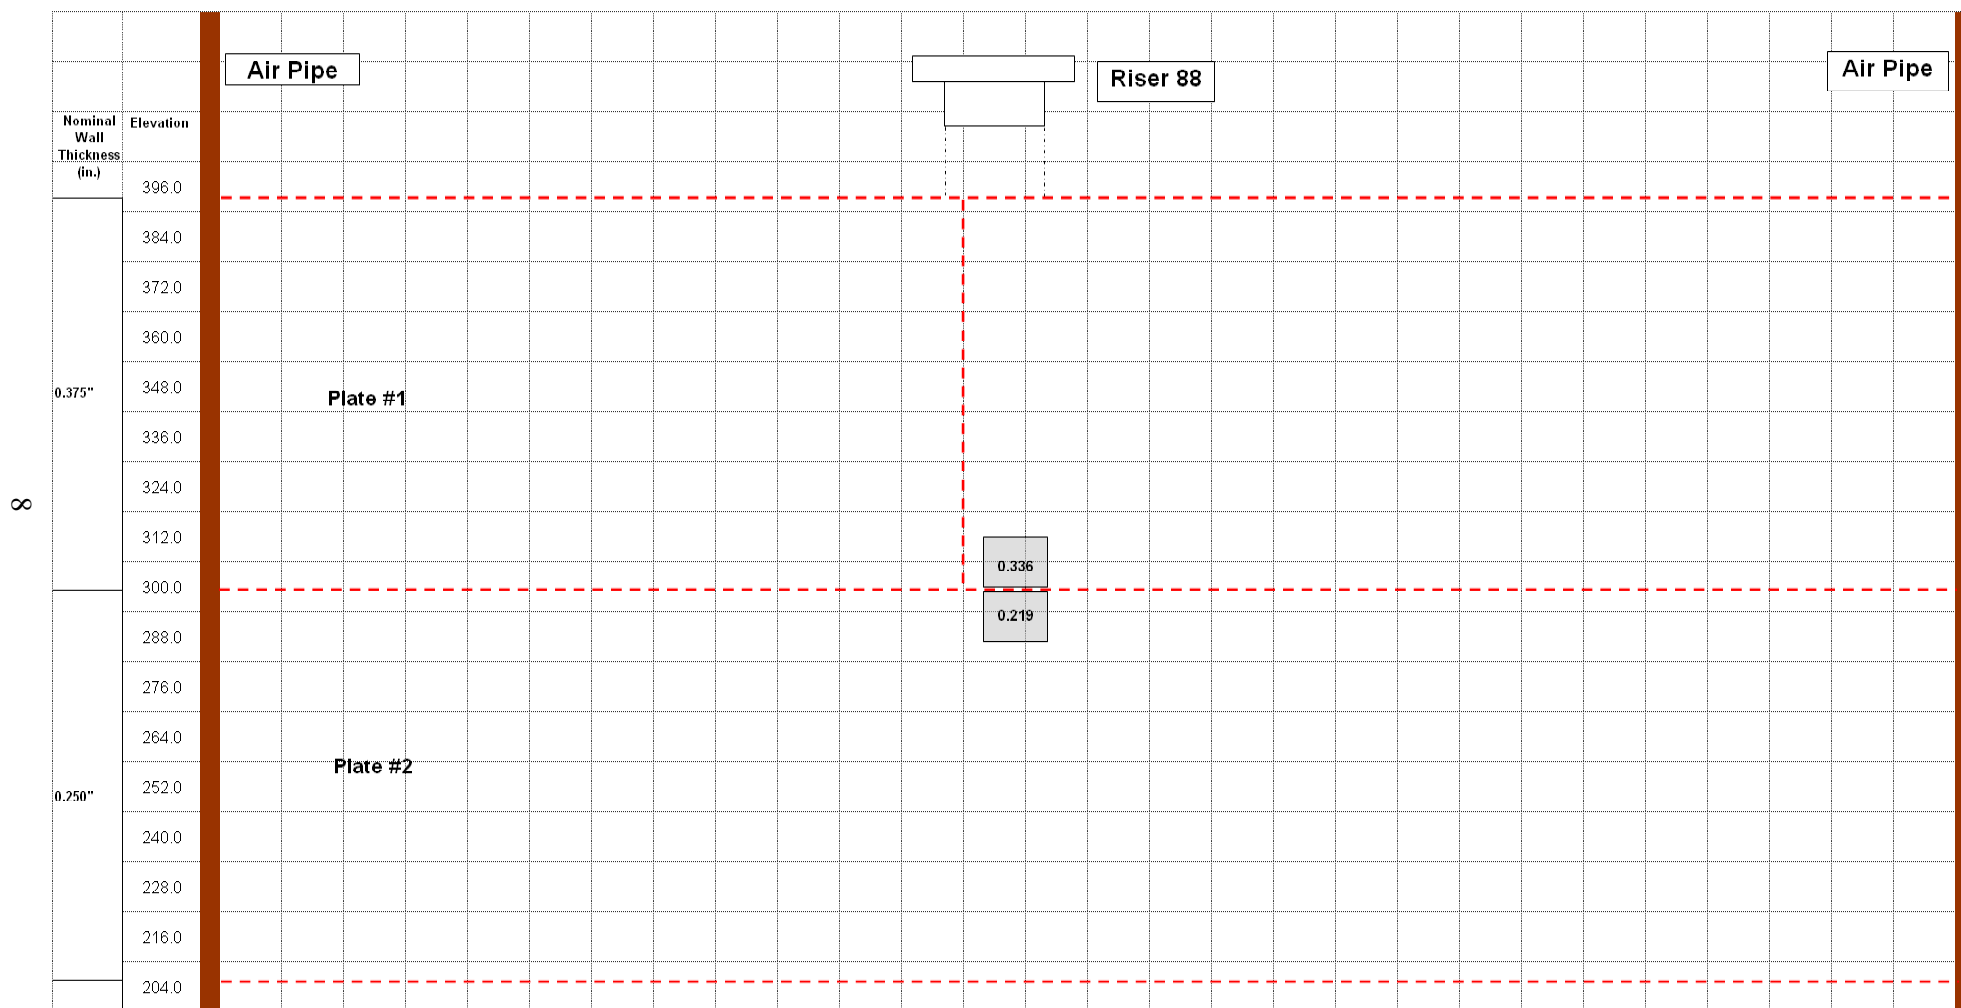
Figure 5.1. UT Data from Secondary Wall of Tank 241-AY-101

Figures 5.1 and 5.2 show the wall thickness examination results for the secondary tank wall. The examination consisted of short vertical paths beneath the 24-in. diameter riser. Vertical scan #1 was 15-in. wide and 12-in. long on the bottom portion of Plate #1. Vertical scan #2 was 15-in. wide and 12-in. long on the top portion of Plate #2. Vertical scan #3 was 15-in. wide and 12-in. long on the bottom portion of Plate #3. Vertical scan #4 was 15-in. wide and 12-in. long on the top of Plate #4. Figures 5.1 and 5.2 display the minimum readings taken in each 15-in. wide by 12-in. long area of the scan. Highlighted areas in Plate #1 and Plate #2 show minimum wall thickness exceeded the reportable level of 10% of the nominal thickness.

One 15-in. wide by 12-in. long scan was performed on each of Plates #1, #2, #3, and #4 of the secondary tank of 241-AY-101. The plates were examined for wall thinning and pitting on the secondary tank wall above and below the Plate #1 to Plate #2 circumferential weld and above and below the Plate #3 to Plate #4 circumferential weld. The results indicated that the nominal thickness in Plate #1 is 0.375-in. and the minimum thickness in this area was 0.336-in. This one area of wall thinning that exceeded the reportable level of 10% of the nominal thickness was located near the bottom of Plate #1. The minimum thicknesses in the areas scanned with nominal thickness of 0.250-in. were as follows; Plate #2 was 0.219-in., Plate #3 was 0.269-in. and Plate #4 was 0.249-in. There were two areas of wall thinning that exceeded the reportable level of 10% of the nominal thickness in Plate #2. The areas were located near the top of Plate #2. No pitting was detected in Plates #1, #2, #3, or #4.
