An Analysis of Stream Culvert Fish Passage on the Navy Railroad Line between Bremerton and Shelton, Washington

Battelle Marine Sciences Laboratory
Sequim, Washington

September 2004

Prepared for:
Puget Sound Naval Shipyard and Intermediate Maintenance Facility

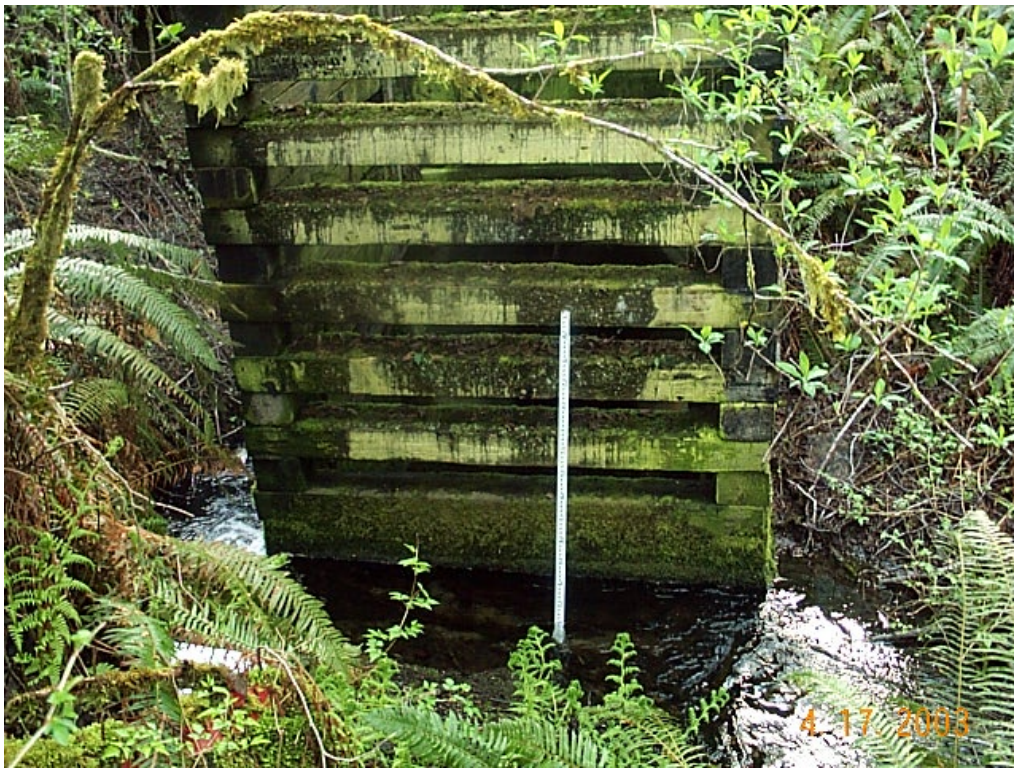
This RR culvert is located at the headwaters of an unnamed stream (WRIA 14.0047) that drains into Oakland Bay near Shelton (Figure 12; WP 146). The stream channel appears to be perennial at this point in the watershed, originating in a forested wetland on the upstream side of the railroad grade. There is a natural barrier in the lower mainstem of this creek upstream of SR-3. In addition, the culvert under SR-3 appears to be a complete fish-passage barrier. The RR culvert was assessed as a complete barrier based on WDFW Level-A analysis (little natural streambed material inside the culvert, slope >1%, and outlet perched approximately 1 foot). The PI score is 6.43. No fish were observed in the stream during cuolvert surveys and the channel is listed as a Type 5 by WA-DNR. The stream is classified as potentially fish-bearing based on the channel size and gradient criteria. The RR culvert is a 6-foot diameter (209 ft in length) reinforced concrete pipe (RCP) with an upstream trash rack made from railroad ties. This trash rack is a barrier to fish passage at the upstream end of the RR culvert. It is recommended that this rack be removed to allow the free flow of water and organic material through the culvert. In addition, the removal will eliminate the potential water quality problem of the creosote railroad ties being in the creek and will improve passage for water, sediment, organic material, and biota through the culvert.

Figure 15. Existing trash rack on inlet of railroad culvert MP 2.19.

10.50	Deer	Passable	6.55	Install Beaver Deceiver and Monitor Passage	\$
32.09	Gorst	Complete	N/A	Replace	\$\$\$\$\$
2.19	Unnamed	Complete	6.43	Remove Trash Rack and Replace Culvert	\$\$\$

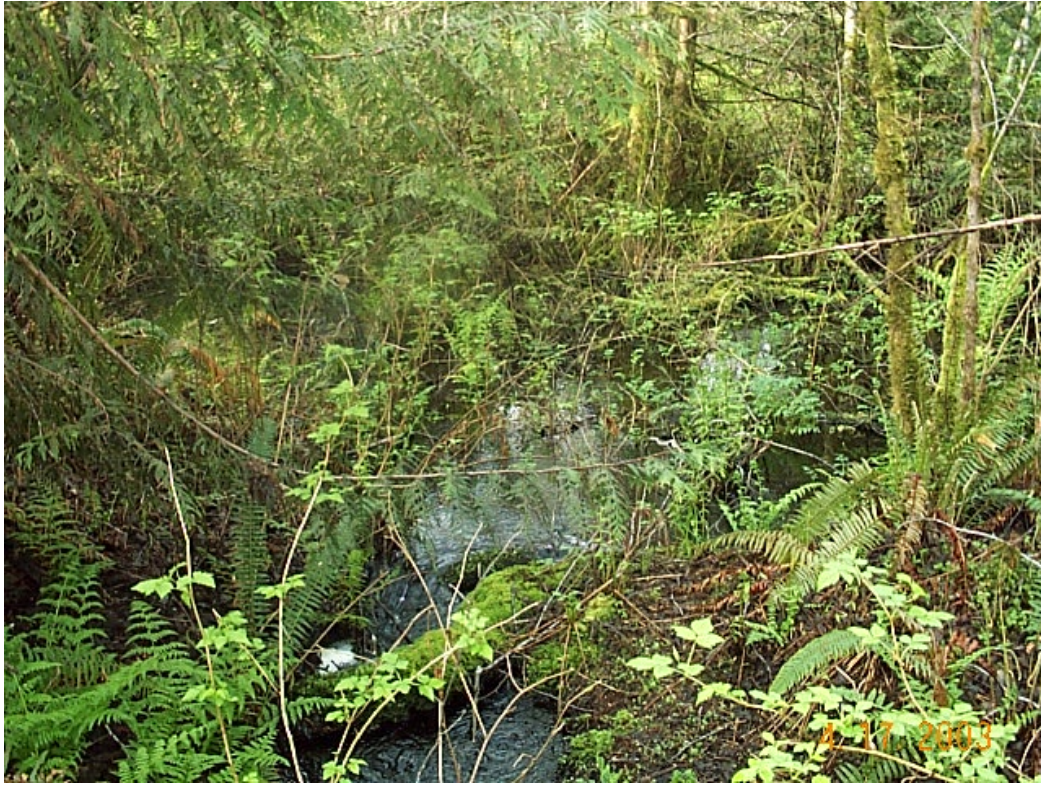
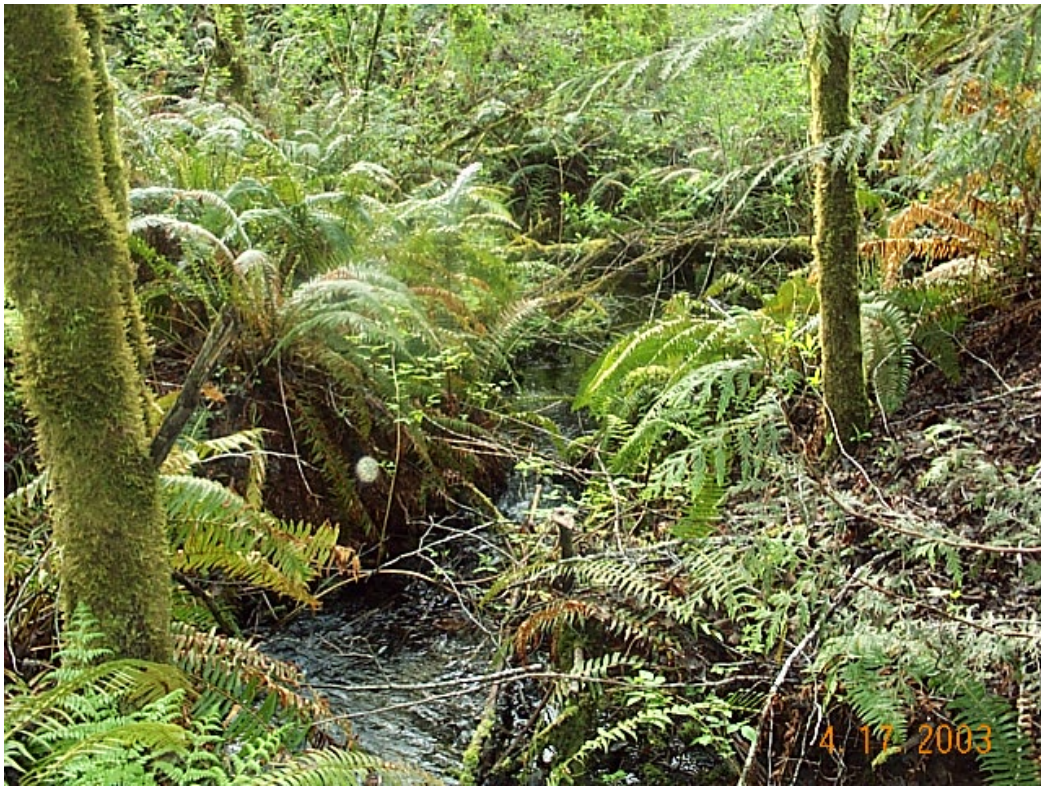
Figure 16. Riparian wetland upstream of railroad culvert MP 2.19.

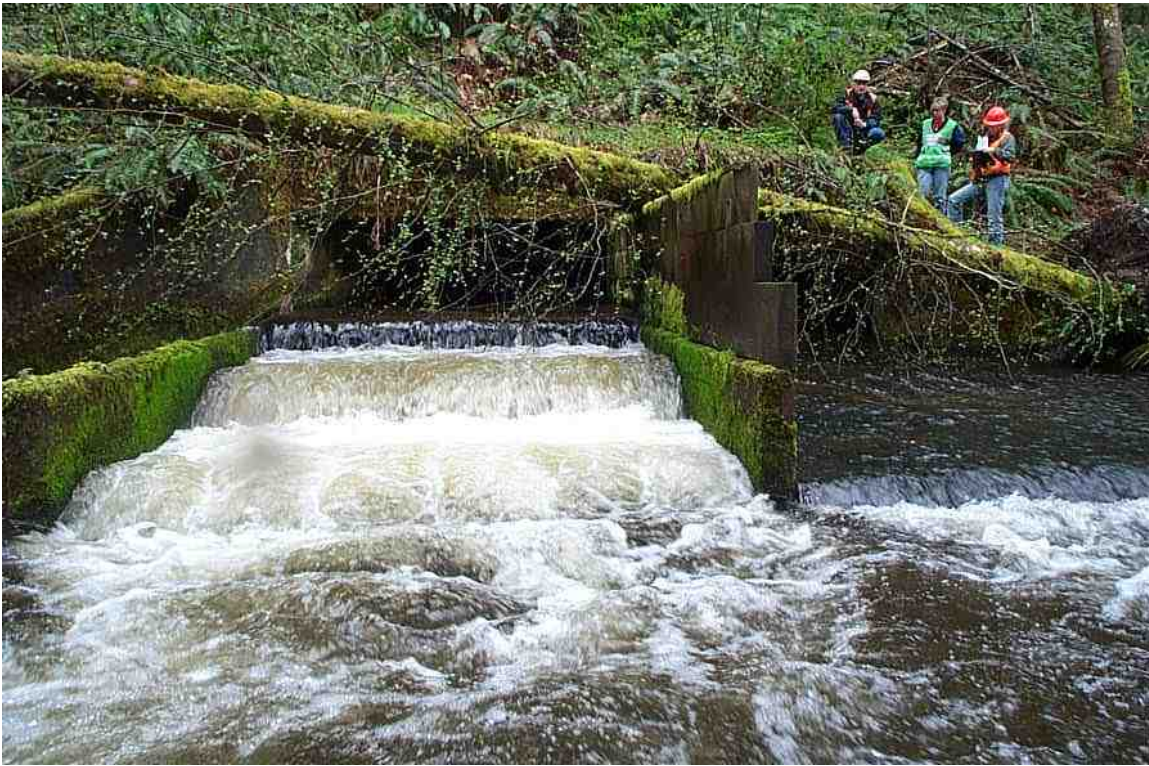
This RR culvert is located on the mainstem of Johns Creek (WRIA 14.0049) northeast of Shelton (Figure 12; WP 162). The culvert is a double-box (8- by 5-ft) concrete culvert. One side is fitted with a fish ladder to allow for adult fish passage upstream. Because of the flat concrete floor of the culvert and the lack of natural streambed material through its length, the culvert is likely a partial barrier to juveniles during high- and low-flow conditions. The fish ladder appears to function adequately for upstream adult passage except for short periods during extreme flow events. The fish ladder meets WDFW criteria for adult fish passage. This culvert is not recommended for replacement at this time, but passage could possibly be enhanced for both adults and juveniles if the culvert could be modified to meet stream simulation guidelines with a more natural streambed (see WDFW 1999).

Figure 17. Johns Creek box culvert and fishway, railroad MP 3.79.

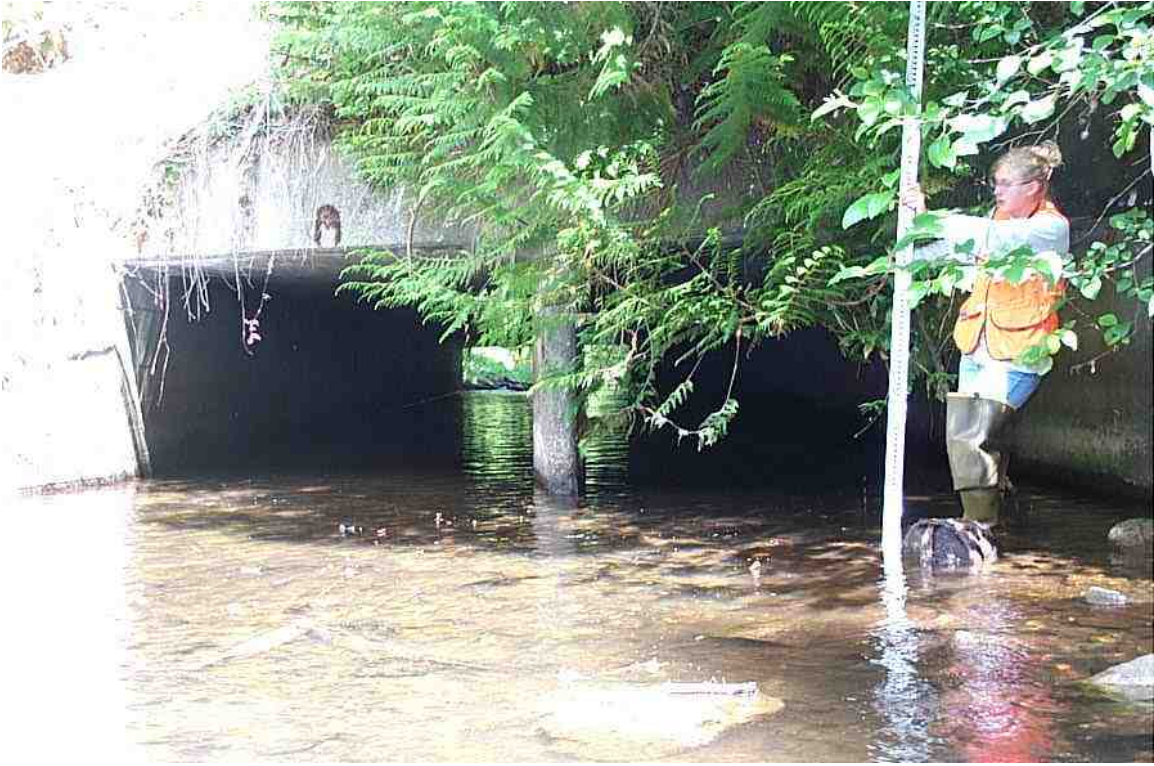
This RR culvert is located in the headwaters of Cranberry Creek (WRIA 14.0051) northeast of Shelton (Figure 12; WP 147). The culvert is a double-box (8- by 5-ft) concrete culvert. The culvert was assessed as passable during LFA surveys (WCC, 2002). No corrective action is needed for this RR culvert.

Figure 18. Cranberry Creek box culvert, railroad MP 6.60.

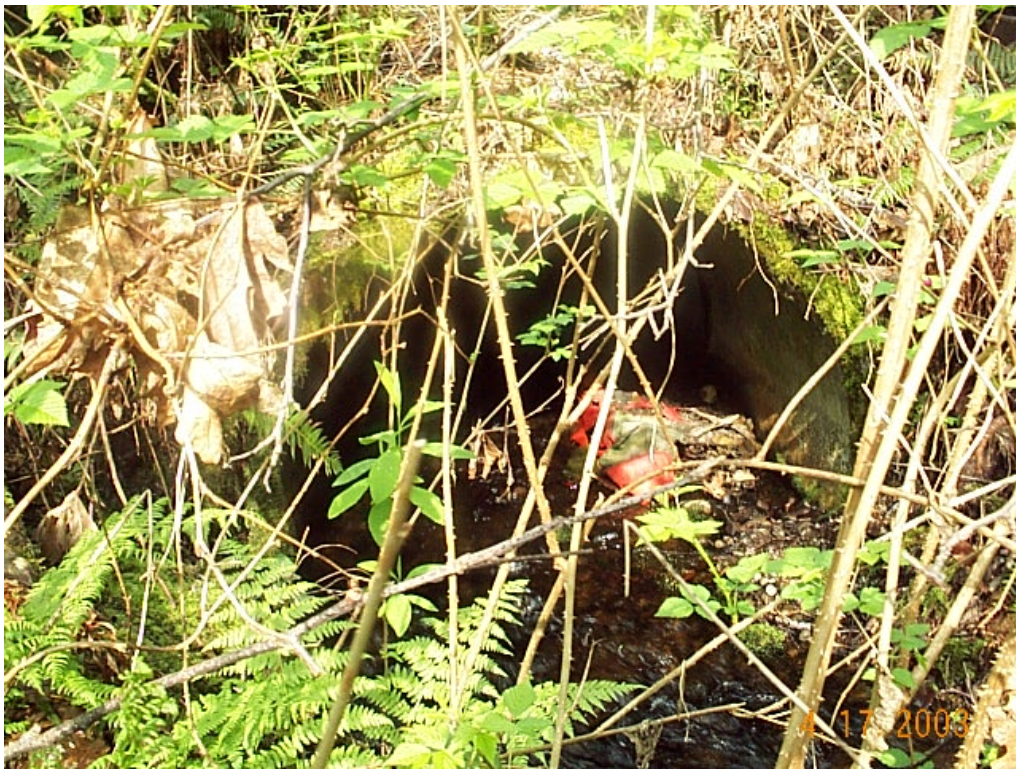
This RR culvert is located on a headwater tributary of Cranberry Creek (WRIA 14.0052) northwest of Shelton (Figure 12; WP 165). The culvert is a 3-ft concrete pipe (125 ft in length). The stream channel appears to be seasonal at this point in the watershed, originating in a forested wetland on the upstream side of the railroad grade. The RR culvert was assessed as passable based on WDFW Level-A analysis (natural streambed material throughout the culvert, slope <1%, and adequate culvert diameter). However, the culvert may be a partial barrier during high and/or low flow periods. Therefore, a habitat assessment was conducted and a PI score of 6.73 was obtained for this culvert. No fish were observed in the stream, and the channel is listed as a Type 5 by WA-DNR. However, based on stream channel size the stream was classified as potentially fish-bearing

19. Outlet of railroad culvert MP 7.52.

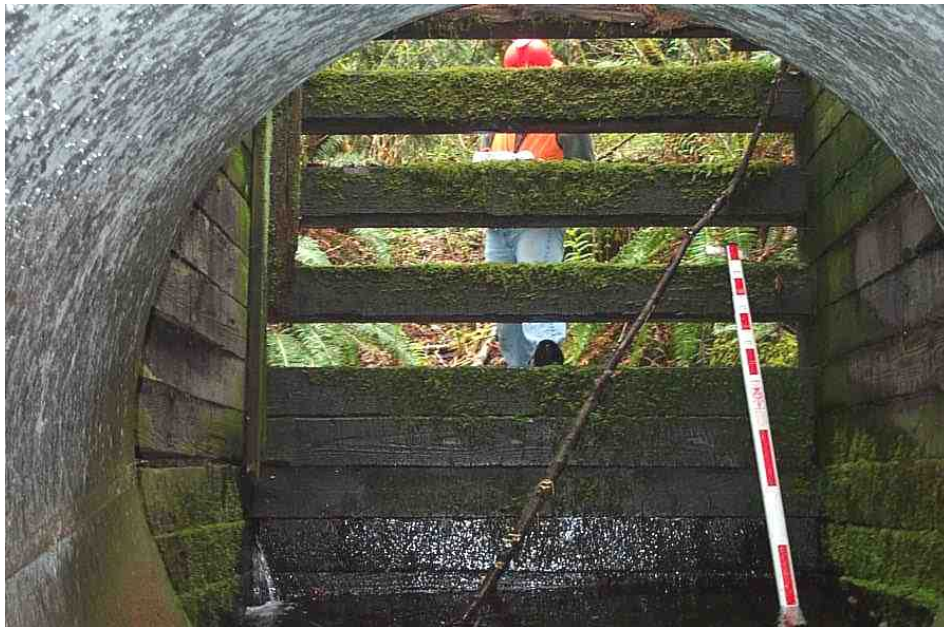
This RR culvert is located on a headwater tributary of Deer Creek (no assigned WRIA number) northeast of Shelton (Figure 12; WP 149). The culvert is a 6-ft concrete pipe (323 ft in length) with an upstream trash rack made from railroad ties. This trash rack is a barrier to fish passage at the upstream end of the RR culvert. It is recommended that this railroad-tie trash rack be removed to allow the free flow of biota, water, and organic material through the culvert. In addition, the removal will eliminate the potential water quality problem of the creosote railroad ties being in the creek and will allow for more unrestricted passage for fish, amphibians, and wildlife through the culvert. The RR culvert was assessed as passable based on WDFW Level-A analysis (natural streambed material throughout the culvert, slope <1%, and adequate culvert diameter). However, the culvert may be a partial barrier during high and/or low flow periods. Therefore, a habitat assessment was conducted and a PI score of 7.32 was obtained for this culvert. Habitat assessment surveys downstream of the railroad culvert indicate extensive wetlands and beaver ponds interspersed with stream channels. Passage through this area is likely seasonal and very dependent on flow conditions and beaver activity. Upstream of the culvert, the habitat is dominated by forested wetlands and beaver ponds, which could provide rearing habitat for both cutthroat and coho. Although no fish were observed during culvert surveys, the stream is still classified as potentially fish-bearing based on channel width and existing habitat.

Figure 20. Trash rack on inlet of railroad culvert MP 8.90.

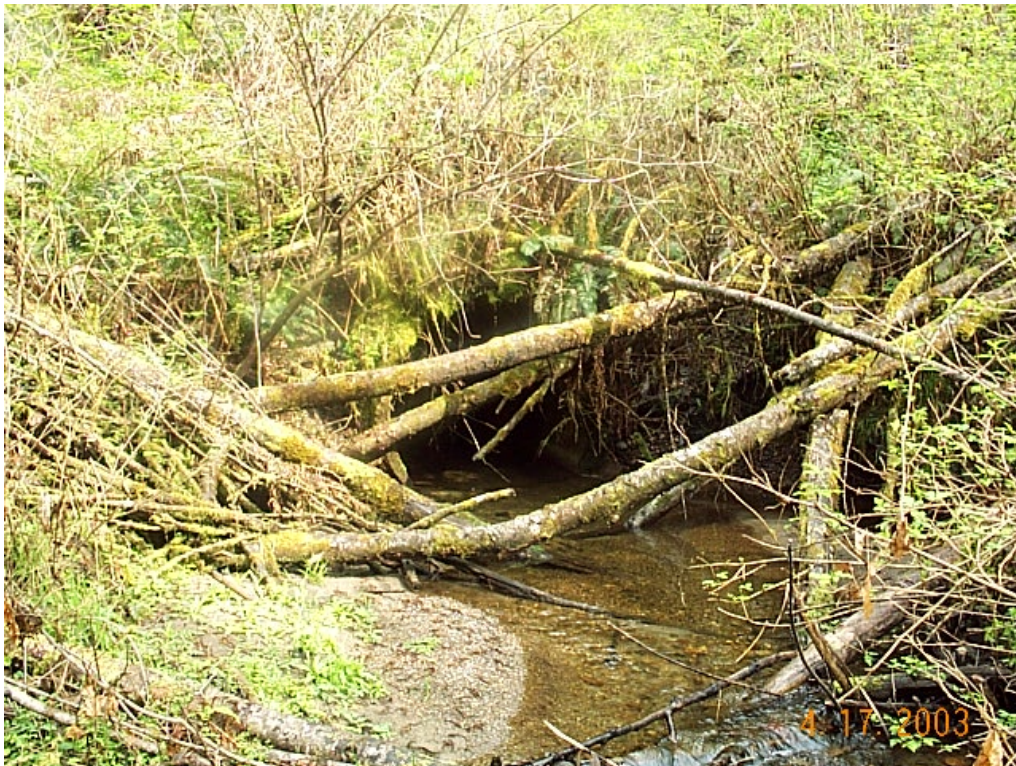
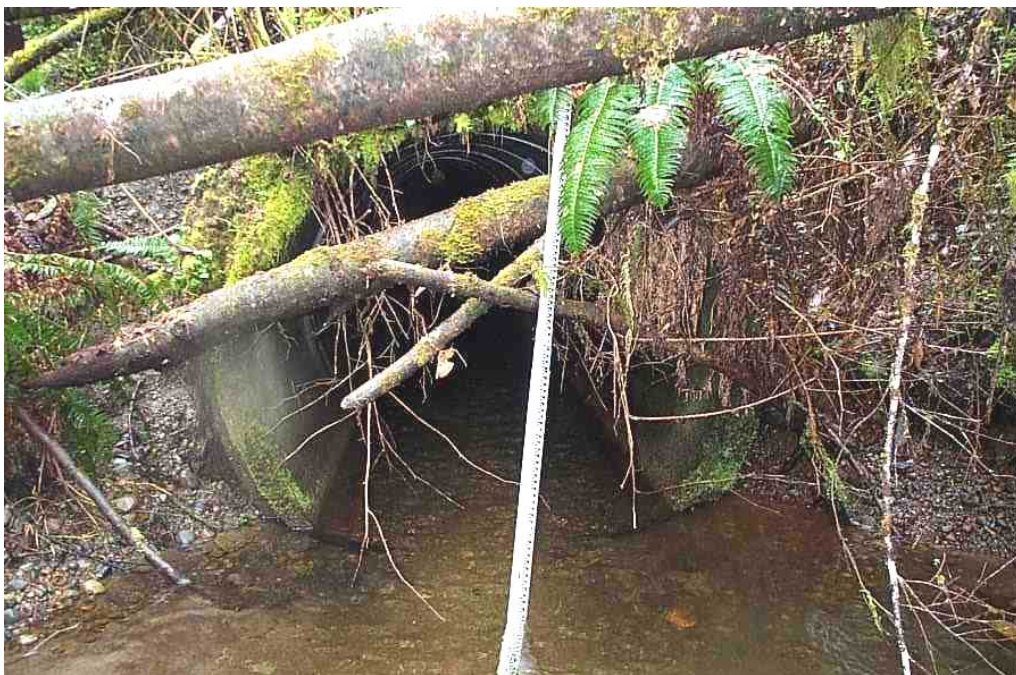
Figure 21. Outlet of railroad culvert MP 8.90.

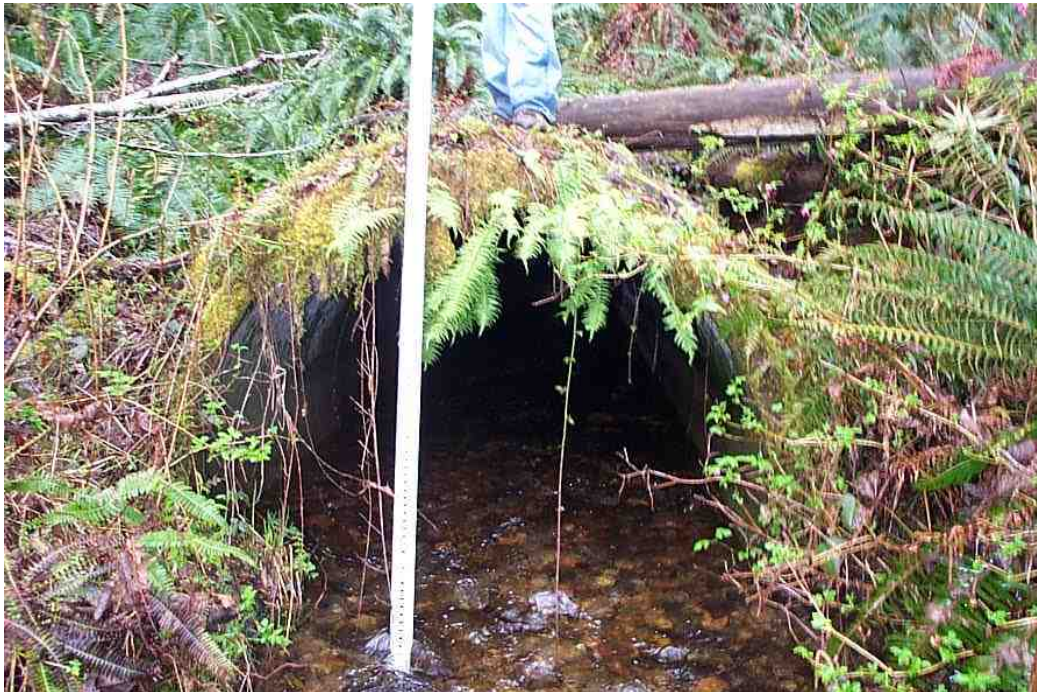
This RR culvert is located on a headwater tributary of Deer Creek (no assigned WRIA number) northeast of Shelton (Figure 12; WP 166). The culvert is a 4-ft concrete pipe (300 ft in length). The stream channel appears to be seasonal at this point in the watershed, originating in a forested wetland on the upstream side of the railroad grade. The RR culvert was assessed as passable based on WDFW Level-A analysis (natural streambed material throughout the culvert, slope <1%, and adequate culvert diameter). However, the culvert may be a partial barrier during high and/or low flow periods. Therefore, a habitat assessment was conducted and a PI score of 7.12 was obtained for this culvert. No fish were observed in the stream during culvert surveys and the channel is listed as a Type 5 by WA-DNR, however the stream was classified as potentially fish-bearing based on channel size. There is a trash rack made from railroad ties located on the upstream end of the RR culvert. This trash rack is a barrier to fish passage at the upstream end of the RR culvert. It is recommended that this railroad-tie trash rack be removed to allow the free flow of biota, water, and organic material through the culvert. In addition, the removal will eliminate the potential water quality problem of the creosote railroad ties being in the creek and will allow for more unrestricted passage for fish, amphibians, and wildlife through the culvert.

Figure 22. **Outlet of railroad culvert MP 9.28**

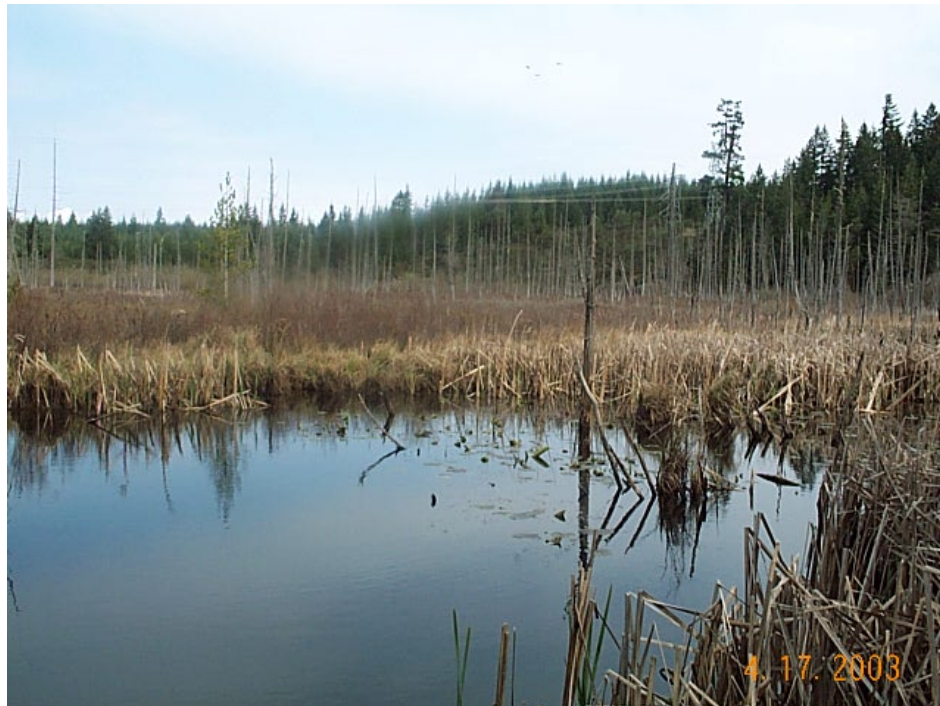
This RR culvert is located on a headwater tributary of Deer Creek (no assigned WRIA number) northeast of Shelton (Figure 12; WP 167). The culvert crossings consist of twin (3-ft) concrete pipes (100 ft in length) approximately 400 feet apart. The stream channel originates from an extensive beaver pond wetland located on the upstream side of the railroad grade (see Figure 22). Very little water was flowing in the culverts or the downstream channels at the time of the survey, although there was water in the upstream beaver pond wetland. The RR culverts were assessed as passable based on WDFW Level-A analysis (natural streambed material throughout the culvert, slope <1%, and adequate culvert diameter). However, because there are two relatively small culverts located at this crossing and because of the presence of beaver activity, these culverts may be partial barriers during some flow conditions or when beaver activity causes a blockage of one or both culverts. No fish were observed in the stream, however the stream should be considered potentially fish-bearing based on existing habitat conditions and stream channel size. Determination of resident salmonid use of the upstream beaver pond wetland would require additional surveys of the downstream channel and upstream wetlands. Stream habitat assessments were conducted and a PI score of 6.55 was determined. The RR culverts were classified as passable based on WDFW Level-A analysis (natural streambed material throughout the culvert, slope <1%, and adequate culvert diameter). However, the beaver pond location at the inlet of the railroad culverts is problematic from both a passage and maintenance perspective. It is recommended that a “beaver deceiver” device (Appendix B) be constructed at the culvert inlets to prevent beaver activity from reducing culvert capacity and restricting passage. These installations are designed to allow unrestricted flow through the culverts, as well as fish passage, while preventing the beaver from damming the culvert inlets. These devices do require special operational and maintenance efforts to ensure fish passage.

Figure 23. Beaver pond at inlet of railroad culvert MP 10.50.

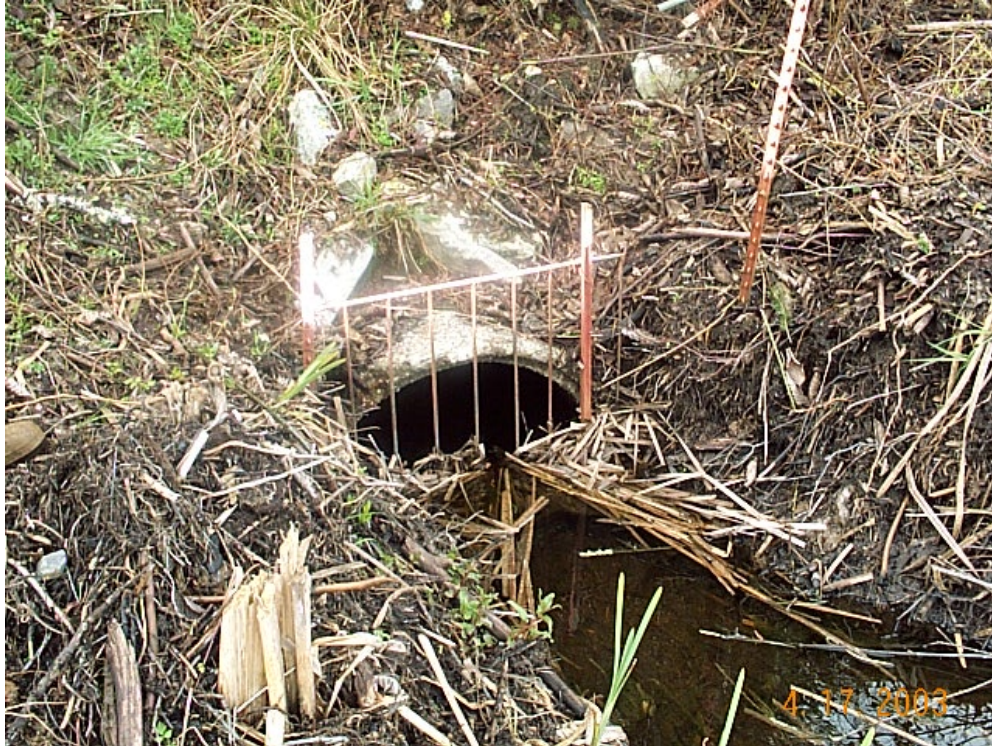
Figure 24. Inlet of railroad culvert MP 10.50.

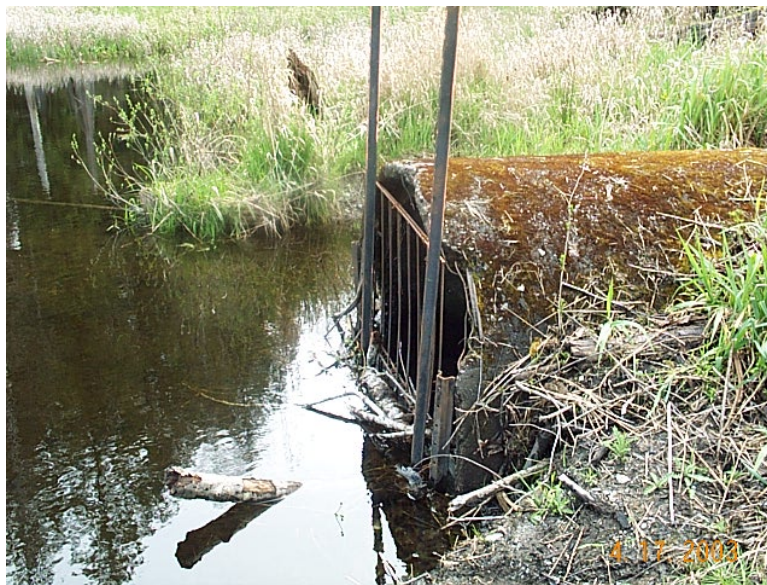
This RR culvert is located on a headwater tributary of Deer Creek (WRIA 14.0060) northeast of Shelton (Figure 13; WP 160). The culvert is a 5-ft concrete pipe (258 ft in length). The stream channel appears to be perennial at this point in the watershed, originating in a beaver pond wetland on the upstream side of the railroad grade. Very little water was flowing in the culvert or the downstream channel at the time of the survey, although there was water in the upstream beaver pond wetland. No fish were observed in the stream. There may be salmonid use of the upstream beaver pond wetland, but this study was not able to make that determination. Therefore, the stream was classified as potentially fish-bearing. There are also wetlands, beaver ponds, and signs of beaver activity downstream of the railroad culvert. The stream system can be described as a series of interconnected headwater wetlands at this point in the watershed. The RR culvert was assessed as passable based on WDFW Level-A analysis (natural streambed material throughout the culvert, slope <1%, and adequate culvert diameter). Although passable, the existing beaver activity may lead to periodic culvert blockages during some flow conditions. Therefore, a habitat assessment was conducted and a PI score of 7.45 was determined. The beaver pond location at the inlet and outlet of the RR culvert is problematic from both a passage and maintenance perspective. It is recommended that a “beaver deceiver” device (Appendix B) be constructed at the culvert inlet to prevent beaver activity from reducing culvert capacity and restricting passage. These installations are designed to allow unrestricted flow through the culvert, as well as fish passage, while preventing the beaver from damming the culvert inlet. The culvert outlet should also be cleared of debris and monitored for debris accumulation in the future. An additional beaver deterrent device may be required on the outlet as well.

Figure 25. Existing inlet of railroad culvert MP 12.01.

14.89	Deer	Passable	N/A	Install Beaver Deceiver and Monitor Passage	\$
12.01	Deer	Passable	7.45	Replace Trash Rack with Beaver Deceiver and Monitor Passage	\$

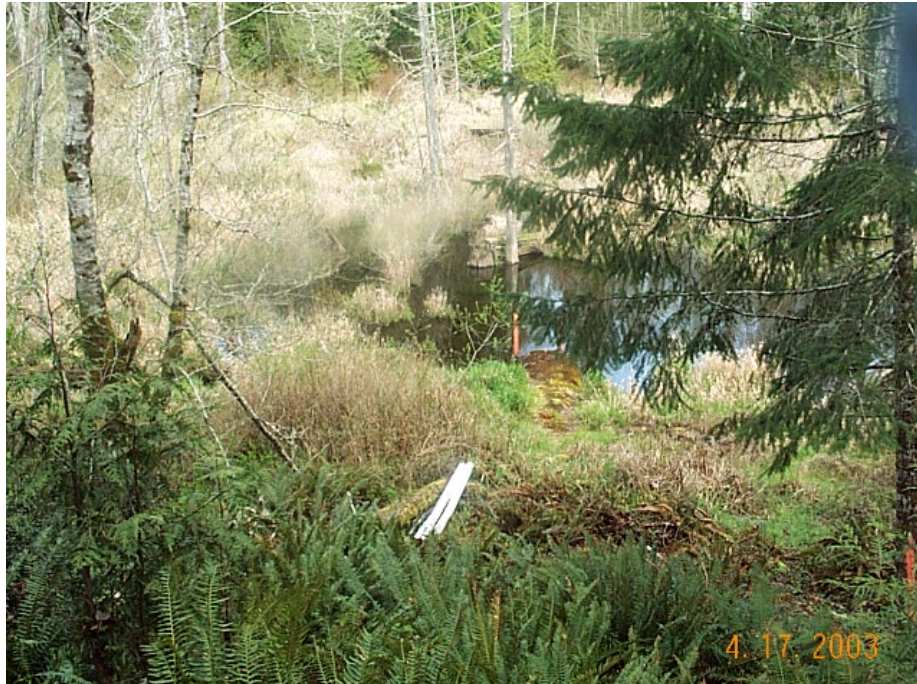
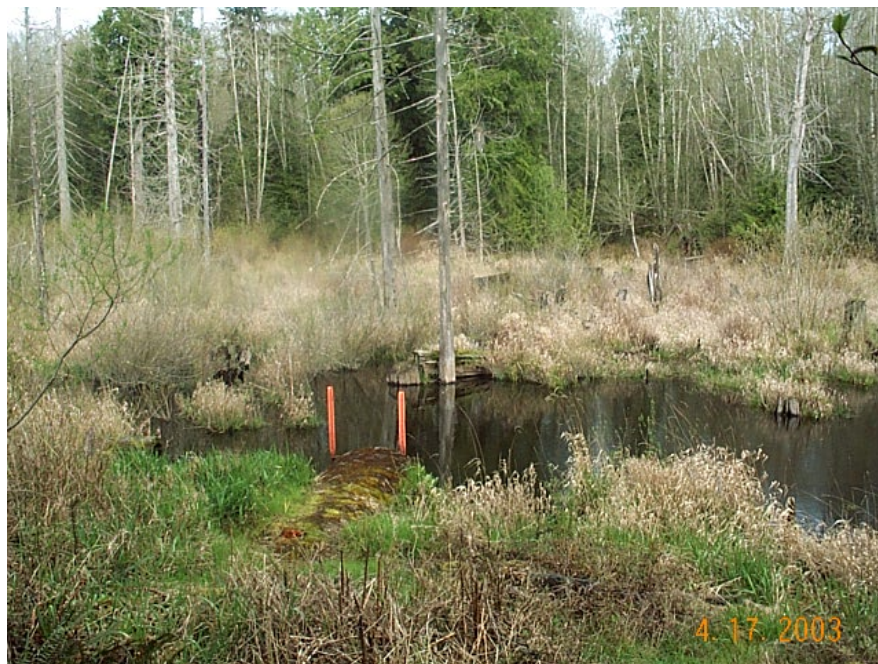
Figure 26. Beaver pond wetland at inlet of railroad culvert MP 12.01.

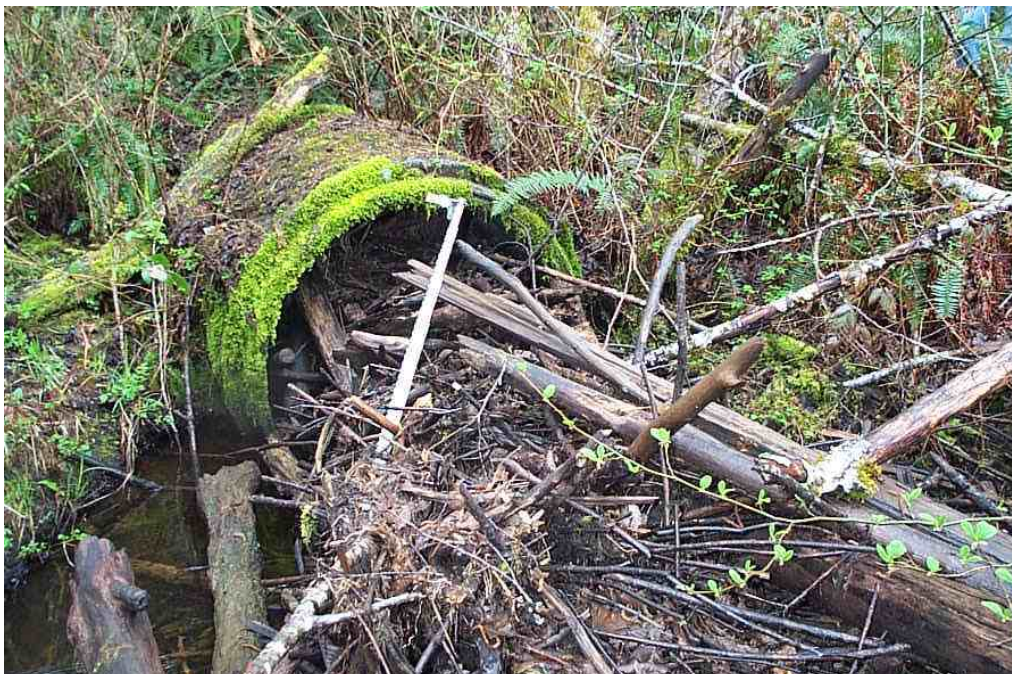
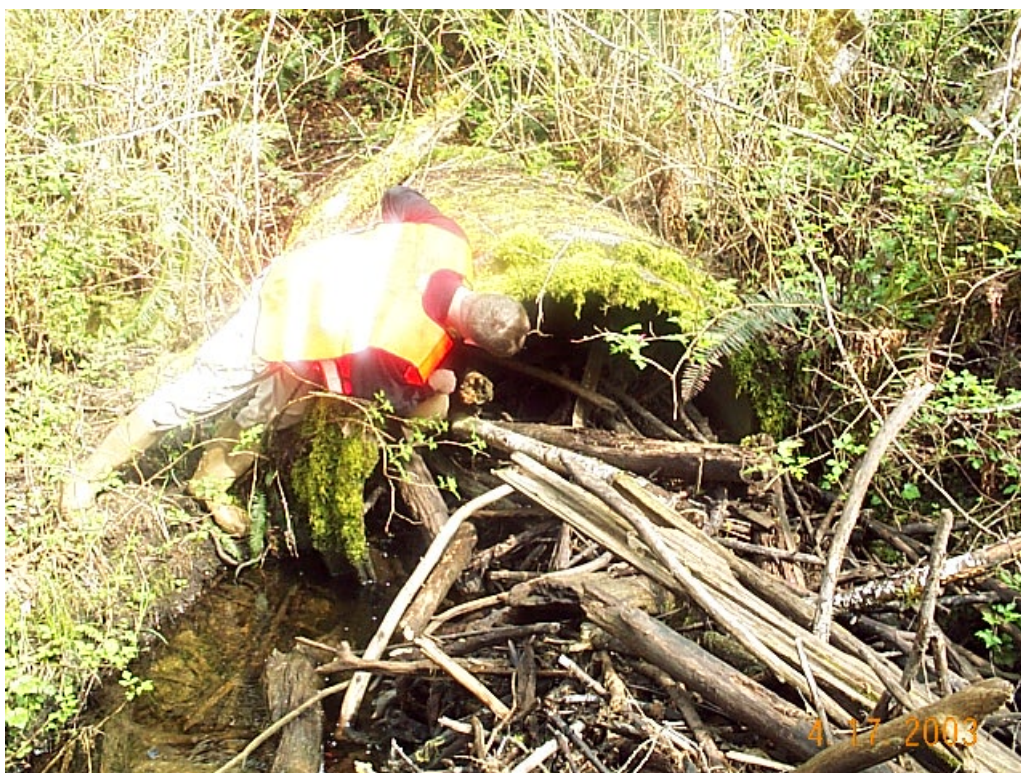
Figure 27. Outlet of railroad culvert MP 12.01.

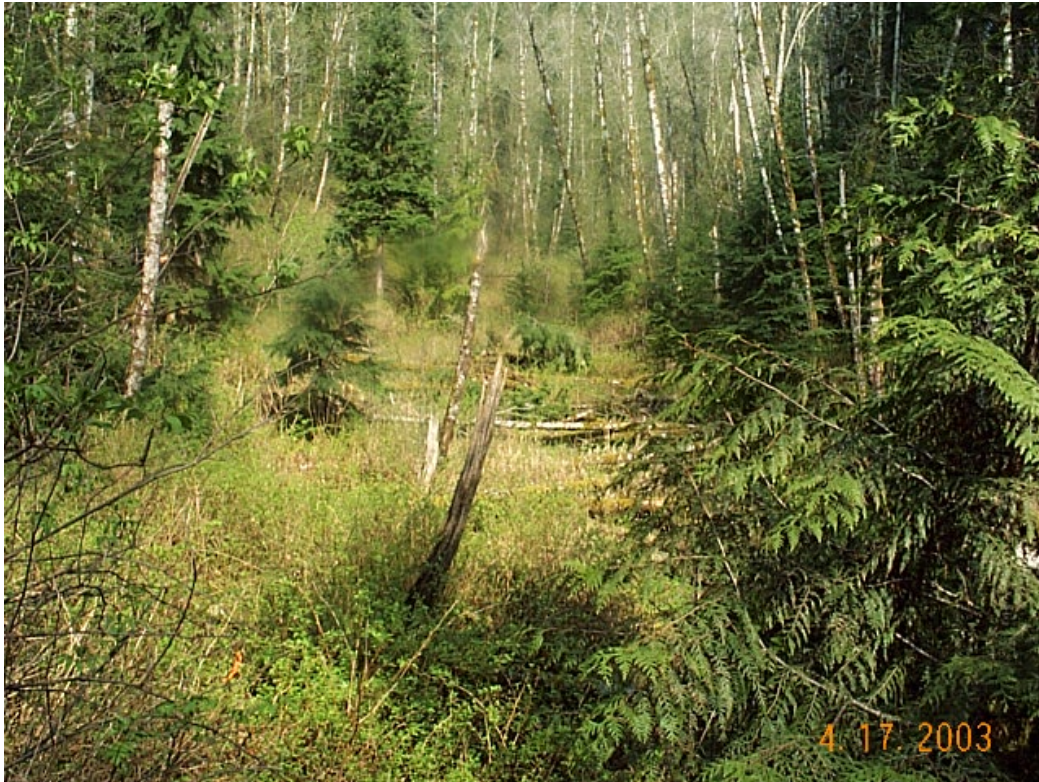
This culvert is located on a headwater tributary of Deer Creek (WRIA 14.0061) northeast of Shelton (Figure 13; WP 150). The culvert is a 4-ft concrete pipe (113 ft in length). The stream channel appears to be perennial at this point in the watershed, originating in a forested wetland on the upstream side of the railroad grade. The RR culvert was assessed as a complete barrier based on WDFW Level-A analysis (little natural streambed material inside the culvert, slope >1%, and outlet perched approximately 1 foot). The PI score is 8.59. No fish were observed in the stream during culvert surveys and the channel is listed as a Type 5 by WA-DNR, however, the stream is classified as potentially fish-bearing based on the channel size and gradient criteria. Determination of resident or anadromous salmonid use would require additional surveys of the downstream channels and upstream wetlands.

Figure 28. Upstream wetland at railroad culvert MP 12.73.

28.24	Union	Complete	15.32	Replace	\$\$\$\$\$
1.04	Jarstad	Complete	10.17	Replace	\$\$\$
21.67*	Lake Devereaux	Complete	7.34	Replace	\$\$\$
12.73	Deer	Complete	8.59	Replace	\$\$\$\$

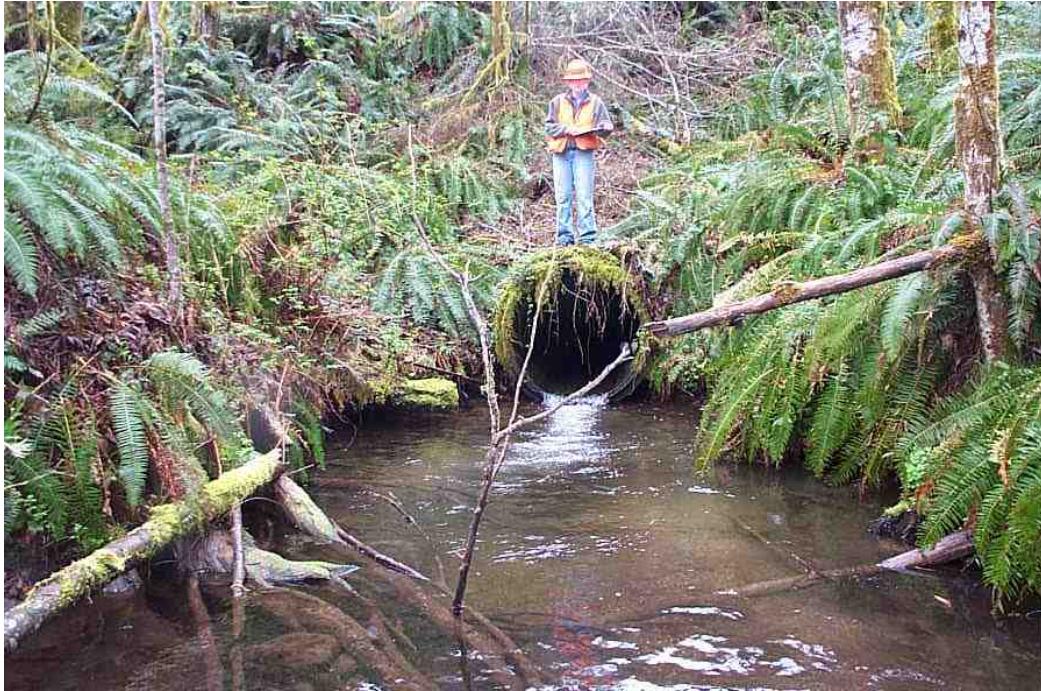
Figure 29. Outlet of railroad culvert MP 12.73.

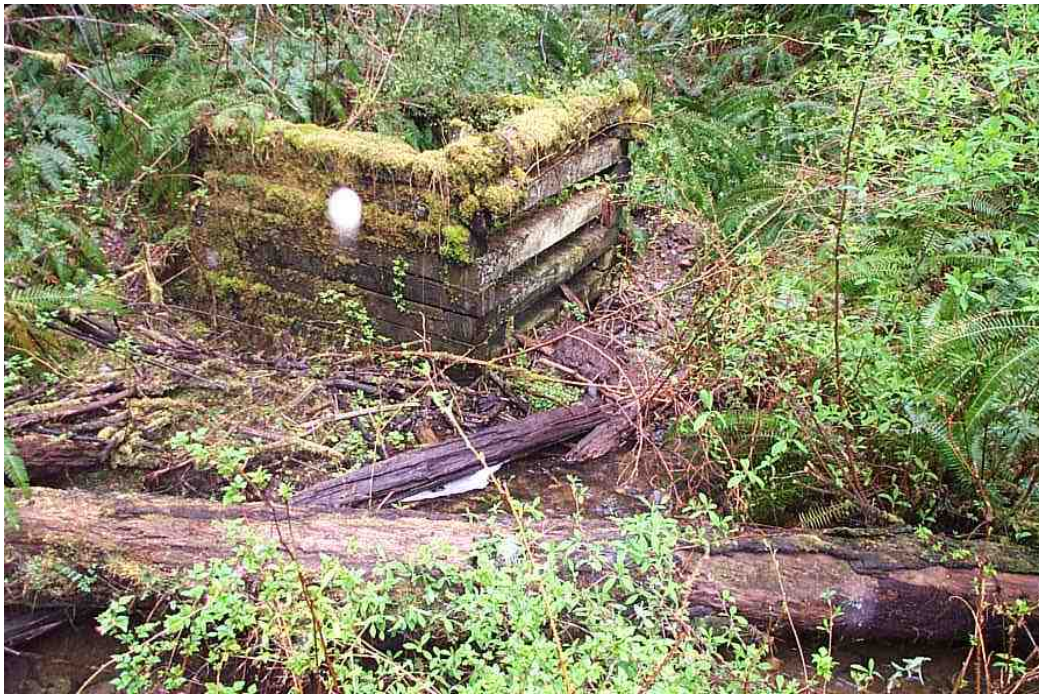
This RR culvert is located on a headwater tributary of Deer Creek (WRIA 14.0065) northeast of Shelton (Figure 13; WP 151). The culvert is a 6-ft concrete pipe (134 ft in length). The stream channel appears to be perennial at this point in the watershed, originating in a forested wetland and an abandoned beaver pond on the upstream side of the railroad grade. The RR culvert was assessed as passable based on WDFW Level-A analysis (natural streambed material throughout the culvert, slope <1%, and adequate culvert diameter). The culvert has an upstream trash rack made from railroad ties. This trash rack is a barrier for fish passage upstream of the culvert. It is recommended that this railroad-tie trash rack be removed to allow the free flow of water and organic material through the culvert. Removal of these ties will also eliminate the potential water quality problem of the creosote railroad ties being in the creek, and will further allow more unrestricted passage of fish, amphibians, and wildlife through the culvert. Although no fish were observed in this channel during culvert surveys, the creek is still considered to be potentially fish-bearing. Therefore, a habitat assessment was conducted and a PI score of 8.16 was determined.

Figure 30. Trash rack at inlet of railroad culvert MP 13.10.

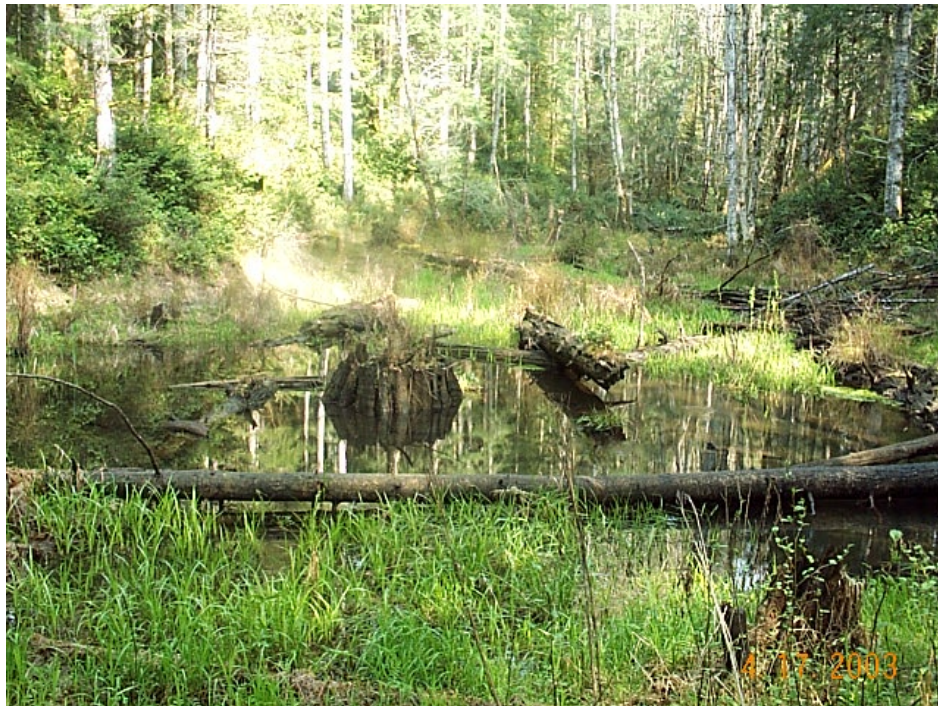
Figure 31. Upstream abandoned beaver pond at railroad culvert MP 13.10.

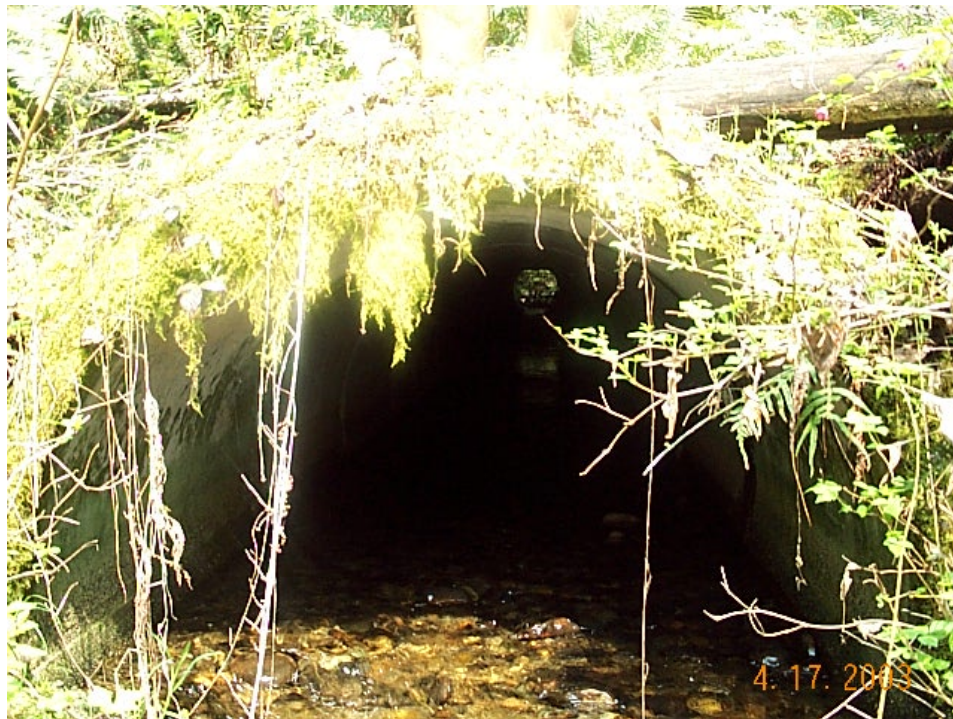
Figure 32. Outlet of railroad culvert MP 13.10.

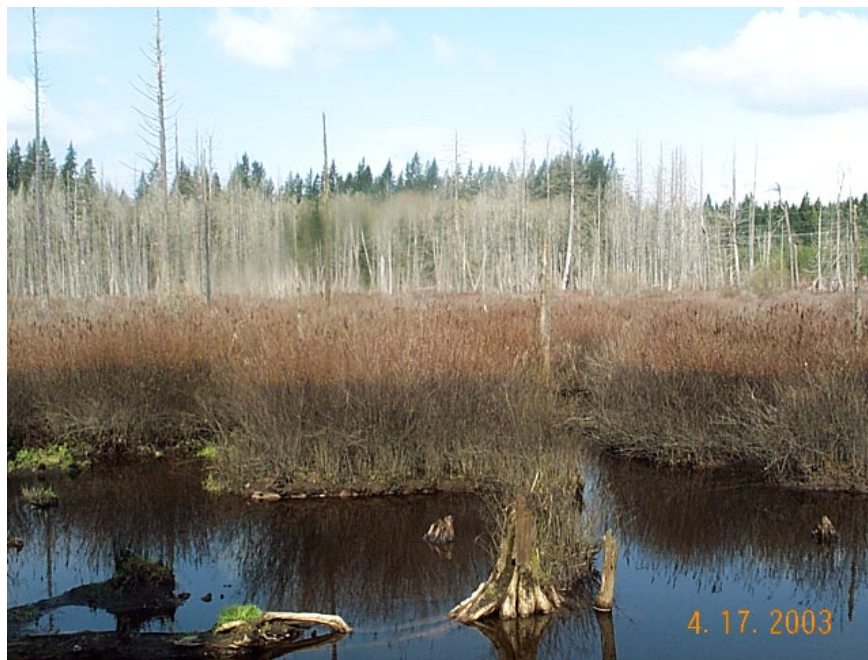
This RR culvert is located on a headwater tributary of Deer Creek (WRIA 14.0066) northeast of Shelton (Figure 13; WP 152). The culvert is a 4-ft concrete pipe (100 ft in length). The stream channel appears to be perennial at this point in the watershed, originating in a beaver pond wetland on the upstream side of the railroad grade. There is also a beaver pond wetland located on the downstream end of the culvert. The RR culvert was assessed as passable based on WDFW Level-A analysis (natural streambed material throughout the culvert, slope <1%, and adequate culvert diameter). However, the beaver pond location at the inlet of the railroad culvert is problematic from both a passage and maintenance perspective. It is recommended that a “beaver deceiver” device (Appendix B) be constructed at the culvert inlet to prevent beaver activity from reducing culvert capacity and restricting passage. These installations are designed to allow unrestricted flow through the culvert, as well as fish passage, while preventing the beaver from damming the culvert inlet.

Figure 33. Beaver pond wetland at inlet of railroad culvert MP 14.89.

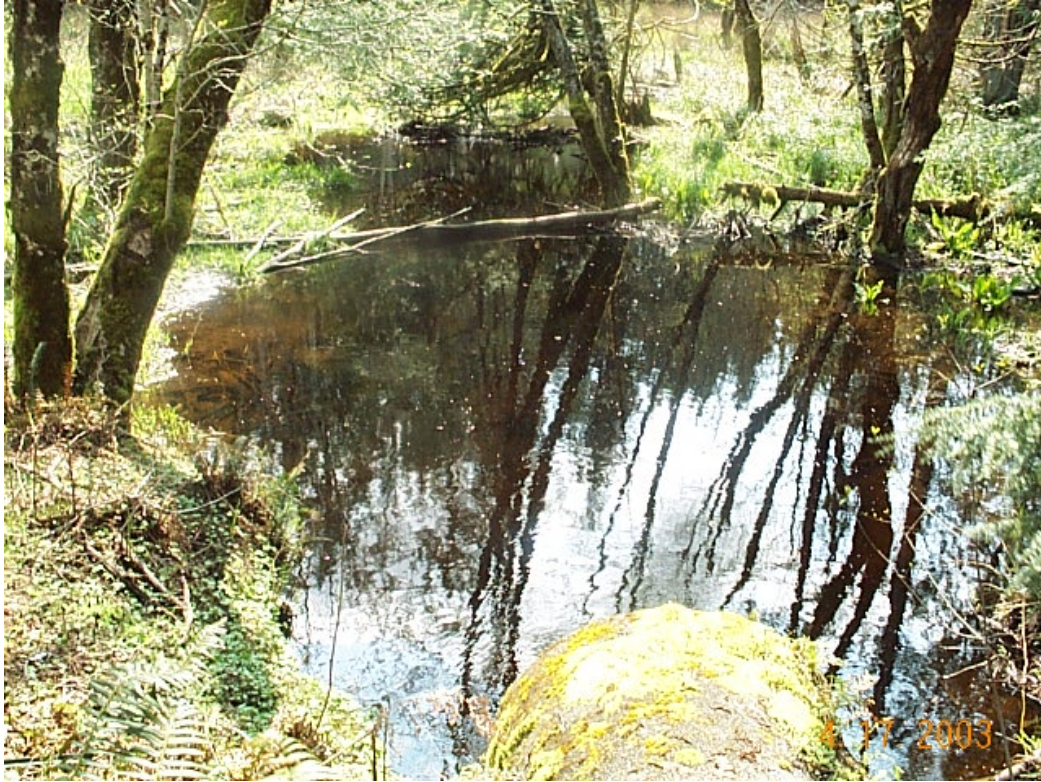
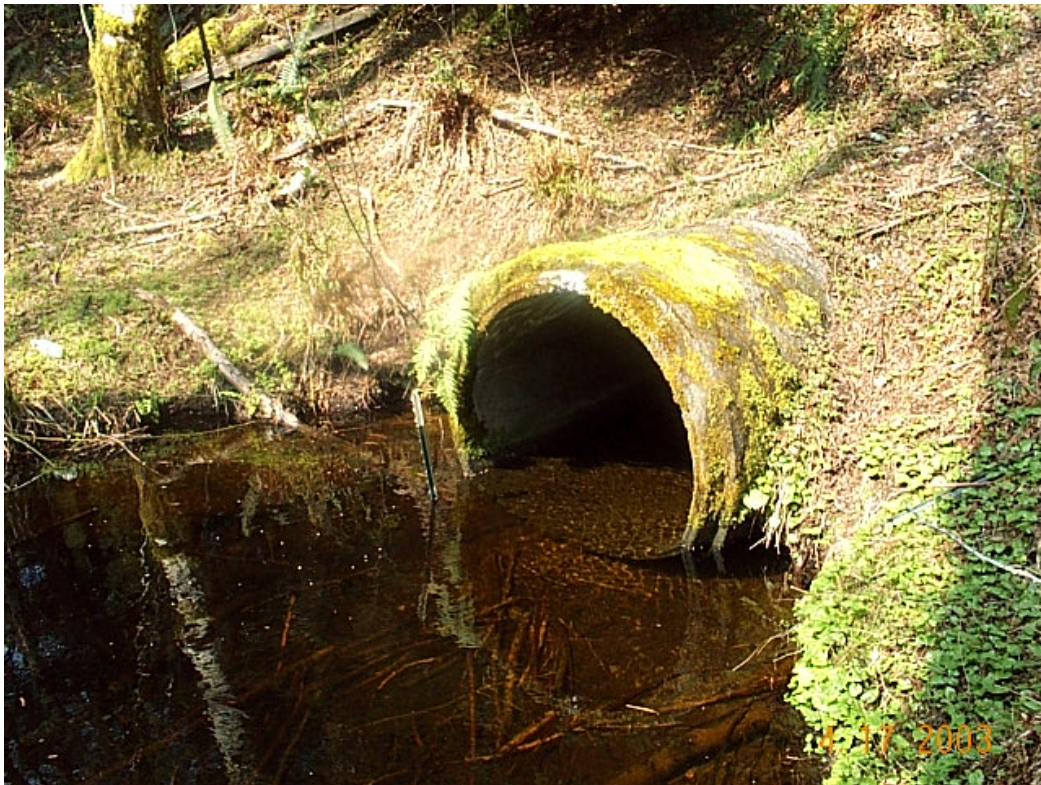
Figure 34. Beaver pond wetland at outlet of railroad culvert MP 14.89.
