An Analysis of Stream Culvert Fish Passage on the Navy Railroad Line between Bremerton and Shelton, Washington

Battelle Marine Sciences Laboratory
Sequim, Washington

September 2004

Prepared for:
Puget Sound Naval Shipyard and Intermediate Maintenance Facility

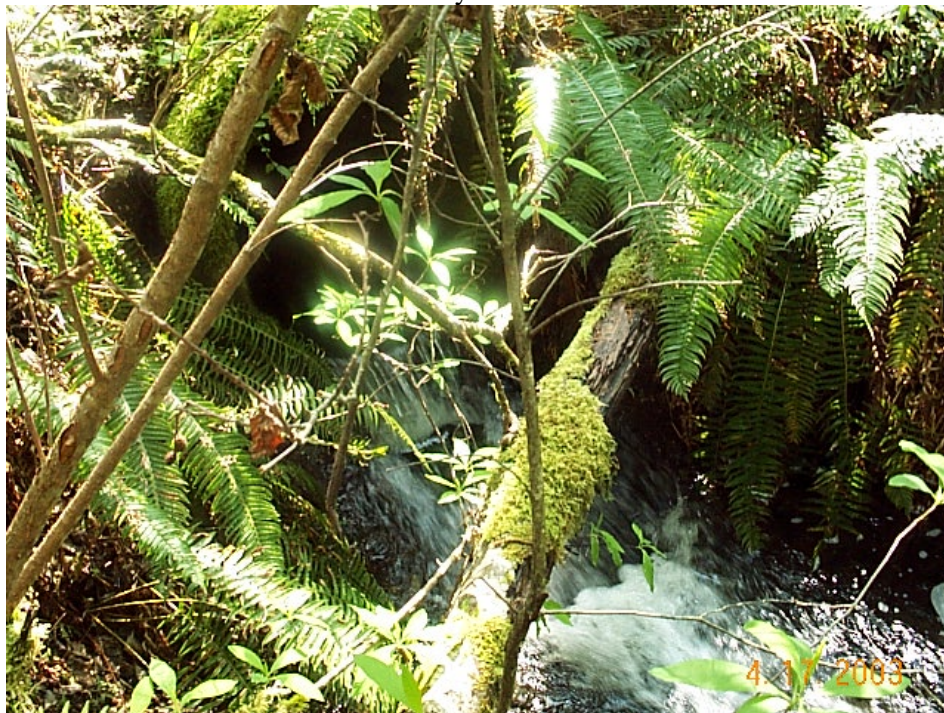
This RR culvert is located in the headwaters of Lake Devereaux Creek (WRIA 14.0125) between Allyn and Belfair (Figure 13; WP 159). The culvert is a 3-ft concrete pipe (132 ft in length). The culvert is classified as a fish passage barrier based on WDFW Level-B analysis. The culvert is undersized and there is a small (~6 ft) water fall located just downstream of the culvert outlet. This barrier may have formed as a result of excessive flows through this culvert or may have been natural, however, its location at the culvert outlet exacerbates the fish passage problem at this culvert. The culvert has a PI score of 7.34 based on habitat assessment surveys. Lake Devereaux and the outlet wetlands provide good rearing habitat upstream of the culvert, although the creek is seasonal and very dependent on flows from the lake. There is adequate spawning and rearing habitat located downstream; however, there are at least two other barrier culverts downstream of the railroad culvert. The most significant of these barriers is at the mouth of the creek (SR-104), which should be replaced by the Washington State Department of Transportation (WSDOT) so as to allow full access to the stream system for native salmonids.

Figure 35. Outlet of railroad culvert MP 21.67.

28.24	Union	Complete	15.32	Replace	\$\$\$\$\$
1.04	Jarstad	Complete	10.17	Replace	\$\$\$
21.67*	Lake Devereaux	Complete	7.34	Replace	\$\$\$
12.73	Deer	Complete	8.59	Replace	\$\$\$\$

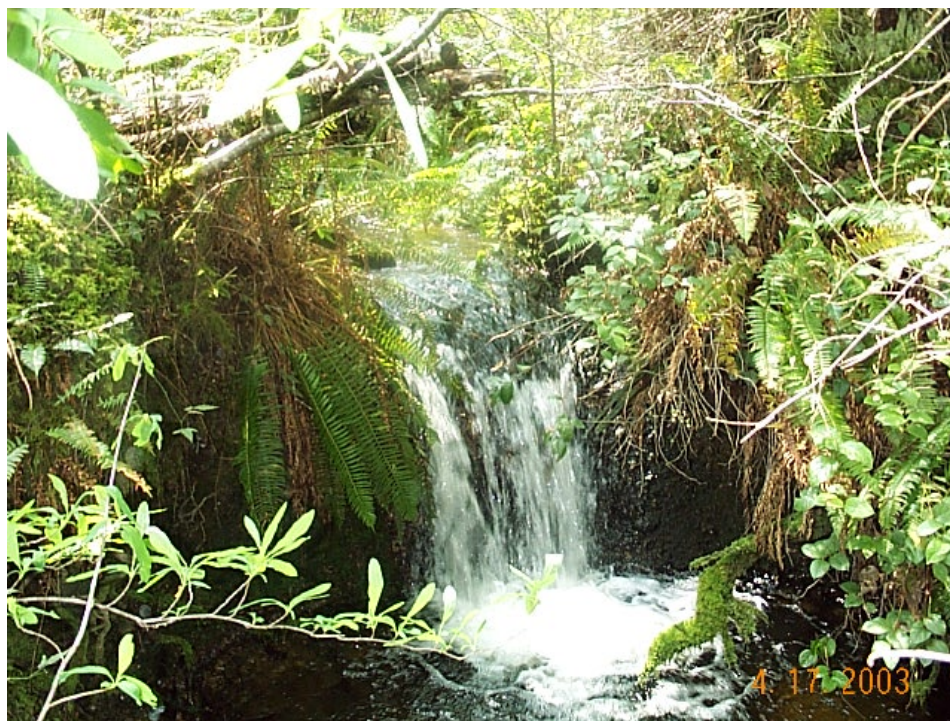
Figure 36. Falls just downstream of outlet of railroad culvert MP 21.67.

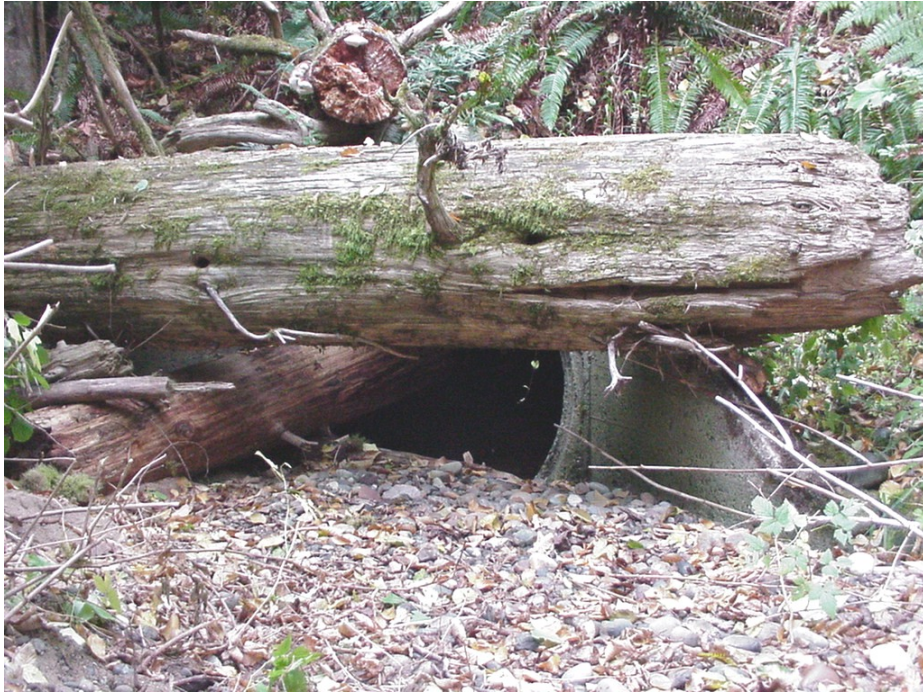
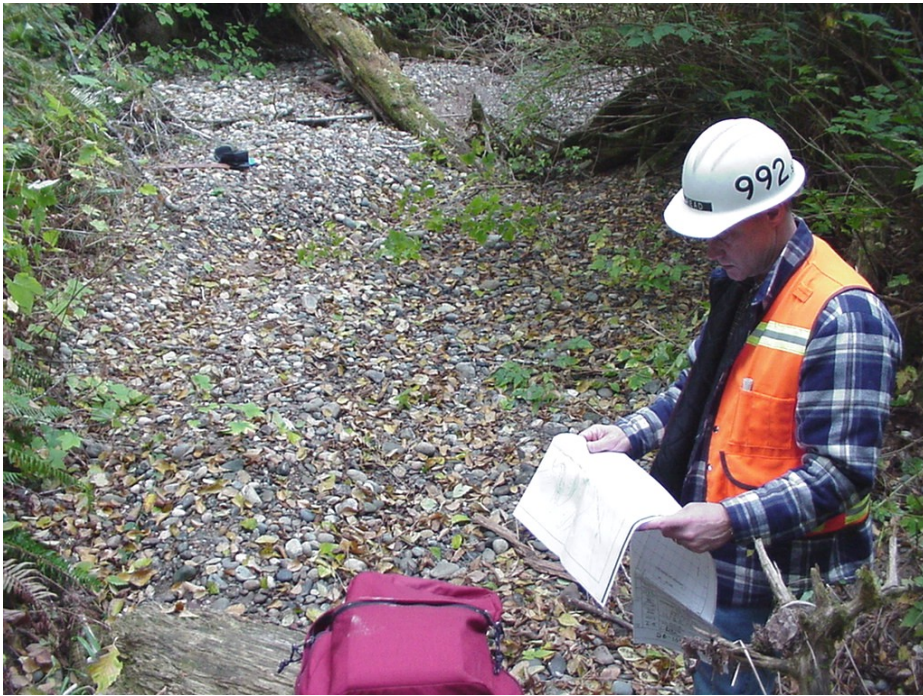
Stormwater runoff from the Bremerton Airport (City of Bremerton and Kitsap County jurisdiction) has also resulted in significant stormwater flow increases in the upstream channel, as well as streambank erosion and streambed scour. The result has been significant degradation in spawning and rearing habitat upstream of the railroad culvert and an exacerbation of the flow-capacity problems of the original culvert design (WDFW, 2001). The correction of this stormwater runoff problem should be integrated with any long-term plan for culvert replacement. In addition, rehabilitation of damaged or lost habitat between the railroad grade and the airport will also be required. Although this stream is classified as perennial by WDFW, flow is very seasonal and is dependent on the headwater wetlands located on airport property for flow. There are water quality concerns with these wetlands, as they receive runoff from the airport runway and hanger areas. Coordination between WDFW, City of Bremerton, Kitsap County, HCSEG, and the Navy will be required to correct this fish passage barrier, as well as the stormwater problems and instream habitat rehabilitation needs.

Figure 37. Inlet of railroad culvert MP 28.24.

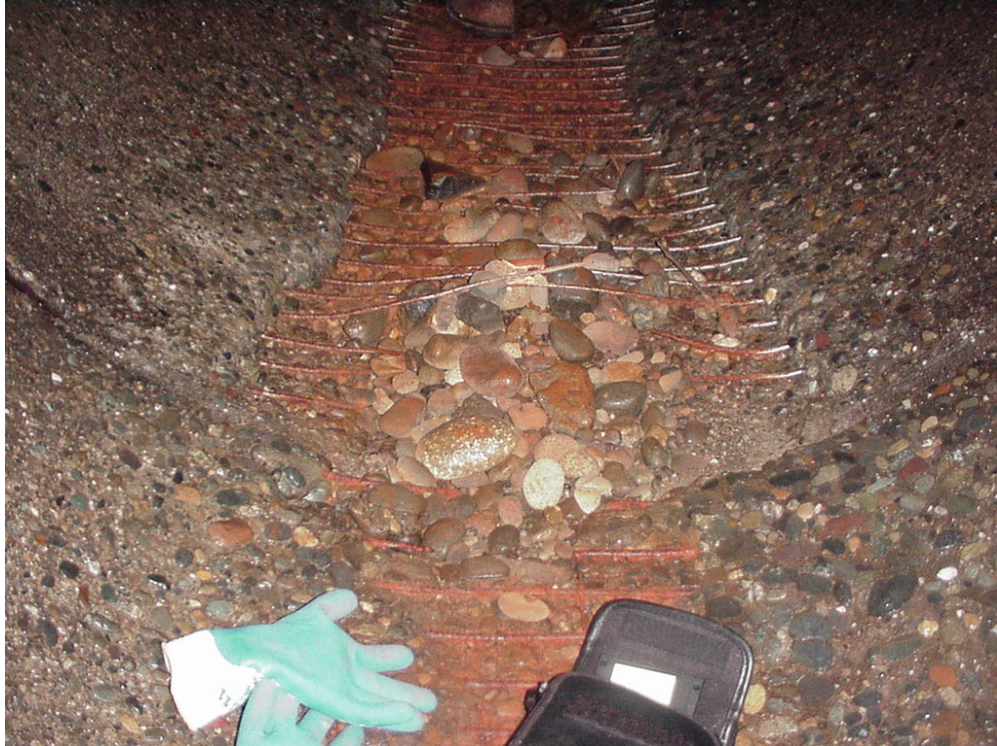
Figure 38. Interior structural damage to railroad culvert MP 28.24.

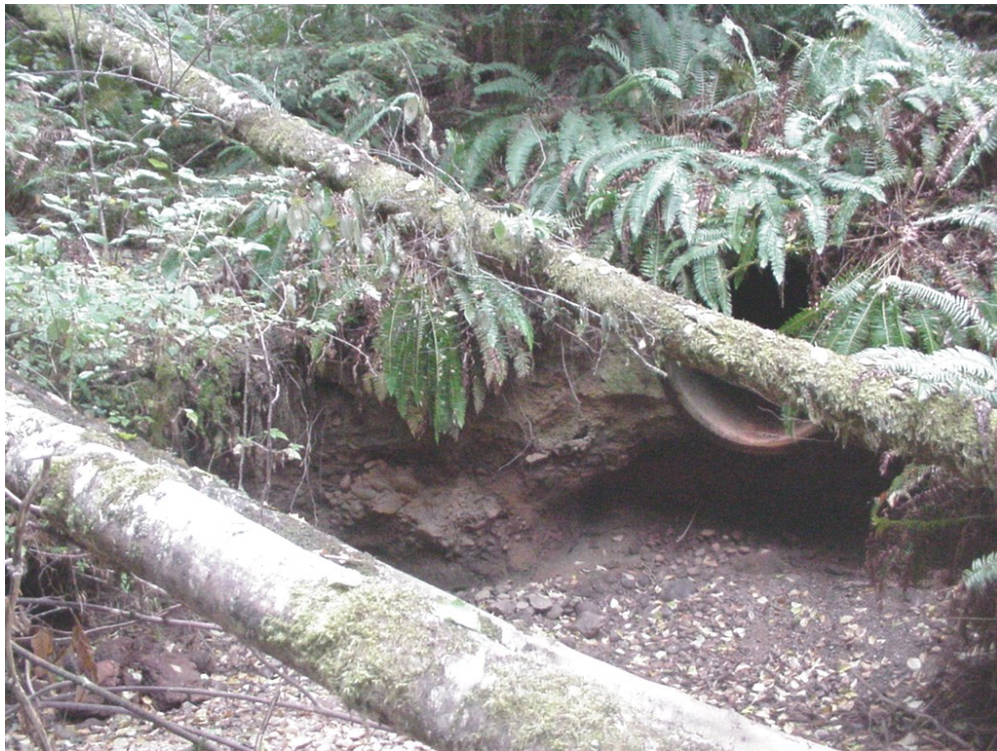
Figure 39. Outlet of railroad culvert MP 28.24.

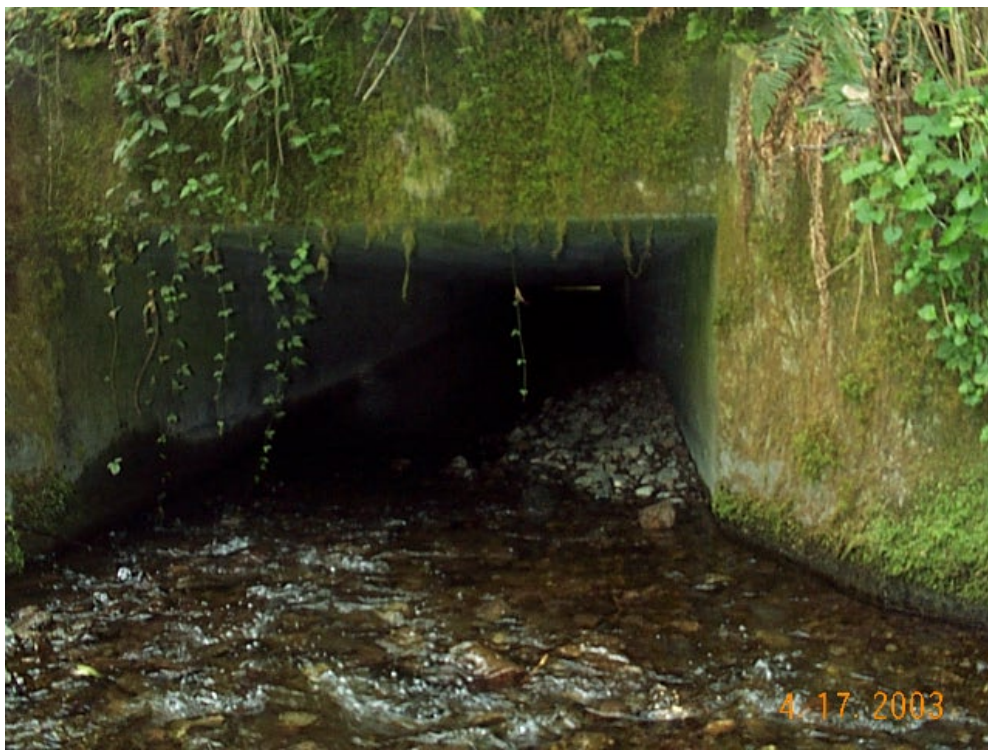
This RR culvert is located on a tributary of Gorst Creek (WRIA 15.0223) northwest of Gorst (Figure 14; WP 161). The culvert is an 8- by 5-ft concrete box culvert (180 ft in length) that has been classified as passable by WDFW Level-A analysis. There is adequate flow capacity in the culvert as sized, the culvert gradient is <1%, and natural streambed material exists throughout. However, there is a debris jam located just downstream of the culvert that may be causing a partial barrier at the culvert inlet during high flow conditions. The Suquamish Tribe and WDFW habitat biologists have recommended that this debris jam be relocated downstream (WDFW Hydraulic Permit required) and the creek monitored. One section of the culvert roof may also be cracked. Although not believed to be a structural or passage problem, it should be investigated by railroad engineers. These corrective actions have been scheduled. There is ample, good quality spawning and rearing habitat upstream and downstream of the culvert. Juvenile salmonids were observed upstream and downstream of the culvert during stream surveys. In addition, the Suquamish Tribe spawning surveys have noted that this is a very productive tributary in the Gorst Creek system.

Figure 40. Inlet of railroad culvert MP 31.55.

Culvert MP	Creek	Barrier Status	PI Score	Corrective Action	Cost Estimate
31.55	Gorst	Passable	N/A	Remove Debris and inspect culvert	\$
0.71	Heinz	Partial	9.79	Modify (Fishway) or Replace	\$\$\$

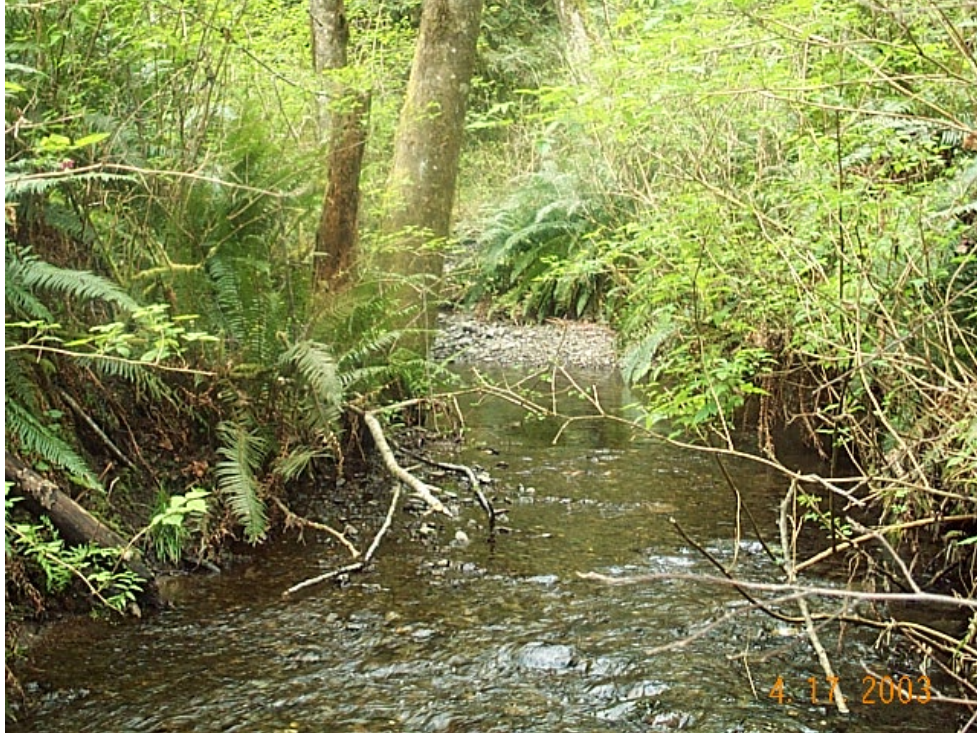
Figure 41. Instream habitat upstream of railroad culvert MP 31.55.

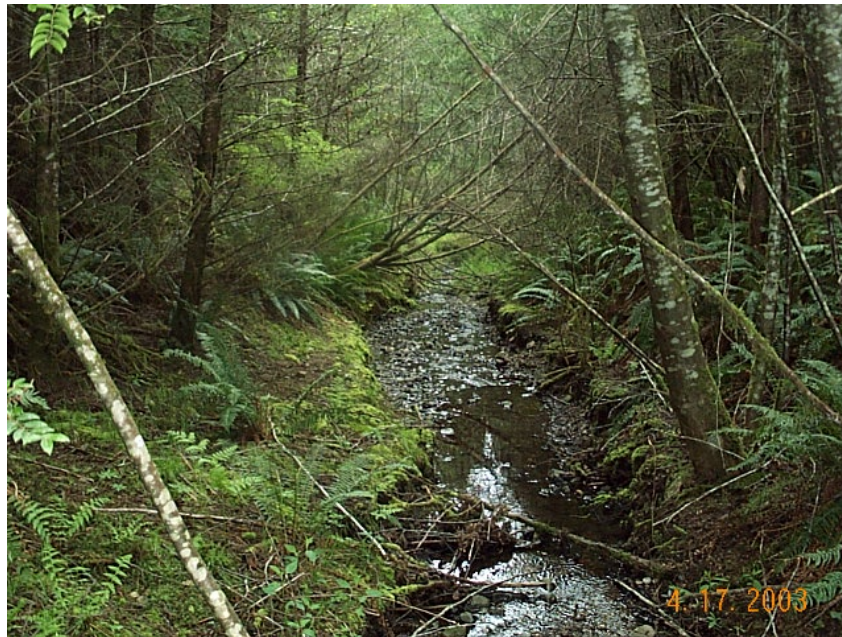
This RR culvert is located at the headwaters of an un-named tributary of Gorst Creek northwest of Gorst (Figure 14; WP 156). The culvert is a 30-in. concrete pipe (213 ft in length). The stream channel is seasonal at this point in the watershed, originating in a steep (>20% slope) forested area on the upstream side of the railroad grade. No water was flowing in the culvert or the downstream channel at the time of the survey, although there was flow upstream of the culvert, so the creek is likely hyporheic for much of the year throughout sections of this tributary. The culvert was assessed as a fish-passage barrier based on WDFW Level-B analysis. An instream habitat assessment was conducted and a PI score of 2.17 was determined. Upstream habitat is limited mainly by the steep gradient. No fish were observed in the stream, however limited resident salmonid use may be possible just upstream of the culvert based on channel size and habitat conditions. In addition, limited juvenile rearing habitat also exists. Therefore, the stream is classified as potentially fish-bearing. There were several potential barriers noted downstream of the culvert (beaver dams and logging road culverts on City of Bremerton property). These culverts should be evaluated and PI scores derived for each.

Figure 42. Instream habitat downstream of railroad culvert MP 32.09.

10.50	Deer	Passable	6.55	Install Beaver Deceiver and Monitor Passage	\$
32.09	Gorst	Complete	N/A	Replace	\$\$\$\$\$
2.19	Unnamed	Complete	6.43	Remove Trash Rack and Replace Culvert	\$\$\$

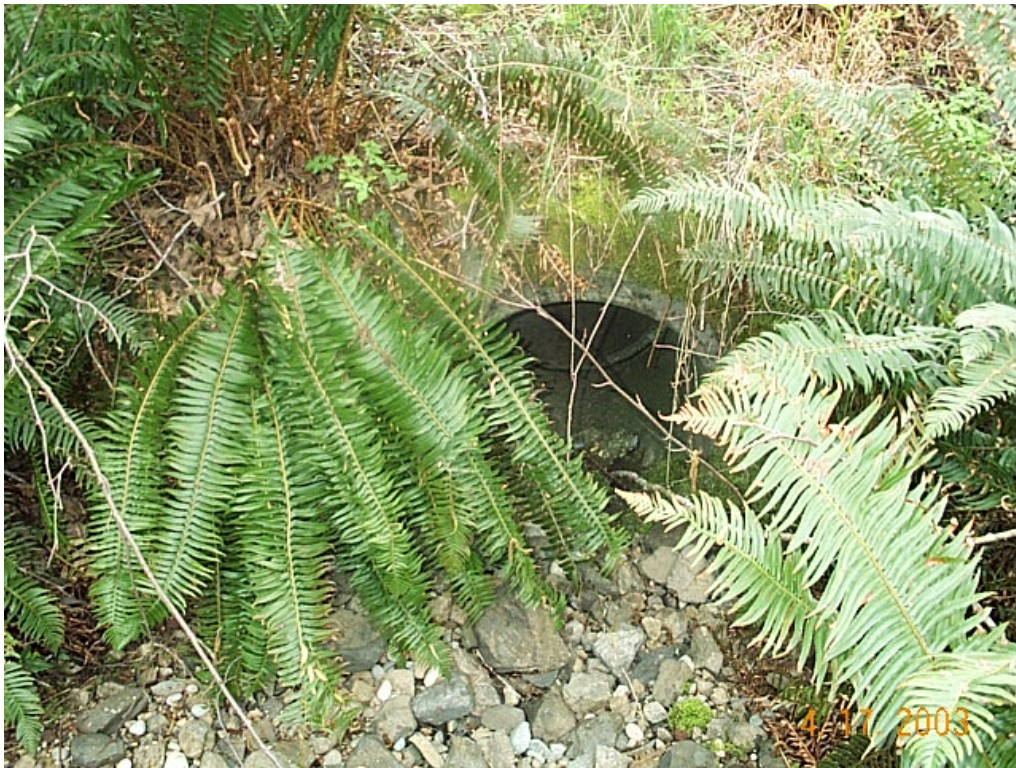
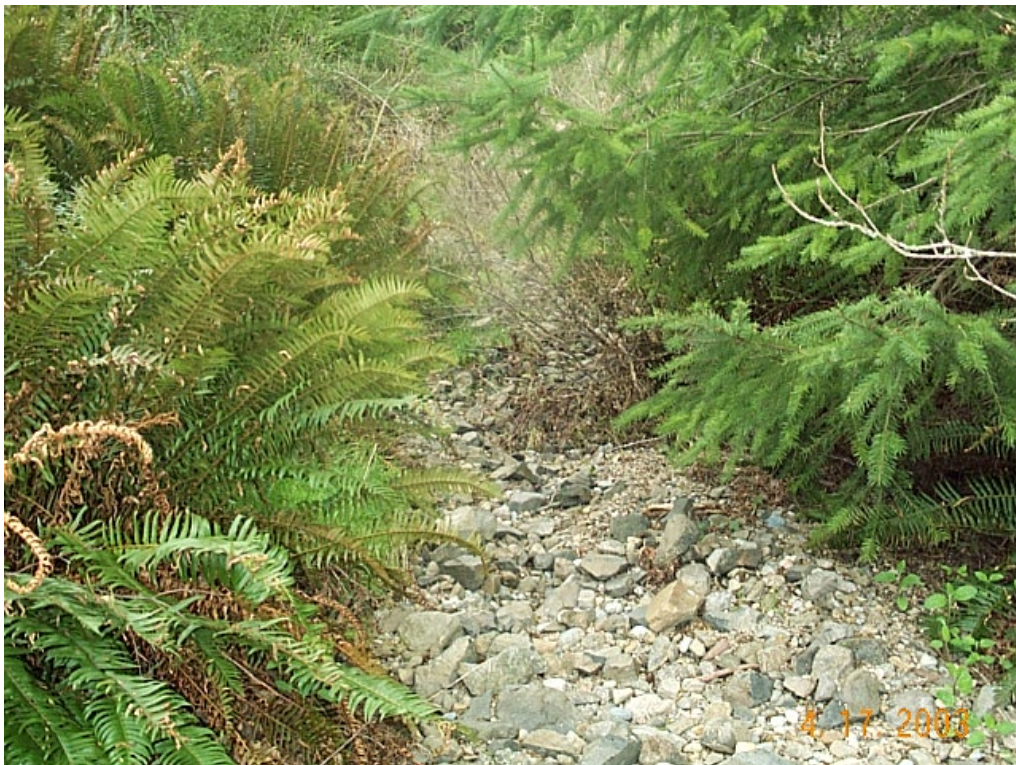
Figure 43. Outlet of railroad culvert MP 32.09.

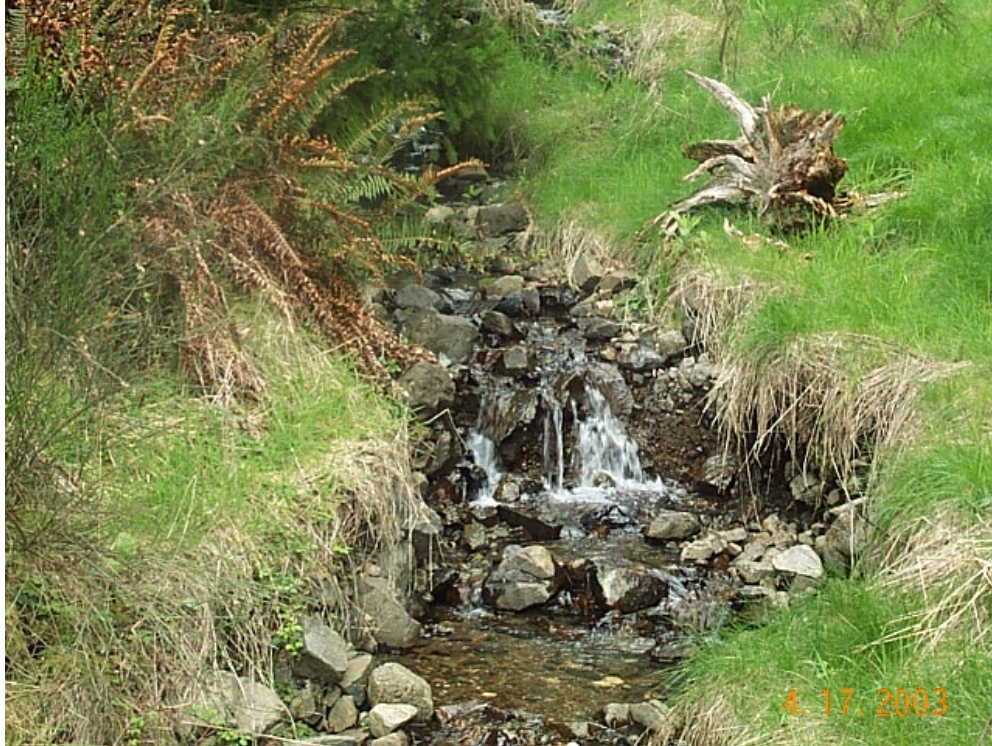
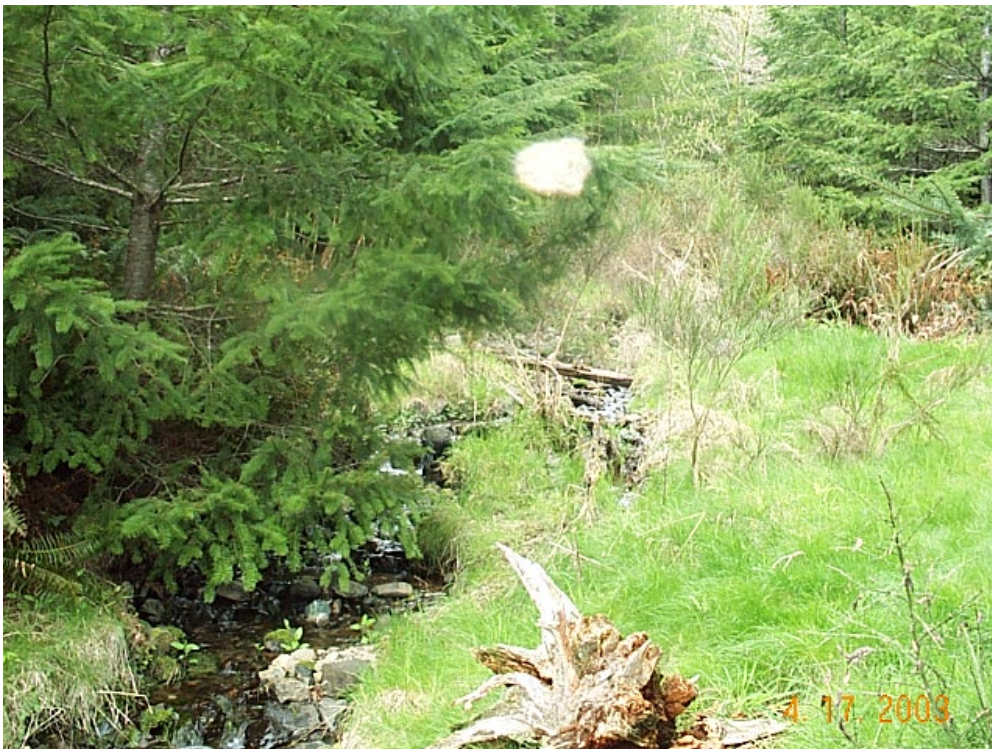
Figure 44. Instream habitat just upstream of railroad culvert MP 32.09.

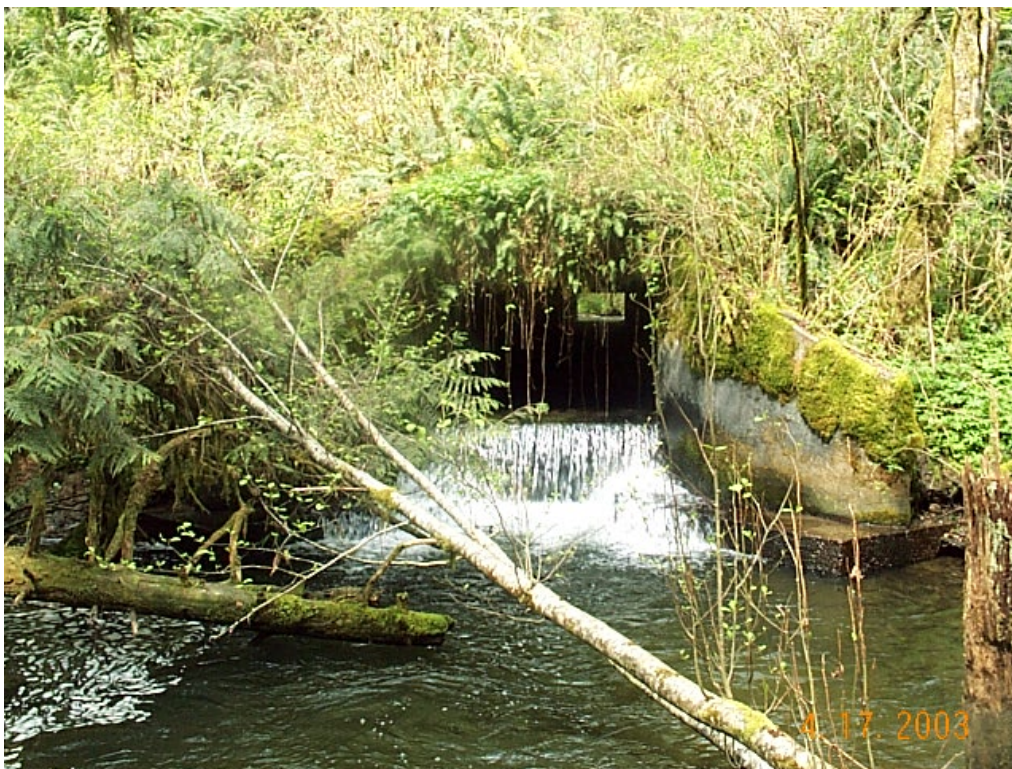
This RR culvert is located on the Heins Creek tributary of Gorst Creek (WRIA 15.0221) northwest of Gorst (Figure 14; WP 157). The culvert is an 8- by 5-ft concrete box culvert (159 ft in length) that has been classified as a barrier by WDFW Level-A analysis (survey conducted by WDFW in 2002). Juvenile and adult salmonids have been observed upstream and downstream of the culvert, so it is likely passable during certain flow conditions. There is ample, good quality spawning and rearing habitat upstream and downstream of the culvert. The culvert has a PI score of 9.79 (based on WDFW surveys conducted in 2002). There is also a downstream (partial) barrier on the City of Bremerton access road that should be corrected by the City in coordination with work on the RR culvert. Current plans call for the replacement of this downstream barrier and the installation of an engineered fishway on the railroad culvert during the summer of 2004. The use of grade-control weirs instead of a bridge or new culvert to correct this passage problem will likely necessitate some long-term maintenance, but should be sufficient to correct the barrier problem in the near-term.

Figure 45. Heins Creek (railroad MP 0.71) culvert outlet.

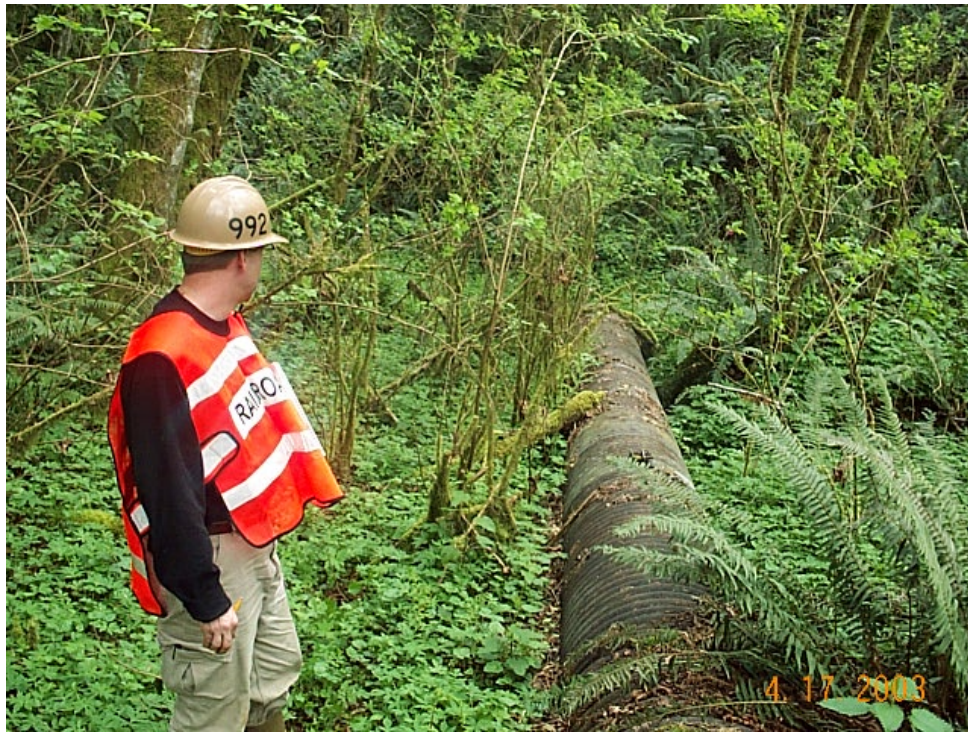
This culvert is located on the Jarstad Creek tributary of Gorst Creek (WRIA 15.0218) northwest of Gorst (Figure 14; WP 158). The culvert is a 3-ft concrete pipe with 30-in. corrugated-metal piping attached to each end (267 ft in length). The reason for this unusual configuration is unknown, but it has resulted in a complete barrier to fish passage. There is also a downstream (partial) barrier at the City of Bremerton access road that should be corrected by the City as soon as possible. This undersized, downstream culvert is a 2-ft concrete box, with no natural streambed material in the culvert. This culvert is likely a barrier to juveniles during all flows and possibly adults under low or high flow conditions. The railroad culvert was found to be a complete barrier to fish passage based on the standard WDFW culvert survey (Level-A analysis). There is ample, good quality spawning and rearing habitat upstream of the railroad culvert. The railroad culvert has a PI score of 10.17. This culvert should be replaced with a bottomless arched culvert or a box-culvert bridge. As with Heins creek, the downstream (partial) barrier should also be replaced by the City of Bremerton in coordination with any scheduled railroad culvert corrective action.

Figure 46. Upstream extension on Jarstad Creek (railroad MP 1.04) culvert.

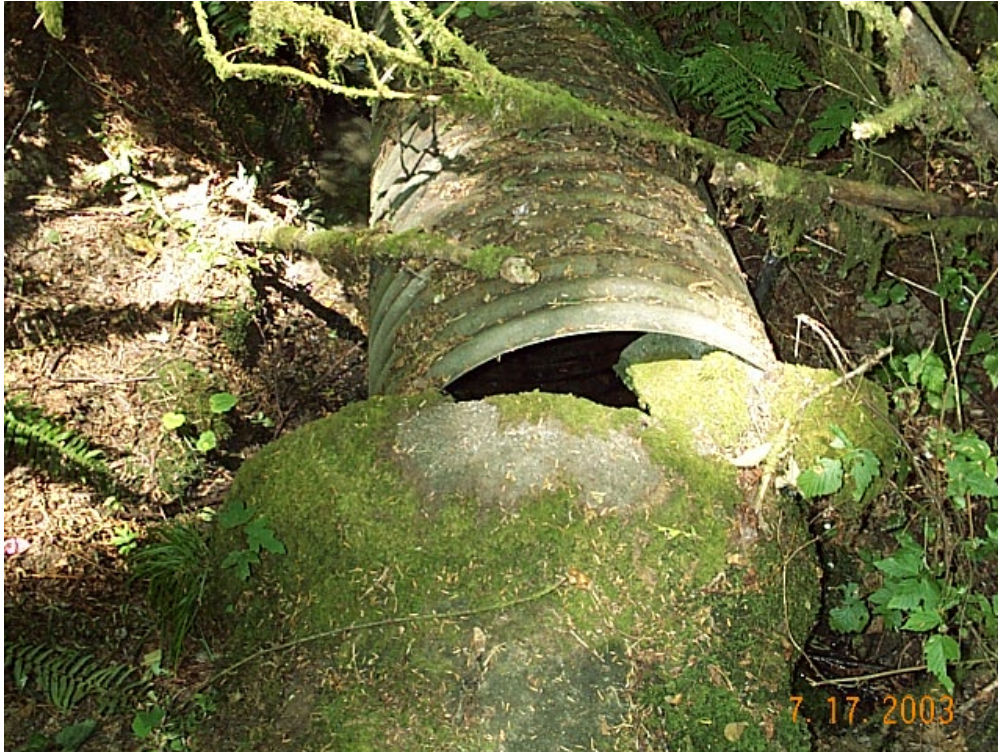
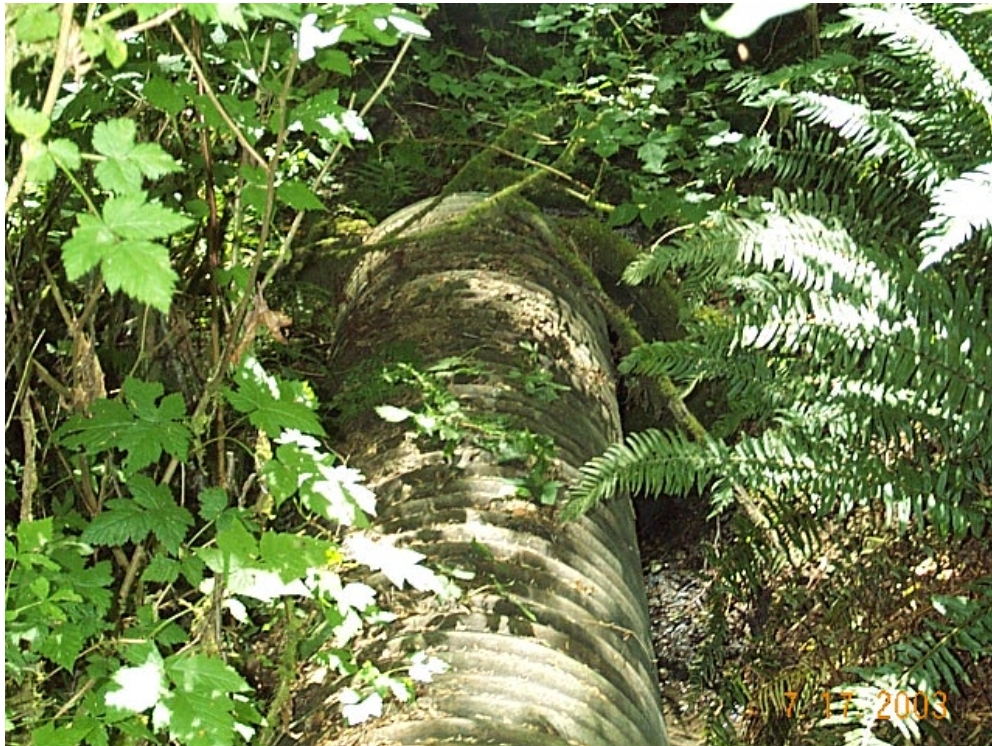
Figure 47. Upstream extension on Jarstad Creek (railroad MP 1.04) culvert.

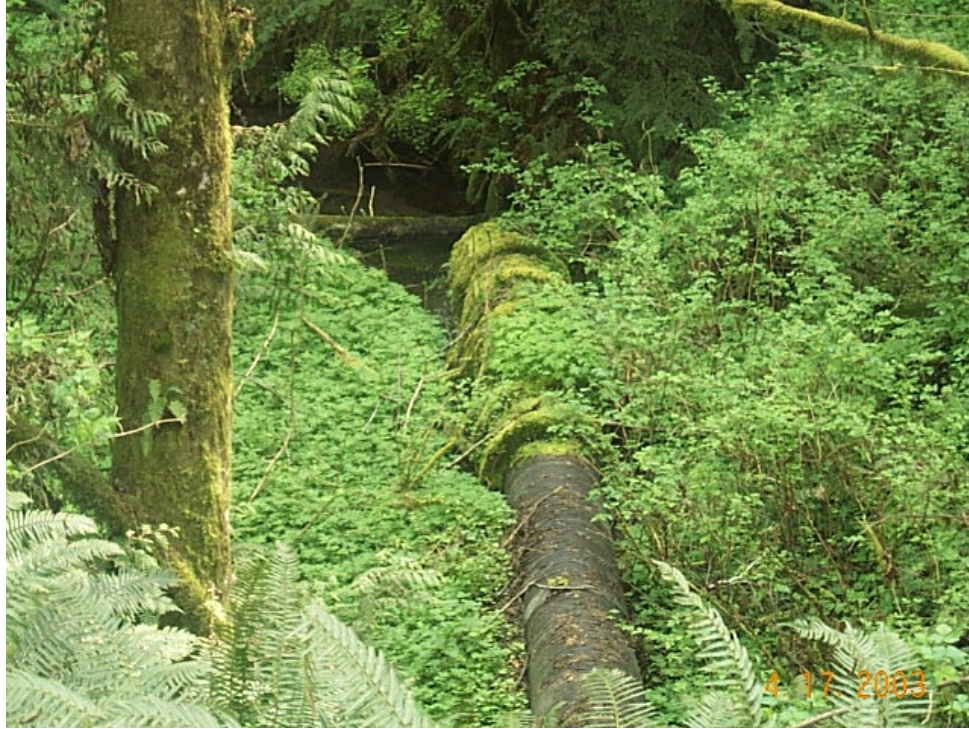
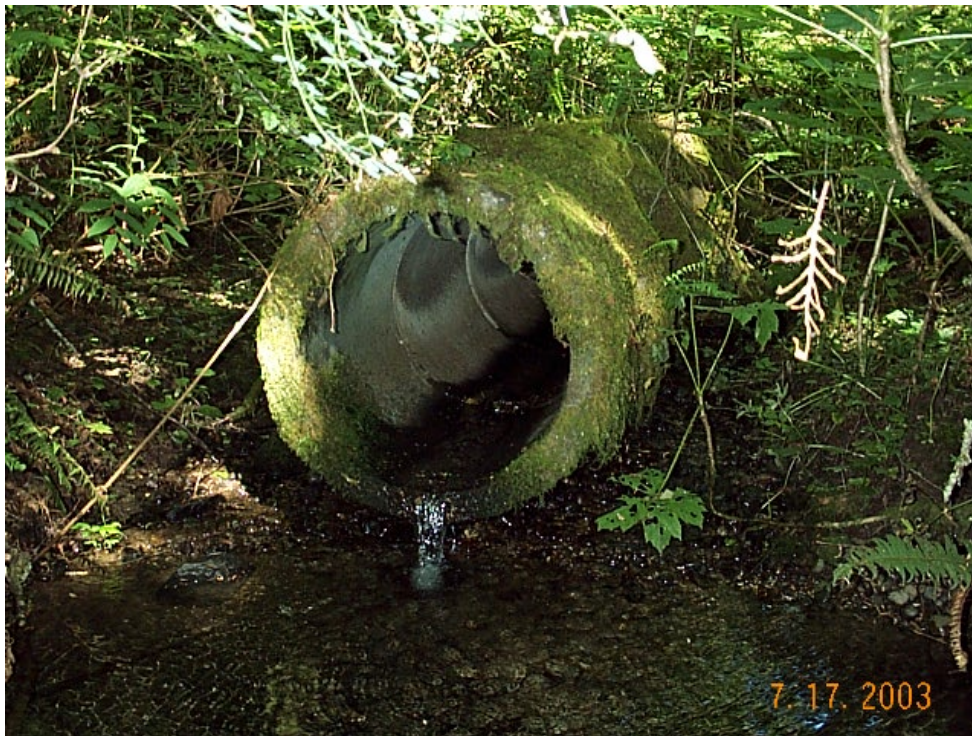
Figure 48. Outlet of Jarstad Creek (railroad MP 1.04) culvert.

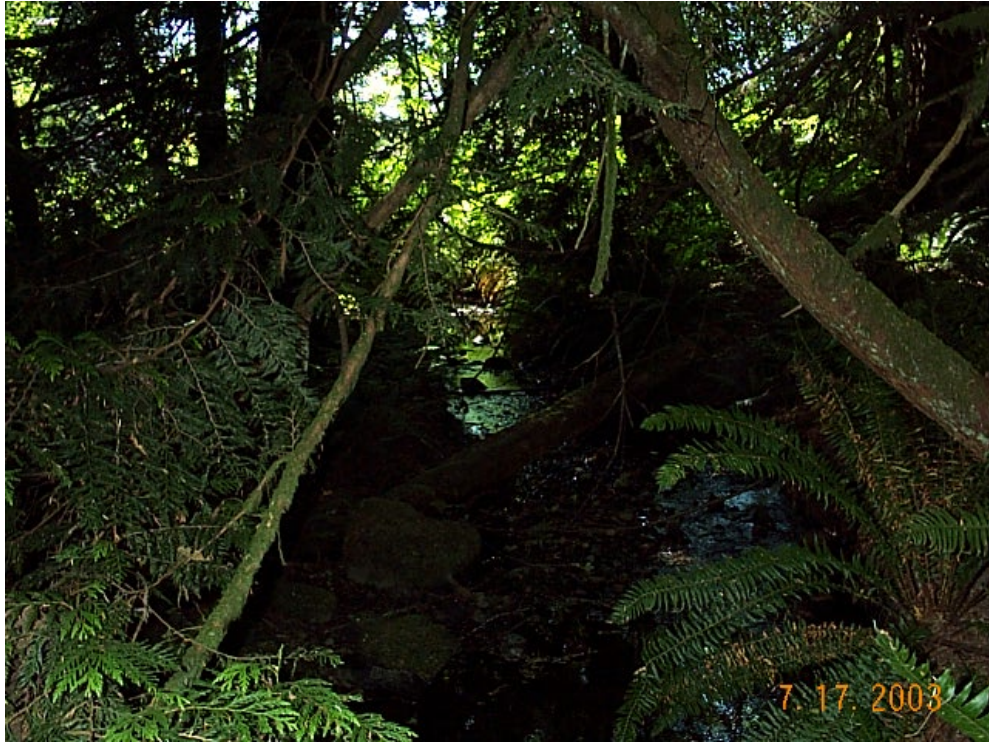
Figure 49. Instream habitat downstream of Jarstad Creek (railroad MP 1.04) culvert.

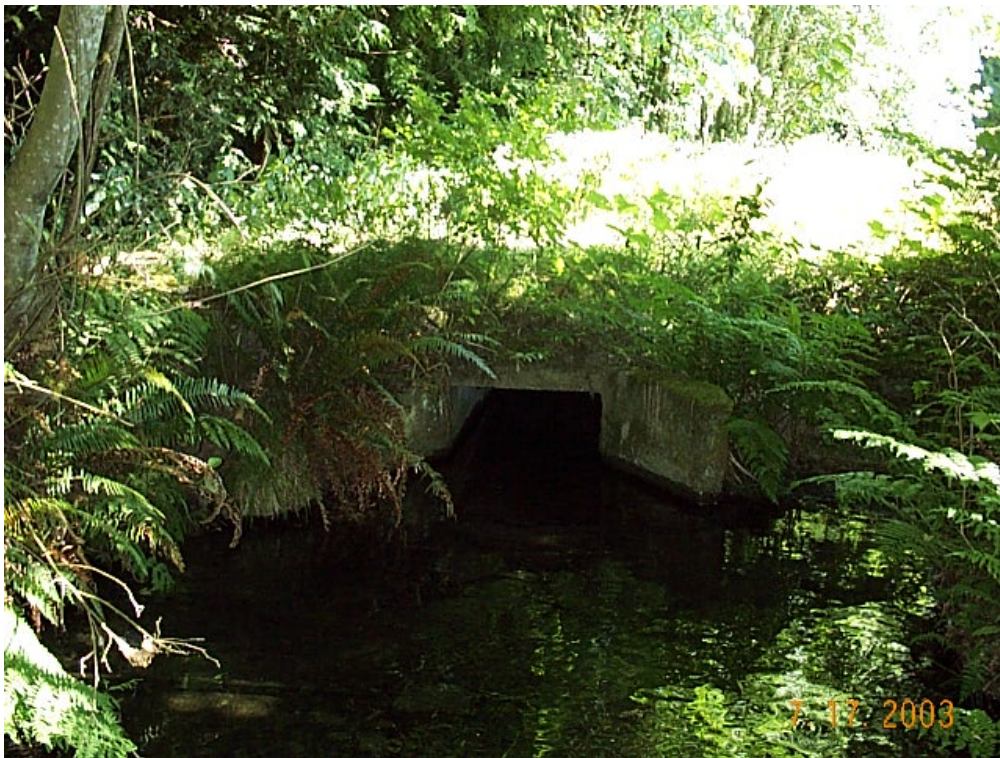
Figure 50. Bremerton culvert downstream of Jarstad Creek (railroad MP 1.04) culvert.
