**Pacific Northwest
National Laboratory**

Ultrasonic Examination of Double-Shell Tank 241-AP-104 Examination Completed February 2005

A.F. Pardini
G.J. Posakony

March 2005

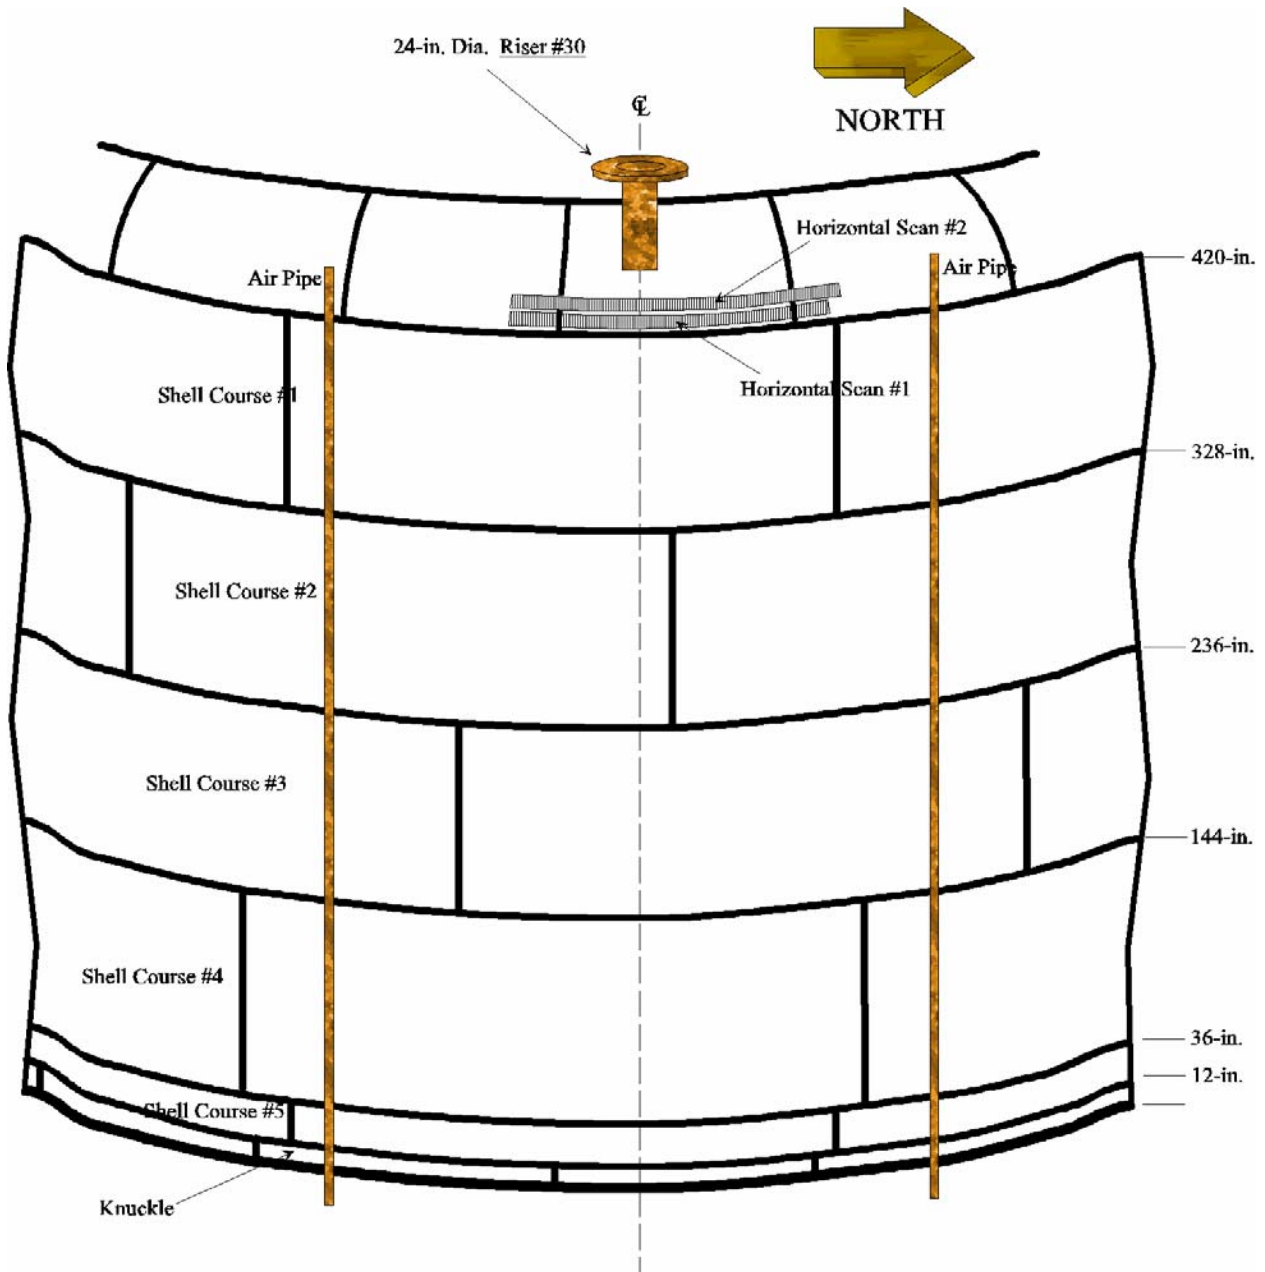
Figure 4.2. Sketch of Scan Paths on Tank 241-AP-104 Primary Tank Upper Knuckle

Figures 4.2 and 4.3 describe the areas on the primary and secondary walls of Tank 241-AP-104 that were ultrasonically examined. Two approximately 12-in.-wide by 15-ft.-long circumferential scan paths (one above the other) were performed on the upper knuckle of the primary tank near Riser 30. One approximately 12-in.-wide by 20-ft.-long circumferential scan path was performed on the lower knuckle of the secondary tank below Riser 30.

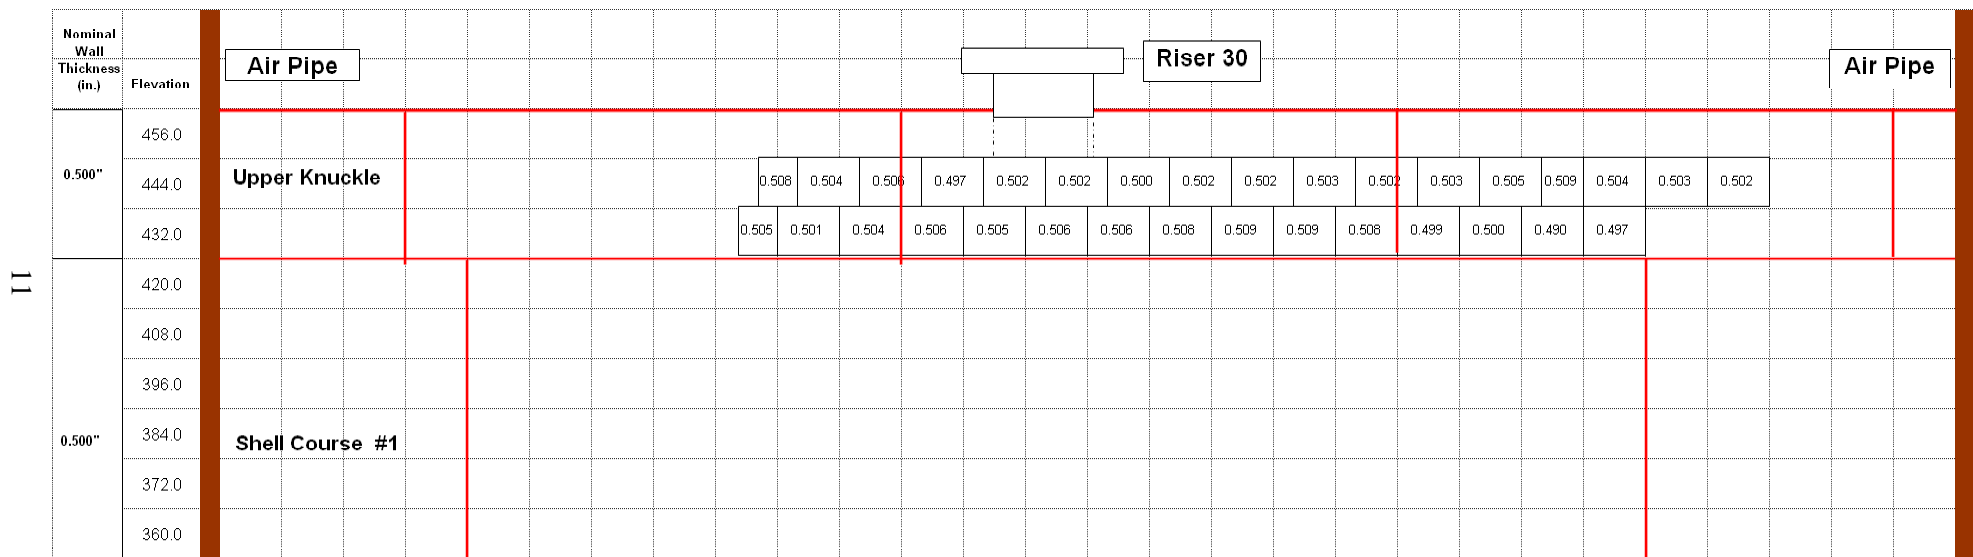
Figure 5.1. UT Data from Tank 241-AP-104 Primary Tank Upper Knuckle Region

Figure 5.1 shows the wall thickness examination results for the primary tank wall upper knuckle region. The examination consisted of two horizontal scan paths near the 24-in. diameter entrance riser #30. Horizontal scan #1 was approximately 12-in. wide beginning approximately 1-in. above the shell course #1 to upper knuckle weld. Horizontal scan #2 was approximately 12-in. wide beginning approximately 11-in. above the shell course #1 to upper knuckle weld.

Two approximately 12-in.-wide scan paths were performed on the upper knuckle of the primary tank above shell course #1. The upper knuckle was examined for wall thinning. The nominal thickness of the upper knuckle of the primary tank is 0.500-in. The results indicated that the minimum thickness in horizontal scan #1 was 0.490-in. The results indicated that the minimum thickness in horizontal scan #2 was 0.497-in. There were no areas of wall thinning that exceeded the reportable level of 10% of the nominal thickness.

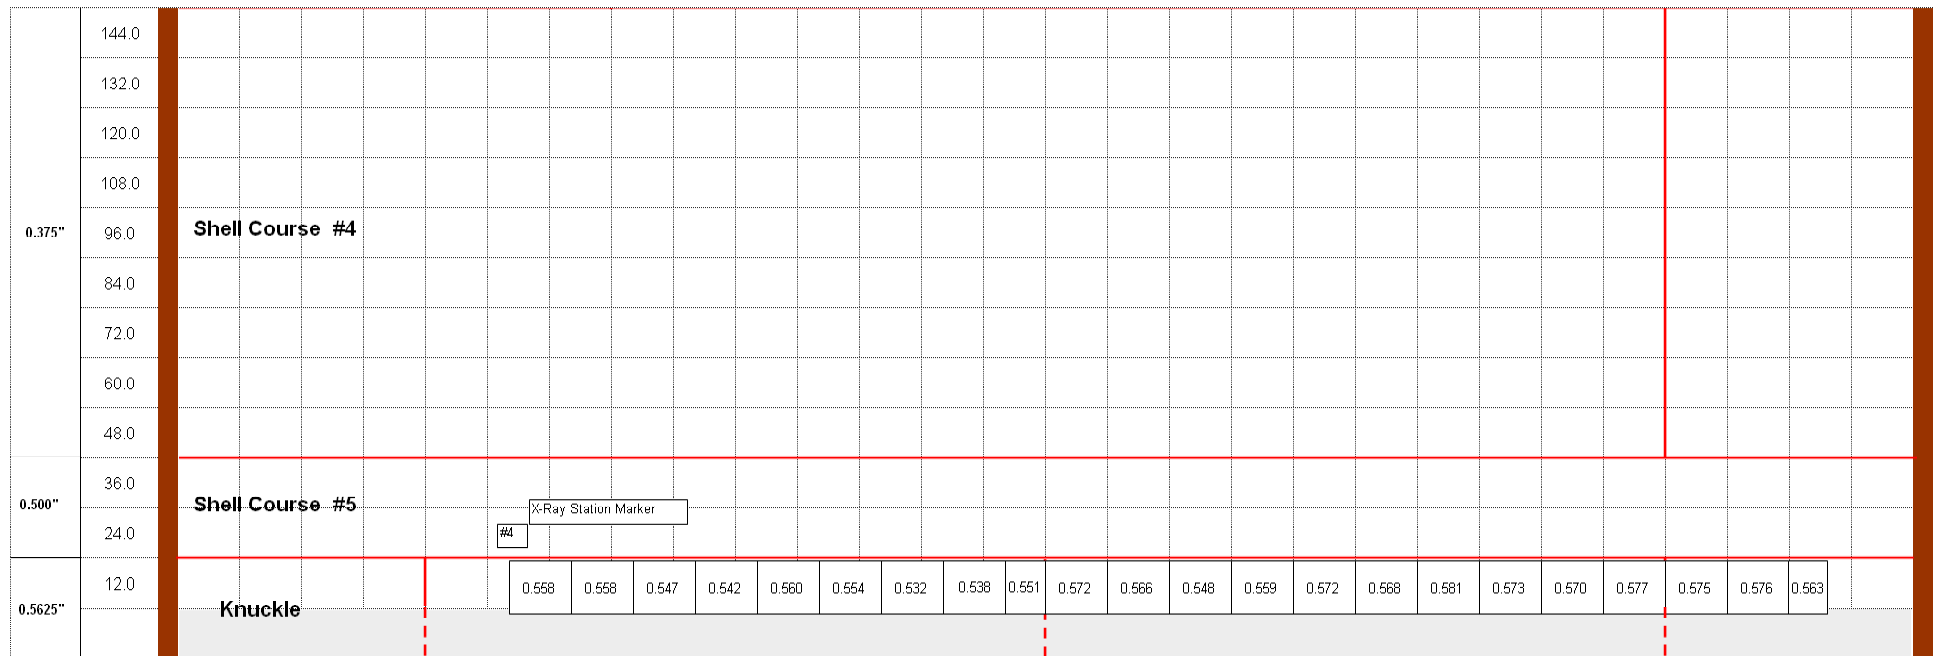
Figure 5.2 UT Data from Tank 241-AP-104 Secondary Tank Lower Knuckle Region

Figure 5.2 shows the wall thickness examination results for the secondary tank wall lower knuckle region. The examination consisted of one horizontal scan path below the 24-in. diameter entrance riser #30. The horizontal scan was approximately 12-in. wide beginning approximately 1-in. below the shell course #5 to lower knuckle weld.

One approximately 12-in.-wide scan path was performed on the lower knuckle of the secondary tank below shell course #5. The lower knuckle was examined for wall thinning, pitting, and cracks oriented circumferentially. The nominal thickness of the lower knuckle of the secondary tank is 0.5625-in. The results indicated that the minimum thickness in the horizontal scan was 0.532-in. There were no areas of wall thinning that exceeded the reportable level of 10% of the nominal thickness. No pitting or crack-like indications were detected.
