**Pacific Northwest
National Laboratory**

**Ultrasonic Examination of
Double-Shell Tank 241-AY-102
Examination Completed January 2007**

May 2007

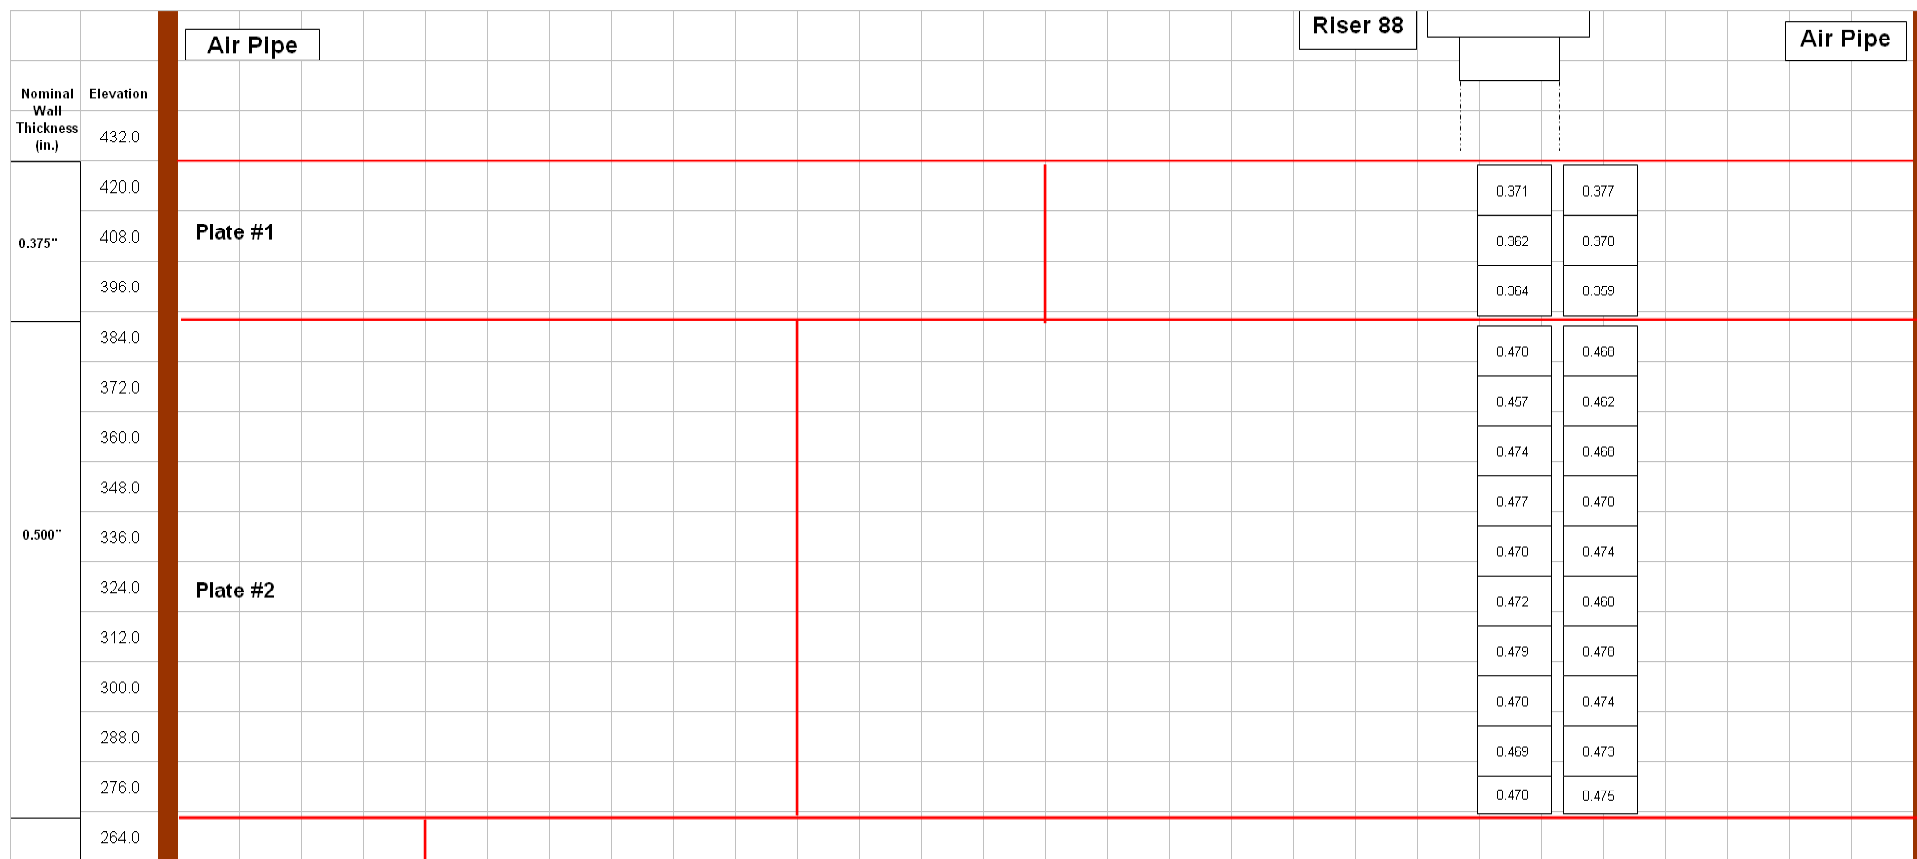
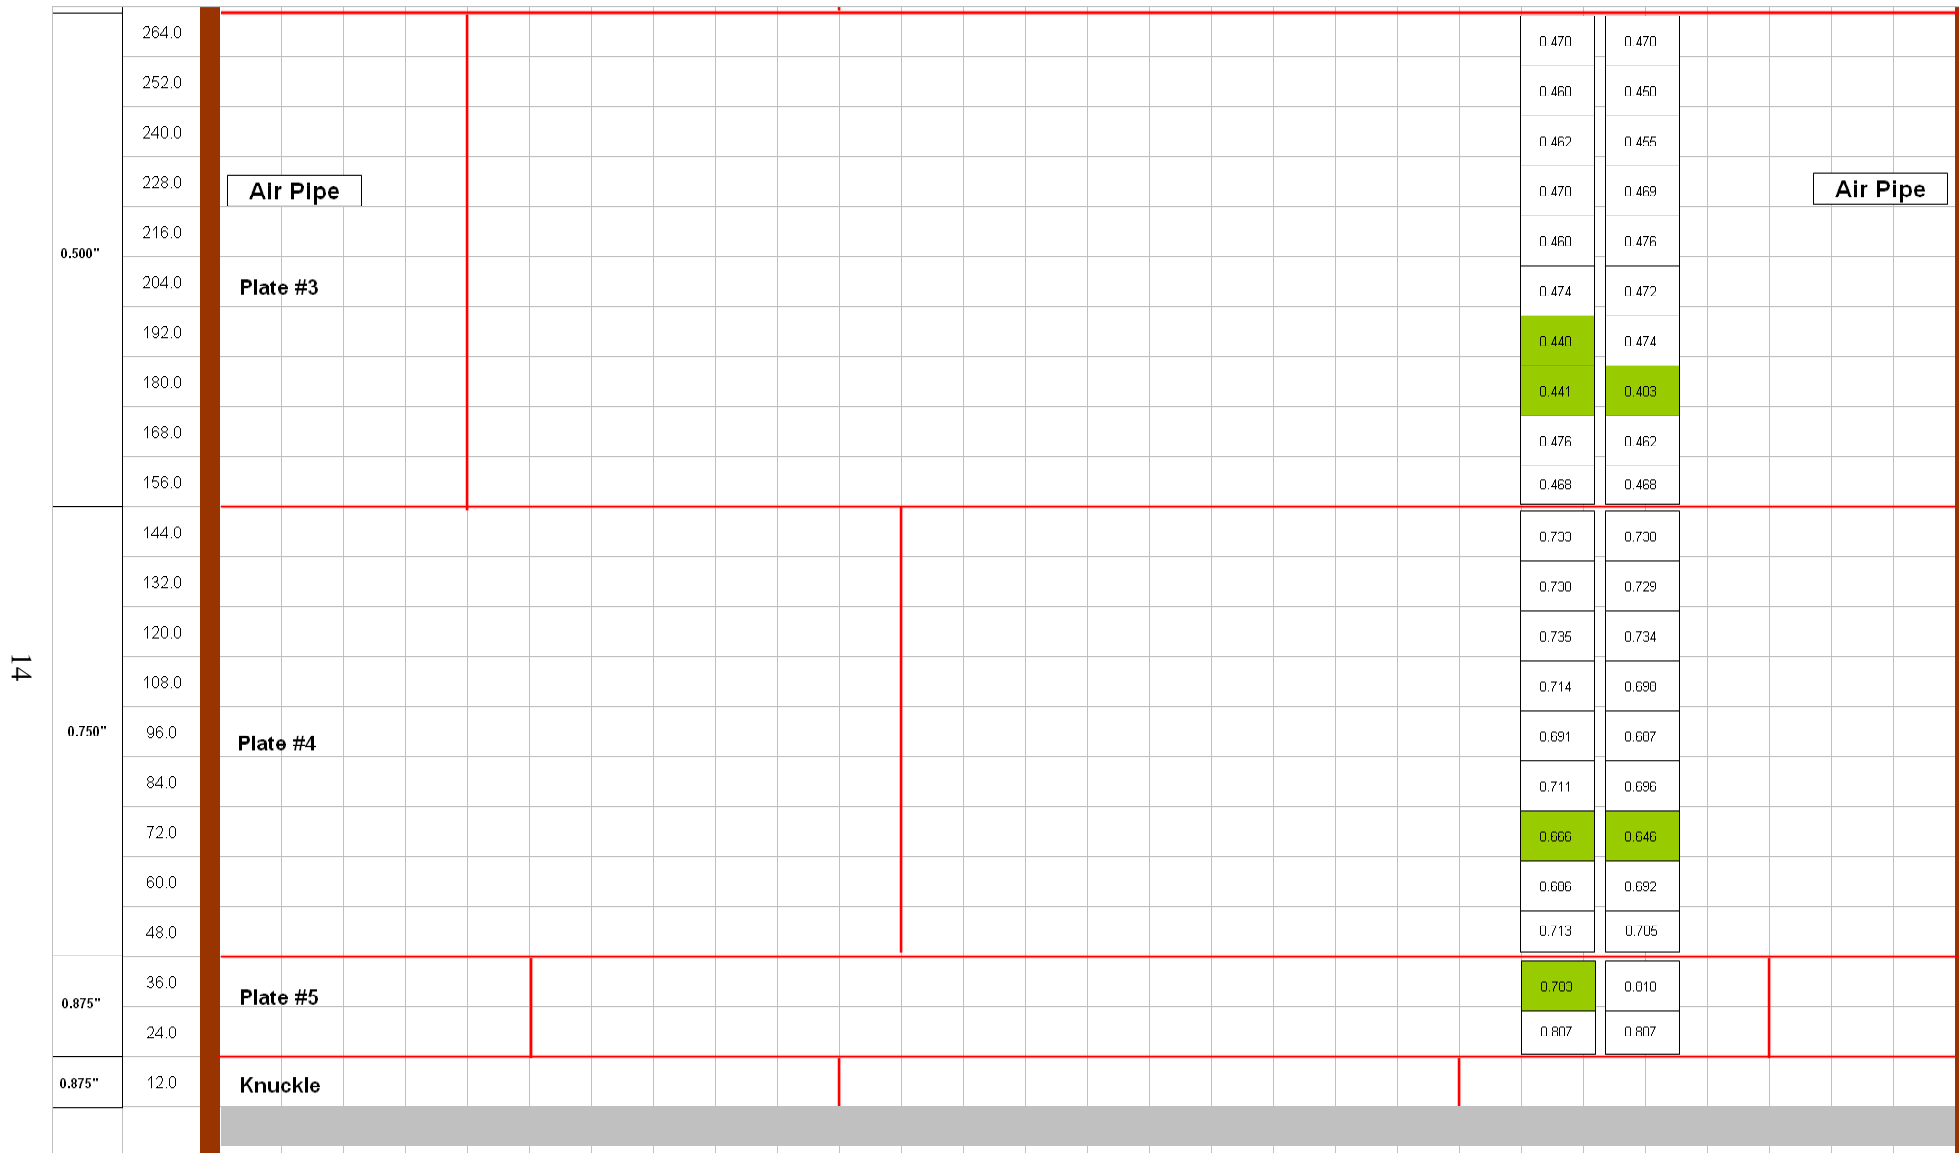
- Plate #1 results indicate no areas that exceed the minimum thinning reportable level of 10% of the nominal thickness. No pitting or vertical crack-like indications were detected in Plate #1.

- Plate #2 results indicate no areas that exceed the minimum thinning reportable level of 10% of the nominal thickness. No pitting or vertical crack-like indications were detected in Plate #2.

- Plate #3 results indicate three areas that exceed the minimum thinning reportable level of 10% of the nominal thickness. However, these three areas (with remaining ligament of 0.403-in., 0.440-in., and 0.441-in.) were analyzed by the UT Level III and were considered pit-like and therefore do not exceed the reportable pitting level of 25% of the nominal thickness. No vertical crack-like indications were detected in Plate #3.

- Plate #4 results indicate two areas that exceed the minimum thinning reportable level of 10% of the nominal thickness. However, these two areas (with remaining ligament of 0.646-in., and 0.666-in.) were analyzed by the UT Level III and were considered pit-like and therefore do not exceed the reportable pitting level of 25% of the nominal thickness. No vertical crack-like indications were detected in Plate #4.

- Plate #5 results indicate one area that exceeded the minimum thinning reportable level of 10% of the nominal thickness. However, this one area (with remaining ligament of 0.783-in.) was analyzed by the UT Level III and was considered pit-like and therefore does not exceed the reportable pitting level of 25% of the nominal thickness. No vertical crack-like indications were detected in Plate #5.

Figures 5.1 and 5.2 show the wall thickness examination results for the primary tank wall from Riser 88. The examination consisted of two vertical paths beneath the 24-in. diameter riser. Vertical scan #1 was 15-in.-wide on Plates #1, #2, #3, #4, and #5 near the centerline of the 24-in. riser. Vertical scan #2 was adjacent to vertical scan #1 and was also 15-in.-wide on Plates #1, #2, #3, #4, and #5. Vertical scans were conducted in the downward direction. Figures 5.1 and 5.2 display the minimum readings taken in each 15-in.-wide by 12-in.-long area of the scan.

Figure 5.1. UT Data from Tank 241-AY-102 Primary Tank Riser 88

Figure 5.2. UT Data from Tank 241-AY-102 Primary Tank Riser 88 cont.

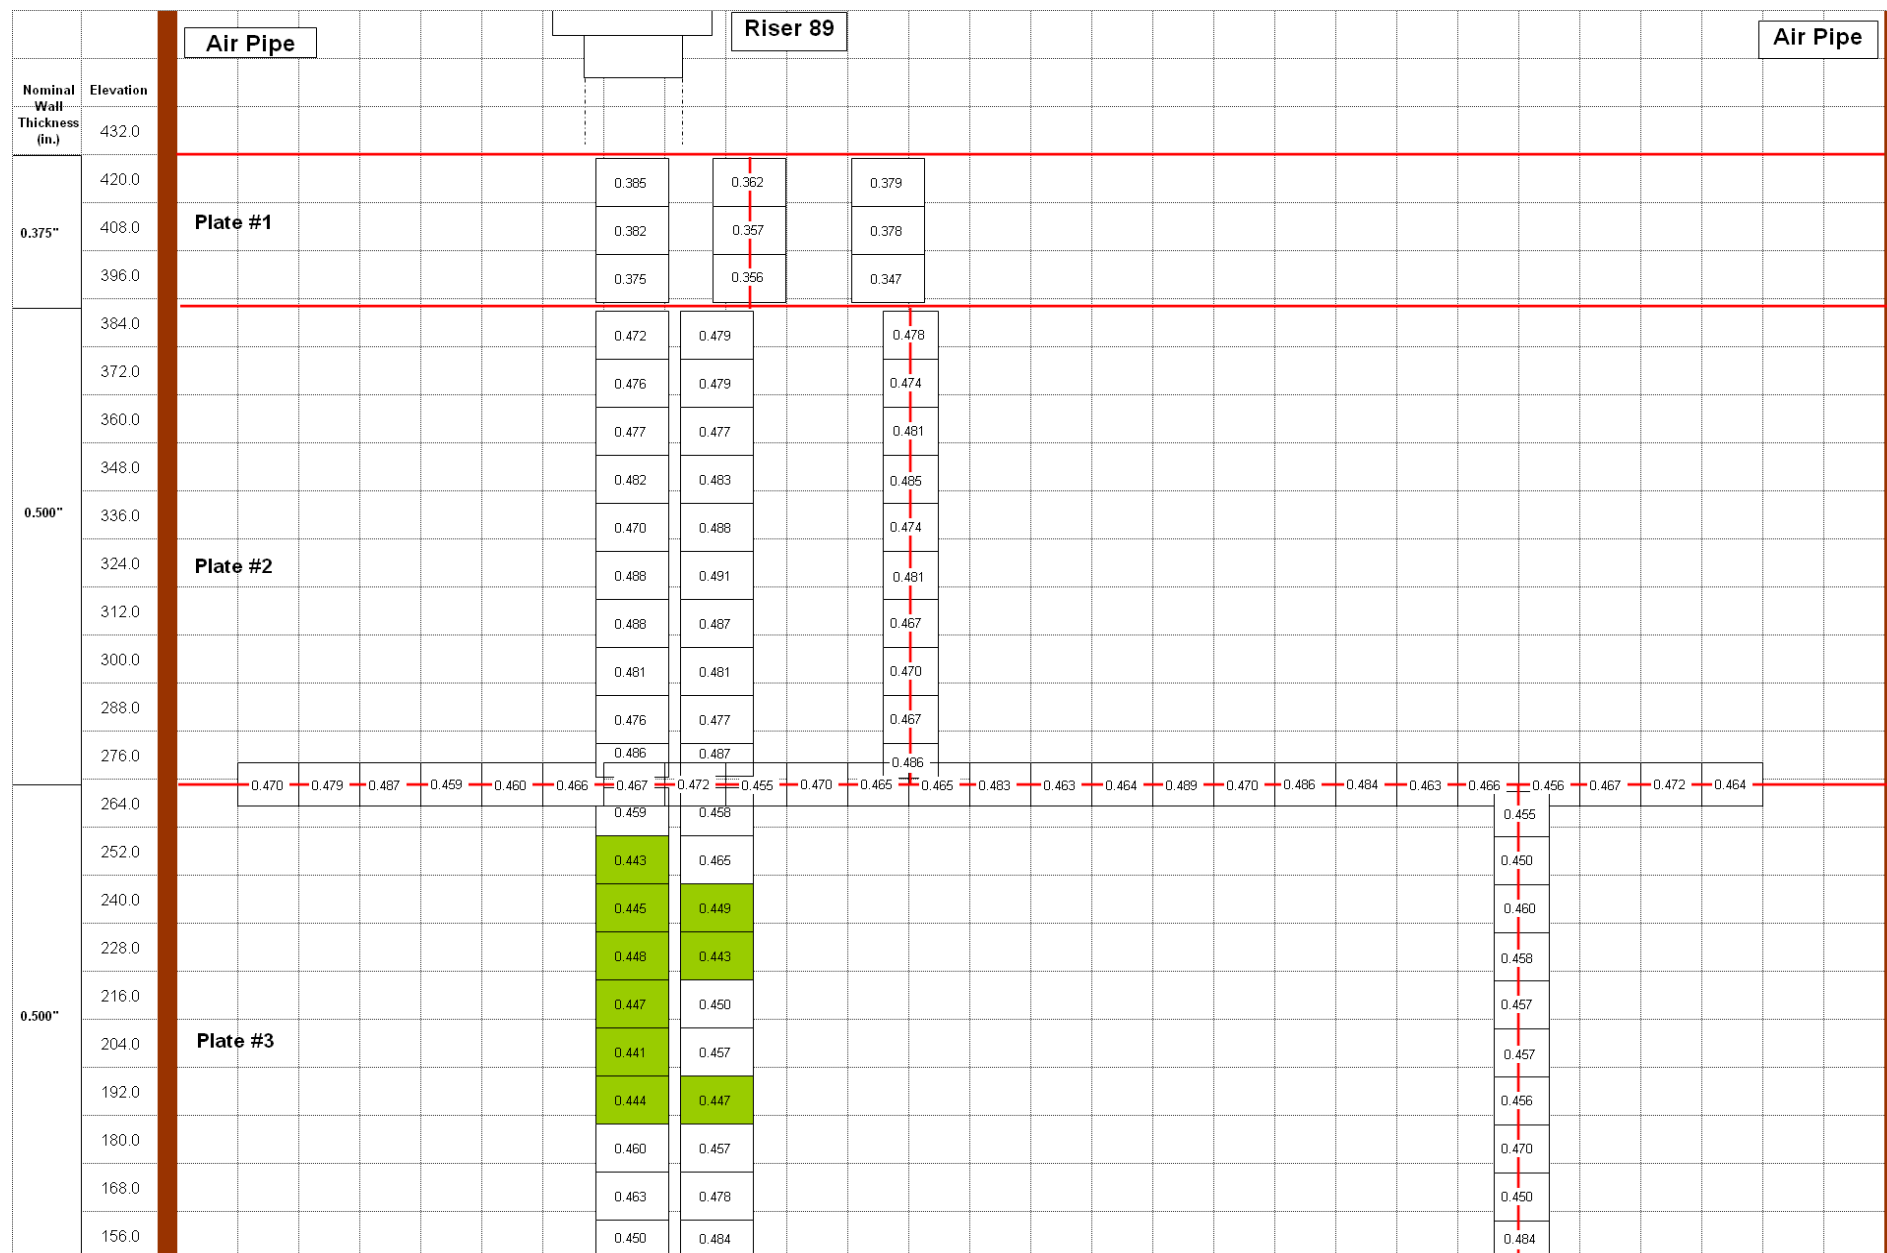
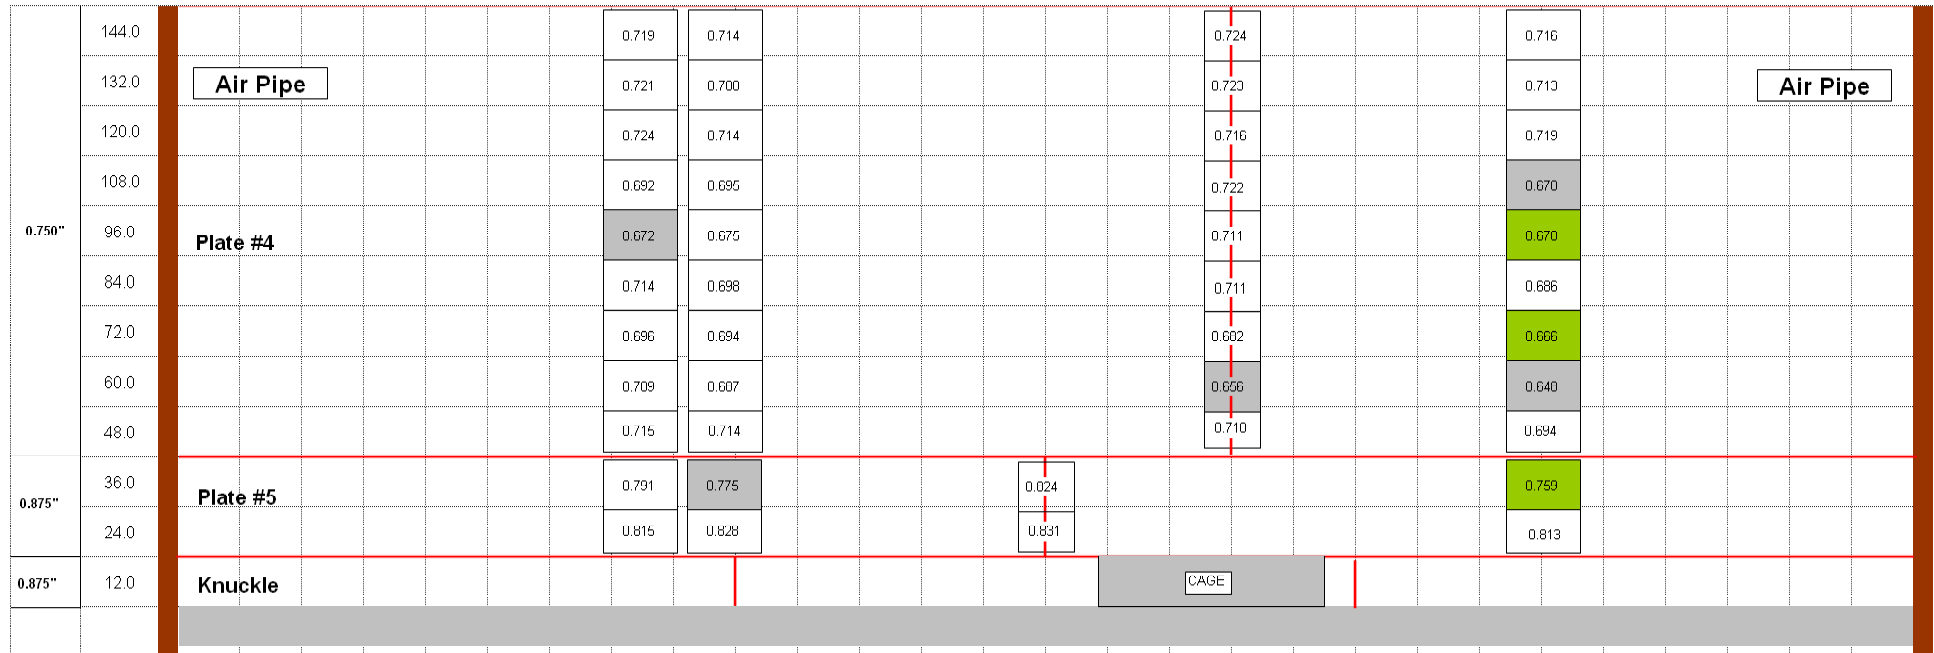
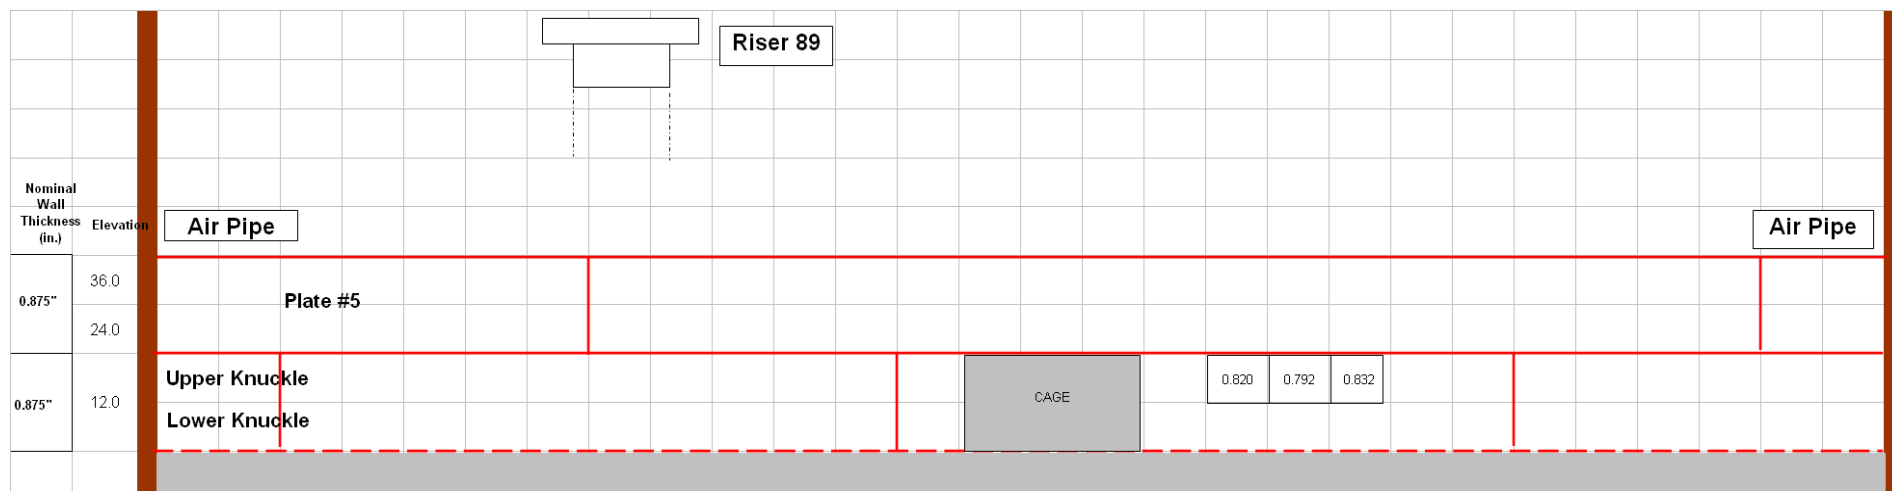
- Plate #3 results indicate nine areas that exceed the minimum thinning reportable level of 10% of the nominal thickness. However, these nine areas (with remaining ligament of 0.441-in., 0.443-in., 0.443-in., 0.444-in., 0.445-in., 0.447-in., 0.447-in., 0.448-in., and 0.449-in.) were analyzed by the UT Level III and were considered pit-like and therefore do not exceed the reportable pitting level of 25% of the nominal thickness. No vertical crack-like indications were detected in Plate #3.

- Plate #4 results indicate five areas that exceed the minimum thinning reportable level of 10% of the nominal thickness. However, two of these areas (with remaining ligament of 0.666-in., and 0.670-in.) were analyzed by the UT Level III and were considered pit-like and therefore do not exceed the reportable pitting level of 25% of the nominal thickness. Three of the five areas were evaluated by the UT Level III and were considered wall thinning with minimum thicknesses of 0.648-in., 0.670-in., and 0.672-in. and do exceed the reportable level of 10% of the nominal thickness. No vertical crack-like indications were detected in Plate #4.

- Plate #5 results indicate two areas that exceed the minimum thinning reportable level of 10% of the nominal thickness. However, one of these areas (with remaining ligament of 0.759-in.) was analyzed by the UT Level III and was considered pit-like and therefore does not exceed the reportable pitting level of 25% of the nominal thickness. One of the two areas was evaluated by the UT Level III and was considered wall thinning with minimum thicknesses of 0.775-in., and does exceed the reportable level of 10% of the nominal thickness. No vertical crack-like indications were detected in Plate #5.

Plate 4 results indicate one area with a minimum thickness of 0.656-in. that exceeded the minimum thinning reportable level of 10% of the nominal thickness. No pitting or crack-like indications were detected in the weld areas in Plate #4

Figures 5.3, 5.4, and 5.5 show the wall thickness examination results for the primary tank wall, the HAZs of both vertical and horizontal welds, and a portion of the knuckle from Riser 89. The examination consisted of two vertical paths beneath the 24-in. diameter riser and an additional short vertical path on Plates #4 and #5. Vertical scan #1 was 15-in.-wide on Plate #1, #2, #3, #4, and #5 near the centerline of the 24-in. riser. Vertical scan #2 was adjacent to vertical scan #1 and was also 15-in.-wide on Plates #1, #2, #3, #4, and #5. Vertical Scan #3 was a few feet to the south of vertical scan #2 and was only performed on Plates #4 and #5. Vertical scans were conducted in the downward direction. The HAZs of vertical welds in Plates #1, #2, #3, #4, and #5 were examined and the HAZ in the horizontal weld between Plate #2 and Plate #3 was also examined. Weld area exams include approximately 5-in. on each side of the weld. Approximately 3-ft. circumferentially was examined on the upper portion of the knuckle. Areas in the figures that show two measurements in the same box are the result of the vertical scan paths overlapping the horizontal scan paths. Figures 5.3 and 5.4 display the minimum readings taken in each 15-in.-wide by 12-in.-long area of the scan. Figure 5.5 displays the minimum readings taken in each 9-in.-wide by 12-in.-long area of the scan. In the overlapping areas, both minimum readings from each vertical and horizontal scan paths are given. The gray highlighted areas indicate that the minimum wall thickness exceeded the reportable level of 10% of the nominal wall thickness. The green highlighted areas indicate that the minimum wall thickness exceeded the 10% level, but the UT Level III has characterized these as pit-like indications. None of these pit-like indications exceed the pitting criteria of 25% of nominal thickness and are therefore not reportable.

Figure 5.3. UT Data from Tank 241-AY-102 Primary Tank Riser 89

Figure 5.4. UT Data from Tank 241-AY-102 Primary Tank Riser 89 cont.

Figure 5.5. UT Data from Tank 241-AY-102 Primary Tank Riser 89 cont.

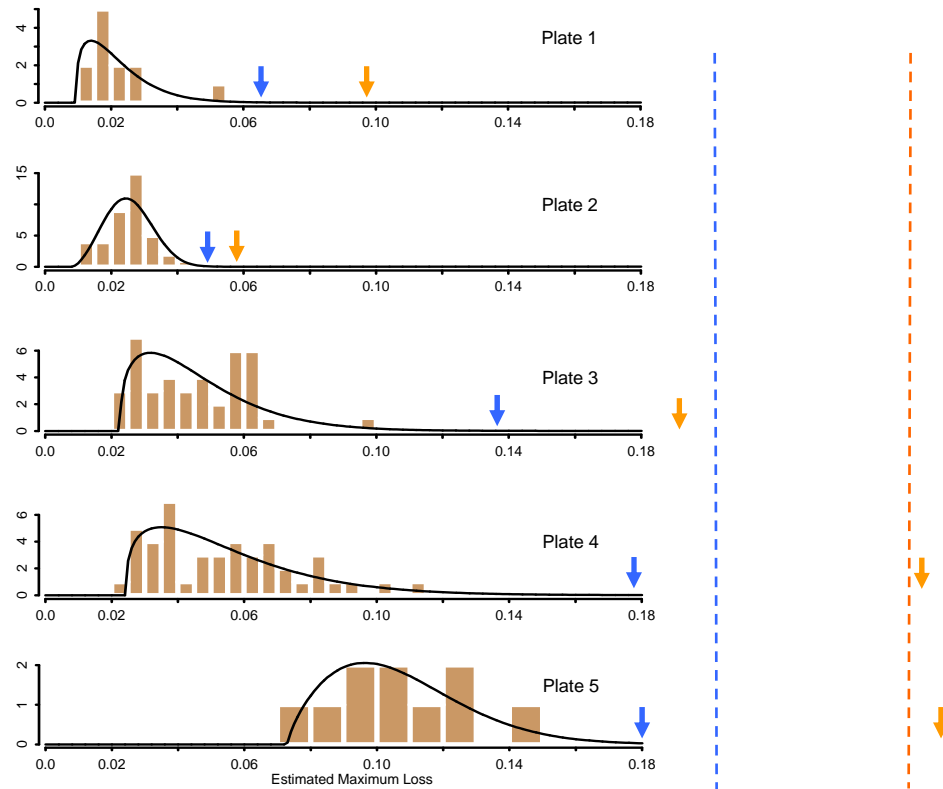
Figure 6.2. Weibull Distribution Fits to UT Maximum Wall Thickness Loss by Plate Course

The histograms in Figure 6.2 show such wall thickness loss data grouped by plate course. That is, the UT image maximum losses from the four paths, two per riser, within each plate course are combined. Three parameter Weibull distributions are fit to these histograms and are shown as the smooth curves. Three parameter Weibull distributions are fit to these histograms and are shown as the smooth curves.

The obvious characteristic of the Tank 241-AY-102 histograms in Figure 6-2 is that grouping the measurements across plates is inappropriate. The deeper into the tank (that is, going from Plates #1 to #5), the more wall thickness loss that has apparently been realized. If all plates were indeed grouped, the

“Combined” numbers from the table in Figure 6.3, and denoted by the vertical dotted lines in Figure 6.2 and the arrows in Figure 6.4, show an estimated worst case loss of 0.198-in. with a confidence bound of 0.231-in. Such losses obviously cannot be applied appropriately to Plate #1 with a drawing nominal of 0.375-in., which would result in obviously unrealistic losses. Also note that the combined distribution in Figure 6.4 appears to have a “double-hump”, again suggesting that grouping the measurements into a single distribution is inappropriate.

Therefore the wall thickness losses are considered separately across all five plate courses for Tank 241-AY-102, and shown both by the arrows in Figure 6.2 and the tabled values in Figure 6.3. But in so doing, the tendency to have fairly abrupt left-hand tails, with outlying values to the right for Plates #3, #4, and #5 give quite heavy-tailed distributions and resulting extreme values estimates and bounds considerably larger than any of the observed results. These characteristics of the distributions fit, and the minimal number of measurements per plate, result in the extremely large values. It is questionable if they are of practical use.

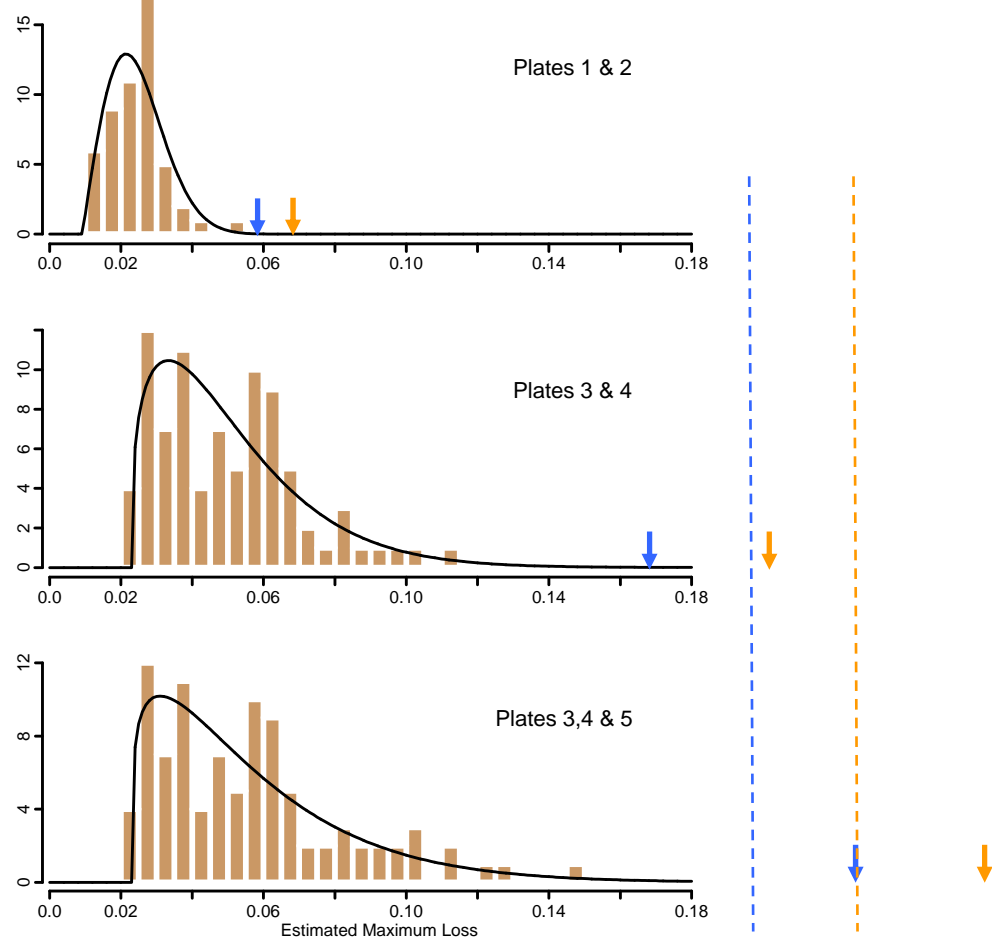
Figure 6.6. Weibull Distribution Fits to Wall Thickness Loss for Plate Course Combinations

These combinations of plates give much more reasonable estimates for Plates #1 and #2, and even for the Plates #3 and #4 combination, but little can be done to avoid the problems caused by including Plate #5, either individually as before, or here grouped with Plates #3 and #4. The estimates and bounds simply become very extreme. Note the vertical dotted lines on Figure 6.6 are still those from the combination of all five plates as before in Figure 6.2.

While extreme value results have been relatively straightforward to interpret for previous tanks, Tank 241-AY-102 is obviously more problematical. It is suggested that the reader consider the tabled values in Figures 6.3 and 6.5, and interpret them appropriately. Preferred estimates for Plates #1 and #2 and for Plates #3 and #4 are probably those listed in Figure 6.5. But the methodology simply doesn’t lend itself to application to the minimal amount of data in Plate #5 alone. And when Plate #5 measurements

are incorporated with those of other plates, many of the Plate #5 values become outlying values considerably greater than those for the other plates. They then unduly influence the estimates for the other plates as well.
