**Pacific Northwest  
National Laboratory**

**Ultrasonic Examination of double-shell  
tank 241-AY-101 Examination  
Completed October 2007**

AF Pardini  
DR Weier

January 2008

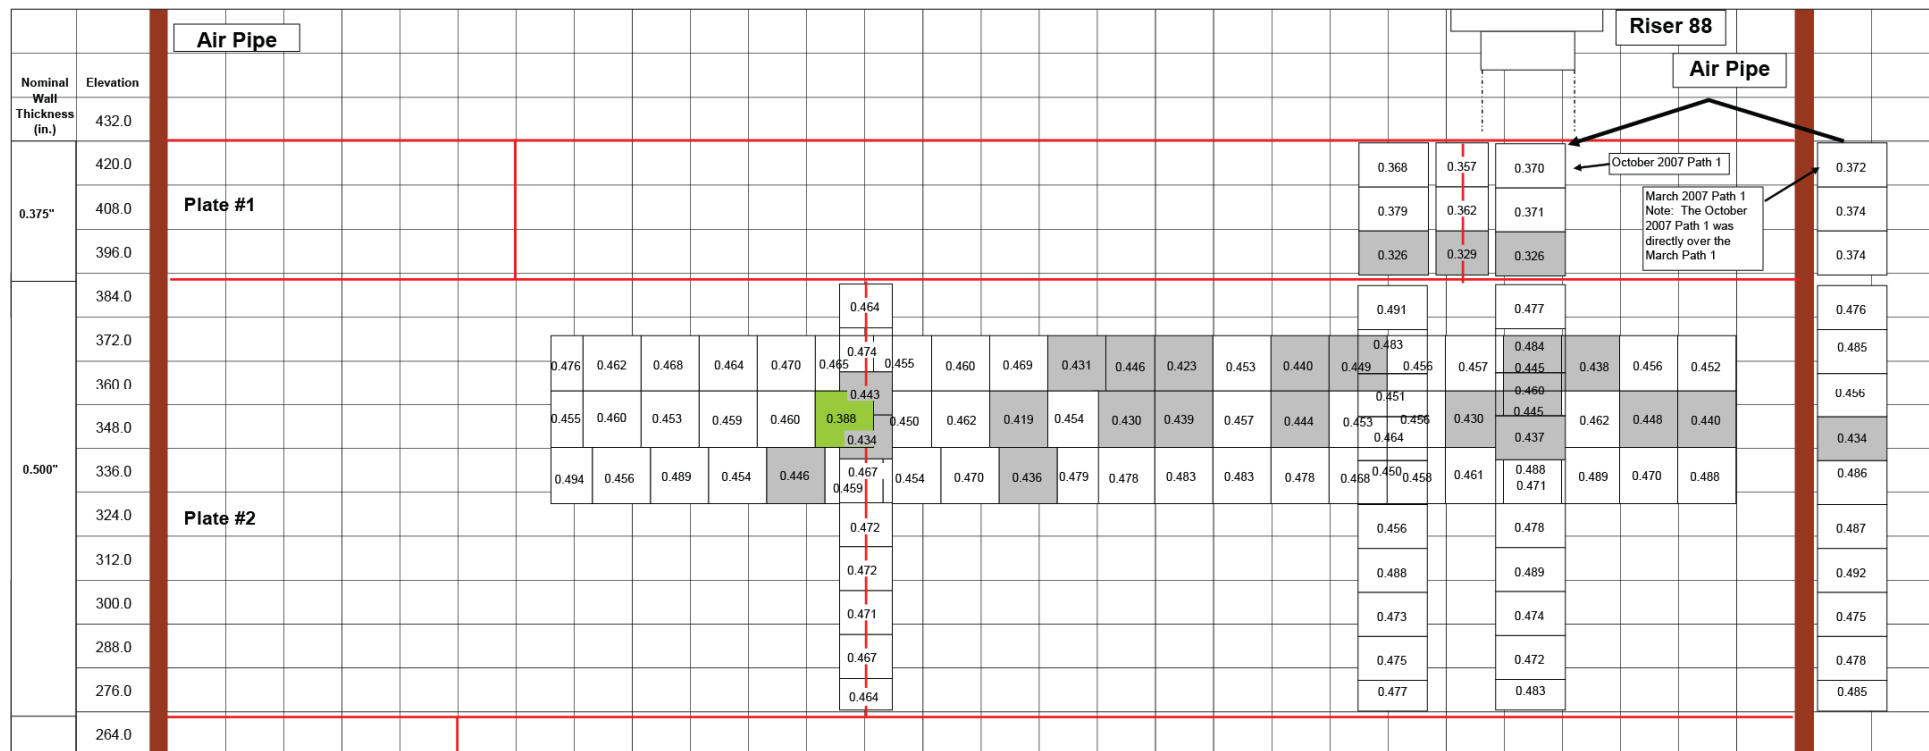
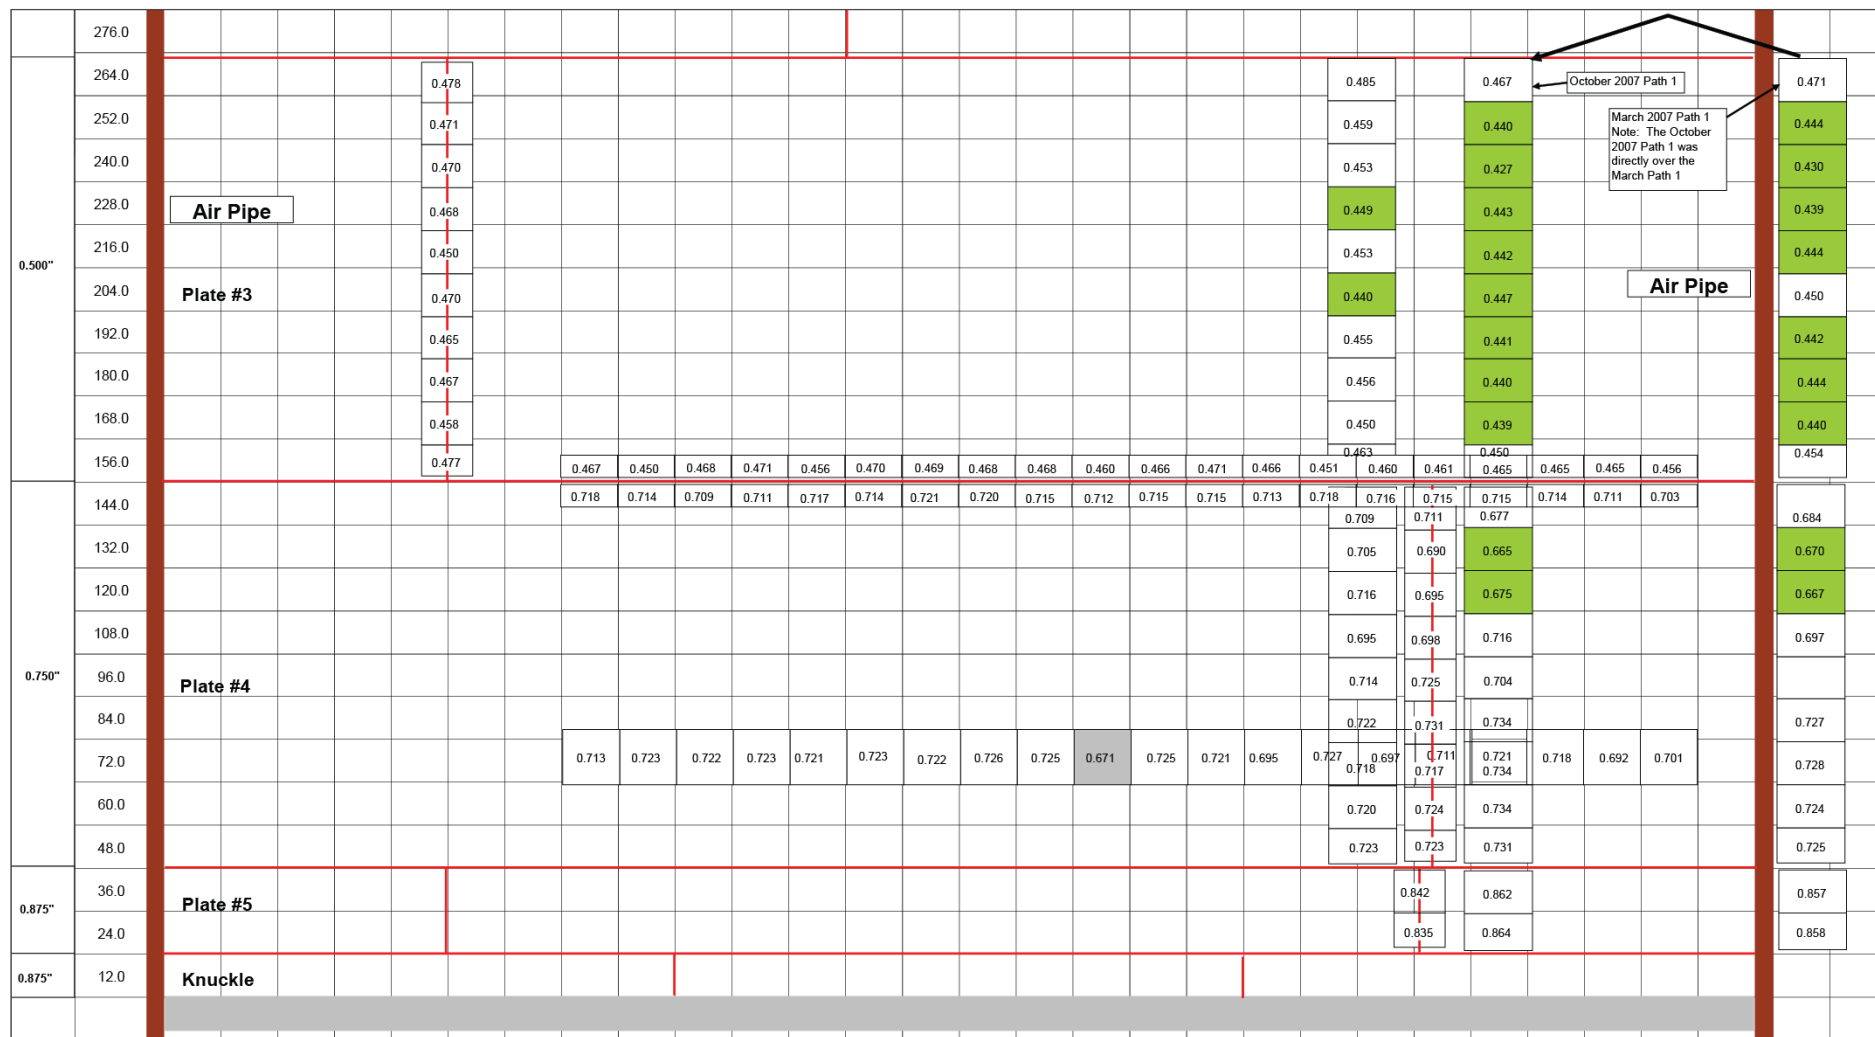
**Figure 5.1.** UT Data from Tank 241-AY-101 Primary Tank Riser 88

Figures 5.1 and 5.2 show the wall thickness examination results for the primary tank wall and the HAZs of both vertical and horizontal welds from Riser 88. The examination consisted of one 15-in.-wide vertical path beneath the centerline of the 24-in. diameter riser on Plates #1, #2, #3, #4, and #5 and one 15-in.-wide vertical path adjacent to scan path 1 on Plates #1, #2, #3, and #4. Vertical scans were conducted in the downward direction. Note that an additional scan which was completed in March 2007 and is shown on the right side of the graphic. Since the exact same area was rescanned in October 2007, the latest data is shown on the tank wall and the older data is shown on the side for reference. Three horizontal scans were performed in the LAI region on Plate #2 and one horizontal scan was performed in the LAI region on Plate #4. Figures 5.1 and 5.2 display the minimum readings taken in each 15-in.-wide by 12-in.-long area of the scan. The HAZs of vertical welds in Plates #1, #2, #3, #4, and #5 were examined and the HAZ in the horizontal weld between Plate #3 and Plate #4 was also examined. Weld area exams include approximately 5-in. on each side of the weld. Areas in the figures that show two measurements in the same box are the result of the vertical scan paths overlapping the horizontal scan paths. In the overlapping areas, both minimum readings from each vertical and horizontal scan paths are given. The gray highlighted areas indicate that the minimum wall thickness exceeded the reportable level of 10% of the nominal wall thickness. The green highlighted areas indicate that the minimum wall thickness exceeded the 10% level, but the UT Level III has characterized these as pit-like indications. None of these pit-like indications exceed the pitting criteria of 25% of nominal thickness and are therefore not reportable.

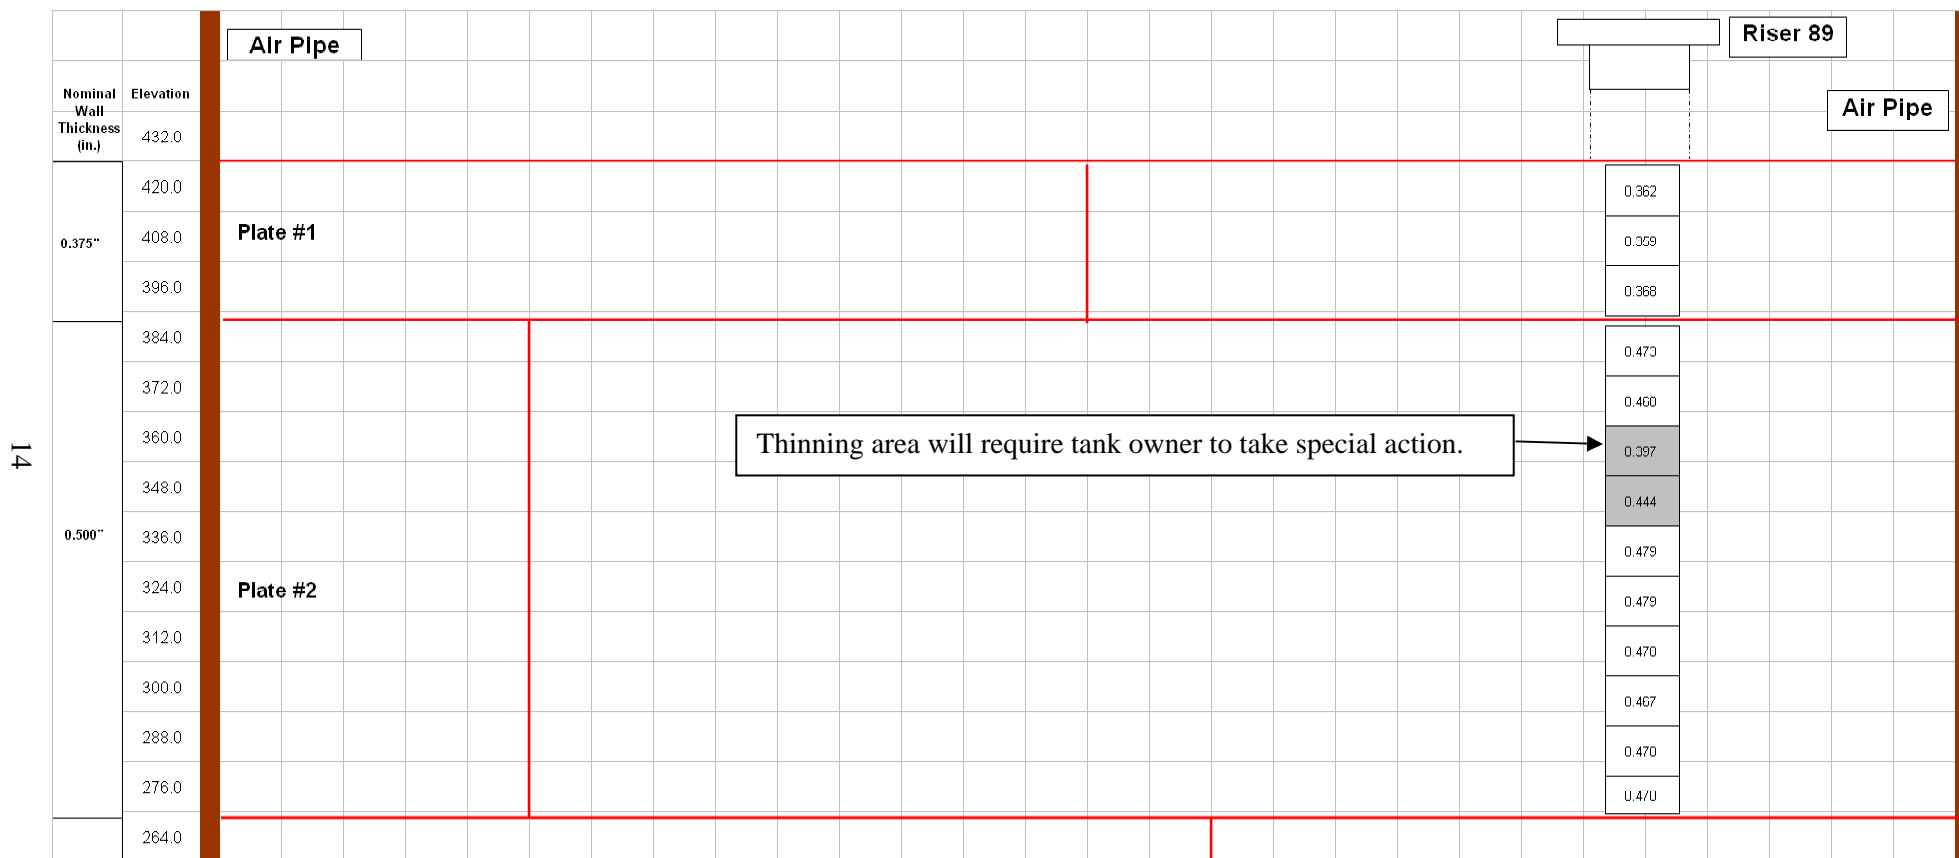
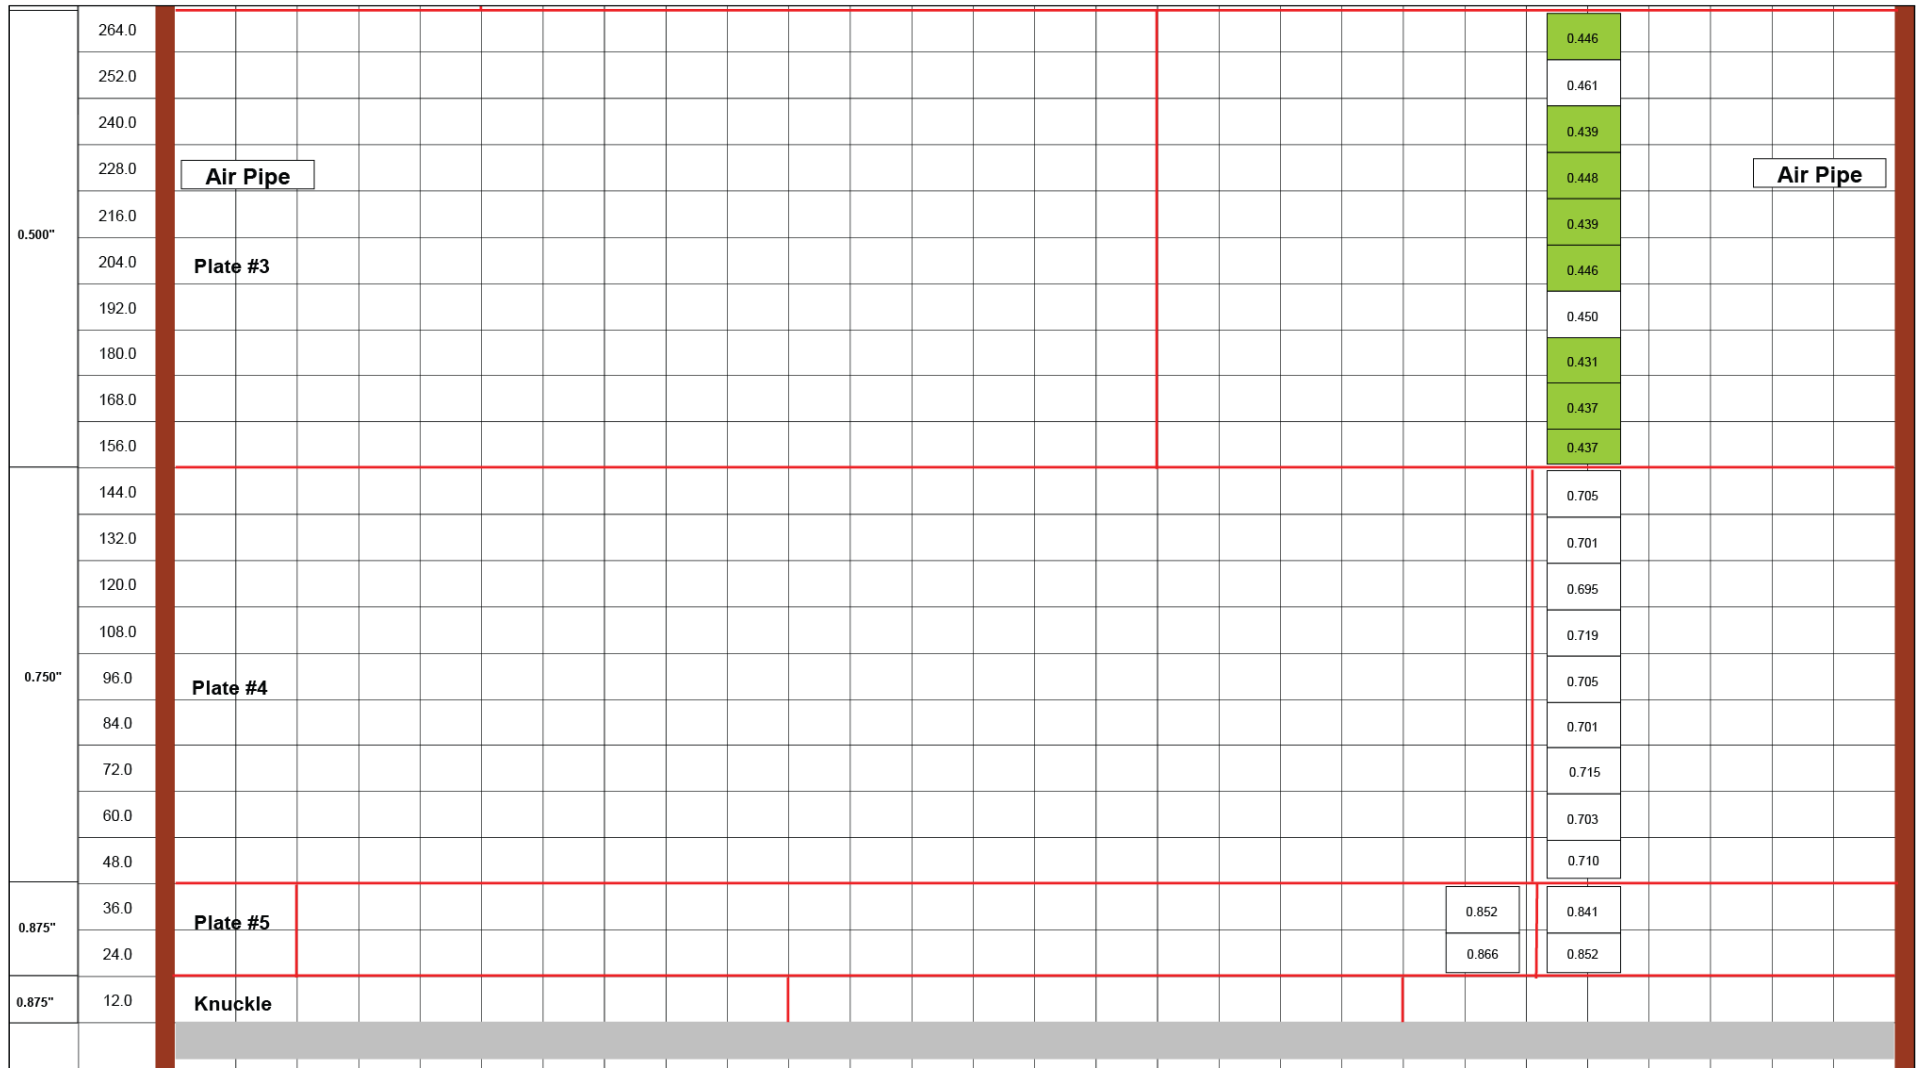
**Figure 5.3.** UT Data from Tank 241-AY-101 Primary Tank Riser 89

Figures 5.3 and 5.4 show the wall thickness examination results for the primary tank wall from Riser 89. The examination consisted of one vertical path beneath the centerline of the 24-in. diameter riser on Plates #1, #2, #3, #4, and #5 and one 15-in.-wide vertical path adjacent to scan path 1 on Plates #5. Vertical scans were conducted in the downward direction. Figures 5.3 and 5.4 display the minimum readings taken in each 15-in.-wide by 12-in.-long area of the scan. The gray highlighted areas indicate that the minimum wall thickness exceeded the reportable level of 10% of the nominal wall thickness. The 0.397-in. shown as a gray highlighted area exceeded the acceptance criteria of 20% and will require the tank owner to take special action. The green highlighted areas indicate that the minimum wall thickness exceeded the 10% level, but the UT Level III has characterized these as pit-like indications. None of these pit-like indications exceed the pitting criteria of 25% of nominal thickness and are therefore not reportable.

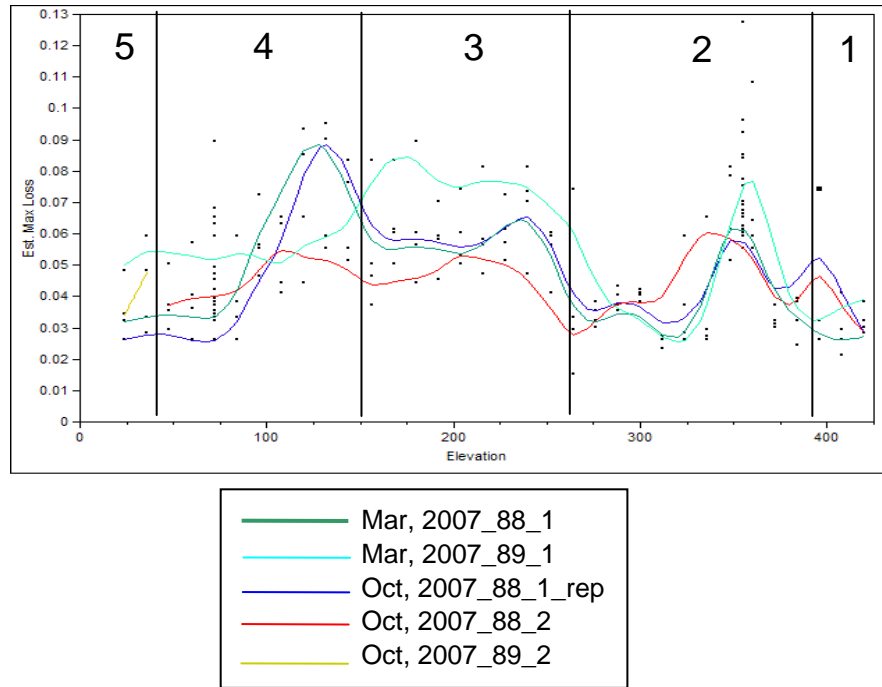
**Figure 6.2.** Estimated Maximum Wall Thickness Loss by Riser Path

The maximum estimated wall thickness loss per UT image obtained in the manner described above is shown for each path in Figure 6.2. For example consider the green curve in the figure and in the legend below the figure. The “Mar, 2007\_88\_1” label indicates the March 2007 inspection, Riser 88, Path 1. The top of the tank and Plate #1 are located on the right of the figure with the horizontal axis representing tank elevation. Numbered sections of the graphs represent the different plate courses.

The blue path on the figure is the re-inspection of the same Riser 88 Path 1; its label includes the “rep” designation indicating it constitutes replicated measurements. Recall that it was discussed how these measurements vary both due to measurement error and to the actual physical variability of tank wall thickness. Now if measurement error dominated, then the two replicate measurement paths on the figure would not look particularly like each other regardless of the physical condition of the wall. On the other hand, if the measurement paths tracked each other well, then minimal measurement error would be indicated with most of the variability more likely due to differing tank wall thickness. The latter case applies here since the two sets of path measurements track very closely to each other.

The only exception is an outlying result from a wall condition indicated at the lowest elevation of Plate #1. The darkened point on the figure at this elevation represents a thinned wall on the October 2007 inspection that was not similarly observed in the March 2007 inspection. It is obviously quite a substantial outlier relative to the rest of Plate #1. But it does appear to be a legitimate measurement since the same result was attained from the second, and new, Riser 88 path as well; in fact that darkened point is actually two points, one from each path. And surprisingly these two points are on opposite sides of a vertical weld and therefore on different steel plates. Review of the March data does show similar thinning at that elevation in the weld inspection done at that point even though it didn't show up in the original Riser 88, Path 1.

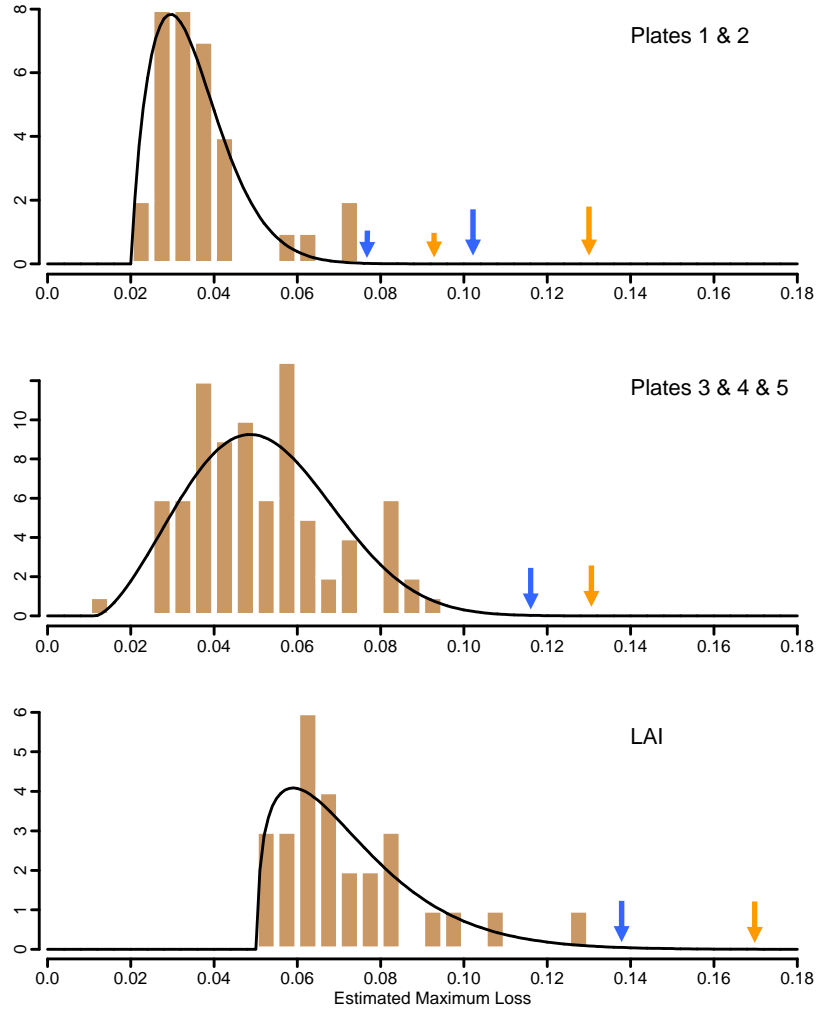
**Figure 6.3.** Weibull Distribution Fits to UT Maximum Wall Thickness Loss

The shift between the Figure 6.3 histograms indicates the basis for the plate groupings selected. Note however, that such shifts and differences between plates may result as much from the UT maxima that were used to estimate original nominal thicknesses as from wall thickness loss. It is indeed unfortunate

The values indicated by the arrows on the histograms are the estimated worst case losses per plate course combination (colored blue and to the left) and their associated 95% confidence bounds (colored orange and to the right). For the Plate #1 & #2 combination, the short arrows are those associated with the indicated curve that results from deleting the two large outlying values. The taller arrows result if the curve were refit to include the two outliers. The corresponding extreme value estimates and bounds are given in the table shown in Figure 6.4. Included in the table are: 1) the number of measurements, 2) the estimated extreme value loss expected for the plate course combination around the entire circumference of the tank, and 3) the 95% confidence bound for the extreme loss.
