# Ultrasonic Examination of Double-Shell Tank 241-AZ-101 Examination Completed July 2007

AF Pardini DR Weier

August 2007

Pacific Northwest National Laboratory Richland, Washington 99352

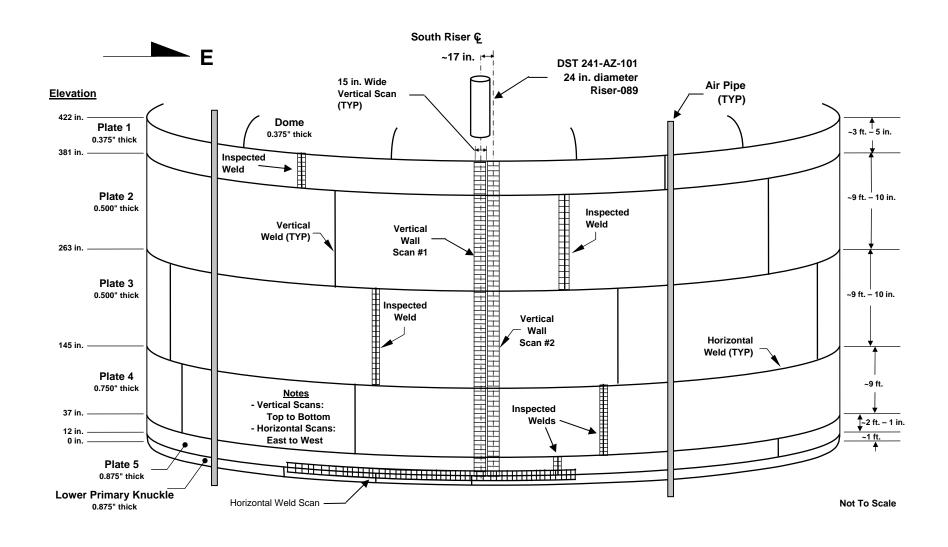
Figure 4.2. Sketch of Scan Paths on 241-AZ-101 Primary Tank from Riser 89

Figure 4.2 describes the areas on the primary wall of Tank 241-AZ-101 that were ultrasonically examined from Riser 89 located on the south side of the tank. Two 15-in.-wide vertical scan paths were performed on Plates #1, #2, #3, #4, and #5 below the entrance to Riser 89. Vertical weld HAZ examinations were done on Plates #1, #2, #3, #4, and #5, and the horizontal weld HAZ examination was done on the transition Plate #5 to knuckle weld.

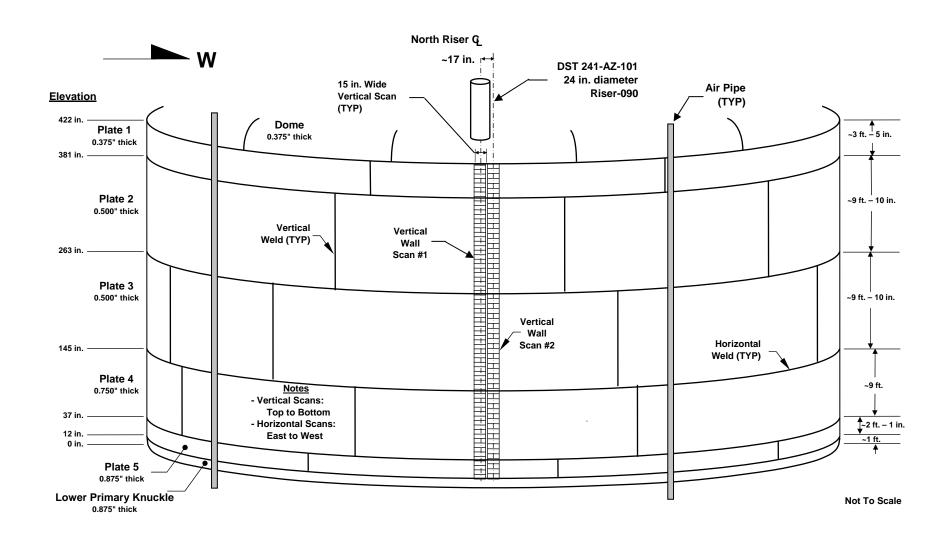
Figure 4.3. Sketch of Scan Paths on Tank 241-AZ-101 Primary Tank from Riser 90

Figure 4.3 describes the areas on the primary wall of Tank 241-AZ-101 that were ultrasonically examined from Riser 90 located on the north side of the tank. Two 15-in.-wide vertical scan paths were performed on Plates #1, #2, #3, #4, and #5 below the entrance to Riser 90.

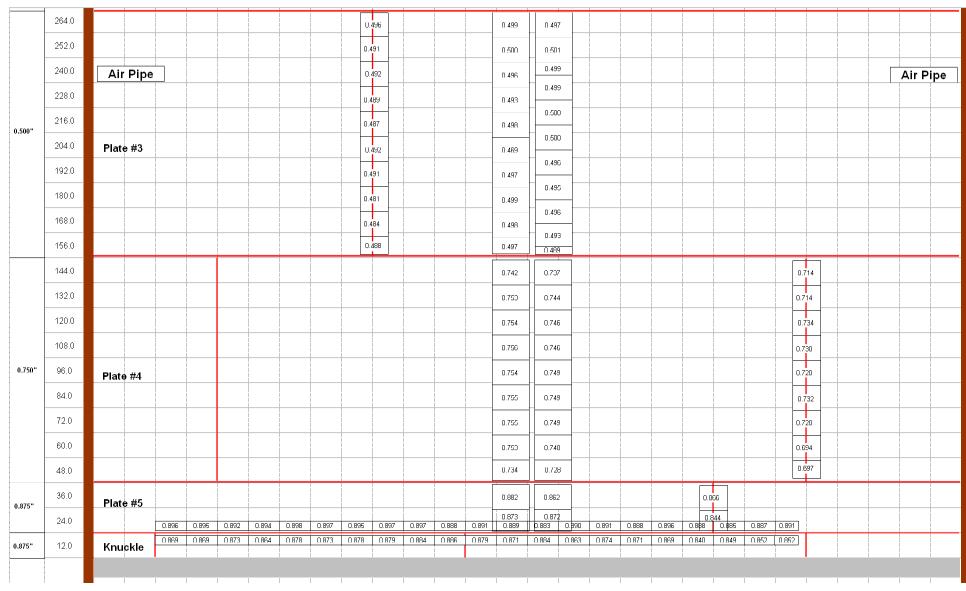
Figure 5.1. UT Data from Tank 241-AZ-101 Riser 89

Figures 5.1 and 5.2 show the wall thickness examination results for the primary tank wall and the HAZs of both vertical and horizontal welds taken below Riser 89. The examination consisted of two vertical paths beneath the 24-in. diameter riser. Vertical scan #1 was 15-in.-wide on Plate #1, #2, #3, #4, and #5 near the centerline of the 24-in. riser. Vertical scan #2 was adjacent to vertical scan #1 and was also 15-in.-wide on Plates #1, #2, #3, #4, and #5. Vertical scans were conducted in the downward direction. Figures 5.1 and 5.2 display the minimum readings taken in each 15-in.-wide by 12-in.-long area of the scan. The HAZs of vertical welds in Plates #1, #2, #3, #4, and #5 were examined and the HAZ in the horizontal weld between Plate #5 and the knuckle section was also examined. Weld area exams include approximately 5-in. on each side of the weld and figures 5.1 and 5.2 display the minimum readings taken in each 5-in.-wide by 12-in.-long area of the scan. Areas in the figures that show two measurements in the same box are the result of the vertical scan paths overlapping the horizontal scan paths. In the overlapping areas, both minimum readings from each vertical and horizontal scan paths are given.

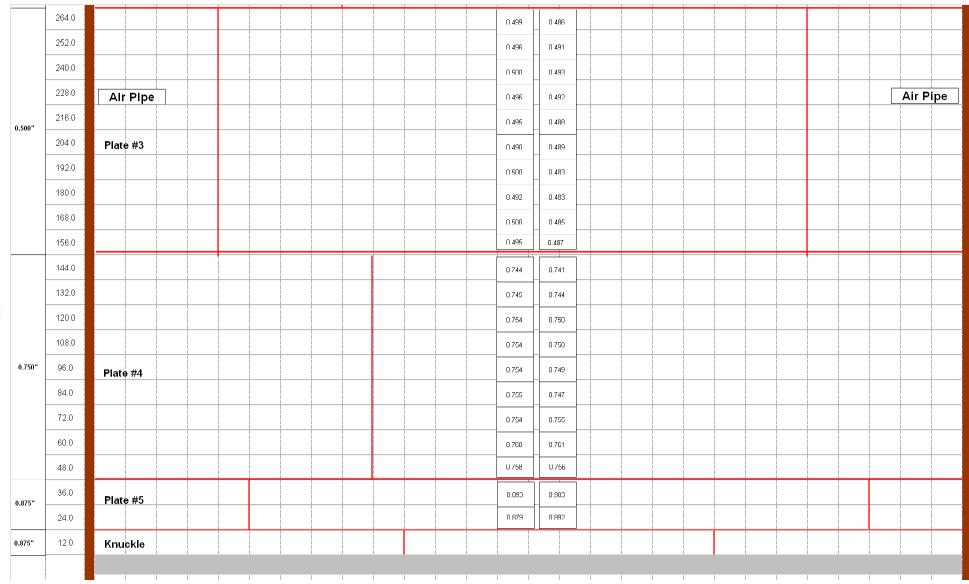
Figure 5.3. UT Data from Tank 241-AZ-101 Riser 90

Figures 5.3 and 5.4 show the wall thickness examination results for the primary tank wall taken below Riser 90. The examination consisted of two vertical paths beneath the 24-in. diameter riser. Vertical scan #1 was 15-in.-wide on Plate #1, #2, #3, #4, and #5 near the centerline of the 24-in. riser. Vertical scan #2 was adjacent to vertical scan #1 and was also 15-in.-wide on Plates #1, #2, #3, #4, and #5. Vertical scans were conducted in the downward direction. Figures 5.3 and 5.4 display the minimum readings taken in each 15-in.-wide by 12-in.-long area of the scan.

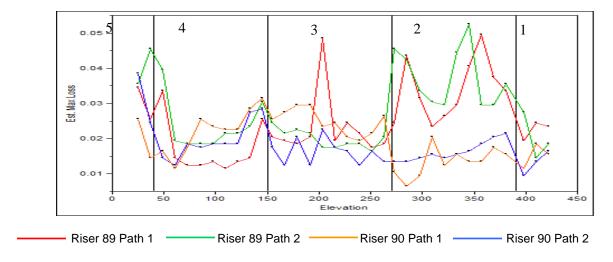
**Figure 6.2.** Estimated Maximum Loss by Path

Deciding whether grouping the estimated wall thickness maximum losses across plates is appropriate is somewhat difficult for the Tank 241-AZ-101 measurements. Figure 6.2 shows the four paths of maximum UT loss values obtained when using the estimated nominal values from Figure 6.1. In Figure 6.2, plate courses are as indicated near the top of the figure. Each line represents a riser/path combination as indicated in the legend below the figure. Plate #5 shows somewhat elevated losses; Plate #4 less loss, except at its lowest edge for Riser 89; Plate #3 has less loss except for a single outlying value; Plate #2 dramatically differs between Riser 89 and Riser 90 with much greater losses in the particular plate associated with Riser 89; Plate #1 losses are again reduced. If the plate courses are treated individually, the histograms in Figure 6.3 result.

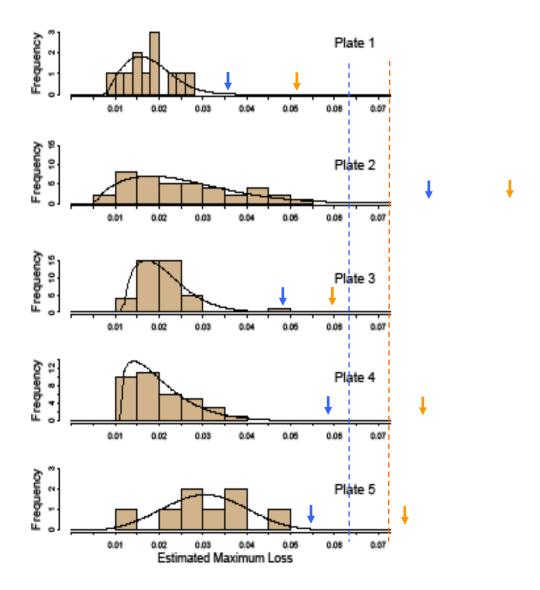
Figure 6.3. Weibull Distribution Fits to UT Maximum Wall Thickness Loss by Plate Course

The histograms in Figure 6.3 show estimated maximum wall thickness loss data for the individual plate courses. Three-parameter Weibull distributions are fit to these histograms and are shown as the smooth curves. The total surface area of a plate course, and thus the number of 15-in. by 12-in. UT images needed to 100% inspect the entire plate course combination, is computed. The percentile of the distribution that then corresponds to the maximum expected loss among this many UT images, based on the distribution fit to the histogram, is considered as the expected estimated worst case loss.

The values indicated by the arrows on the histograms are the estimated worst case losses per plate course (blue, to the left) and their associated 95% confidence bounds (orange, to the right). The corresponding values are given in the table shown in Figure 6.4. Included in the table are: 1) the number of measurements, 2) the estimated extreme value loss expected for the plate course around the entire circumference of the tank, and 3) the 95% confidence bound for the extreme value loss.

Recall that the relatively large loss values for Plate #2 result only from Riser 89. With so much variability in the losses between the two risers, the extreme value estimate and bound are quite large for this plate course. The Plate #4 estimate and bound seem rather large relative to the measured values; this occurs rather unfortunately due to the "pile-up" of measurements at the low end of the distribution and the nature of the estimated Weibull distribution that results.

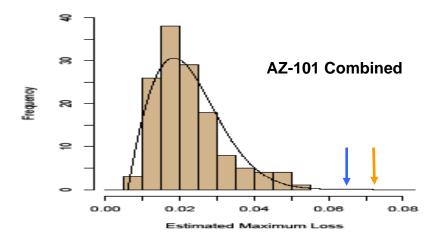
Figure 6.5. Weibull Distribution Fit to Combined UT Maximum Wall Thickness Loss

The resulting Weibull fit to the combined measurements is shown in Figure 6.5. The fit of this distribution is much better than those for the individual plates. The quality of this fit, and the larger numbers of measurements, result in the tighter upper bound as well. With the understanding that we have proportionately represented the various plate courses in the numbers of measurements taken, this combined approach is recommended for this tank for the extreme value estimate and bound. They are shown by the arrows in Figure 6.5, the vertical dotted lines in Figure 6.3, and in the final column of the table in Figure 6.4. The extreme value estimated measured maximum loss for the tank is therefore 0.064-in. with an upper 95% confidence bound of 0.072-in. Recall that these losses should not be considered relative to the tank drawing nominal values, but rather relative to the estimated plate maximum values given in the table of Figure 6.1.
