Technical Letter Report

**Preliminary Assessment of NDE
Methods on Inspection of HDPE
Butt Fusion Piping Joints for
Lack of Fusion**

JCN N6398, Task 2D

May 2008

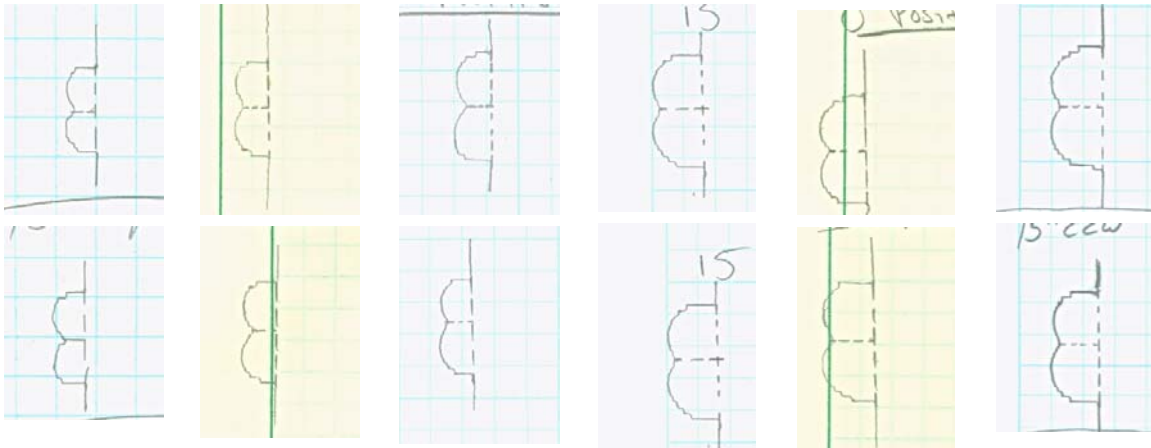
The left and right weld bead widths, total width, and left and right bead heights were measured for the 24 fused pipes at eight positions around the pipe or approximately every 45 degrees. Figure 3.2 shows from left to right, two profiles taken from one pipe in each of the six fusion conditions. The top profile was taken at 0 degree, the print line of the pipe, and the lower profile at 135 degrees. Notice that the beads in conditions 1–3 are smaller than the beads fused with conditions 4–6. The average difference in left and right bead width and height was 0.67 and 0.34 mm, respectively, with no apparent correlation between the good four welds and the other welds expected to contain LOF. Also calculated was the average bead width-to-height ratio, which should be in the 2 to $2\frac{1}{2}$ range. Figure 3.3 shows the results for this calculation for each of the 24 pipes. Joints fused with fusion pressure during the heat cycle, conditions 1–3, were out of bounds in the width-to-height ratio and the beads were smaller in these joints as already mentioned. With fusion pressure during the heat cycle, the weld bead width was approximately 15 percent smaller and the bead height 32 percent smaller than a bead with a normal heat cycle.

Figure 3.2. Weld Bead Profiles Taken Left to Right from a Pipe Fused at Conditions 1–6. The top profile was acquired at zero degrees and the bottom at 135 degrees. The grid spacing is 0.25 inch (0.64 cm).

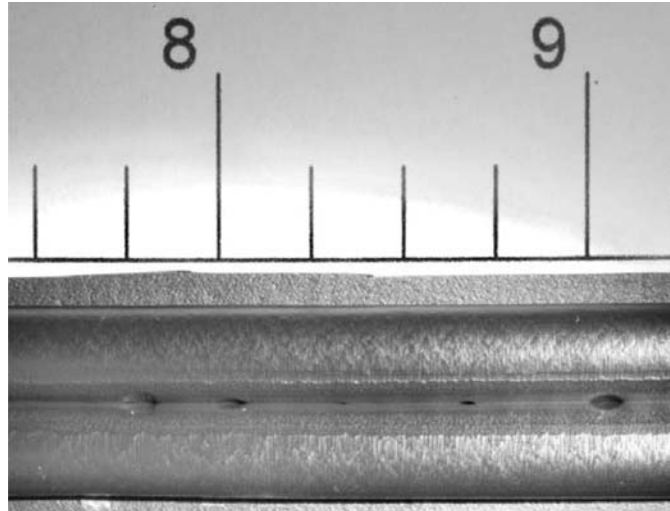
The weld bead fusion zone from the outer diameter (OD) of each pipe was visually inspected and areas with anomalies were photographed. Typical anomalies were voids or dimples in the v-groove between the weld beads as shown in Figure 3.4. In general there was little or no correlation between the VT results and the ultrasonic TOFD data from the Fluor/NDT Innovations, Inc. workshop, which is discussed later. As an example, one pipe contained many TOFD indications with 70 percent of the pipe fusion zone showing flaw signals. From the VT results, only four small defective areas were noted in the fusion joint from an OD inspection.

Figure 3.4. Fusion Zone Anomalies. The scale is in inches (1 inch = 2.54 cm).

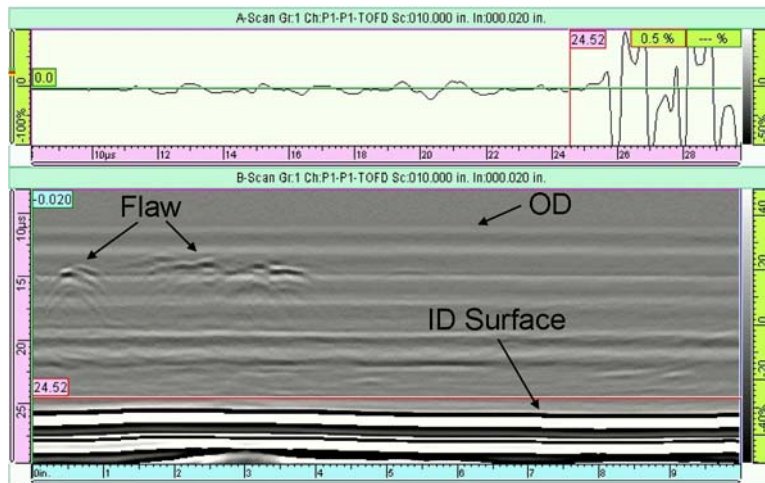
A screen capture for a 10-inch (25.4-cm) section of pipe, one quadrant, is shown in Figure 3.8. The upper portion of the image shows the A-scan, amplitude–time trace. The lower portion shows the B-scan gray-scale image of the inspected 10 inches (25.4 cm) of fusion zone. An OD surface signal (lateral wave) runs across the top of the B-scan image and towards the bottom is the ID surface signal (back wall echo). Embedded flaw signals occur between these two signals. An OD-connected flaw typically disrupts the OD surface signal and an ID surface-connected flaw typically disrupts the ID surface signal. Several flaw signals are noted in the left portion of the image and are representative of the hyperbolic diffracted signals seen in a TOFD inspection. The technique relies on a disturbance of the base material signals caused by flaw tip diffracted signals.

Figure 3.8. TOFD Image Showing the OD and ID Surface Signals and a Flawed Area

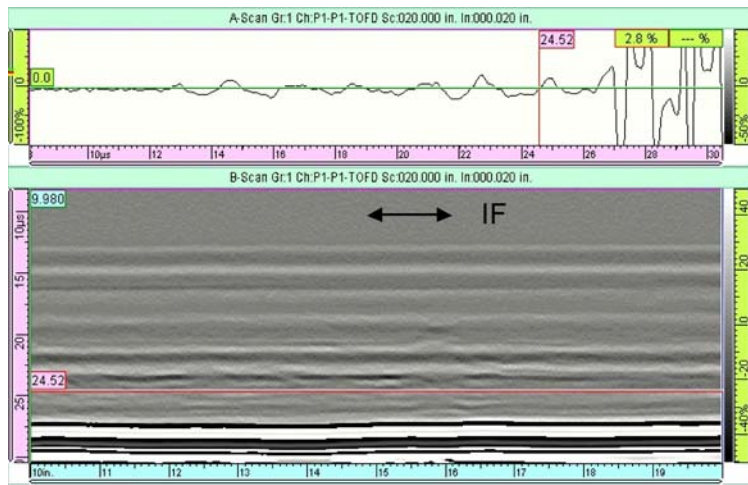
In general the technique appeared to detect acoustical anomalies in the pipes. Figure 3.9 shows an area that was identified as having incomplete fusion. Figure 3.10 shows an area called flawed in one of the good pipes, fusion condition 6. Images of all the data are shown in Appendix B. Destructive analysis is needed to verify these results. These calls, as noted on the images, were made by NDT Innovations personnel during their two-day inspection of all 24 joints. Some of the calls are obvious as in Figure 3.8 and others are less obvious as in Figure 3.9. It also needs to be noted that the original data had high resolution and contrast, which unfortunately is reduced in these figures.

Figure 3.9. Area Identified as Incomplete Fusion

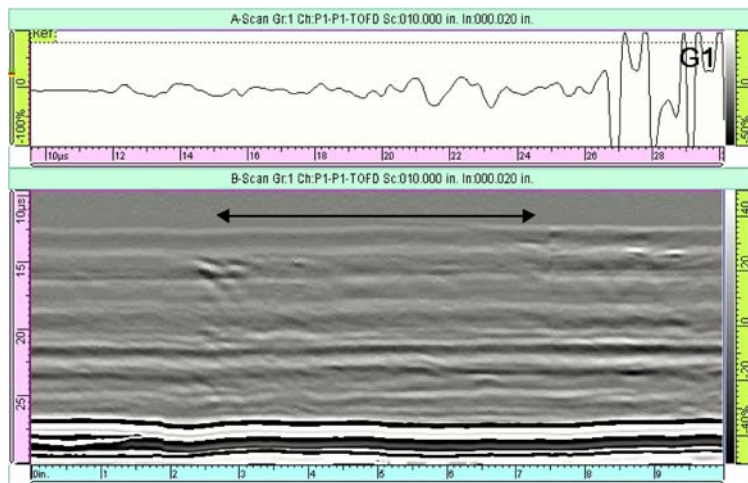
Figure 3.10. Possible Flaw Indications in One of the “Good” Pipes

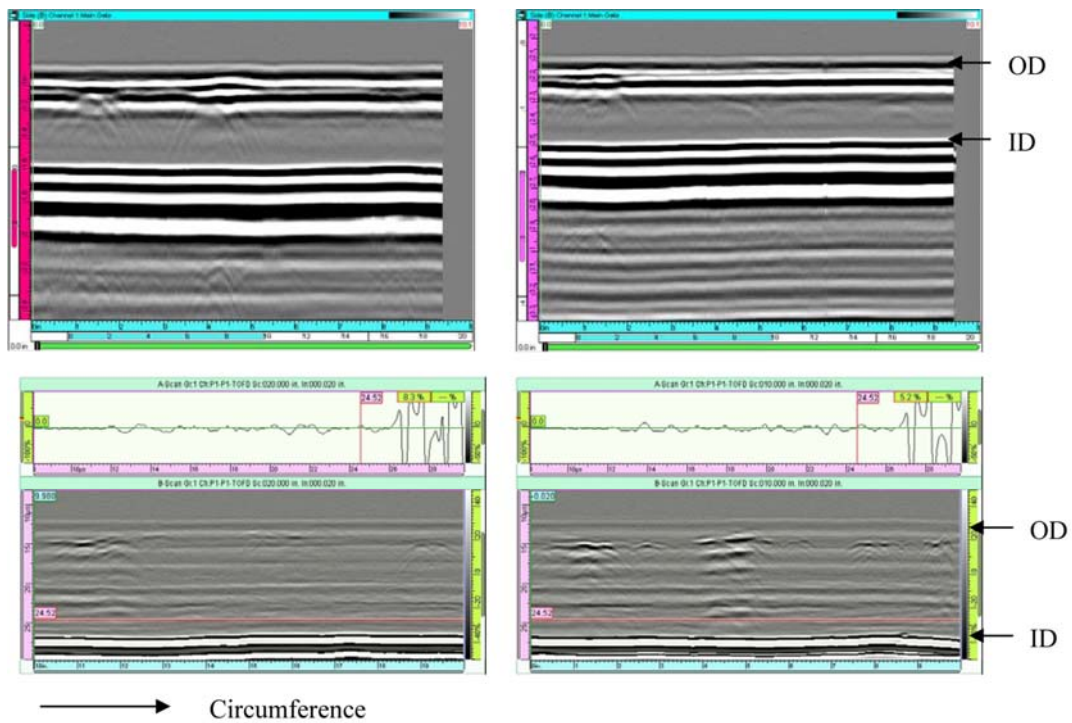
The worst-case condition for pipe fusion, out of the McElroy batch of 24 test assemblies, and the one most likely to produce LOF was condition 2 with fusion pressure during the heat cycle and a 20-second open/close time. One of these pipes was examined with TOFD by PNNL showing results comparable to those presented by Fluor/NDT Innovations, Inc. The data are shown in Figure 3.13 and Figure 3.14 for the four pipe quadrants, with the PNNL data shown in the top of each figure and the Fluor/NDT Innovations, Inc. data at the bottom of each figure. Notice that the PNNL data show the mode-converted signals beyond the longitudinal-wave back wall (ID) echo. The time window was extended to include the slower mode-converted signals with the thought that this additional data would enhance the detection of defects. The Fluor/NDT Innovations, Inc. data images are cropped at the ID and additionally do not have the saturated OD lateral wave signal seen in most TOFD images and in the PNNL data. This results in a cleaner looking image and should provide better near-surface sensitivity to flaws. Fluor/NDT Innovations, Inc. data is also much more sensitive, due most likely to their patented processing of the raw data. Regardless, in this data comparison flaw indications are identified at similar locations by both PNNL and Fluor/NDT Innovations, Inc. Each quadrant represents approximately 10 inches (25.4 cm) of pipe circumference.

Figure 3.13. TOFD Data Acquired on Pipe 125, First and Second Quadrants (left and right), by PNNL in the Top and by Fluor/NDT Innovations, Inc. in the Bottom

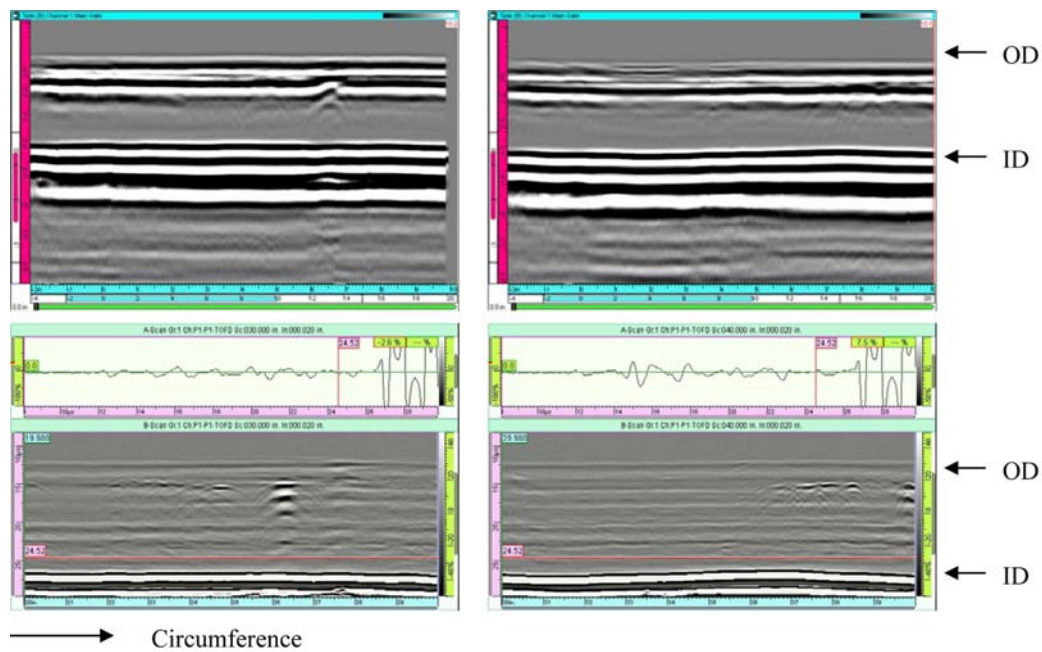
Figure 3.14. TOFD Data Acquired on Pipe 125, Third and Fourth Quadrants (left and right), by PNNL in the Top and by Fluor/NDT Innovations, Inc. in the Bottom

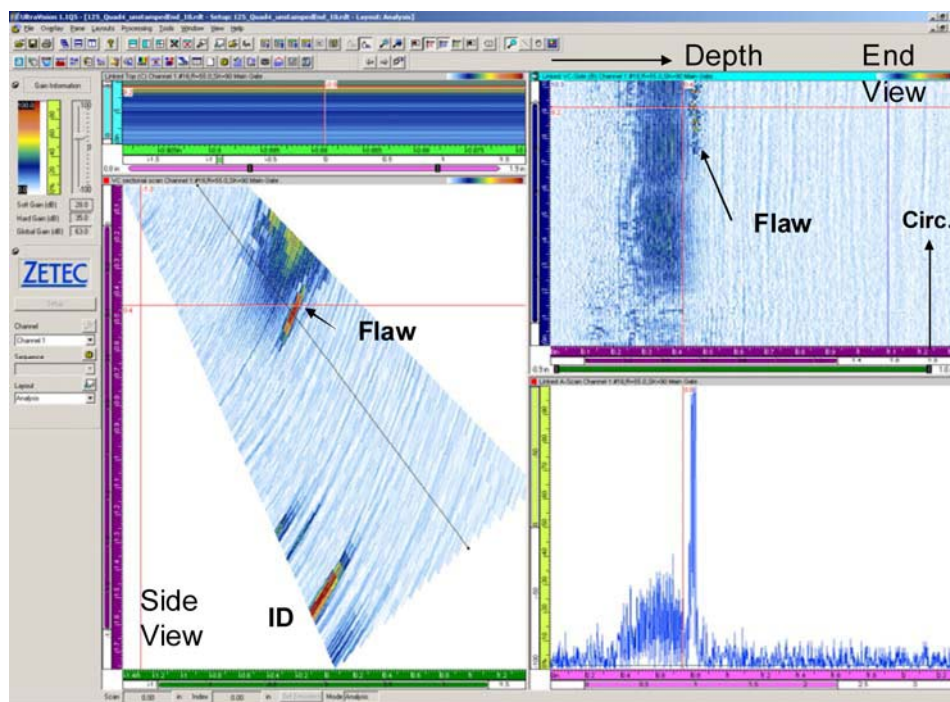
PA data was acquired on the fusion joint from pipe 125, a worst-case condition for joint integrity, and is displayed in Figure 3.17. The side view on the left shows the ID signal at the angle sweep start of 30 degrees. Data is acquired from 30 to 60 degrees at 1-degree increments. The highlighted flaw indication was centered at approximately 55 degrees as shown by the black line at the flaw indication in the side view. The associated end view at 55 degrees is shown on the top right with the flaw signal noted. Its circumferential extent is approximately from 7 to 9 inches (17.8–22.9 cm) in quadrant 4. The bottom right shows the A-scan trace from the position marked by the red horizontal line in the end view image.

Figure 3.17. Phased Array Results on HDPE Pipe 125, Quadrant 4 Showing a Possible Lack of Fusion in the Noted Flaw Area

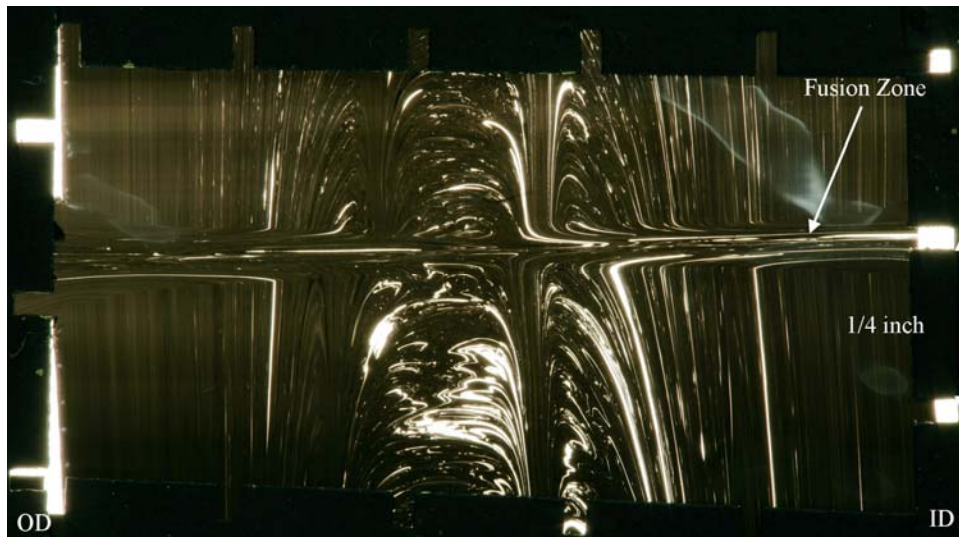
A weld area from pipe 125 containing a flaw indication at approximately 7–9 inches (17.8–22.9 cm) was cut out of the pipe. Slices were made in the axial direction, perpendicular to the weld. These slices were in the 25–35 micron thick range and were thin enough to see through yet thick enough to still hold together. A slice at approximately 8.6 inch (21.8 cm) in the pipe circumference is shown in Figure 4.4. Because of uneven mixing of carbon black in the base material of this 3408 pipe there are light and dark swirls in the pipe. In the joining of the two pipe sections, this swirl pattern changes direction due to the melting and fusing and runs along the fusion line. These light and dark lines in the fusion zone camouflage lack of fusion in this region. Evidence of lack of fusion is, however, seen on the cut (or sectioned) pipe surface as shown in Figure 4.5. The microtome cut is made from the bottom of the piece in Figure 4.5 to the top, leaving cut marks that run perpendicular to the fusion line. Sufficient and appropriate lighting or tilting of the pipe section highlights the lack-of-fusion lines in the fusion zone. A liquid penetrant test (PT) or evaluation of this surface was also performed in attempts to enhance the LOF indication. A red dye was applied to the cut surface and allowed to soak for at least one hour. Normally during this dwell time the liquid penetrant is absorbed into surface discontinuities by capillary action. After the dwell time the surface was wiped clean of the dye and a white developer applied. The developer typically draws dye out of discontinuities and maps out the flaw shape/opening on the surface of the specimen. No flaw was seen on this specimen face with the PT. It is assumed that these LOF areas are so tight that the dye did not seep into the discontinuity.

Figure 4.4. A Slice from HDPE Pipe 125, Quadrant 4 at Approximately 8.6 Inches (21.8 cm). Lack of fusion in the fusion zone is not evident due to light colored material streaks and swirls from uneven base material mixing.

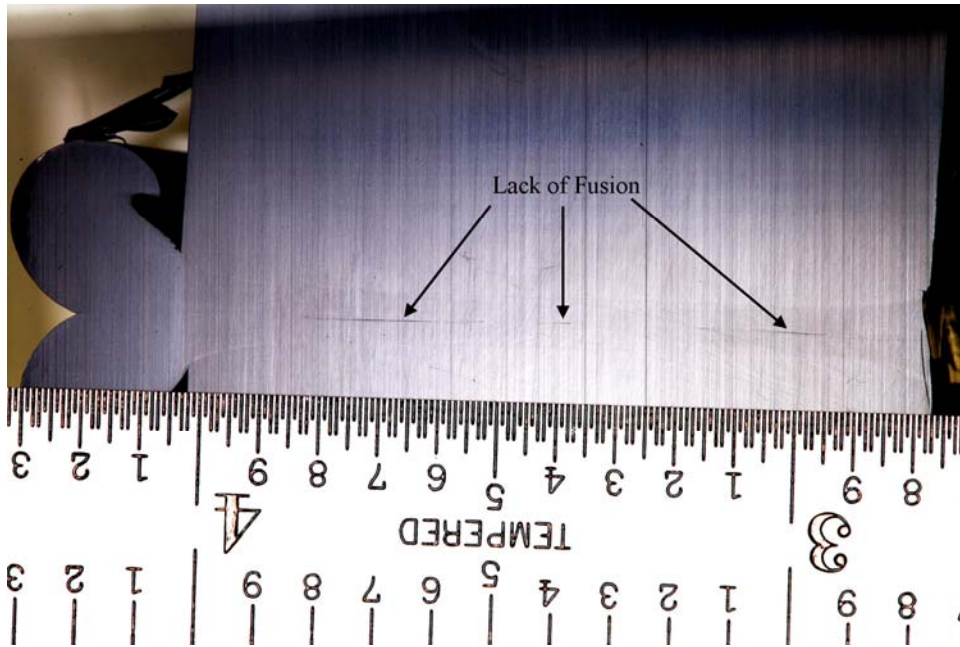
Figure 4.5. Surface of HDPE Pipe 125, Quadrant 4 at Approximately 8.6 Inches (21.8 cm). Areas of lack of fusion are noted.

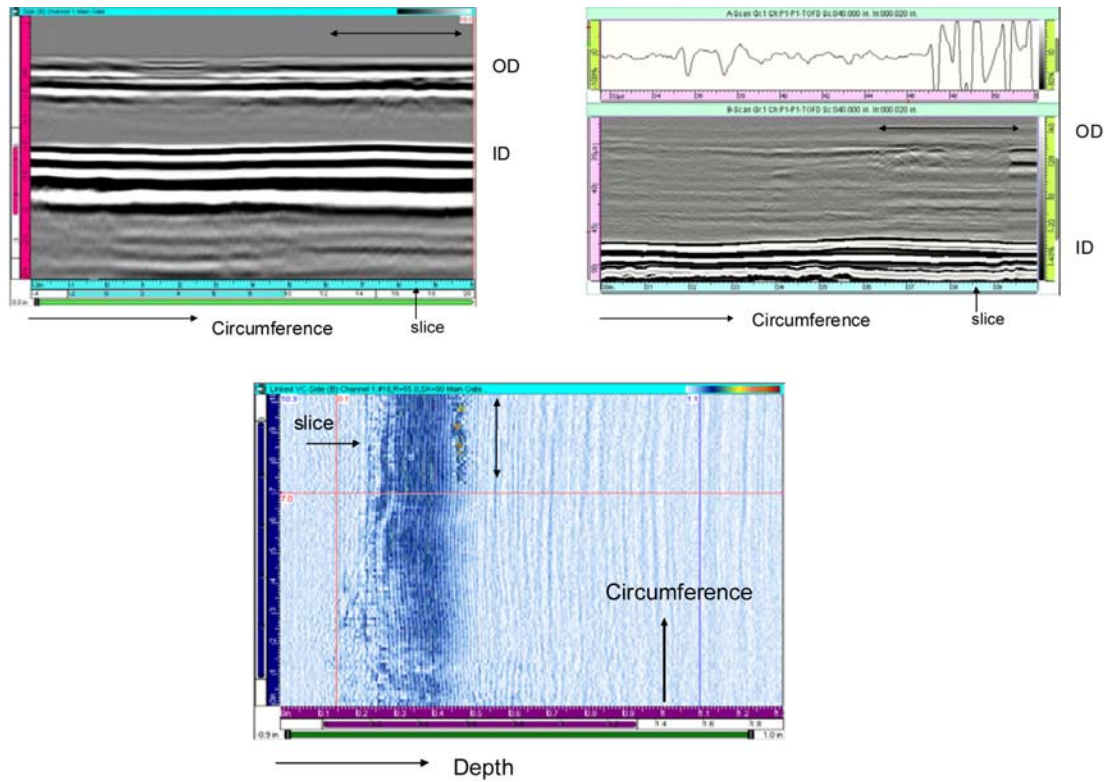
The TOFD and PA results from the fourth quadrant of pipe 125 are shown in Figure 4.6. The approximate area of the slice and surface shown above in Figure 4.4 and Figure 4.5 is noted in each of the ultrasonic images. Both the PNNL TOFD (left) and Fluor/NDT Innovations, Inc. TOFD (right) data show a flaw indication in the end of the B-scan image. The PA data, below center, is a rotated-in-orientation B-scan image and also contains a flaw indication at the end of the circumferential scan line. This is confirmation that the ultrasonic techniques were able to detect this LOF.

Figure 4.6. PNNL TOFD (upper left), Fluor/NDT Innovations, Inc. TOFD (upper right), and PNNL PA Data from the Fourth Quadrant of Pipe 125 All Show a Flaw Indication in the Approximately 7–9 Inch (17.8–22.9 cm) Circumferential Position

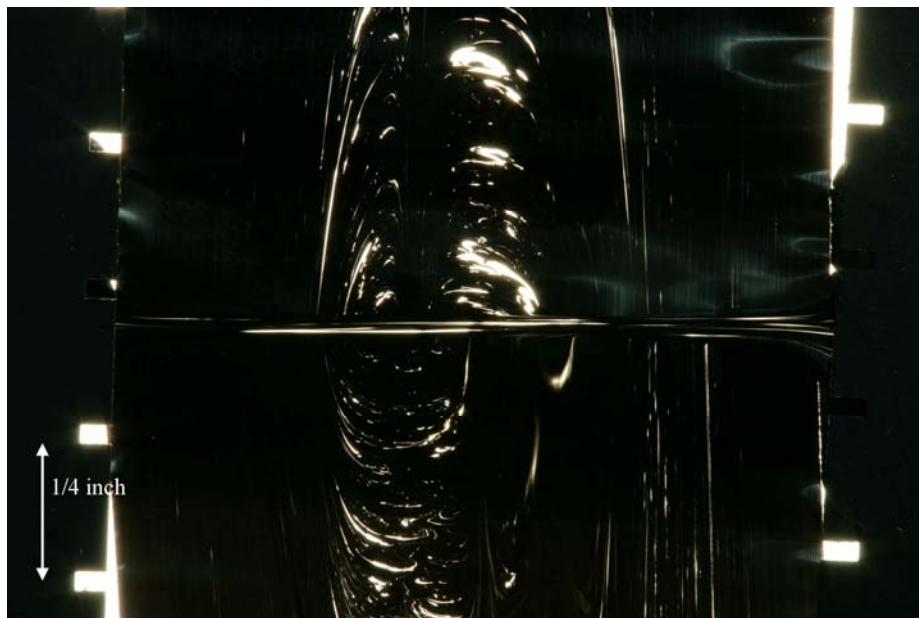
For comparison a piece of a reportedly good weld was also evaluated. TOFD and PA ultrasonic examinations showed no indications in quadrant four of pipe 1224 at 3 to 4 inches (7.6–10.2 cm). This area was cut out and sectioned. Figure 4.7 shows a slice from this weld at approximately 3.4 inch (8.6 cm). As in pipe 125, streaks of light material due to uneven mixing with the dark carbon black pipe material are evident and make a lack-of-fusion detection from the slice difficult or impossible. The pipe surface after slicing appears to be a better indicator of the weld condition. Figure 4.8 shows the cut surface with no evidence of lack of fusion in the fusion zone.

Figure 4.7. Slice from HDPE Pipe 1224, Quadrant 4 at Approximately 3.4 Inches (8.6 cm)

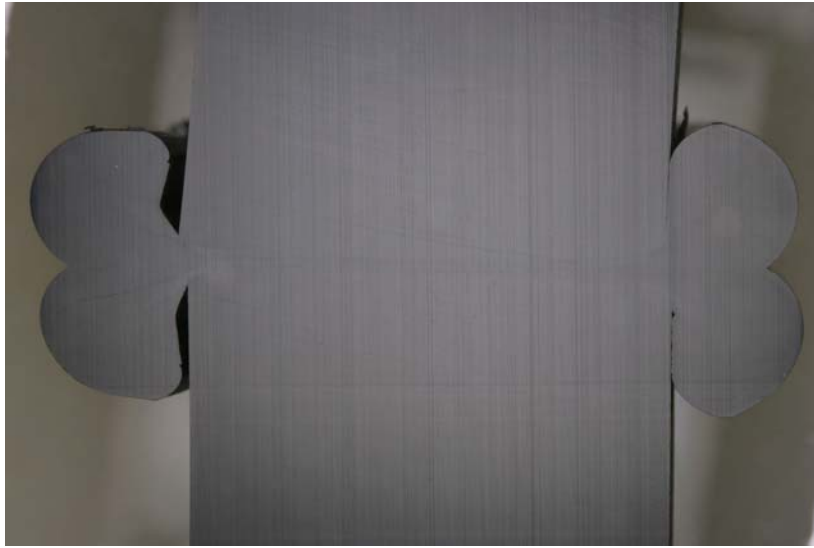
Figure 4.8. Surface of HDPE Pipe 1224, Quadrant 4 at Approximately 3.4 Inches (8.6 cm). No lack of fusion is seen.

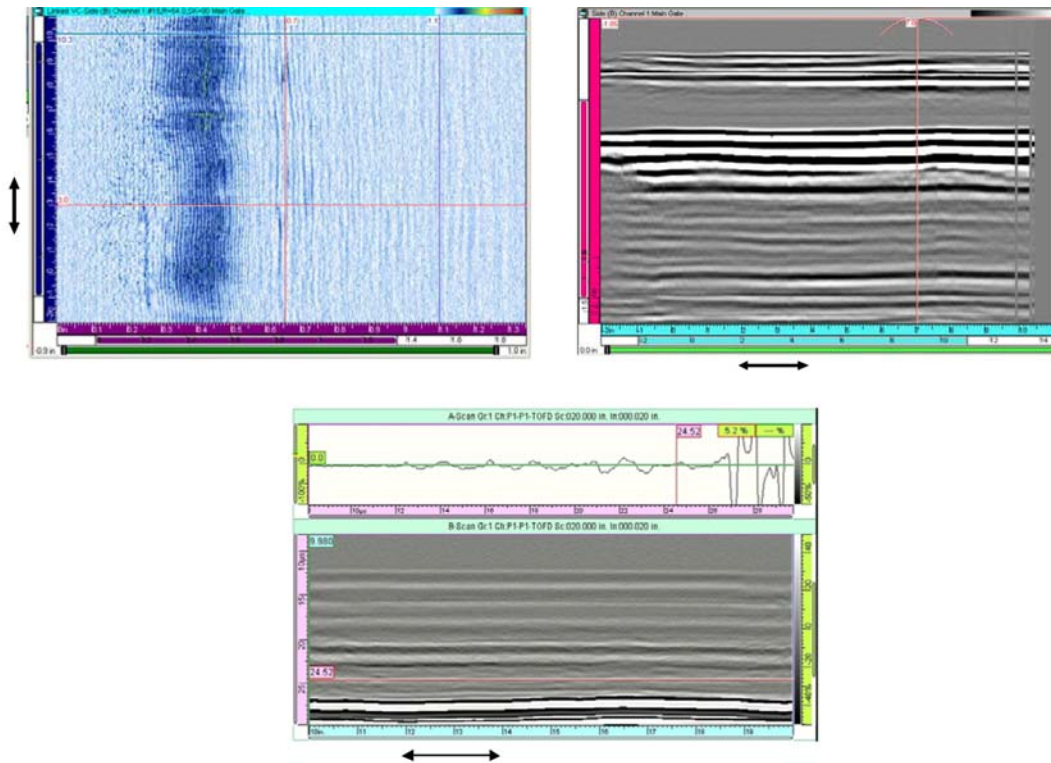
The ultrasonic responses from quadrant two in the fusion joint in this good pipe, 1224, are shown in Figure 4.9. The area marked with a double-ended arrow has been sent out for tensile testing.

Figure 4.9. Ultrasonic Responses from Quadrant Two of Pipe 1224 All Show No Flaw Indication. The PNNL PA data is in the upper left, PNNL TOFD data in the upper right, and Fluor/NDT Innovations, Inc. TOFD data in the bottom.

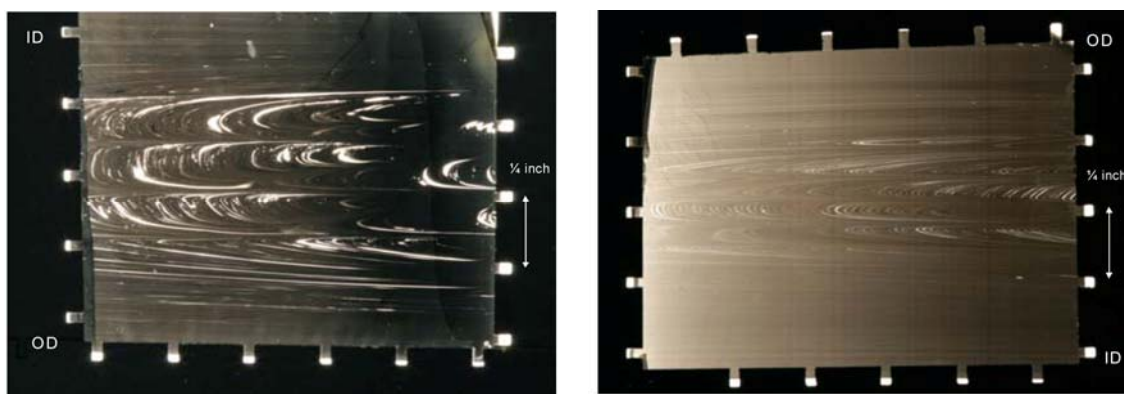
A preliminary evaluation of base material showed no ultrasonic indications in one 3408 pipe and one 4710 pipe. Slices from the 3408 and 4710 base material are shown in Figure 4.10, left and right, respectively. The spacing between the fiducial notch marks on the edges of each image is 0.25 inch (0.64 cm). The 3408 material is less uniformly mixed. The 4710 material still shows some nonuniformity but to a lesser extent. Even with this amount of swirling it would likely still be difficult to examine a thin slice through a 4710 fusion joint for LOF. No porosity was found in the few slices through base material. Only one or two areas were found with a single pin hole or porosity in or near a fusion joint in the numerous fusion joint slices evaluated. This could approximately represent a 1 percent or less rate of porosity in a slice.

Figure 4.10. Base Material Slices from 3408 on the Left and 4710 on the Right Show Swirls from Nonuniform Mixing. The spacing between edge notches is 0.25 inch (0.64 cm).
