# **Ultrasonic Phased Array Assessment of the Interference Fit and Leak Path of the North Anna Unit 2 Control Rod Drive Mechanism Nozzle 63 with Destructive Validation**

Manuscript Completed: July 2012

S. L. Crawford, A. D. Cinson, P. J. MacFarlan, B. D. Hanson,  
R. A. Mathews

Pacific Northwest National Laboratory  
P.O. Box 999  
Richland, WA 99352

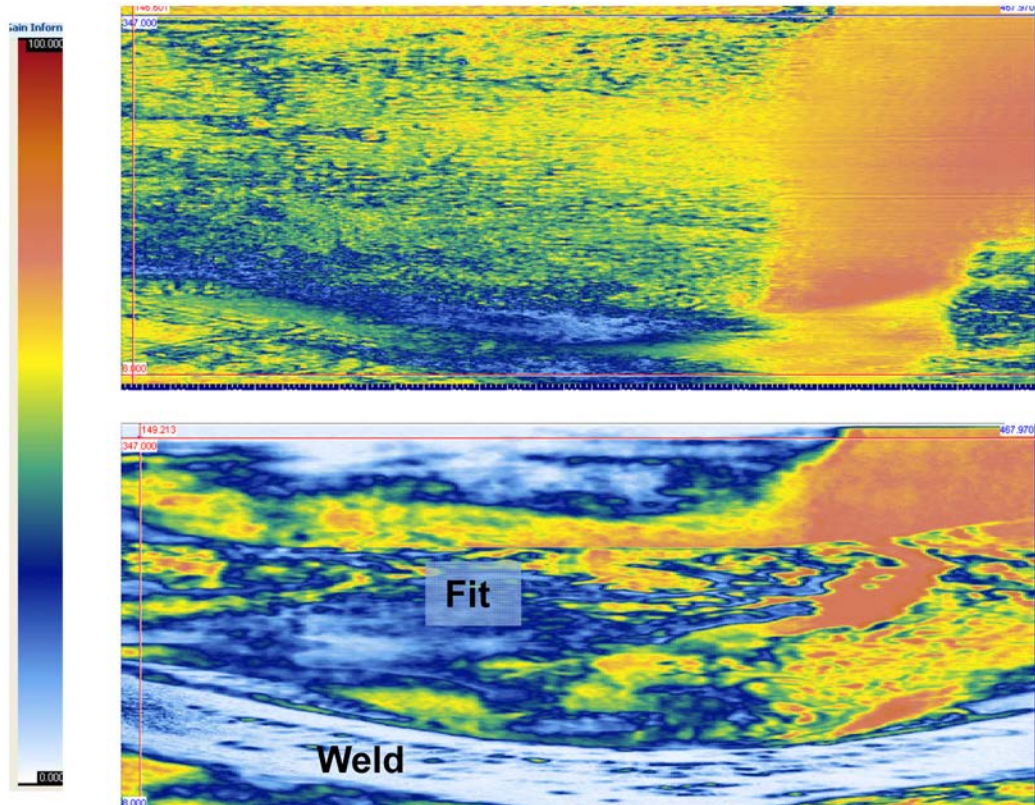
**Figure 5.2 First PA Ultrasonic Data from Nozzle 63. The front surface or nozzle ID echo is on the top and the interference fit echo on the bottom. The horizontal axis represents the 86 to 274 degree area and the vertical axis represents 360 mm (14.17 in.). The color scale is represented on the far left.**

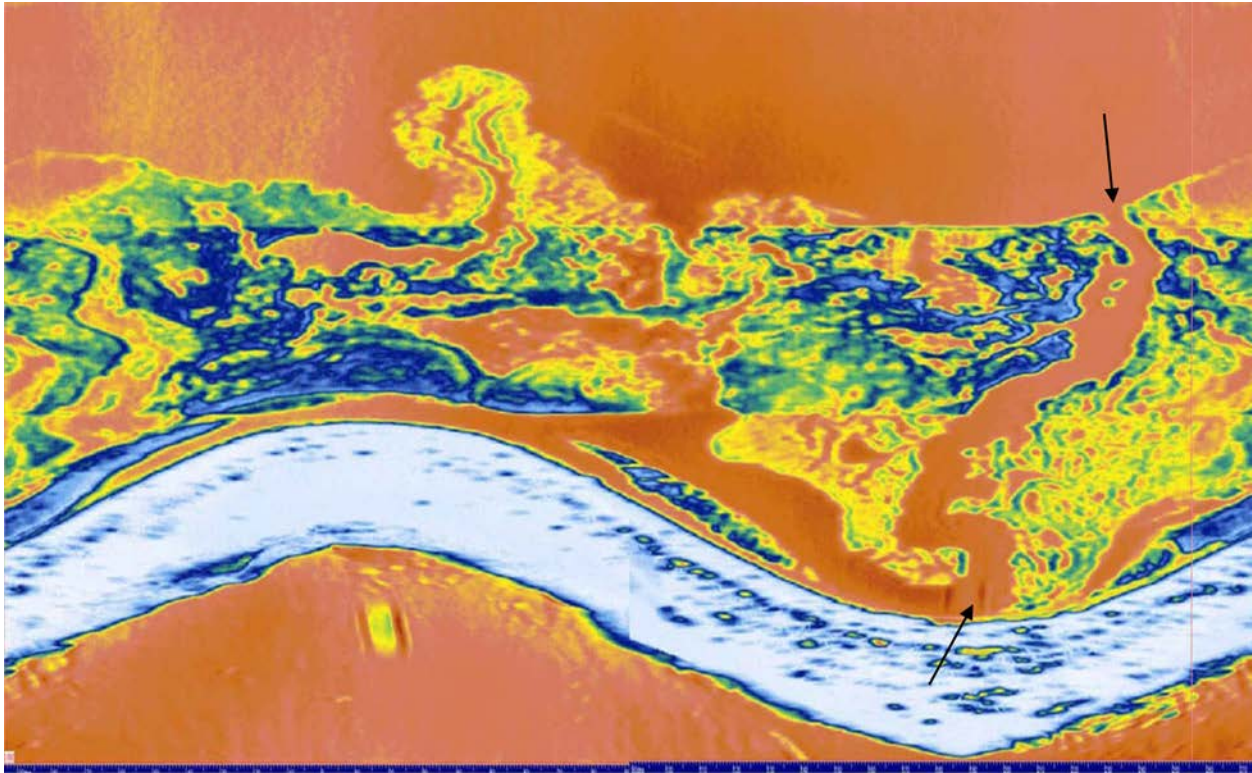
**Figure 5.3 PA Ultrasonic Data from the Interference Fit in Nozzle 63 Acquired After the Second Brushing of the Nozzle ID. The horizontal axis represents the full 360-degree area and the vertical axis represents 360 mm (14.17 in.). Black arrows indicate primary leak path. The left edge marks the -90 degree location and the right edge the 270 degree location.**

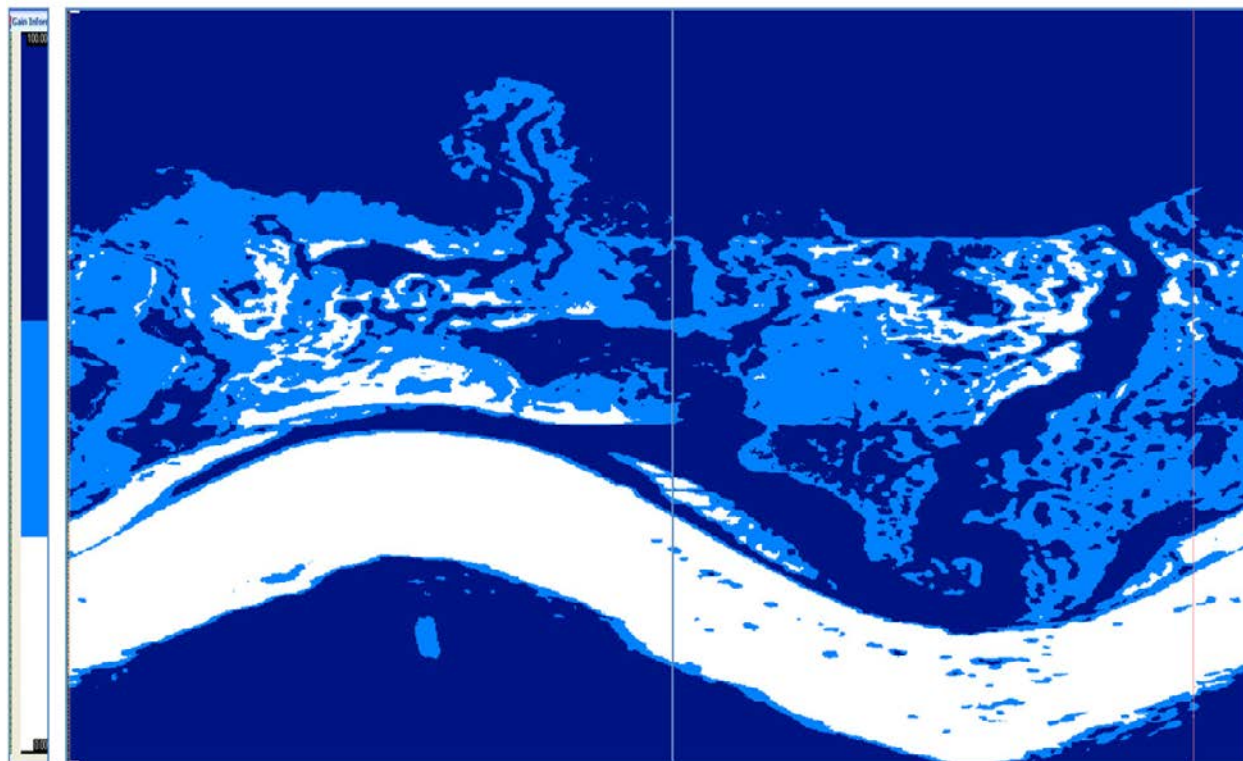
**Figure 5.7 A Tri-Color Representation of the Interference Fit Data. The dark blue represents a leak path or tube-to-air interface, the light blue represents the nominal interference fit and counter bore regions and the white represents the weld and suspected boric acid presence in the interference fit.**

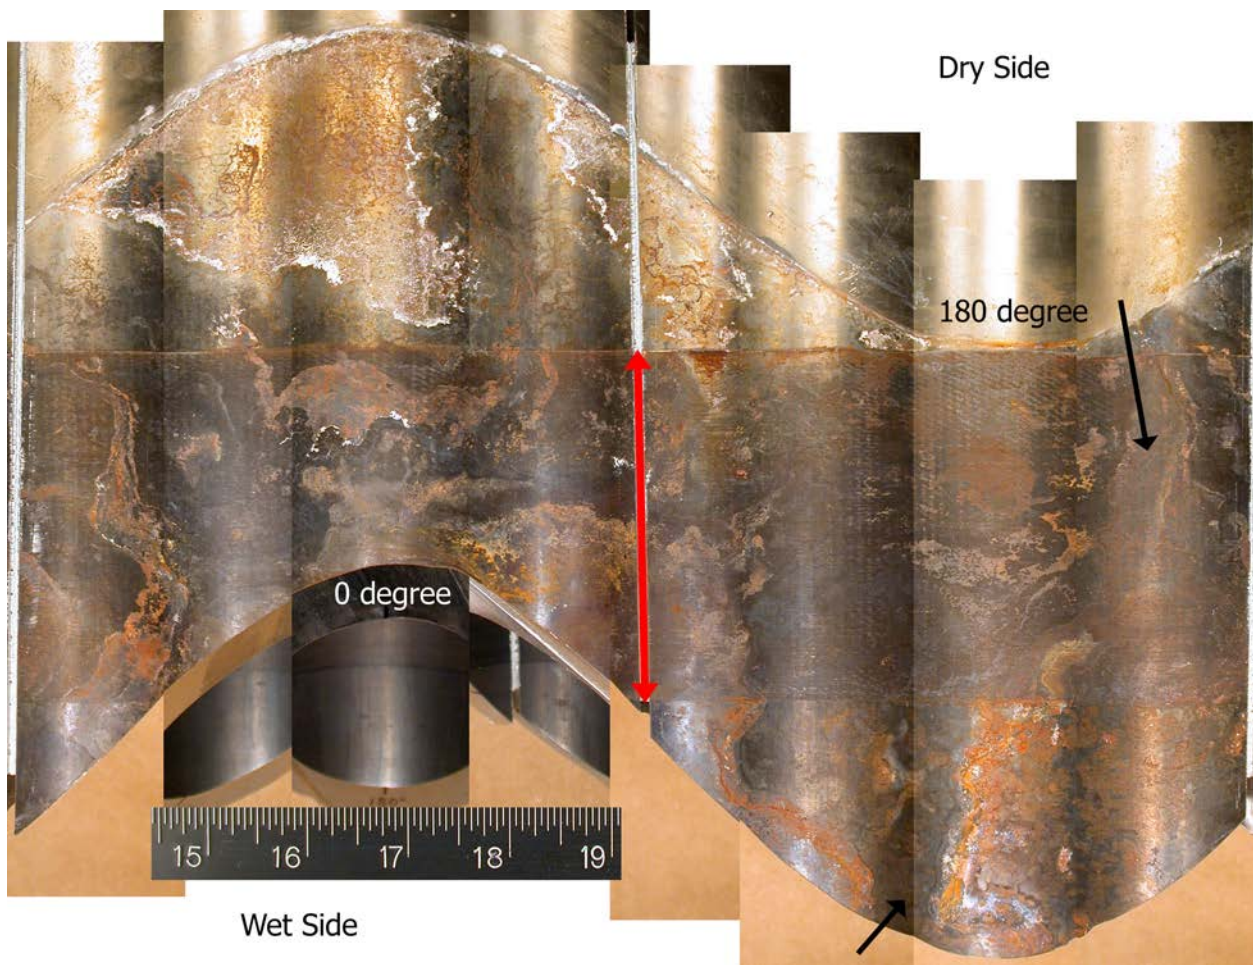
**Figure 7.1** Nozzle Surface. The red line marks the interference fit region and the two black arrows identify the main leak path.

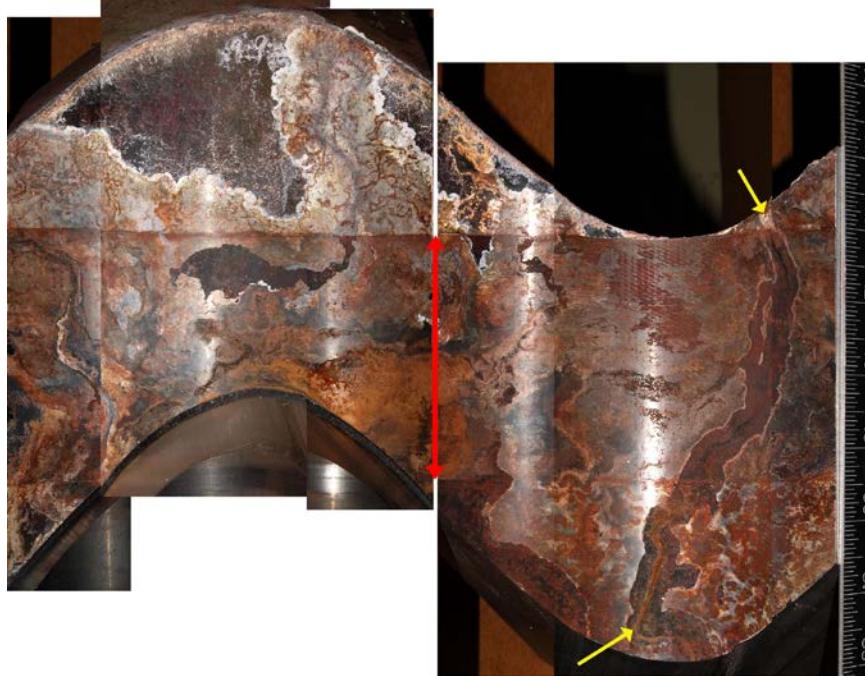
**Figure 7.2 RPV Head Surface.** The red line marks the span of the interference fit region and the two yellow arrows identify the main leak path.

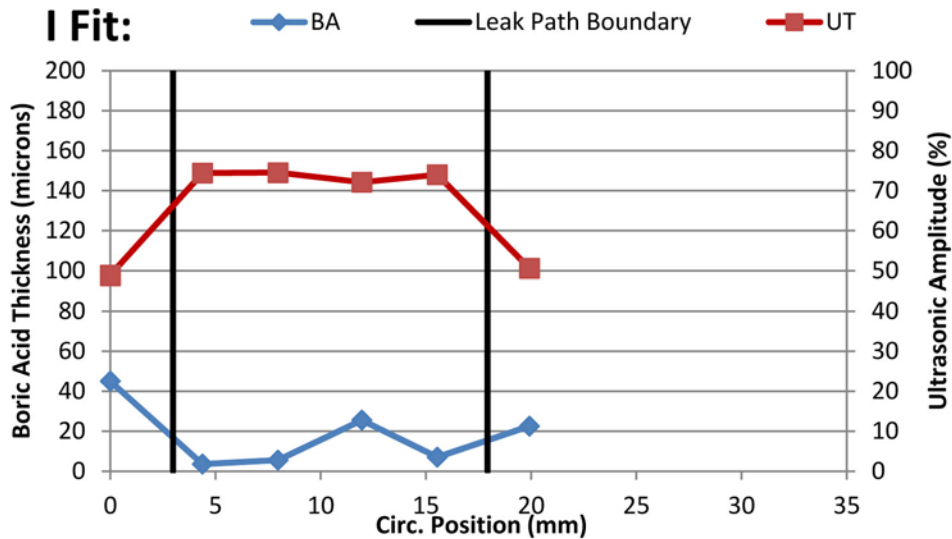
**Figure 8.4 Ultrasonic and Boric Acid/Corrosion Layer Thickness Along a Line Across the Main Leak Path in the Interference (I) Fit**

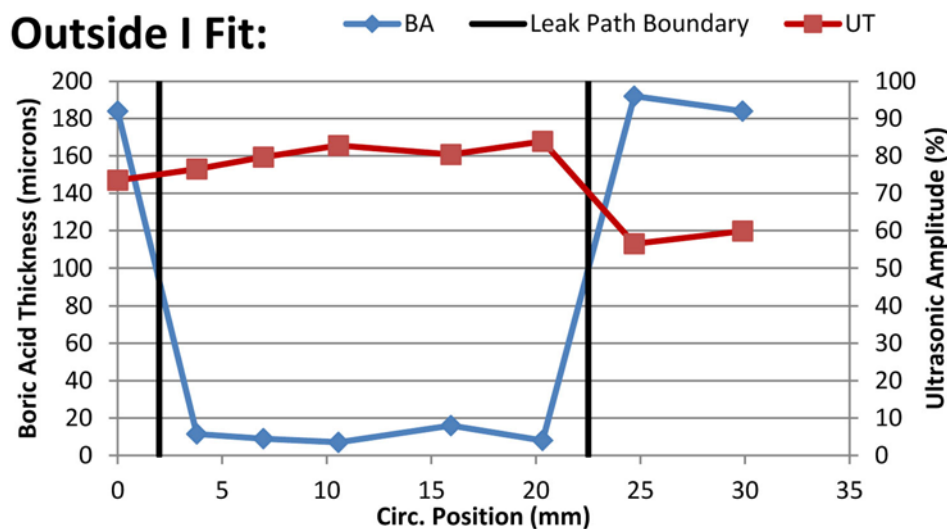
**Figure 8.5 Ultrasonic and Boric Acid/Corrosion Layer Thickness Along a Line Across the Main Leak Path Outside the Interference Fit**

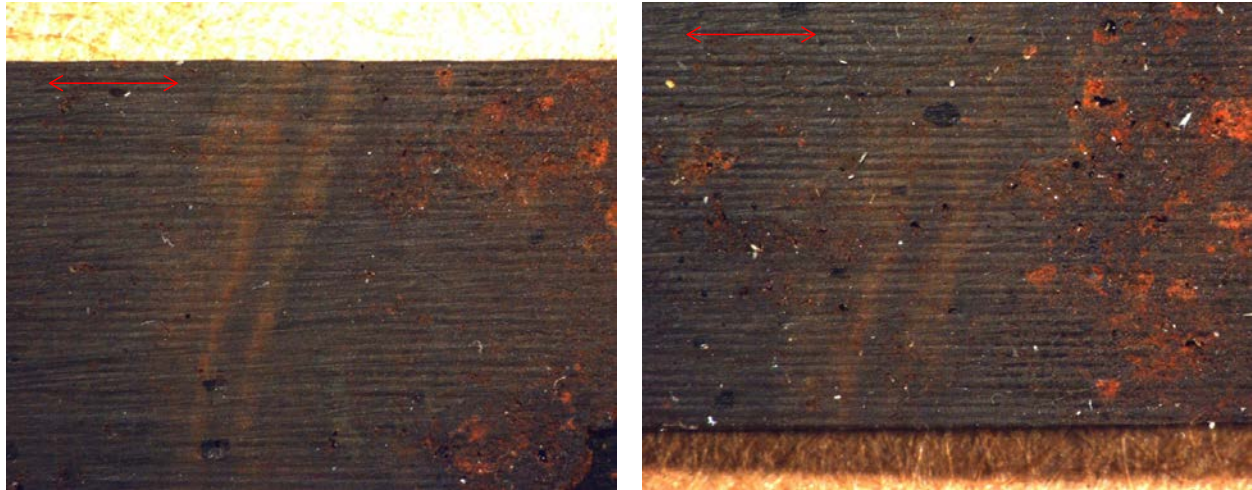
**Figure 8.11 Staining Streaks in the Leak Path Below the Interference Fit from Replica Pieces 2 and 3, Left and Right, Respectively. The red line represents 2.0 mm (0.080 in.) in length.**

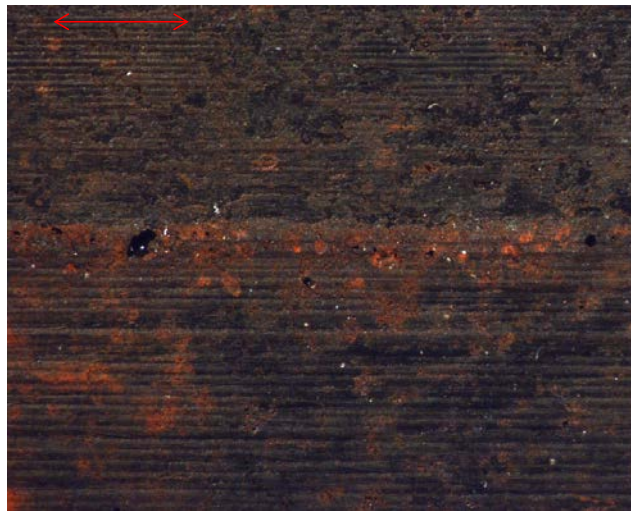
**Figure 8.12 Transition from Below the Interference Fit to the Interference Fit Region. Machining marks are evident in this replica piece 4. The red line represents 2.0 mm (0.080 in.) in length.**

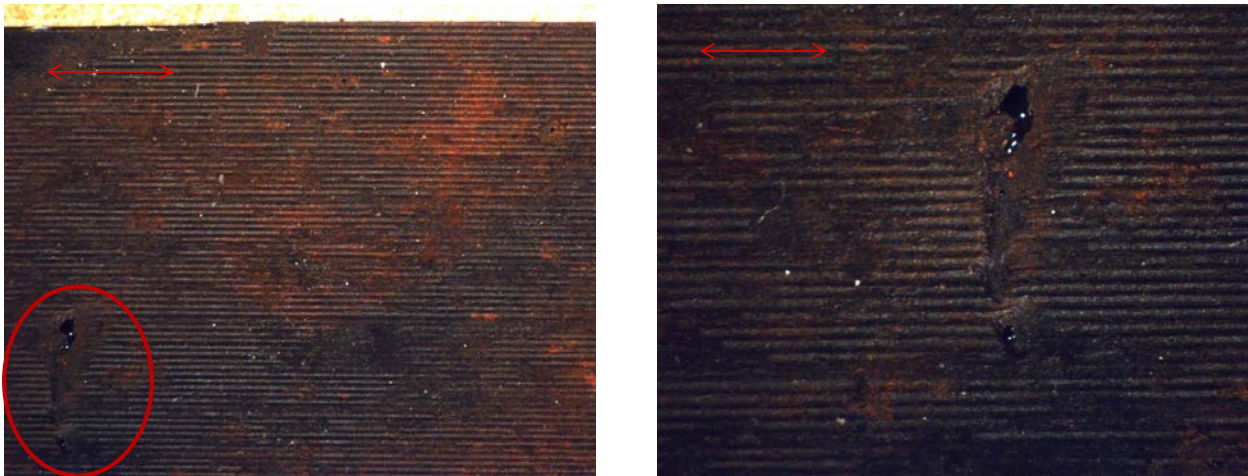
**Figure 8.13 Piece 5 from the Interference Fit Region Shows an Indication of a Scrape. In the left image the red line represents 2.0 mm (0.080 in.) in length. The image on the right at twice the magnification of the left shows more detail.**

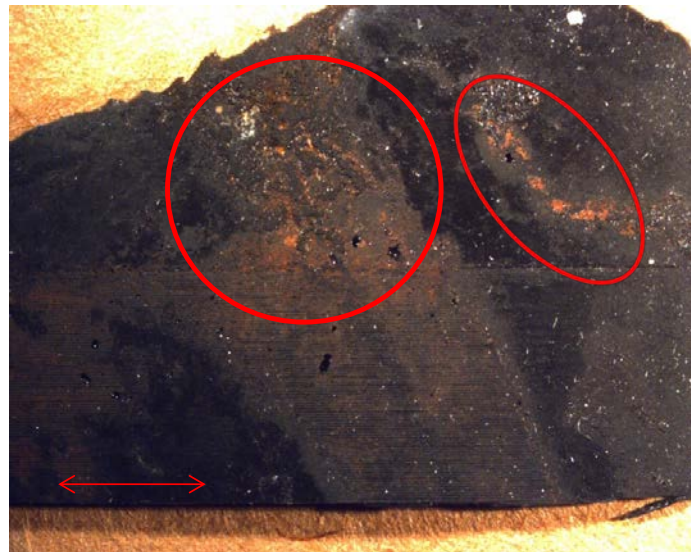
**Figure 8.14 Corrosion Areas Observed Above the Interference Fit Region. The red line represents 2.0 mm (0.080 in.) in length.**
