Long-Term Evaluation of SSL Field Performance in Select Interior Projects

February 2017

Pacific Northwest National
Laboratory

Prepared in support of the DOE Solid-State Lighting Technology GATEWAY Program

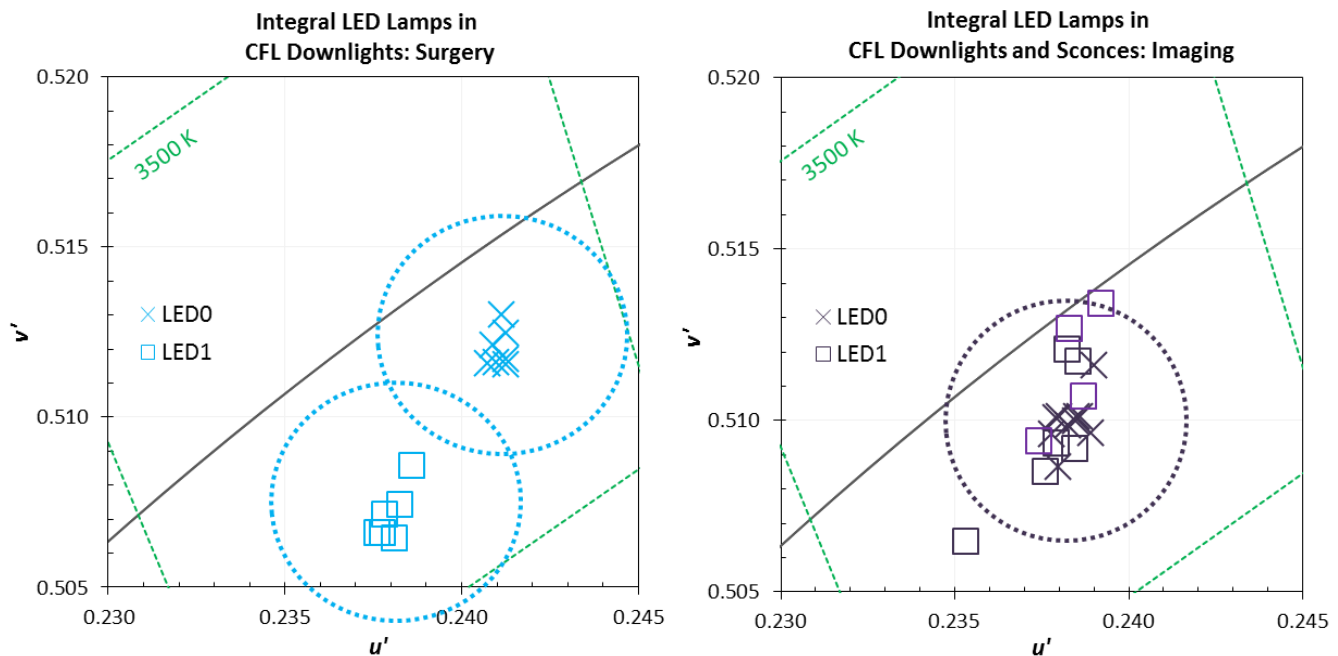
The downlights in the surgery waiting area had an initial average CCT of 3329 K with a range of 24 K and an average D_{uv} of -0.0020; after 8,800 estimated operating hours, these luminaires had an average measured CCT of 3484 K with a range of 111 K and an average D_{uv} of -0.0037. The same model of LED replacement lamps were used in the changing room area. The products had an initial average CCT of 3431 K with a range of 62 K and an average D_{uv} of -0.0020; after less than 8,800 estimated operating hours, these luminaires had an average measured CCT of 3439 K with a range of 197 K and an average D_{uv} of -0.0017. For both spaces, the CRI and R_g values remained relatively consistent, on average 84 to 85 and 23 to 27, respectively.

Figure 2. Chromaticity coordinates for 7 downlights in a surgery waiting area (left) and 10 fixtures in the imaging changing rooms (right) at St. Anthony Hospital plotted on 1976 CIE uniform color space (UCS) (u' , v') chromaticity diagram with MacAdam ellipses. The circles have a radius of 0.0035 in the (u' , v') chromaticity diagram to approximate a 3.5-step MacAdam ellipse, where the step size refers to the distance from the center of the ellipse to the perimeter. The circles are centered on the average u' and v' coordinates for each set of measurements. For the surgery downlights, the tight clustering of the chromaticity coordinates at each of the two measurement times shows that, although the average chromaticity shifted over time, it shifted consistently among the luminaires measured and remained within the 3500 K ANSI bin.¹² Unlike the downlight luminaires in the surgery waiting area, the LED1 measurements for the downlight and scone luminaires in the imaging rooms are not tightly clustered; instead, the follow-up measurements indicate a range in color performance, with a spread that is greater than seven steps (i.e., outside of a 3.5-step ellipse). Despite this variation, all of the fixtures remained within the 3500 K ANSI bin.

For the six downlights and four wall sconces in the imaging rooms (right graph, Figure 2), the average $\Delta u'v'$ from the initial to follow-up measurements was 0.0017 and the maximum was 0.0045, well within ENERGY STAR requirements. In terms of $\Delta u'v'$, these fixtures are shifting less in chromaticity over time than those in the surgery waiting area, perhaps because they have operated for fewer hours since the area is individually controlled and the lights are turned off after hours. However, they are not shifting as homogeneously as the waiting area, thus their color difference may be more noticeable. The variability in fixture types and corresponding measurement techniques are also possible (even likely) explanations for the differences from the surgery area.

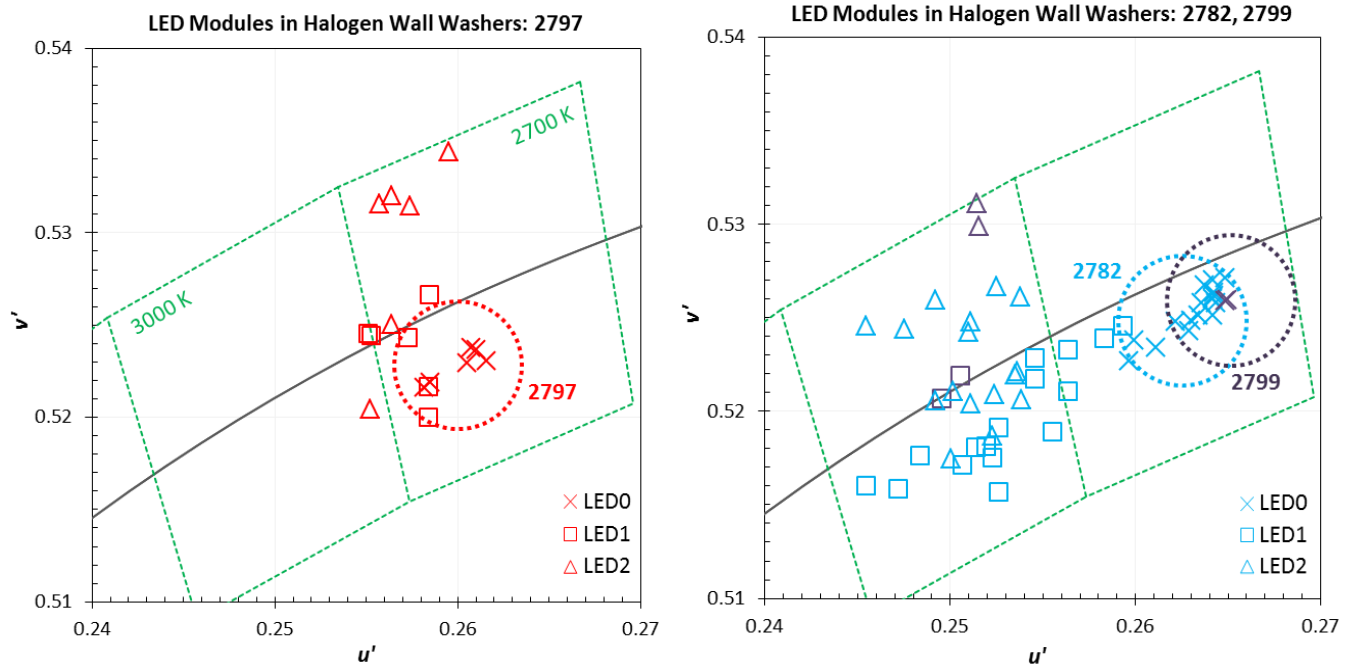
The small wall washers had an initial average CCT of 2718 K with a range of 167 K and an average D_{uv} of -0.0017; after 4,600 estimated operating hours, these luminaires had an average measured CCT of 2927 K with a range of 402 K and an average D_{uv} of -0.0015. The third set of measurements, after an additional 7,400 hours (12,000 hours total), revealed an average CCT of 2930 K with a range of 383 K and an average D_{uv} of -0.0016. The CRI and R_9 values remained relatively consistent, as delineated in Table 5. However, the chromaticity shift, $\Delta u'v'$, ranged from 0.0033 to 0.0212 after 4,600 operating hours with 16 modules exceeding the ENERGY STAR maximum of 0.007; $\Delta u'v'$ ranged from 0.0046 to 0.0187 after 12,000 hours with all but three of the 24 modules exceeding 0.007. For the large wall washers, the average CCT increased from 2701 to 2801 K, with the average D_{uv} changing from -0.0028 to 0.0038. The chromaticity shift ($\Delta u'v'$) ranged from 0.0049 to 0.0081 after the first follow-up measurements and increased to 0.0092 after 12,000 hours. Figure 5 and Figure 6 show the chromaticity coordinates for the light exiting the small and large wall washers at the three different measurement times. After the second round of measurements (LED1), the small wall washers in hallway 2782 and area 2799 were generally shifting toward blue, while those in hallway 2797 remained relatively stable. Despite the initial blue shift, the third round of measurements (LED2) indicated a yellow shift, shown more clearly in Figure 5. The large wall washers in hallway 3797 (Figure 6) indicated trends similar to those in hallway 2797.

Figure 5. Chromaticity coordinates for the small wall washers at UMD CSPAC plotted on 1976 CIE uniform color space (UCS) (u' , v') chromaticity diagram with MacAdam ellipses. The diagram on the left shows the chromaticity coordinates of the light exiting the wall in hallway 2797 while the diagram on the right is for hallway 2782 and area 2799. In August 2014, the six modules in hallway 2797 (graphed on the left) had been operating for 700 hours whereas 18 of the modules in hallway 2782 and area 2799 (on the right) had just been installed. The circles have a radius of 0.0035 in the (u' , v') chromaticity diagram to approximate a 3.5-step MacAdam ellipse, where the step size refers to the distance from the center of the ellipse to the perimeter. The circles are centered on the average u' and v' coordinates for each set of measurements.

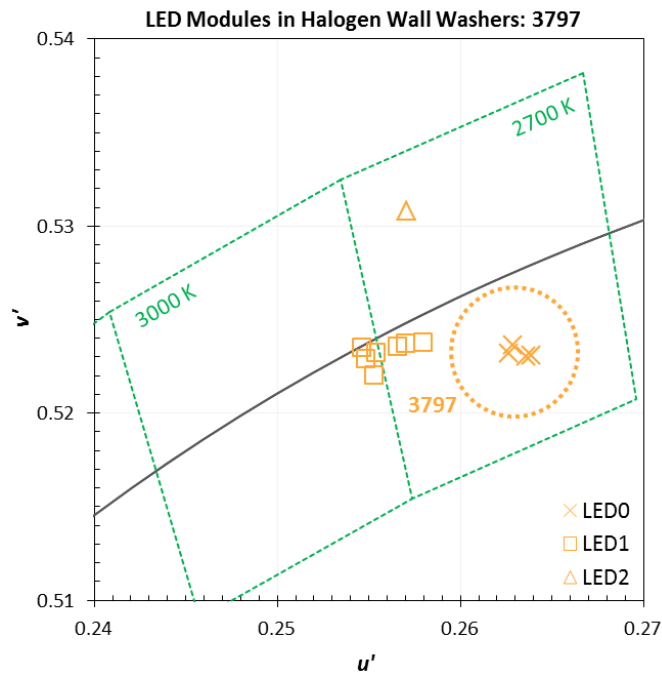
Figure 6. Chromaticity coordinated for the large wall washers at UMD CSPAC plotted on 1976 CIE UCS (u' , v') chromaticity diagram with MacAdam ellipses. The diagram shows the chromaticity coordinates of the light exiting the wall in hallway 3797. In August 2014, two modules were installed in one fixture; the rest were installed in March 2015 with follow-up measurements taken in March 2016.

The 3.5 step MacAdam ellipses indicate that the products generally shifted more than the diameter of the ellipses (seven steps) from the original measurements and also inconsistently, causing noticeable color differences. The color shift crossed the blackbody in both directions, indicated by the negative and positive D_{uv} values, which visually manifest as pink and green tints (demonstrated in the photo in Figure 7).

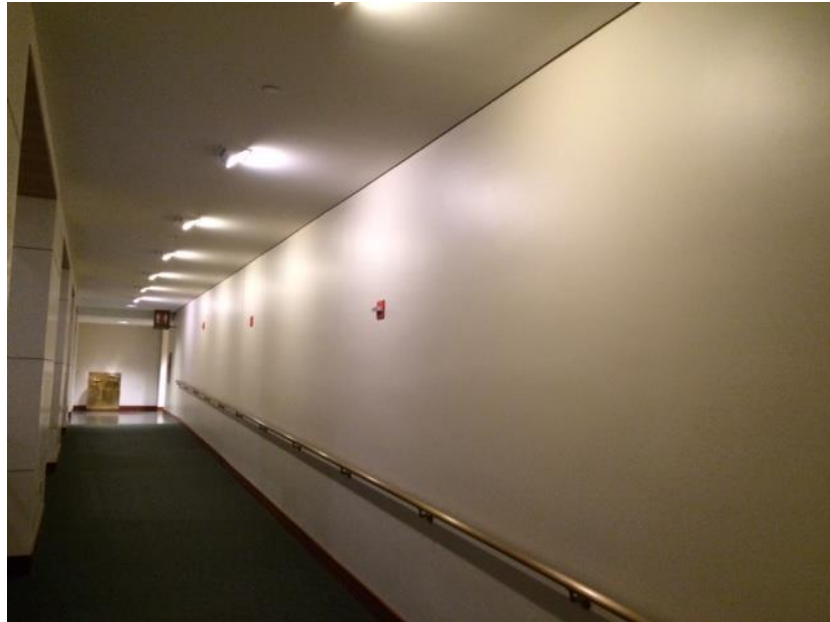
Figure 7. Disparity in color shift shown in a photograph taken during the LED2 measurements. Note: While photographs do not ensure exact replication of the conditions, this image gives an idea of the noticeable color difference.

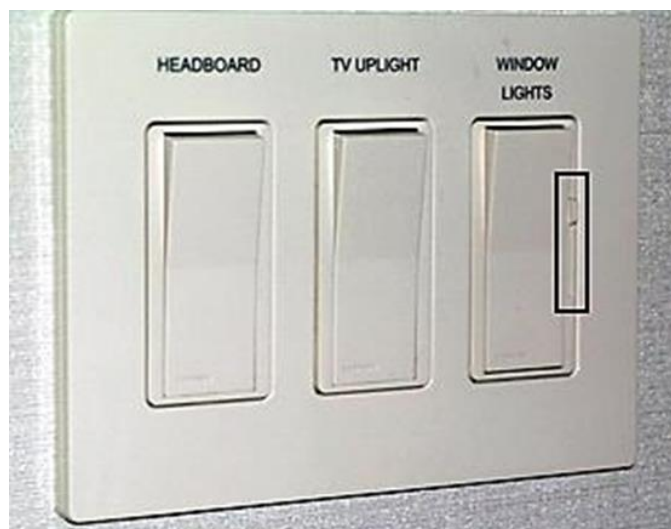
Dimming controls are the only element of the LED lighting solution that has caused guests to complain. Guests occasionally are confused about the dimming capability, maybe because the slide dimmer that controls the downlights in the seating area is relatively small and located alongside a conventional rocker switch (see Figure 8). Hilton staff believes that a different style of dimmer with more obvious functionality would make it easier for guests to adjust the lighting.

Figure 8. Lighting controls in the guest rooms at the Columbus Downtown Hilton. The switch marked “Window Lights” controls two LED downlights with an on/off rocker switch and a small slide dimmer located next to the rocker switch (outlined in a box in the photo). Some guests are confused by the controls and do not understand the dimming functionality and control.
