PNNL-29326

PIE of Cycle 13 316SS Cladding Using Aberration Corrected STEM Image and Analysis

September 2019

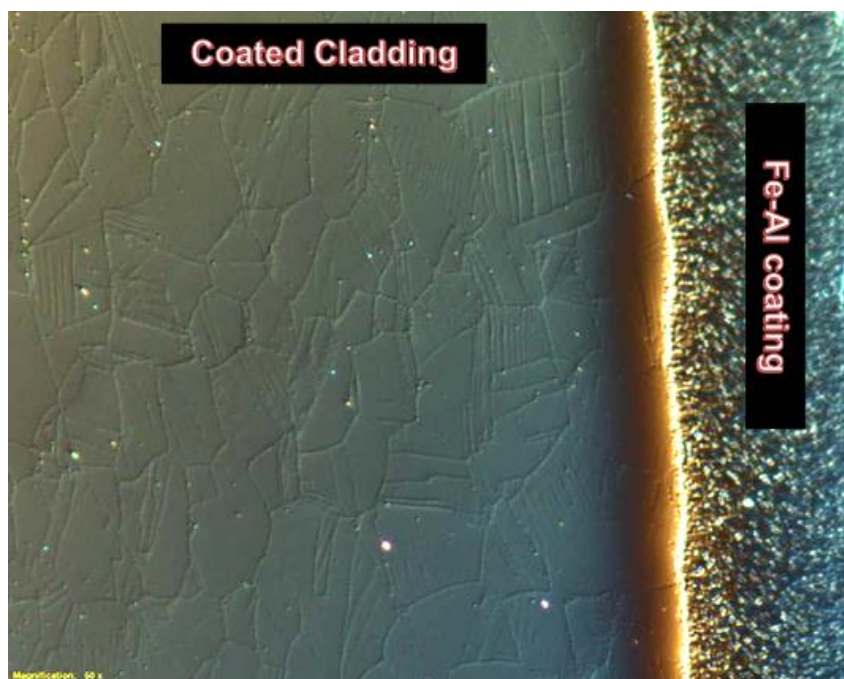
Limited optical results are available for a sample of the coated tube with an end plug cap welded to the thin walled coated tube. Though not Cycle 13 archive material, the sample is representative of what the coating treatment does to the TPBAR tubing microstructure, highlighting the carbide distribution and grain structure of the tube and what effect welding has on the sensitization. **Figure 3** shows a differential interference contrast (DIC) image of the polished cross-section of the thin walled tube with Fe-Al coating on the right side. The grain boundaries and deformation twins are easily distinguished by selective etching from the slightly caustic colloidal silica final polish. The SEM images in **Figure 4** show more clearly the fine, semi-discontinuous carbides decorating the grain boundaries, which are a direct result of the sensitization that pulls Cr from the boundaries and forms carbides, making them susceptible to etching by the colloidal silica. The SEM images don't necessarily indicate etching of the boundary itself, but more relief etching of the carbides. This grain boundary grooving disappears as you move into the weld HAZ, which arises because the carbides have been dissolved and the Cr and C placed back into solution. The SEM images in **Figure 5** show the recrystallized grain structure, lack of carbides, and the subsequent lack of grooving with the Cr depletion removed by the welding temperature exposure.

Figure 3. DIC imaging shows the grain boundaries by virtue of the relief etching that occurs under the final colloidal silica polish. The etching arises due to the sensitization present in the cladding, which produced fine carbides. The carbides aren't easy to see in the optical images, however, SEM and TEM clearly show their presence.

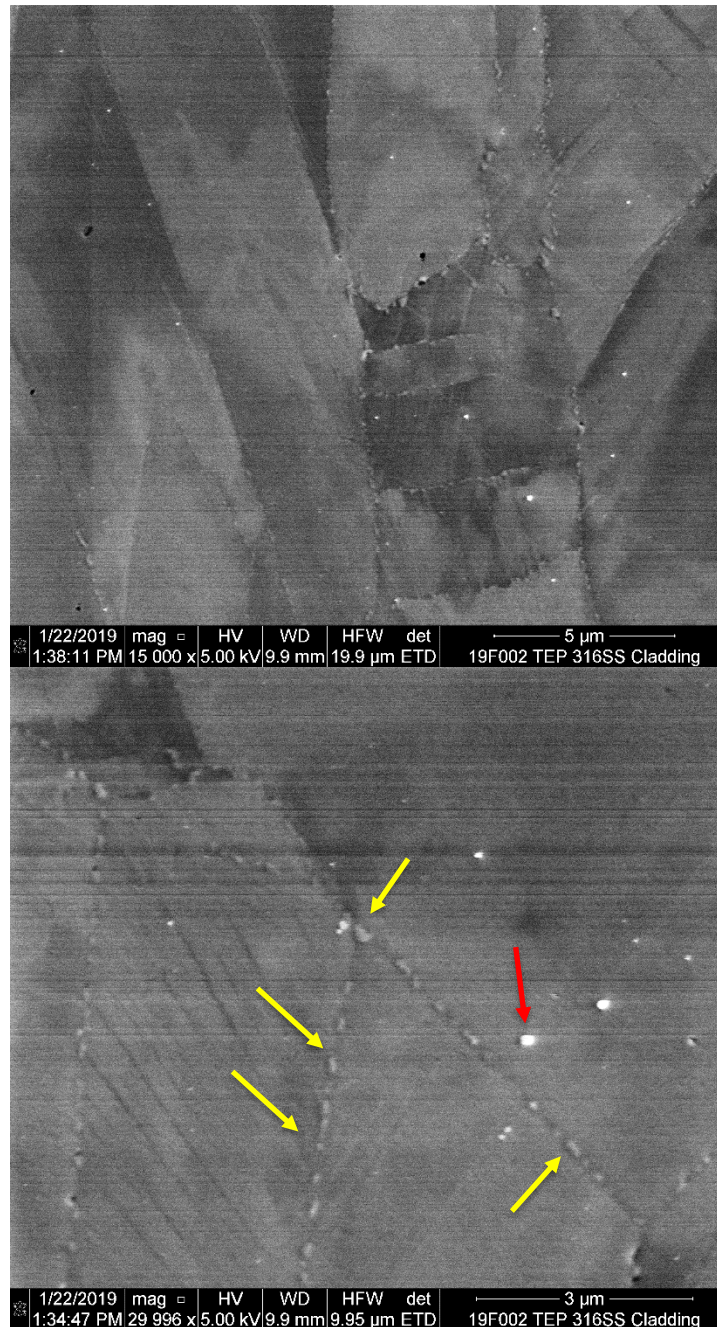
Figure 4. The yellow arrows point to fine carbides located on each grain boundary in the coated cladding welded to the end plug cap. The bright spots (red arrow) are colloidal silica particles that didn't rinse off.

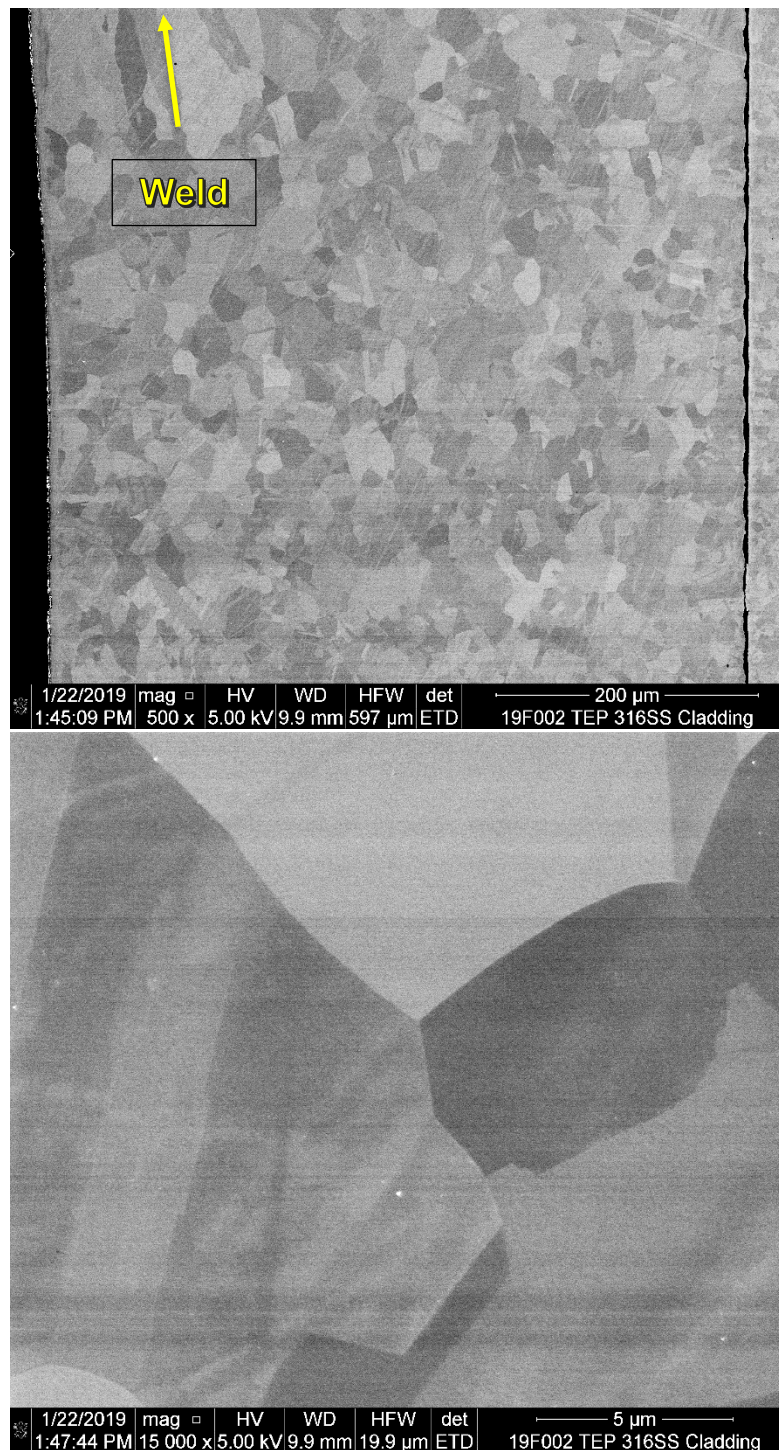
Figure 5. Secondary electron images reveal in the HAZ that the thermal transients lead to recrystallization of the cold worked tube and dissolved the carbides.

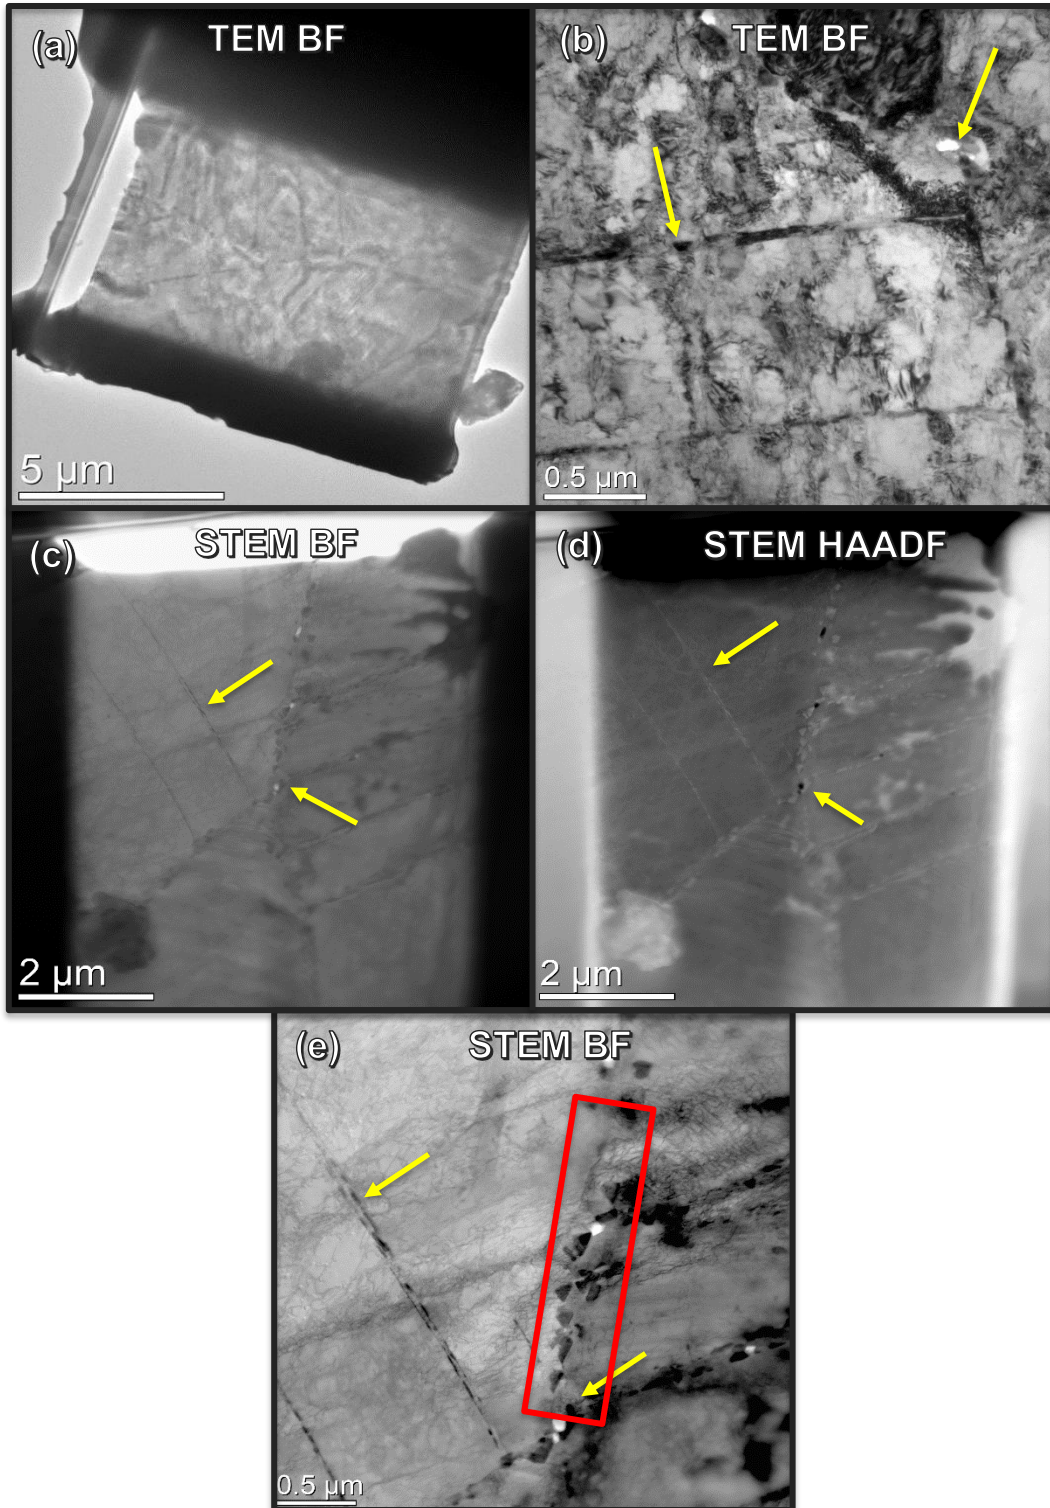
The coated cladding exhibits a high dislocation density with multiple deformation twins and deformation bands, examples of which are shown in **Figure 6**. The line dislocation density near the edge of the TEM lamella was found to be $\sim 10^{15}$ per m^2 , near the limit of being able to measure accurately with TEM. The yellow arrows in **Figure 6** point to the twin and grain boundary regions that are common to each of the images (Note that the image in 6(b) is rotated from the STEM images in 6(c) through 6(e). Fine carbides are distributed on both grain boundaries and incoherent twin interfaces, the latter of which were induced by the heavy cold work prior to coating. Edge-on boundaries exhibit closely spaced carbides that are difficult to resolve individually except in the thin regions. By comparison, the inclined grain boundary in **Figure 6(e)** shows more clearly the discrete carbide particles, which are often faceted, triangular shaped particles. A rough size estimate places the carbides ~ 100 nm in longest dimension. The elemental map shown in **Figure 7** paints a clear picture of the extent of carbide precipitation in this heavily deformed microstructure. There was no suggestion of any carbide precipitation in the matrix.

Figure 6. TEM and STEM of coated 316SS archive: (a) an overview after FEP, (b) TEM bright field of the highly cold worked dislocation structure and twins, (c) and (d) are STEM HAADF and BF images, respectively, and (e) is a STEM showing the dense dislocation structure and carbides on a highly inclined grain boundary (red box). Yellow arrows refer to the same features in each micrograph.

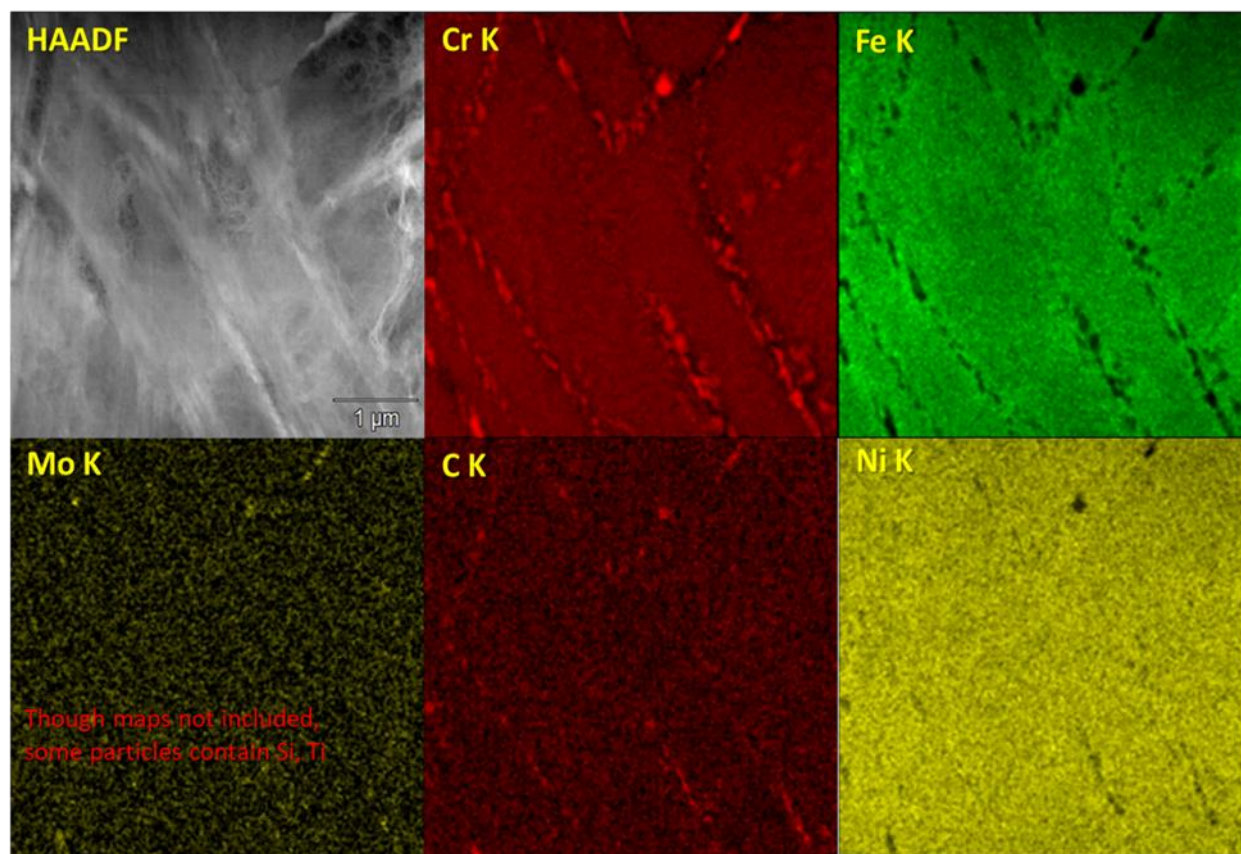
Figure 7. Elemental maps with a high current density probe, revealing the extensive carbide precipitation present throughout the sample. Note the carbon map is less reliable than the Cr map due to the absorption of the low energy C K α x-ray (0.277 eV). The Cr depletion is primarily offset by Fe enrichment.

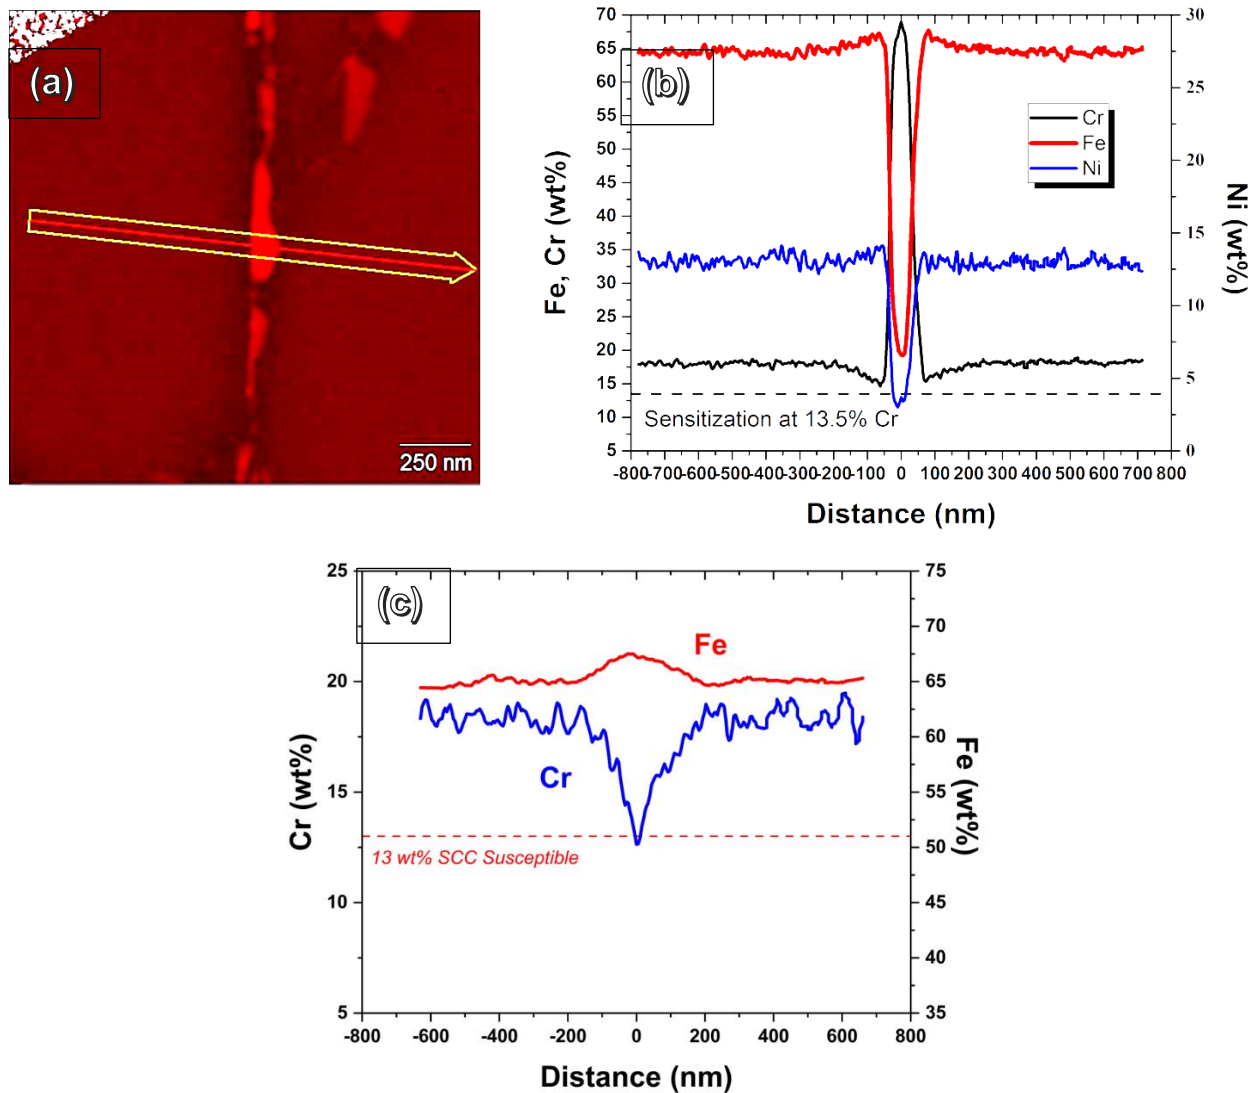
To quantitatively assess the extent of Cr-depletion at the sensitized grain boundaries, full resolution profiles (0.13 nm pixel spacing) were extracted from the elemental maps. **Figure 8** presents the profiles obtained from across the carbides and at locations between carbides, which is somewhat difficult given their close spacing. Bruemmer et al [3] indicated that 316SS becomes susceptible to stress corrosion cracking when the Cr-depletion levels reach a threshold of 12.5 to 13.5%, dependent of course on the corrosion potential, water chemistry, and stress state. The profiles shown in **Figure 8** reveal that Cr depletion, though variable from location to location, reached this threshold on the interface between the carbide/matrix interface and in grain boundaries between carbides. The profile width approaches ± 250 nm on either side of the boundary or carbide.

Figure 8. The STEM image in (a) shows a grain boundary near the edge of the FIB lamella which was mapped. The two sets of elemental profiles in (b) and (c) show the maximum Cr-depletion found in this condition (b) adjacent to a carbide and (c) on the grain boundary between carbides. In both cases the Cr-depletion reaches a level below 13.5 wt% Cr.

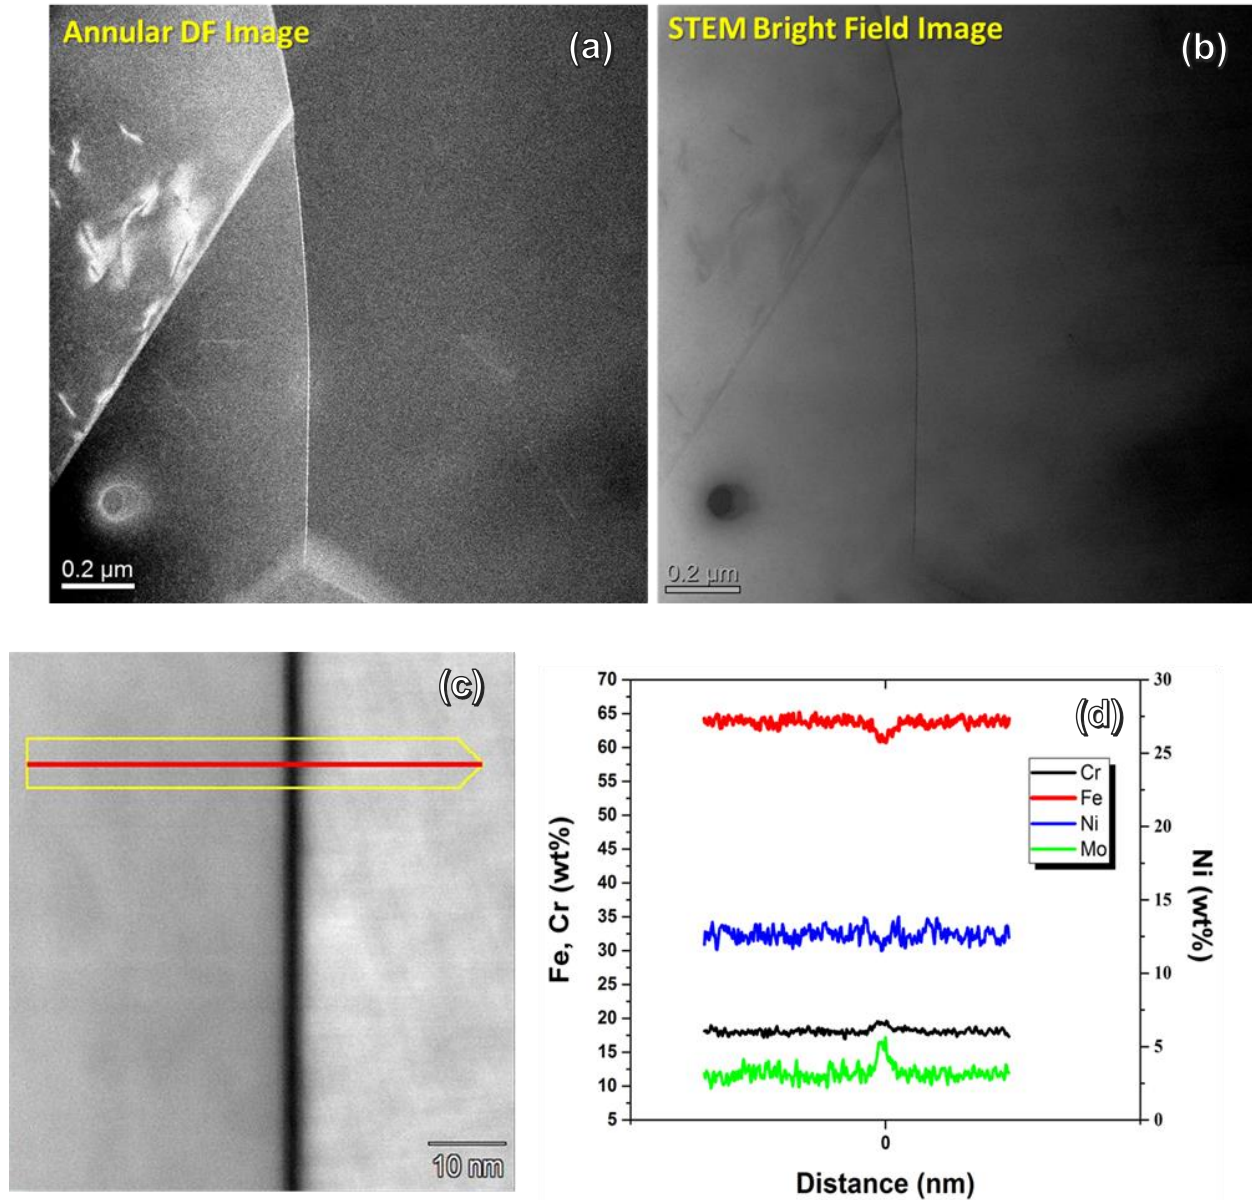
To assess the effect of welding upon the sensitized microstructure, a FIB lamella was taken from within the HAZ where the grain structure had clearly been recrystallized based upon optical and SEM images. The set of figures in **Figure 9** reveals clean grain boundaries, with no hint of carbide precipitation and very few dislocations, indicating the Cr and carbon were placed back into solution. Careful examination of the grain boundary chemistry revealed that thermal nonequilibrium segregation (TNES) [4] had occurred during the welding, resulting in both Cr and Mo being enriched by a couple of wt% each to the grain boundary, which has a minor beneficial effect of delaying radiation-induced depletion of Cr.

Figure 9. Recrystallized grain structure in the HAZ was found to possess no carbides, and the Cr and Mo were actually enriched by a couple of wt% due to thermal non-equilibrium segregation.

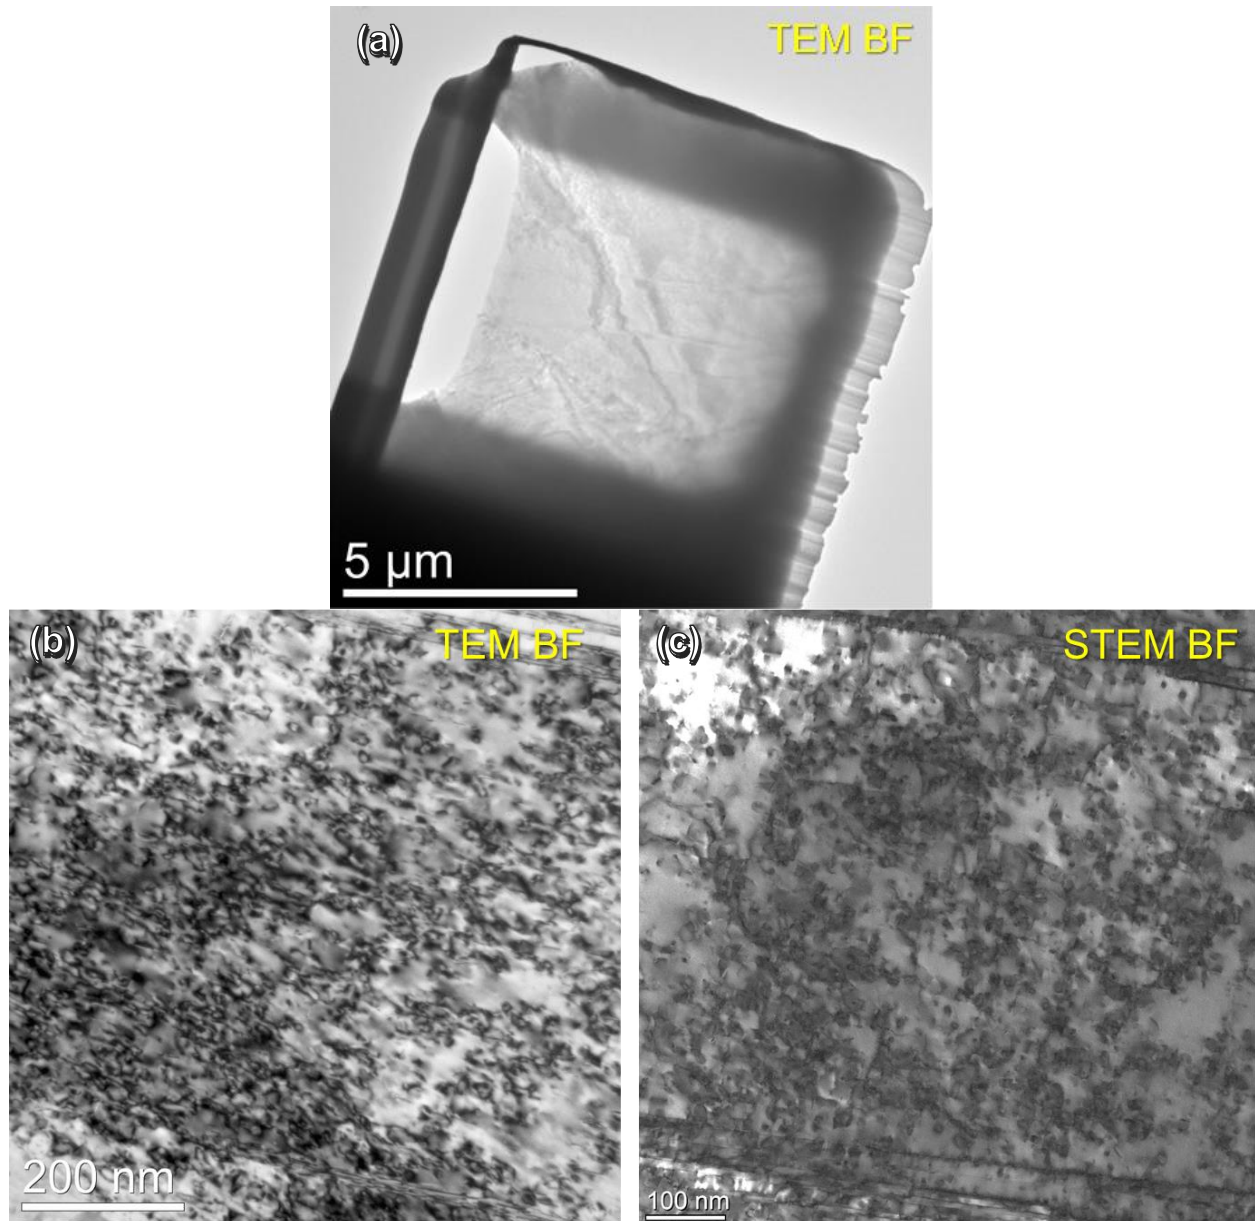
Figure 10. Overview of the FIB lamella with bright field TEM and STEM images below. Cold worked dislocation structure has been restructured into segments that are interacting to form clusters.

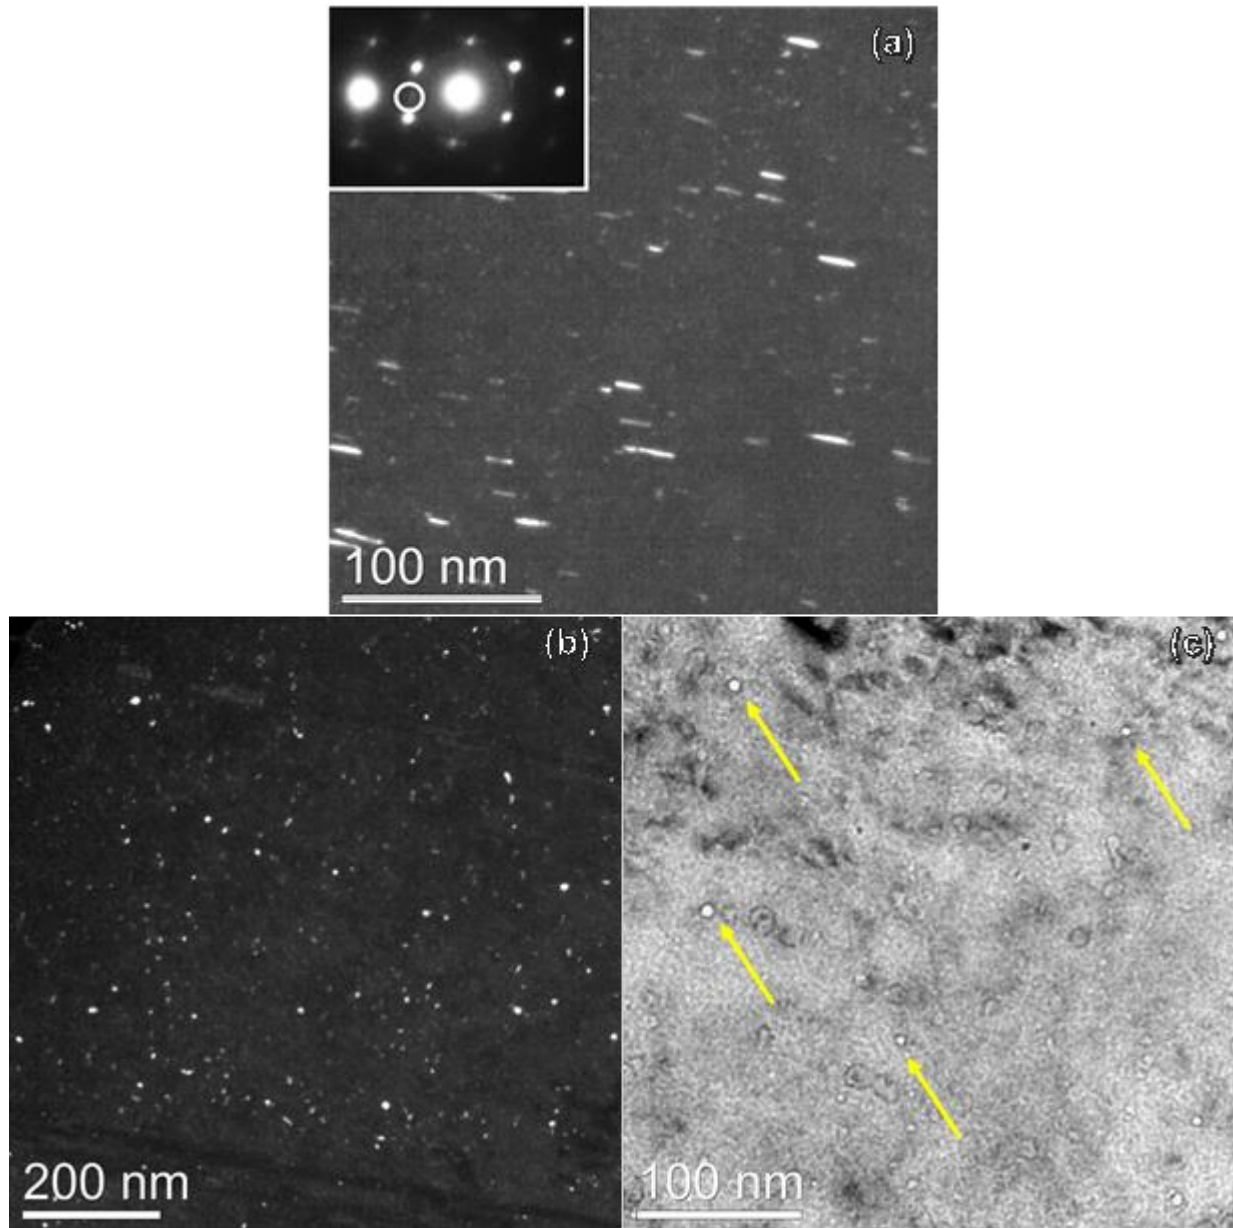
Figure 11. A centered dark field image of edge-on Frank loops is shown in (a), taken using the encircled streak in the diffraction pattern. γ' precipitates are shown in (b), imaged using a reflection at the $1/2g_{220}$ position in the diffraction pattern. A low density of voids are shown in (c), taken by underfocus image in TEM bright field.

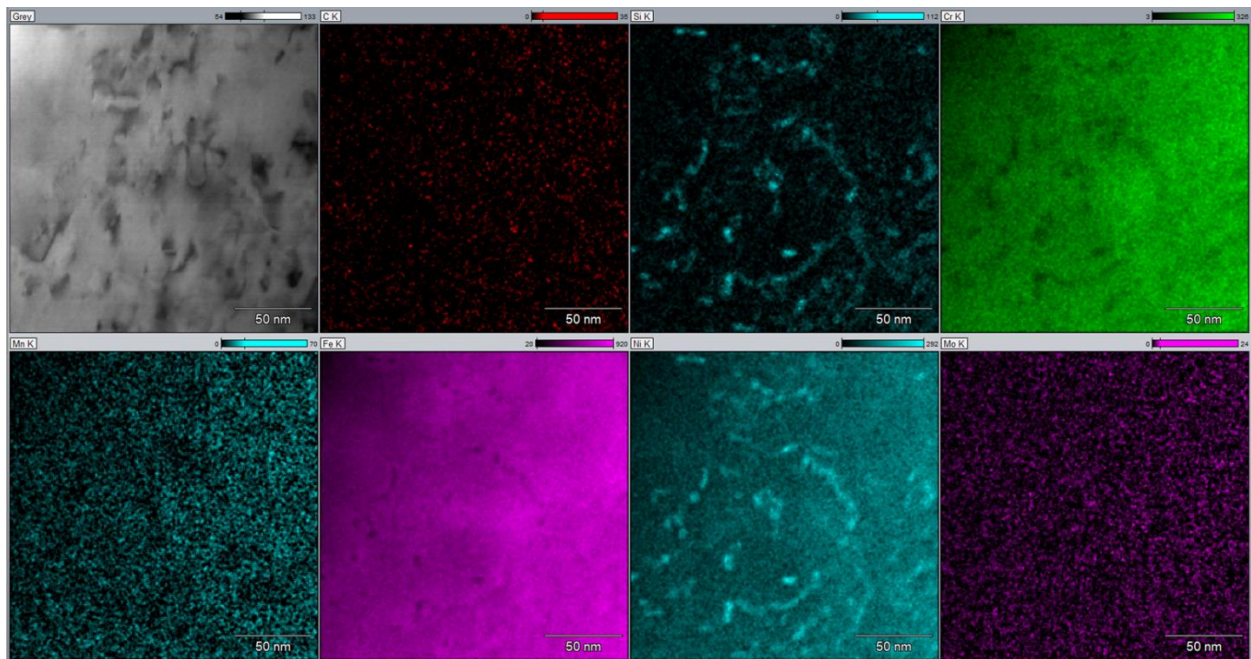
Figure 12. Elemental mapping shows Ni and Si segregation to line dislocations and possible loops. There isn't always a 1-to-1 association between dislocation and Ni/Si, but some loops and dislocations are out of contrast at this tilt. The ratio of Ni/Si is ~3 to 1, suggesting it could be γ' precipitation on dislocations.

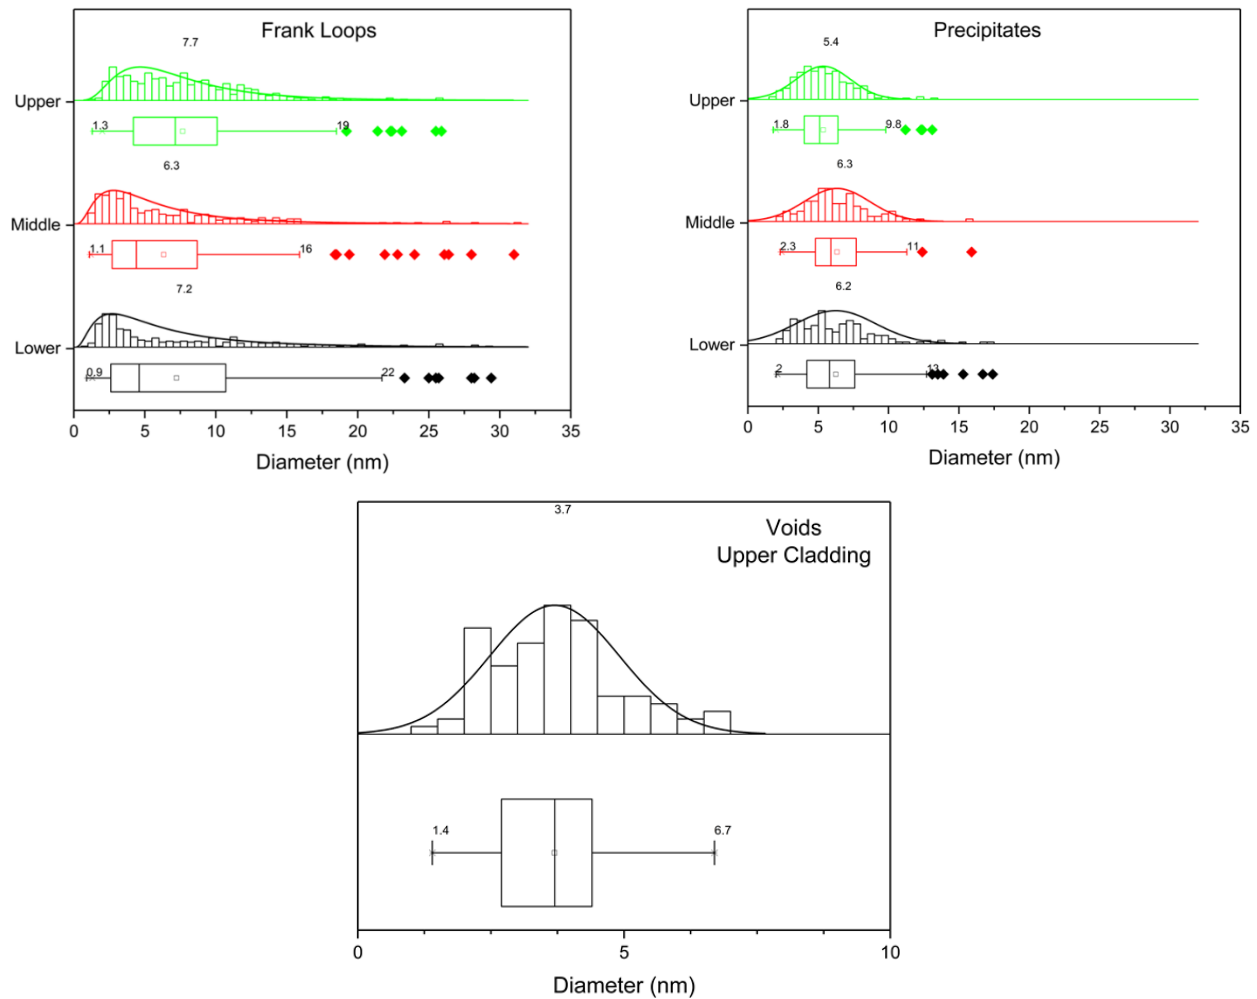
Figure 13 and **Table 3** present a summary of the loop, precipitate and void statistics for each of the 3 locations within the TPBAR assembly. The average size of the loops is fairly similar; however, it is worth noting that in the upper location the loop distribution exhibits a broader distribution. In contrast, at the midplane and lower position the distribution is definitively asymmetric, with a peak around 2.5 to 3.5 nm and a tail that extends up to 30 nm. The precipitation is less temperature sensitive, with perhaps a slightly smaller average size in the upper region, but still fairly Gaussian in all three locations. The void distribution is fairly Gaussian.

Figure 13. A comparison of the Frank loop, precipitate, and void distributions for each of the three locations in the TPBAR. Note voids were only observed in the upper region of the TPBAR.

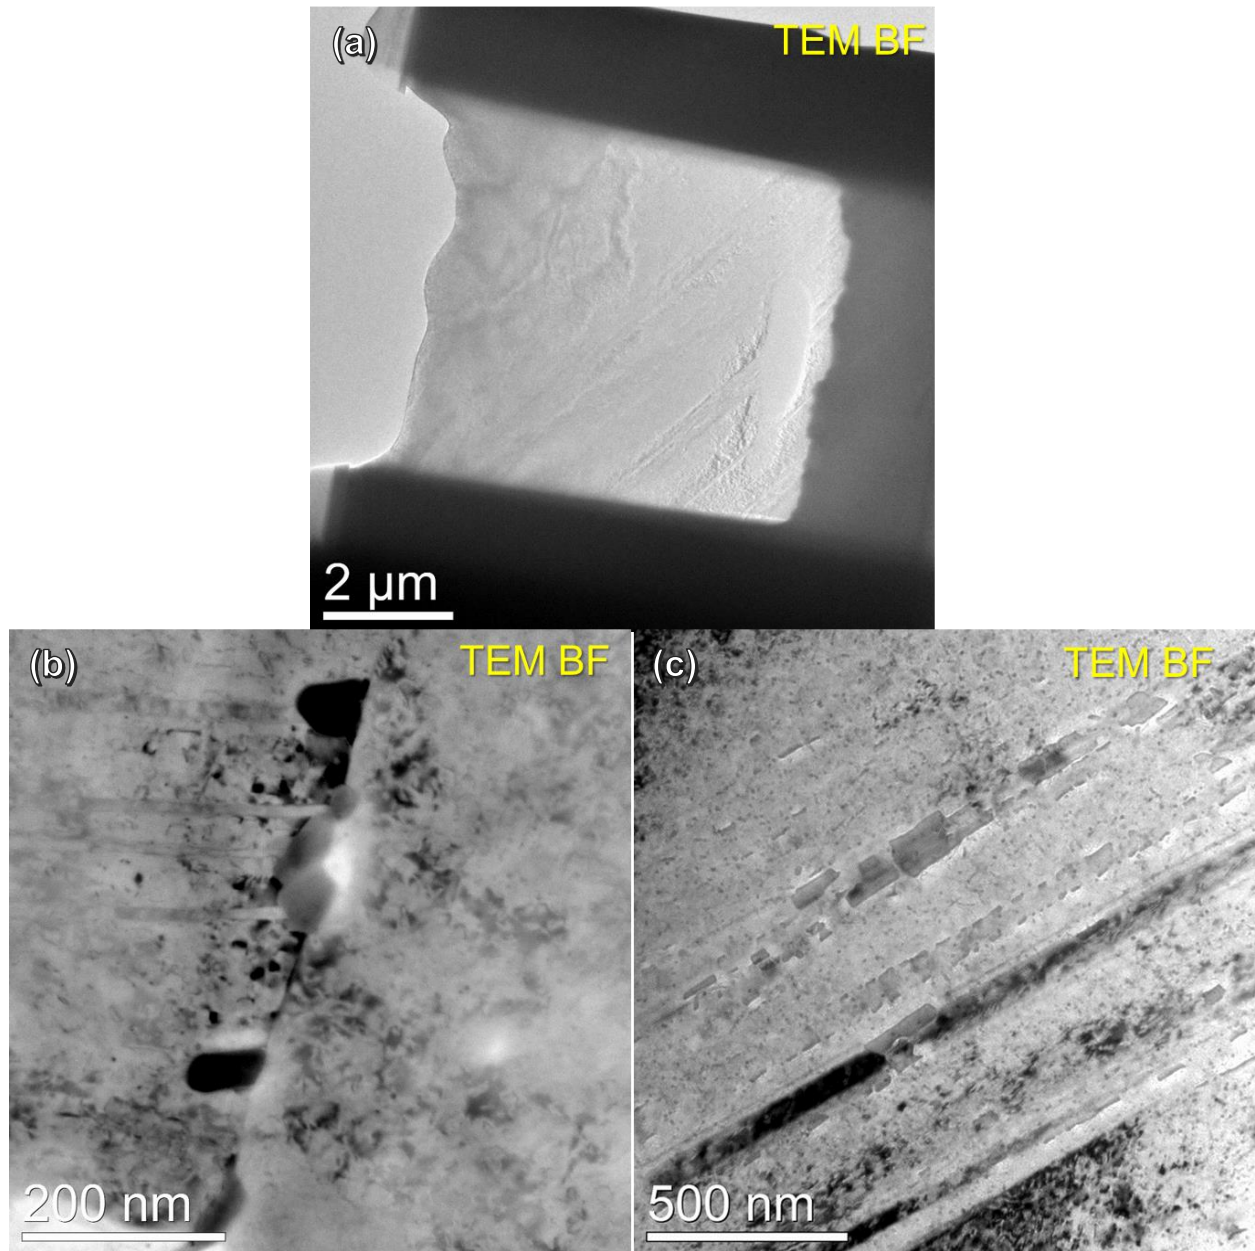
Figure 14. The TEM bright field image in (a) shows an overview of the TEM lamella. Examples of the carbides still present after irradiation are shown in (b) and (c), the latter of which are on a inclined twin boundaries within the foil.

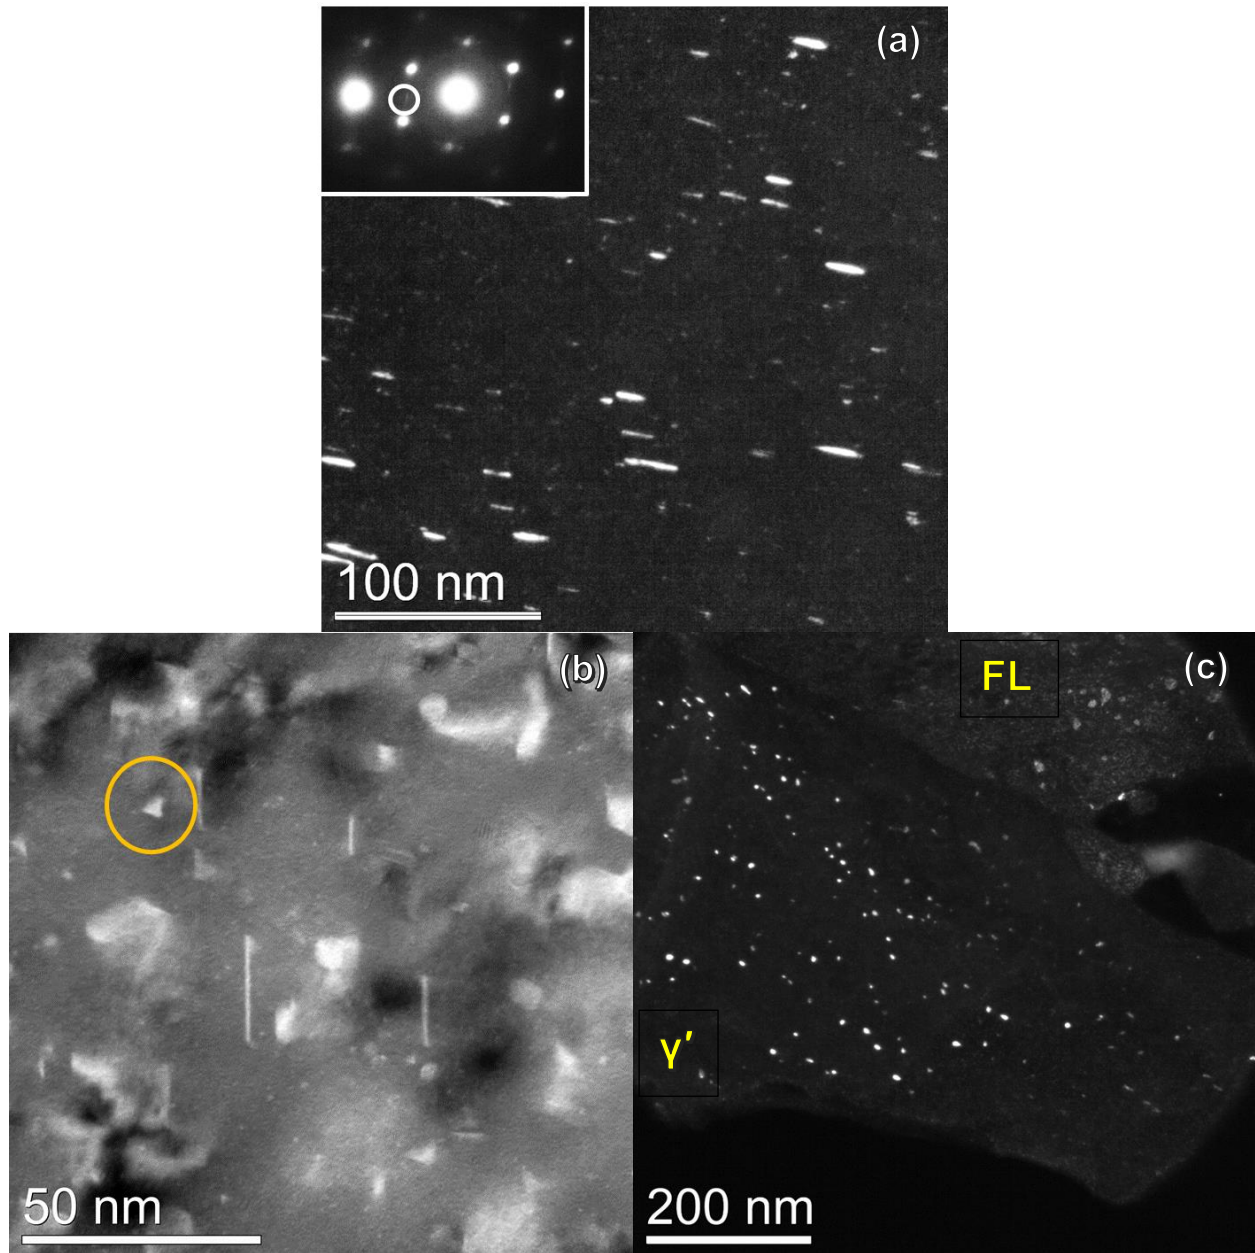
Figure 15. In the middle position, Frank loops, stacking fault tetrahedra and γ' precipitation are all present, with no indication of cavities. Edge-on loops are shown in CDF in (a), with both the edge-on loops and small SFT visible in the TEM bright field image in (b). In (c) CDF imaging was used to show the distribution of γ' precipitates in the bottom grain. In the upper RH corner of are CDF images of inclined Frank loops (FL).

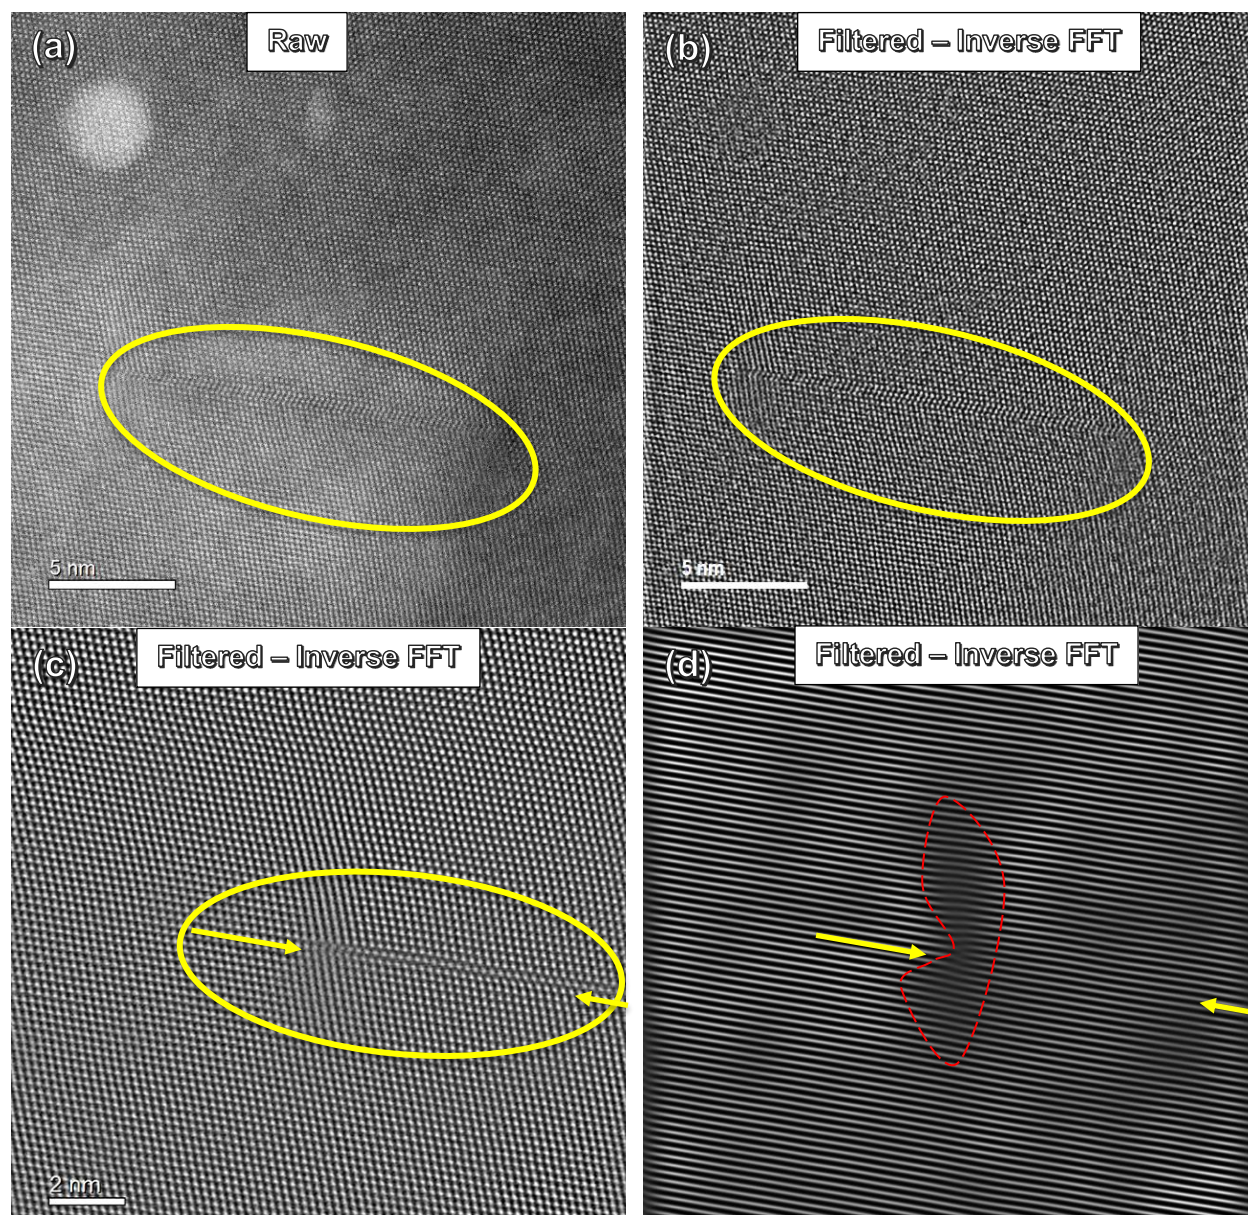
Figure 16. Lattice images taken in high angle annular dark field show an edge-on Frank loop (inside the yellow ellipse) ~ 15 nm in diameter. (a) is the raw image, (b) has been filtered using an inverse FFT of the image in (a) after applying an array mask on the power spectra from the image. The image in (c) is a close-up of one end of the loop, with the yellow arrows pointing to the inserted half-plane. The image in (d) is the same loop, but filtered using a spot mask within Digital Micrograph. The dark regions enclosed by the red dotted line are regions of lattice dis-registry due to strain at the end of the loop.

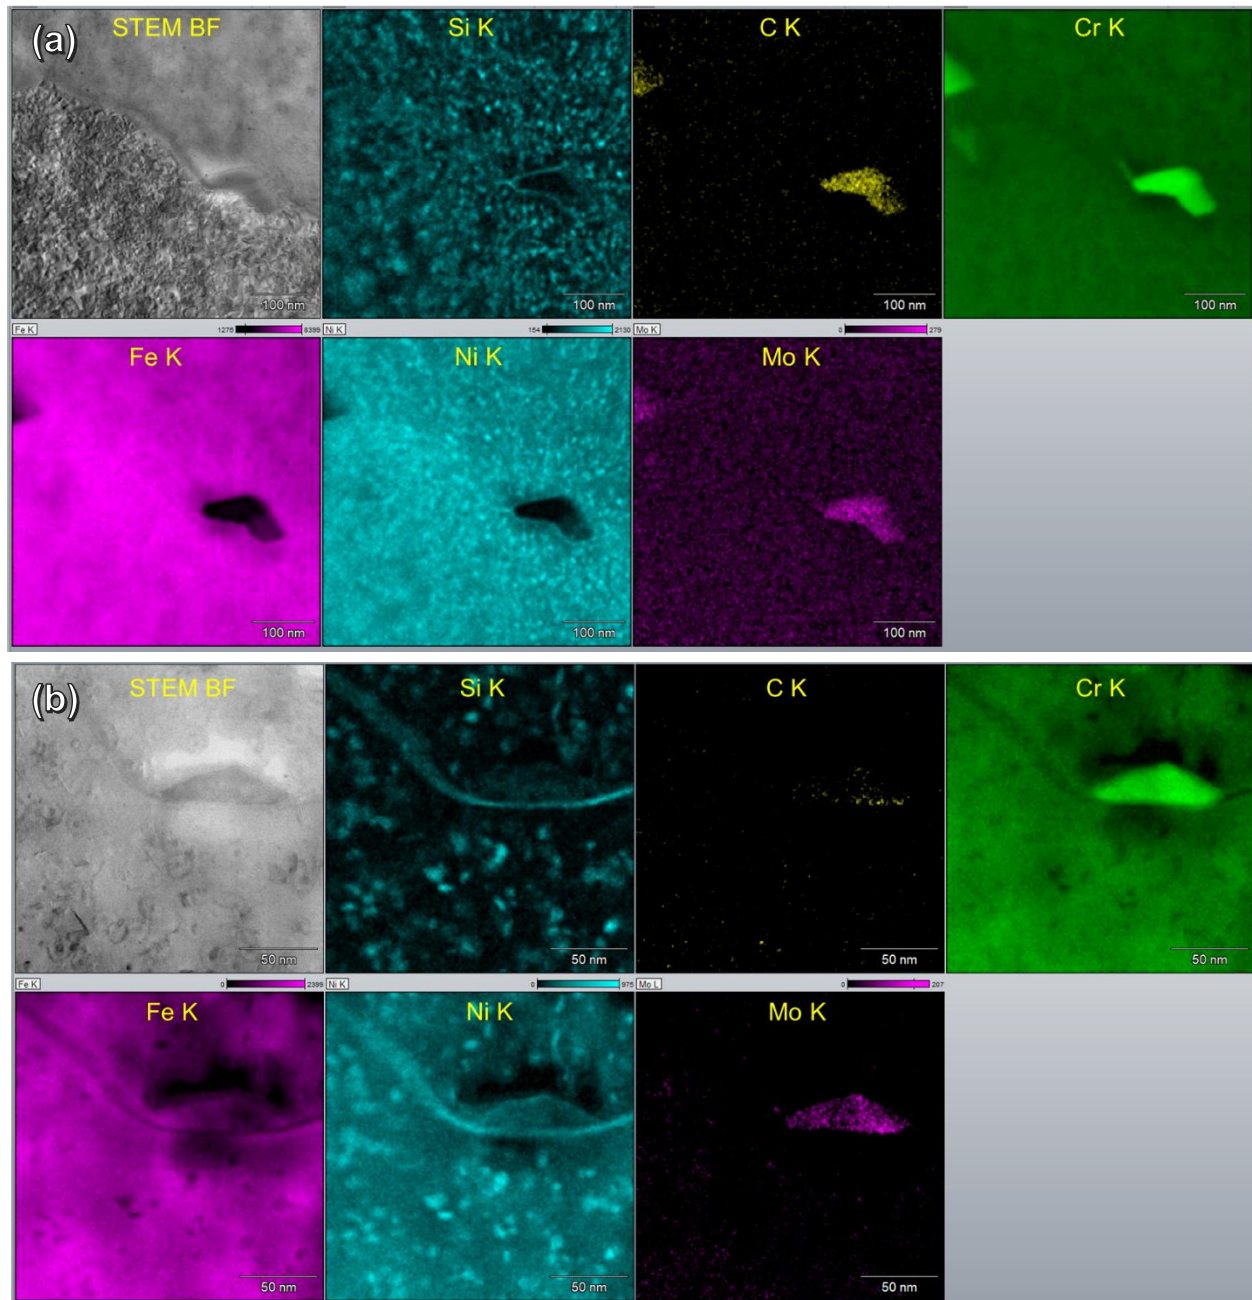
One of the surprising discoveries was the extensive RIS that leads to Ni and Si enrichment, accompanied by extreme Cr depletion, on the sensitized grain boundaries. As shown in **Figure 17**, two sets of elemental maps show the extent of this RIS, both in the matrix and on the grain boundary with a large carbide captured in a thin region of the flash electropolished foil. EDS analysis of the precipitates in the matrix reveal the same ratio of Ni/Si as observed in the upper region, confirming their identity as γ' . The greatest surprise, however, involved the degree of RIS on the grain boundary proper and around the interface of the carbide, which should be evident in the maps. Line profiles (**Figure 18**) extracted from the high resolution, high count elemental maps confirmed this RIS, demonstrating Ni enrichments up to $\sim 40 \text{ wt\%}$ and Si levels up to $\sim 12\%$, with the Cr depleted to $\sim 8 \text{ wt\%}$ and the Fe depleted down to $\sim 38 \text{ wt\%}$. The profile width has changed from a thermally sensitized width of $\pm 250 \text{ nm}$ to a prototypical RIS profile width of $\pm 10 \text{ nm}$, with most of the enrichment occurring in a narrower width of $\pm 5 \text{ nm}$. These levels of enrichment and depletion are higher than found in any of irradiated commercial 316SS, and for the moment, can only be assumed to be a direct consequence of the moderately sensitized state when placed into service [ref?]. One source of the high levels of RIS may be the γ' precipitation observed on an inclined grain boundary in a FIB sample extracted from the lower TPBAR position, described in the next section.

Figure 17. Two sets of elemental maps are shown highlighting the extreme degree of RIS of Ni and Si to the grain boundary, carbide interface, and nearby matrix regions. Up to 40% Ni and 17% Si, accompanied by a depletion of Cr down to 8wt%, is present in this condition. The high levels of Ni and Si on the boundary may be evidence of γ' precipitation, not just solute segregation.
