PNNL-29326

PIE of Cycle 13 316SS Cladding Using Aberration Corrected STEM Image and Analysis

September 2019

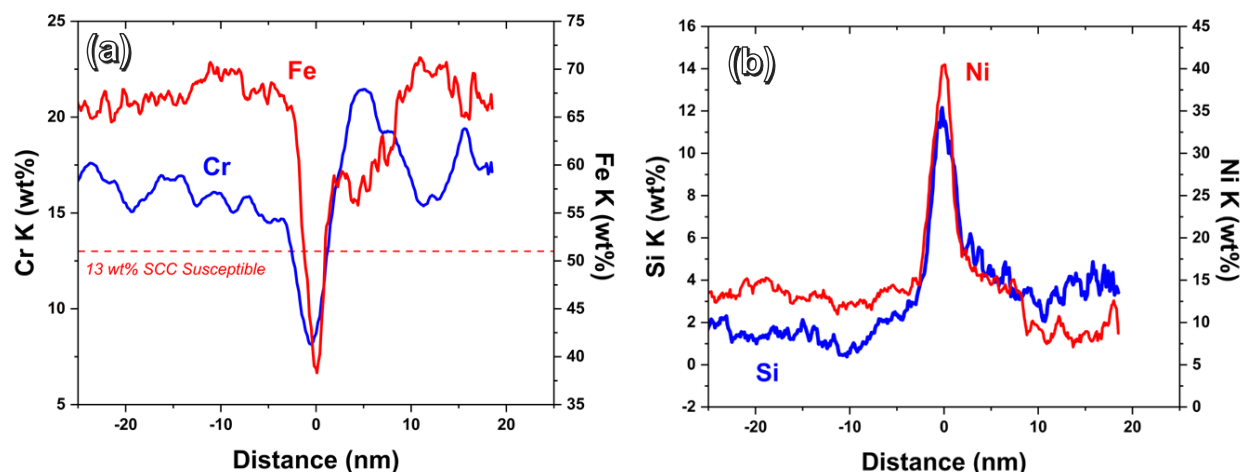
Figure 18. RIS profiles show the extreme levels of Ni and Si enrichment and the accompanying Cr and Fe depletion. The Cr levels are near 8 wt%, whereas the Ni is at 40% and Si at 12%, close to the 3 to 1 ratio of γ' precipitates. These levels of Si and Ni are higher than any reported in the literature or based on the author's experience.

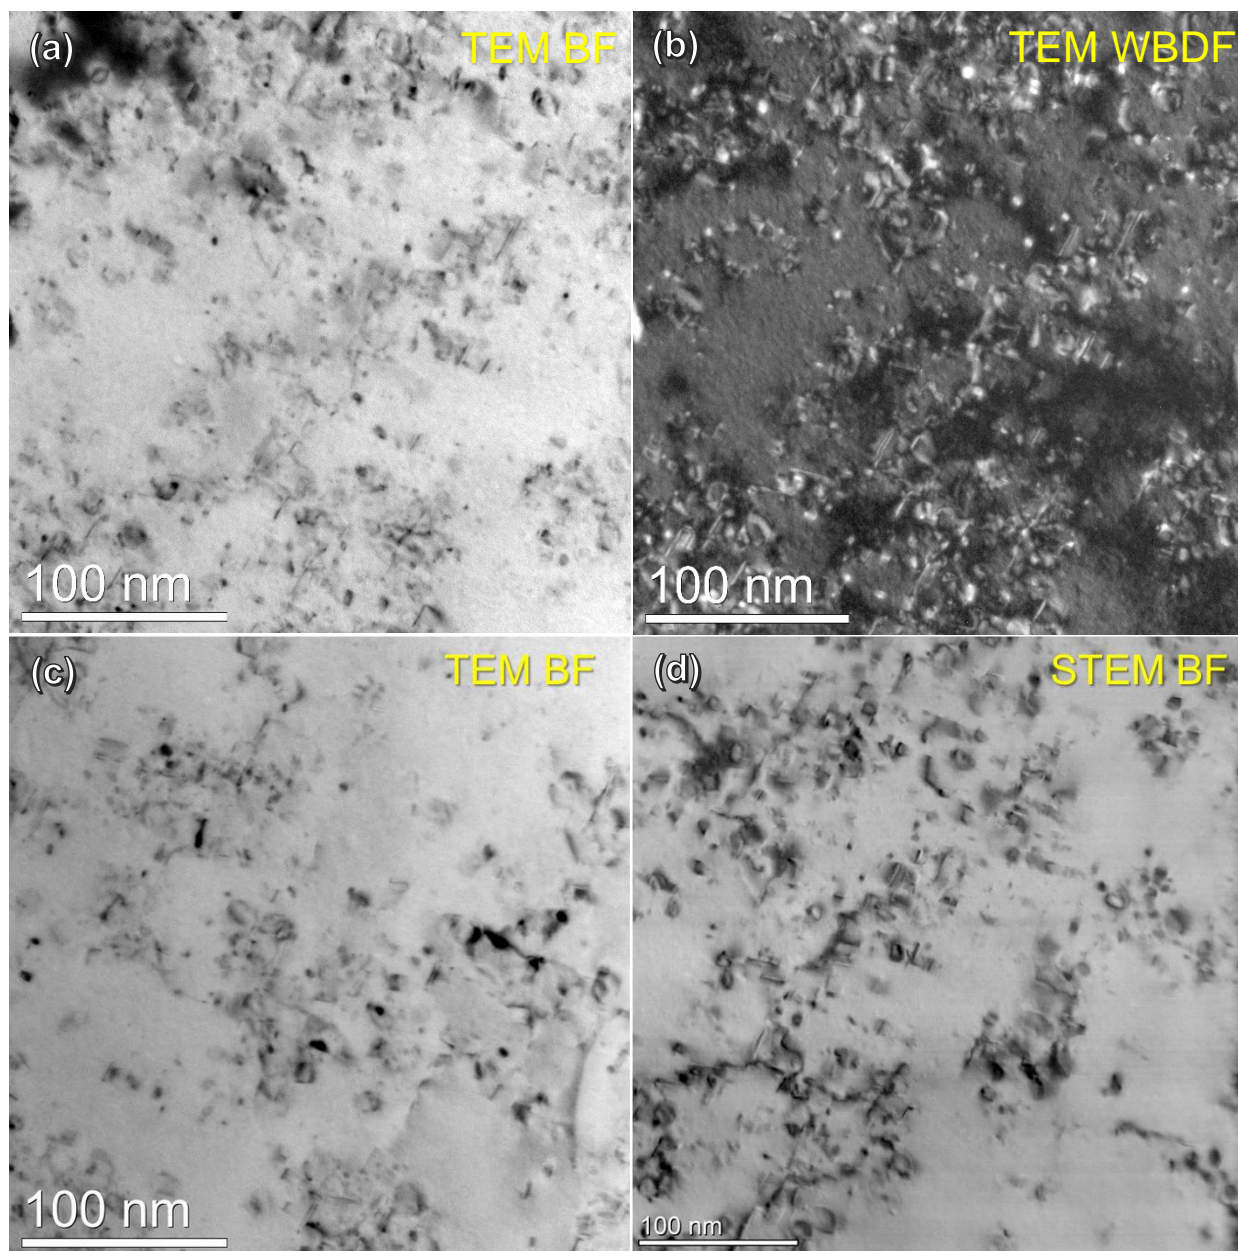
At the lower location, the loop and dislocation clustering visible at the midplane and upper location are present also. **Figure 19** shows examples of the clustered defect distribution of line dislocations segments and dislocation loops. This clustering of loops and dislocations into a cellular wall type structure with defect free regions in-between the walls is not a common microstructural feature based on the authors experience. In looking back through the results obtained in prior work on BOR60 irradiations of model and commercial alloys, and core components such as PWR baffle bolts, PWR Flux thimble tubes, BWR core shrouds, the line dislocation and Frank loop distribution has always been found to be uniform over large areas. The TEM dark field image in **Figure 20(a)** show the Frank loops imaged edge-on, with smaller bright dots in the background that may be loops or SFT. The remaining images show inclined Frank loops in the vicinity of a grain boundary, with γ' decorating line dislocations in the grain boundary and in the nearby matrix, along with other γ' precipitates formed in the matrix at random. It is not clear if the isolated precipitates are forming on loops, this association hasn't been proven directly in this work.

Figure 19. The TEM bright field image in (a) and centered dark field image in (b) show the clustering of the loops and line dislocations, with no evidence of SFT in this condition. The bright field images in (c) and (d) show additional examples of the inhomogeneous distribution of loops and line dislocations.

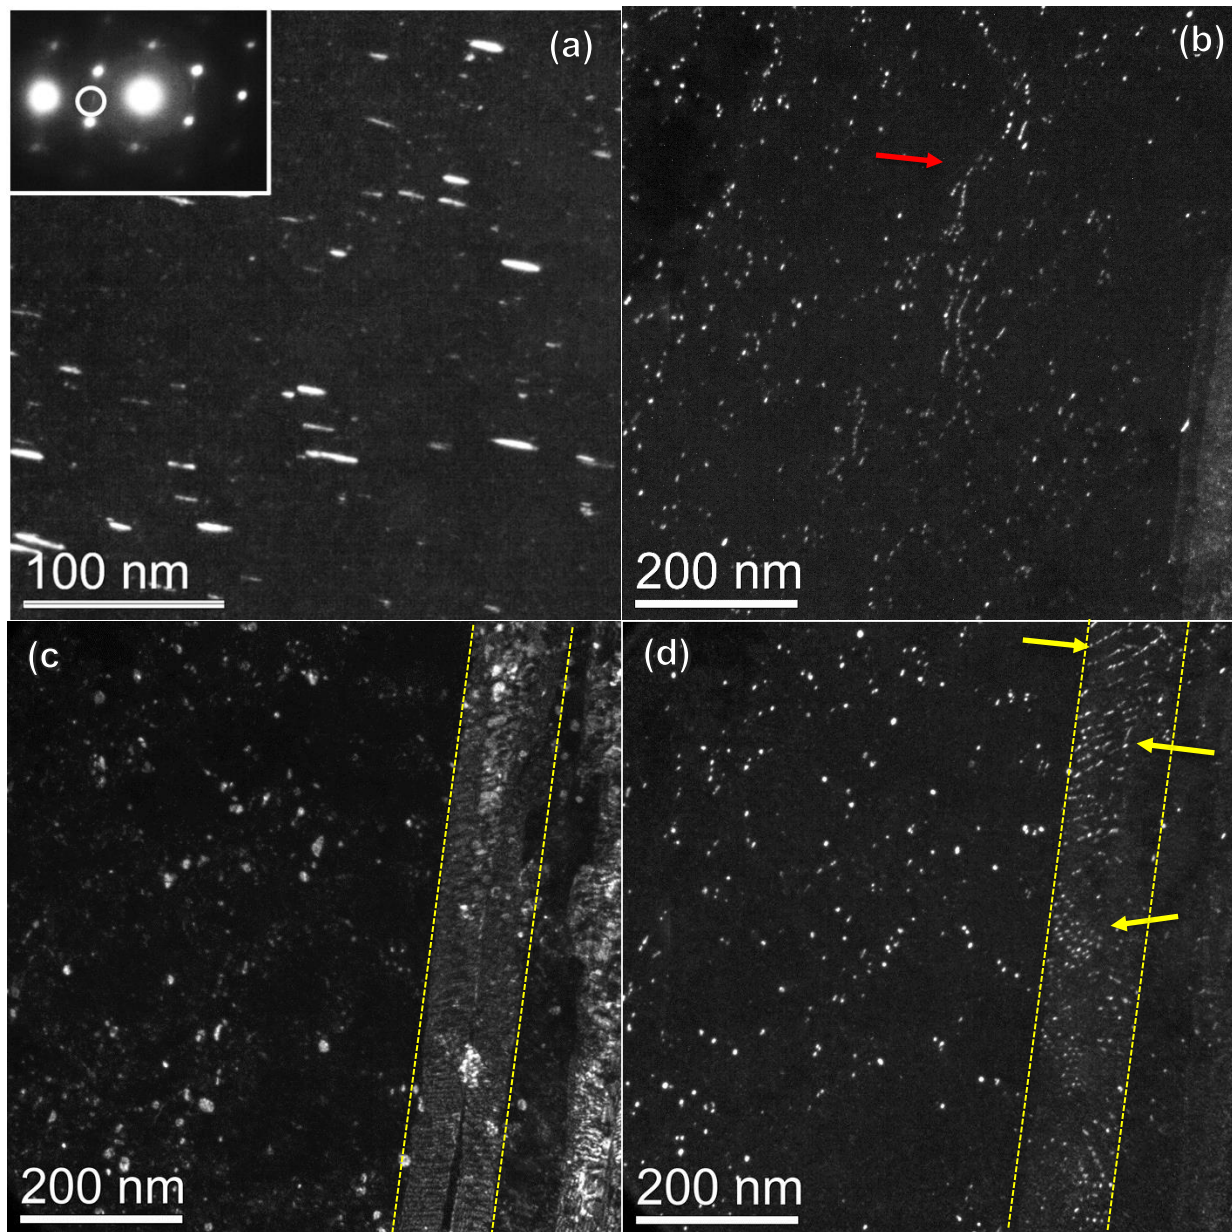
Figure 20. Centered dark field images are shown in (a) for edge-on loops Frank loops and (b) γ' that has formed on dislocations within the matrix near a grain boundary. The centered dark field image in (c) shows inclined Frank loops in the same area as in (d), which shows γ' precipitation on grain boundary dislocations (yellow arrows and dashed lines) and in the matrix.

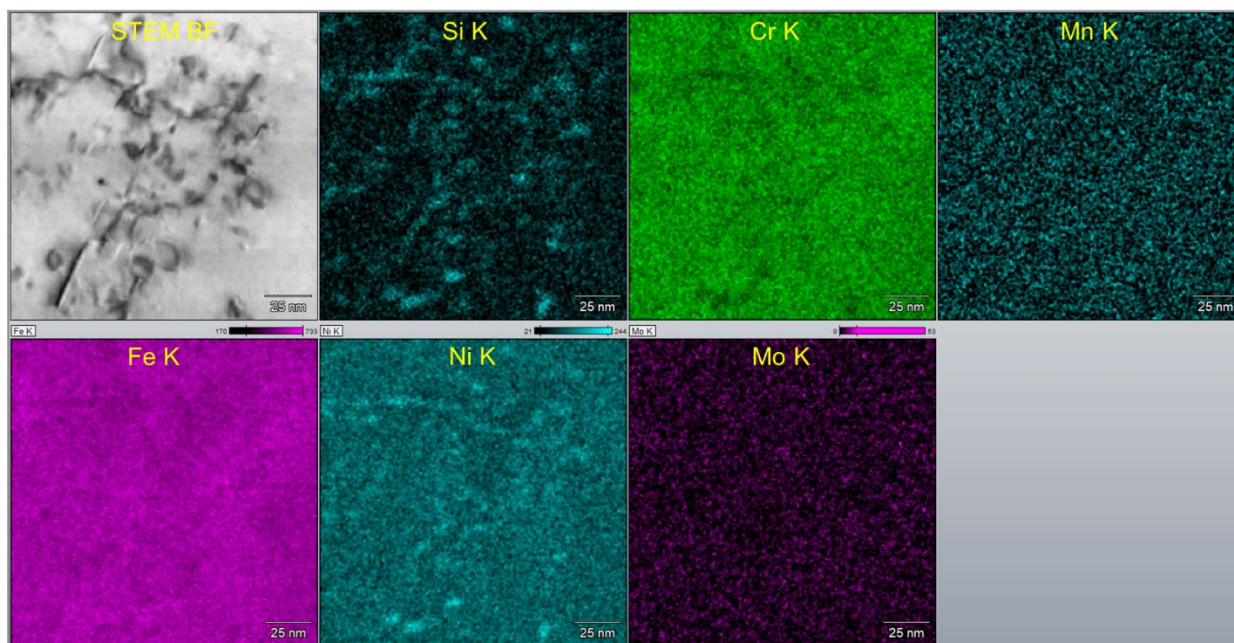
The elemental maps in **Figure 21** show once again that Ni and Si have segregated to these clusters of loops and line dislocations. The Ni and Si are associated with the line dislocations, but the discrete, isolated precipitates are not necessarily associated directly with individual loops. **Figure 22** presents a multivariate statistical analysis of the chemical segregation present in the previous image, and the resulting phase map produced by the Pathfinder software package used to obtain this data indicates that both the Ni-Si regions on the line dislocations and in the discrete particles have the same composition, with a γ' Ni/Si ratio of 3 to 1.

Figure 21. This elemental map shows a region of clustered line dislocations and loops with significant Ni and Si enrichment, offset by Cr and Fe depletion.

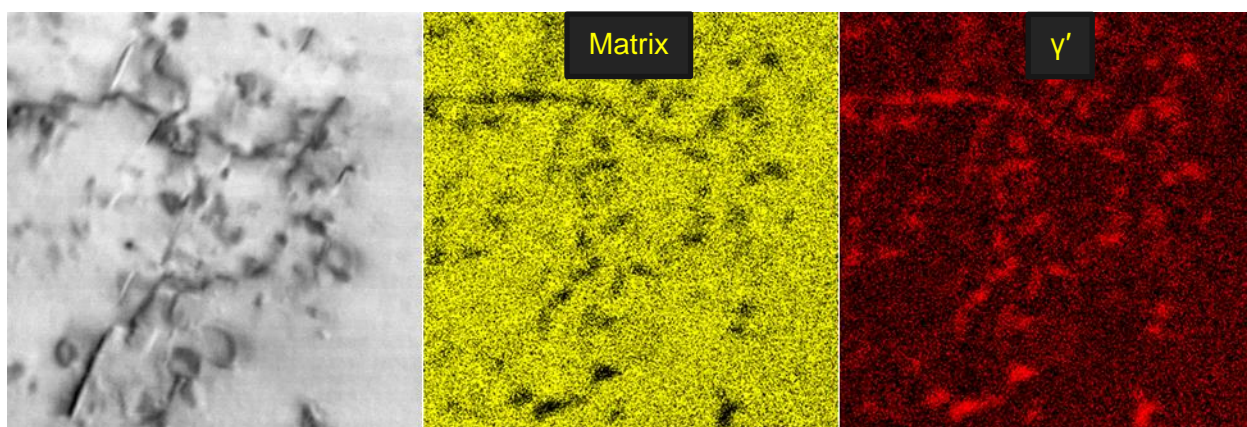
Figure 22. From the maps in the previous figure, phase maps derived from the multivariate statistical analysis module within the software show that the Ni-Si rich regions have approximately the same composition with a Ni to Si ratio of ~3:1.
