# Attic Insulation Upgrade

## Photo Report

**Installation Date:** August 10, 2023

**Installation Address:** 8005 N Projecy St., Portland, Oregon 97215

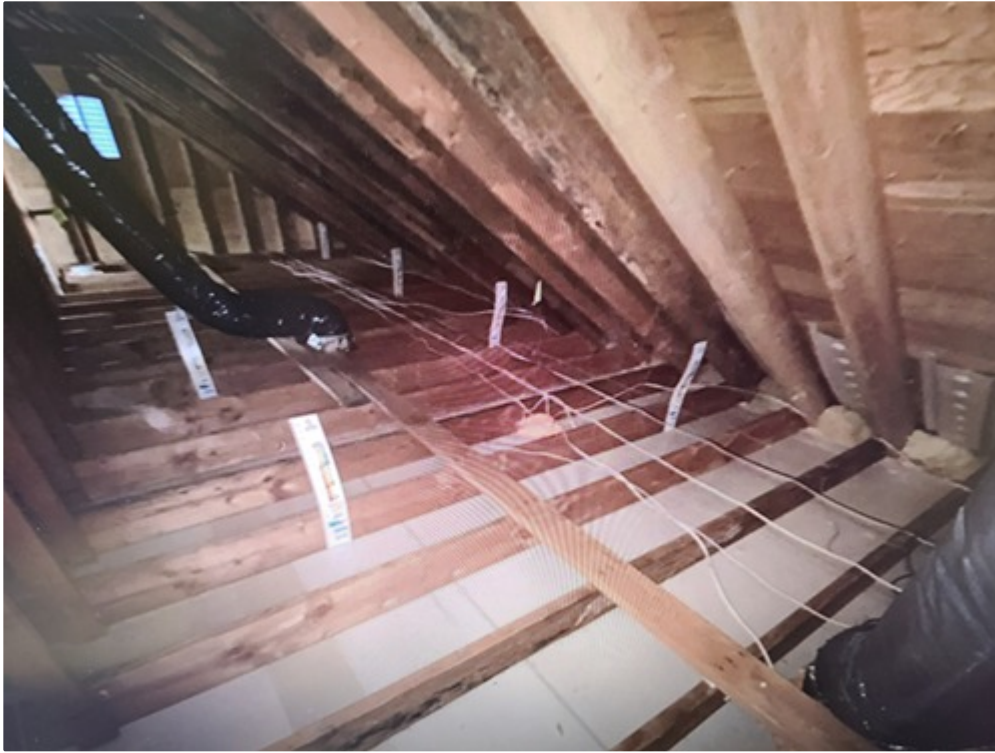
### Insulation Measuring Rulers – Photo

Overview of insulation measuring rulers, one installed every 300 sq. ft. visible from attic entrance (photo taken from attic entrance).

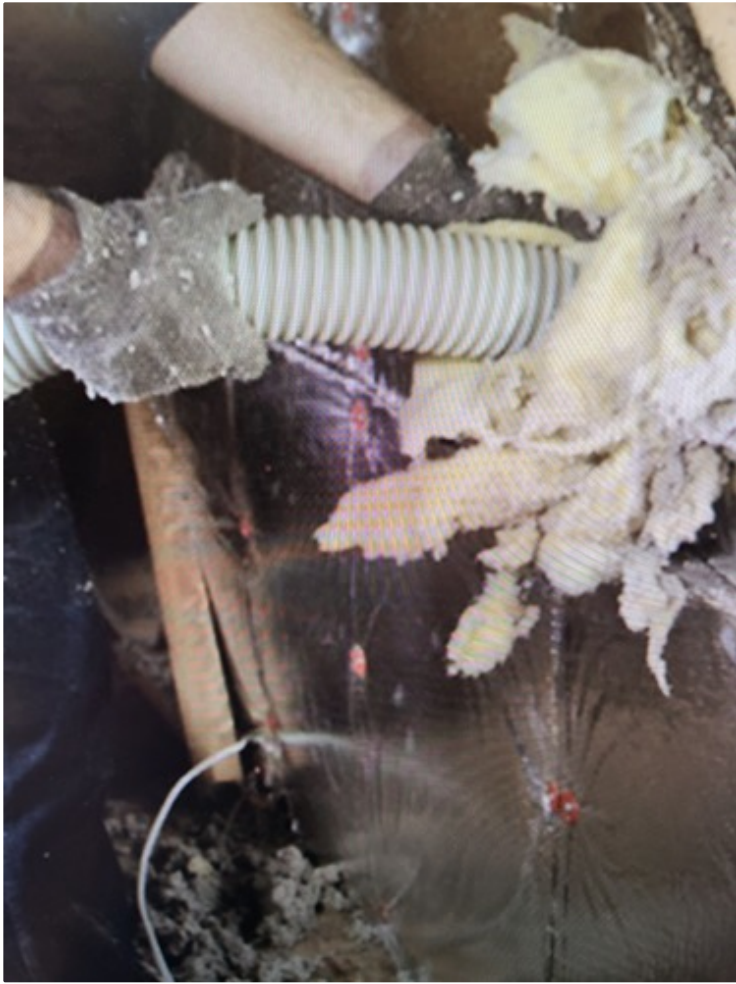
## Skylight Shaft – Photo

Photo of skylight shaft insulation detail

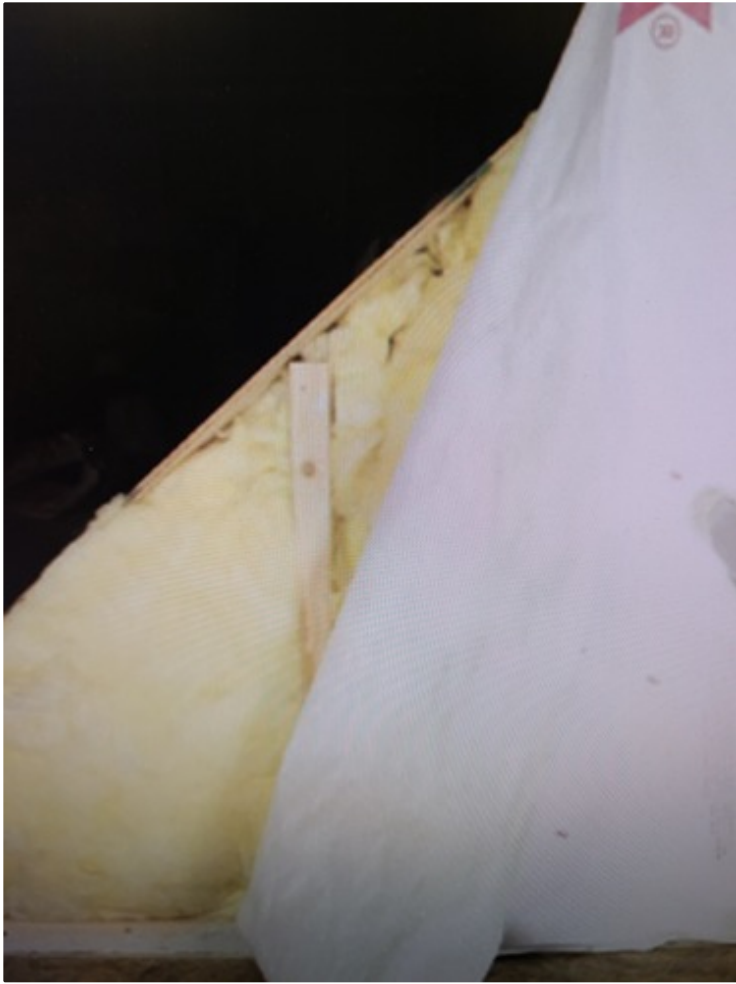
## Knee Wall – Photo

Photo of knee wall insulation detail

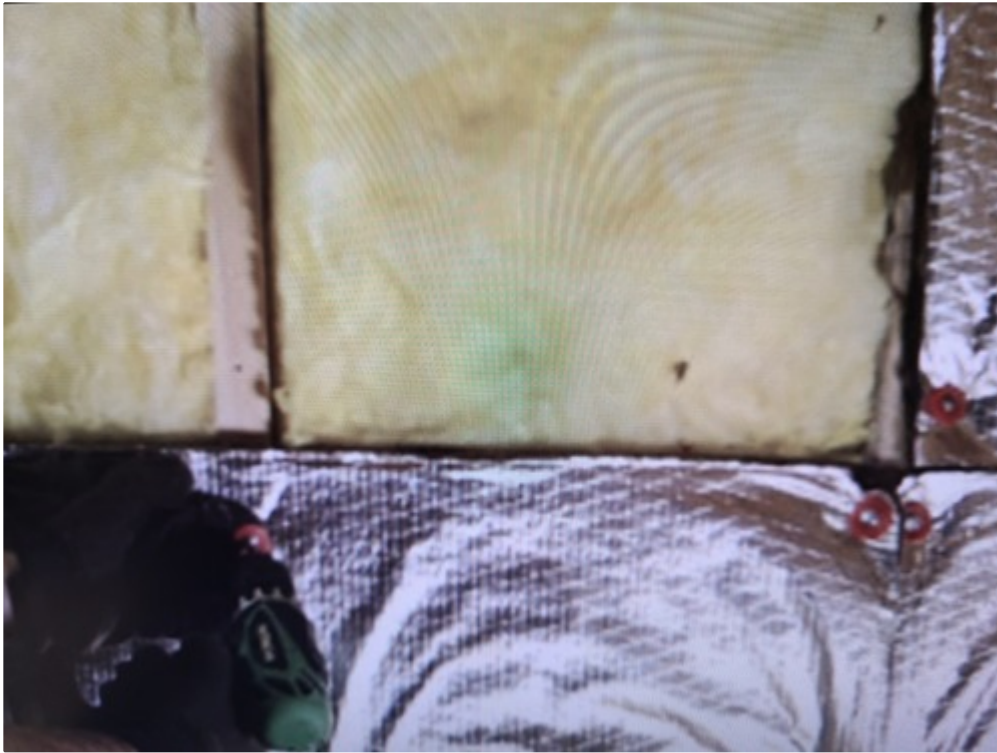
## Stairwell Wall – Photo

Photo of stairwell wall insulation detail

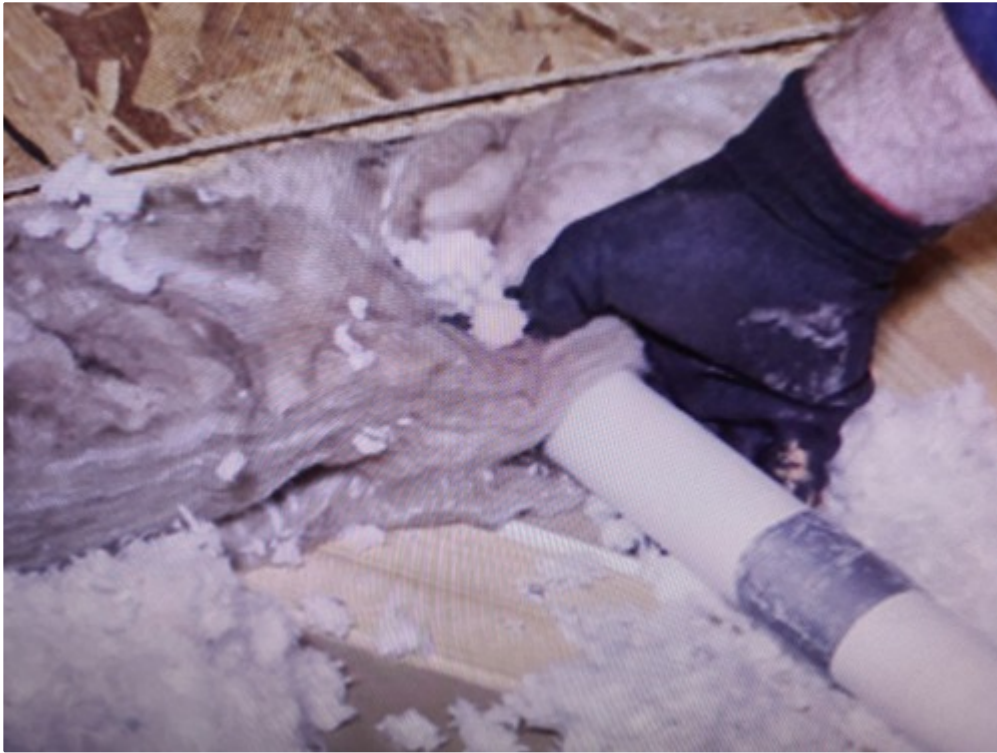
## Storage Platform – Photo

Photo of storage platform insulation detail

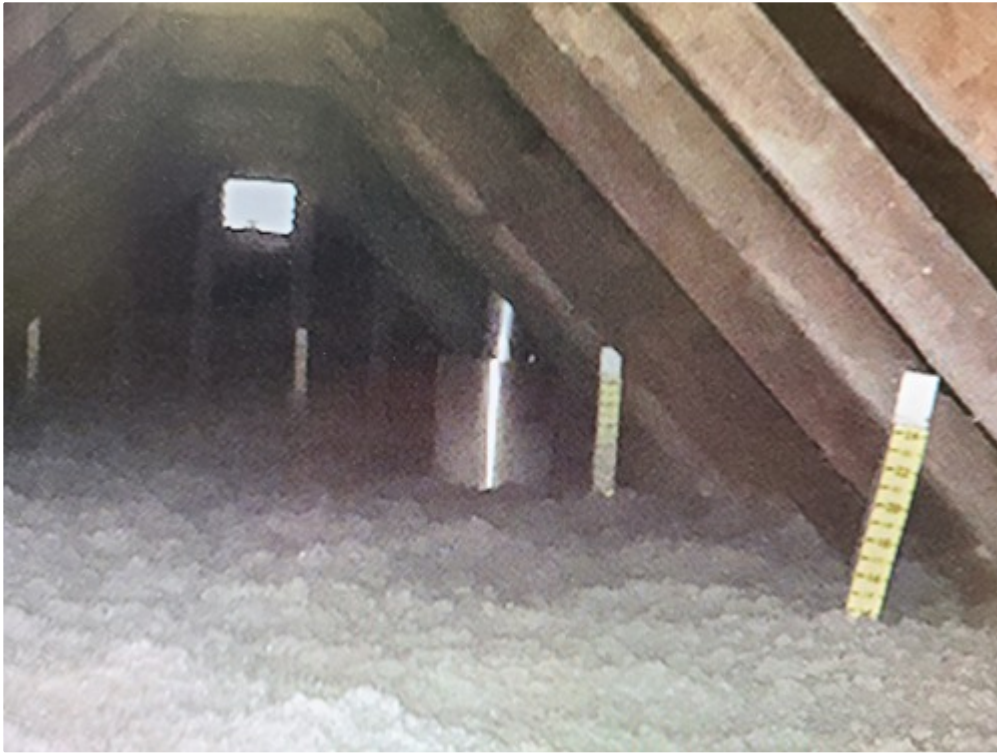
## Wide Angle – Photo

Wide angle photo showing insulation uniformity with rulers visible

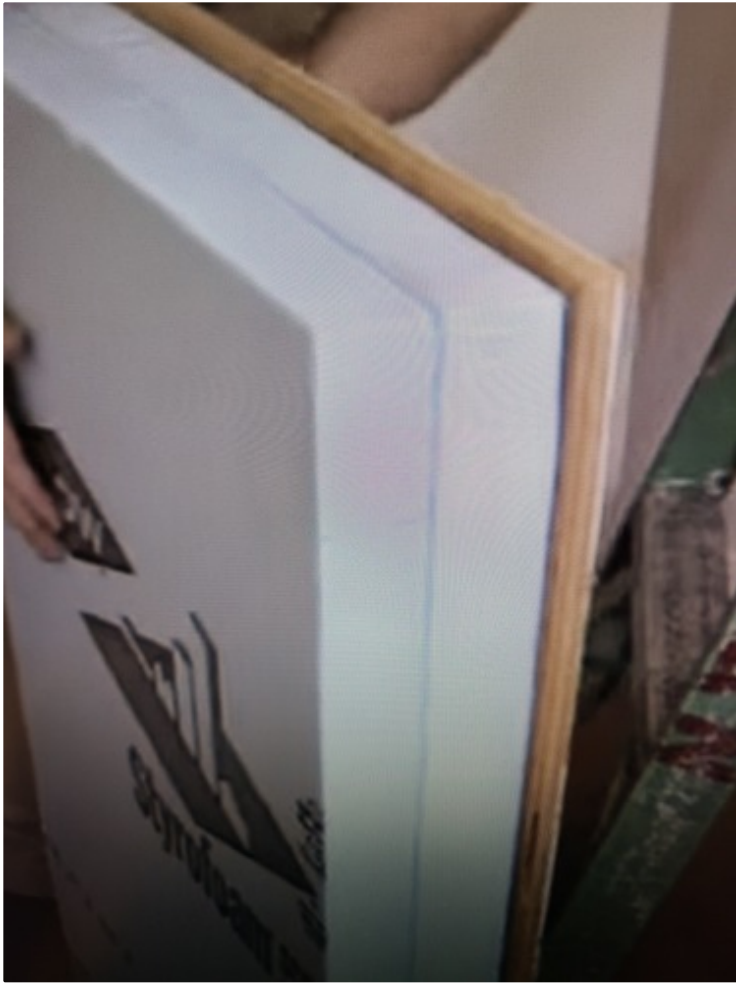
## Attic Door/Hatch - Photo

Photo of insulation on attic door/hatch

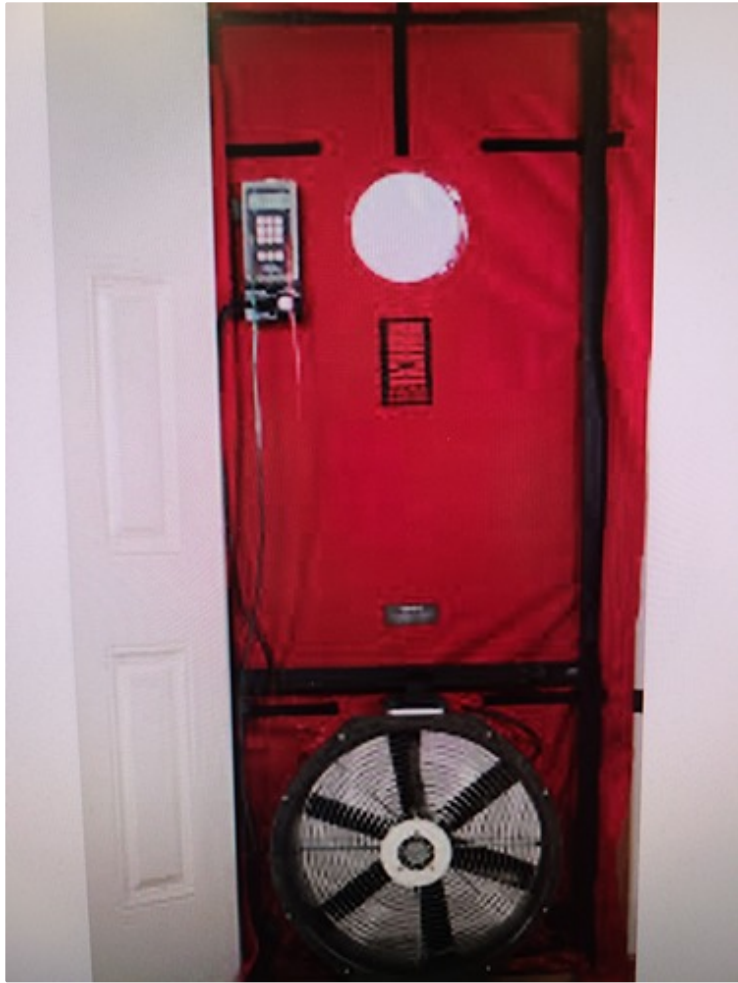
### Blower Door Setup - Photo

Photo of blower door setup

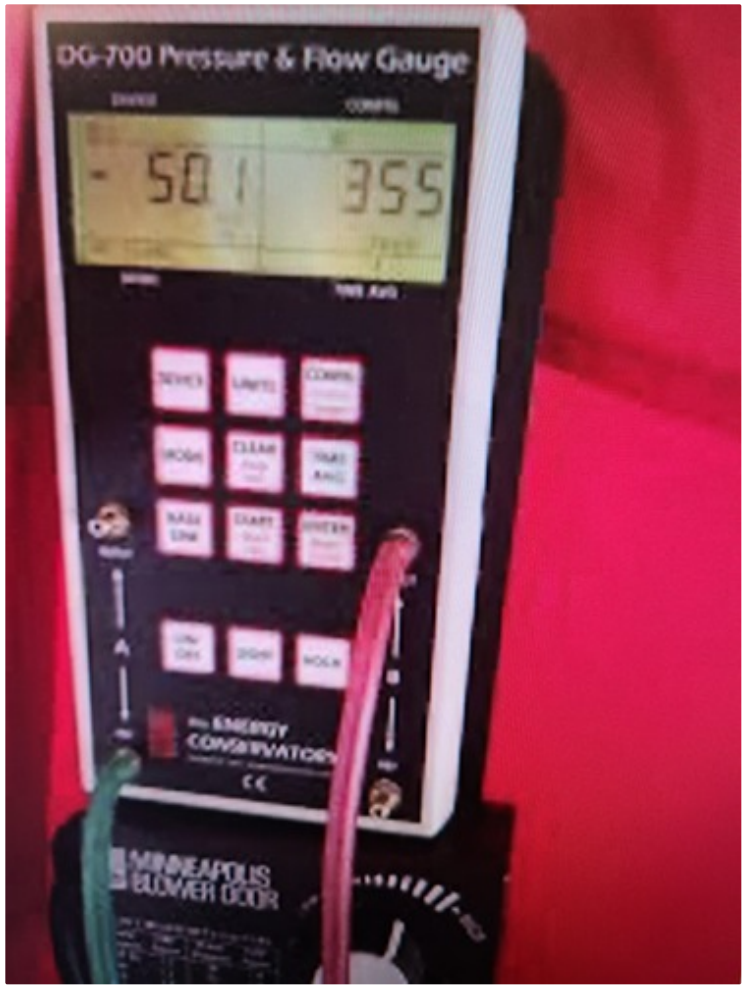
# Manometer CFM50 - Photo

Photo of blower door manometer showing CFM at 50 Pa read out

Final CFM50 = 355

Initial CFM50 = 1820

Initial ACH50 = 12.13

Final ACH50 = 2.37
