Managing Leakage to Ground from an Aging Nuclear Waste Storage Facility

John Heneghan – Sellafield Ltd, UK

Overview

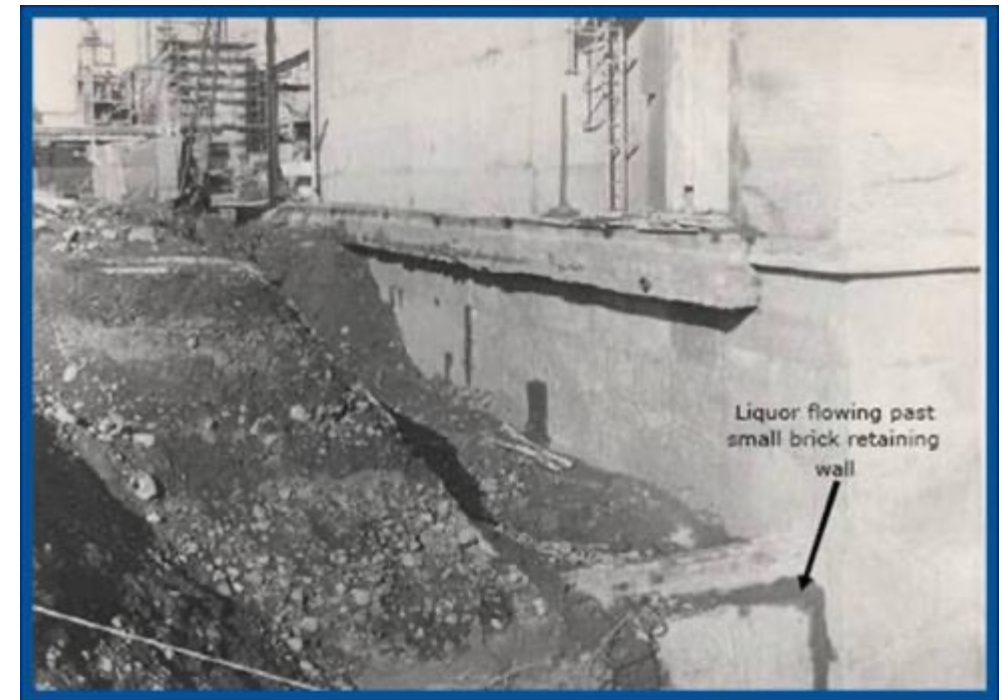
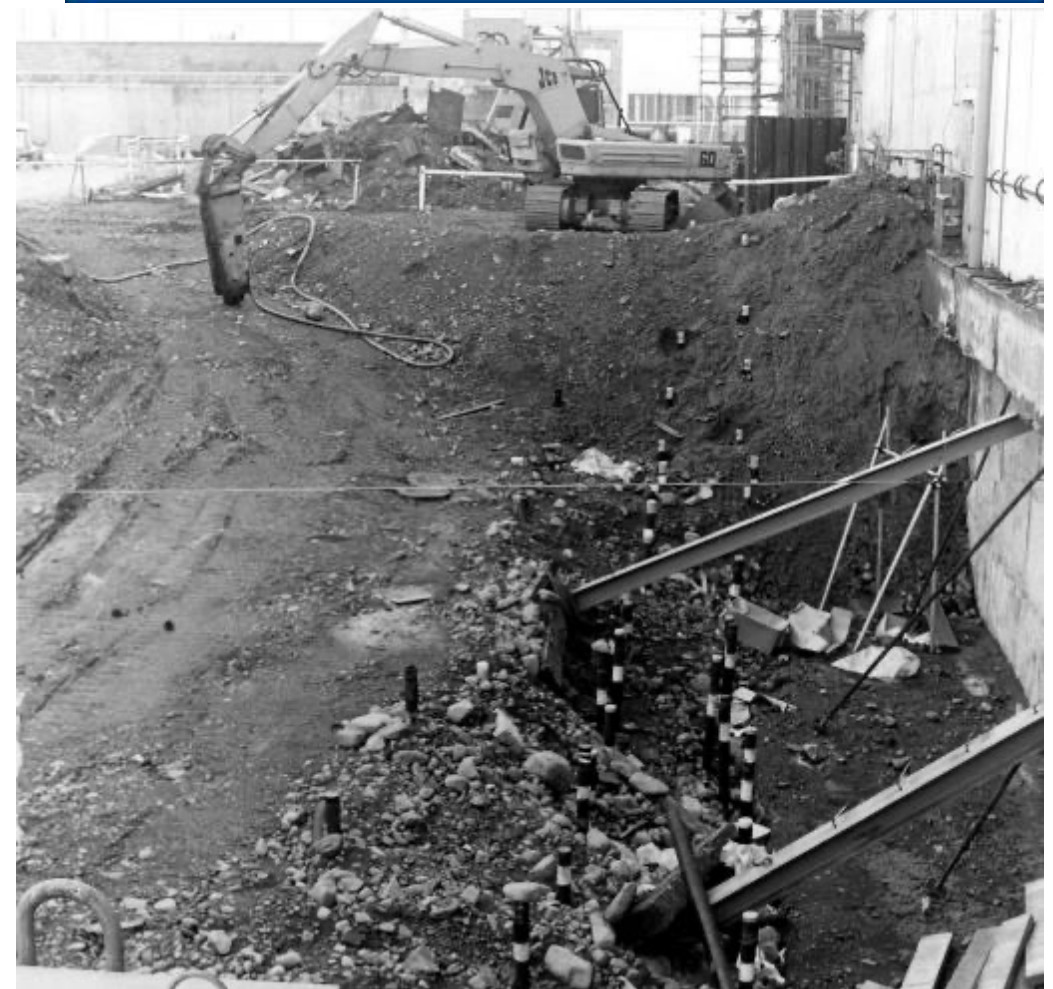
Historical leakage

- Exothermic reactions of swarf with water occurred in silo and damaged the original building
- Below ground leakage discovered during construction of the first extension
- Largest loss of radiological contam. to ground in UK
- Alkaline chemistry (pH ~10.2)
- Leakage dropped below detectable rate, without intervention, around 1980

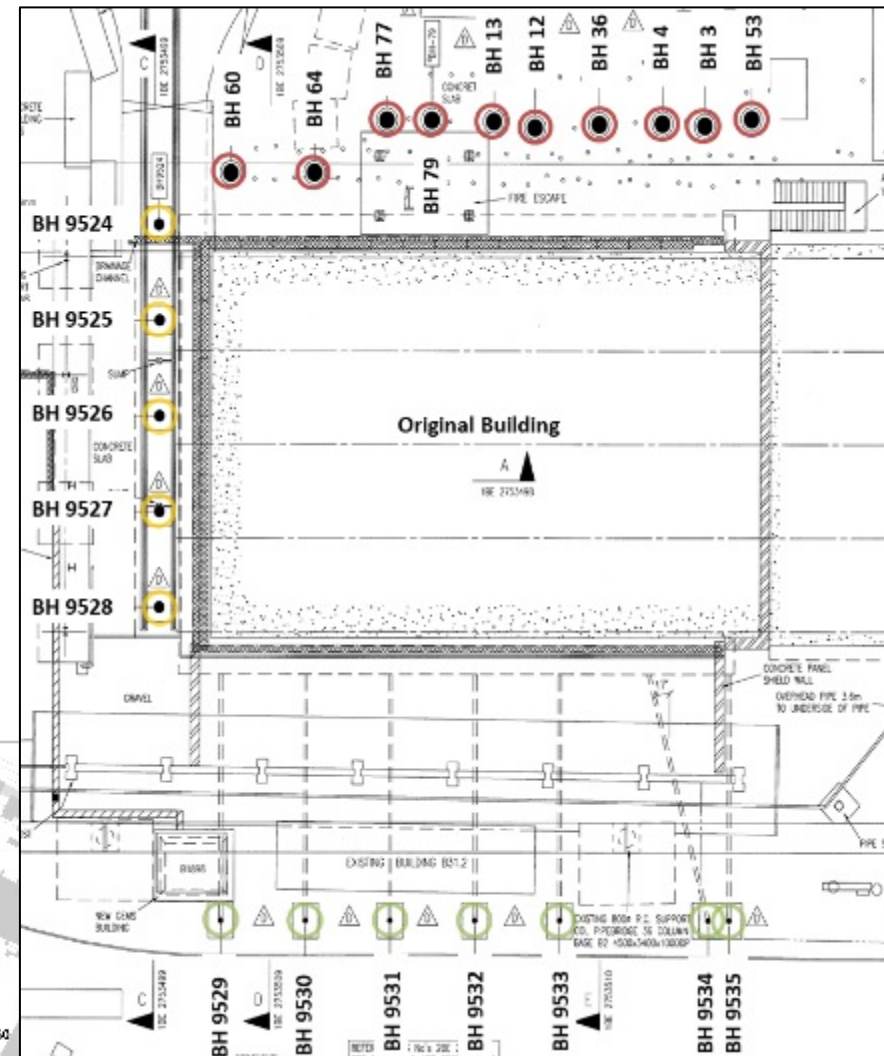
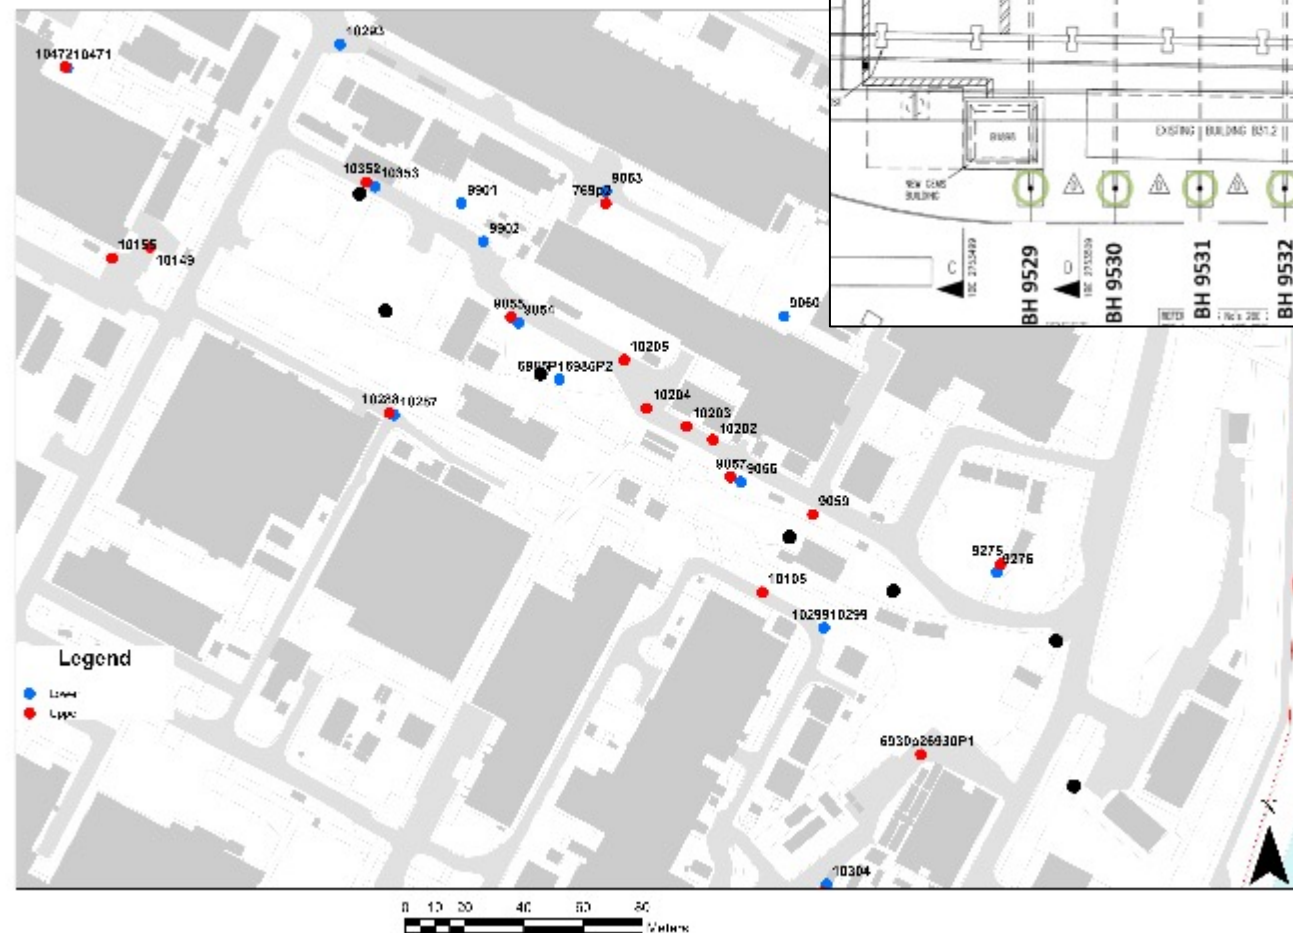
Post-leak blind tube monitoring

- Leak declared in November 2019
- Leak rate progressively increased to approx. 2.5 m³/day – broadly stable at this rate for around three years
- Enhanced monitoring commenced upon declaration of leakage, in line with agreed plans

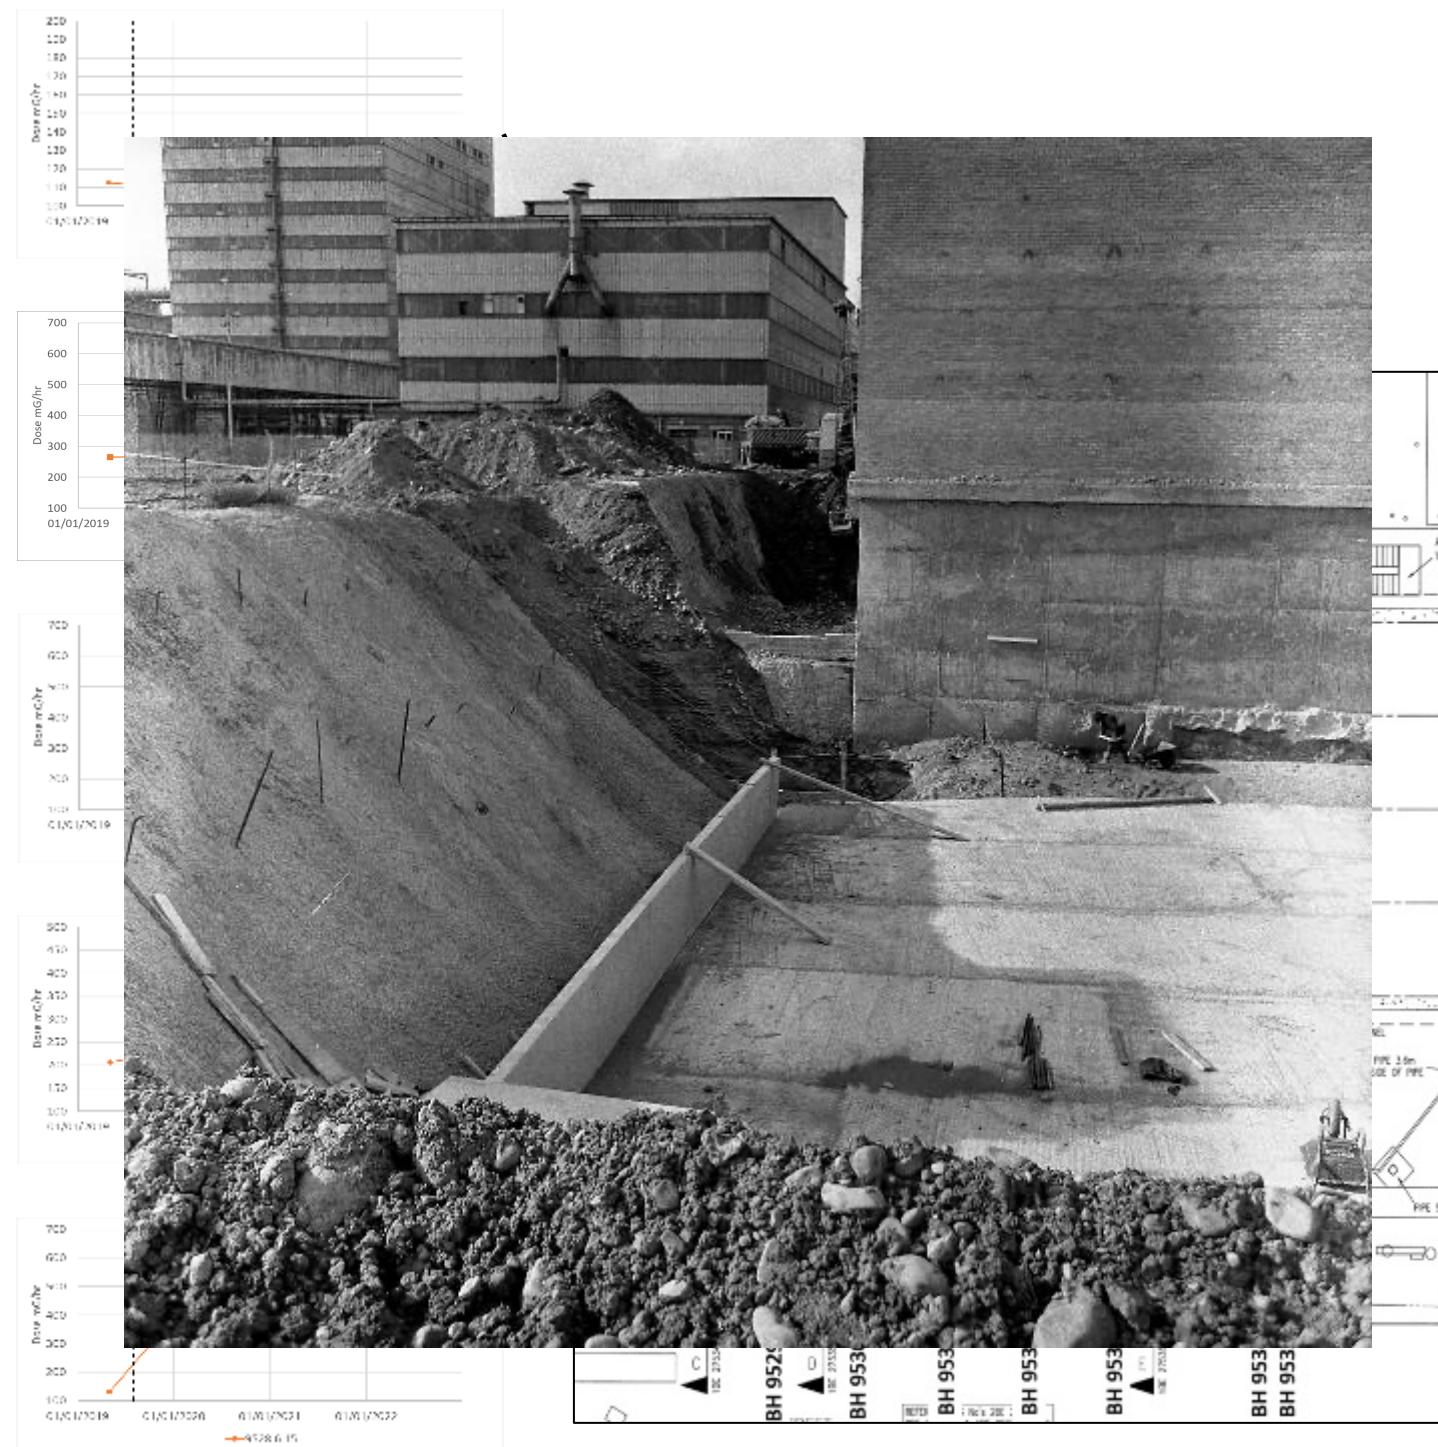
Current leakage

- Limited information on leak location, but some clues
 - Evidence from blind tube monitoring
 - ERT trial works (imaging and Mise-a-la-Masse)
- Migration may be influenced by in-ground features

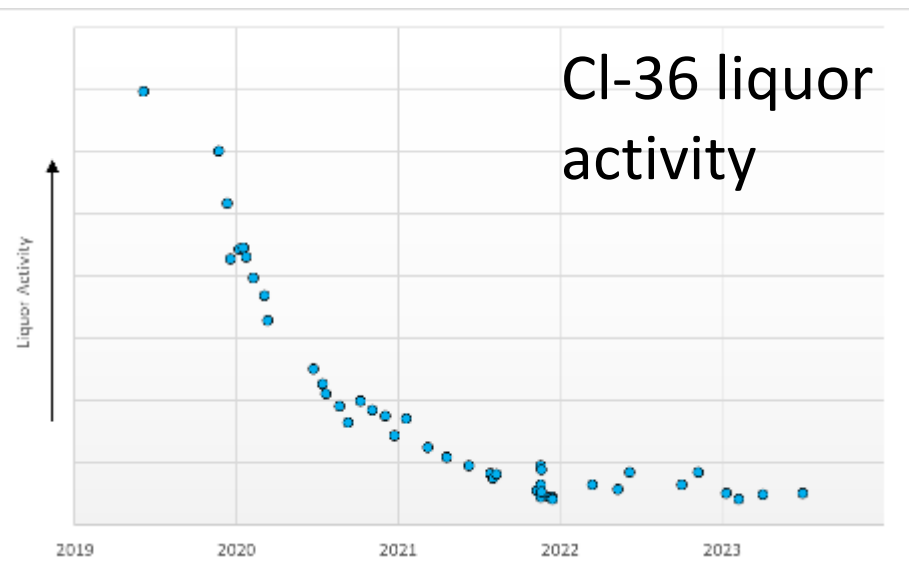
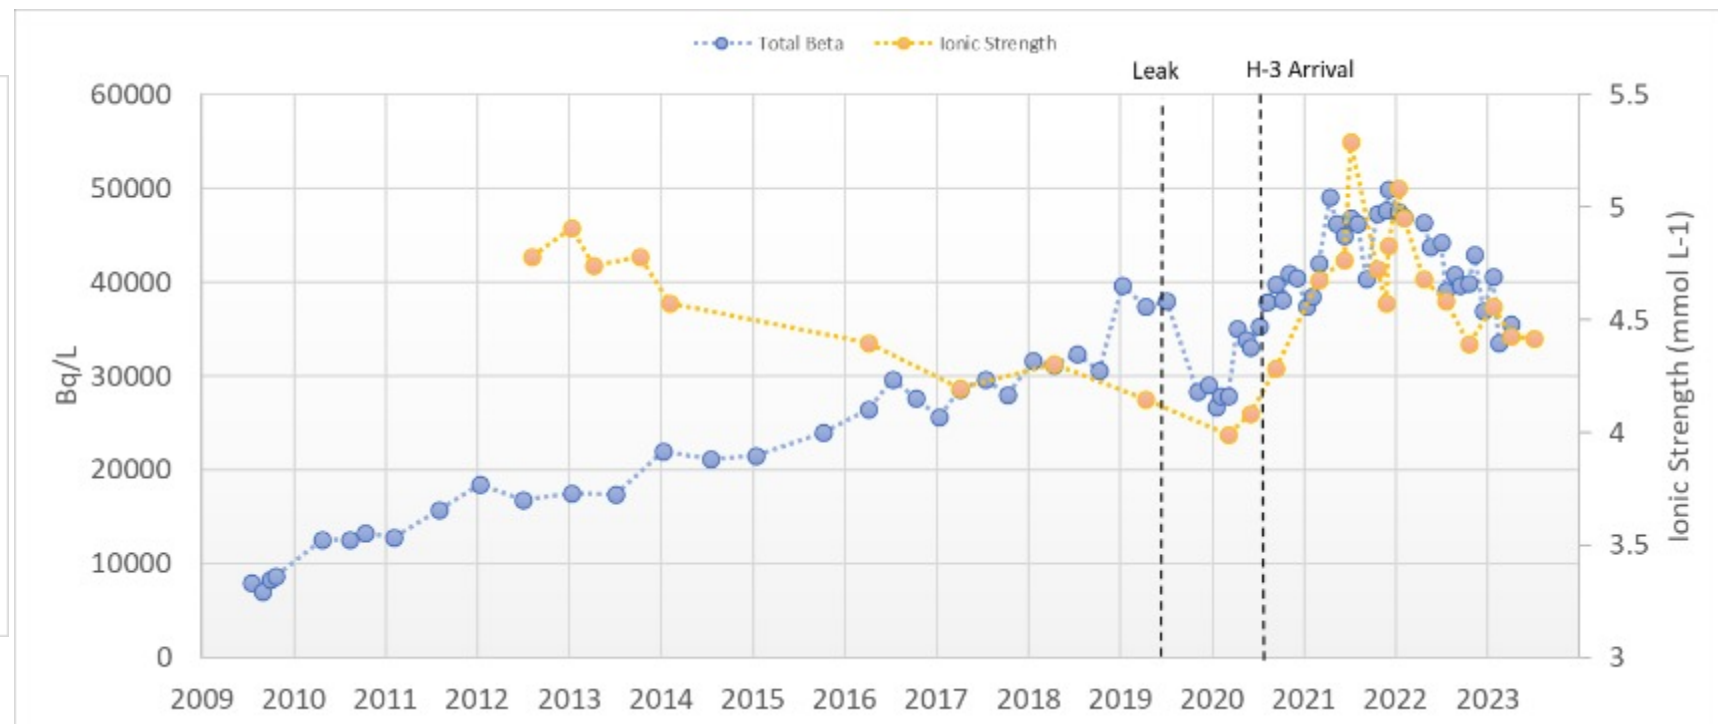
Groundwater monitoring

- ‘Slug’ of initial activity followed by decline – top-up = leak rate
- Gross Beta (Sr-90) trends show a relationship to ionic strength
- Plume ‘slug’ corresponds with increase in ionic strength
 - Ion-exchange perturbations during migration of plume

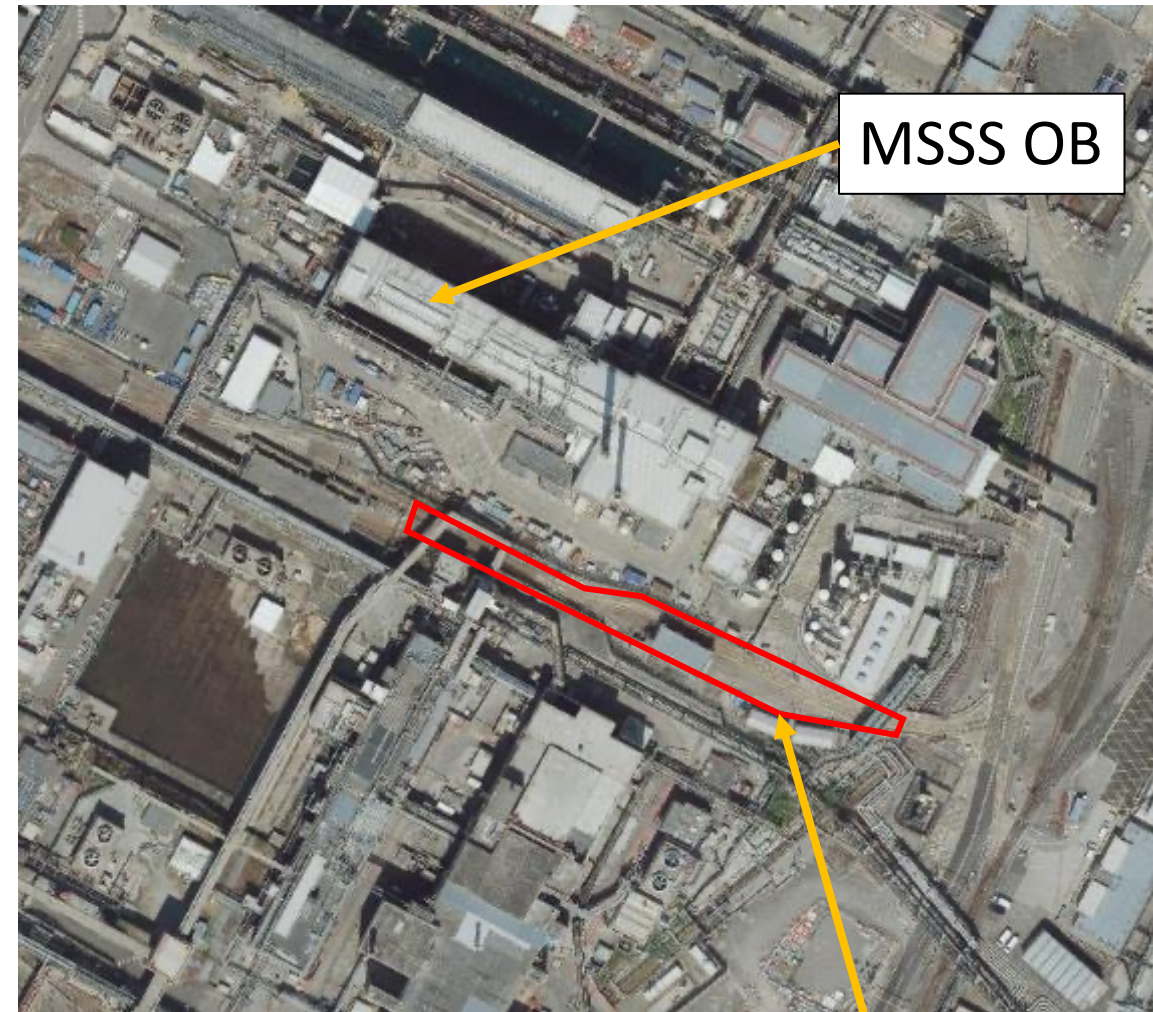
Proposed in-ground deployment area

- Lots of constraints
 - Near silo
 - High dose
 - Limited space
 - Plant operations
 - In-plume
 - Heterogenous geology / hydrogeology
 - Buried infrastructure
 - Rail lines
- Further characterisation and trials proposed – on and off site
- Trial work commencing next month
