PNNL-18747

Evaluation of Fish Passage Conditions for Juvenile Salmonids Using Sensor Fish at Detroit Dam, Oregon

Final Report

January 2010

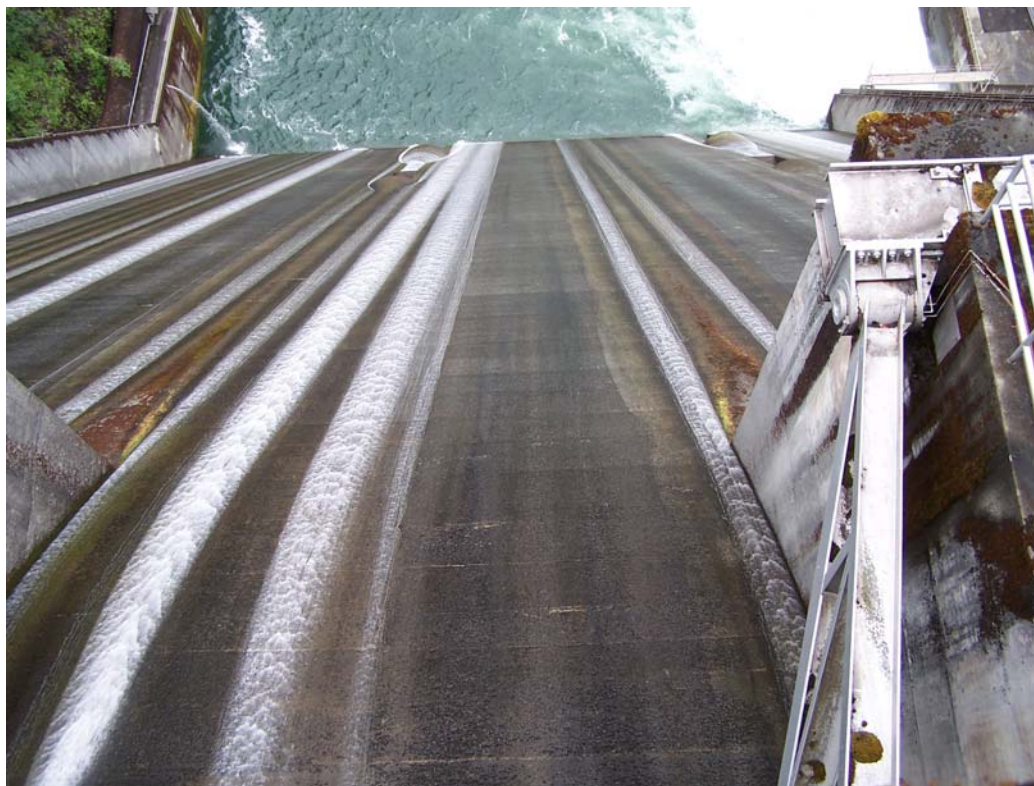
The height and slope of the spillway chute contribute to deleterious exposure conditions observed during the study. Detroit Dam, completed in 1953, is slowly deteriorating due to age. The concrete surface of the spillway is rough from weathering (Figure 4.1), and the descending flow is irregular (Figure 4.2).

Figure 4.1. Spillbay 3 at Detroit Dam showing the rough, irregular concrete surface.

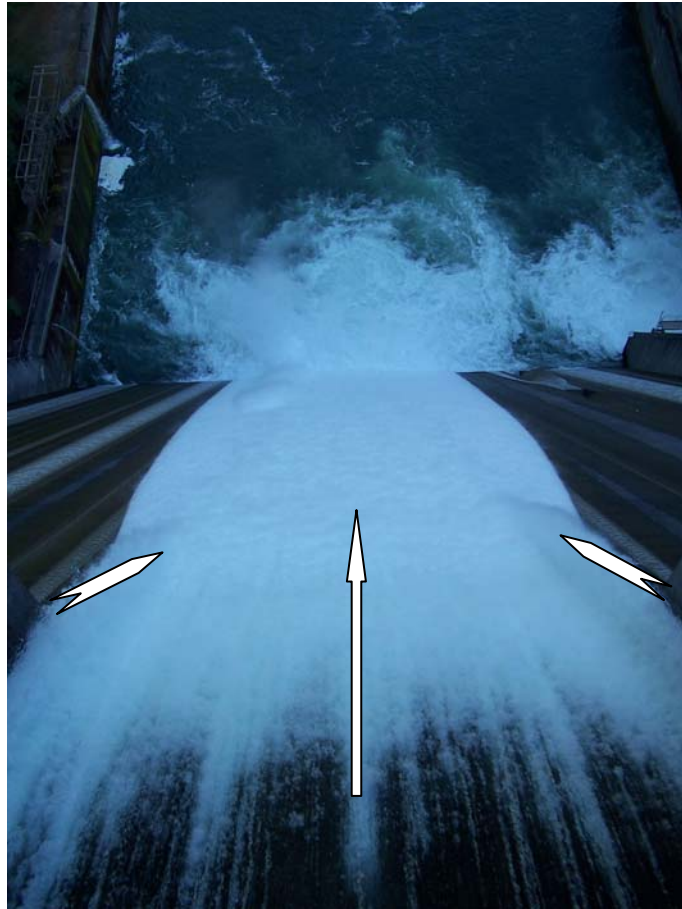
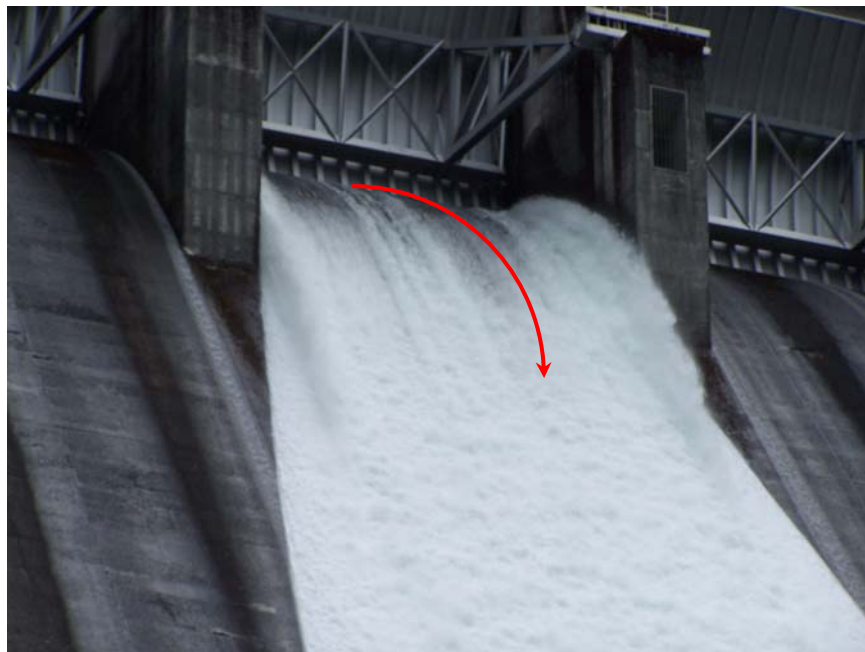
During passage, back pressure behind the tainter gate projects flow forward, resulting in a hydraulic jump as the flow contacts the spillway due to the angle of descent (53-degree slope). The gate opening size affects the time and distance the flow arches before contacting the chute, with the smaller opening propelling the Sensor Fish the greater distance (Figure 4.4). The flow depth and the position of the Sensor Fish within the flow will influence whether there is a relatively smooth transition onto the spillway chute or whether the passage will be more turbulent. Increased turbulence may fragment any flow jet, possibly creating more deleterious fish passage conditions.

Figure 4.4. Hydraulic jump occurs as flow passes under the tainter gate.

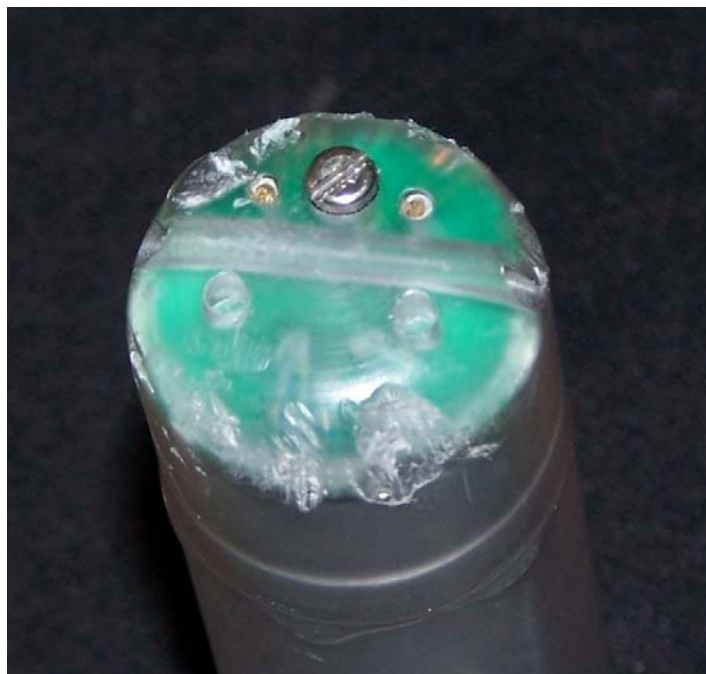
Some Sensor Fish recovered following passage through Detroit Dam were noticeably damaged, revealing scratches and portions of the polycarbonate shell chipped away (Figure 4.5). Extreme forces are needed to fragment polycarbonate, a highly impact-resistant, low-scratch durable polymer plastic. Although the Sensor Fish have been scratched and scraped during previous studies on the Columbia and Snake rivers, the damage observed on the casing following passage at Detroit Dam was much worse.

Figure 4.5. Chips and scratches visible on the polycarbonate Sensor Fish casing.
