PNNL-18515

Initial Component Testing for a Germanium Array Cryostat

An Interim Report for the Radionuclide Laboratories Project

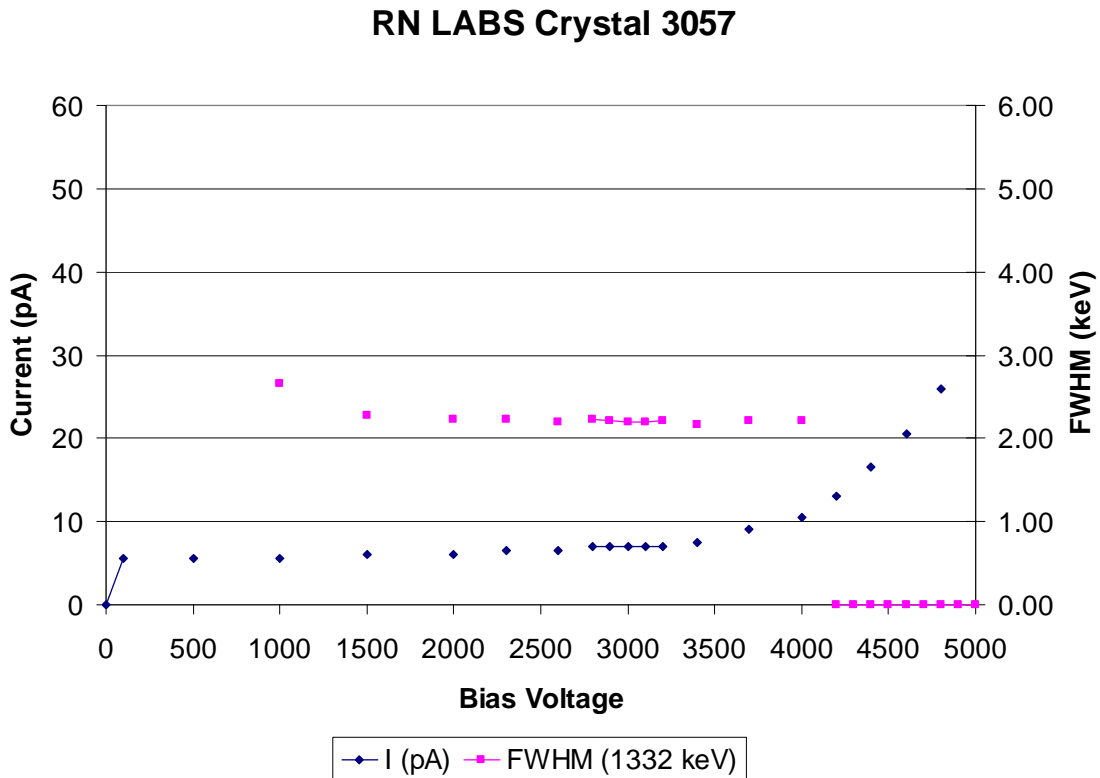
Figure 2.1. I-V Curve for One of the HPGe Crystals Refurbished by PGT. Energy resolution at 1332 keV is also plotted.

Eight HPGe crystals available from the completed NA-22 MEGA project were available for use on the RN Labs research. A contract was arranged with PGT to refurbish these eight crystals. All eight of these crystals have been received, tested, and removed from the shipping cryostats. The agreement with PGT did not include an energy-resolution specification for these refurbished crystals, so acceptance was based on the results of an I-V curve measurement. Figure 2.1 is an example of a typical I-V curve for these PGT crystals. The crystals were stored in a nitrogen dry box for various periods of time (up to ~ 1 year) after initial testing and then moved to vacuum storage. The crystals are currently in vacuum storage awaiting installation in one of the RN Labs cryostats.

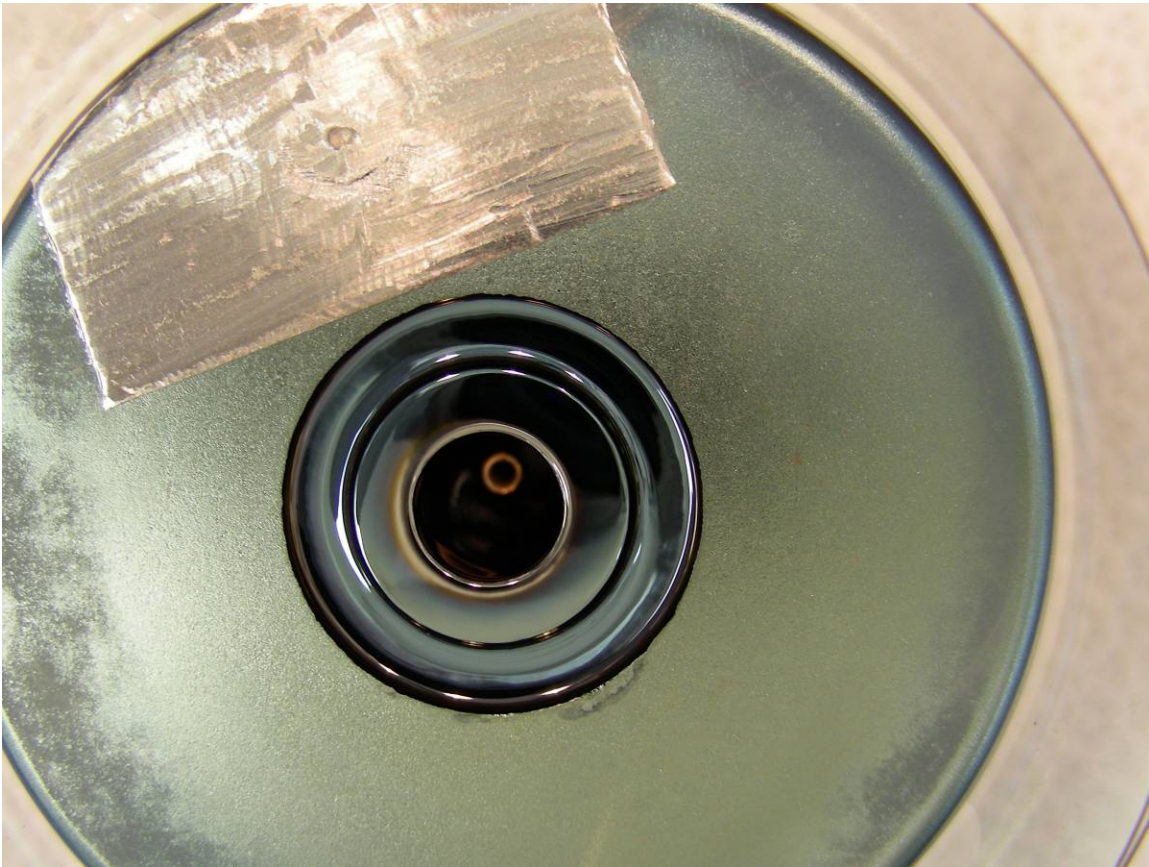
Figure 2.2. HPGe Crystal Received from Canberra. The large indium patch is the silver colored material at the top of the image. The end of the “pogo pin” contact rod is visible inside the bore hole, and the visible end of the bore hole is not plated with gold.

An initial shipment of four new crystals from Canberra Semiconductor was tested against factory specifications. After testing, the first of these crystals was removed from its shipping cryostat. Upon removal, we noted that 1) excessive amounts of indium were used on the crystal (inconsistent with a low

background detector—see Figure 2.3) and 2) the “pogo pin” style of signal contact was used (see Figure 2.3). This latter point made the crystals unsuitable for use in RN Labs, both due to indium at the bottom of the central bore hole and the lack of protective gold plating at the entrance to the bore hole. These features were not consistent with the order specifications, so all four detectors were returned to Canberra for repair. This issue substantially delayed the receipt of the final eight crystals. We have recently received five Canberra detectors that are now in acceptance testing, and we are awaiting the final three crystals.

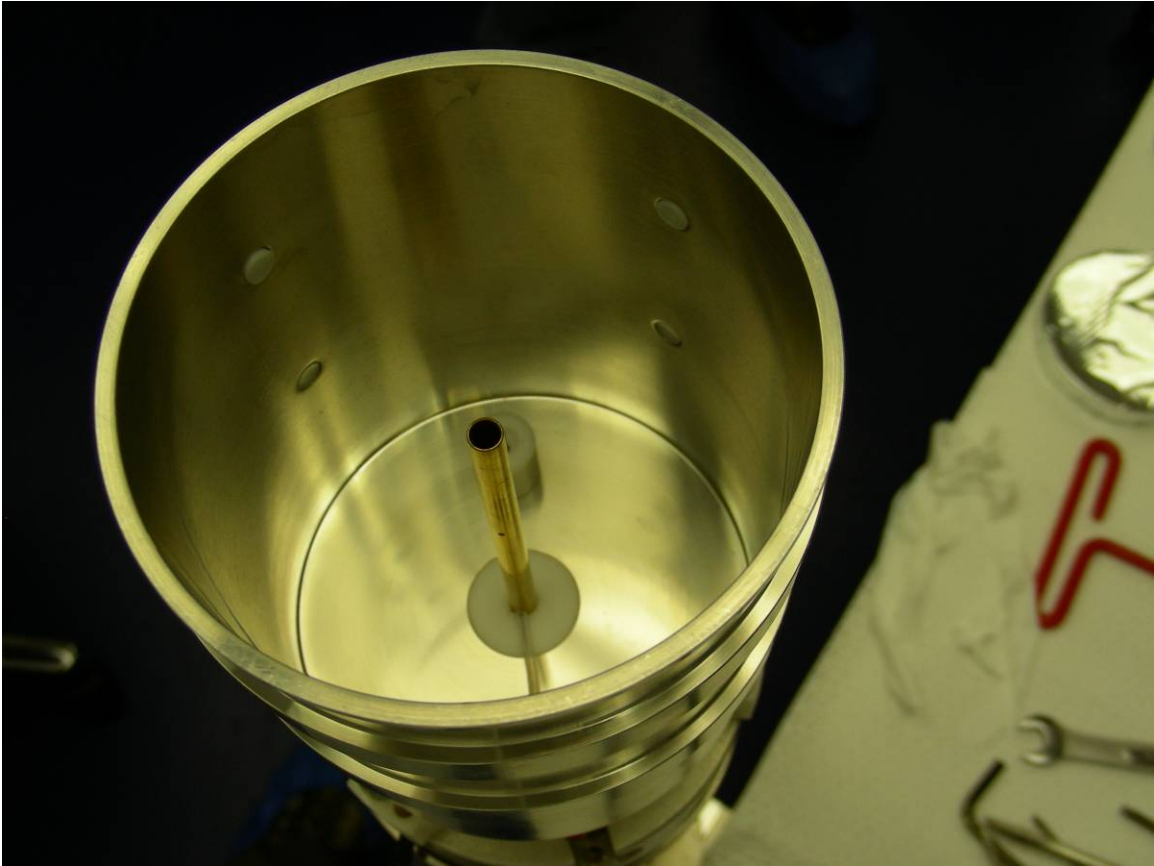
Figure 2.3. This Image of the Canberra Cryostat Shows Part of the “Pogo Pin” Central Contact Rod

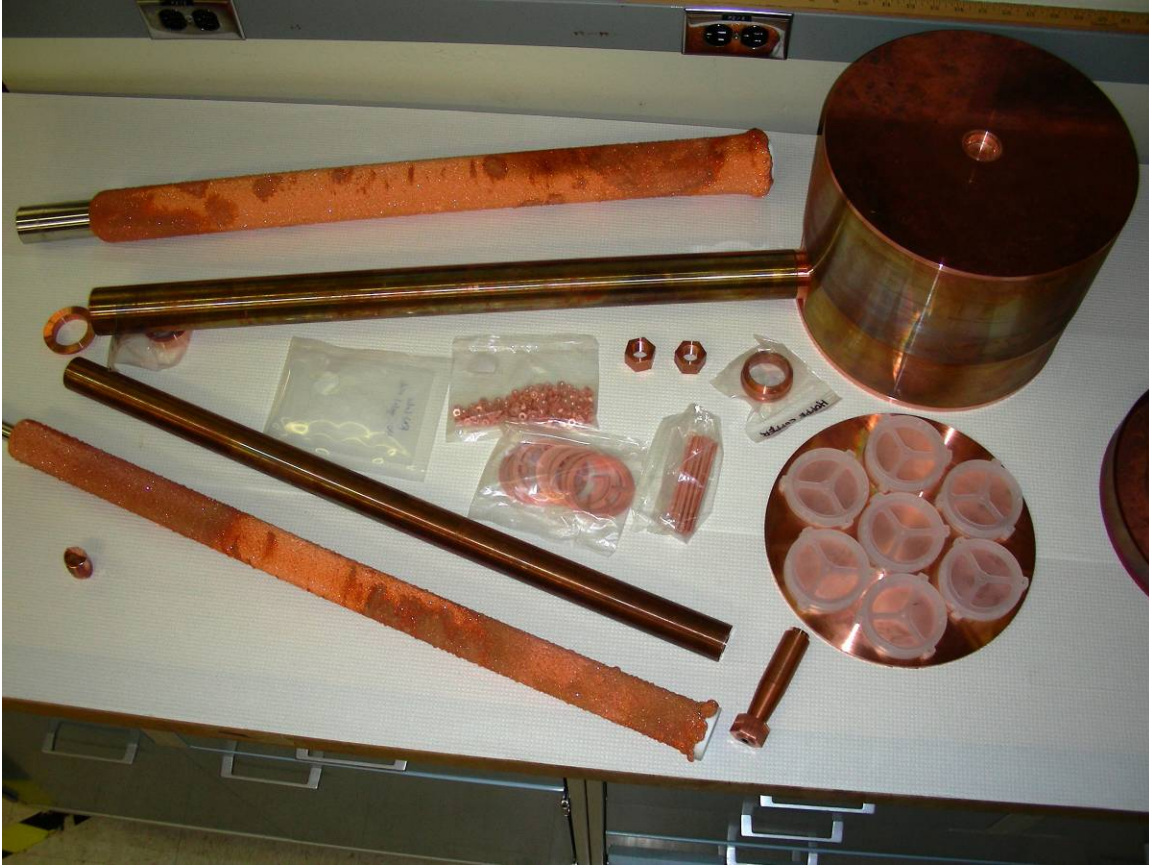
Figure 3.1. Completed Cryostat Parts for First Cryostat of RN Labs Instrument

In general, electroforming parts for RN Labs has proceeded smoothly, and the vast majority of parts have been successfully completed. Figure 3.1 shows nearly all of the copper parts required for the first cryostat, along with the electroformed cross arm and cold finger for the second cryostat (still on mandrels in this image).

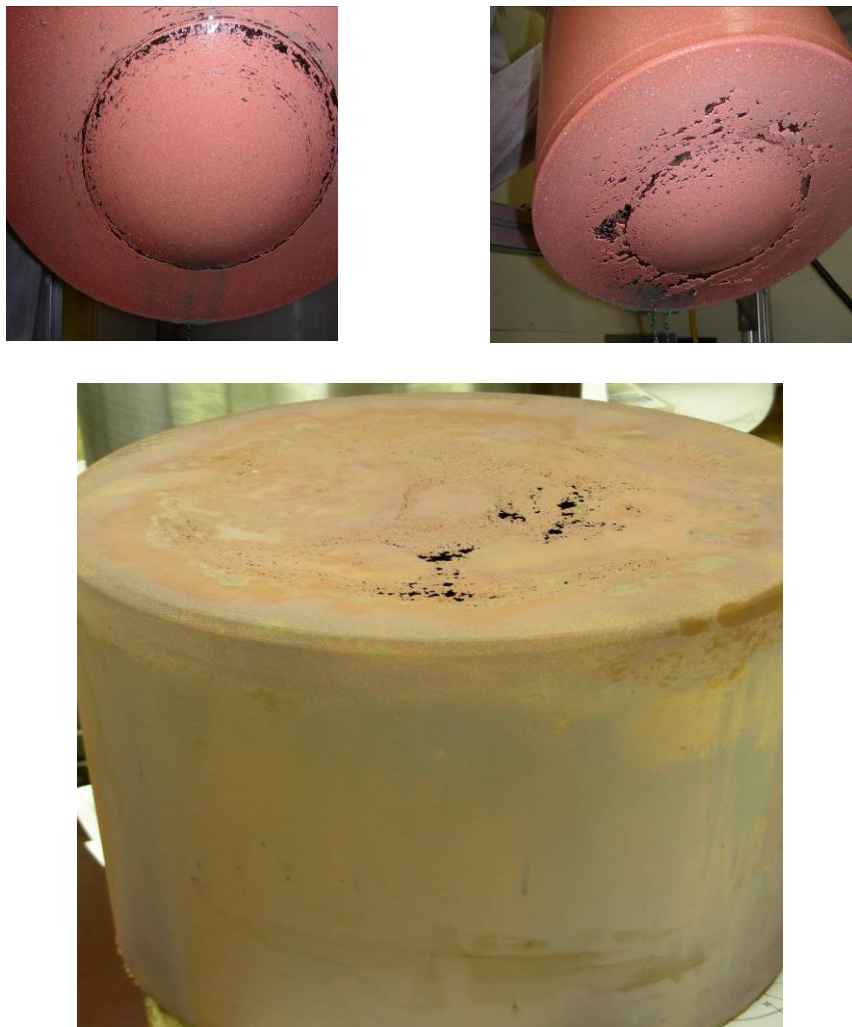
Figure 3.2. Copper Nucleation Problems. Large electroformed parts that have suffered nucleation issues, resulting in numerous holes in the copper

Obtaining proper copper nucleation and adhesion to the stainless steel mandrels is essential to proper growth of the part. Figure 3.2 displays two separate attempts to electroform an entrance window and an attempt at one of the IR shields. These parts all suffered from poor nucleation so that the resulting copper had significant holes. Holes are not acceptable for either the entrance window (which must hold vacuum) or the IR shields (which must prevent infrared radiation from striking the HPGe crystals). We are in the process of determining the source of these issues.

The solution to the difficulties encountered in electroplating these large parts is to provide more controlled surface conditions that favor uniform nucleation on the stainless steel mandrels. Electropolishing, an electrochemical cleaning process, is being aggressively investigated to resolve the problem. Chemical etching is another possible solution that is also being tested.

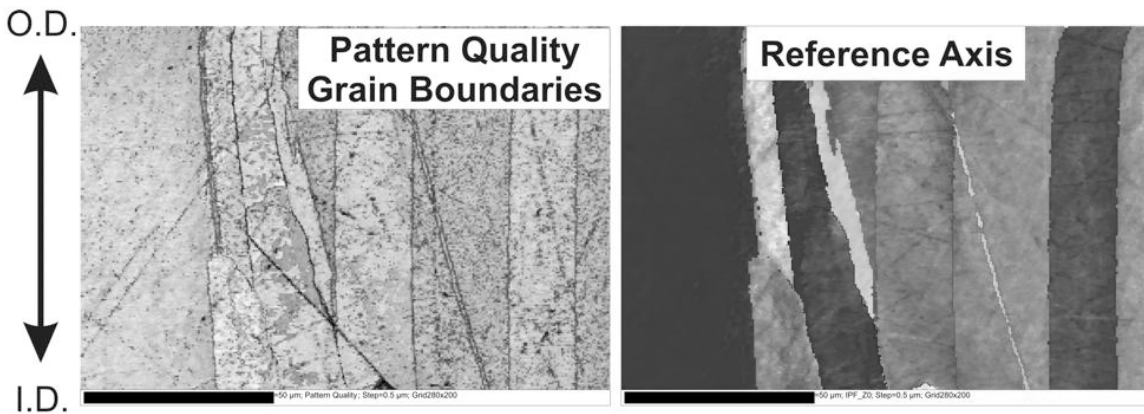
Figure 3.4. SEM Image Showing Large, Oriented Grain Structure

All of the samples showed a very fine grain size at the interior surface directly in contact with the mandrel (see Figure 3.3). After a few hundred microns, this tended to transition to a larger elongated grain structure that often had a strong texture. For some samples, the texture continued to refine itself out to the edge of the sample, producing very large, highly oriented grains (see Figure 3.4).

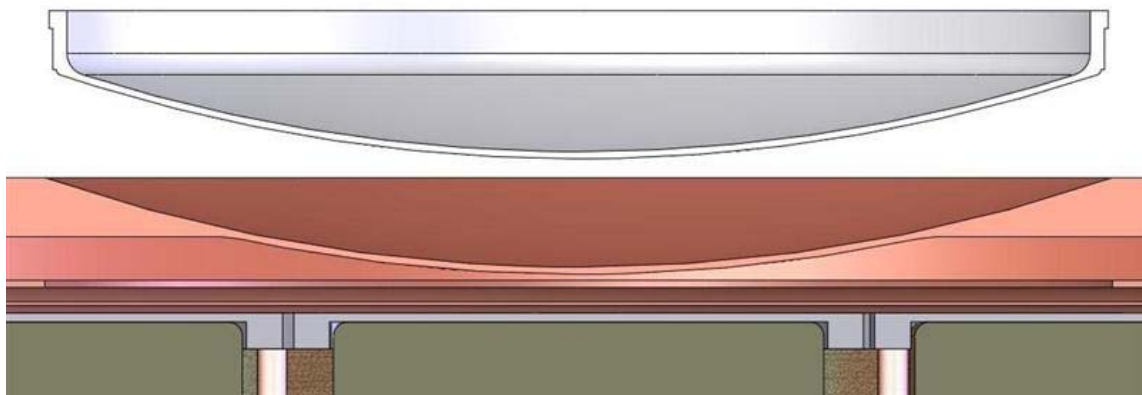
Figure 3.5. Alternative Plating Geometry for Entrance Window. The upper part of the figure shows an entrance window plated on a 6 inch mandrel. This window would then be e-beam welded into the annular plate. This geometry is less likely to suffer from the nucleation issues we have experienced with the larger 11 inch mandrel.

We are also investigating alternative plating geometries that would be quicker to produce. Figure 3.5 shows an alternative entrance window geometry that would allow plating of the entrance window separate from the thicker plate surrounding the window. In this geometry, the window would be electroformed as a 6" diameter part, then e-beam welded into the heavier plate. We are pursuing this alternative in parallel with plating the part as a single unit.

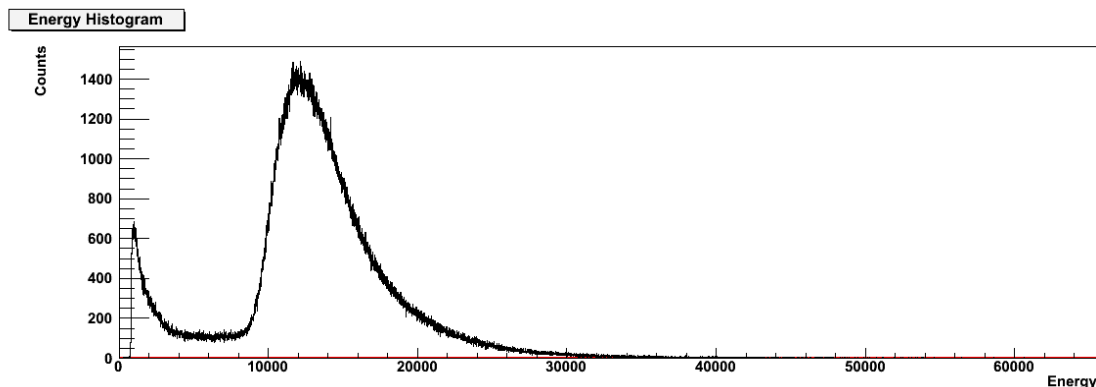
Figure 4.1. Muon Peak in Plastic Anti-Cosmic Detector. This figure shows the muon through-peak in a 2 inch thick plastic scintillator. This spectrum is from “tagged” muons, in other words events observed in two independent scintillators at the same time. Energy is in ADC channel units. The rising continuum at the low energy end is caused by detection of gamma-rays; we anticipate good separation between gamma-rays and muons, as displayed in this spectrum.

An important part of the overall background performance of the RN Labs instrument is suppression of cosmic-ray backgrounds. Tests have been performed with plastic scintillator cosmic-ray detectors, and a design for an effective active cosmic-ray veto system for RN Labs has been prepared. The results of these initial laboratory tests indicate that 2-inch-thick scintillating plastic panels will provide good cosmic-ray identification while remaining relatively insensitive to external gamma-ray backgrounds. Based on the results of these tests, an active anti-cosmic shield system has been designed, and we are currently awaiting bids from suppliers.

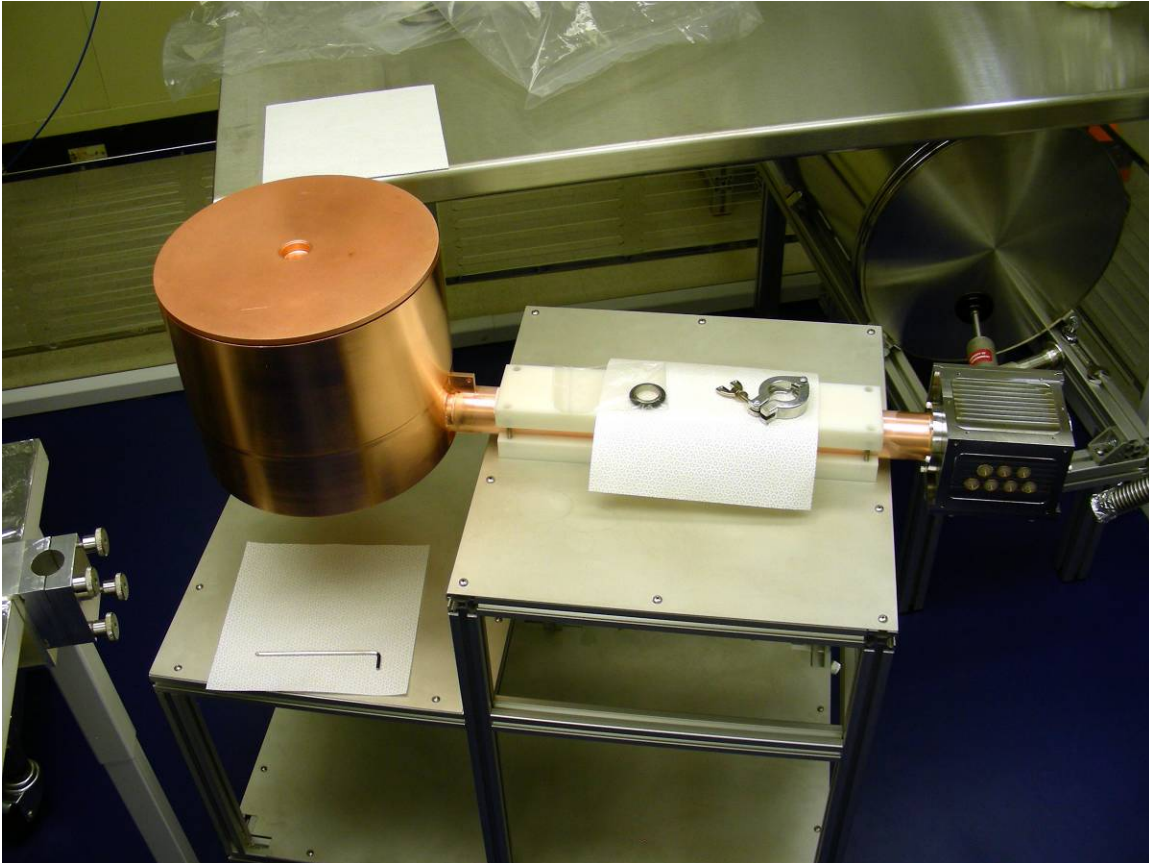
Figure 4.2. Initial Vacuum Testing of the first RN Labs Cryostat. The top plate in this image is a test piece; production of a large, thin entrance window for the cryostat is one of the more challenging aspects of the cryostat production.

The vacuum boundary of cryostat #1 has been assembled for vacuum testing. This assembly includes the main body of the cryostat, the cross arm, and the service body (see Figure 4.2).

The main body of the cryostat, in this test configuration, requires three seals around the circumference of the chamber. Each seal is ~ 36 inches long. In the final configuration of the cryostat, the plate containing the entrance window will be e-beam welded to the corresponding cylinder, eliminating one of these three seals. Several smaller seals are located on the service body, including the cross arm-to-service body connection, the pump out port plate, a blank plate, and the service body-to-Dewar connection. The vacuum integrity of welds was tested: e-beam welds on each end of the cross arm, welds on the service body, and a laser weld test for the 50-pin feed-through on the service body. Thunderline Z high-voltage feedthroughs were cemented into the service body with Torr Seal, and these seals were also checked for vacuum leaks.

During the initial leak testing, we have been unable (thus far) to achieve the seal for the bottom plate. It appears that the “hoop” warped slightly during e-beam welds of the cross arm and cross arm gussets. The integrity of the other two large seals on the main body of the cryostat cannot be verified until the lower seal is corrected. A detailed plan has been developed to resolve this issue, and is currently in progress.

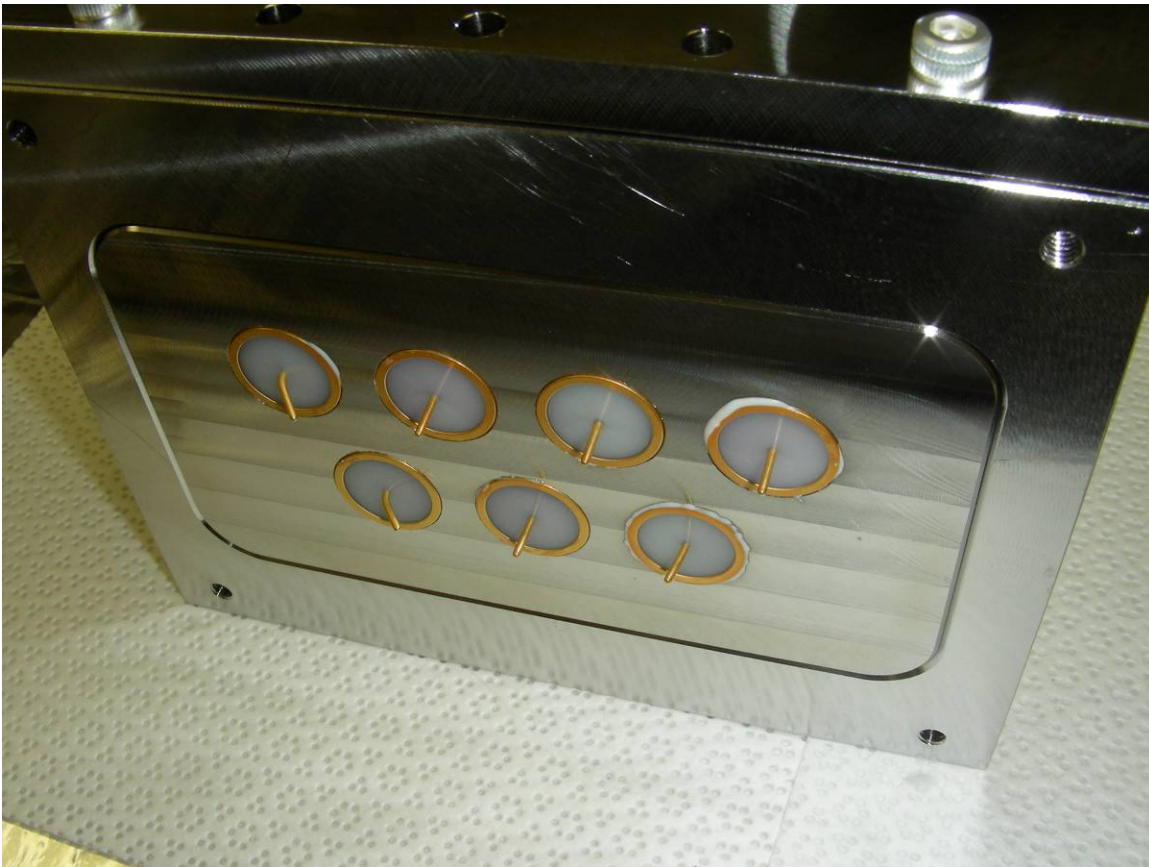
Figure 4.3. HV Feedthrough Pins. Three pins were accidentally bent when the service body was placed with this side down. Leak testing has shown that the vacuum integrity of these feedthroughs was compromised, and they will be replaced. A temporary cover is being fabricated to prevent similar damage in the future.

To proceed with leak testing, a blank plate and o-ring were used to seal the end of the cross arm inside of the main chamber. This allowed us to leak check the cross arm and service body. No response to helium was observed at any of the welds, nor at any of the o-ring seals on the service body. Leaks were observed at three of the high voltage (HV) feedthroughs. These three feedthroughs were accidentally bent when the service body was assembled (see Figure 4.3); the service body was turned onto the side containing the HV feedthroughs, bending three pins. These three pins were subsequently straightened; however, it is now apparent that the seals between the pins and ceramic insulators were compromised. These feedthroughs will be replaced. We are also fabricating a temporary cover to prevent recurrence of damaged HV feedthroughs.
