PNNL-18934

The Effects of Fire on the Function of the 200-BP-1 Engineered Surface Barrier

September 2009

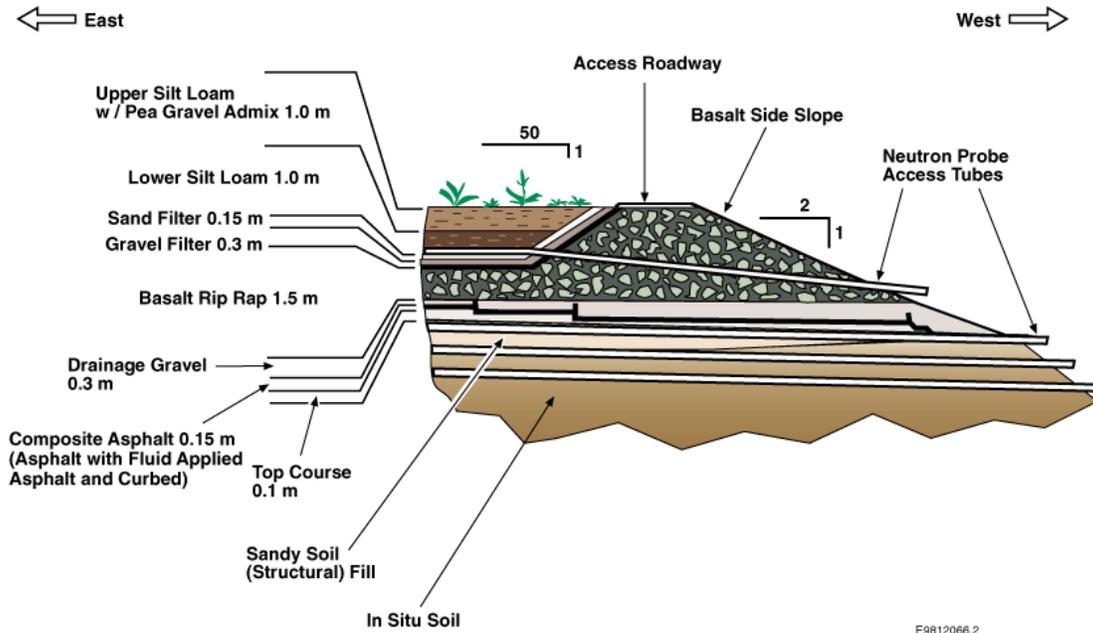
Figure 2.1. Schematic of a Vegetated, Multilayered Capillary Barrier Showing the Layer Sequence. This cross section includes the rip rap side slope on the eastern side.

The barrier is vegetated and multilayered, which is based on the capillary break concept (Figure 2.1). A layer of coarse material is placed directly below finer textured soil. The fine-soil layer acts as a medium in which moisture is stored until the processes of evaporation (E) and plant transpiration (T) can recycle any excess water back to the atmosphere. In other words, the top 2 m of silt loam functions as an evapotranspiration (ET) barrier. The fine-soil layer also provides a rooting medium to support plants that are necessary for transpiration to take place. The gravel admix comprising the surface reduces erosion due to wind and water. The coarser materials that are placed directly below the fine soil layers prevent the finer soils from filtering into the coarser materials and create a capillary break that inhibits the downward percolation of water through the barrier. The basalt riprap sequence controls bio-intrusion by discouraging burrowing animals and creating a low moisture layer to mitigate or prevent root penetration. A low-permeability asphalt layer, placed in the barrier profile below the capillary break and the bio-intrusion layers, diverts any water that passes the capillary break away from the waste zone and limits the upward movement of noxious gases from the waste zone. Figure 2.2 shows a south-facing aerial view of the barrier in September 2008, before the controlled burn.

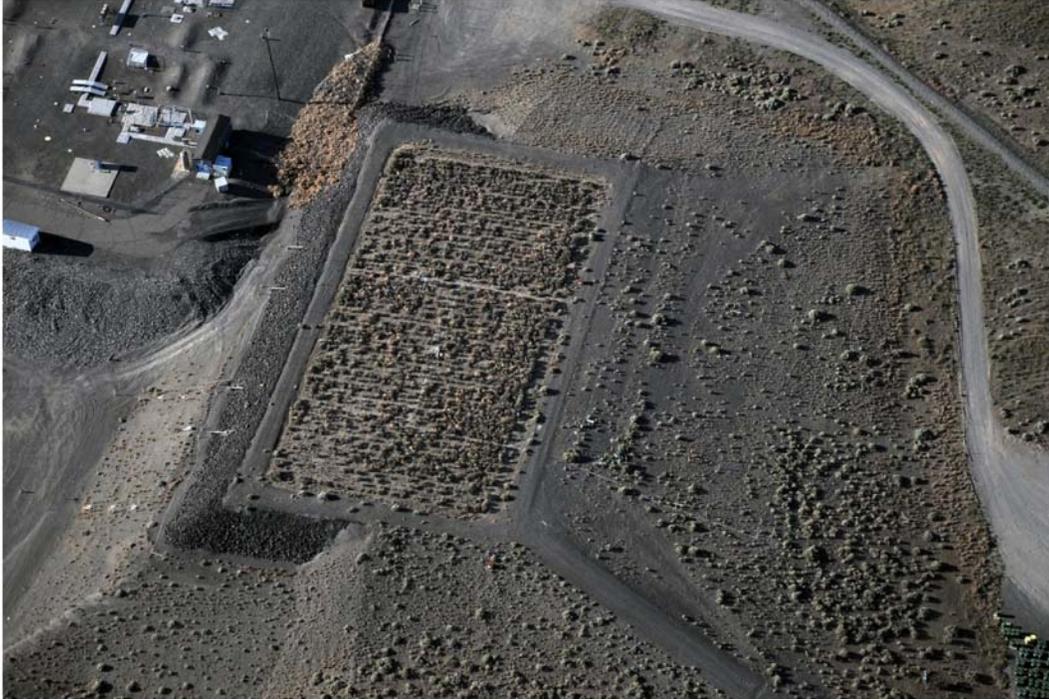
Figure 2.2. South Facing Aerial View of the Barrier Showing Distribution of Plants on the Surface and Side Slopes Photographed on September 20, 2008.

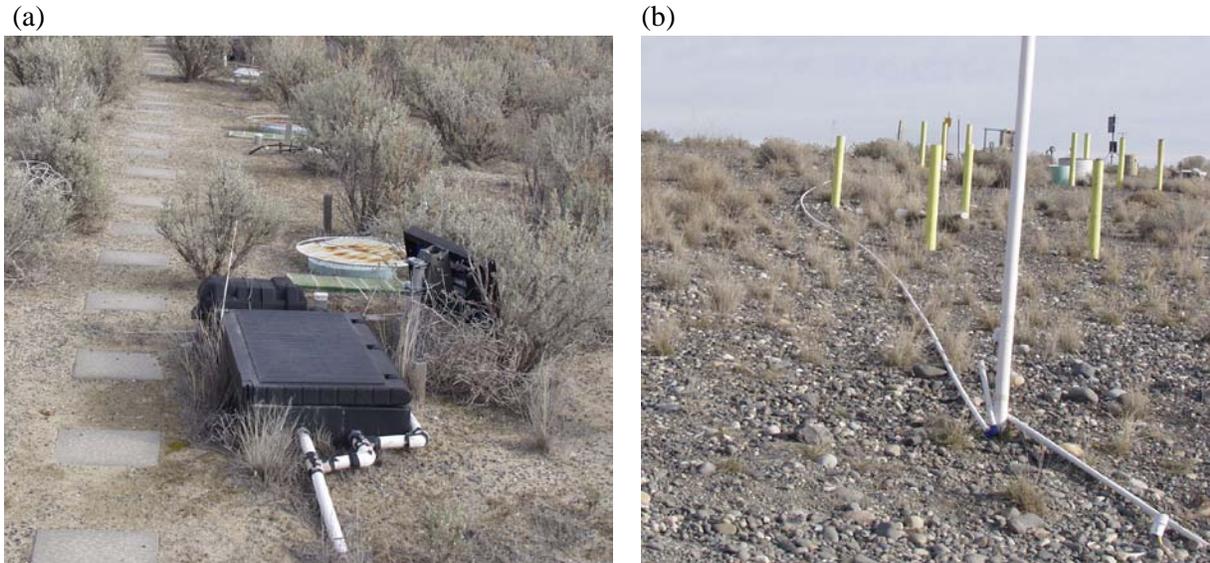
Figure 2.3. Photographs of the Barrier Surface and Gravel Side Slope Showing Examples of Monitoring Infrastructure on the Surface that needed Protection during the Simulated Fire:
(a) instrument boxes containing dataloggers and (b) conduits carrying communication cables for instruments.

Although one of the original objectives of the testing program at the prototype barrier was to investigate monitoring technologies and establish a cost basis for long-term monitoring, not much consideration was given to fire protection during the installation of instruments. Thus, preparing for the simulated fire included preparing the monitoring installations for the anticipated temperature increases. Instruments from the monitoring stations are connected to data loggers housed in two large polyethylene boxes, as shown in Figure 2.3a. A site walk down with the fire crew before the test also identified a number of cables on the surface in polyvinyl chloride (PVC) conduit (Figure 2.3b). During installation, none of the instrument boxes housing electronics were mounted flush with the surface. This was intentional to prevent water or snowmelt from running into the boxes and damaging the instruments. Consequently, most of the cables and conduits used for the cables on the barrier surface and side slopes were exposed near the entry point to the boxes.

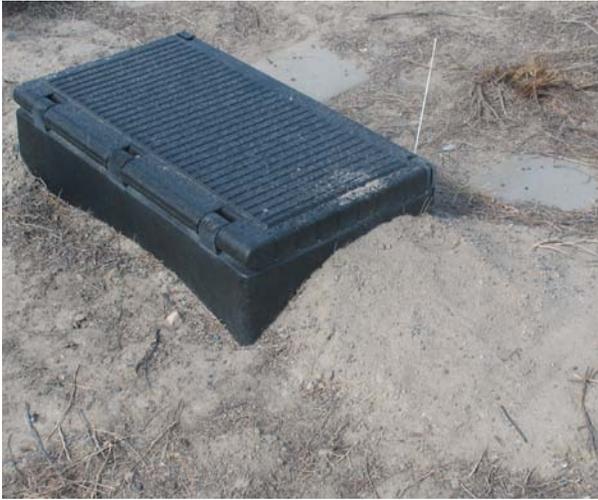
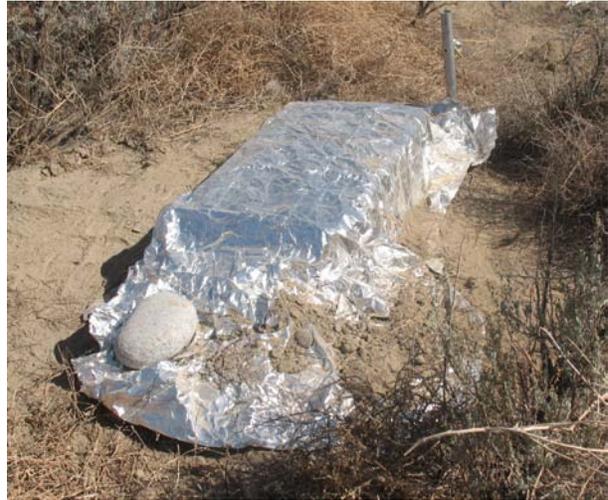
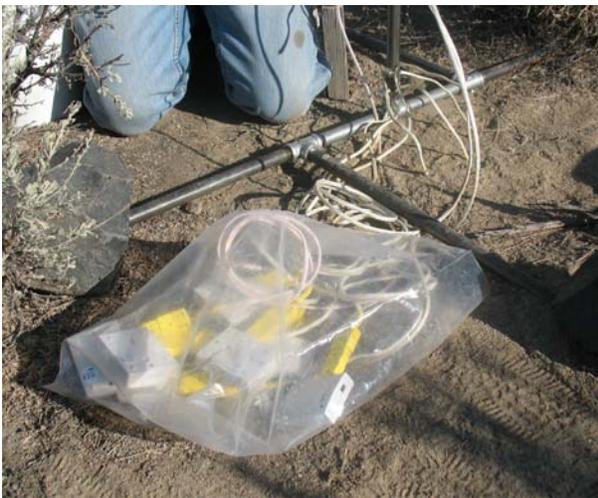
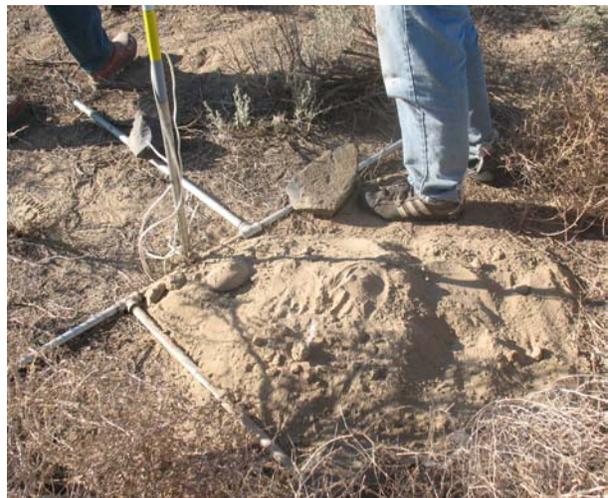
Figure 2.4. Preparation of the Barrier for the Controlled Burn: (a) entry points of conduit into instrument boxes covered with soil, (b) instrument box covered with fire shelter, (c) HOBO data loggers for temperature monitoring in waterproof bag before covering with soil and fire shelter, and (d) soil mound covering the HOBO dataloggers prior to being covered with a fire shelter.

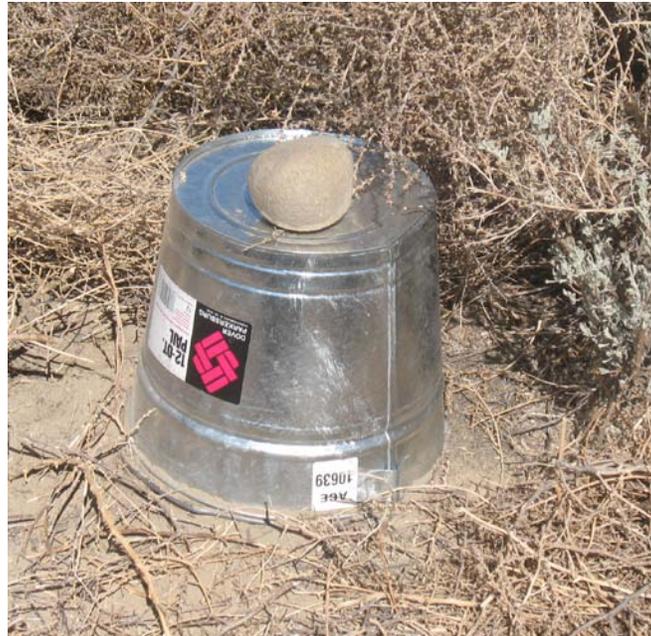
Figure 2.5. Inverted Galvanized Pail Used to Cover Mini-rhizotron Tubes. Tubes were first wrapped in fiberglass insulation.

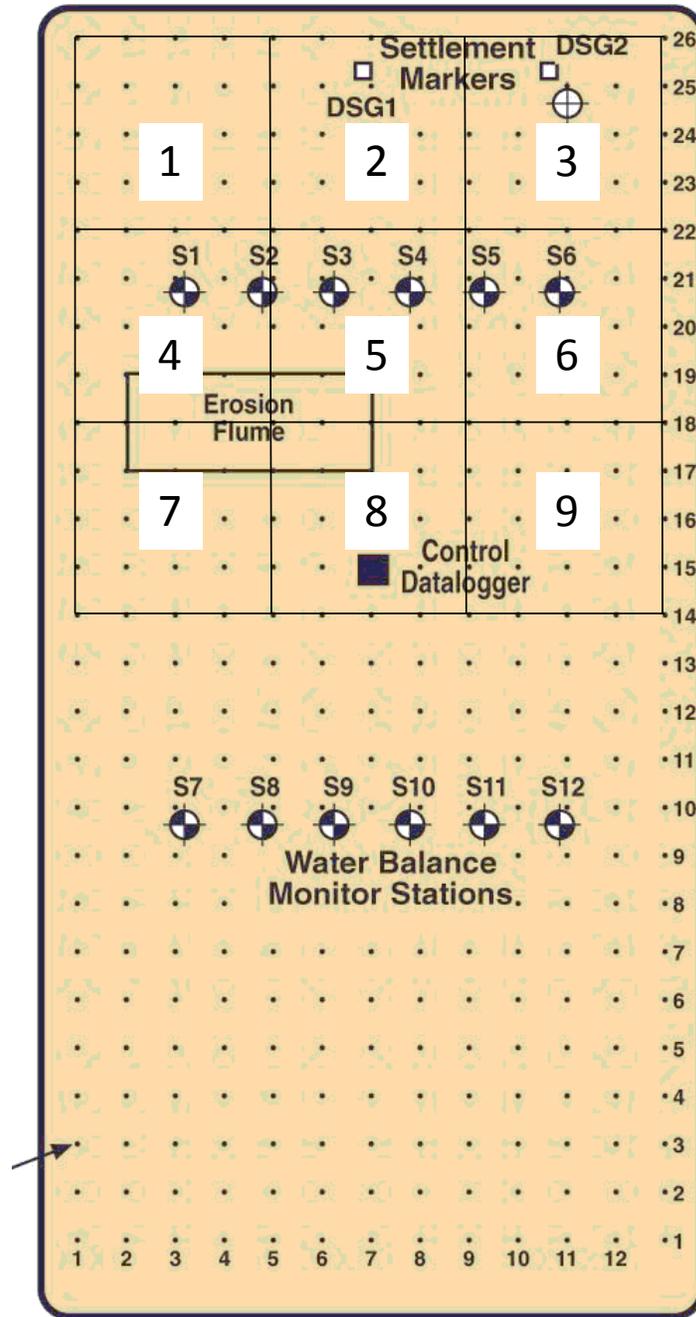
Figure 2.6. Schematic Plan View of the Barrier's Surface Showing Monitoring Stations, the Runoff Plot, the 3 × 3 M Grid, and the Nine (1 through 9) 12 × 12 m Plots to be Used for Comparing Effects of Fuel Loads on Fire Intensity

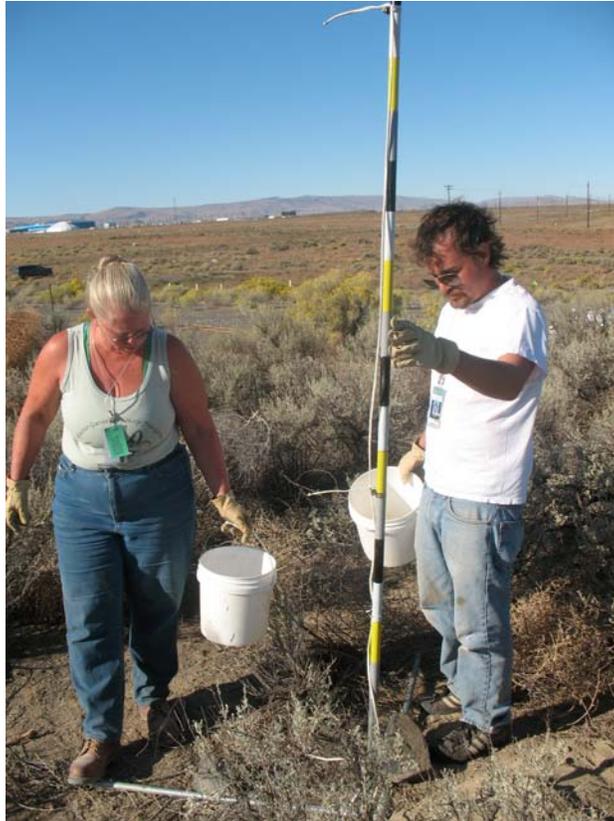
Figure 2.7. Photograph of Fire Pole Used to Measure Flame Characteristics and to Secure Thermocouples

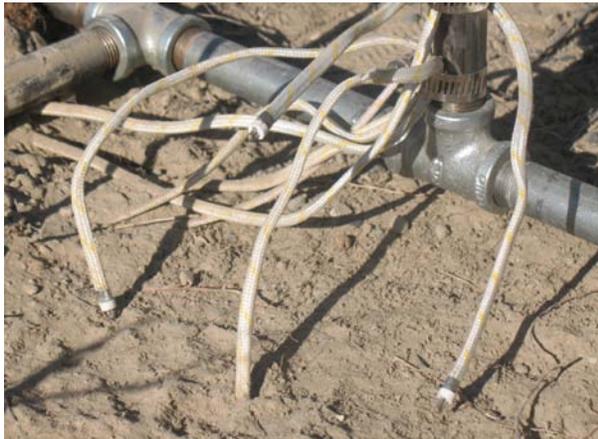
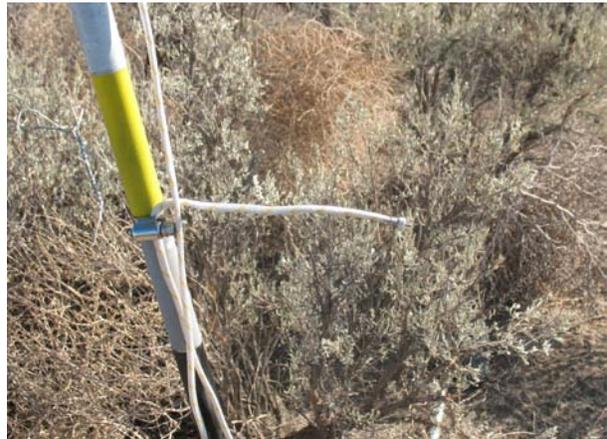
Figure 2.8. Thermocouples for Measuring Soil and Air Temperature Installed on Flame Height Scaffold: (a) Thermocouples Were Installed 1.5 cm Deep, at the Surface (0 cm), 1 cm, 10 cm, and 30 cm, and (b) Above-Ground Thermistors Were Installed at 100 cm, and 200 cm.

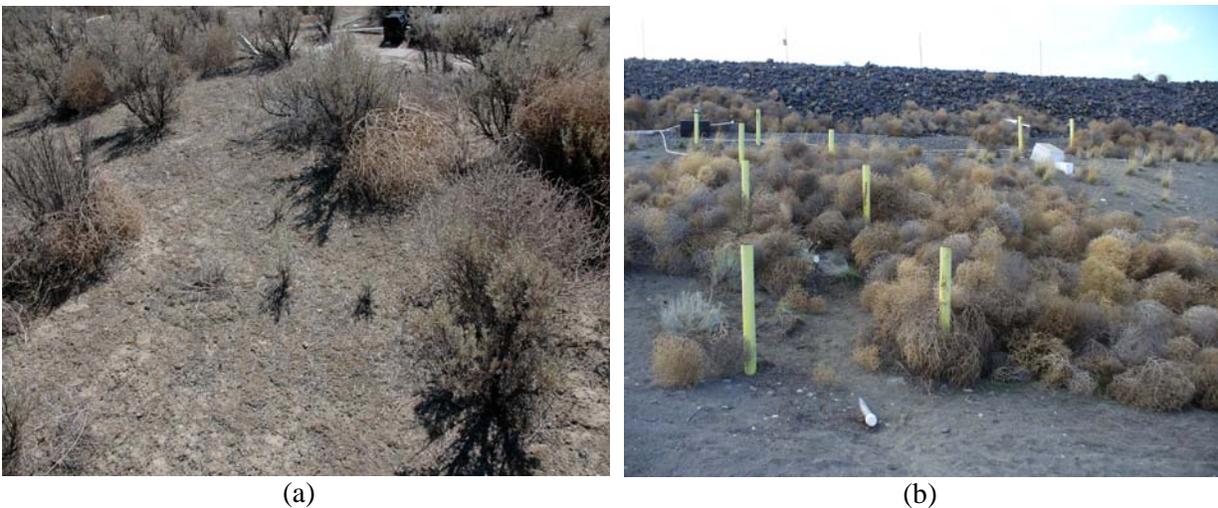
Figure 2.9. Photographs of the Barrier's Surface: (a) Sparse vegetation on the surface suggesting need for increased fuel load to emulate realistic conditions. Some *Salsola kali* (tumbleweed) was already logged among sagebrush plants, and (b) the rip rap side slope of the barrier shows an accumulation of tumbleweed. Dead sagebrush and tumbleweed were imported to the barrier surface to increase the fuel load.

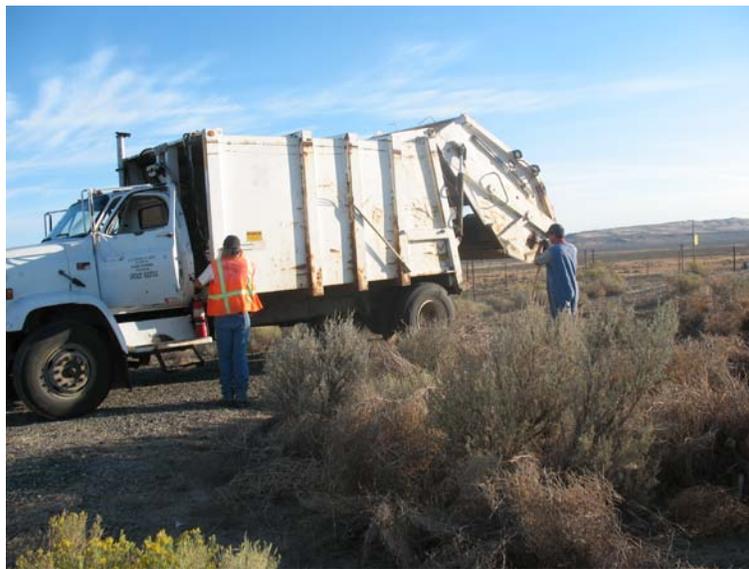
Figure 2.10. Unloading of Tumbleweed Brought to the Barrier to Increase Fuel Load. Over 2 tonnes of tumbleweed were added to the surface.

Over 2 tonnes of clean tumble weeds were brought to the barrier from around the 200 East area. Tumbleweeds were dumped onto the gravel road to the north of the barrier and distributed from there. Subsamples of the imported fuel were weighed and dried to determine the moisture content. The dry tumbleweeds were spread across the surface of the barrier by hand (Figure 2.11) to achieve the randomly assigned fuel loads. Two fuel loads of approximately 10.5 and 12.8 tonnes/ha were assigned to the nine 12×12 m plots.

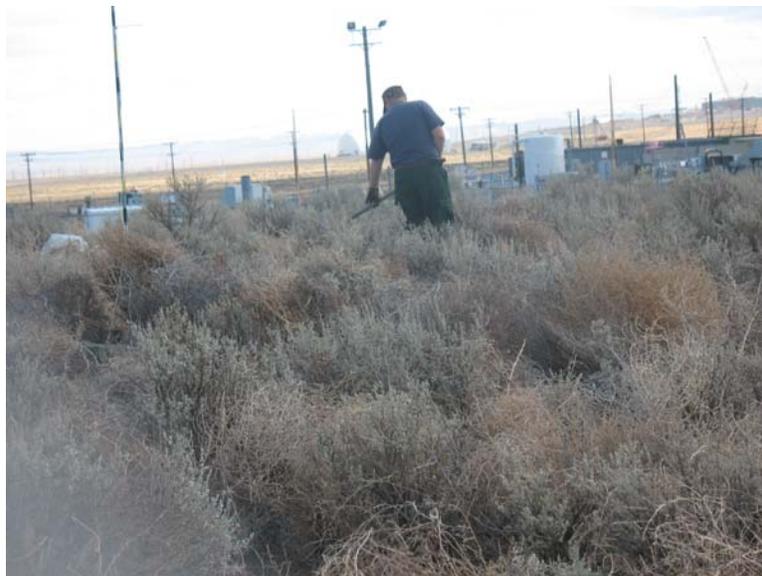
Figure 2.11. Redistribution of Imported Tumbleweed Across the Barrier to Achieve Different Fuel Loads for the Controlled Burn. In this photograph, Captain Jerry Keeline of the Hanford Fire Patrol is shown redistributing tumbleweed with a rake.

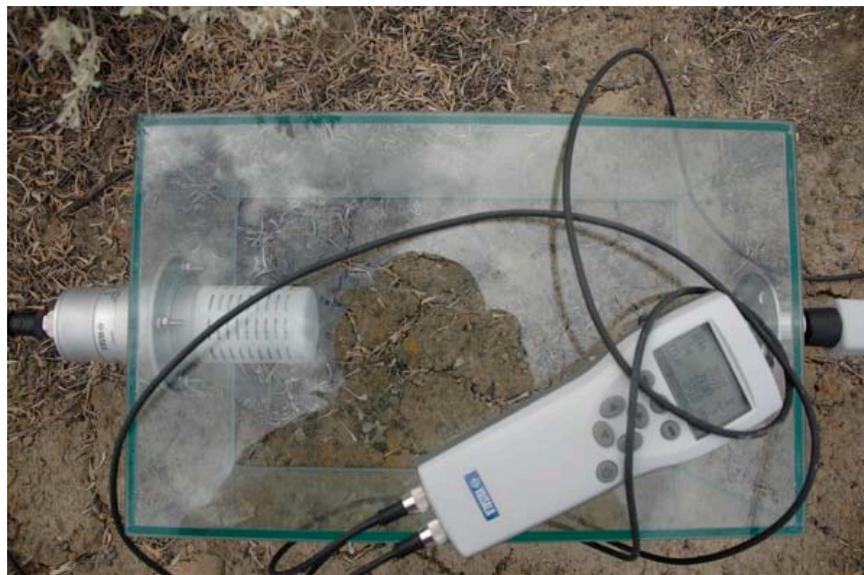
Figure 2.12. Static Diffusion Chamber with Sensors and Readout Device

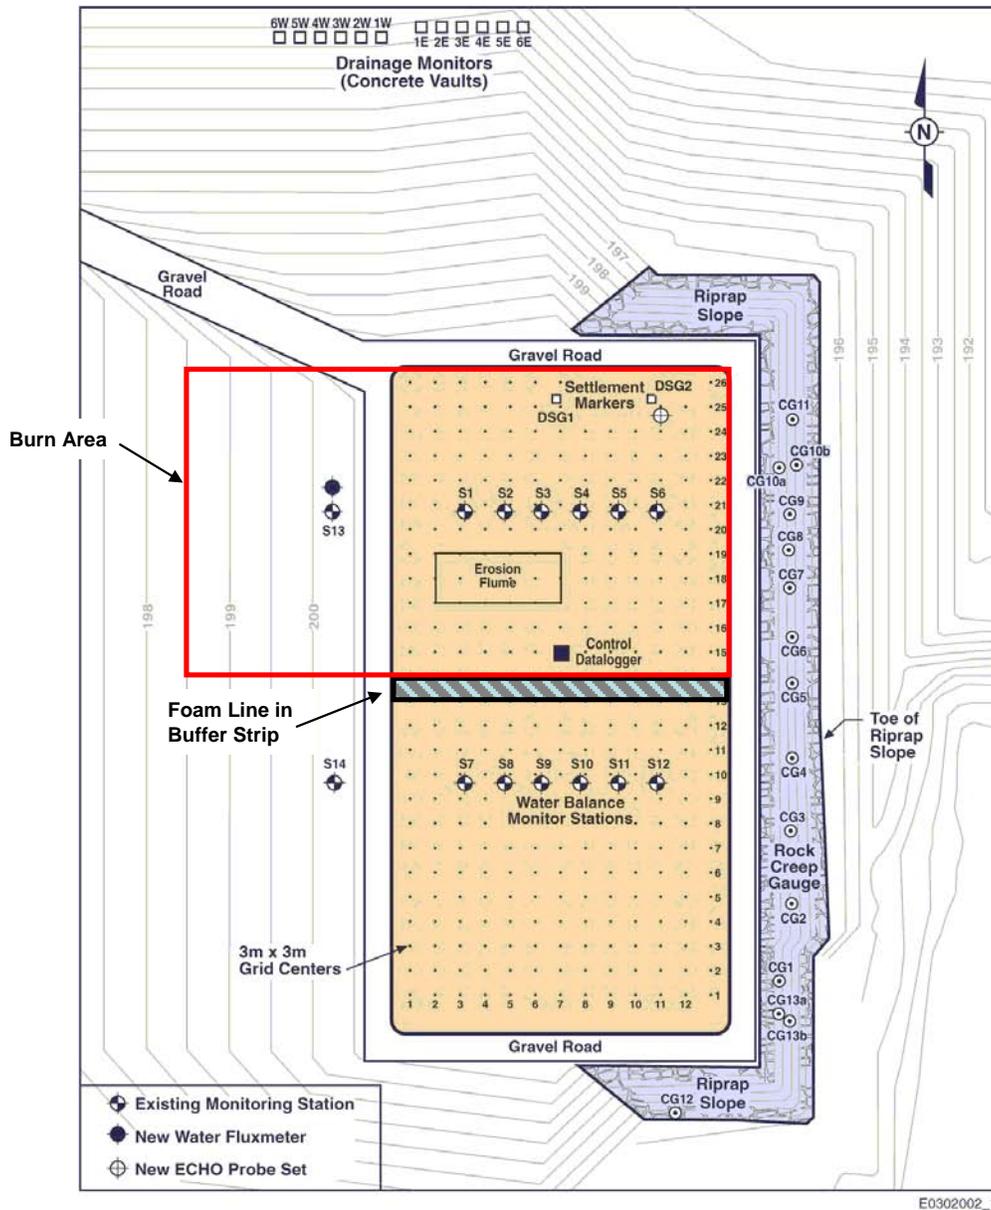
Figure 2.13. Plan View of the Barrier's Surface Showing Proposed Burn Area on the Gravel Side Slope and Silt-Loam Surface

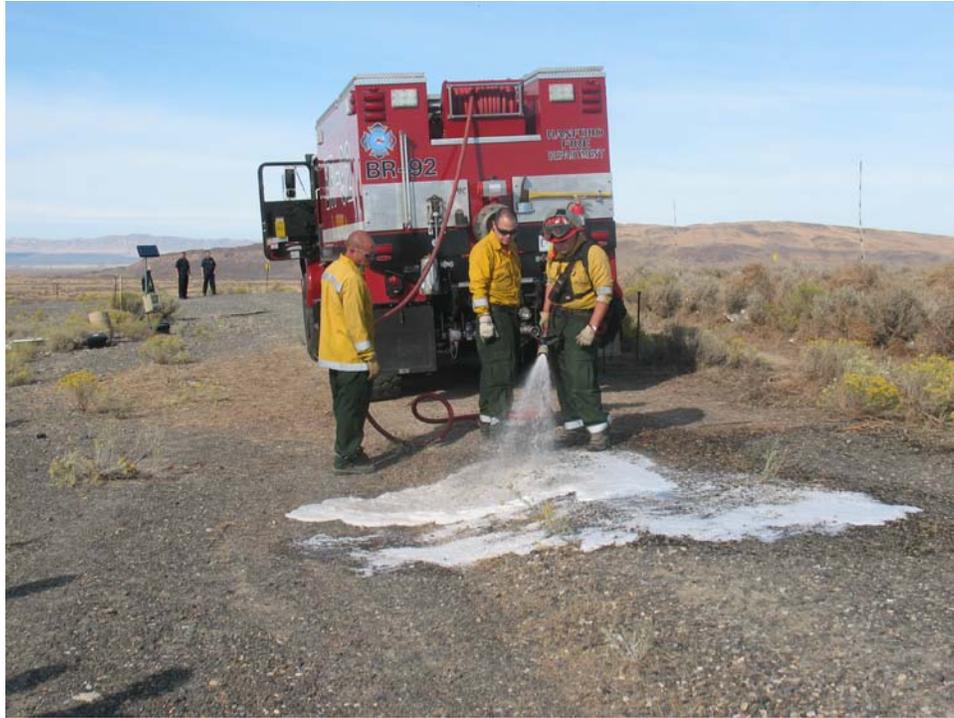
Figure 2.14. Hanford Fire Department Bush Rig Crew Making Adjustments to the Fire Retardant Foam Quality Before the Burn

Prescribed burns are typically conducted under controlled settings to prevent escape, using fuel breaks and ignition patterns as control measures. A controlled burn was used to quantify the effects of the fire on barrier performance. The burn was initiated and managed by the Hanford Fire Department (HFD). The north section of the barrier was divided into nine 12-m × 12-m plots, and each plot was randomly assigned one of two fuel load treatments for the test. The fire was initiated and managed by the Hanford Fire Department in accordance with the HFD 2008 Annual Prescribed Fire Proposal (Ward et al. 2008). The controlled burn was conducted on the north half of the barrier, including the silt loam cover and the gravel side slope (Figure 2.13). Before starting the fire, a 3-m-wide line of fire retardant foam was applied to the buffer strip between the north and south sections of the barrier to protect the south portion of the barrier during the burn (Figure 2.14 and Figure 2.15).

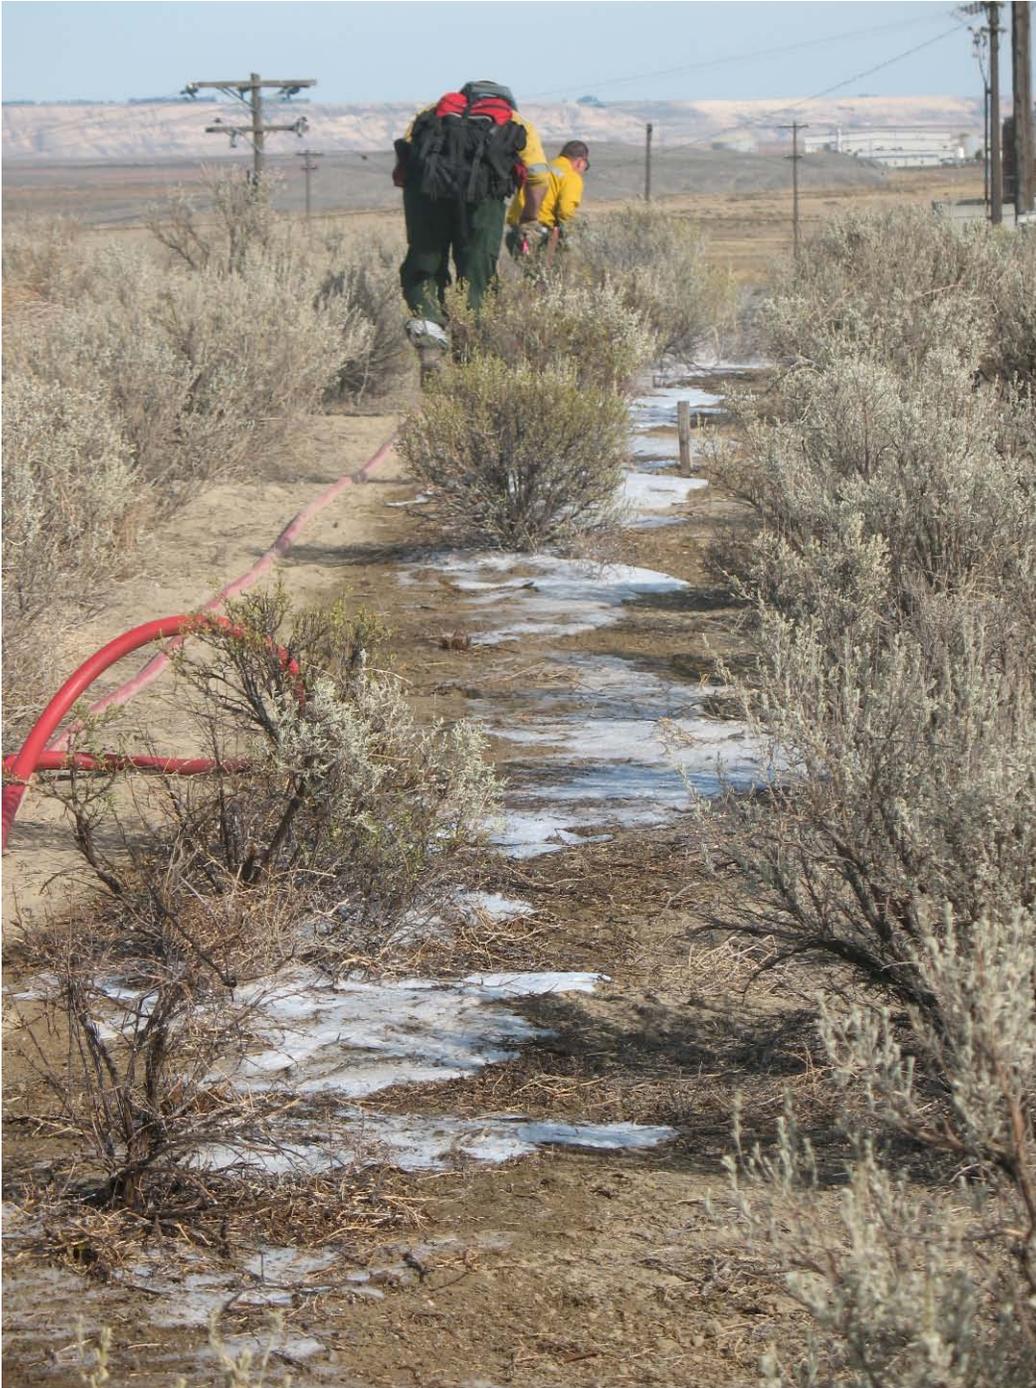
Figure 2.15. The 3-m-Wide Line of Fire Retardant Foam Applied to the Buffer Strip Between the North and South Sections of the Barrier

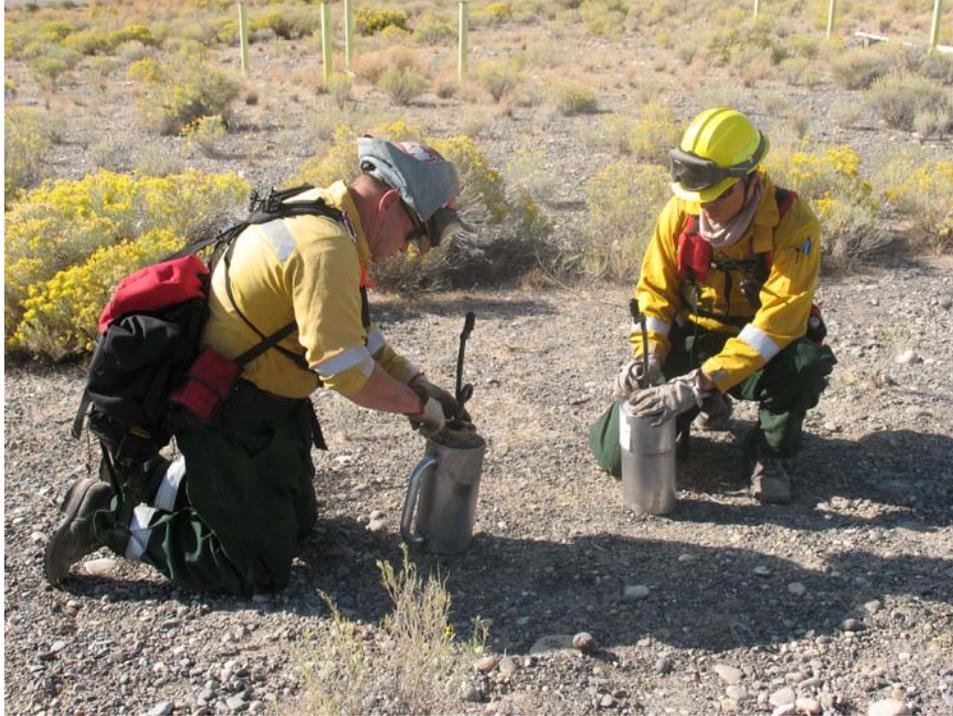
Figure 2.16. Personnel of the Hanford Fire Department Preparing Drip Torches Before Igniting the Test Plots

The ground-fire crew used drip torches (Figure 2.16) to ignite the fire, starting at the center of the southern portion of the northern half of the barrier and working east and west along the southern portion and north, allowing the flames to carry eastward. The three members of the fire ground-crew maintained constant radio contact with the fire rigs. The fire was documented from ignition through completion using a variety of methods, including still photographs and a digital video. A video camera was mounted on top of one of the bush rigs such that the entire burn area could be viewed. During the fire, the flame height was determined using decimeter-scale flame height rods (black and white metal rods) installed outside at the edge of plots. This was accomplished by peering through the flames to the flame height rods and recording the elevation of the flame. After the main fire, plots with incomplete combustion were burned off using a drip torch. All areas were monitored until the threat of spotting had ceased. The surface was also examined to identify any mosaic patterns that are indicative of variable fire severity. The flame speed was determined by measuring the time to travel from the ignition line to the thermocouples, which were located about 3 m from the edge of the plot.

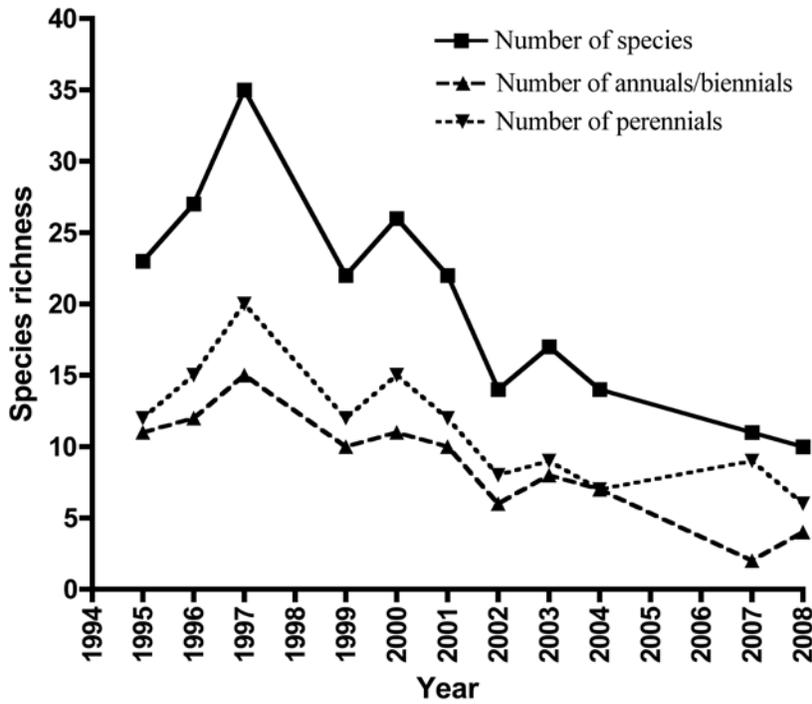
Figure 3.1. Species Richness on the Entire Barrier Surface Since 1995

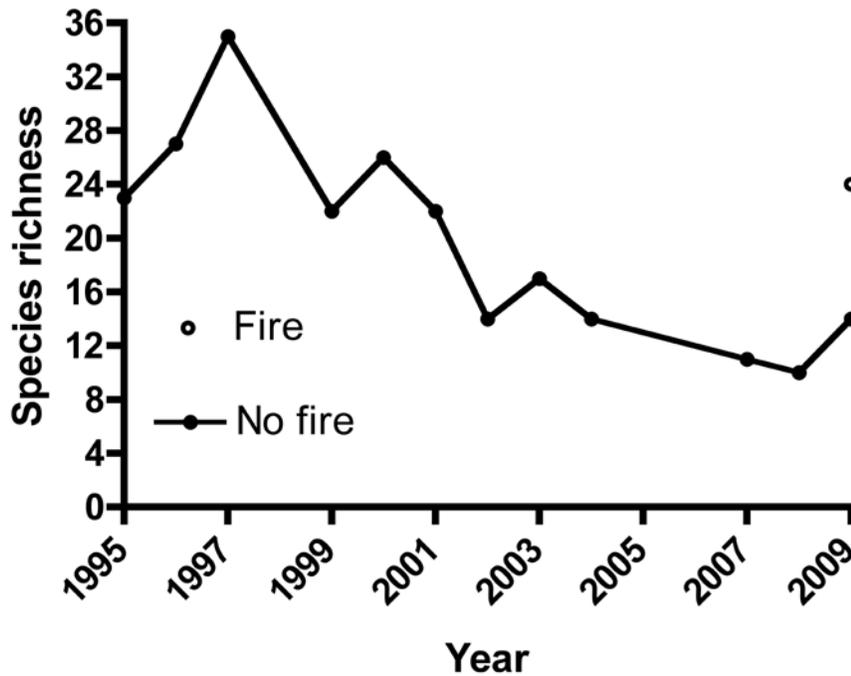
Figure 3.2. Temporal Variation in the Number of Species on the Prototype Hanford Barrier from Inception Through September 2009, 1 Year After the Fire

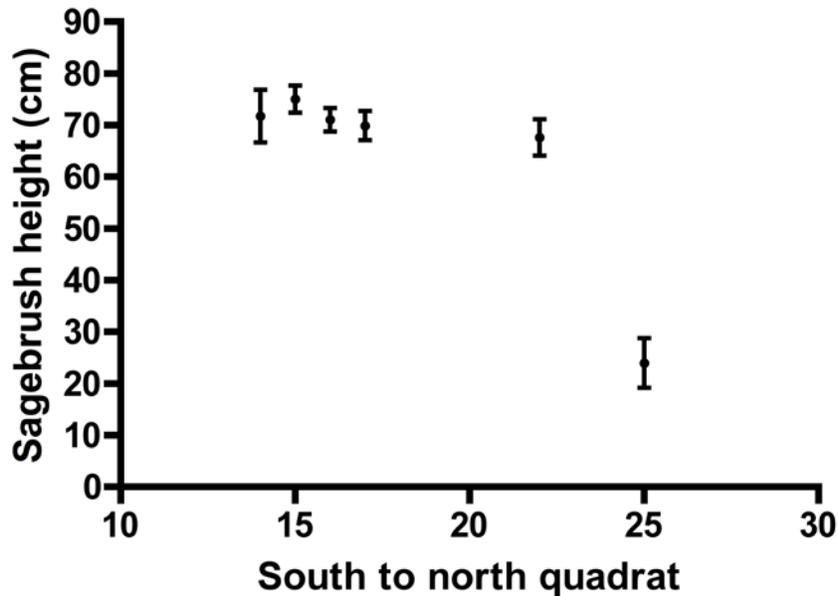
Figure 3.3. Mean Height of Sagebrush Plants in Quadrats from the South Side of the Burn Area to the North Side

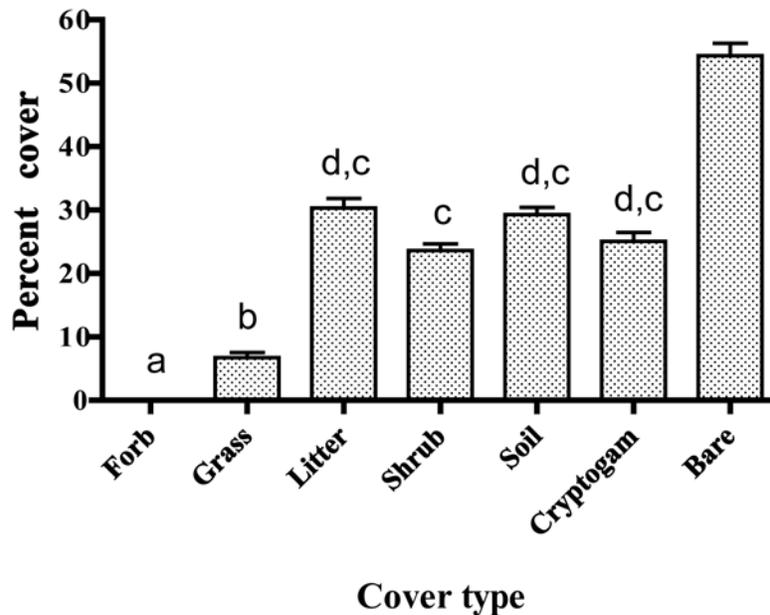
Figure 3.4. Mean Cover on Formerly Irrigated (North) Half of the Barrier Before the Fire. Error bars of one standard error of the mean (n=144). Different letters indicate significant differences.

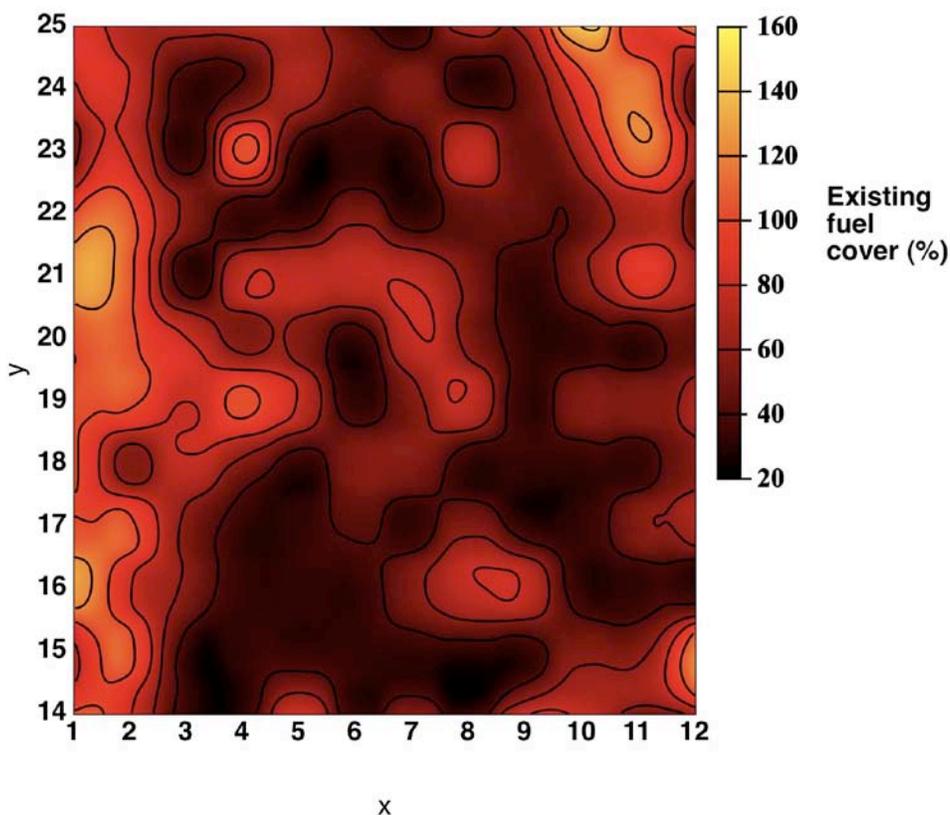
Figure 3.5. Cover of Existing Fuel Before Adding Imported *Salsola Kali* to the Barrier Surface

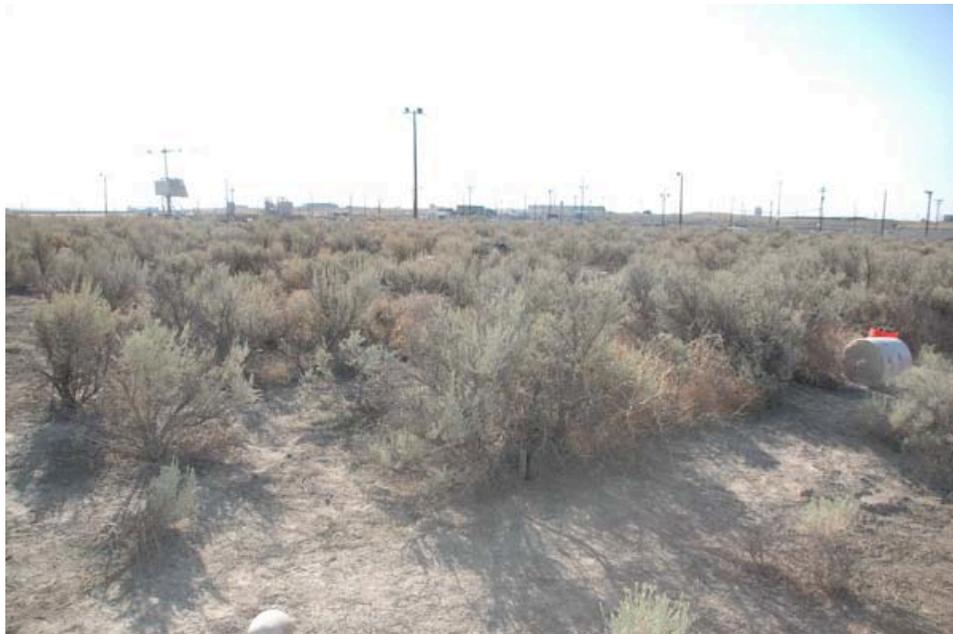
Figure 3.6. Unburned Section of Barrier Dominated by *Artemisia tridentata* in 2009, 15 Years After Establishment

Figure 3.6 shows a photograph of the southern unburned section of the barrier in 2009, 15 years after establishment of the vegetative cover. As is evident from the photograph, the ground cover is dominated by shrubs with *Artemisia tridentata* accounting for 30% of the cover and grass accounting for 2%. Figure 3.7 shows a photograph of the vegetative cover on the north burned section 11 months after the controlled burn. The vegetative cover at this stage is dominated by forbs (24.7%) and grasses (4%) with *Salsola kali* accounting for 19.5% of the total cover. The vegetative cover of the unburned mature community at the McGee Ranch analog site is depicted in Figure 3.8. At this site, the ground cover is mostly by shrubs (22%), with *Artemisia tridentata* being dominant, and grass (23%) with *Poa secunda* accounting for 15.4%. The old burned plant community at the McGee Ranch site is depicted in Figure 3.9. This analog site is mostly grasses (58.9%) with *Poa secunda* accounting for some 18% whereas *Bromus Tectorum* accounts for 39.4%.

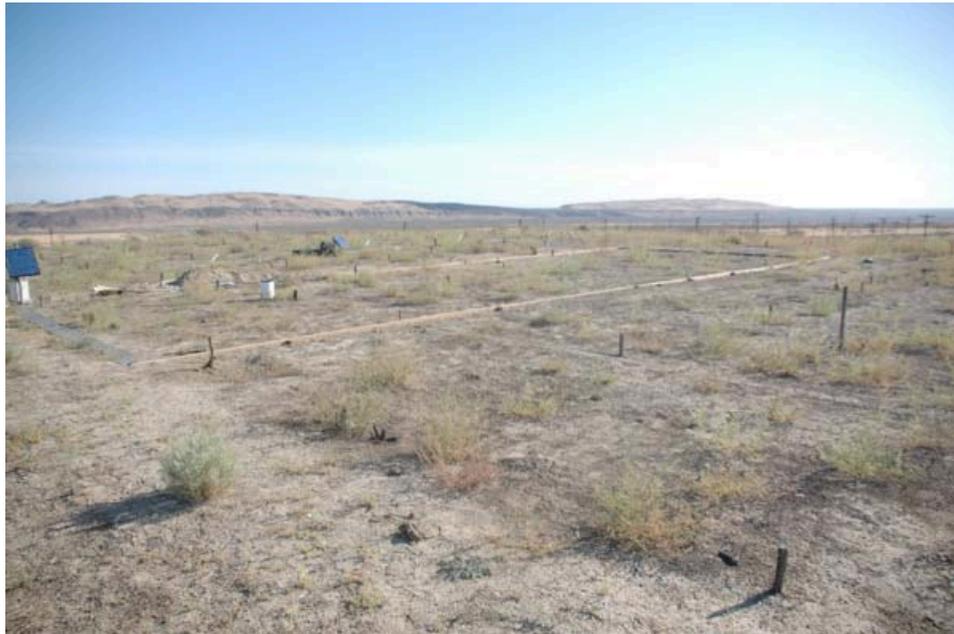
Figure 3.7. Vegetative Cover on the Burned Half of the Barrier Surface 11 Months After the Fire. Most of the Green Vegetation is *Salsola kali*.

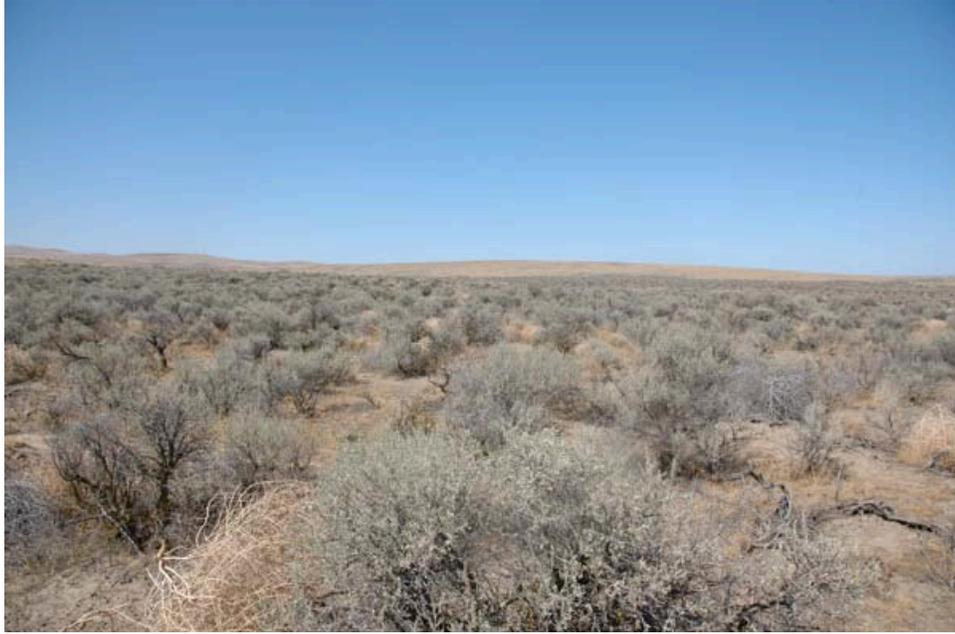
Figure 3.8. Unburned Mature Plant Community at the McGee Ranch Site

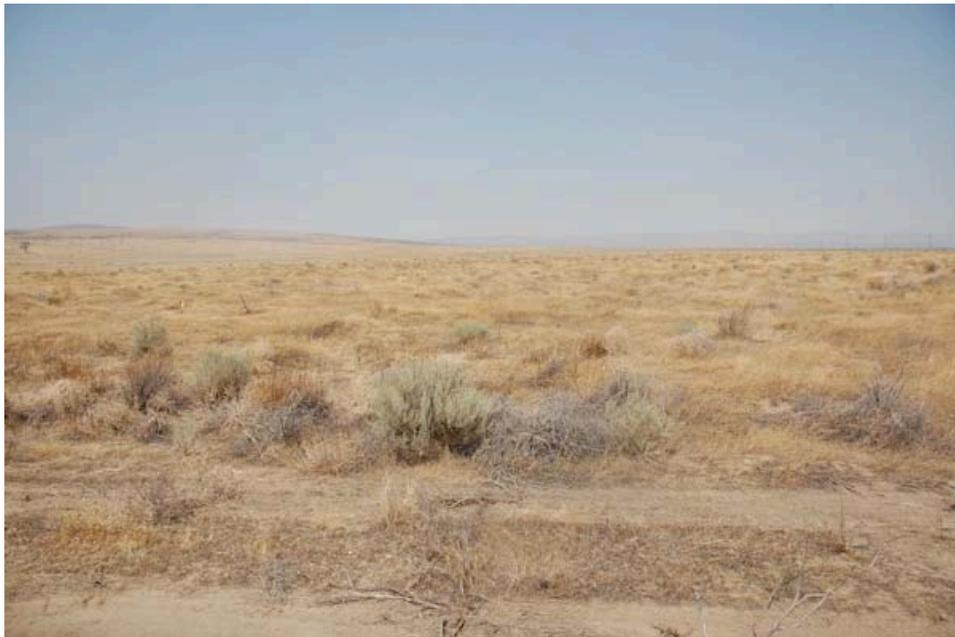
Figure 3.9. Old Burned Plant Community at the McGee Ranch Site

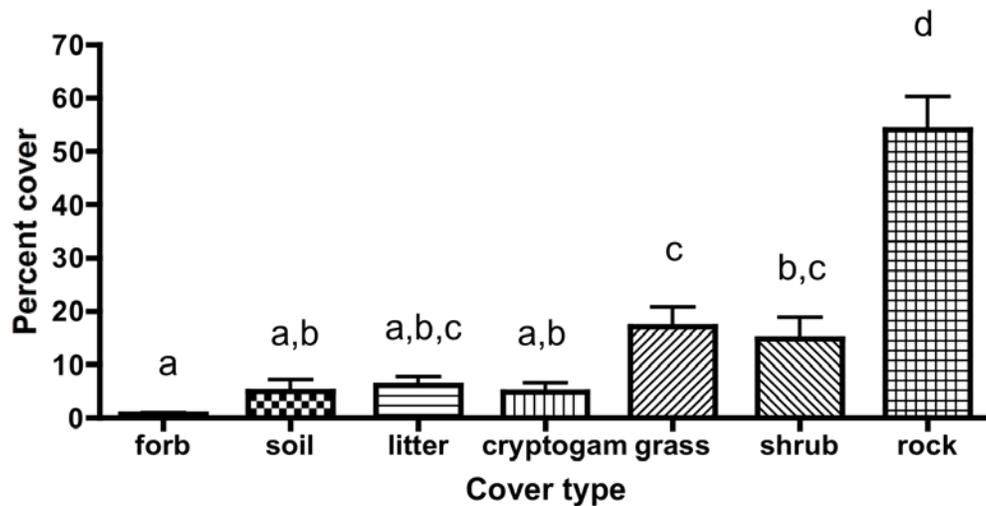
Figure 3.10. Mean Cover on the North and West Side Slopes of the Barrier. Error bars of one standard error of the mean ($n = 24$). Different letters indicate significant differences.

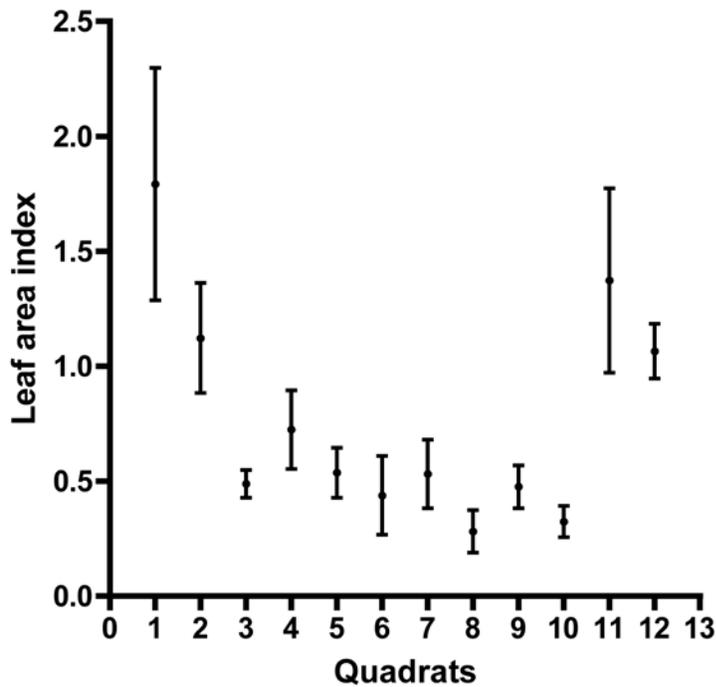
Figure 3.11. Pre-Burn LAI Across the Barrier Surface

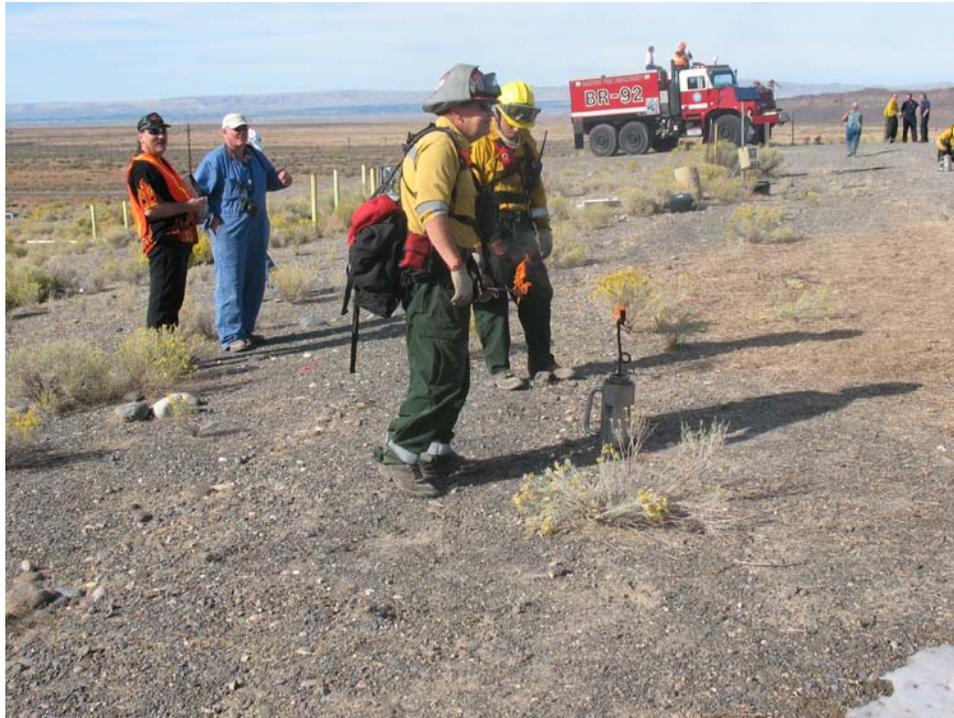
Figure 3.13. Ground Fire Crew from the Hanford Fire Department Preparing to Ignite Test Plots

Weather conditions on the day of the burn were sunny with a mean temperature of 24°C (75°F) and a slight wind from the south to the north. A liquid foam line was applied before the fire was initiated to separate the area to be burned (north half) from the south half. Figure 3.13 shows the ground fire crew for HFD preparing to ignite the test plots.
