PNNL-18934

The Effects of Fire on the Function of the 200-BP-1 Engineered Surface Barrier

September 2009

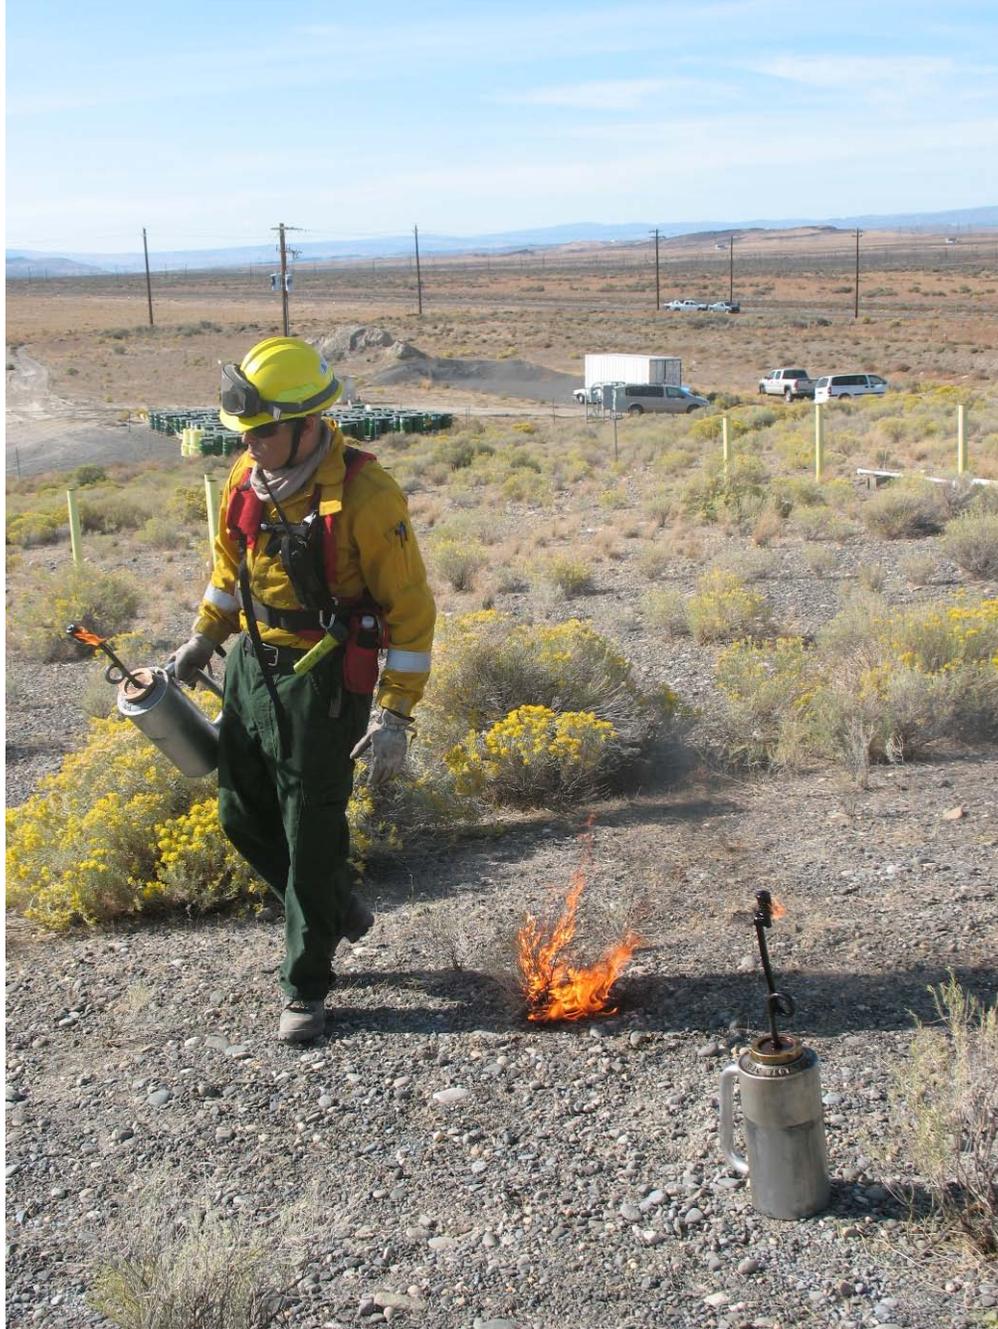
Figure 3.14. Ignition of the Test Plots by the Crew from the Hanford Fire Department. The Fire was Ignited at 3:15 PM September 26, 2008.

The fire was ignited at 3:15 PM by three ground fire crew members (Figure 3.14). The fire on top of the barrier was fast moving with flames reaching as high as 9 m (30 ft). Flame heights exceeded the 6-m (20-ft) flame-height rods but were estimated using video records with nearby infrastructure being used as a scale. Not all of the vegetation near the edges of the barrier was initially consumed. The fire ground-crew revisited unburned areas and ignited unburnt or partially burnt plants with drip torches. The lower burn efficiency around the edges of the barrier may be related to the size and moisture content of the biomass. Plants around the edges of the barrier were typically bigger, perhaps because of a larger amount of available moisture that accumulates at the capillary break near the edge. Figure 3.15 through Figure 3.17 show different stages of the fire.

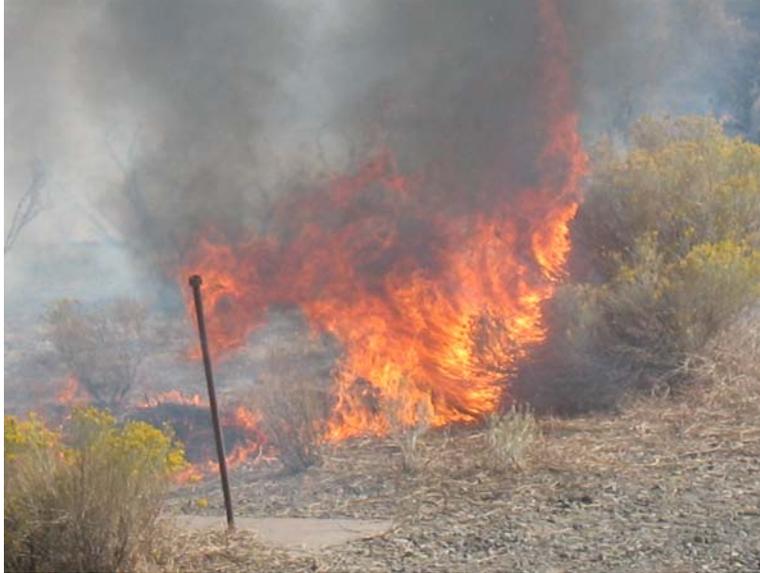
Figure 3.15. Rabbit Brush Near Edge of Barrier Engulfed in Flames Shortly After Ignition

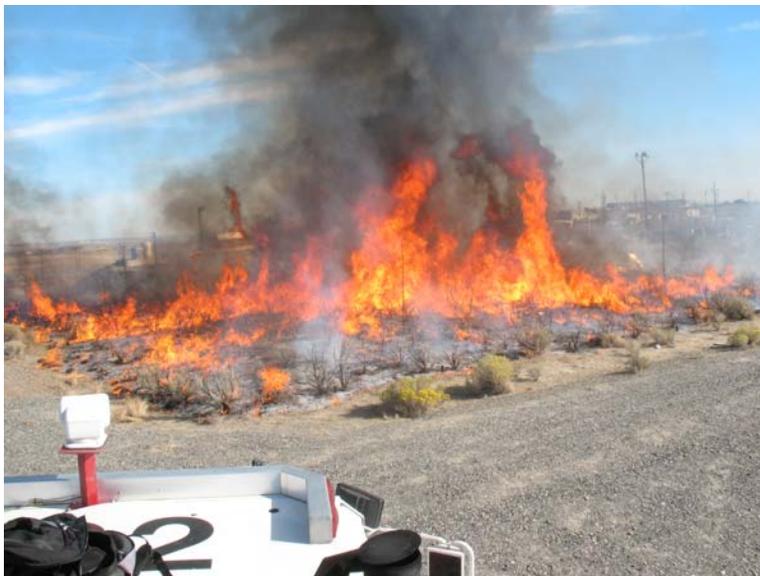
Figure 3.16. A View of the Fire from Southwestern Edge of the Plot About 4 Minutes after Ignition. The Photograph was taken from atop of the HFD Bush Rig.

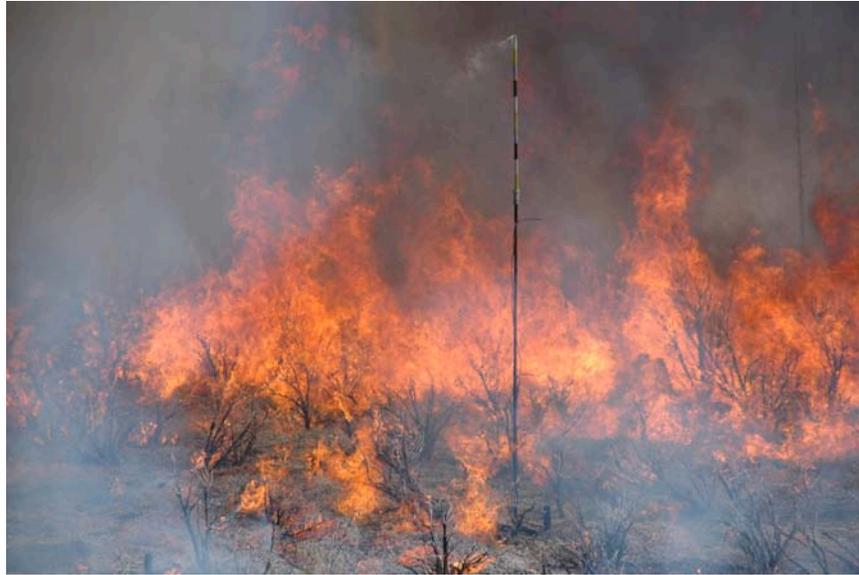
Figure 3.17. Painted Fire Pole in Foreground Showing a Thermocouple Mounted Perpendicular to the Pole at a Height of 2 m

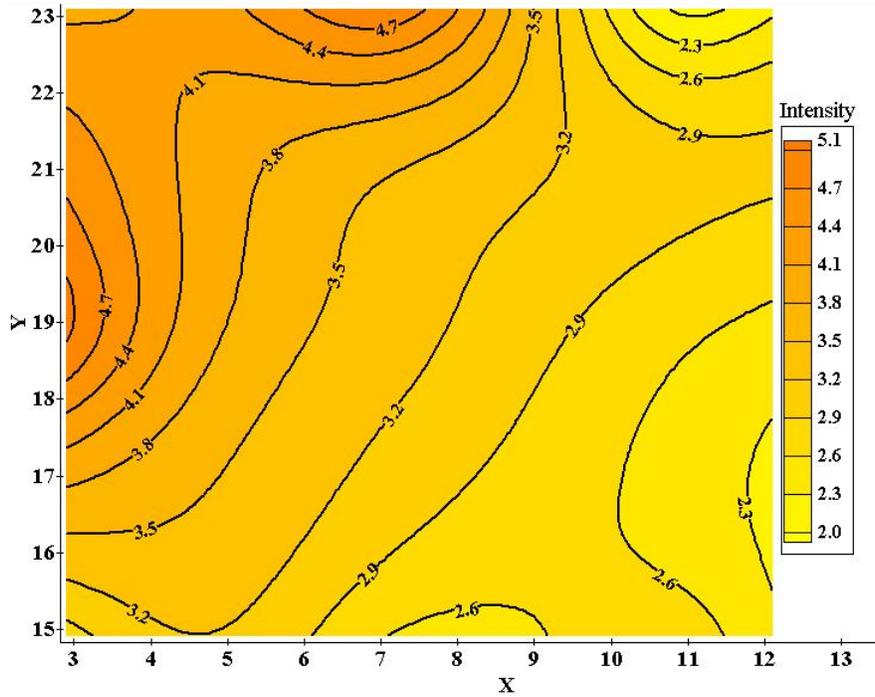
Figure 3.18. Fire or Scorch Intensity Mapped Across the Burned Area. The X and Y edges denote positions on the surface. The distance between coordinate values is 3 meters.

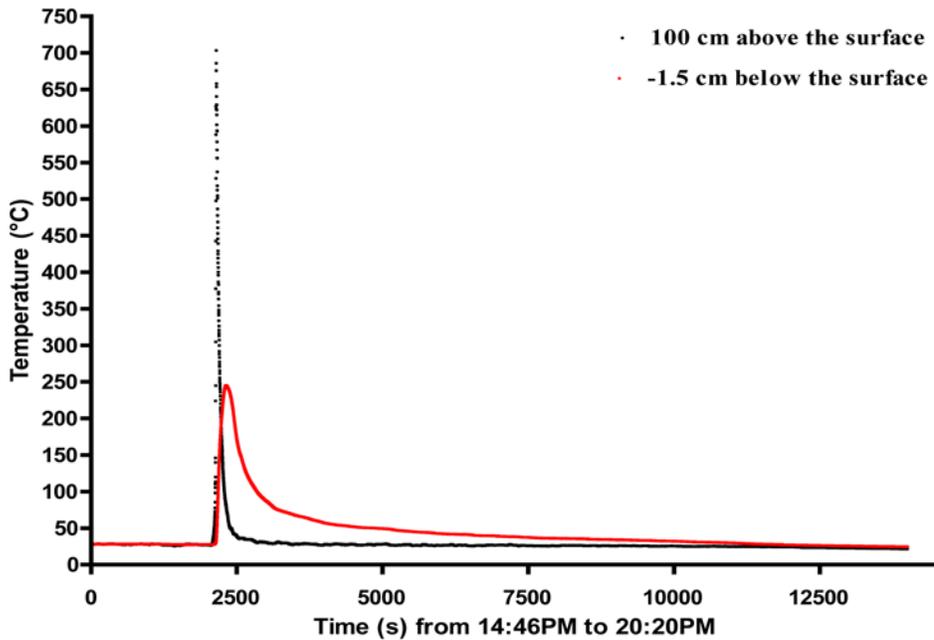
Figure 3.19. Temperature in the Air and Soil Before, During, and After the Fire

After the peak temperature was attained, the air temperature also fell off much more rapidly than the soil temperature. The effect of the fire on soil temperature persisted for about 2 hours (Figure 3.19).

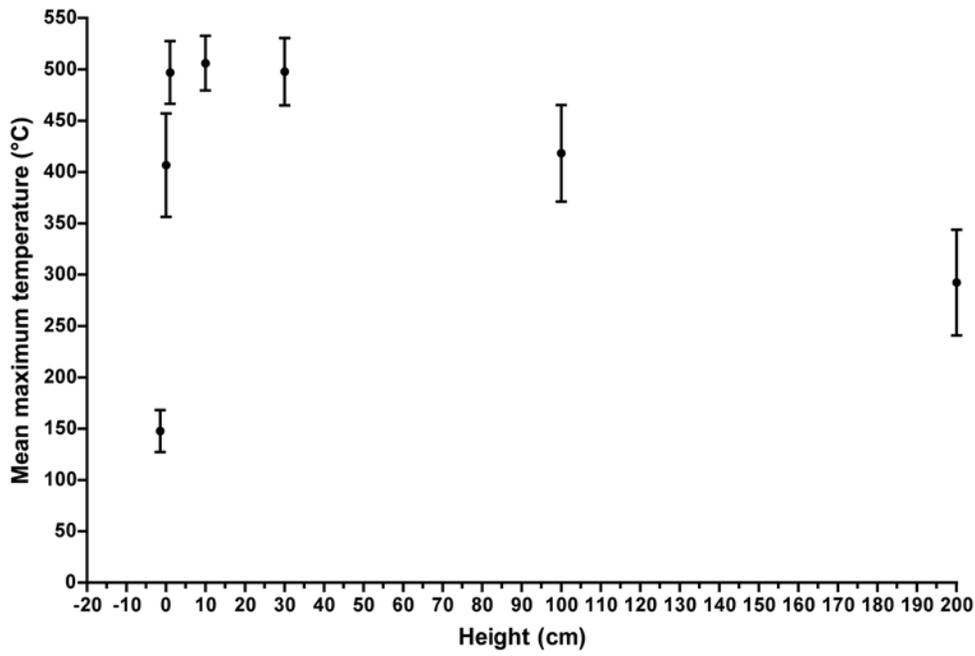
Figure 3.20. Relationship Between Mean Maximum Temperature and Height from about 1.5 cm Below Ground to 200 cm Above the Ground. Error bars are one standard error of the mean.

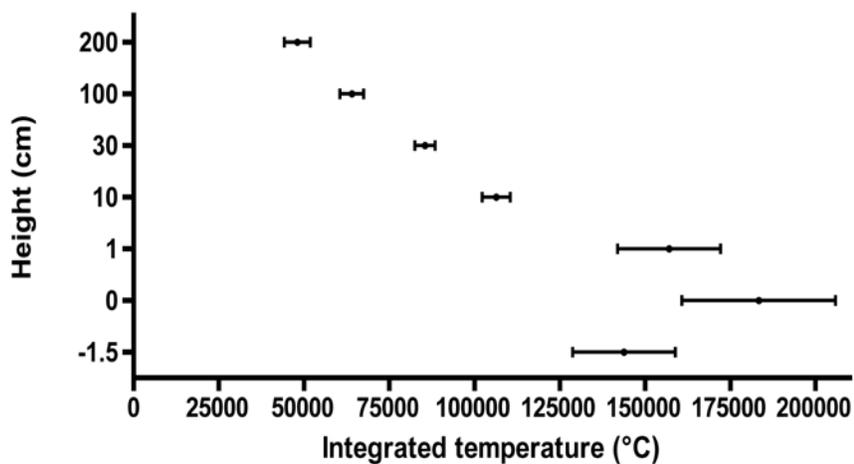
Figure 3.21. Duration of Elevated Temperature. Bars are one standard error of the mean.

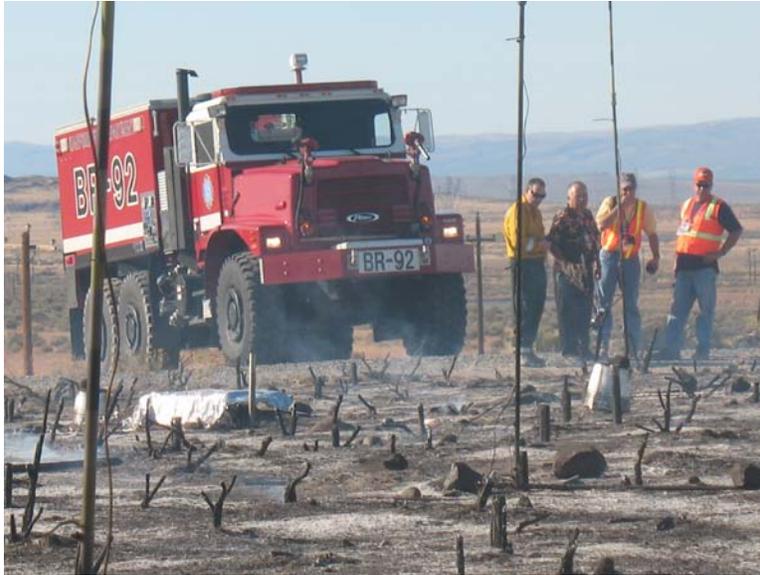
Figure 3.23. Surface of the Barrier at the End of the Fire. The fire lasted about 7 minutes.

The fire lasted approximately 7 minutes by which time all of the imported fuel and most of the natural biomass had been consumed (Figure 3.23). A post-fire site inspection found all instrumentation to be in working order with no evidence of fire damage except for a small amount of singeing on the PVC jackets of the mini-rhizotrons. A thick, white crust of ash had formed across most of the site with large accumulations where larger shrubs were resident (Figure 3.24). Following completion of the fire on the surface of the barrier, attempts were made to ignite the north portion of the gravel side slope. The toe of the gravel side slope did not burn very well, perhaps due to the high-moisture conditions of the plant

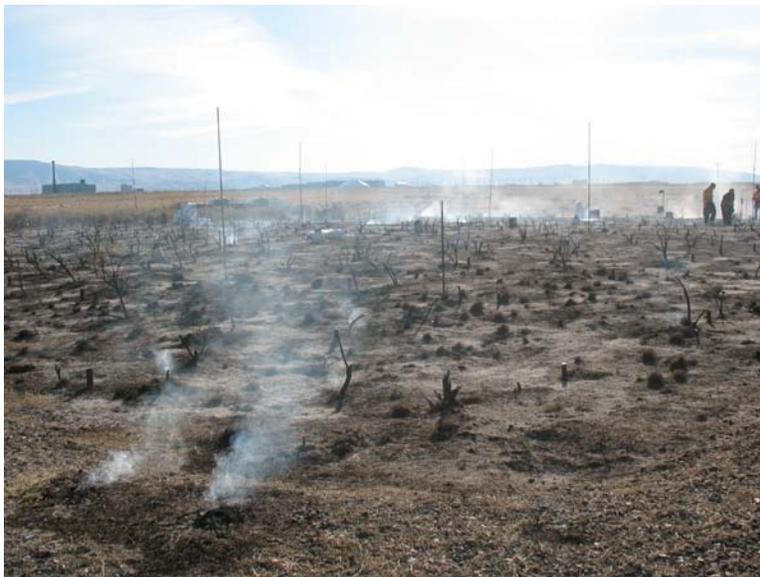
Figure 3.24. Surface of the Barrier at the End of the Fire Showing Sporadic White Ash Crust

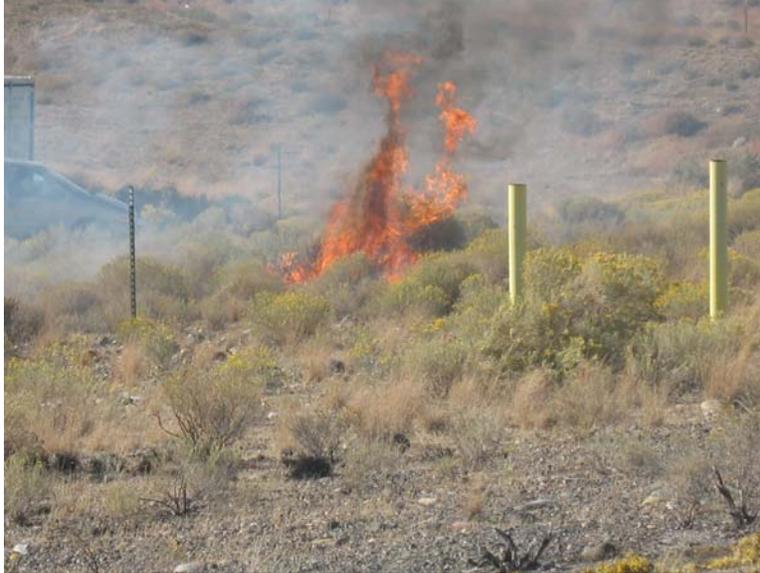
Figure 3.25. North Section of the Gravel Side Slope Under Fire. The sparse canopy and high moisture of the shrubs resulted in a very spotty burn.

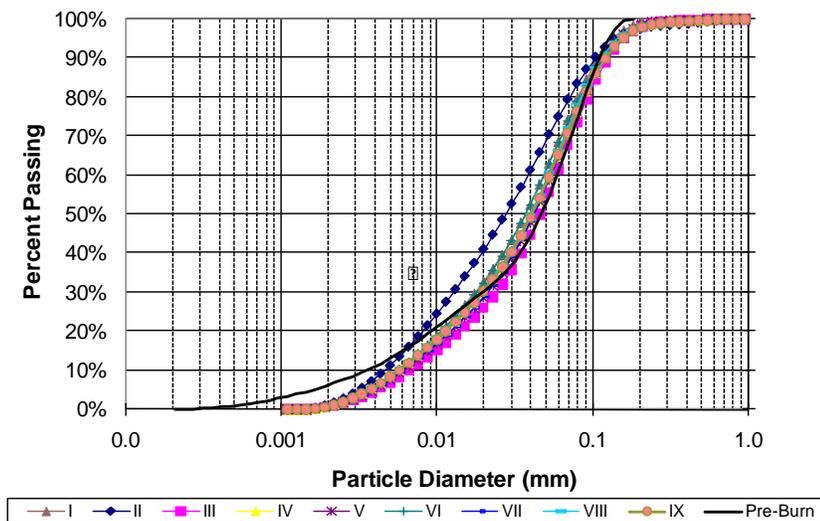
Figure 3.26. Distribution of Gravel from 0 to 2 cm Deep on Burnt Section: (a) Pre-Burn Gravel Content and (b) Difference Between Pre- and Post-Burn Content

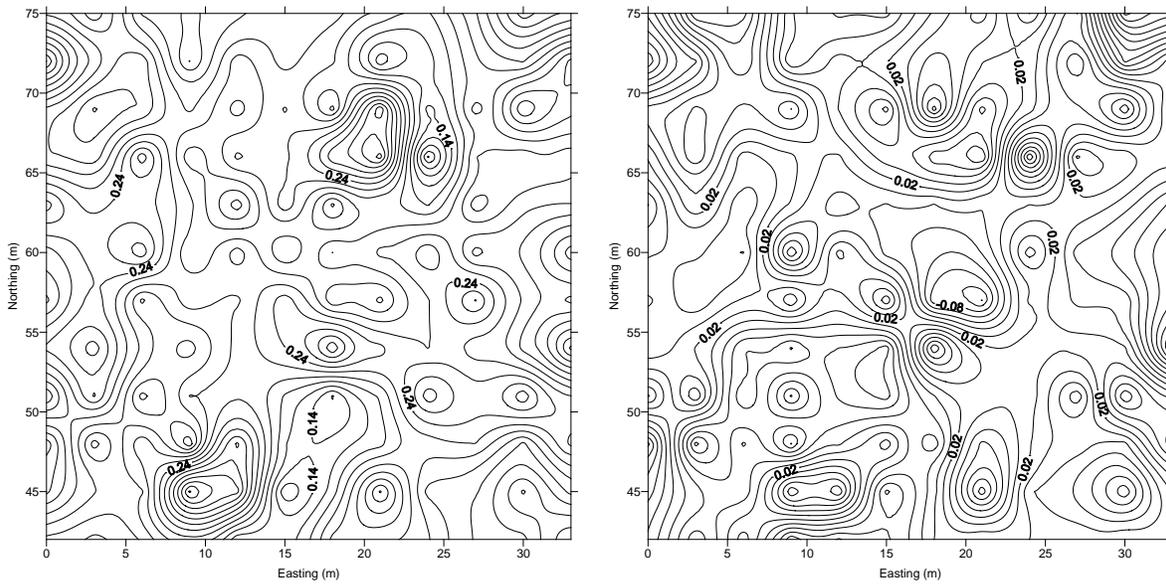
Figure 3.27. Distribution of Gravel from 0 to 2 cm Deep on Burnt Section: (a) Pre-Burn Gravel Content and (b) Difference Between Pre- and Post-Burn Content

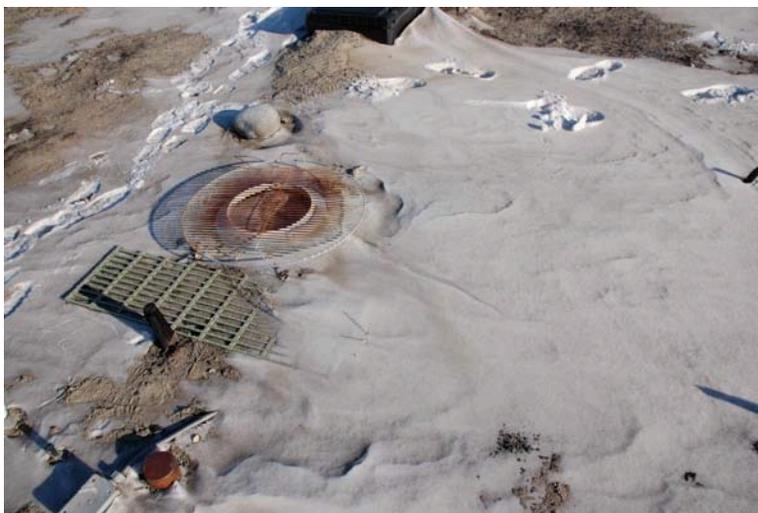
Figure 3.28. Soil Deposition Patterns on a Snow-Covered Surface on December 16, 2008

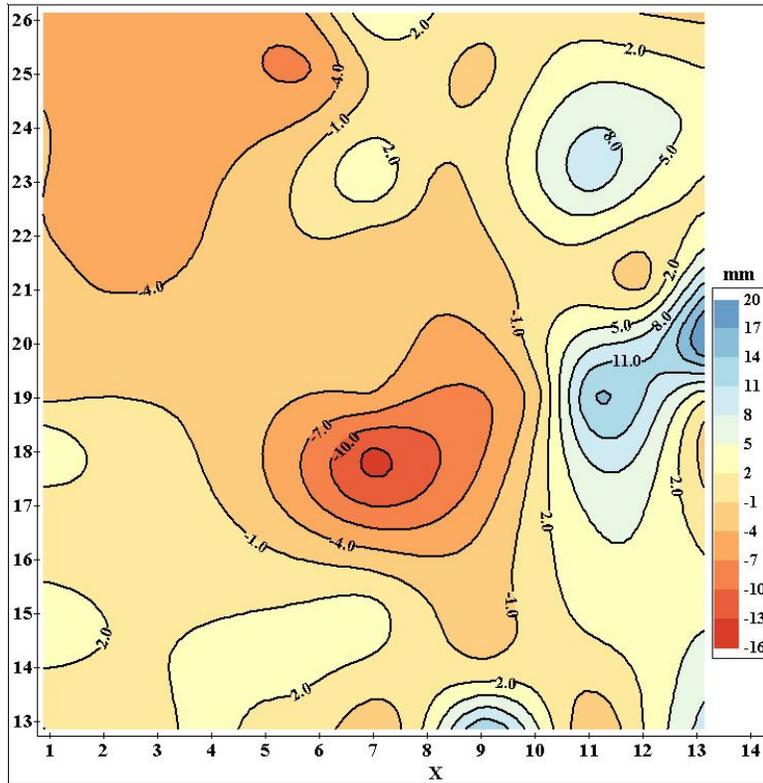
Figure 3.29. Soil Inflation and Deflation Patterns on the Burned Area. The X and Y edges denote positions on the surface. The distance between coordinate values is 3 meters.

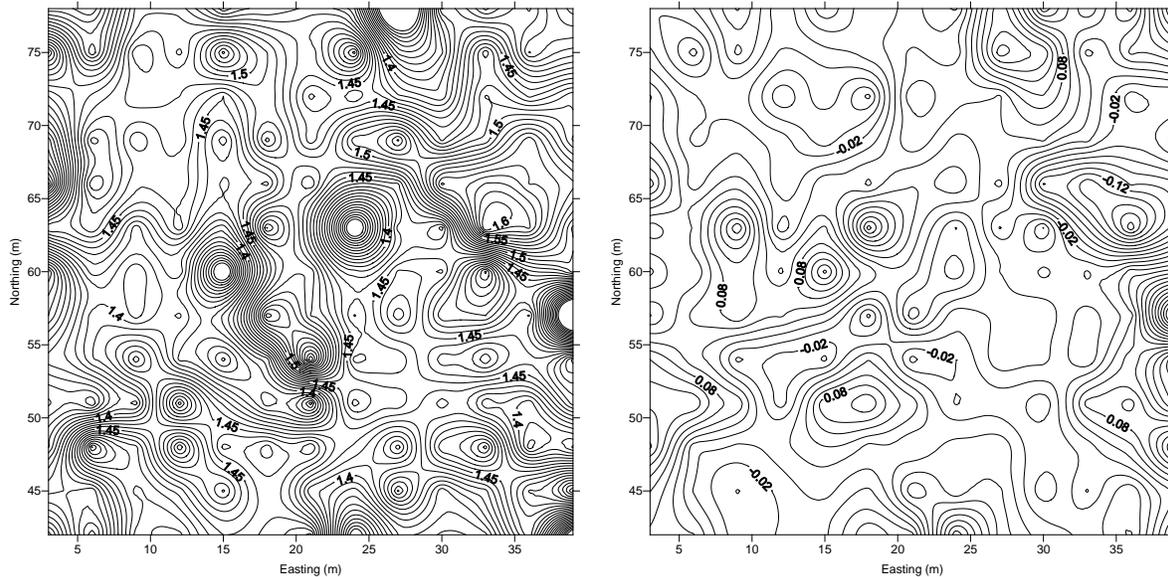
Figure 3.30. Distribution of Dry Bulk Density on Burnt Section: (a) Pre-Burn Bulk Density and (b) Difference Between Pre- and Post-Burn Density

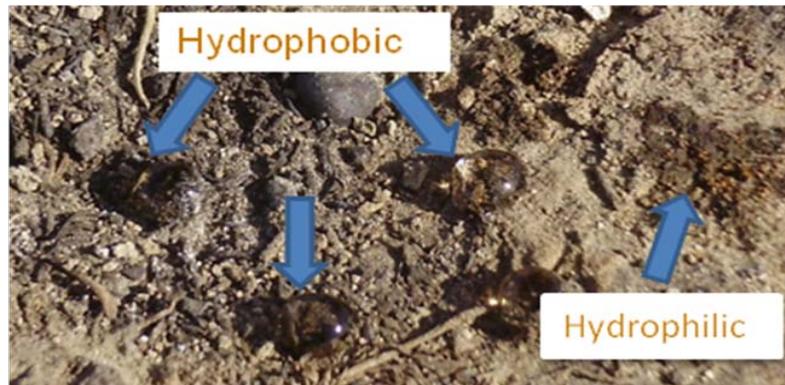
Figure 3.31. Photograph of Burned Surface During Water Drop Penetration Test

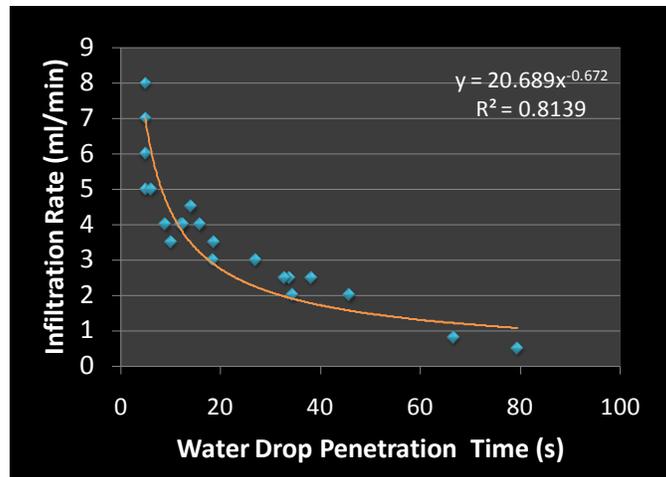
Figure 3.32. Relationship Between Infiltration Rate from a Mini-Disk Infiltrometer and Water Drop Penetration Tests

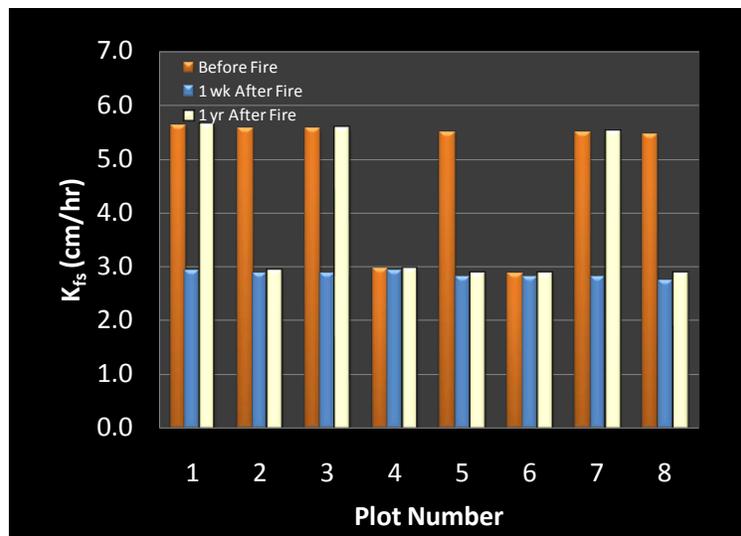
Figure 3.33. Comparison of *In-Situ* Pre-Burn and Post-Burn Estimates of the Hydraulic Conductivity

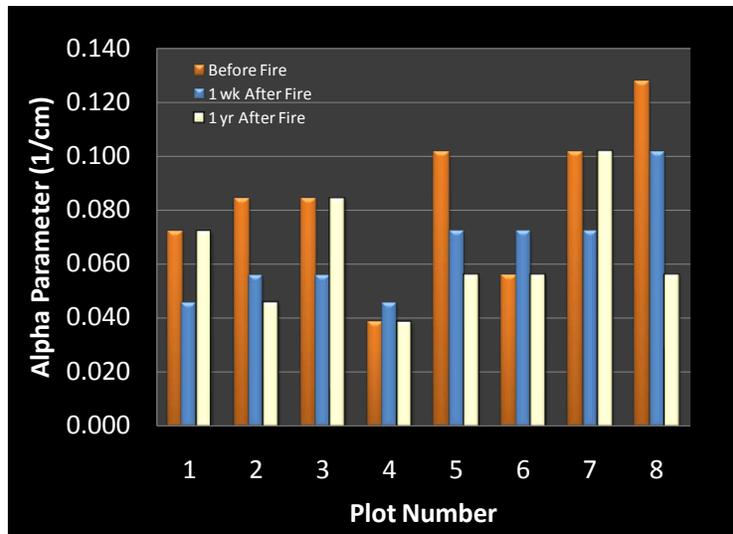
Figure 3.34. Comparison of *In Situ* Pre-Burn and Post-Burn Estimates of the Alpha Parameter
