PNNL-21542

# Wynkoop Building Performance Measurement: Water

August 2012

Prepared for  
the U.S. General Services Administration  
under Department of Energy Contract DE-AC05-76RL01830  
with Battelle Memorial Institute

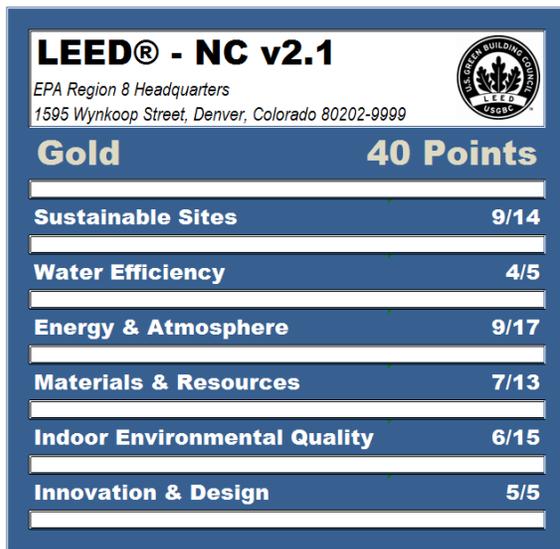
Figure 2. LEED-NC Point Summary

The building design achieved U.S. Green Building Council Leadership in Energy and Environmental Design for New Construction (LEED-NC) Gold Certification in 2008 (Figure 2) and a 2008 EPA Energy Star Rating of 96 with design highlights that include:

Wynkoop was designed with dual flush toilets, low flow fixtures, and water free urinals. The design features earned the building four of five Water Efficiency points in the LEED-NC certification with predicted water use at over 40% less than a typical water fixture design. Other water uses in the building that were not included in the calculations for LEED-NC certification include an indoor fountain, an irrigated green roof, and heating, ventilation and air-conditioning related process water. The designed fixture water use only was calculated to be 1,262,664 gallons per year or 4.2 gallons per gross square foot (GSF). The first year of water use was notably higher than anticipated. The building process water was submetered, which identified process water use as the primary source of the unexpected level of water use. The building managers adjusted the building steam system, reducing tempering water at the drain, putting the water use back into an expected range. Since that fix, the building water use was measured lower than the water use index (WUI) industry average of 15 gallons/gross square foot<sup>1</sup> and lower than GSA targets of 13.3 gallons/gross square foot for the GSA Green Building Average, and 13 gallons/gross square foot for the GSA 2015 goal (see Figure 3).

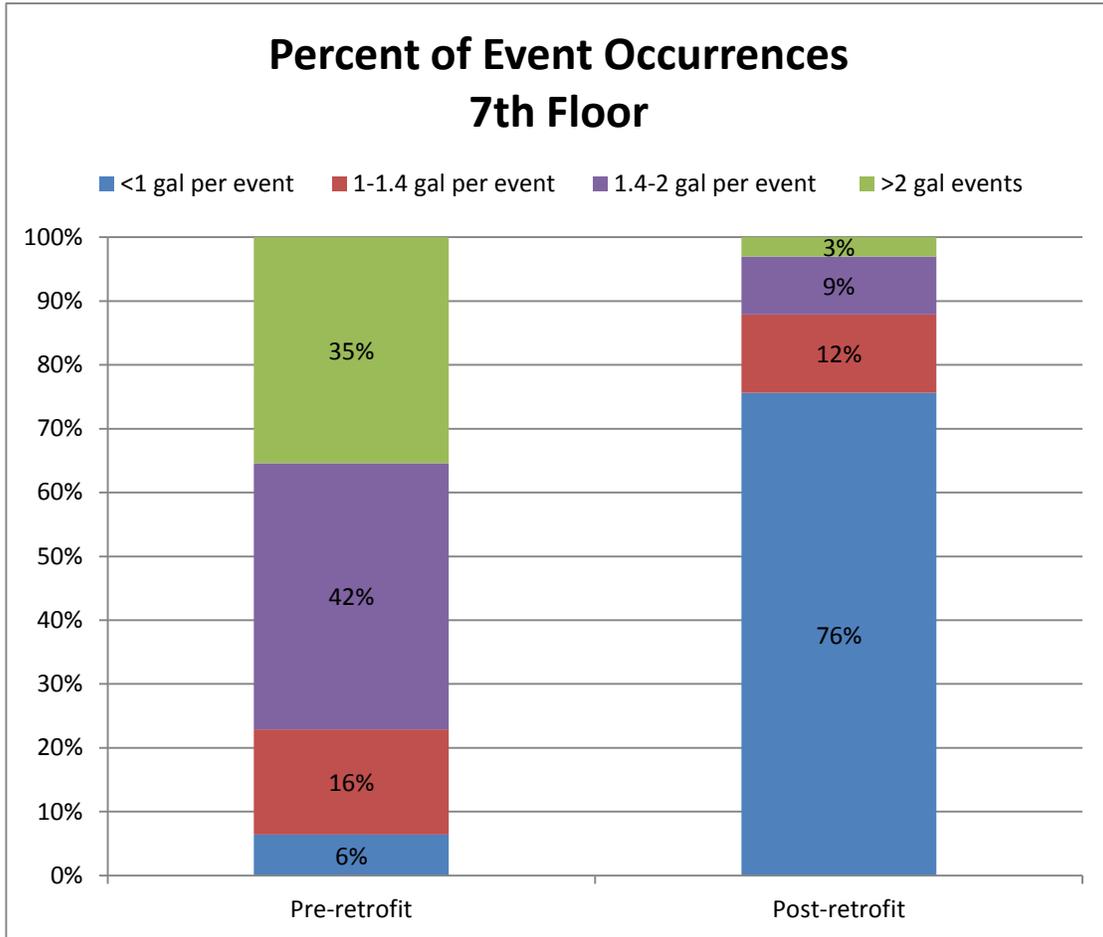
Figure 4. 7<sup>th</sup> Floor Event Occurrences Before and After Toilet Handle Retrofit

March 2011 measurements from the 7<sup>th</sup> floor indicated that occupants appeared to not be using the dual flush toilet handles as designed. The original handles were designed as a full flush (1.1 gallons) when pushed down, and a reduced flush (0.8 gallons) when pulled up. As illustrated in

Figure 4, the majority of the water use events were greater than 1 gallon per flush, indicating mostly full flushes (pushed down). Because of this finding, building management retrofitted

the toilets with handles that reversed the flush, that is, reduced flush when pushed down, and full flush when pulled up.

Figure 4 shows that after the retrofit, the majority of the water use events were less than 1 gallon, indicating that the majority of flushes were reduced flush mode (pushed down).

The average volume per event decreased nearly 70% from 2.3 gallons per event to 0.7 gallons per event. Because of the positive results of this handle retrofit on the 7<sup>th</sup> floor, building management retrofitted the toilet handles throughout the building.

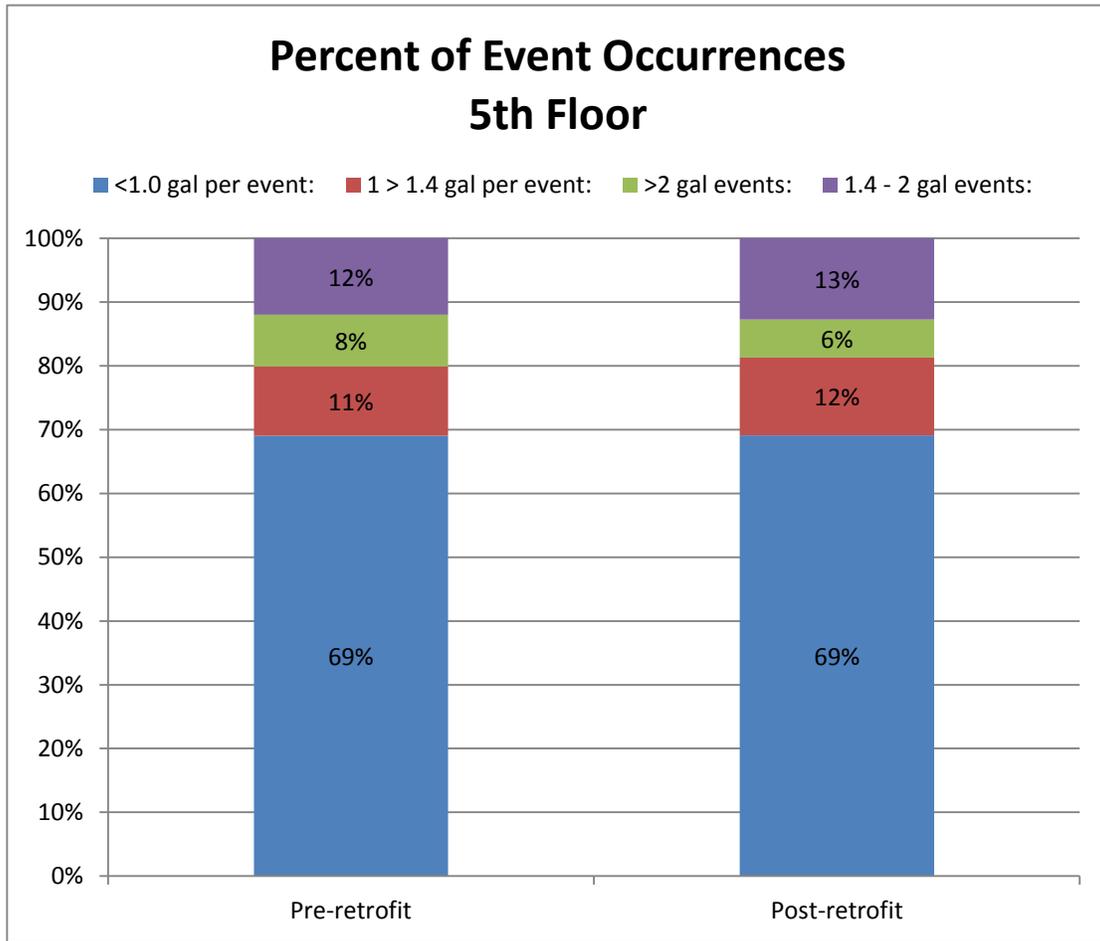
Figure 5. 5<sup>th</sup> Floor Event Occurrences Before and After Toilet Handle Retrofit

Figure 5 illustrates that there were minimal differences in the before and after retrofit data on the 5<sup>th</sup> floor. Of the 5<sup>th</sup> floor, the aggregate average volume per event decreased by about 5%, from 0.88 gallons per event to 0.84 gallons per event.

Metered data from 5<sup>th</sup> and 2<sup>nd</sup> floors did not show the same level of water savings as was seen on the 7<sup>th</sup> floor.

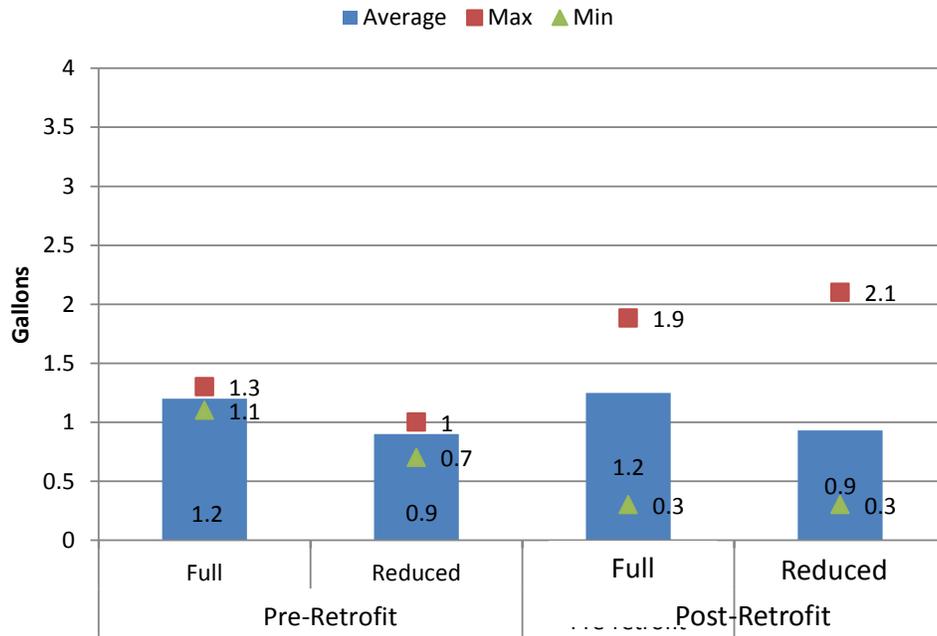
Figure 6. 5<sup>th</sup> Floor Toilet Flush Test Results (volume per flush)

Figure 6 illustrates that on the 5<sup>th</sup> floor, the average flush volume for the full and reduced flush was the same before and after the retrofit, 1.2 and 0.9 gallons per flush respectively.

In addition to analyzing aggregate data, toilet flush tests were completed on the 2<sup>nd</sup> and 5<sup>th</sup> floors to develop profiles of an average full and reduced flush. The results of these flush tests are shown in

Figure 6 and  
Figure 7.

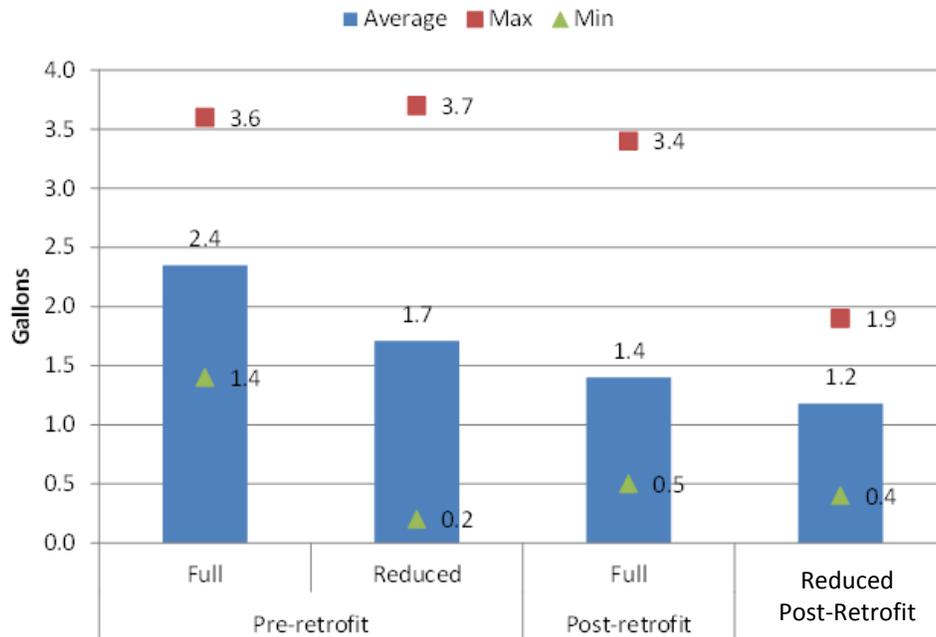
Figure 7. 2<sup>nd</sup> Floor Toilet Flush Test Results (volume per flush)

Figure 7 illustrates a more noticeable difference in the average pre-and post-data on the 2<sup>nd</sup> floor.

The second floor water use was examined prior to and following the toilet fixture retrofit. This floor is where conference rooms for non-building occupants are available for use, thus occupancy is highly variable. The 3-day average volume per flush event was higher post-retrofit (0.79 gallons per event), in contrast to pre-retrofit (0.57 gallons per event). There were 40% more flush events post retrofit, which impacted the findings.

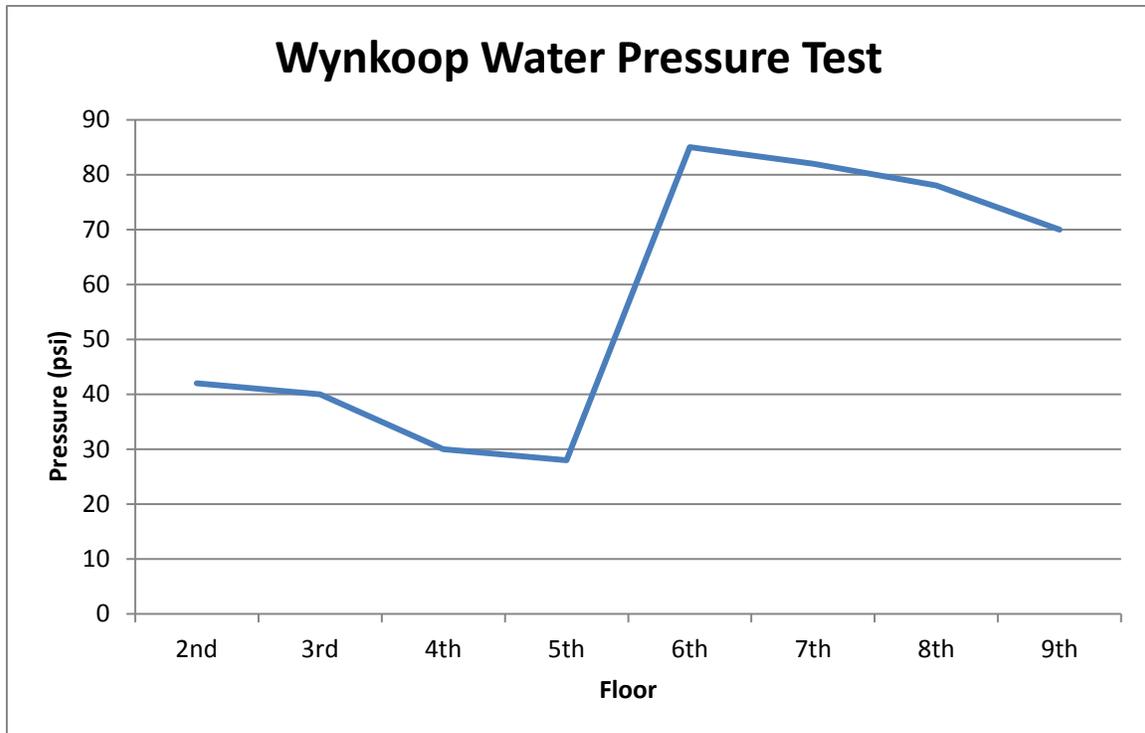
Figure 8. Water Pressure Test Results

Historically, occupant feedback indicated that water pressure varied throughout the building, and was particularly low on the 5<sup>th</sup> floor. The building is served by city supplied water pressure for floors 2-5; a booster pump supports proper water pressure on floors 6-9. The results from the water pressure readings taken on each floor are shown in

Figure 8, and illustrate that water pressure varies floor to floor with a significant increase from the 5<sup>th</sup> to 6<sup>th</sup> floor.

This difference in water pressure could be one reason for the variances in fixture performance floor to floor identified in the 2<sup>nd</sup>, 5<sup>th</sup>, and 7<sup>th</sup> floor analysis.

The water pressure on the 5<sup>th</sup> floor (< 30 psi) is less than half the pressure on the 7<sup>th</sup> floor (>80 psi). The measured water savings post-retrofit was lower on the 5<sup>th</sup> floor than the 7<sup>th</sup> floor. The differences in water pressure may have had an impact on the quantity of water used per floor.
