PARENT Quick Blind Round-Robin Test Report

September 2014

The U.S. Nuclear Regulatory Commission has established the Program to Assess the Reliability of Emerging Nondestructive Techniques (PARENT) whose goal is to investigate the effectiveness of current and novel nondestructive examination procedures and techniques to find flaws in nickel-alloy welds and base materials. This is to be done by conducting a series of open and blind international round-robin tests on a set of piping components that include large-bore dissimilar metal welds, small-bore dissimilar metal welds, and bottom-mounted instrumentation penetration welds. The blind testing is being conducted in two segments, one is called Quick-Blind and the other is called Blind. The Quick-Blind testing and destructive analysis of the test blocks has been completed. This report describes the four Quick-Blind test blocks used, summarizes their destructive analysis, gives an overview of the nondestructive evaluation (NDE) techniques applied, provides an analysis inspection data, and presents the conclusions drawn.

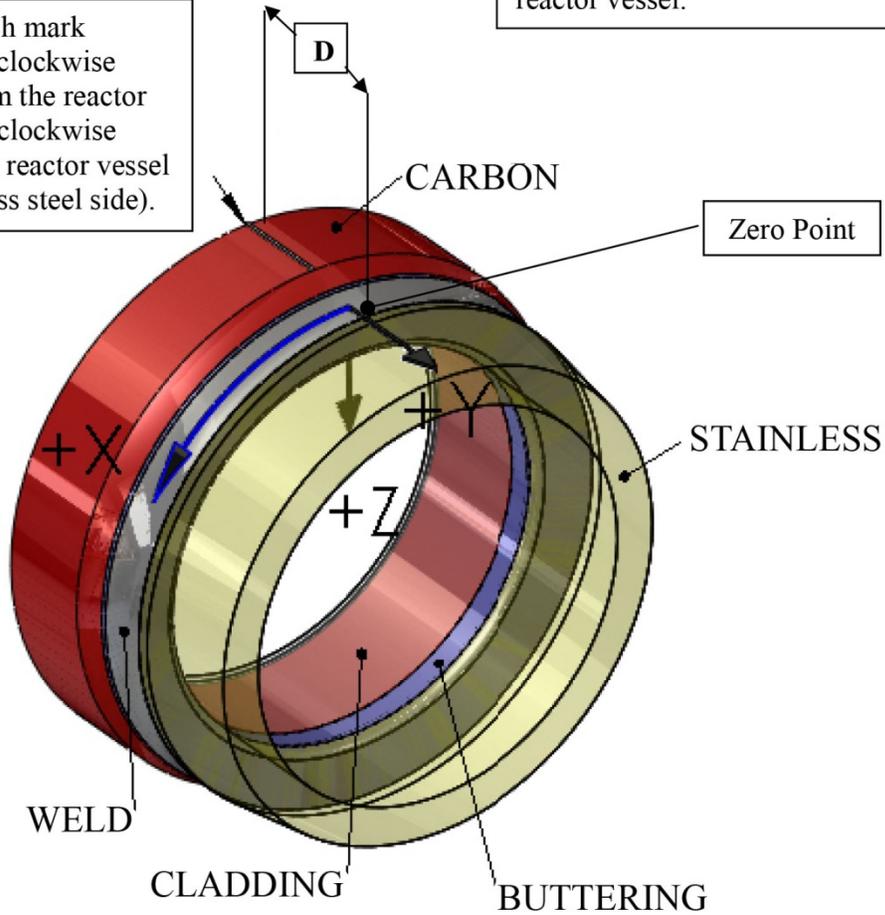
Figure 2.1. Coordinate System for Dissimilar Metal Weld Pipe Test Blocks

X=0 at the punch mark
 X+ direction is clockwise looking out from the reactor vessel (counter clockwise looking into the reactor vessel from the stainless steel side).

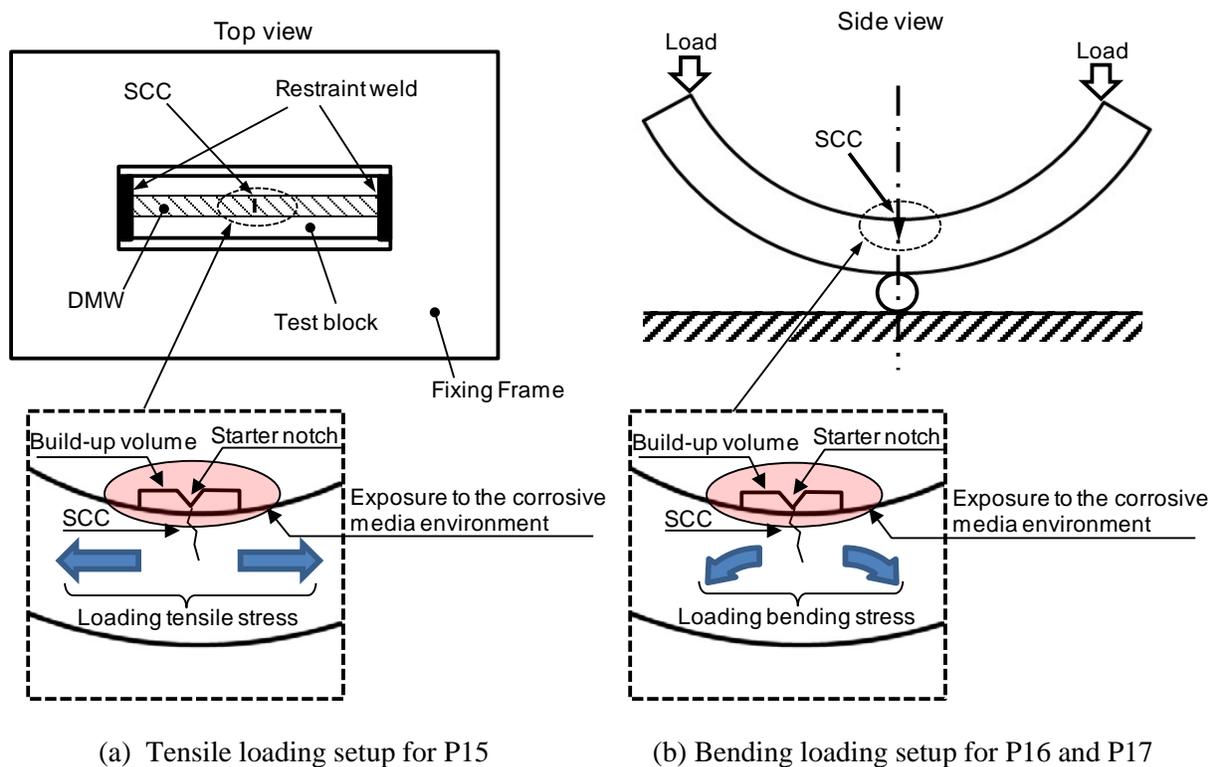
Figure 2.8. Depiction of the Approach Used to Produce a Laboratory-Grown PWSCC/IGSCC

The two configurations shown in Figure 2.8(a) and 9(b) were used to fabricate laboratory-grown PWSCC in test blocks P15, P16, and P17. In order to grow a deep SCC flaw and also avoid the large crack opening, which typically accompanies bending loading techniques, the tensile loading type setup shown in Figure 2.8(a) was used to produce the flaw in P15. During the cooling process of the restraint weld and fixing frame, a tensile stress was generated due to the difference of shrinkage between restraint weld and fixing frame. The bending loading type setup shown in Figure 2.8(b) was used for P16 and P17, which were planned to fabricate middle and shallow SCC. The process used is depicted as a flowchart in Figure 2.9.

1. Fabrication of large-bore DMW test block
 - Large-bore DMW test block is made from the same groove geometry, materials, and welding conditions as the real plant.

4. Exposure to the corrosive environment and loading
 - The build-up region on inner surface of large-bore DMW is exposed to corrosive media.
 - The tensile stress or the bending stress is loaded, which induces PWSCC from starter notch.

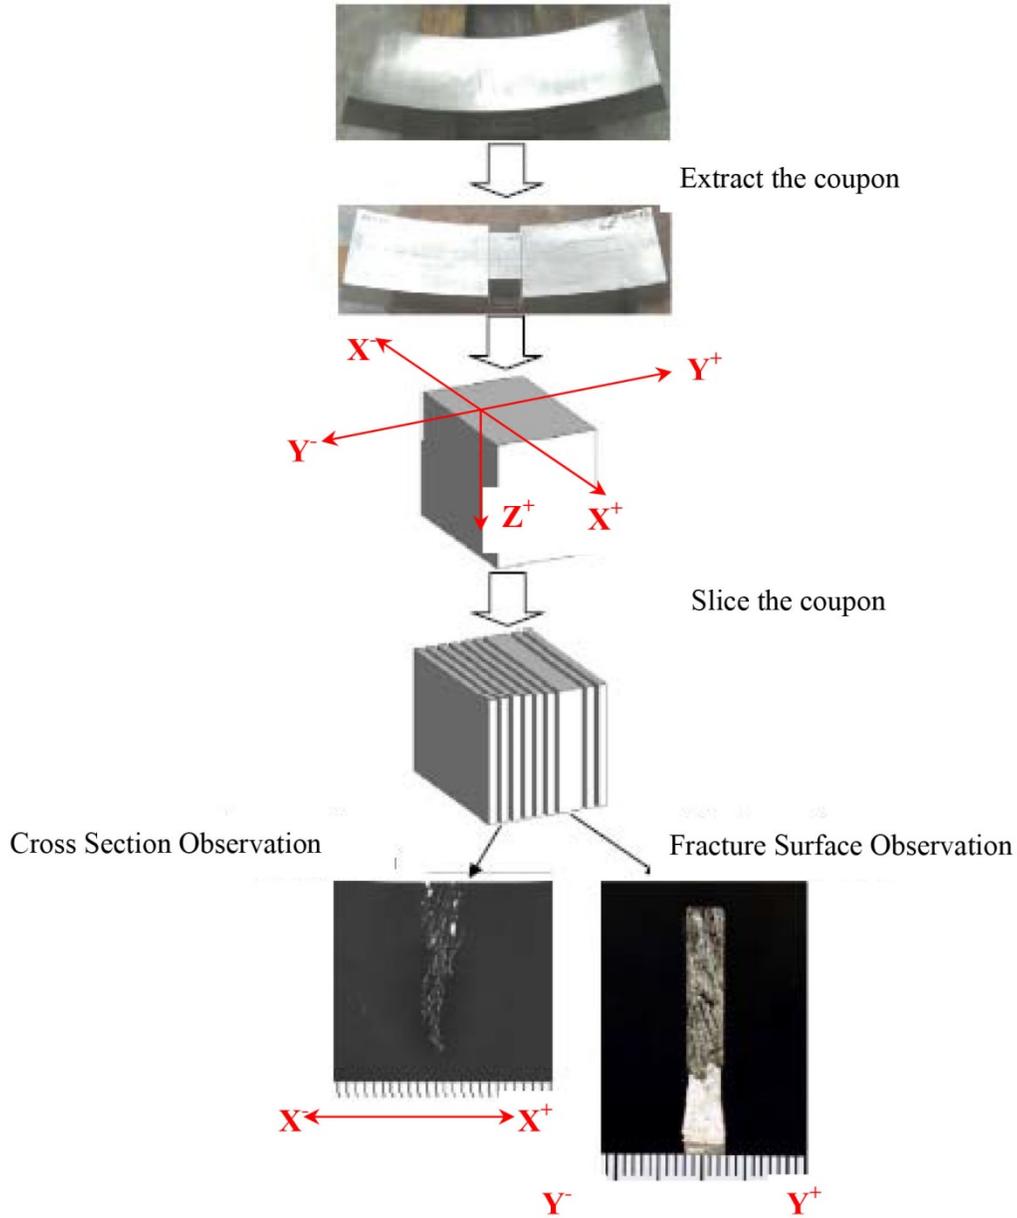
Figure 2.10. Stepwise Depiction of Coupon Extraction for Destructive Analysis

It is instructive to review the flaws in Table 2.1 in further detail because each one has a complex form and structure (morphology) in the X, Y, and Z directions. Note that all of the flaws have extensive morphology in the X dimension: ~12 mm for P15, ~24 mm for P16, and ~33 mm for P17. The implanted flaws exhibit a cluster or volumetric nature. A stepwise progression through the items in Appendix A that pertain to P15 will help to facilitate an understanding of the destructive analysis performed on P15 and in particular its morphology in the X dimension. To begin, the figures shown on Page A.0 in Appendix A are duplicated in Figure 2.10 with directional axes added.

Figure 2.10 shows that a portion of each test block was removed for fracture surface observation. For P15, there were two fracture surface observation segments. The first segment extended as one piece from Y=0 to Y=-4 and the second as one piece from Y=-5 to Y=-9. These two segments are shown on page A-1.17. Figure 2.12 shows the fracture surface for the Y=-5 to Y=-9 segment. The value shown for “d” is the crack depth at the indicated Y value.

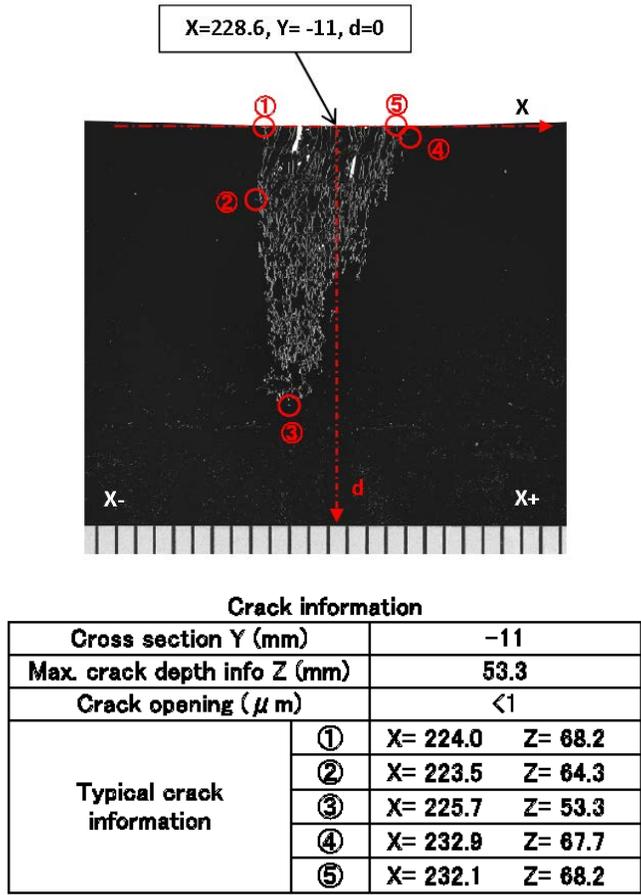
Figure 2.11. Cross Section and Crack Information for Test Block P15 at Y=-11

showing quite extensive morphology in the X (width) dimension. A review of page A-1.6 at Y=1, page A-1.7 at Y=0, page A-1.8 at Y=-4, page A-1.9 at Y=-5, A-1.10 at Y=-9, A-1.11 at Y=-10, A-1.12 at Y=-11, A-1.13 at Y=-12, and A1.14 at Y=-13 shows that this flaw has a very extensive morphology in all three dimensions. Figure 2.11 shows the enlarged cross section and corresponding crack information table at Y=-11.

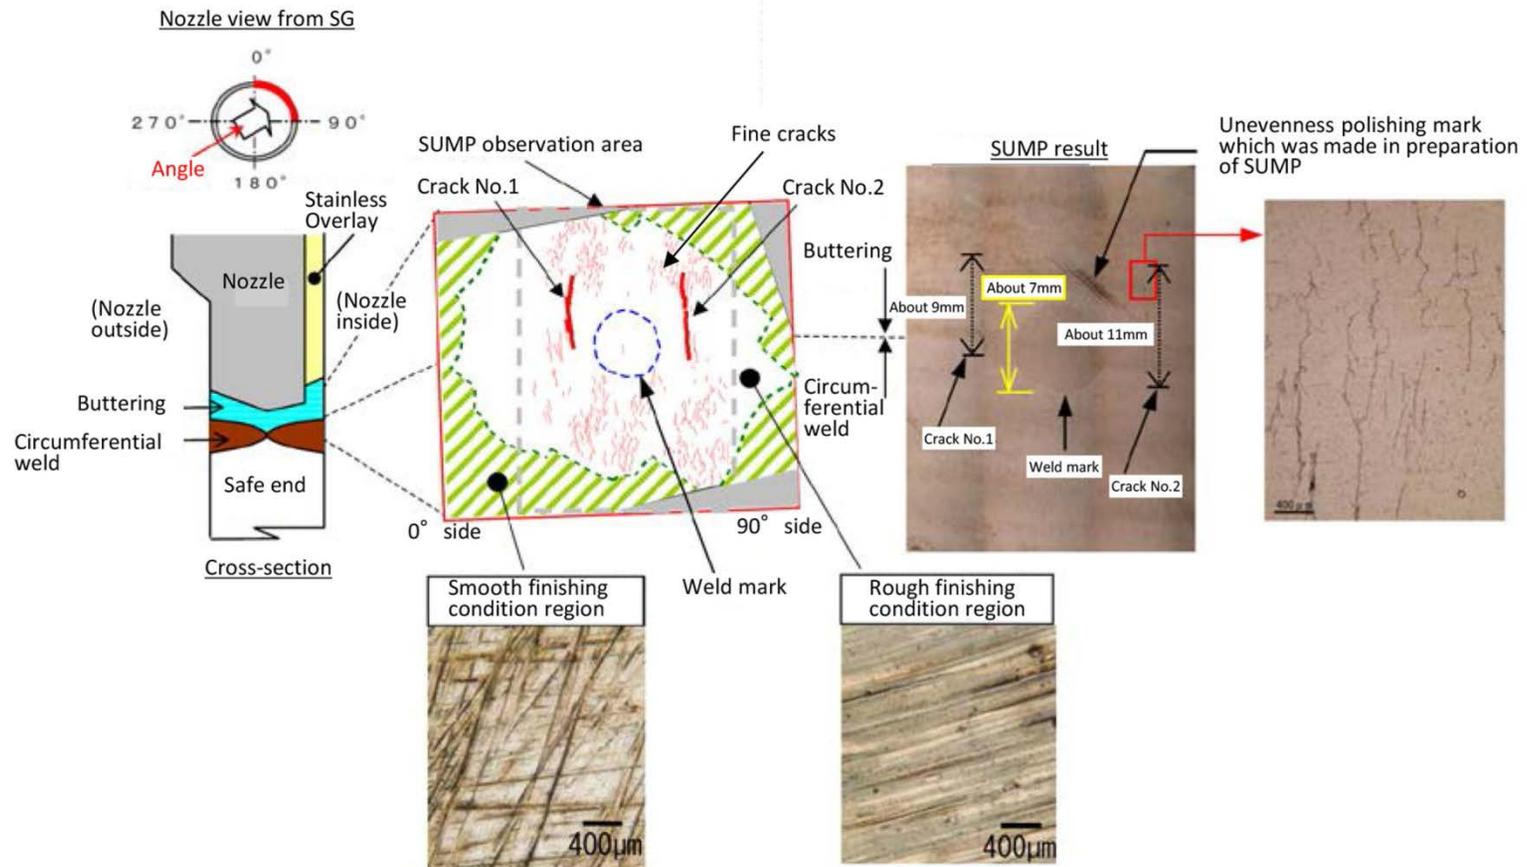
Figure 2.13. Complex Stress Corrosion Crack Morphology of Stress Corrosion Cracks Found During 2007 in Japan in the Dissimilar Metal Weld of a Steam Generator Nozzle

The complex nature of the flaws in the quick blind study are similar to the morphology of stress corrosion cracks detected in dissimilar metal welds of steam generator nozzles in a Japanese nuclear power plant in 2007. The lengths of the two main cracks were approximately 9 mm and 11 mm. Fine cracks were observed to be surrounding the two main cracks. These flaws are shown in Figure 2.13.

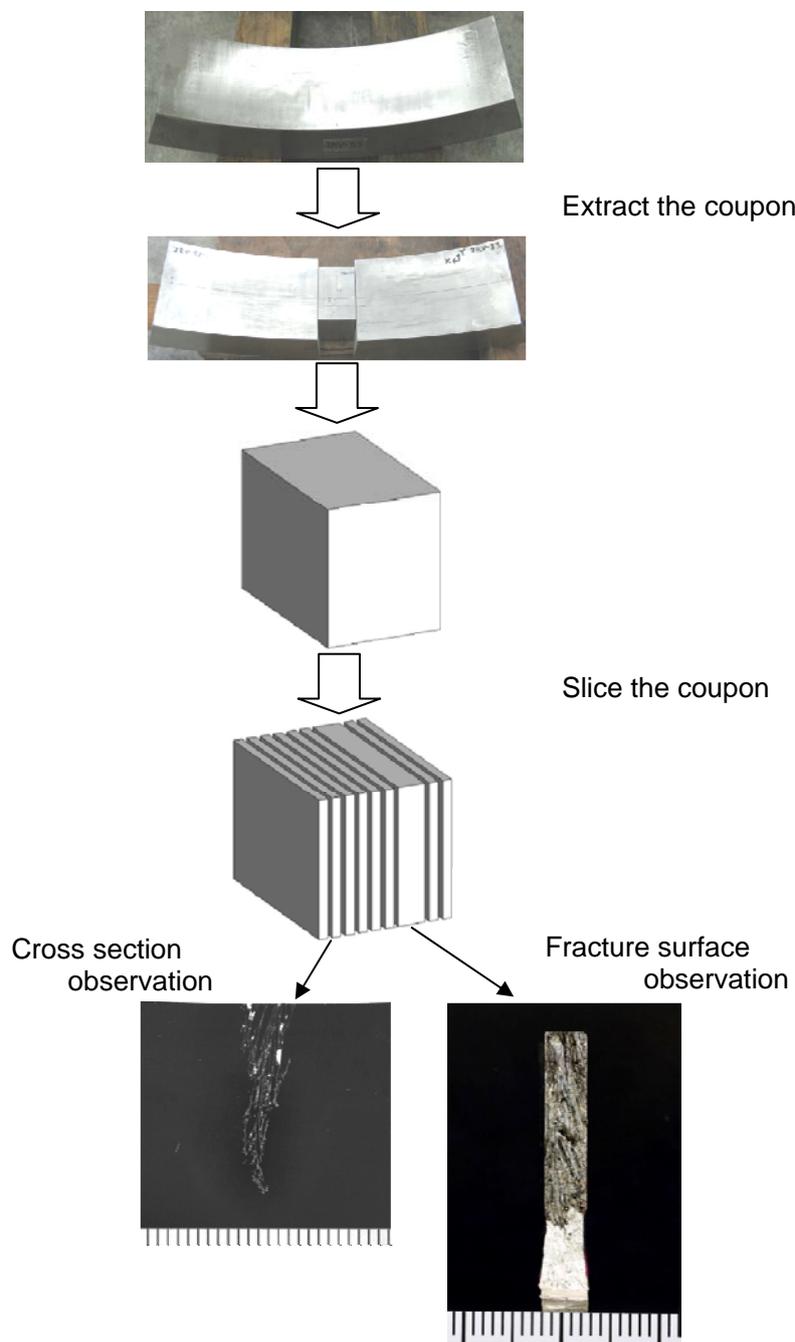
1. Extract the coupon from SCC induced region.
2. This coupon was sliced by one mm pitch.
3. The cross sections of sliced pieces were polished and observed by the microscope.
The cross sections were etched and observed by microscope again.
3. Some regions were not sliced. These regions were broken by crack opening force.
The fracture surfaces were observed by microscope, and the distribution of SCC depth was measured on the photograph of microscope.

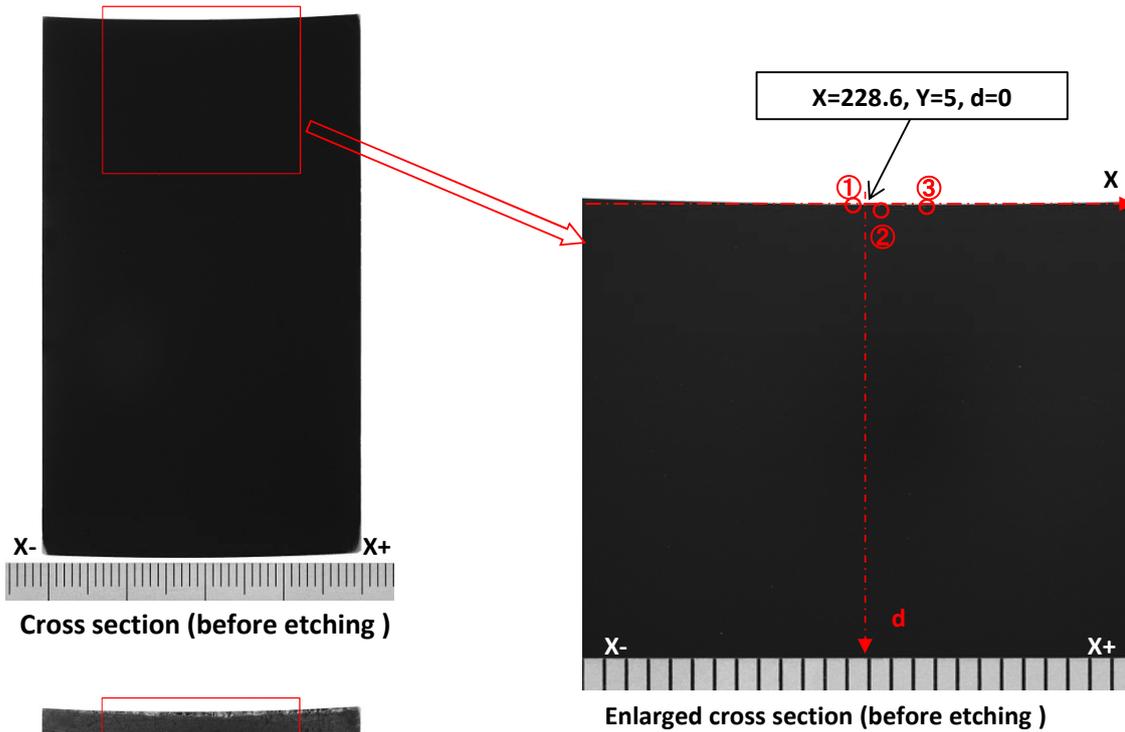
Fig. A-1.2 Detailed crack information at Y=5 section in P15 (JRV-S1)

Cross section Y (mm)	5.0
Max. crack depth info Z (mm)	68.1
Crack opening (μ m)	<1
Typical crack information	① X= 227.6 Z= 68.2
	② X= 229.5 Z= 68.1
	③ X= 232.1 Z= 68.2

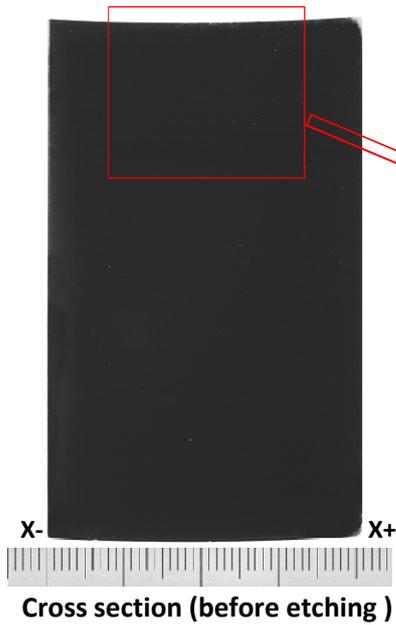
Position of cross section for observation (Y=4)

Crack information	
Cross section Y (mm)	4.0
Max. crack depth info Z (mm)	67.5
Crack opening (μ m)	5.0
Typical crack information	① X= 224.2 Z= 68.2
	② X= 224.3 Z= 67.8
	③ X= 227.9 Z= 67.5
	④ X= 233.5 Z= 67.8
	⑤ X= 233.3 Z= 68.2

Z = 68.2 - d

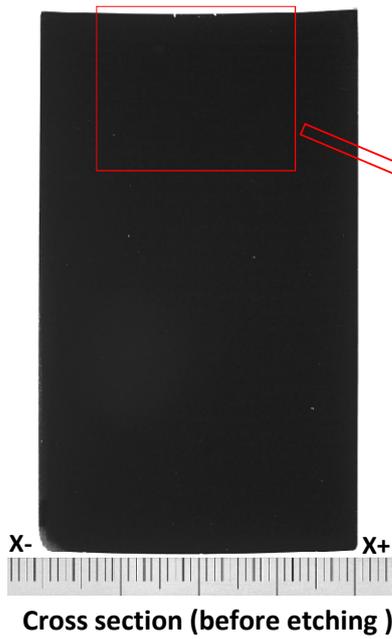
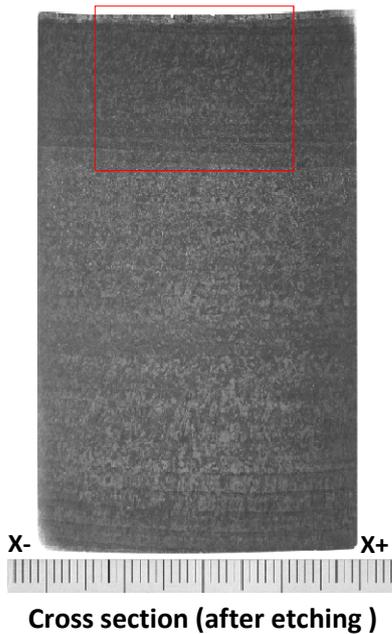
Position of cross section for observation (Y=3)

Crack information	
Cross section Y (mm)	3.0
Max. crack depth info Z (mm)	67.5
Crack opening (μ m)	<1
Typical crack information	① X= 224.1 Z= 68.2
	② X= 225.1 Z= 67.5
	③ X= 232.0 Z= 68.2

Z = 68.2 - d

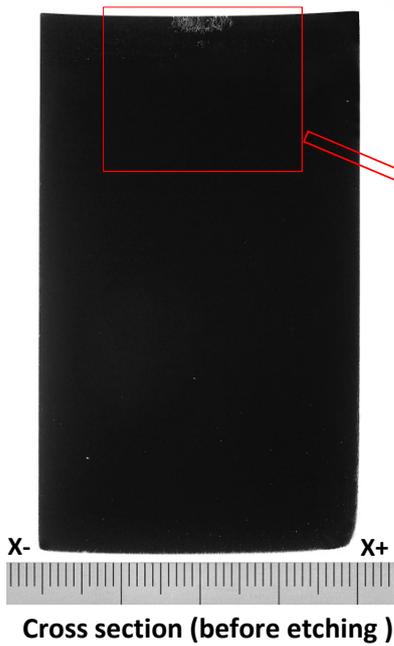
Position of cross section for observation (Y=2)

Cross section (before etching)

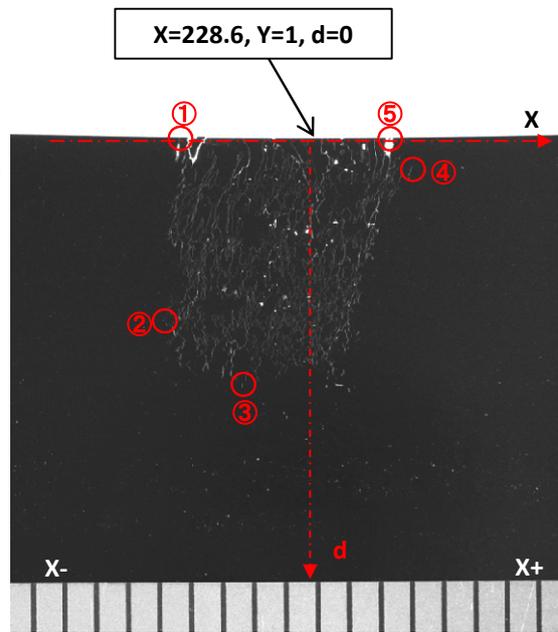
Fig. A-1.6 Detailed crack information at Y=1 section in P15 (JRV-S1)

Crack information	
Cross section Y (mm)	1.0
Max. crack depth info Z (mm)	60.1
Crack opening (μm)	<1
Typical crack information	① X= 223.5 Z= 68.2
	② X= 222.9 Z= 62.3
	③ X= 225.9 Z= 60.1
	④ X= 232.2 Z= 67.3
	⑤ X= 231.4 Z= 68.2

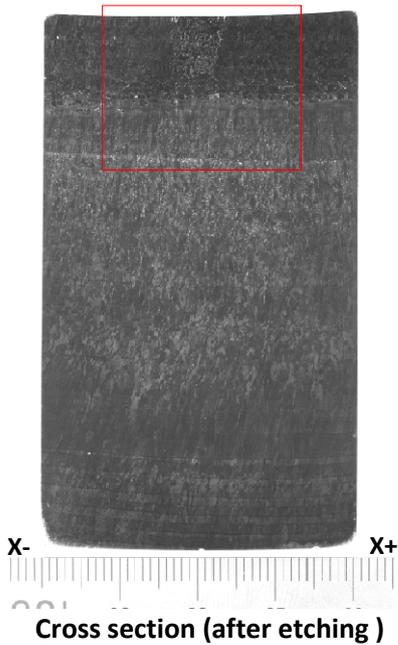
Position of cross section for observation (Y=1)

Z = 68.2 - d

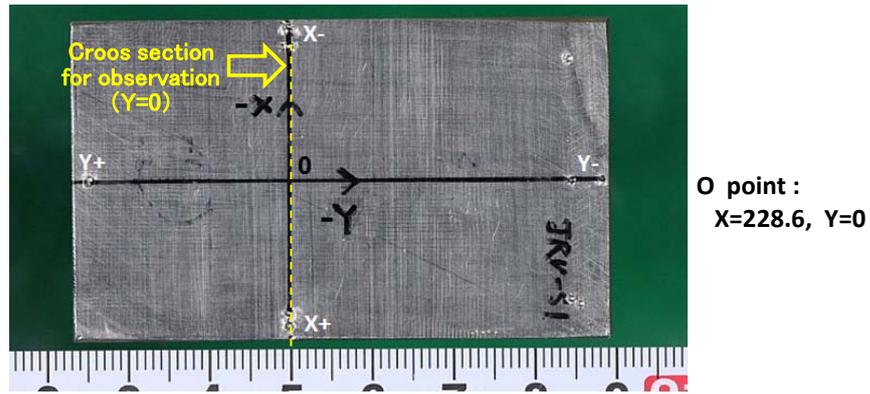
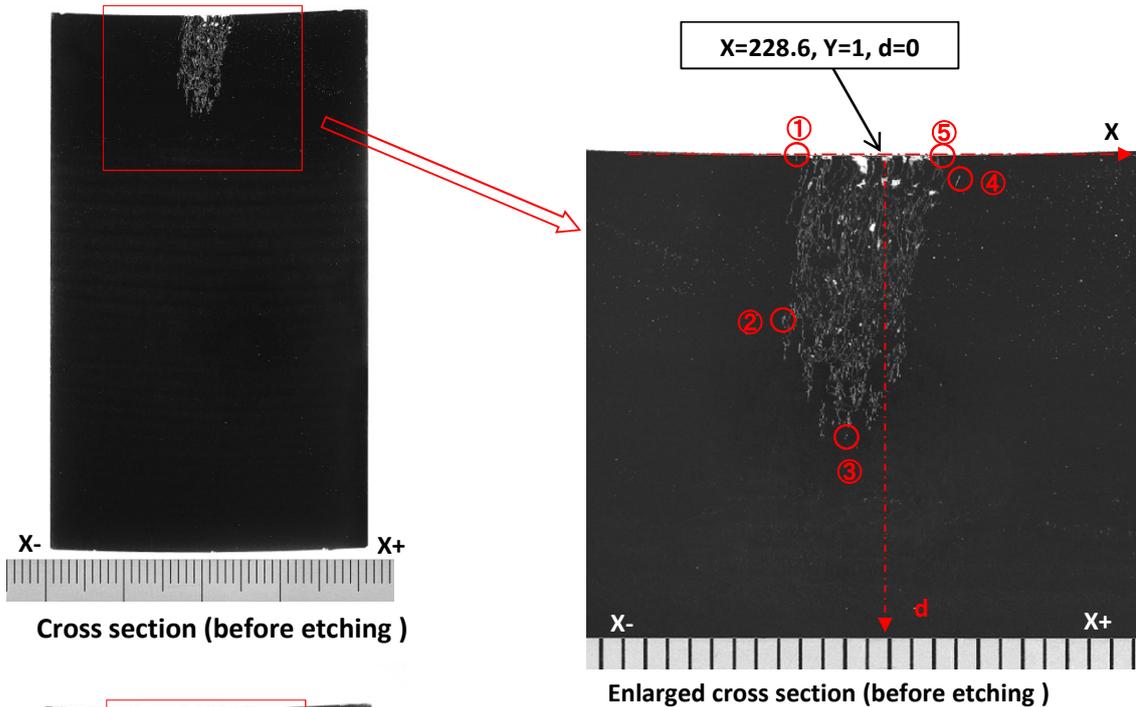
Fig. A-1.7 Detailed crack information at Y=0 section in P15 (JRVS-1)

Crack information	
Cross section Y (mm)	0.0
Max. crack depth info Z (mm)	55.2
Crack opening (μm)	<1
Typical crack information	① X= 223.9 Z= 68.2
	② X= 223.2 Z= 60.8
	③ X= 226.7 Z= 55.2
	④ X= 232.6 Z= 67.4
	⑤ X= 231.7 Z= 68.2

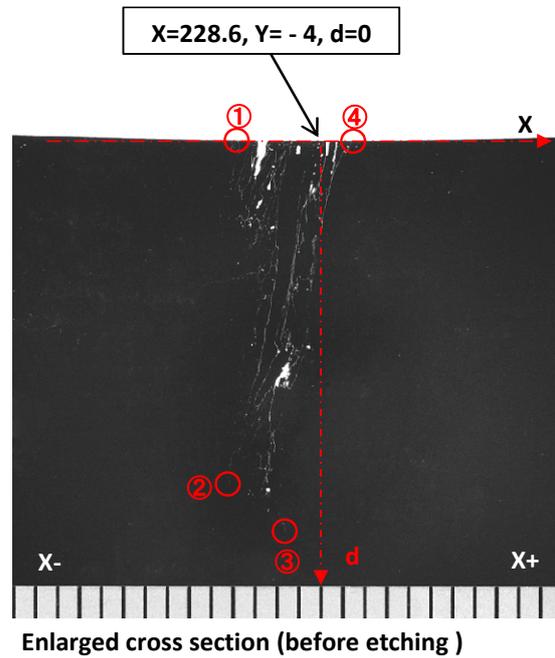
Fig. A-1.8 Detailed crack information at Y= - 4 section in P15 (JRV-S1)

Crack information	
Cross section Y (mm)	-4.0
Max. crack depth info Z (mm)	49.4
Crack opening (μ m)	<1
Typical crack information	① X= 224.3 Z= 68.2
	② X= 224.1 Z= 51.9
	③ X= 227.2 Z= 49.4
	④ X= 230.5 Z= 68.2

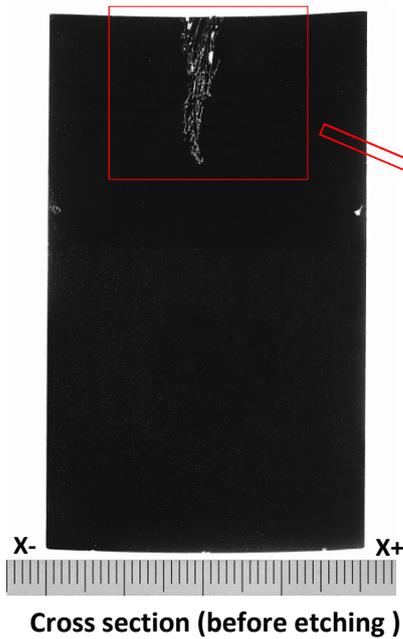
Position of cross section for observation (Y= - 5)

Crack information	
Cross section Y (mm)	-5
Max. crack depth info Z (mm)	49.4
Crack opening (μm)	5.0
Typical crack information	① X= 224.7 Z= 68.2
	② X= 224.3 Z= 65.3
	③ X= 227.1 Z= 49.4
	④ X= 230.7 Z= 68.2

Z = 68.2 - d

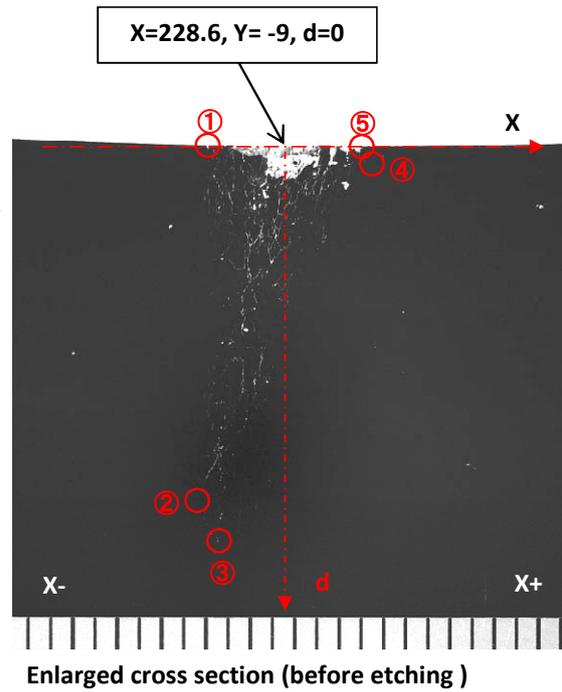
Fig. A-1.10 Detailed crack information at Y= - 9 section in P15 (JRV-S1)

Crack information	
Cross section Y (mm)	-9
Max. crack depth info Z (mm)	49.6
Crack opening (μm)	<1
Typical crack information	① X= 224.2 Z= 68.2
	② X= 223.9 Z= 52.0
	③ X= 225.2 Z= 49.6
	④ X= 232.8 Z= 67.4
	⑤ X= 232.4 Z= 68.2

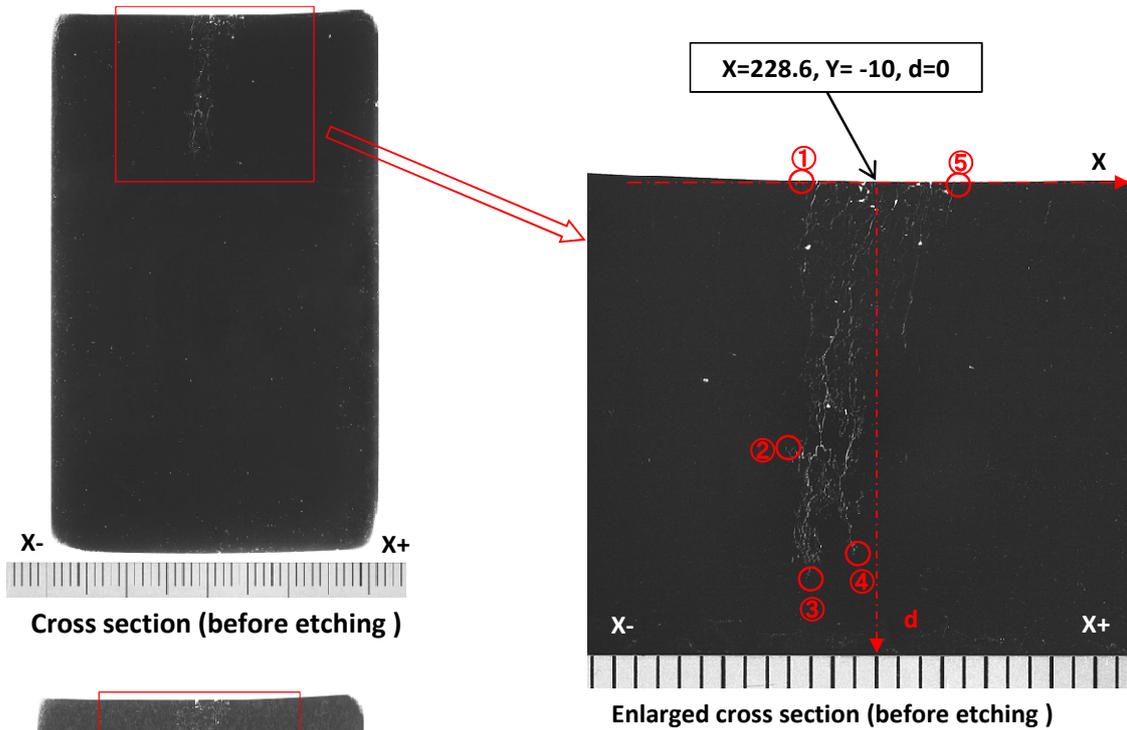
Fig. A-1.11 Detailed crack information at Y= - 10 section in P15 (JRV-S1)

Cross section Y (mm)	-10
Max. crack depth info Z (mm)	49.7
Crack opening (μ m)	<1
Typical crack information	① X= 224.4 Z= 68.2
	② X= 223.9 Z= 55.9
	③ X= 225.1 Z= 49.7
	④ X= 227.7 Z= 51.0
	⑤ X= 232.7 Z= 68.2

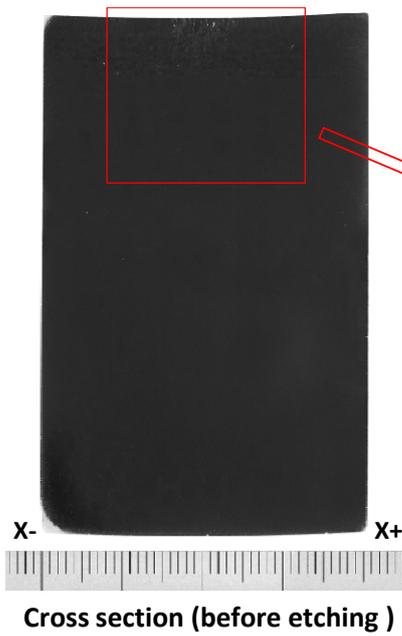
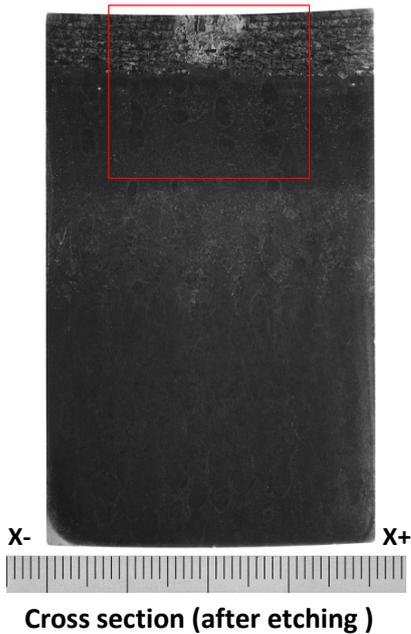
Position of cross section for observation (Y=

Crack information

Cross section Y (mm)	-12
Max. crack depth info Z (mm)	61.8
Crack opening (μ m)	5.0
Typical crack information	① X= 224.3 Z= 68.2
	② X= 224.2 Z= 66.4
	③ X= 224.7 Z= 62.6
	④ X= 228.5 Z= 61.8
	⑤ X= 231.2 Z= 61.9
	⑥ X= 234.1 Z= 67.6
	⑦ X= 233.6 Z= 68.2

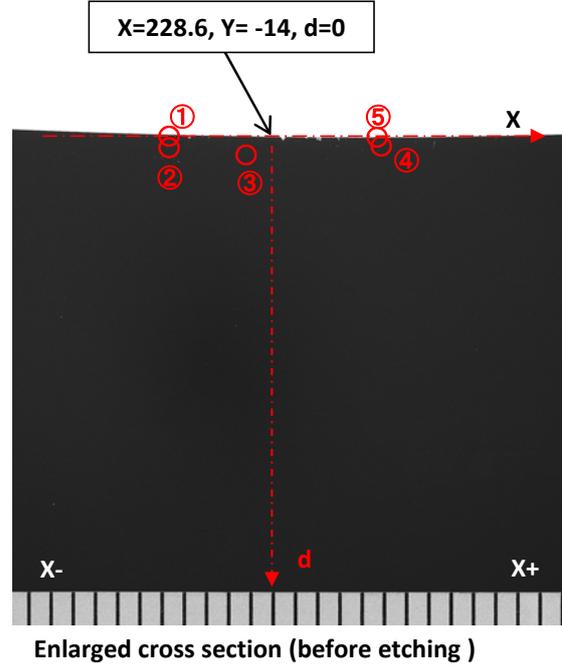
Fig. A-1.15 Detailed crack information at Y= - 14 section in P15 (JRV-S1)

Crack information	
Cross section Y (mm)	-14
Max. crack depth info Z (mm)	67.4
Crack opening (μm)	<1
Typical crack information	① X= 222.4 Z= 68.2
	② X= 222.6 Z= 67.5
	③ X= 225.5 Z= 67.4
	④ X= 233.9 Z= 67.9
	⑤ X= 233.8 Z= 68.2

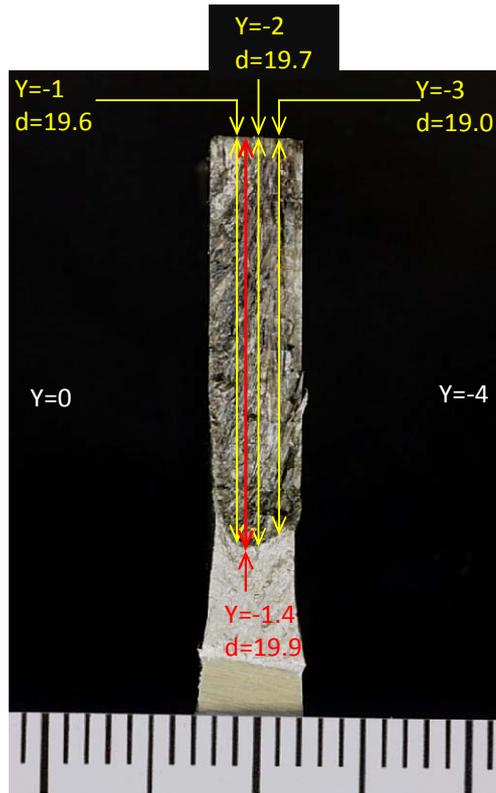
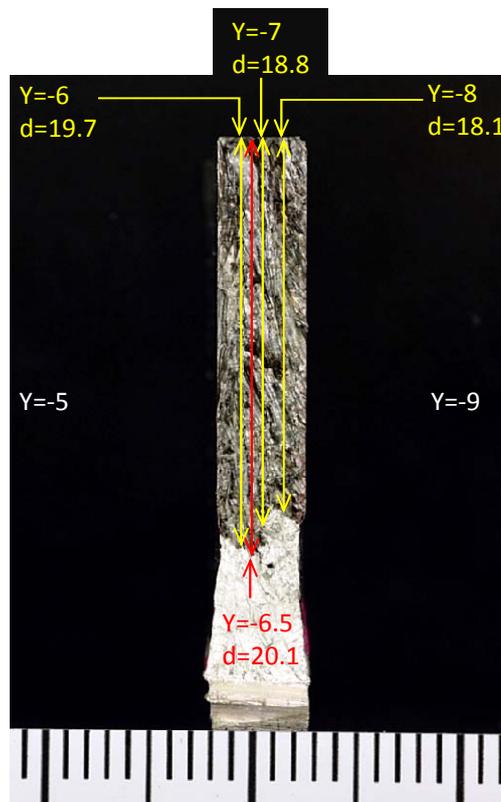
Fig. A-1.17 Detailed crack information at Y= 0 to -4 and Y= -5 to -9 fracture surface in P15 (JRV-S1)

Y=0 to Y= - 4 fracture surface

Y= - 5 to Y= - 9 fracture surface

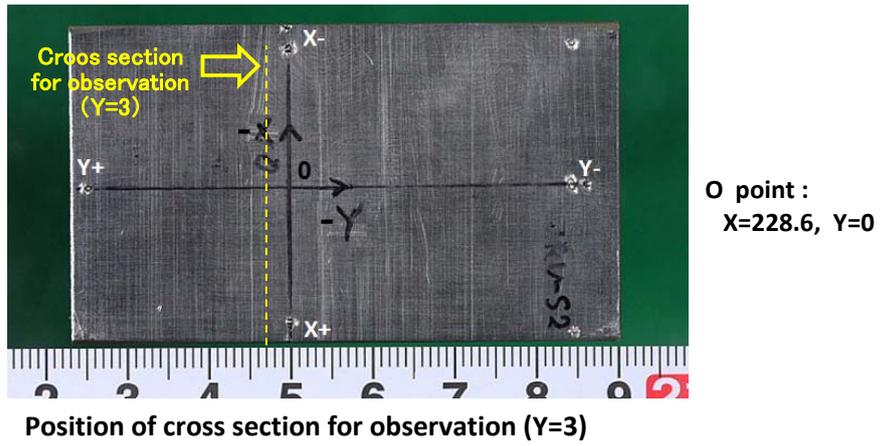
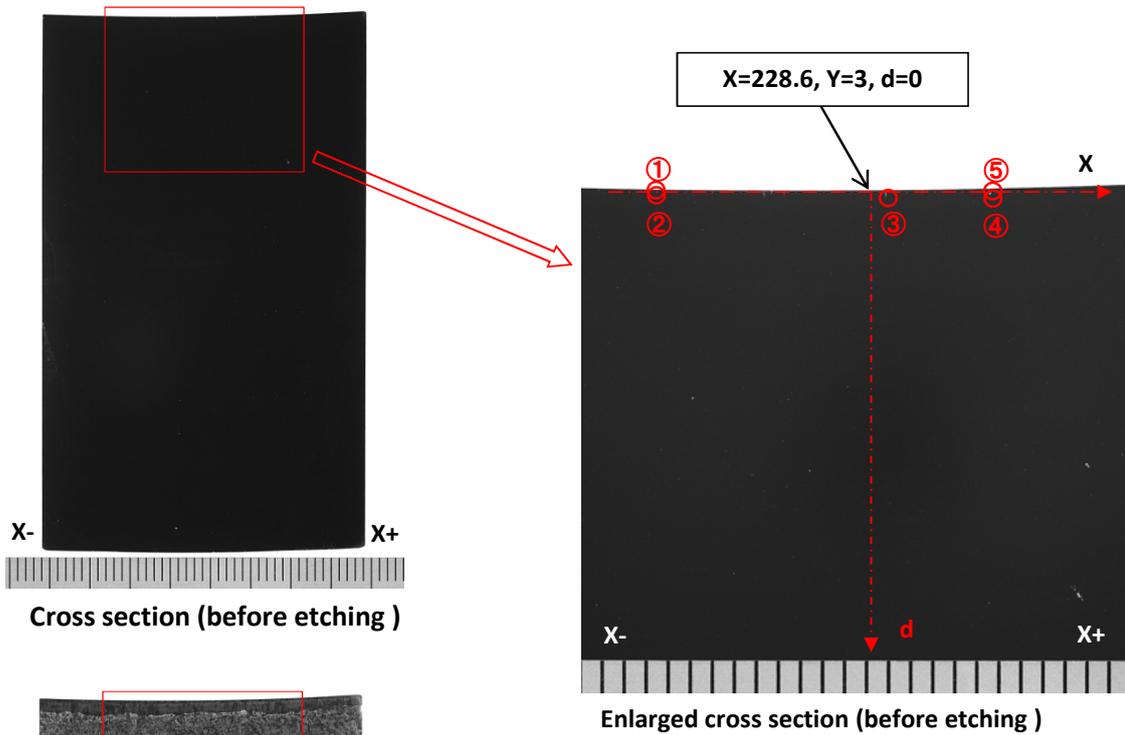
Fig. A-2.2 Detailed crack information at Y=3 section in P16 (JRV-S2)

Cross section Y (mm)	3.0
Max. crack depth info Z (mm)	67.8
Crack opening (μm)	15
Typical crack information	① X= 216.7 Z= 68.2
	② X= 216.7 Z= 68.1
	③ X= 229.3 Z= 67.8
	④ X= 234.9 Z= 67.9
	⑤ X= 234.9 Z= 68.2

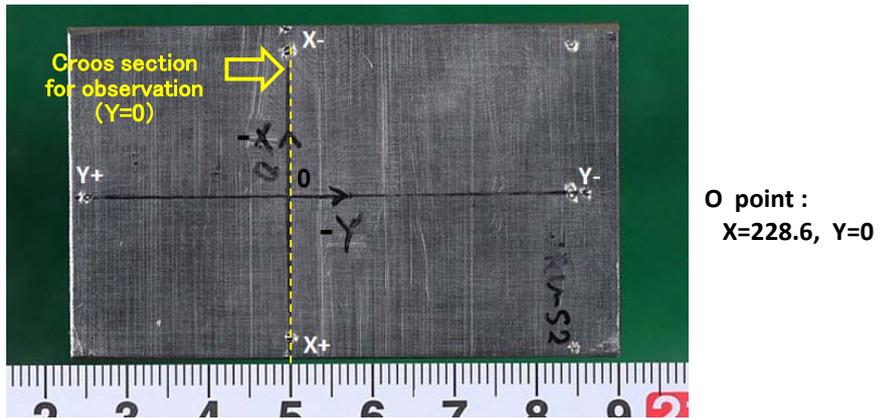
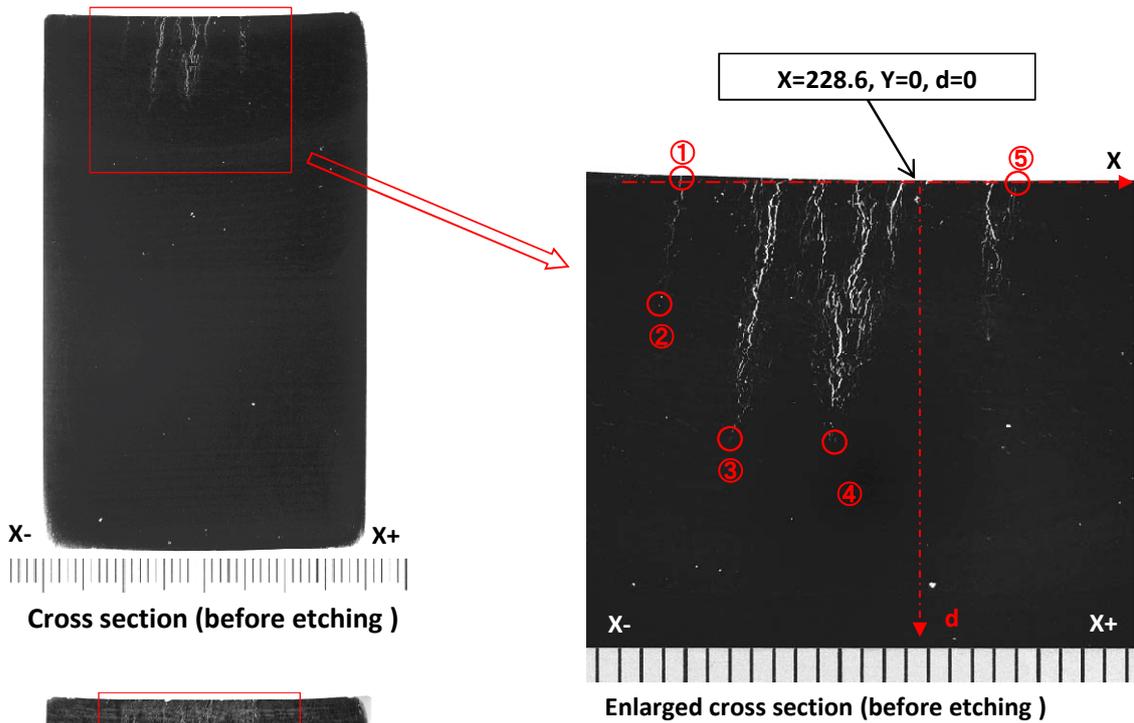
Fig. A-2.5 Detailed crack information at Y=0 section in P16 (JRV-S2)

Crack information	
Cross section Y (mm)	0.0
Max. crack depth info Z (mm)	56.1
Crack opening (μ m)	11
Typical crack information	① X= 215.6 Z= 68.2
	② X= 214.6 Z= 62.7
	③ X= 218.7 Z= 56.4
	④ X= 224.2 Z= 56.1
	⑤ X= 233.7 Z= 68.2

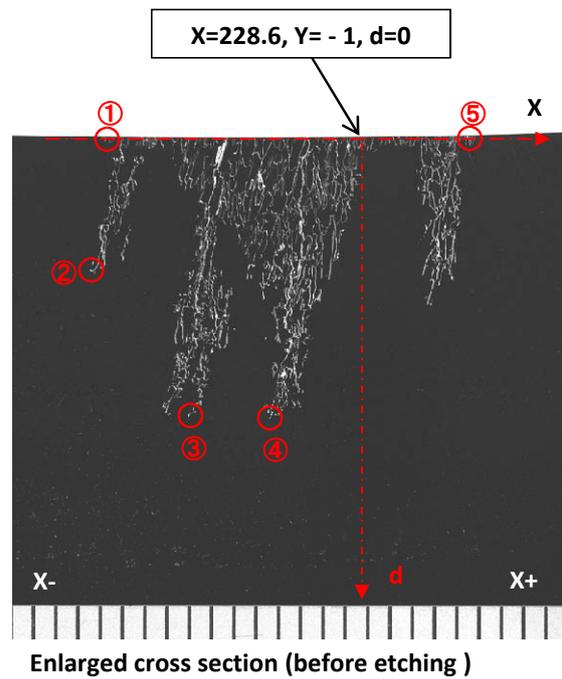
Fig. A-2.6 Detailed crack information at Y= - 1 section in P16 (JRV-S2)

Crack information	
Cross section Y (mm)	-1.0
Max. crack depth info Z (mm)	55.2
Crack opening (μm)	30
Typical crack information	① X= 214.5 Z= 68.2
	② X= 213.9 Z= 62.0
	③ X= 219.2 Z= 55.3
	④ X= 223.5 Z= 55.2
	⑤ X= 234.4 Z= 68.2

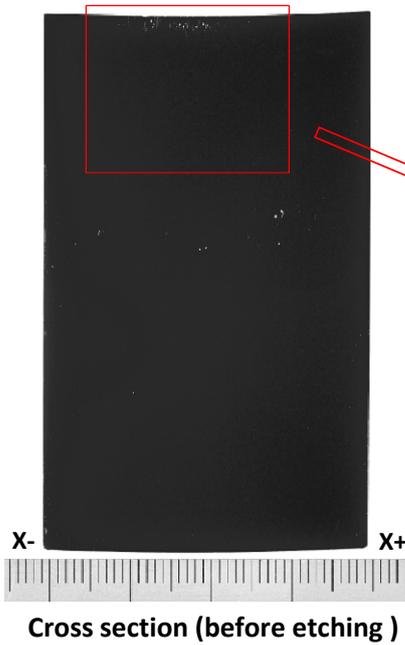
Position of cross section for observation (Y= -

Crack information	
Cross section Y (mm)	-6.0
Max. crack depth info Z (mm)	65.1
Crack opening (μm)	22.0
Typical crack information	① X= 215.7 Z= 68.2
	② X= 214.0 Z= 67.3
	③ X= 219.8 Z= 65.1
	④ X= 233.7 Z= 67.5
	⑤ X= 232.2 Z= 68.2

$Z = 68.2 - d$

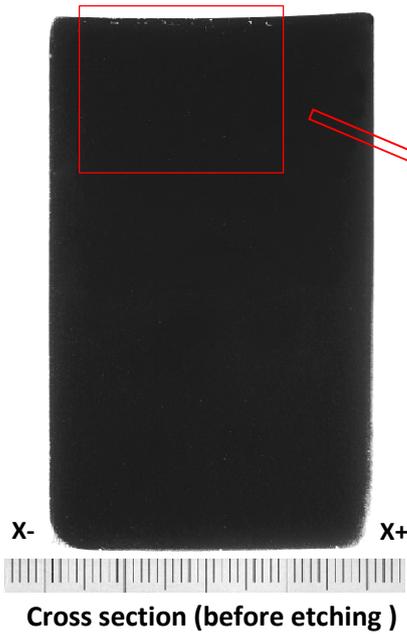
Position of cross section for observation (Y= - 7)

Crack information	
Cross section Y (mm)	-7.0
Max. crack depth info Z (mm)	66.5
Crack opening (μ m)	<1
Typical crack information	① X= 212.3 Z= 67.5
	② X= 216.3 Z= 68.2
	③ X= 226.4 Z= 66.5
	④ X= 232.8 Z= 68.2
	⑤ X= 236.1 Z= 67.2

Z = 68.2 - d

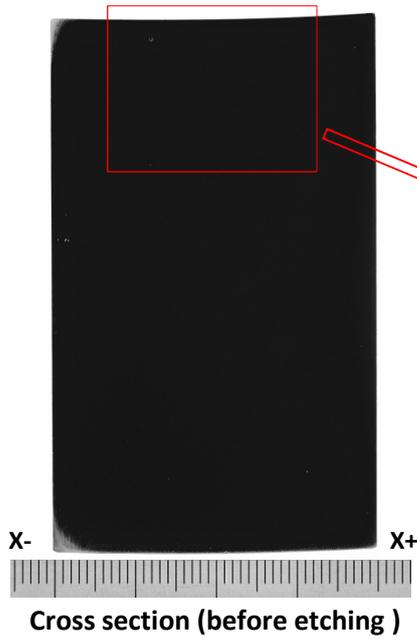
Position of cross section for observation (Y= - 10)

Crack information	
Cross section Y (mm)	-10.0
Max. crack depth info Z (mm)	68.1
Crack opening (μ m)	3.0
Typical crack information	① X= 224.8 Z= 68.2
	② X= 224.8 Z= 68.1
	③ X= 228.2 Z= 68.2

Z = 68.2 - d

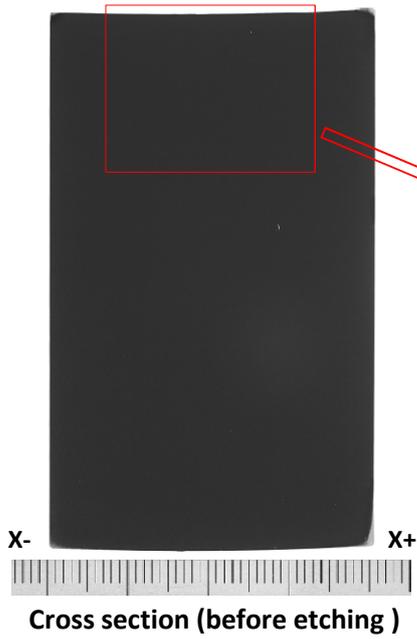
Position of cross section for observation (Y= - 11)

Crack information	
Cross section Y (mm)	-11.0
Max. crack depth info Z (mm)	68.0
Crack opening (μ m)	2.0
Typical crack information	① X= 224.6 Z= 68.2
	② X= 224.6 Z= 68.0
	③ X= 229.2 Z= 68.2

Z = 68.2 - d

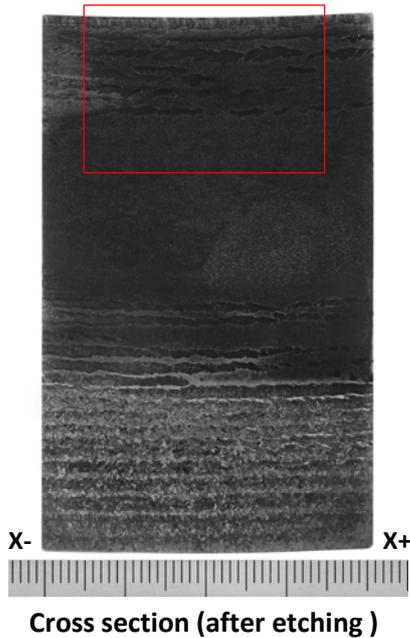
Position of cross section for observation (Y=4)

Crack information

Cross section Y (mm)	4.0
Max. crack depth info Z (mm)	67.9
Crack opening (μm)	<1
Typical crack information	① X= 225.7 Z= 68.2
	② X= 225.8 Z= 67.9
	③ X= 226.4 Z= 68.0
	④ X= 226.3 Z= 68.2

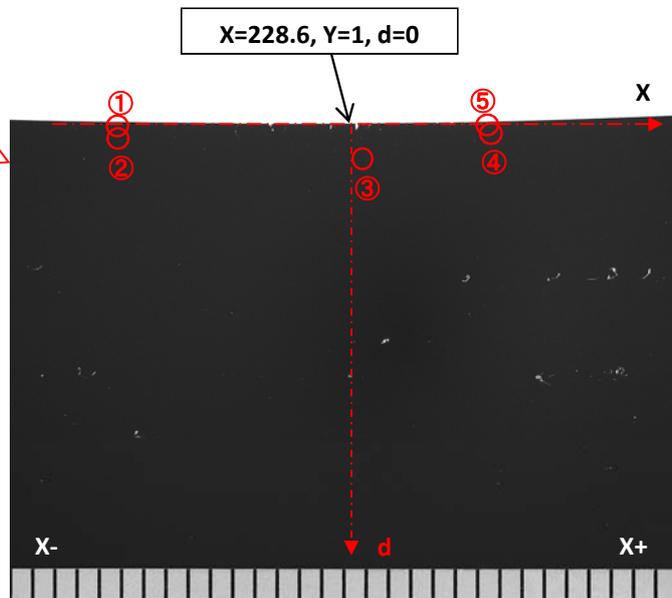
Fig. A-3.5 Detailed crack information at Y=1 section in P17 (JRV-S3)

Crack information	
Cross section Y (mm)	1.0
Max. crack depth info Z (mm)	66.8
Crack opening (μm)	<1
Typical crack information	① X= 215.7 Z= 68.2
	② X= 215.7 Z= 68.2
	③ X= 229.1 Z= 66.8
	④ X= 235.9 Z= 68.1
	⑤ X= 235.9 Z= 68.2

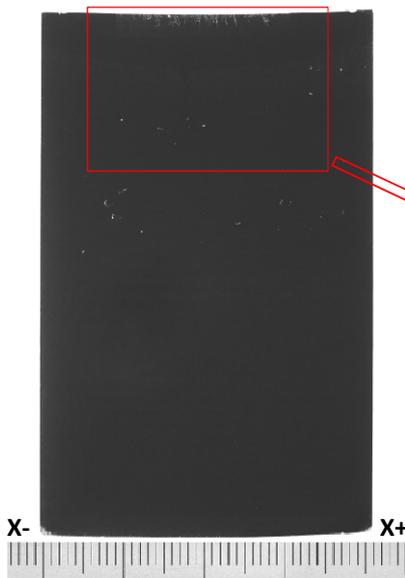
Position of cross section for observation (Y=0)

Cross section (before etching)

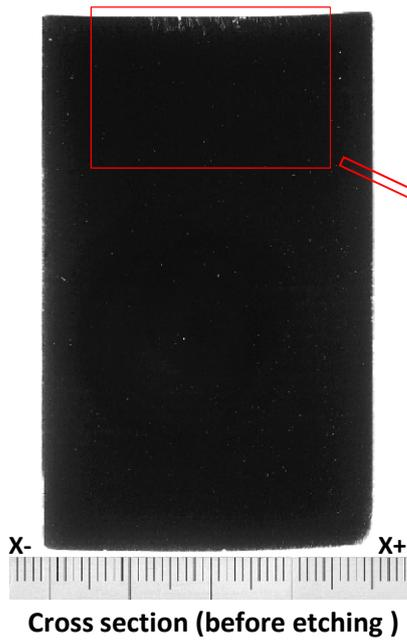
Position of cross section for observation (Y= - 2)

Crack information	
Cross section Y (mm)	-2.0
Max. crack depth info Z (mm)	65.8
Crack opening (μ m)	<1
Typical crack information	① X= 212.9 Z= 68.2
	② X= 220.0 Z= 66.1
	③ X= 225.7 Z= 65.8
	④ X= 235.7 Z= 66.1
	⑤ X= 244.1 Z= 68.2

Z = 68.2 - d

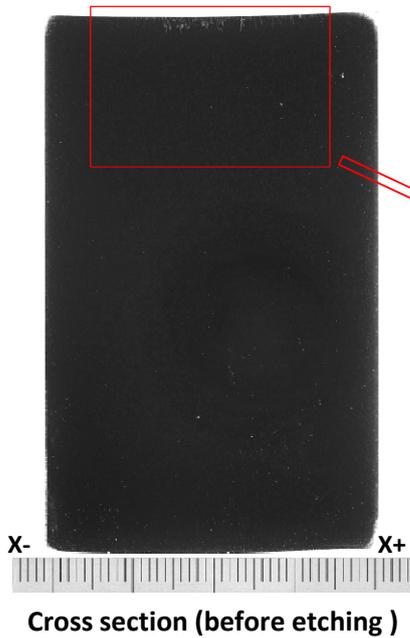
Position of cross section for observation (Y= - 3)

Crack information	
Cross section Y (mm)	-3.0
Max. crack depth info Z (mm)	66.0
Crack opening (μ m)	<1
Typical crack information	① X= 213.7 Z= 68.2
	② X= 219.7 Z= 66.1
	③ X= 226.1 Z= 66.0
	④ X= 230.5 Z= 66.3
	⑤ X= 243.6 Z= 68.2

Z = 68.2 - d

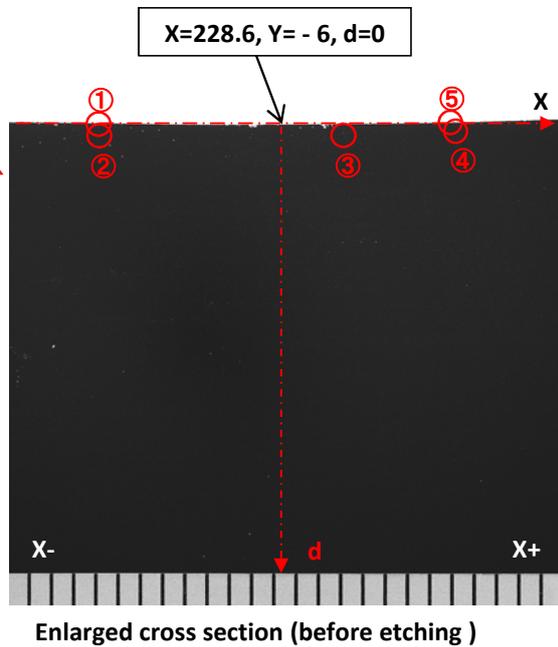
Fig. A-3.12 Detailed crack information at Y= - 6 section in P17 (JRV-S3)

Crack information	
Cross section Y (mm)	-6.0
Max. crack depth info Z (mm)	67.9
Crack opening (μm)	<1
Typical crack information	① X= 218.8 Z= 68.2
	② X= 218.7 Z= 68.1
	③ X= 231.8 Z= 67.9
	④ X= 237.8 Z= 68.1
	⑤ X= 237.8 Z= 68.2

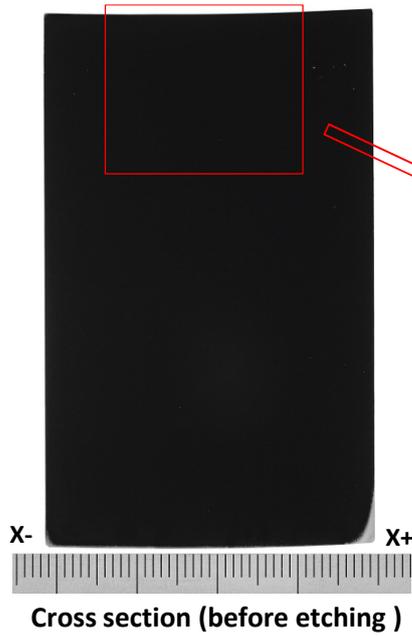
Position of cross section for observation (Y = - 9)

Crack information

Cross section Y (mm)	-9.0
Max. crack depth info Z (mm)	68.1
Crack opening (μm)	<1
Typical crack information	① X= 220.7 Z= 68.2
	② X= 225.4 Z= 68.1
	③ X= 232.5 Z= 68.2
