**STRESS CORROSION CRACK INITIATION OF COLD-WORKED
ALLOY 600 AND ALLOY 690 IN PWR PRIMARY WATER**

**Technical Milestone Report: M2LW-14OR0404023
PNNL-23712 September 2014**

Research Project:
**Stress Corrosion Crack Initiation of
Nickel-Base Alloys in LWR Environments**
Project Manager: S. M. Bruemmer
Pacific Northwest National Laboratory

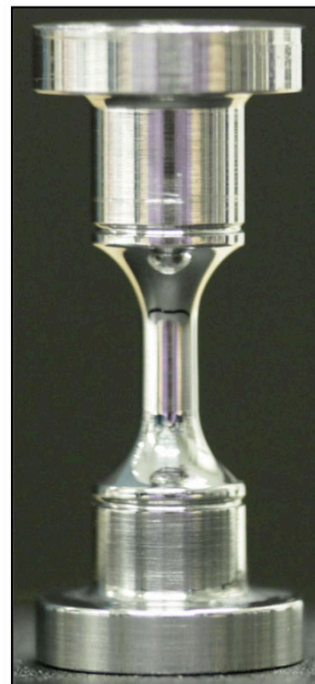
Figure 1. PNNL 1.2" tall SCC tensile initiation specimen.

Several factors played into the specific design of the tensile specimens employed for SCC initiation testing, however the most important of which was maximizing the ability of DCPD to detect crack initiation. One practical issue was the desire to have an initiation specimen size that fit within the dimensions of a 0.5T CT specimen such that any material prepared for SCC crack growth studies could also be used for SCC crack initiation studies. The final tensile design was refined to the point that a crack initiation specimen could be cut from an SCC-tested 0.5T CT specimen as long the crack length to width ratio (a/W) in the CT specimen did not exceed 0.7. This a/W is below the range of typical crack lengths in SCC studies conducted by PNNL allowing routine extraction of crack initiation specimens as desired. Other factors that went into the design were a need to electrically isolate the specimen and eliminate any significant stress risers. A photograph of the final design is shown in Figure 1.

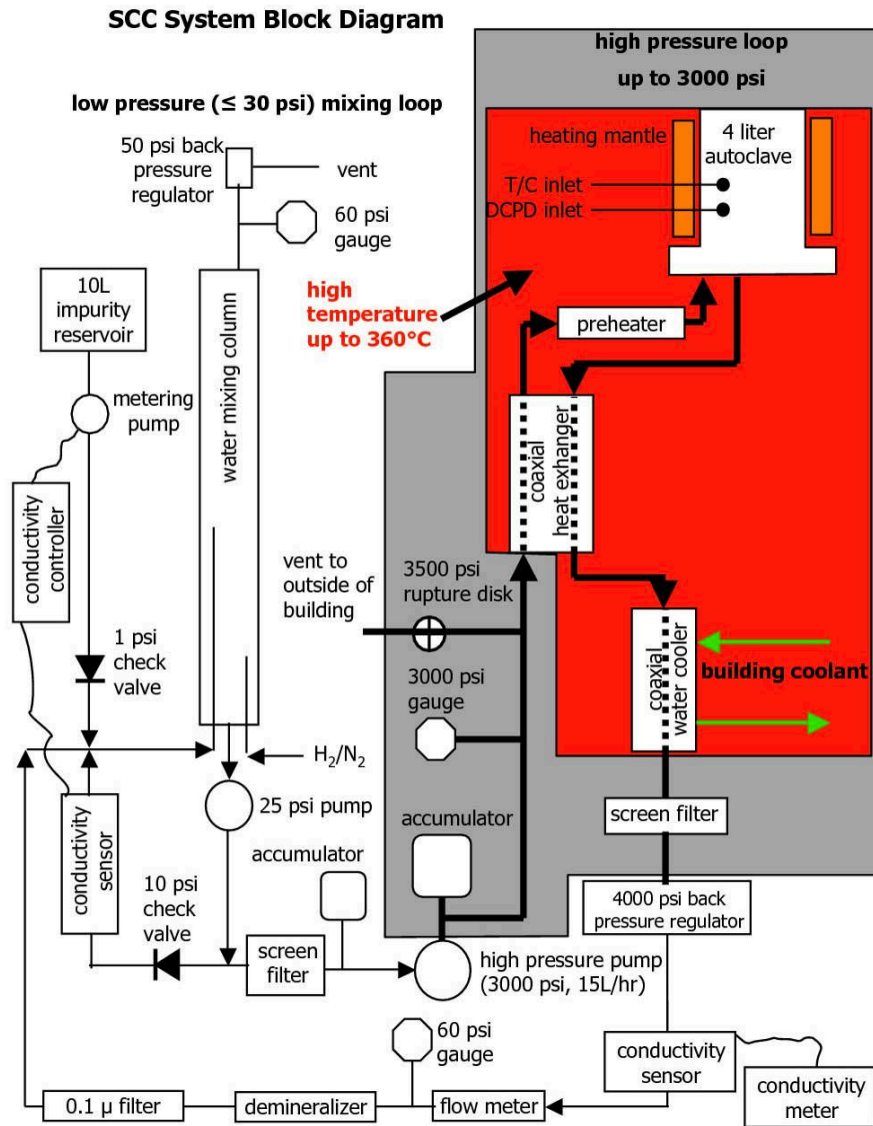
Figure 2. General water flow diagram for PNNL SCC crack-growth and initiation test systems.

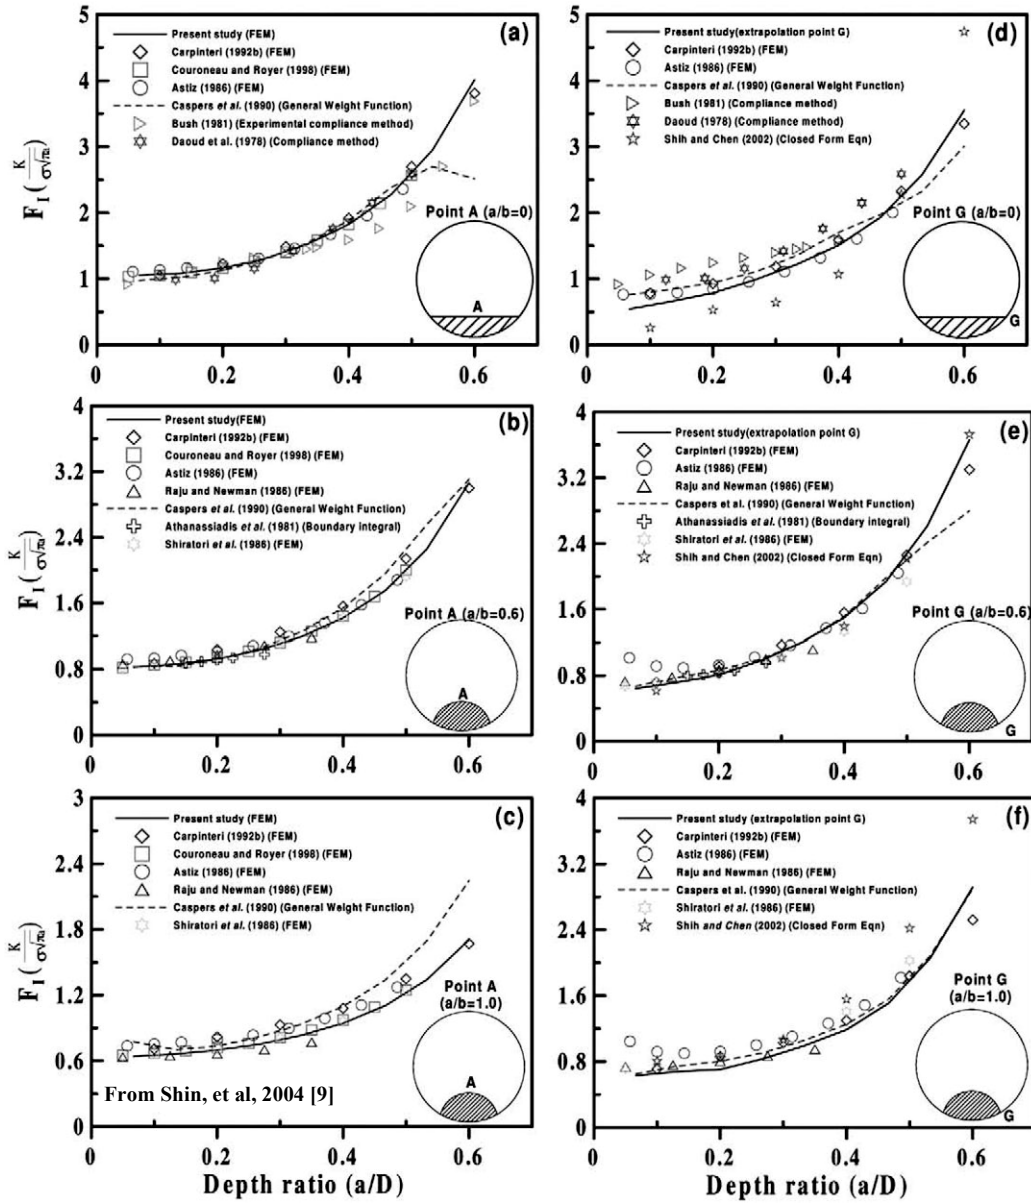
Figure 7. Dimensionless stress intensity factor at either the center or edge of the crack plotted against a/D for three different crack shapes as given by Shin [9].

F_I is typically plotted or tabulated against a/D as defined in Figure 6. One of the more concise results provided by Shin [9] in Figure 7 reveals that F_I is ~ 0.8 for likely crack shapes having a depth of $\sim 150 \mu\text{m}$ ($a/D = 0.05$).

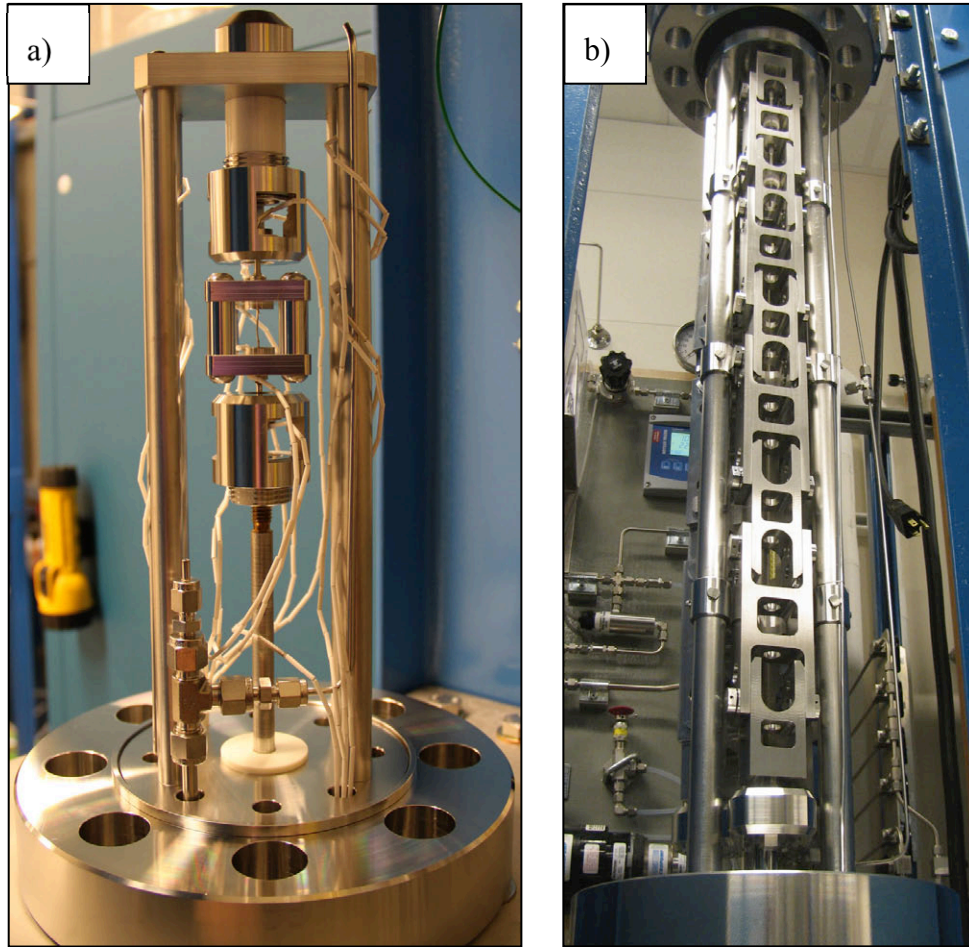
Figure 8. Crack initiation test system load trains at PNNL for (a) 1-3 specimens and (b) up to 36 specimens.

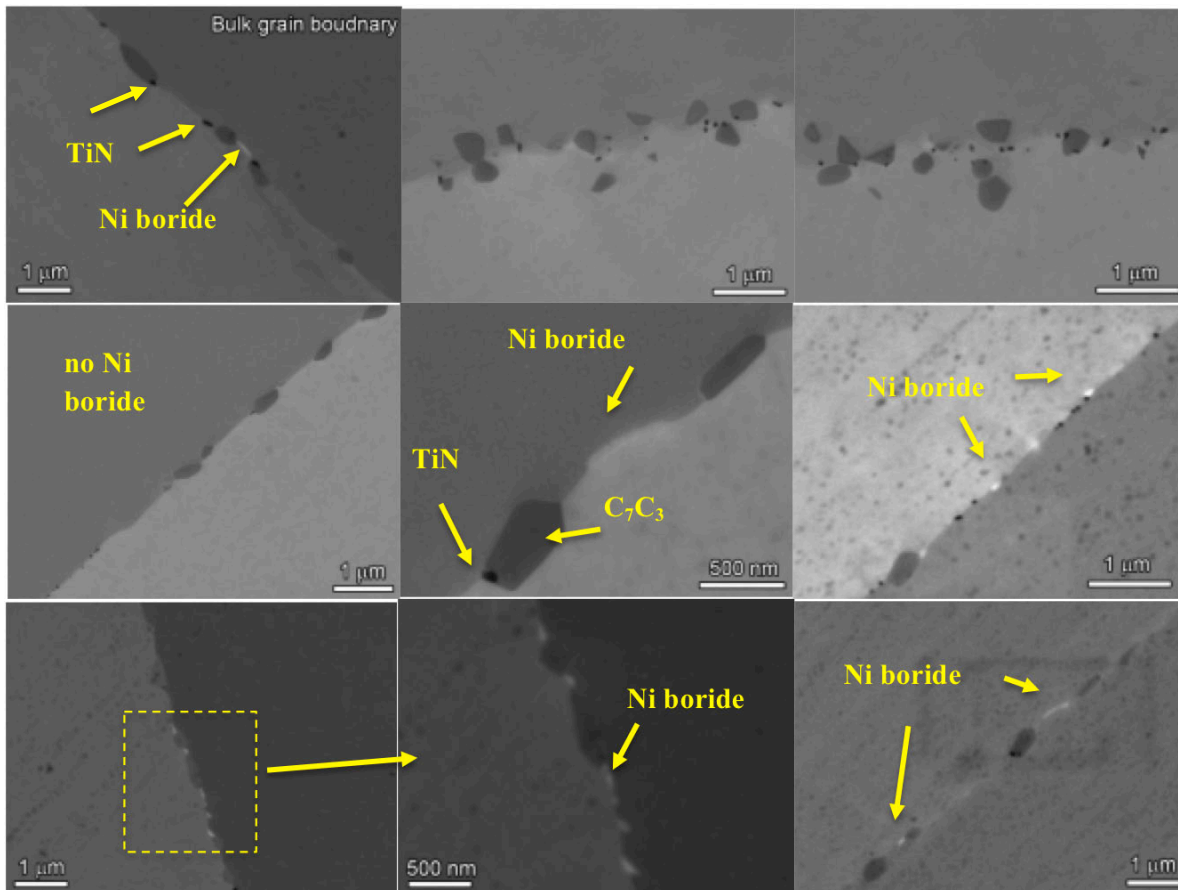
Figure 16. SEM (BSE) images illustrating the general microstructures in the mill-annealed alloy 600 CRDM heat M3935 material at higher magnification illustrating the distribution of Cr_7C_3 , TiN and Ni borides on the grain boundaries.

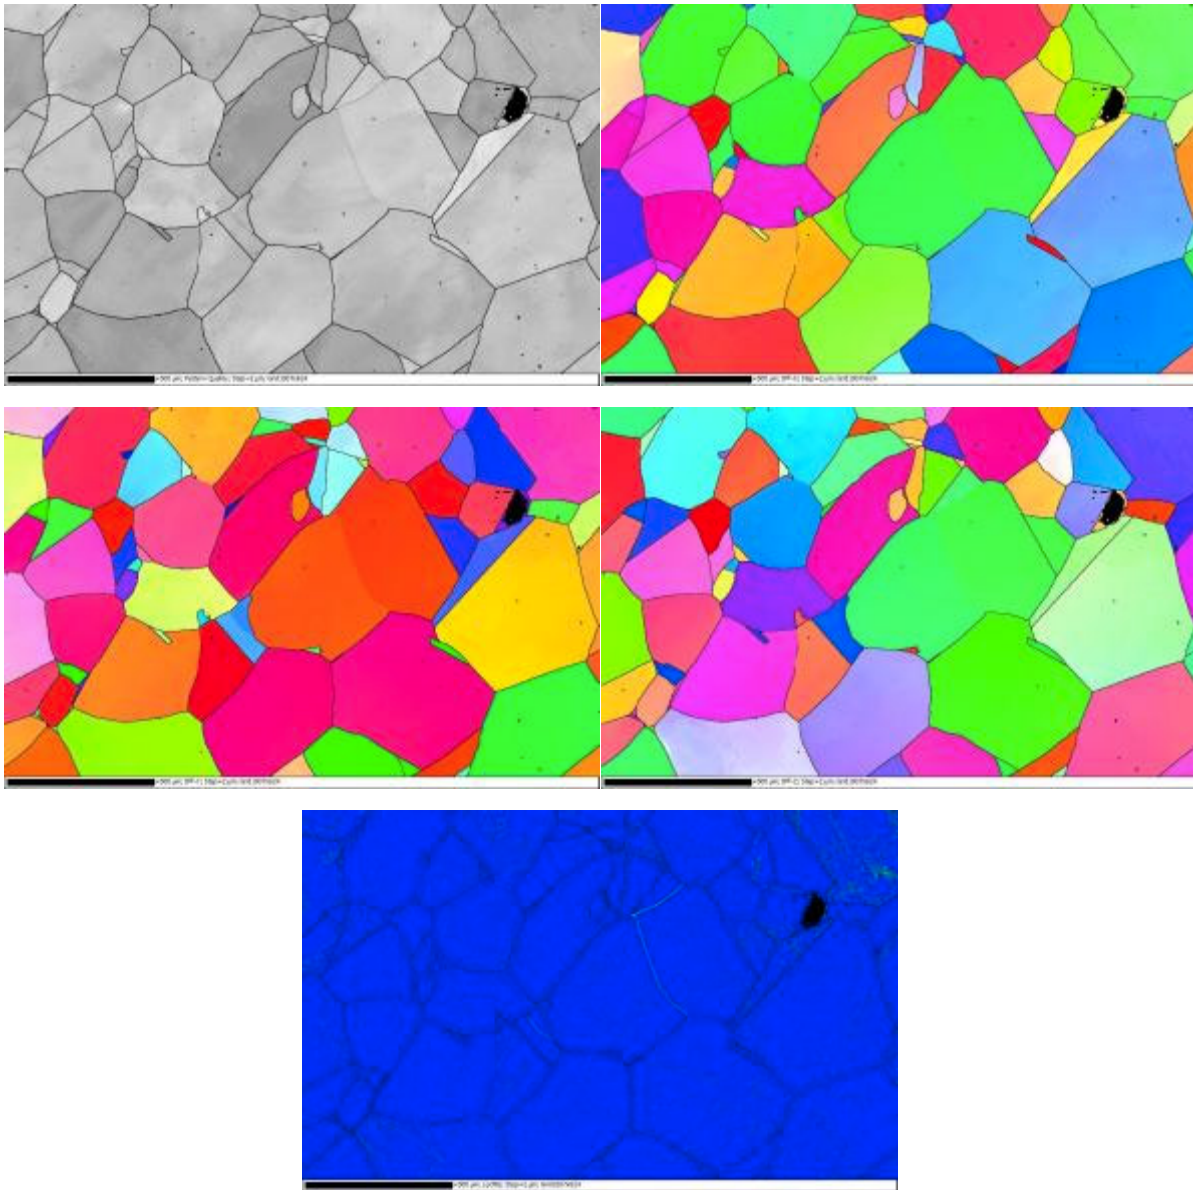
Figure 17. EBSD pattern quality map is shown in upper left image, inverse pole figure maps in upper right (X orientation), middle left (Y orientation) and middle right (Z orientation) images along with misorientation density map in bottom center for Davis Besse heat M3935.

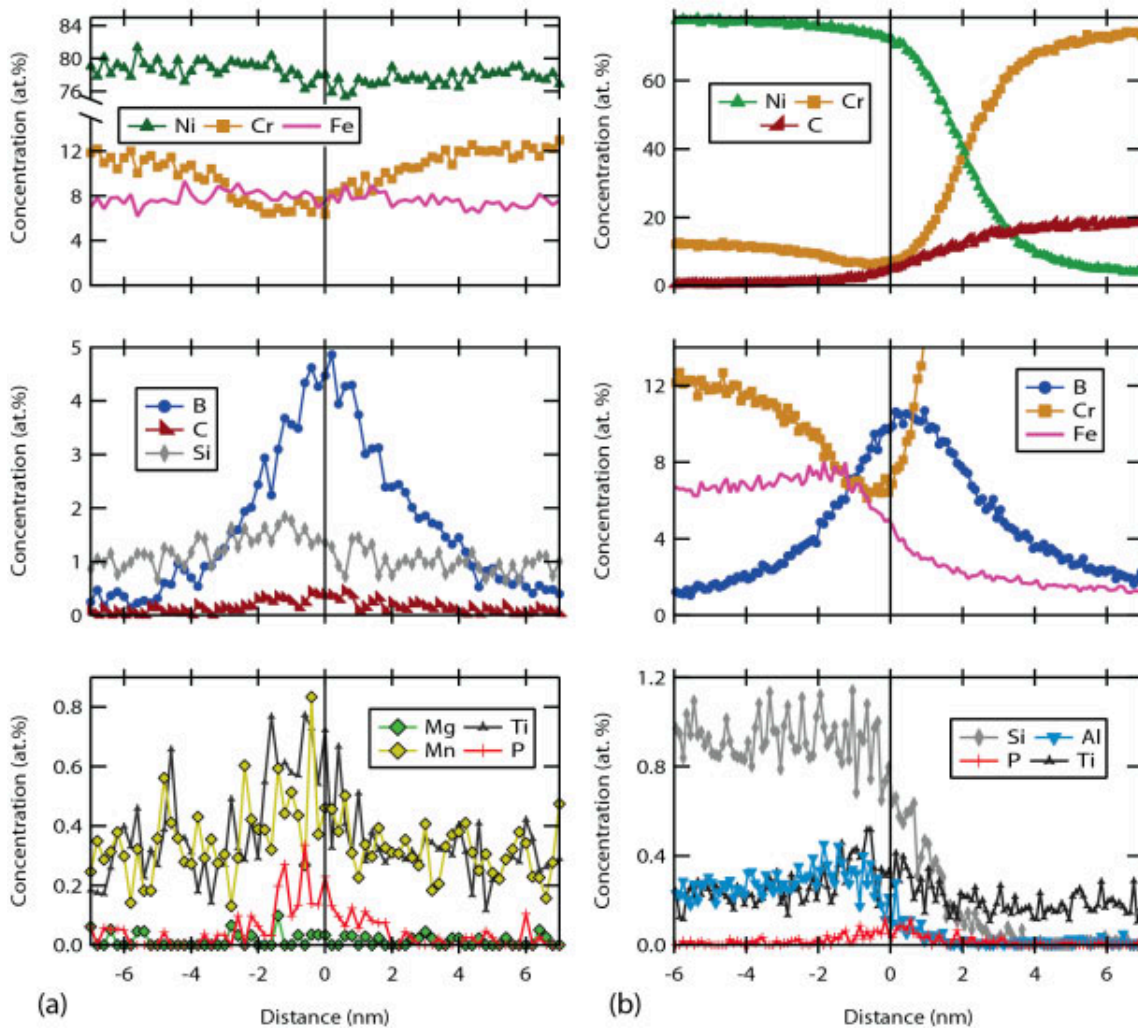
Figure 23. Concentration profiles across (a) the metal/metal grain boundary and (b) across the IG Cr carbide / metal interface in Davis Besse CRDM heat M3935. Both types of interfaces exhibit particularly strong B segregation (5 at% and 11 at%, respectively) and Cr depletion (< 8 at% each). Relatively strong P segregation is apparent at each interface (~ 0.2 at%) and no significant Si segregation is observed.

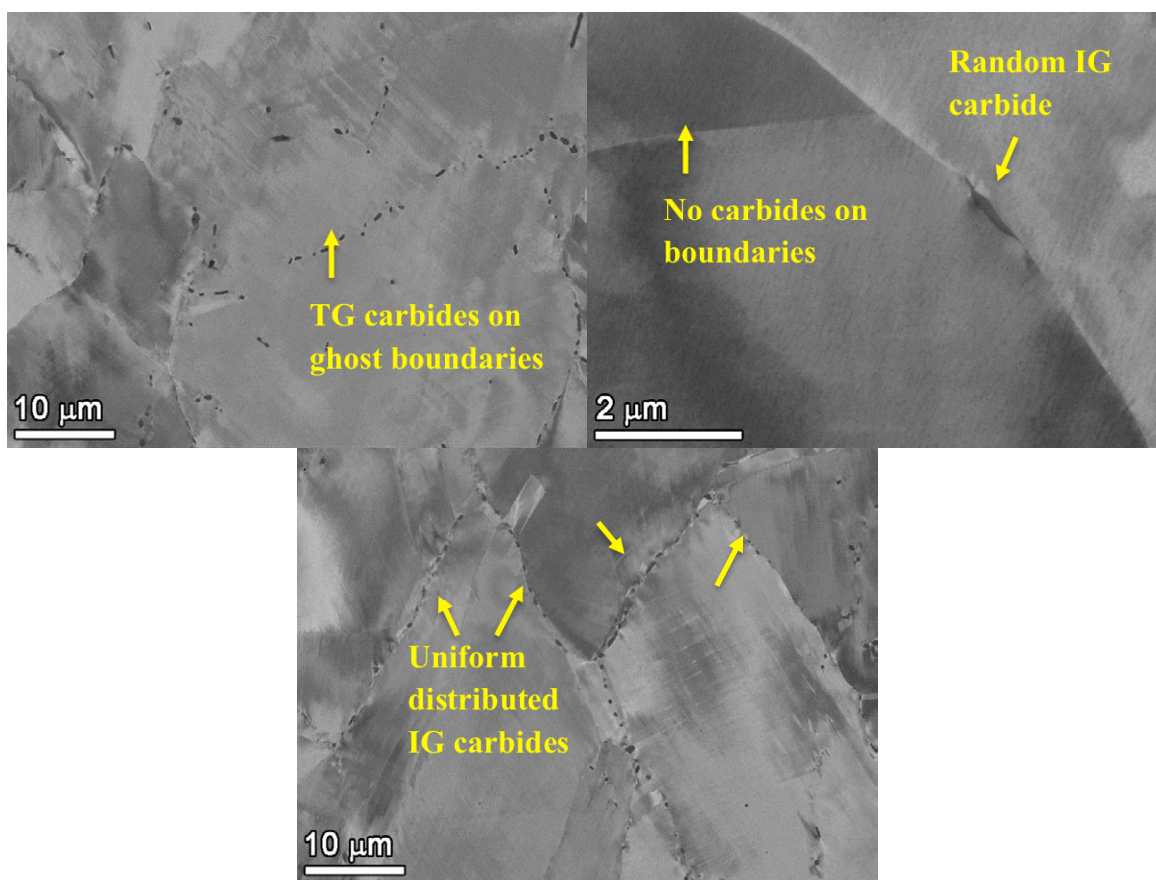
Figure 26. SEM (BSE) micrographs illustrating the microstructure of plate material NX6106XK-11 and the intergranular nature of the carbides.

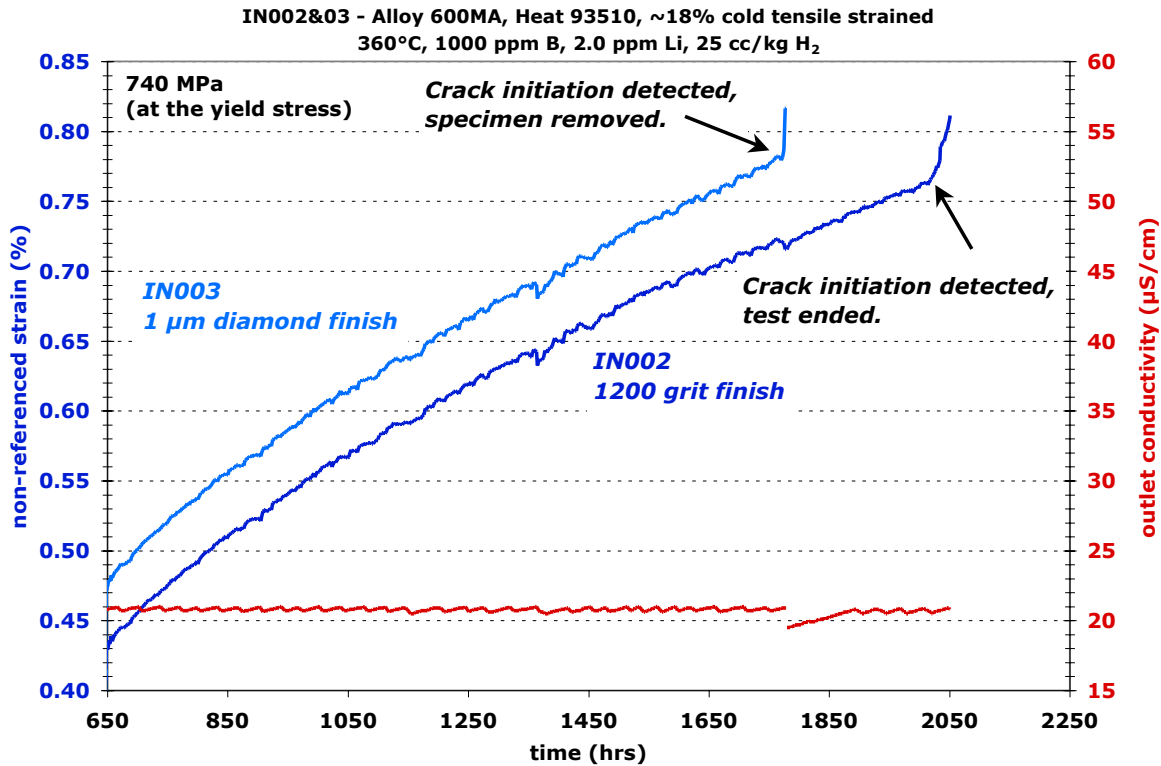
Figure 27. SCC crack initiation tests on 18% tensile prestrained alloy 600 CRDM Heat 93510.

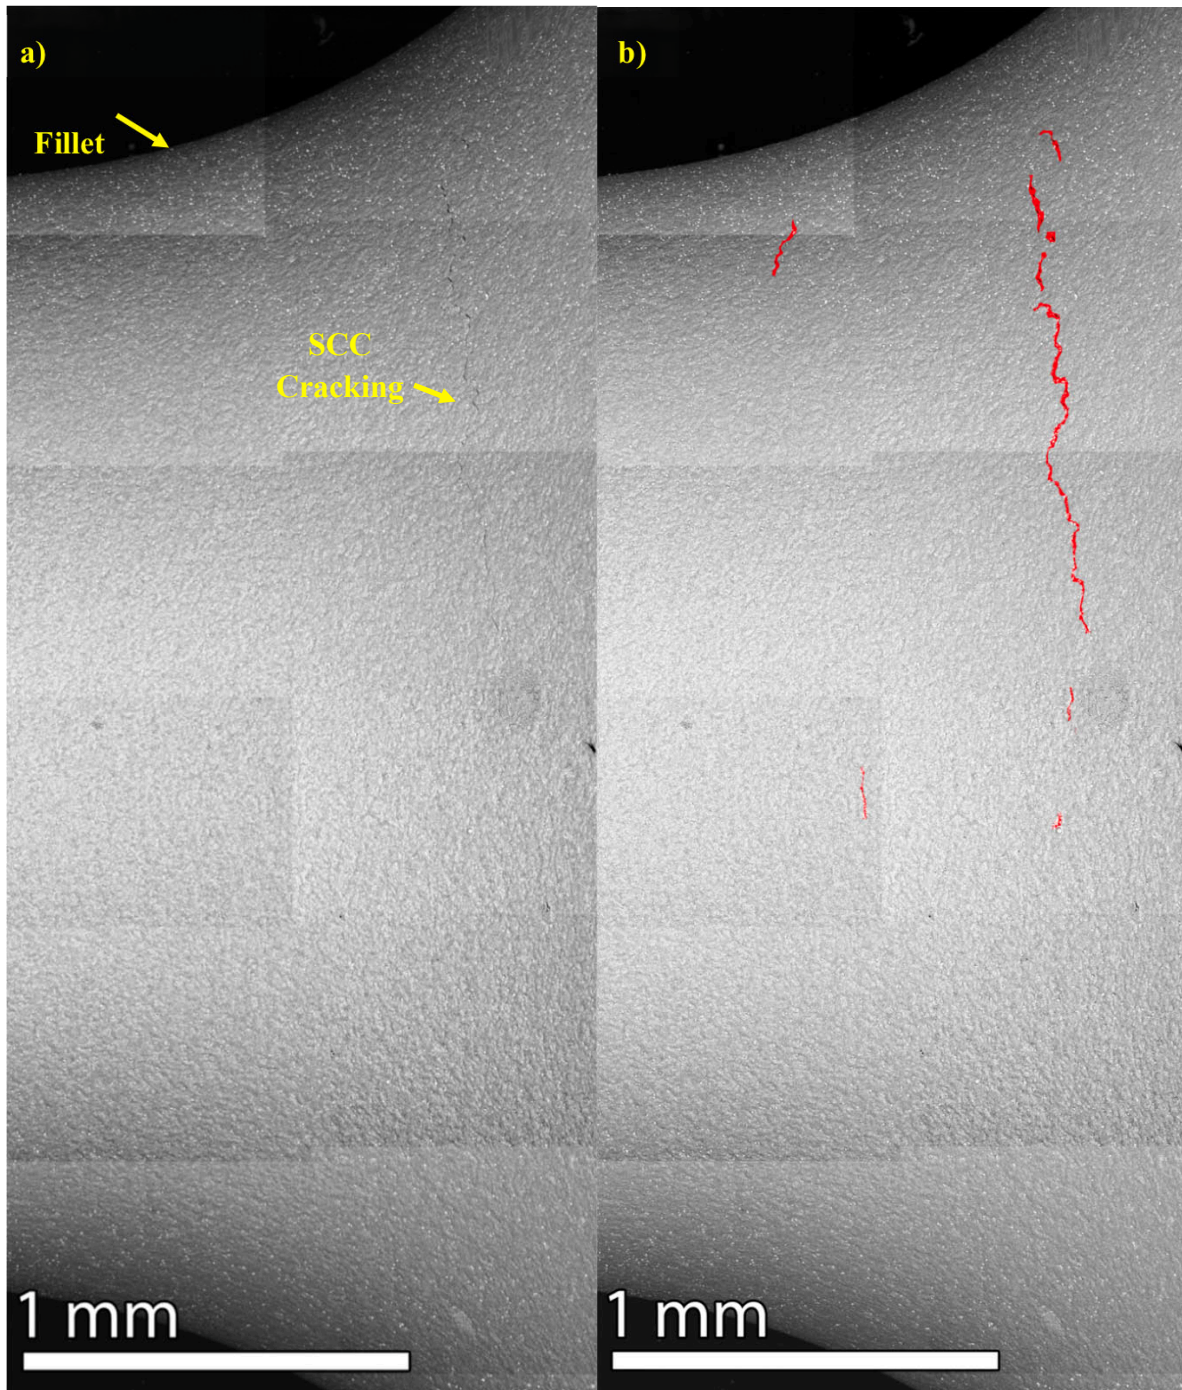
Figure 28. SEM (BSE) images of the alloy 600 tensile initiation specimen IN003 surface that exhibited cracking near the fillet. Image (b) is identical image to (a), but cracks have been colored red as guide to the eye. The longest crack observed in this region was nearly 1 mm in length.

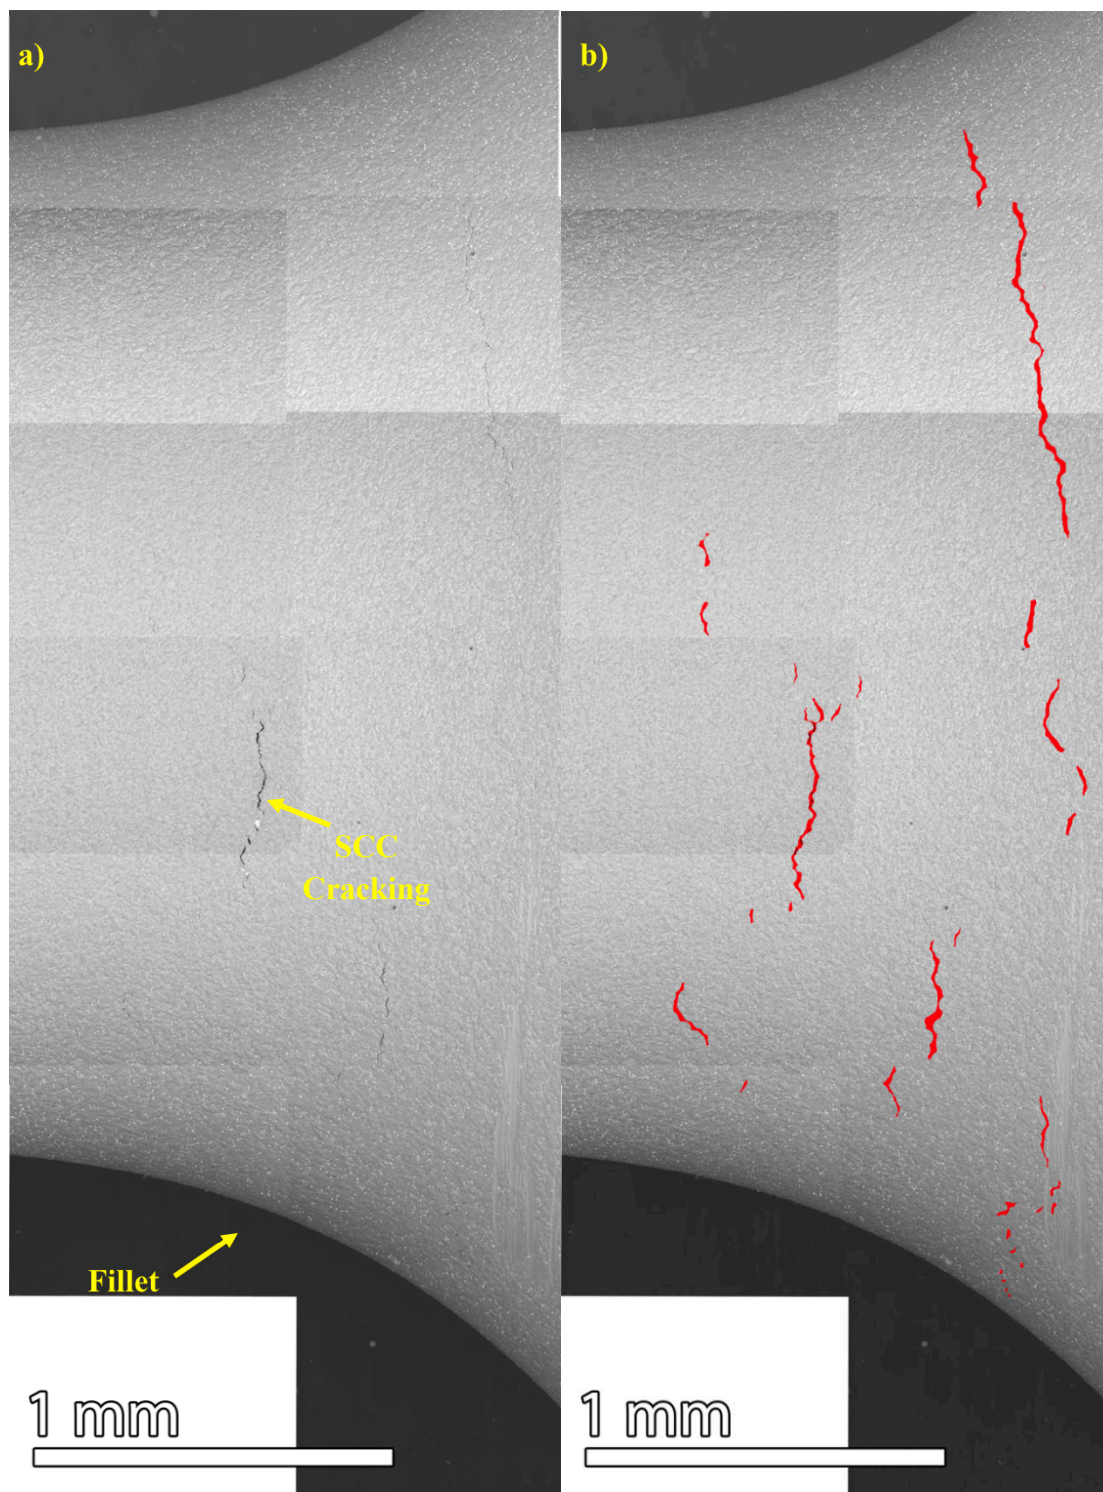
Figure 29. SEM (BSE) image of the alloy 600 tensile initiation specimen IN003 (rotated 120° from Figure 28) that exhibits cracking near the fillet. Image (b) is the identical image but cracks have been colored red as guide to the eye. SCC cracks were observed with a circumferential length as long as ~1 mm.

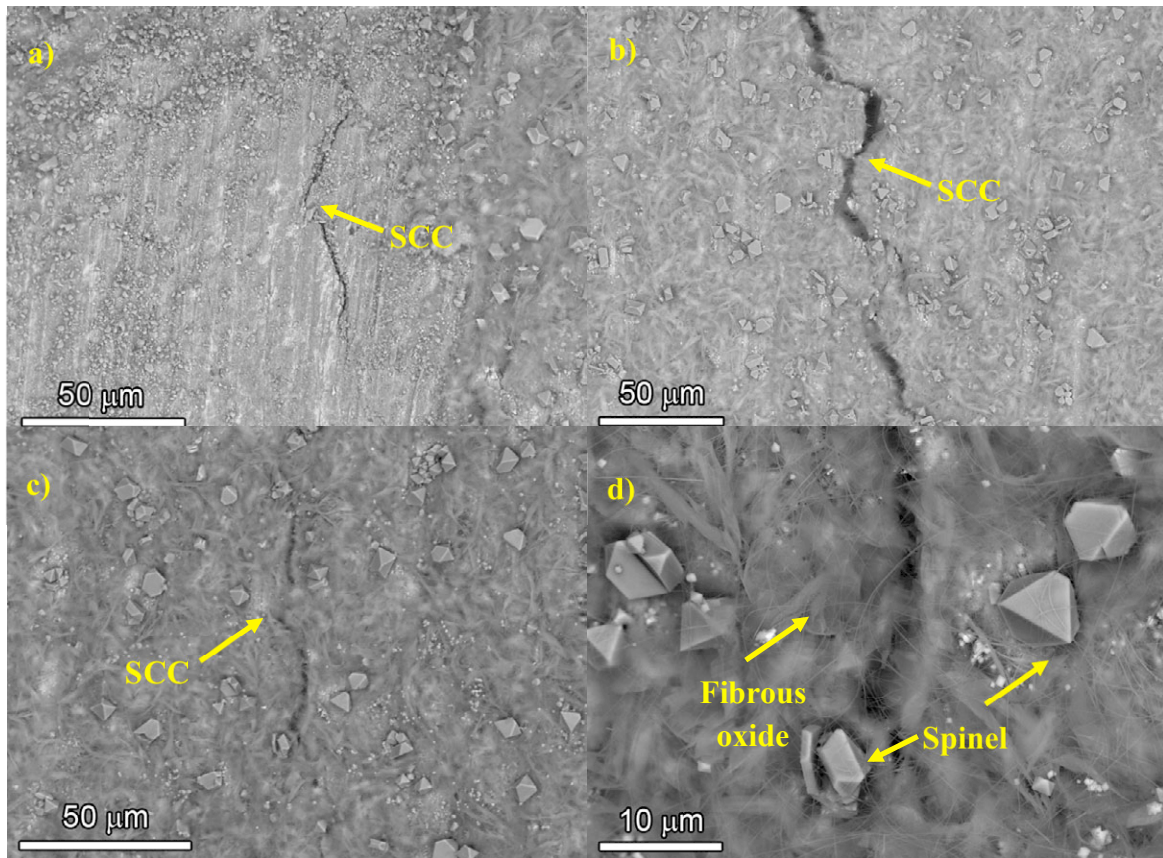
Figure 30. Low magnification SEM (BSE) images of the surface of the IN003 alloy 600 tensile initiation specimen illustrating various SCC cracks and surface oxides.

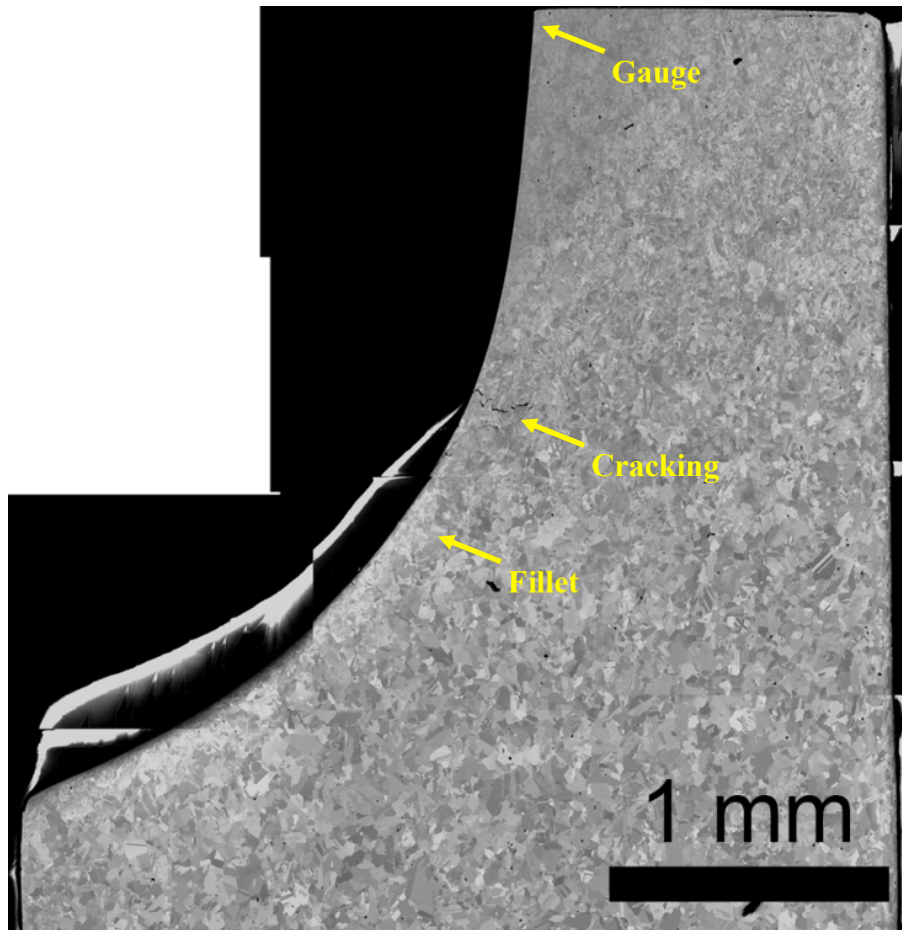
Figure 31. SEM (BSE) images of a cross-section from the alloy 600 tensile initiation specimen IN003 that exhibited cracking near the fillet. Note that strain contrast in the gauge section obscures the grain morphology.

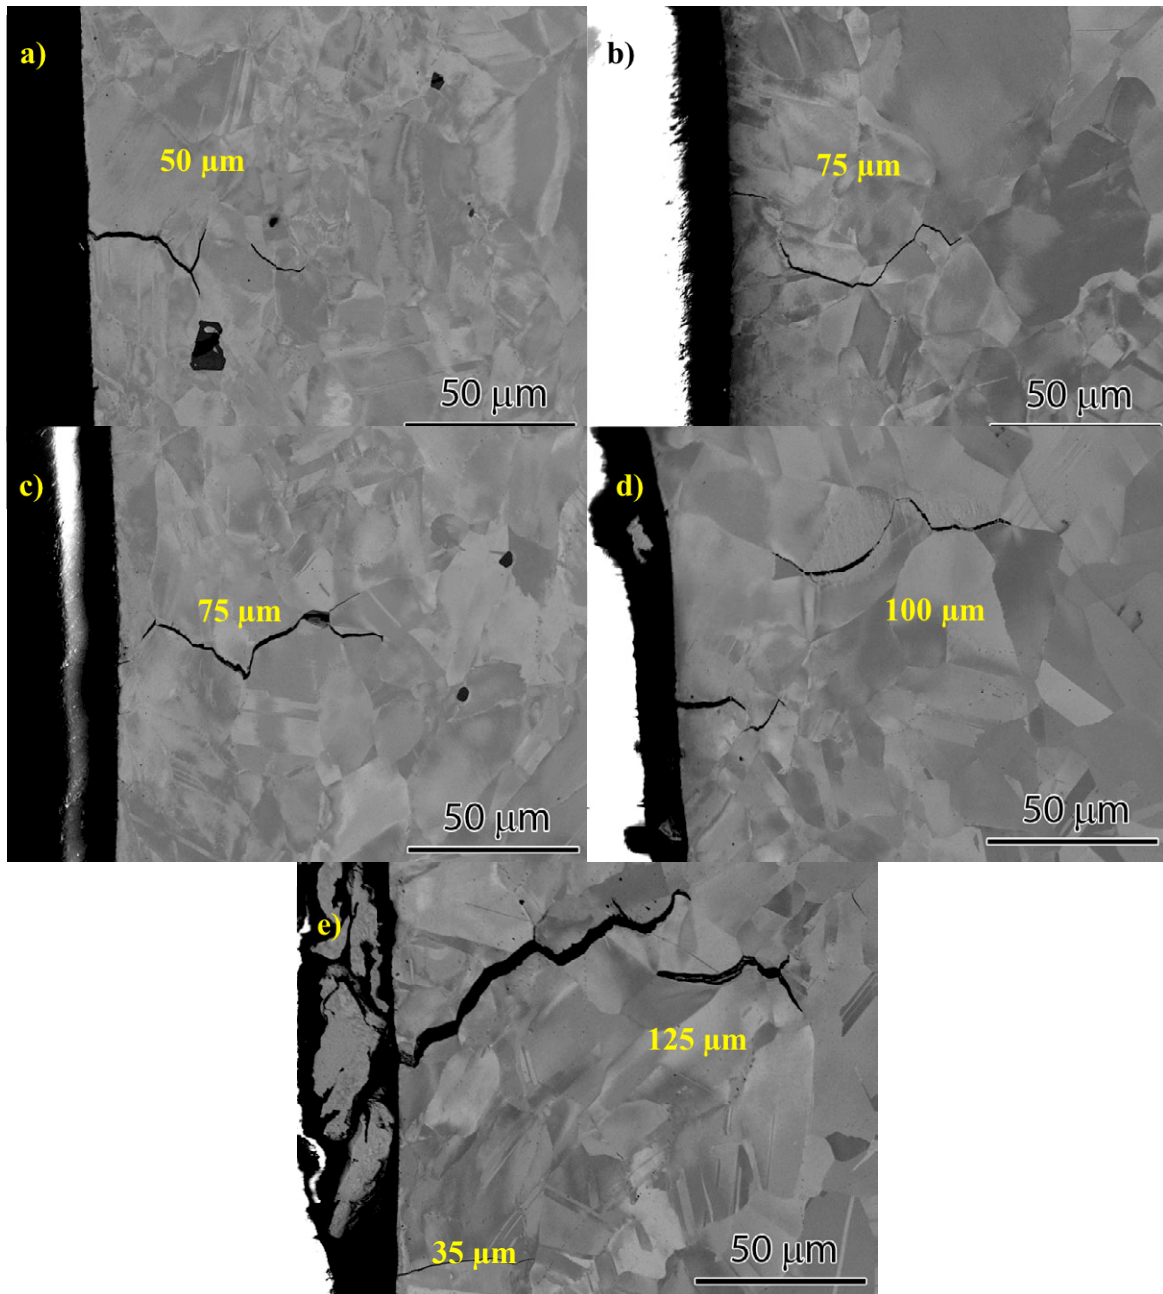
Figure 32. SEM-BSE images of a cross-section for the alloy 600 tensile initiation specimen IN003 showing deep SCC cracks initiating from the surface. Apparent crack depths are listed for each figure.

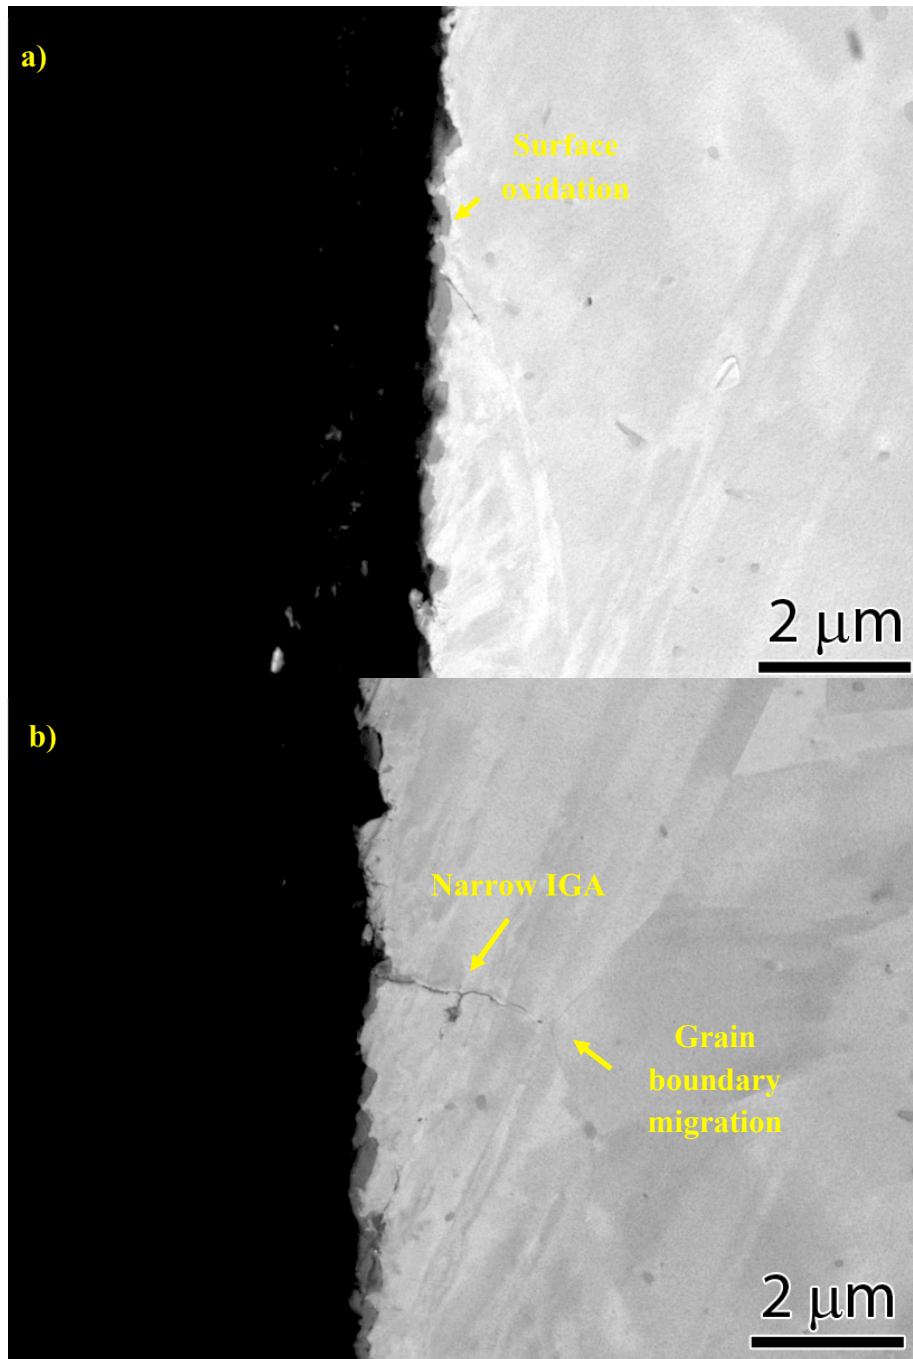
Figure 33. SEM-BSE images of a cross-section for the alloy 600 tensile initiation specimen IN003 illustrating representative TG (surface oxidation) and IG corrosion in the gauge section.

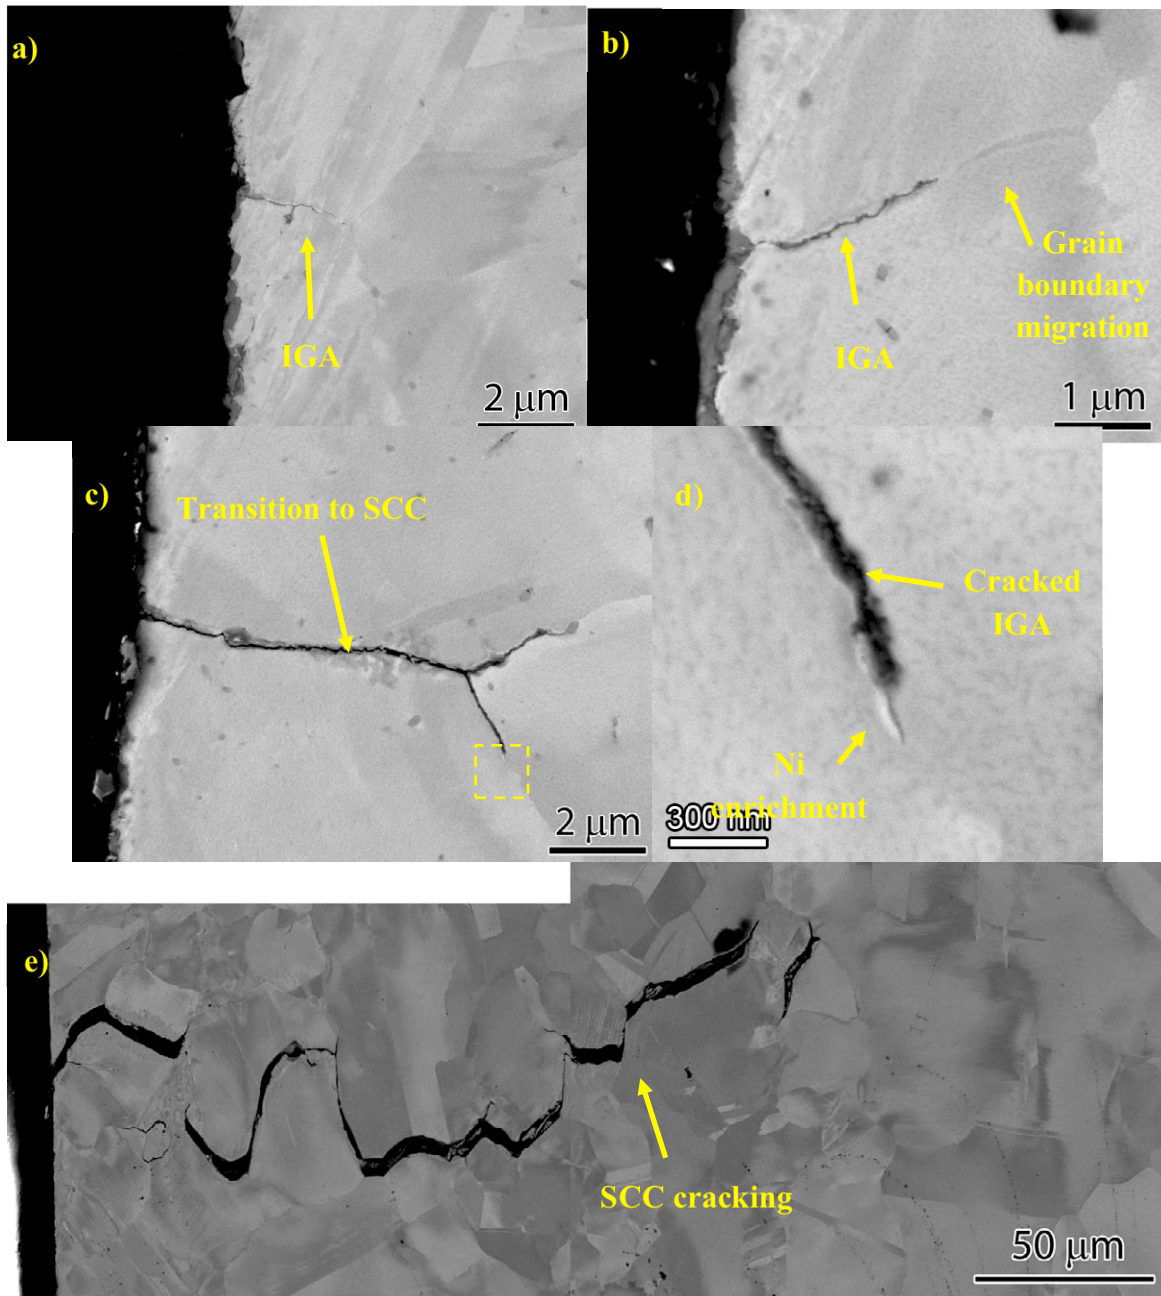
Figure 34. SEM-BSE images of the cross-section for the alloy 600 initiation specimen IN003 highlighting various stages of SCC cracking: (a,b) IG attack in gauge section without cracks, (c,d) IG attack transitioning to an IGSCC crack and e) a long IGSCC crack in the fillet region.

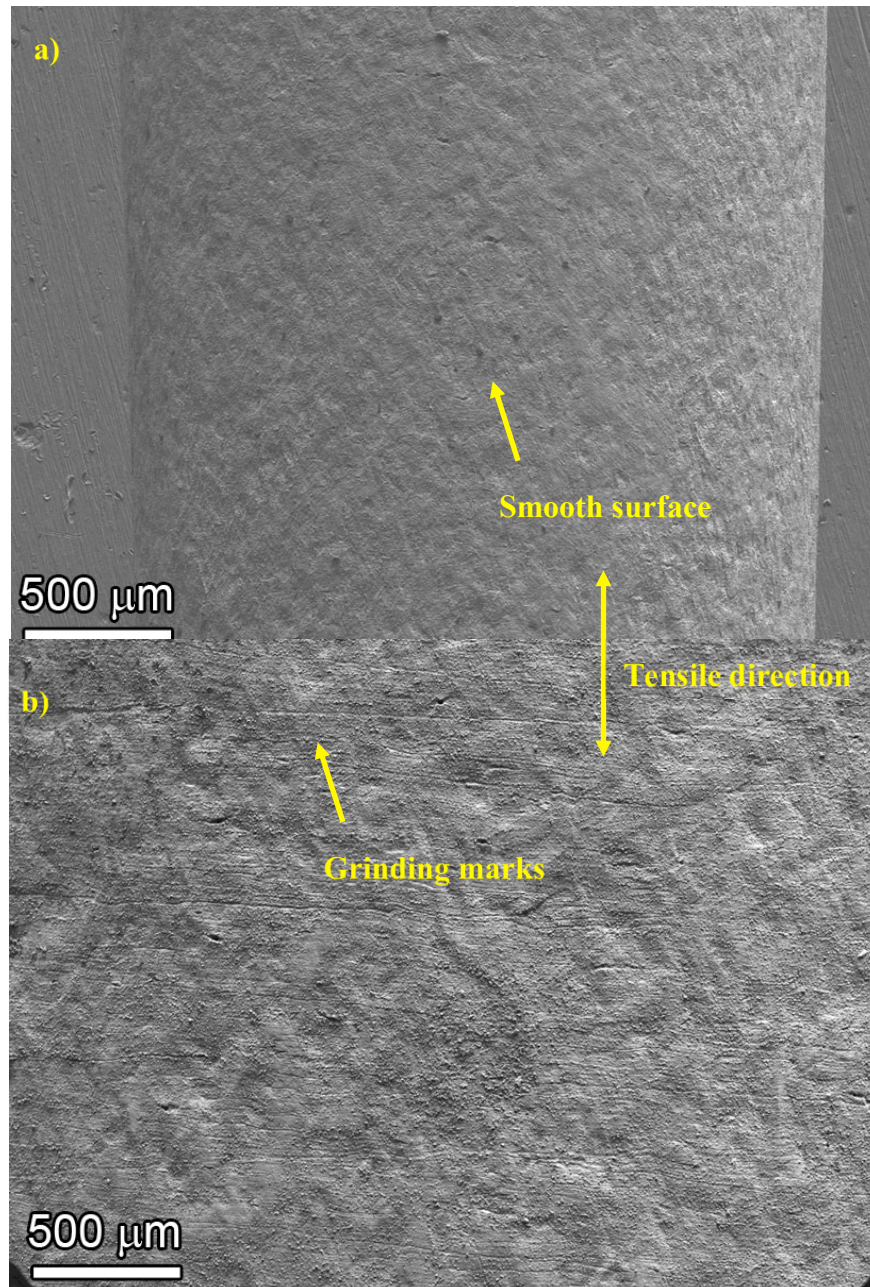
Figure 35. SEM-SE images of exposed surfaces for the alloy 600 initiation specimens that had a) highly polished gage section surface (IN003) or b) surfaces polished to 1 μm and then ground with 1200 grit SiC ground gage section surface (IN002).

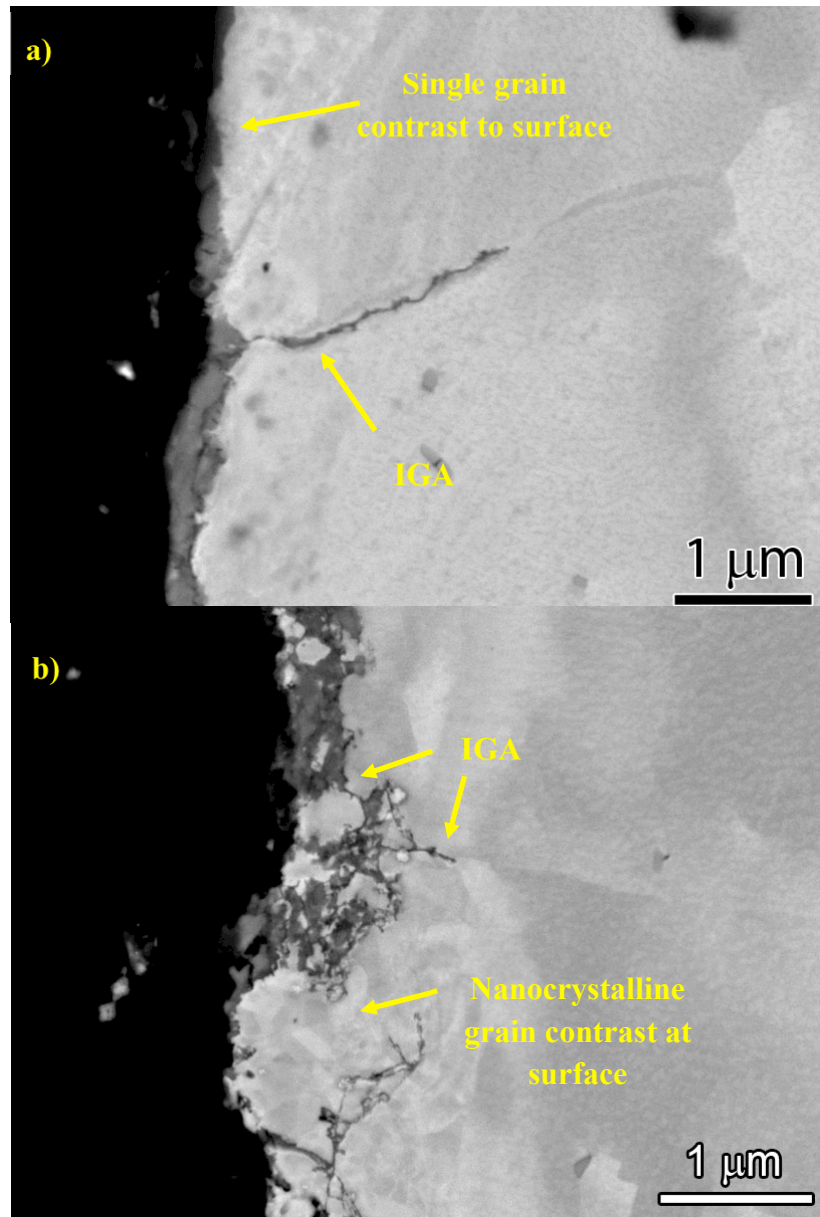
Figure 36. SEM-BSE images of cross-sections from the alloy 600 initiation specimens with surfaces of 1 μm diamond (IN003) and 1200 grit SiC (IN002) after exposure to PWR primary water.

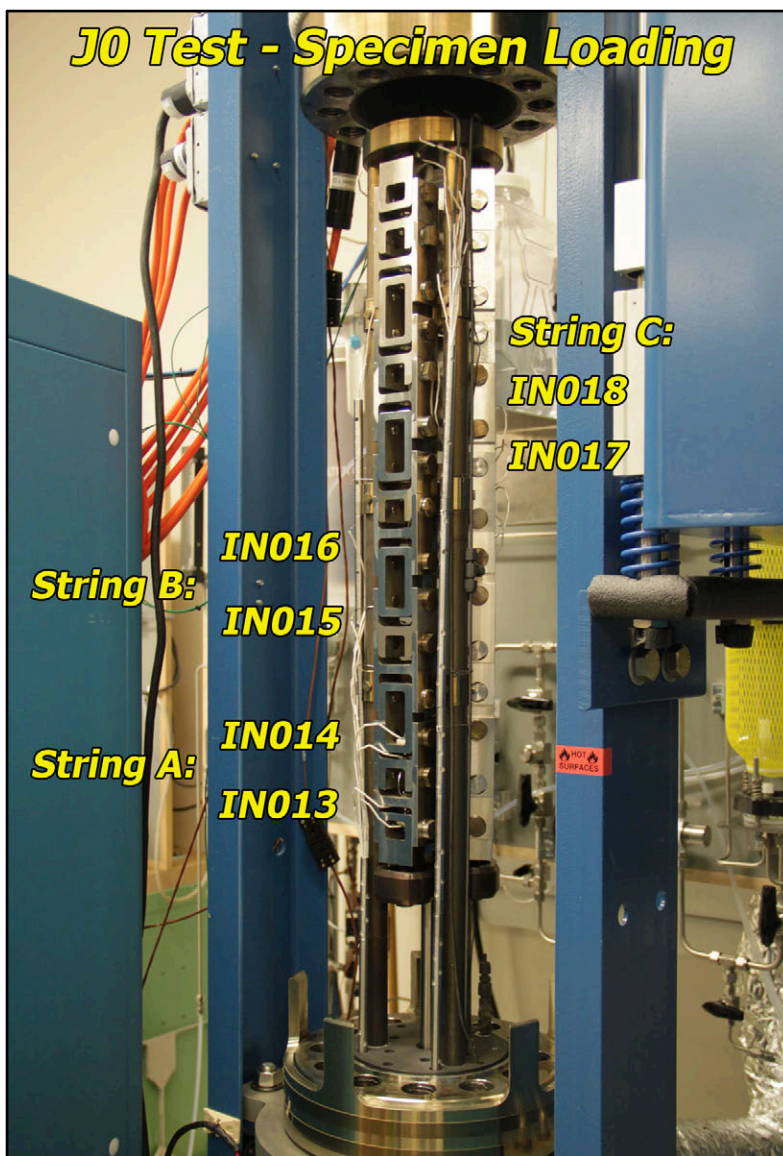
Figure 37. Load train for the LWR system #1 crack initiation test system set up for the demonstration test.
