**STRESS CORROSION CRACK INITIATION OF COLD-WORKED
ALLOY 600 AND ALLOY 690 IN PWR PRIMARY WATER**

**Technical Milestone Report: M2LW-14OR0404023
PNNL-23712 September 2014**

Research Project:
**Stress Corrosion Crack Initiation of
Nickel-Base Alloys in LWR Environments**
Project Manager: S. M. Bruemmer
Pacific Northwest National Laboratory

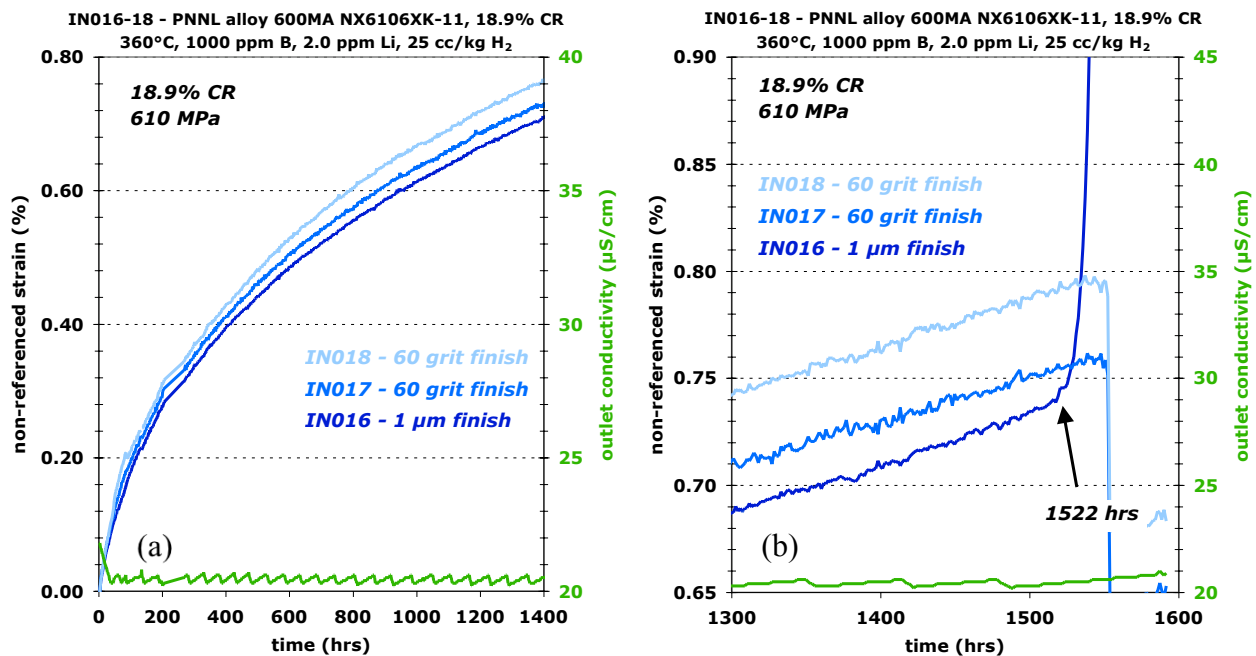
Figure 38. SCC initiation test plots for 19%CR alloy 600 specimens IN016, IN017 and IN018 during testing in 360°C PWR primary water: (a) early DCPD response and (b) observation of crack initiation and growth for the IN016 specimen.

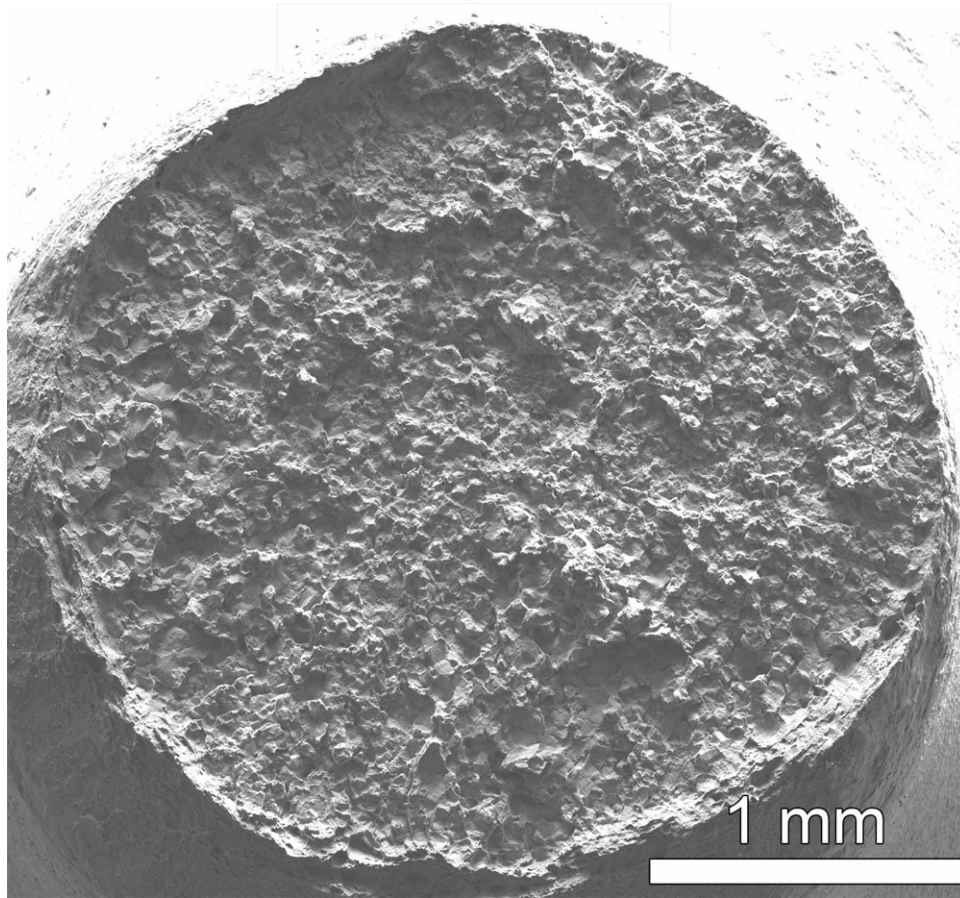
Figure 39. SEM-SE image showing IG fracture surface for 19%CR alloy 600 specimen IN016 after testing in PWR primary water.

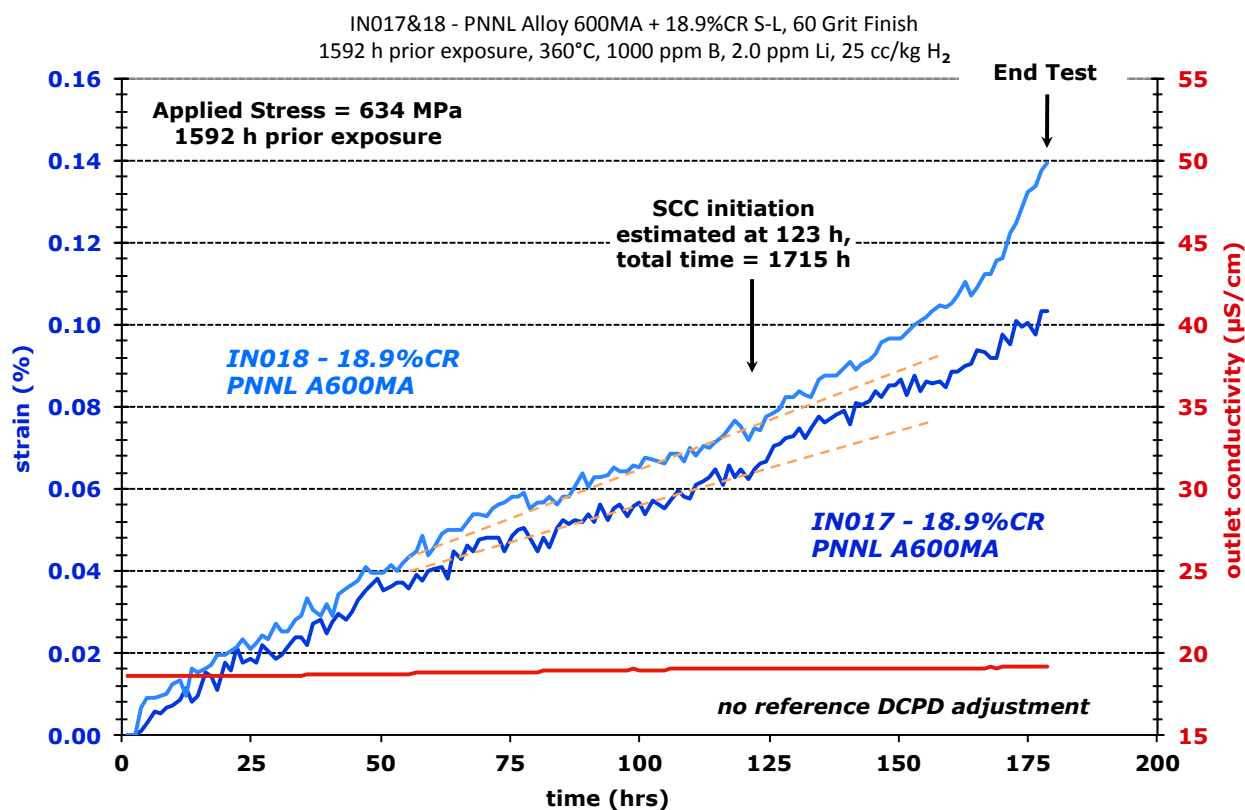
Figure 40. SCC initiation test plot for the continuing test on 19%CR alloy 600 specimens IN017 and IN018 in 360°C PWR primary water.

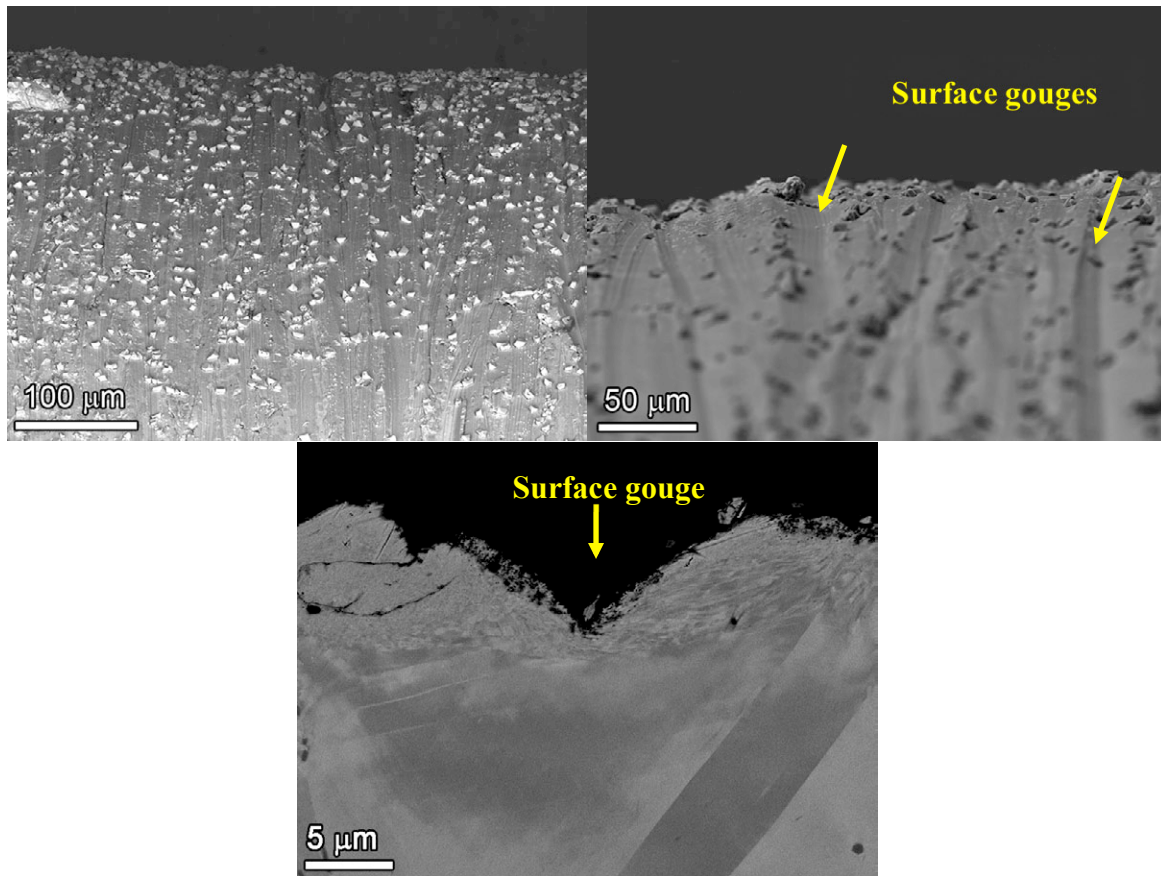
Figure 43. SEM-BSE images of IN018 gauge section in both plan view at two different angles as well as a cross-sectional example. The depth and microstructure of the gouges observed in the plan view can clearly be observed in the cross-section image to be on the order of tens of micrometers.

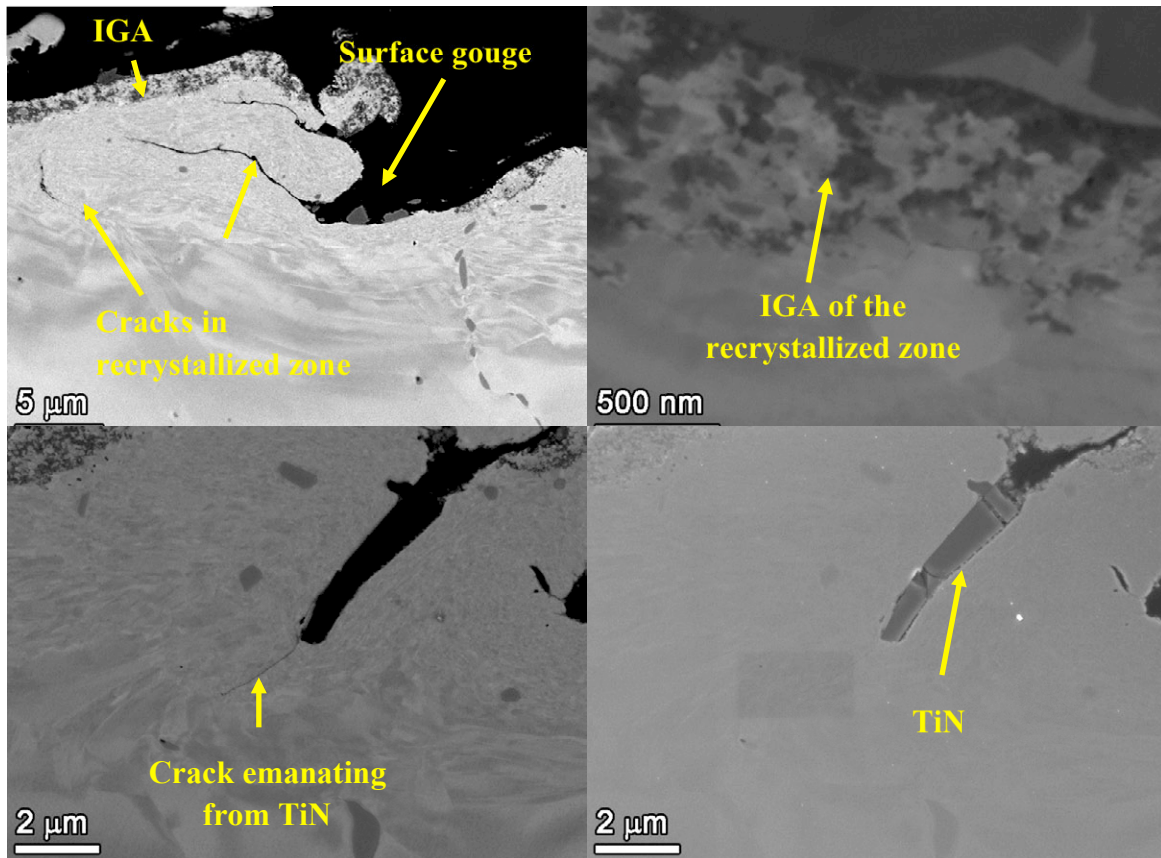
Figure 44. SEM-BSE image of the IN018 cross-section showing that the surface is comprised of a recrystallized zone of nanocrystalline grains. Once exposed, this surface slowly corrodes. Random cracking within the nanocrystalline zone was observed and was most likely imparted during grinding. Lastly, cracks were observed to emanate from TiN particles near the surface.

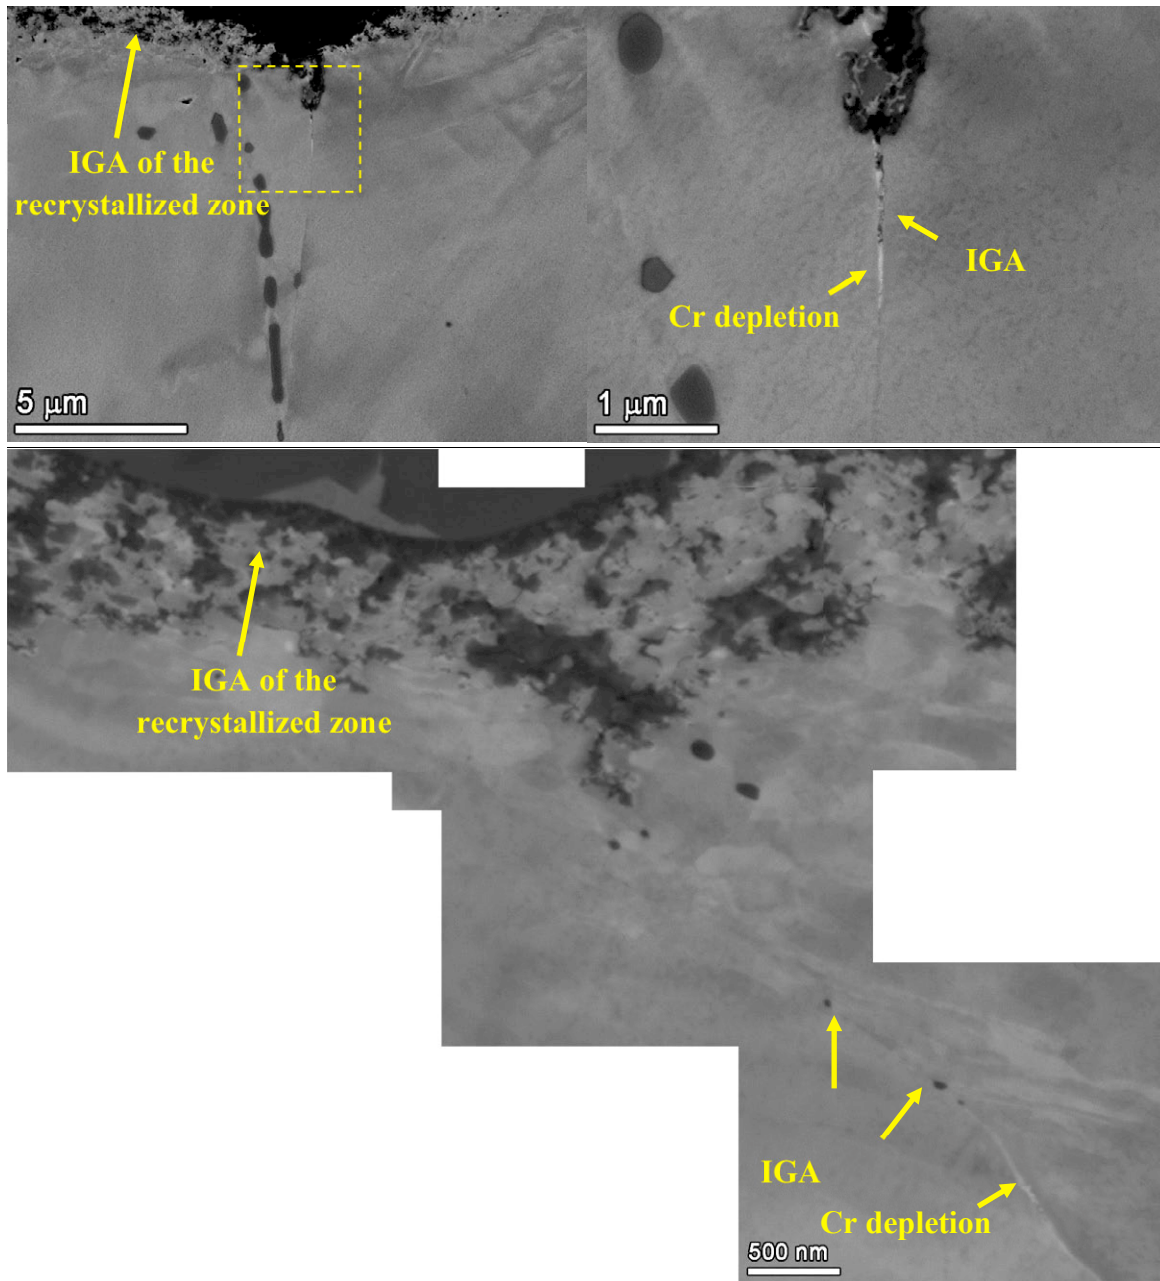
Figure 45. SEM-BSE micrographs of IN018 showing IG attack of boundaries that intersect the surface as well as a boundary below the recrystallized layer.

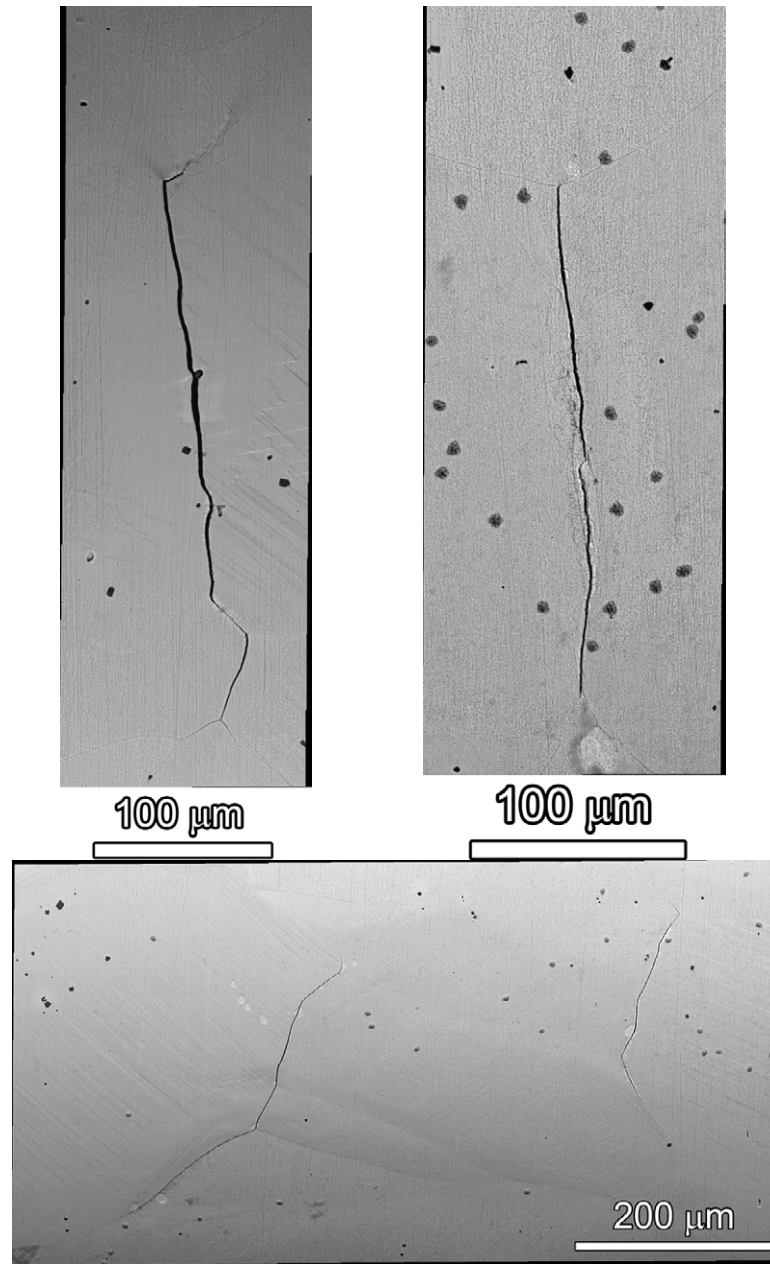
Figure 48. SEM-BSE images illustrating morphology of several large IGSCC cracks on the gauge surface of the IN022 specimen.

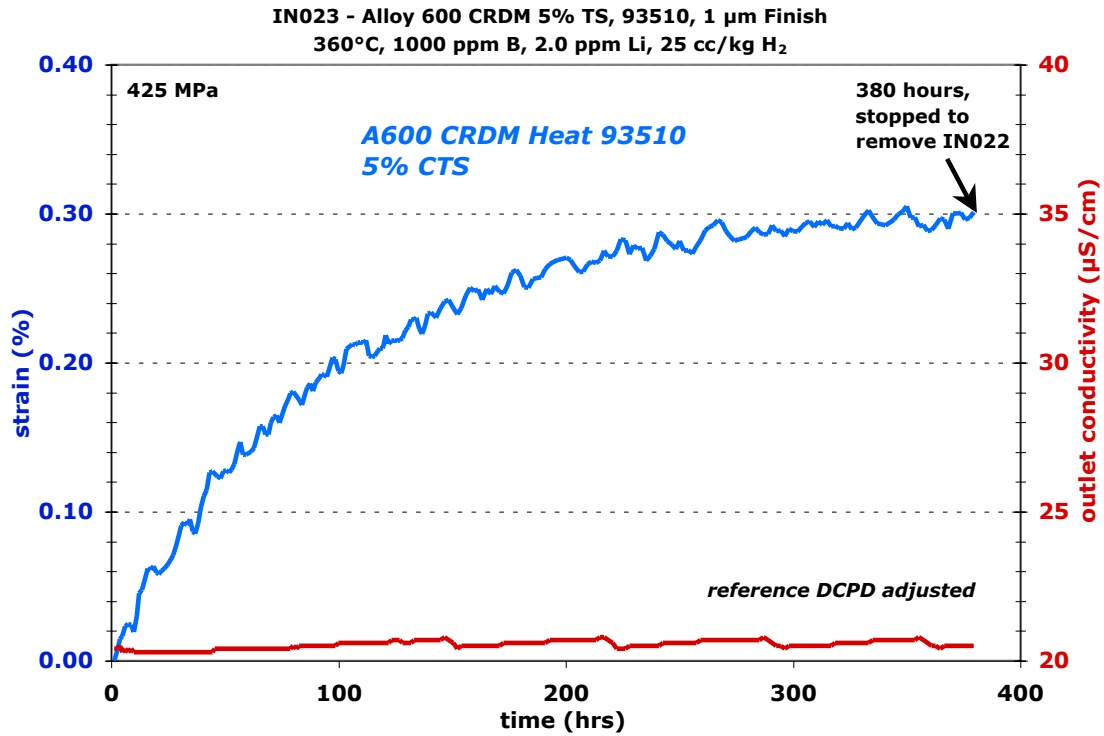
Figure 49. Strain versus time plot for specimen IN023 showing reference DCPD adjusted strains during testing in 360°C PWR primary water.

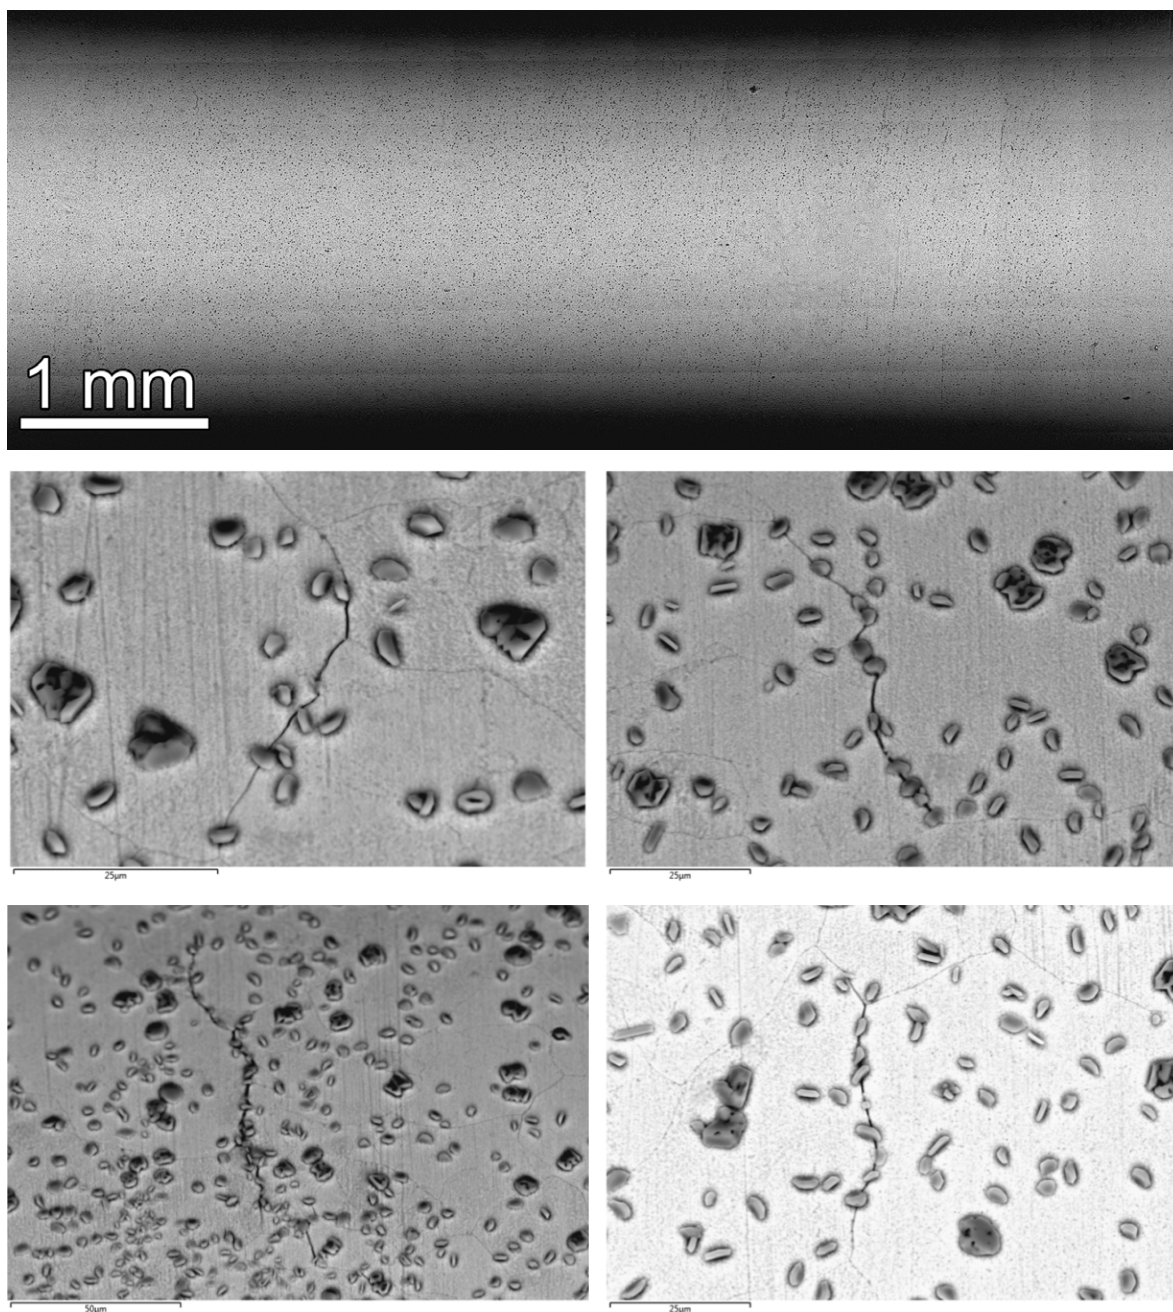
Figure 51. SEM-BSE examples of small surface cracks on the IN023 specimen gauge after a combined test time of ~1870 hours. The top image shows rotation 1 at low magnification illustrating that no obvious SCC cracks are present. The bottom four images provide examples of typical small cracks that were extremely tight and reached lengths approaching ~100 μm in isolated locations.

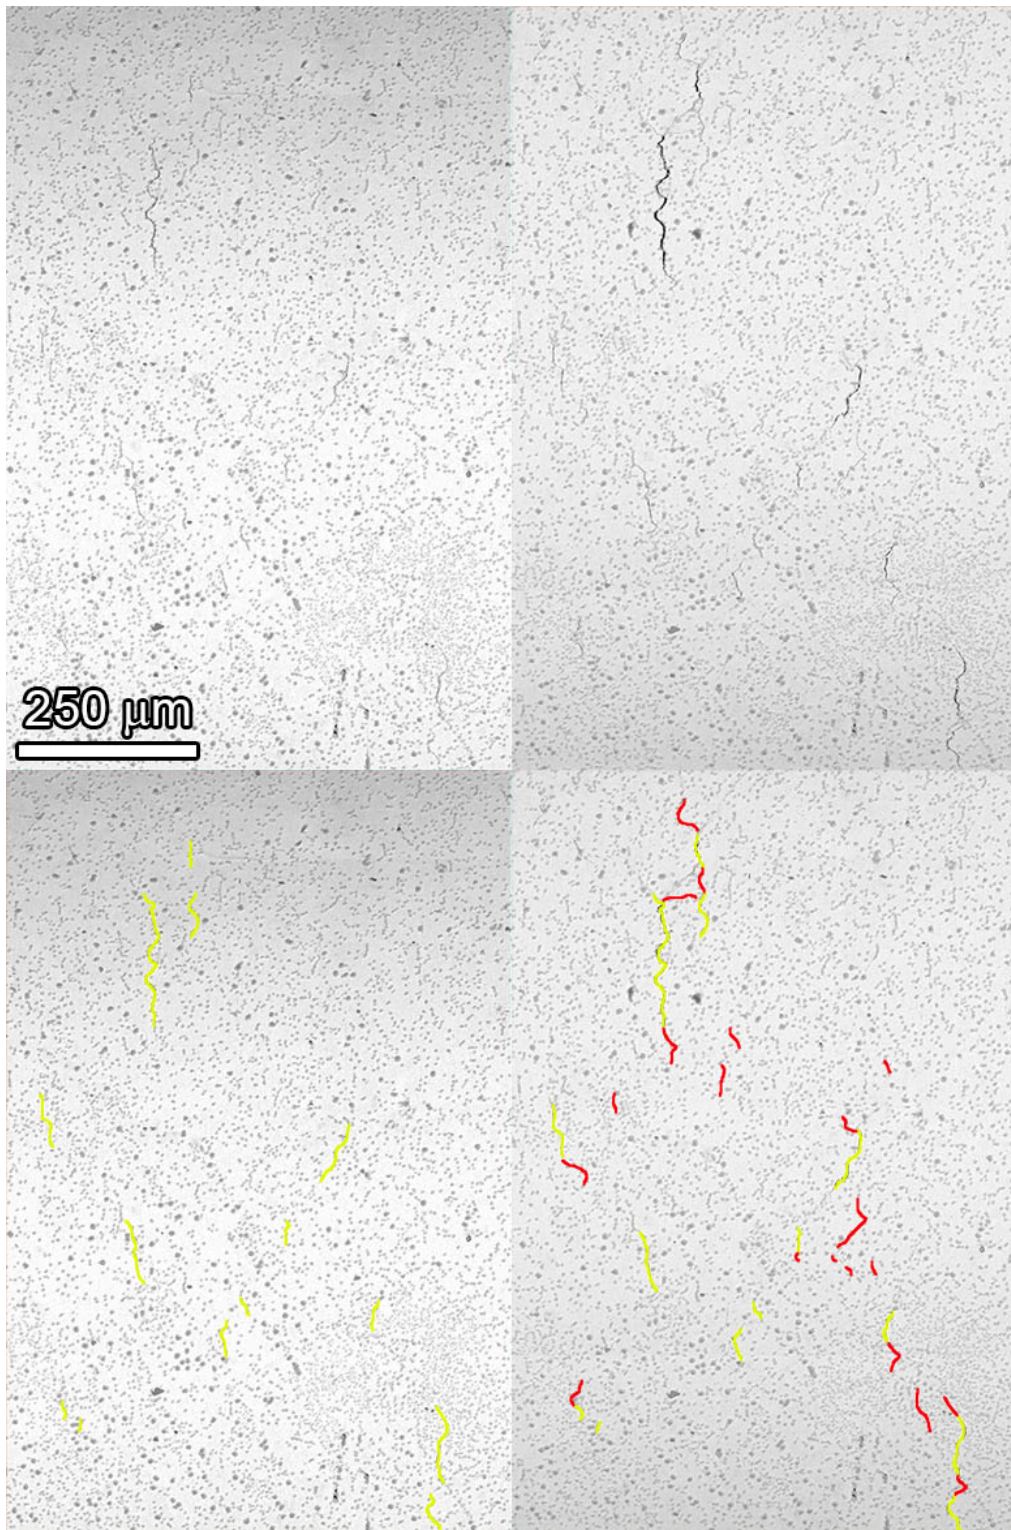
Figure 55. SEM-BSE images of IN023 Rotation #2 illustrating the sample at 1713 hours (left columns) and 2591 hours (right columns). The bottom two figures highlight the cracks in yellow present at 1713 hours and new cracks in red present at 2591 hours (red).

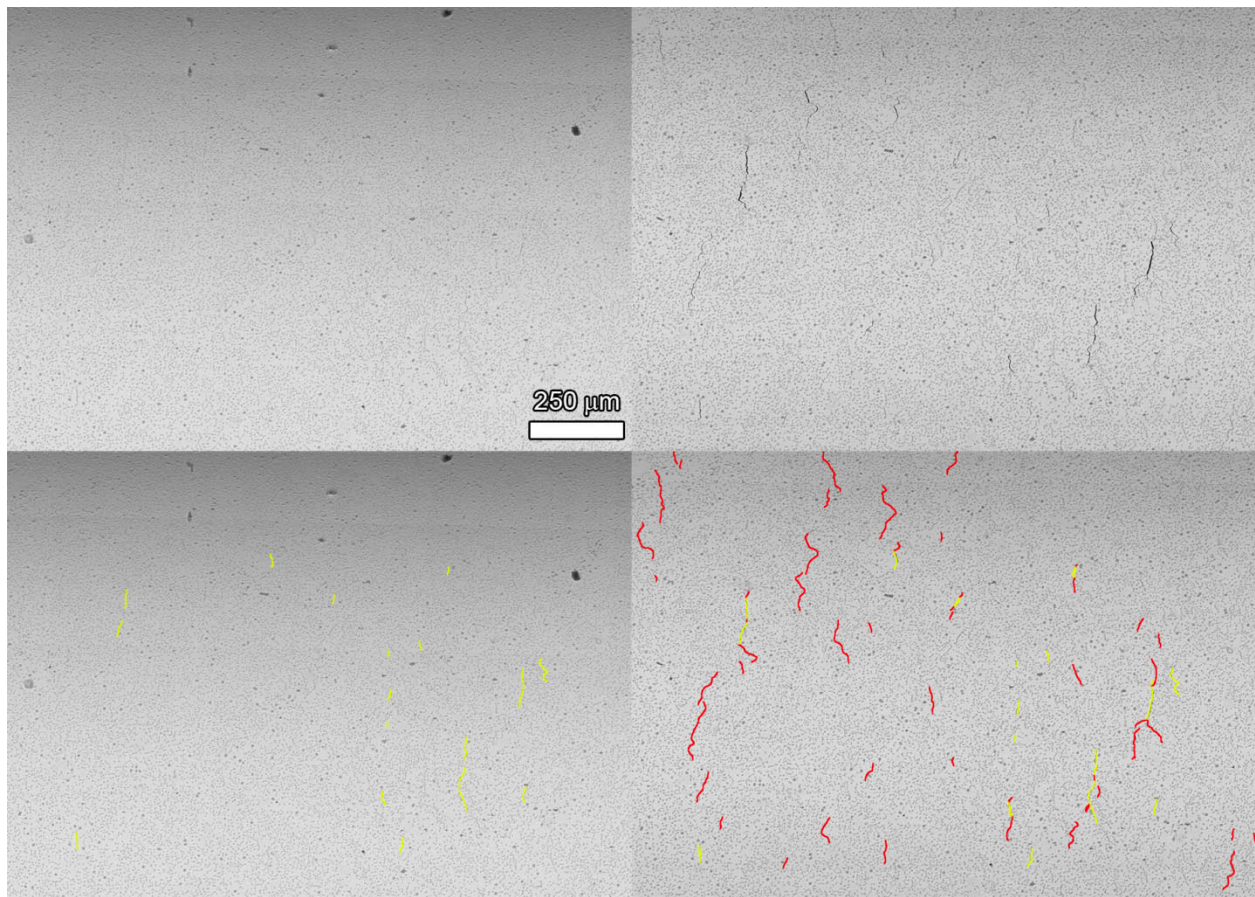
Figure 56. SEM-BSE images of IN023 Rotation 3 illustrating the sample at 1713 hours (left columns) and 2591 hours (right columns). The bottom two figures highlight the cracks in yellow present at 1713 hours and new cracks in red present at 2591 hours (red).

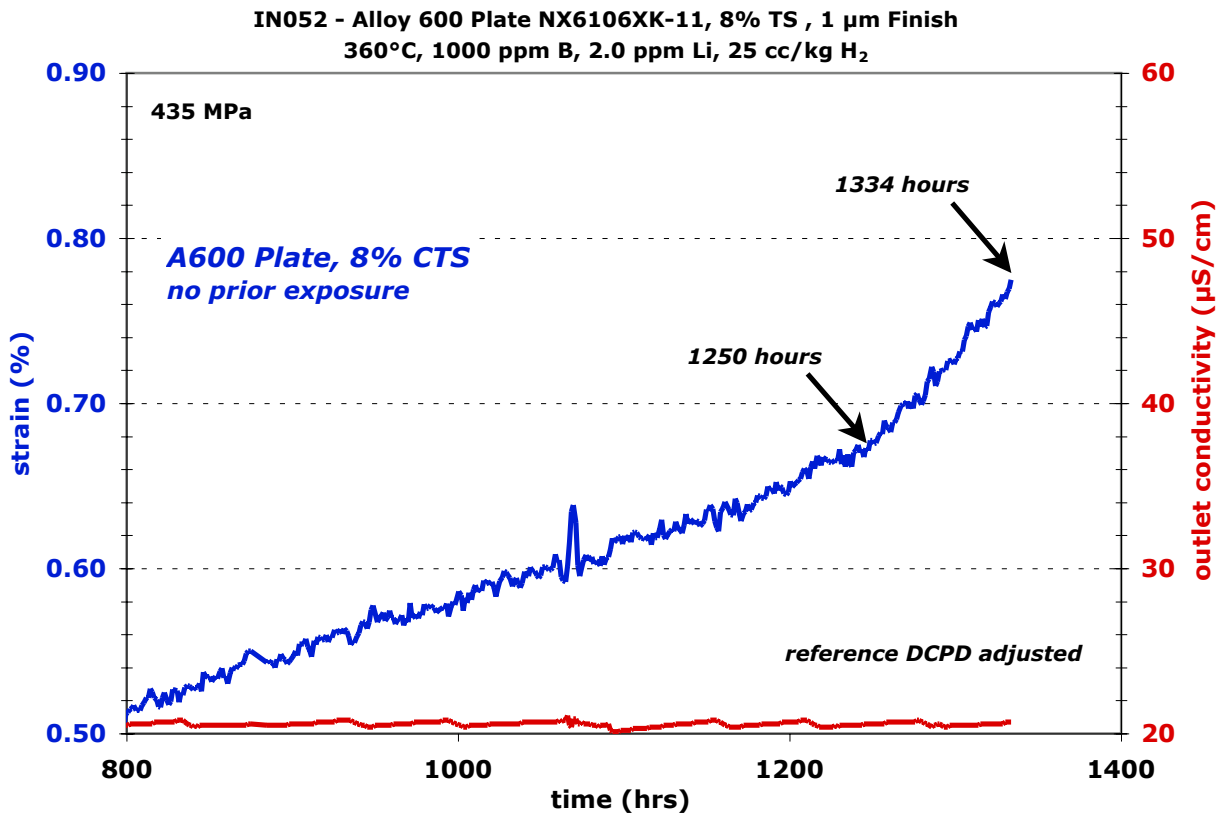
Figure 57. SCC initiation plot for the 8%TS alloy 600 specimen IN052 revealing evidence for crack nucleation at ~1250 hours.

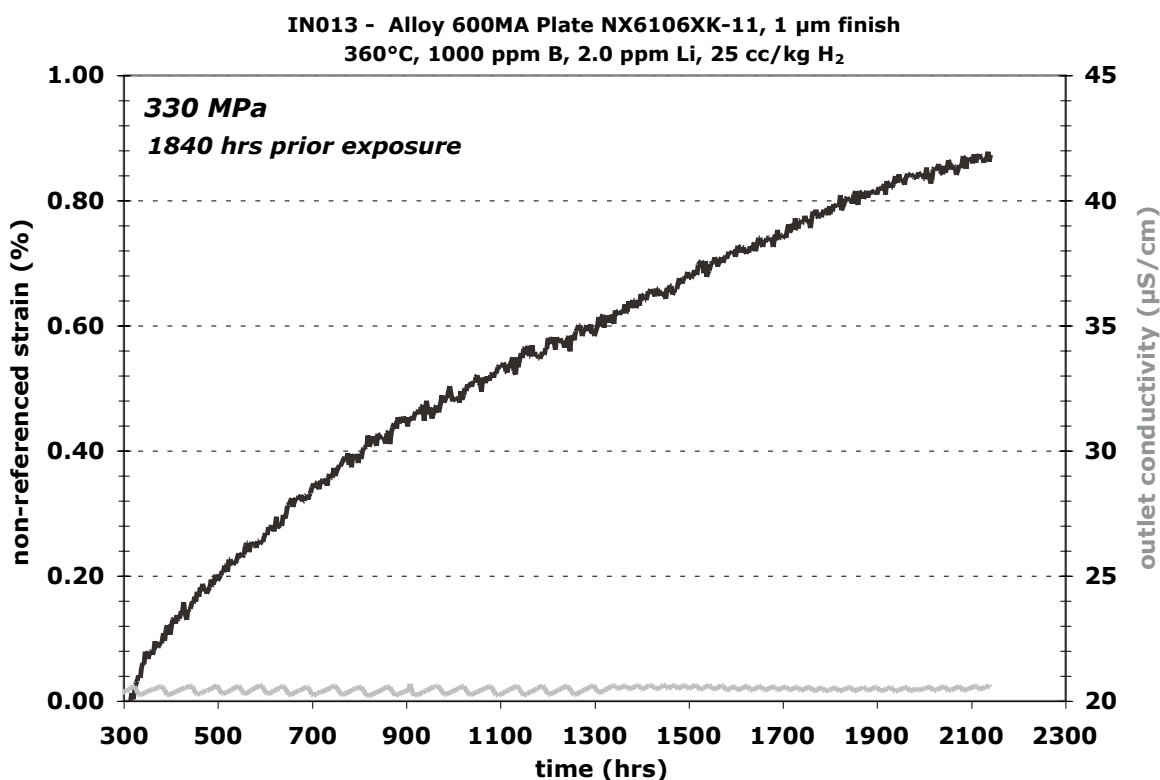
Figure 60. DCPD response for as-received alloy 600 plate specimen IN013 during its second exposure that lasted for 1840 hours giving a total exposure of 3392 hours. Neither IN014 nor IN015 were instrumented for DCPD measurement during this exposure.

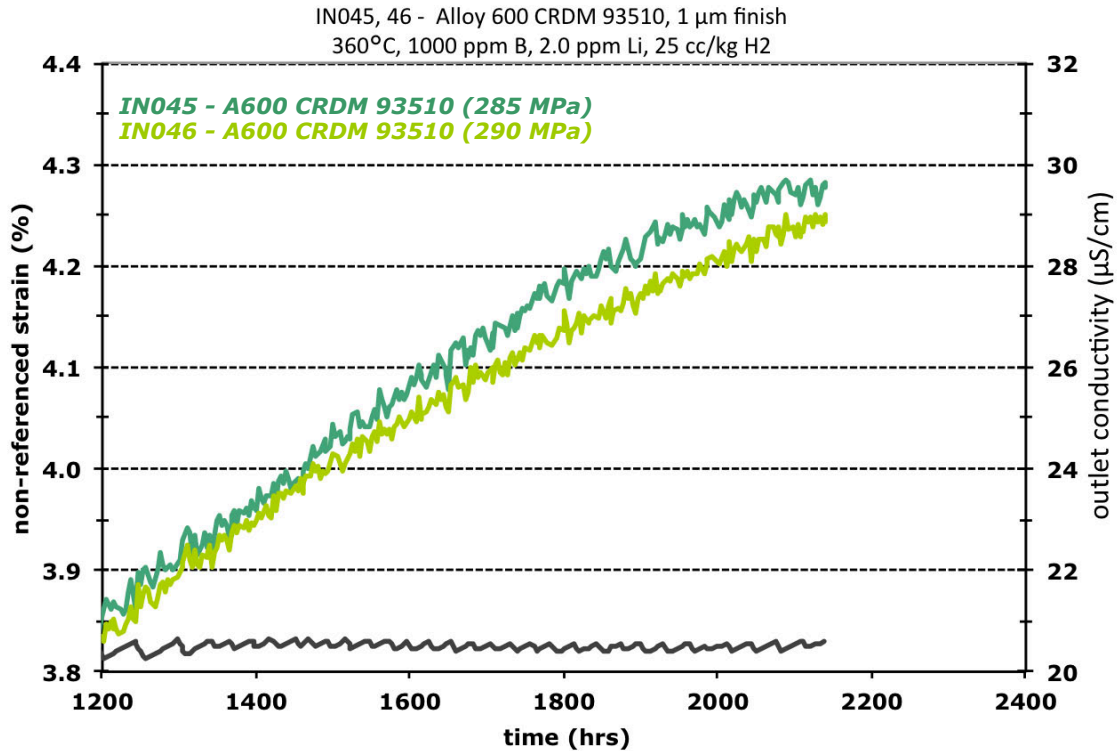
Figure 62. DCPD response for as-received alloy 600 CRDM specimens IN045 and IN046 during their first exposure in 360°C PWR primary water. IN047 was not instrumented in this exposure.

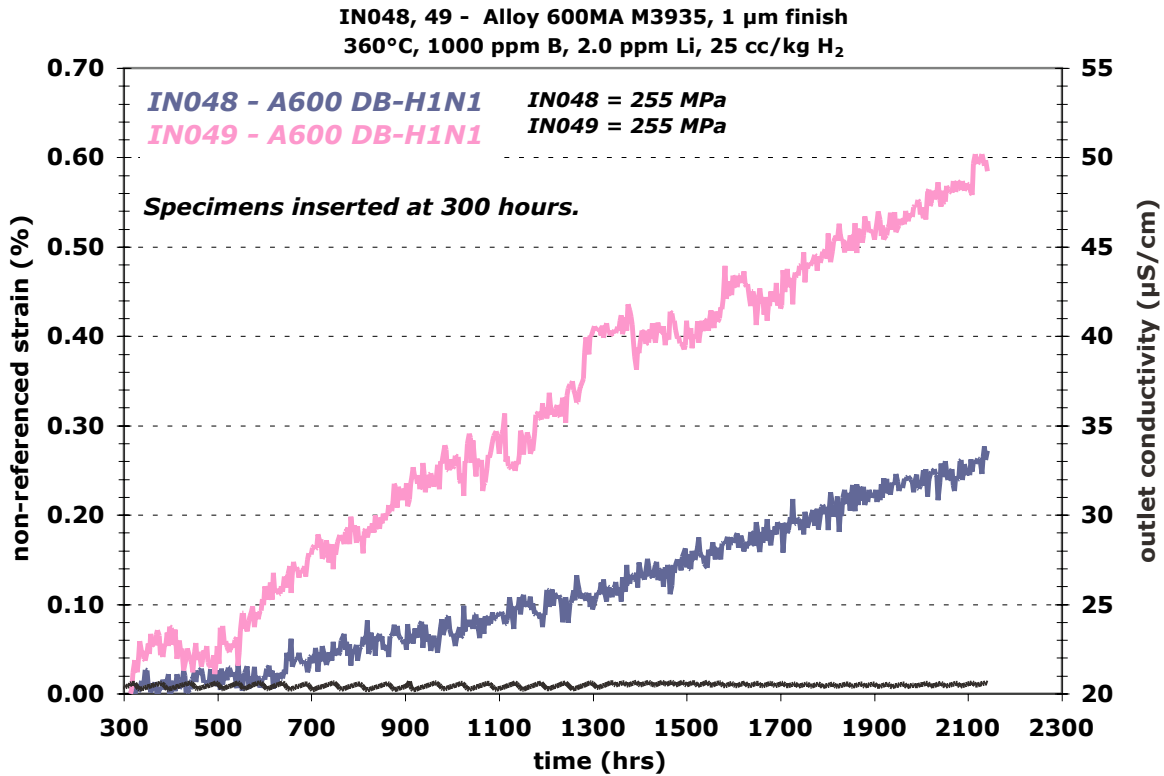
Figure 63. DCPD response for the two instrumented alloy 600 CRDM specimens from PWR service (IN048 and IN049) during their first exposure in 360°C PWR primary water for 1840 hours.

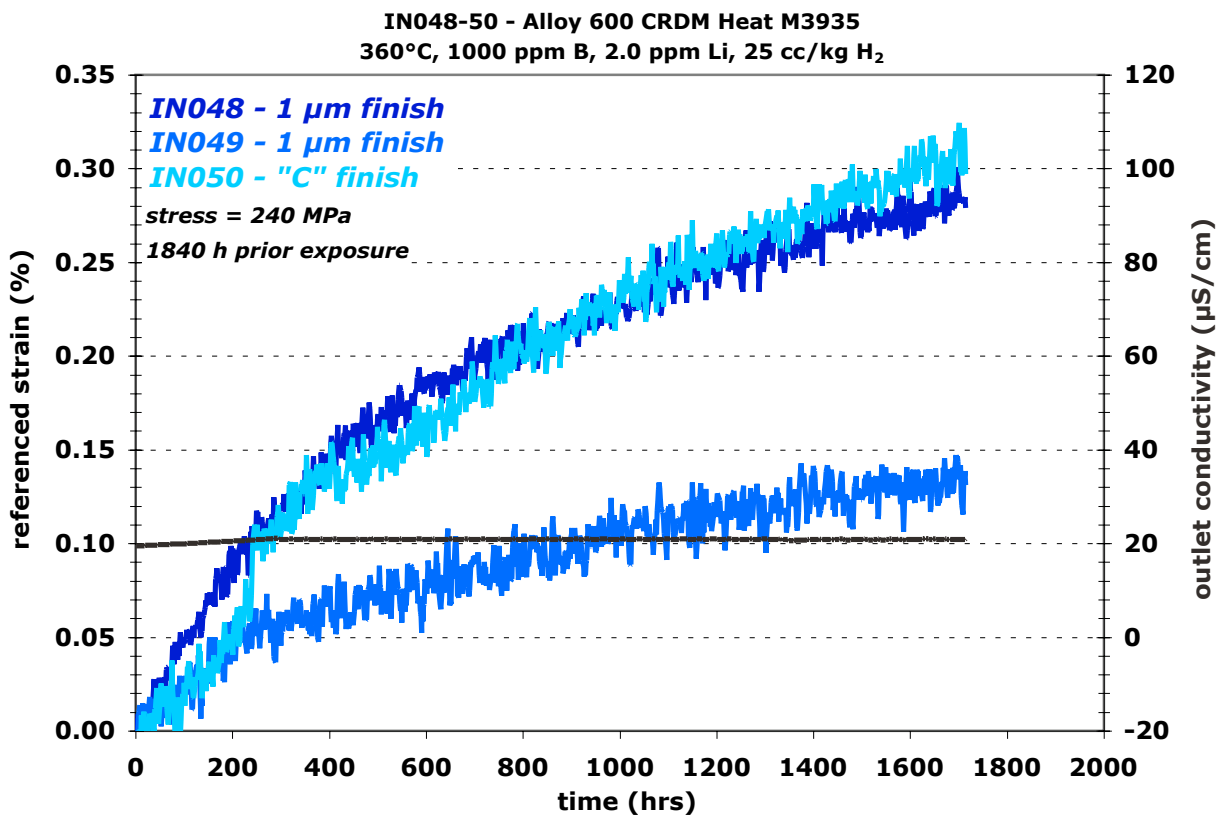
Figure 65. DCPD response for the alloy 600 CRDM specimens from PWR service (IN048, IN049 and IN050) during the ongoing second exposure in 360°C PWR primary water.

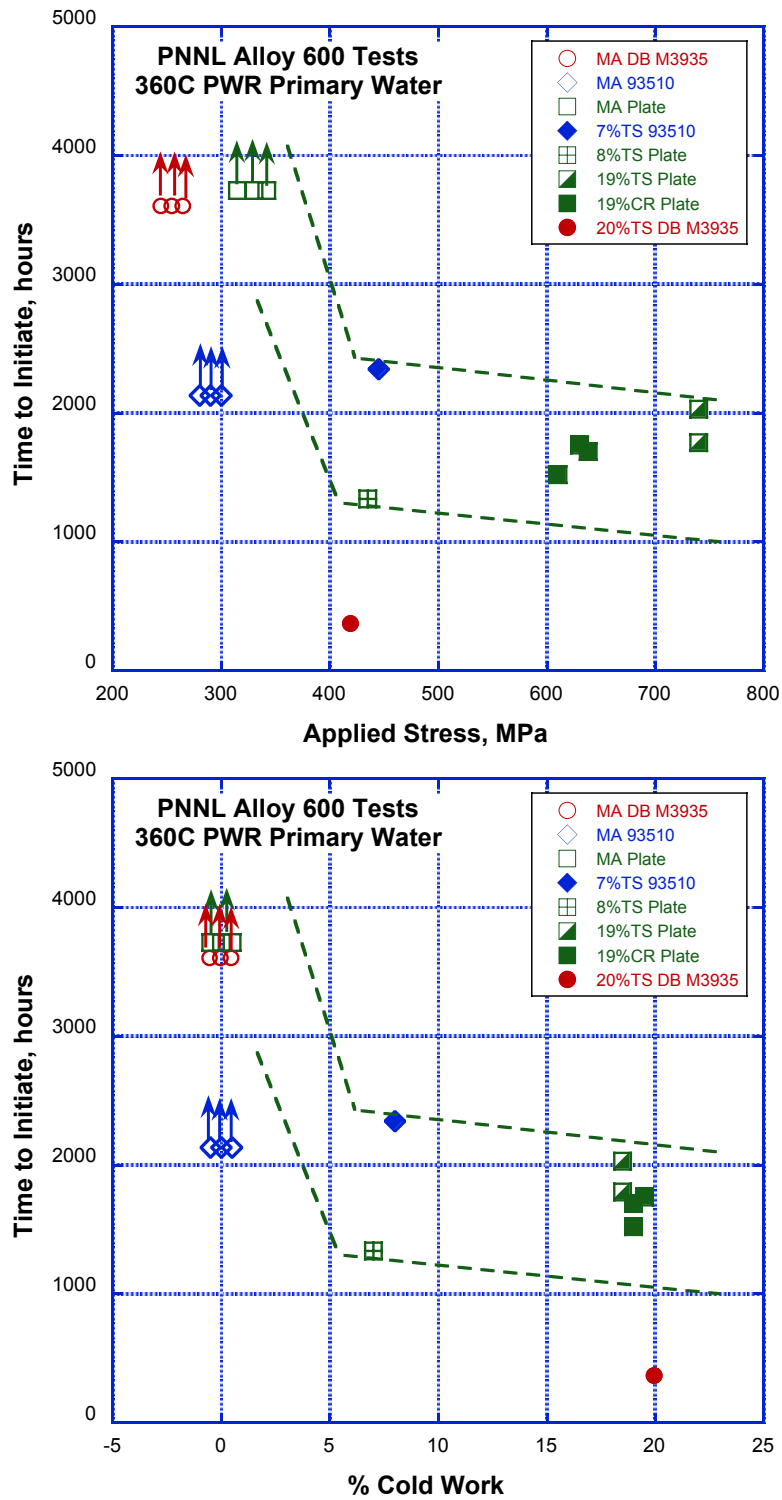
Figure 66. Summary of PNNL SCC initiation test results for alloy 600 heats showing no failures for as-received materials at applied stresses below ~400 MPa. All specimens were tested at their yield strength.

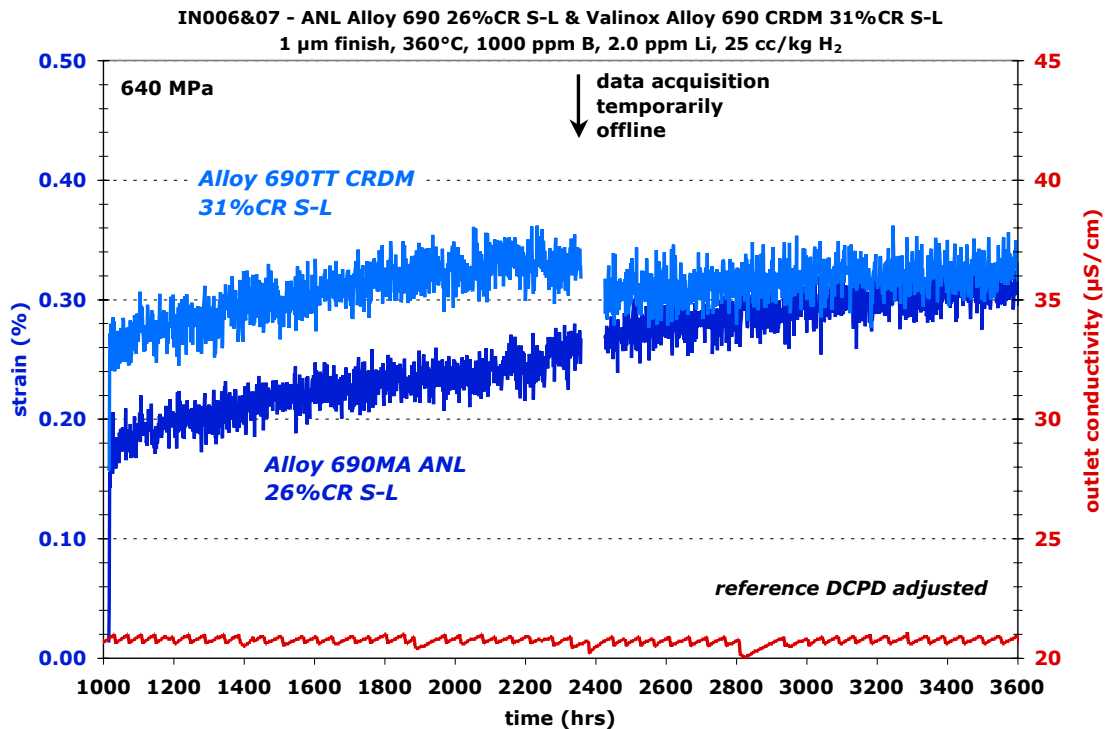
Figure 77. DCPD-based strain response for specimens IN006 and IN007 after stress increase to 640 MPa.

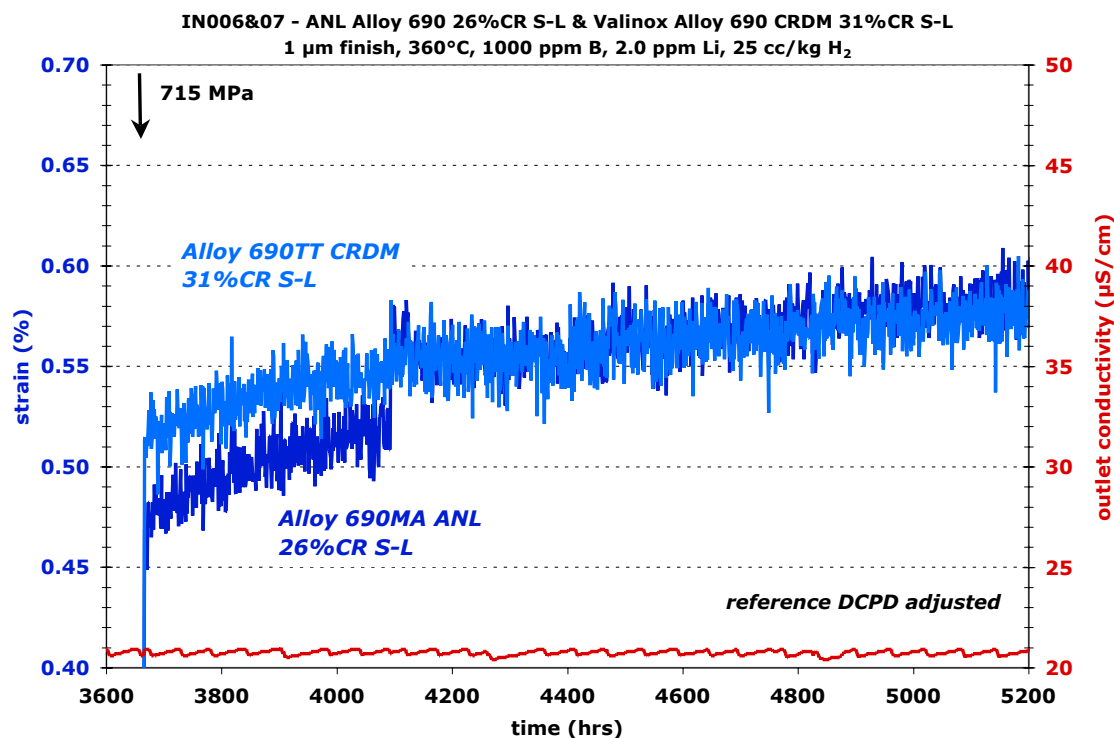
Figure 80. DCPD-based strain response of the two cold-rolled alloy 690 specimens (IN006 and IN007) from 3630 - 5200 hours after stress increase to 715 MPa.

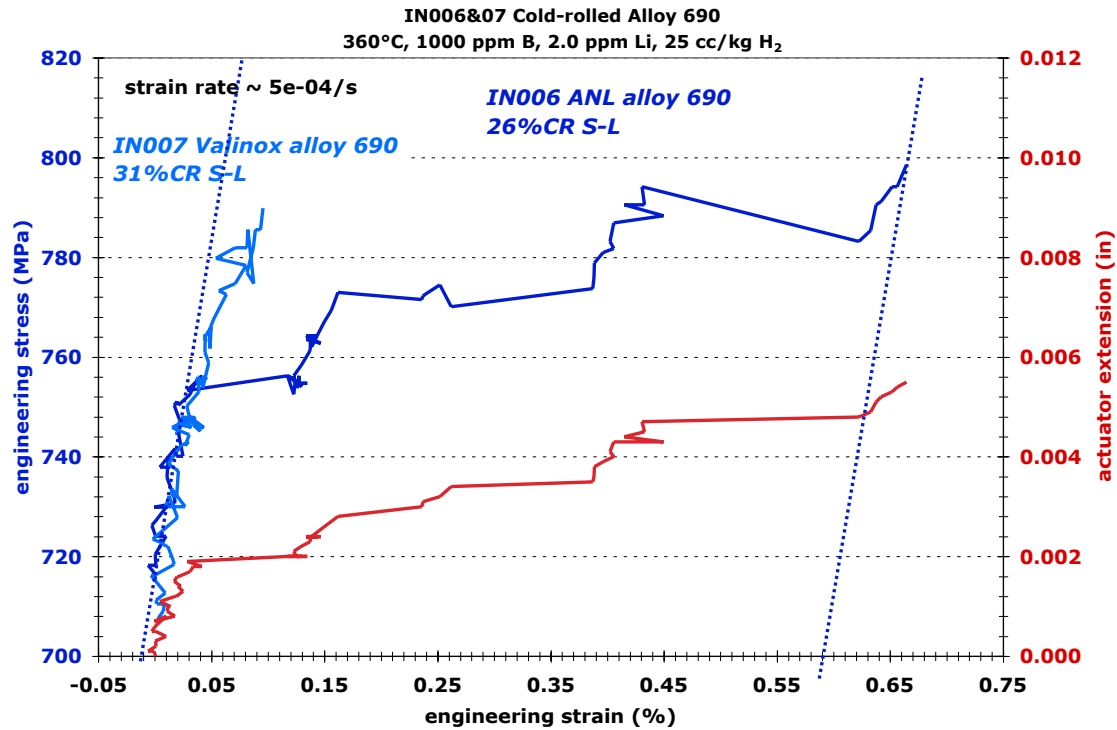
Figure 81. Tensile straining performed on the alloy 690 materials at ~5300 hours. The 26%CR plate material (IN006) underwent approximately 0.6% plastic strain while the 31%CR CRDM material (IN007) did not yield.

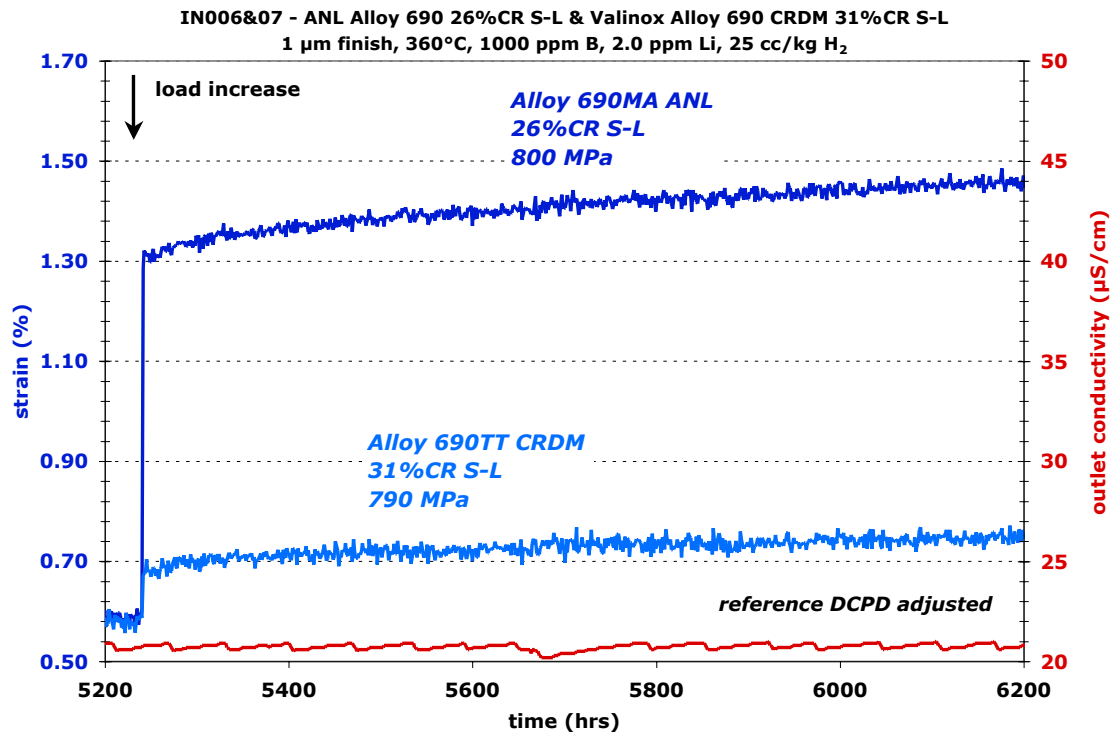
Figure 82. DCPD-based strain response for the IN006 and IN007 specimens from 5220 to 6200 hours after another load increase to 790-800 MPa.
