**STRESS CORROSION CRACK INITIATION OF COLD-WORKED
ALLOY 600 AND ALLOY 690 IN PWR PRIMARY WATER**

**Technical Milestone Report: M2LW-14OR0404023
PNNL-23712 September 2014**

Research Project:
**Stress Corrosion Crack Initiation of
Nickel-Base Alloys in LWR Environments**
Project Manager: S. M. Bruemmer
Pacific Northwest National Laboratory

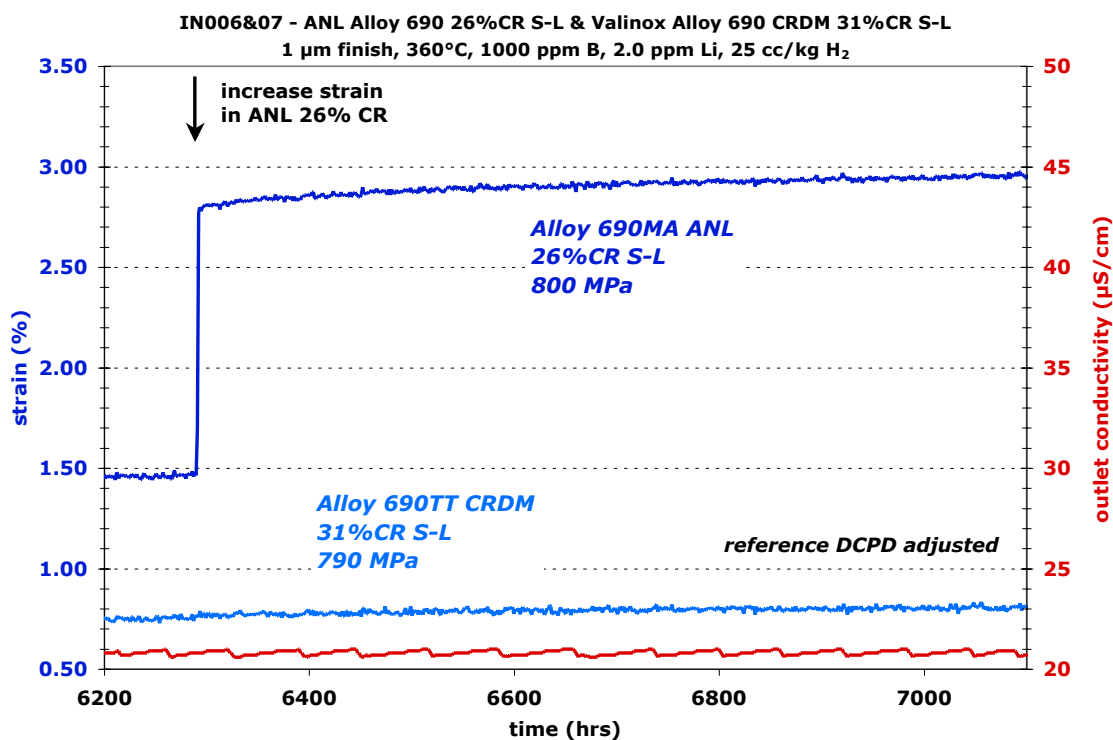
Figure 84. DCPD-based strain response of the two CR alloy 690 specimens (IN006 and IN007) from 6200 - 7100 hours after plastic deformation in plate specimen IN006.

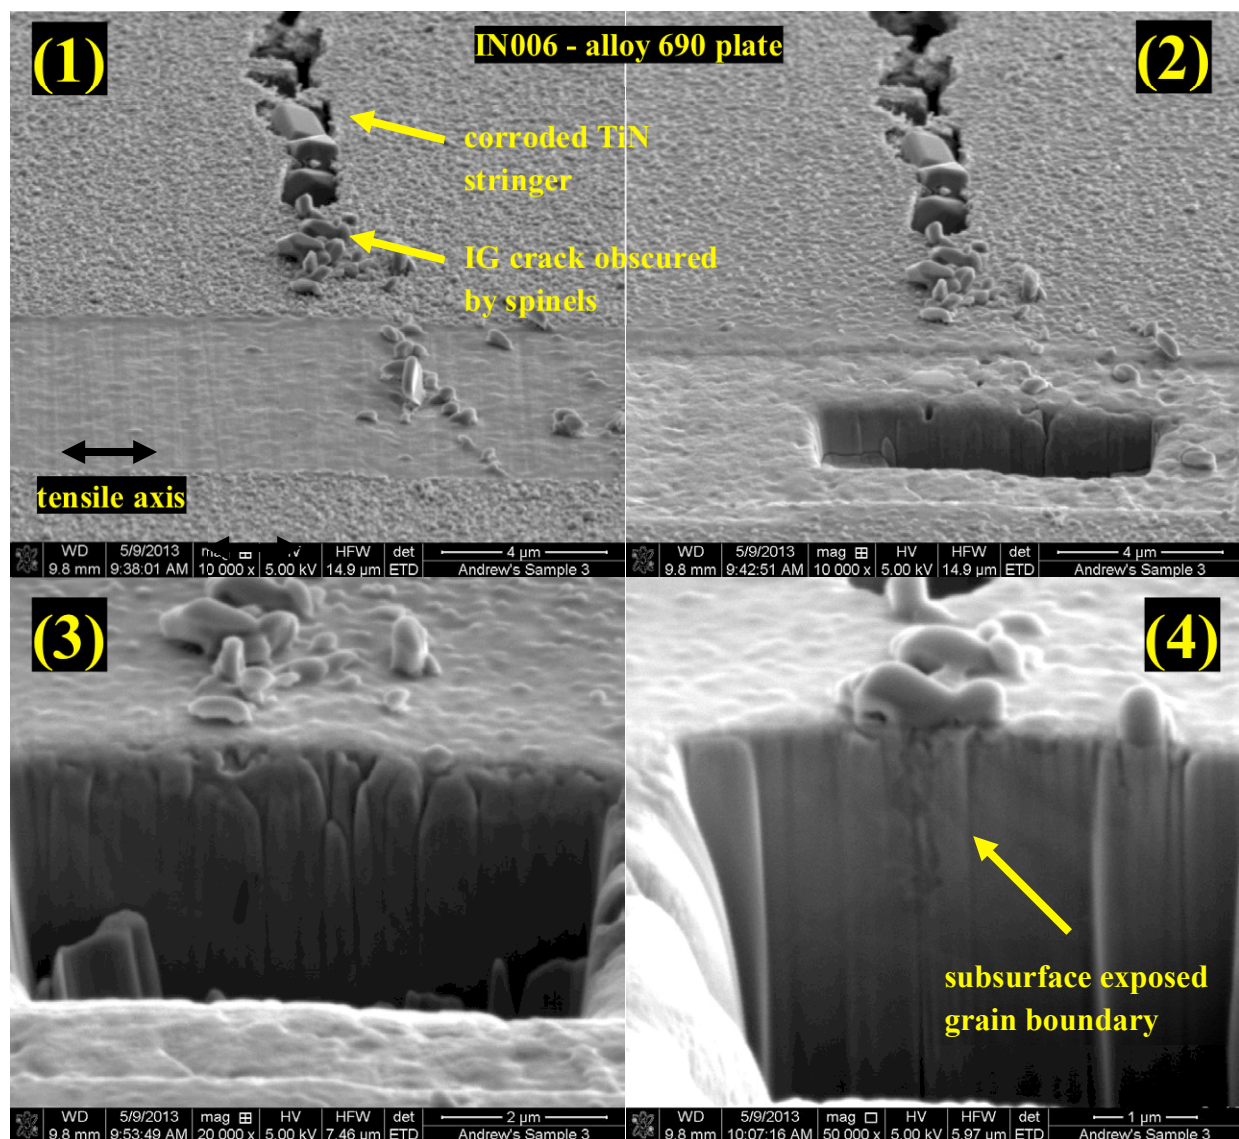
Figure 89. Step-by-step imaging of the formation of a trench into the surface of the 26%CR plate specimens (IN006) to reveal a subsurface IG crack in cross section.

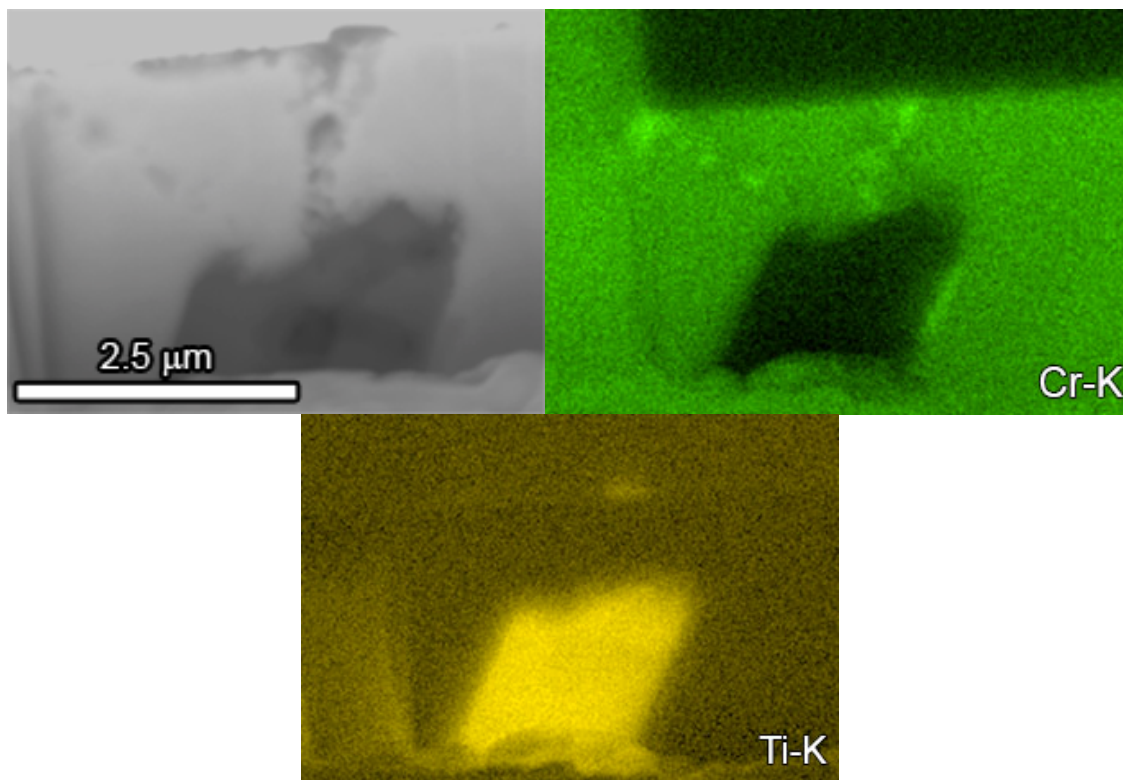
Figure 99. Near-surface grain boundary microstructure from a FIB trench in the IN007 specimen after 9144 h. Corrosion of the grain boundary is observed extending from the TiN inclusion.

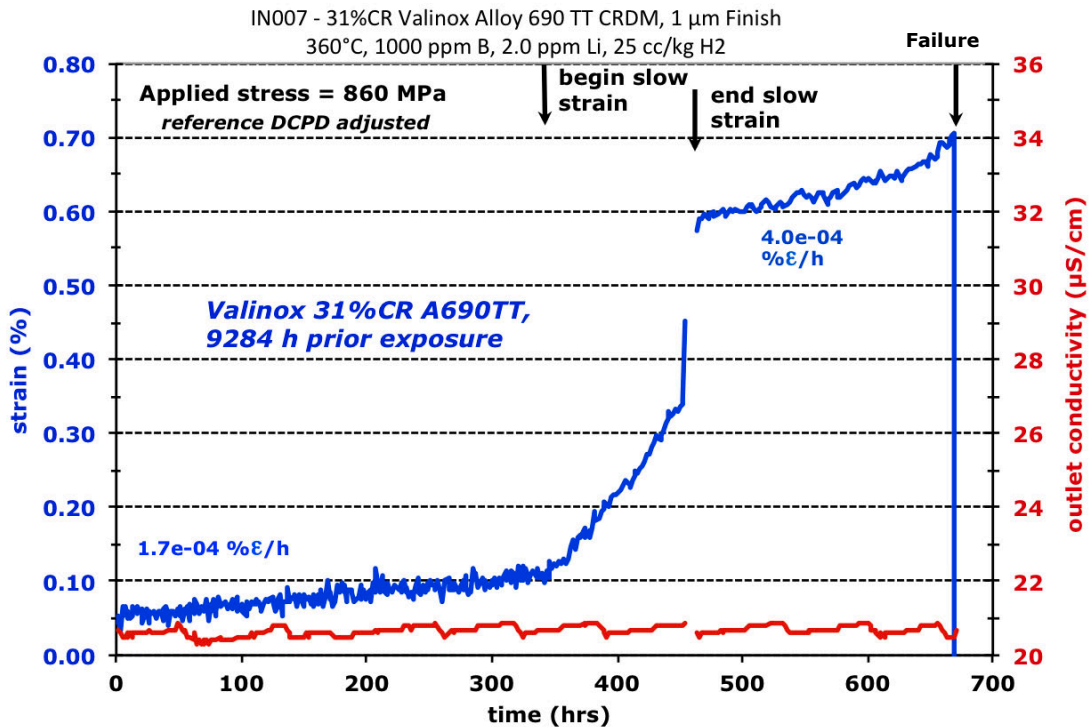
Figure 100. DCPD-based strain response of the 31%CR alloy 690 CRDM specimen IN007 after restart at the yield stress (860 MPa).

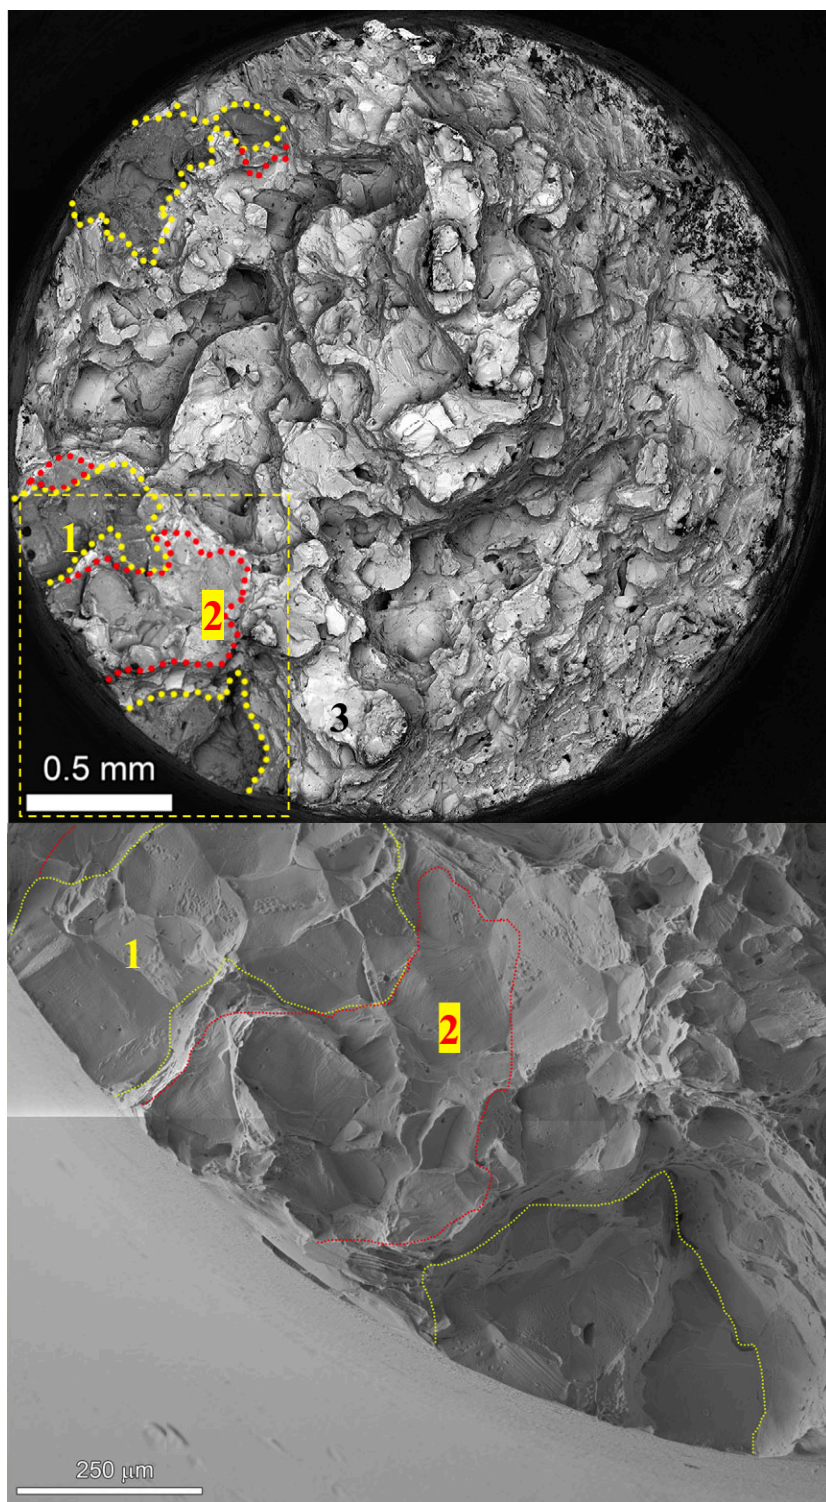
Figure 101. Low kV SEM-BSE of the fracture surface and high kV SEM-SE micrographs illustrating the fracture surface for the 31%CR CRDM specimen IN007. Several pockets of IG cracking were found where yellow is initial SCC, red is secondary SCC. Remainder of fracture surface appears to be mixture of IG and TG fracture with no apparent oxide.

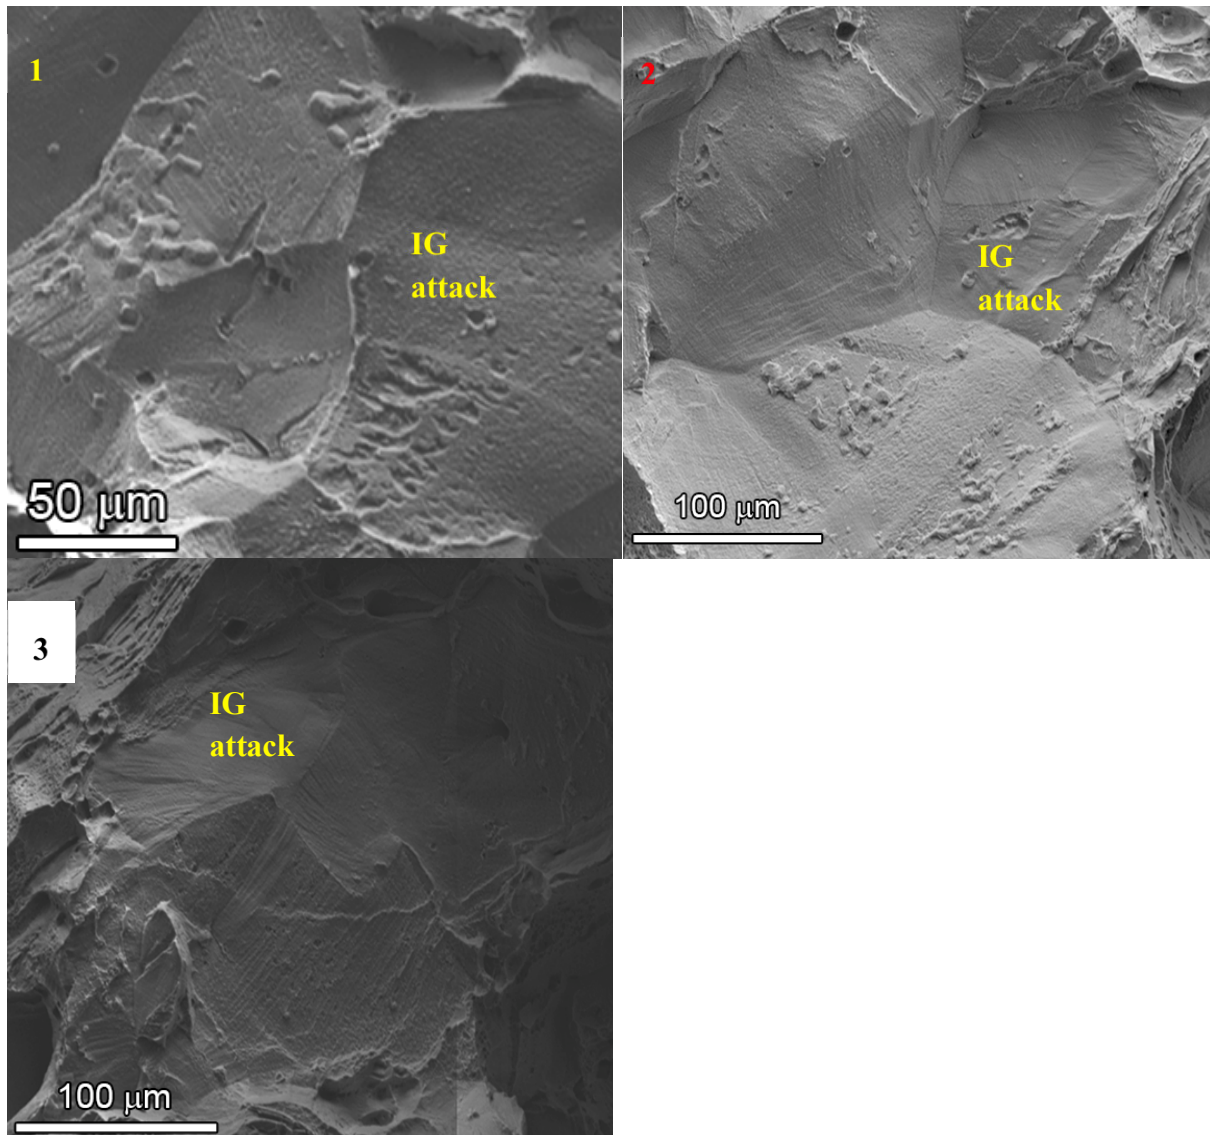
Figure 102. SEM-SE images of IG cracking of various regions denoted in Figure 101.

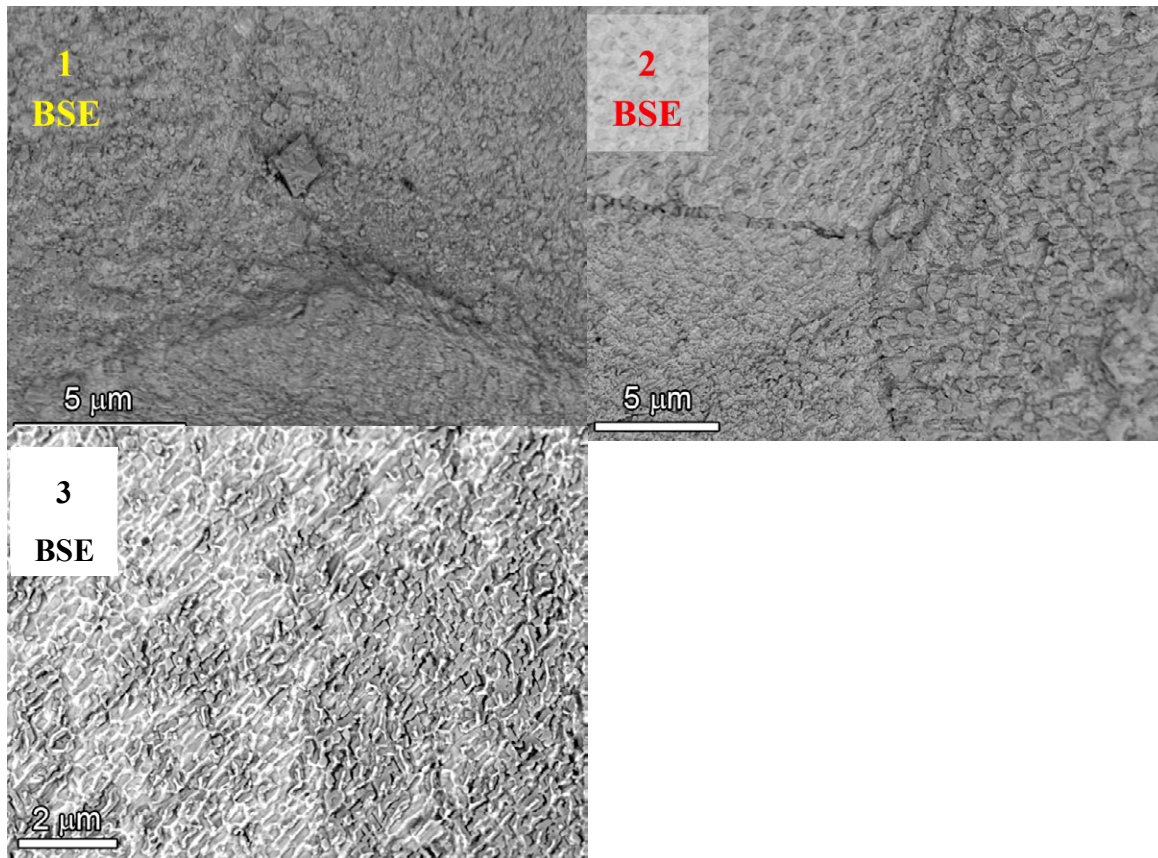
Figure 103. High magnification SEM-BSE images of IG cracking of various regions denoted in Figure 101.

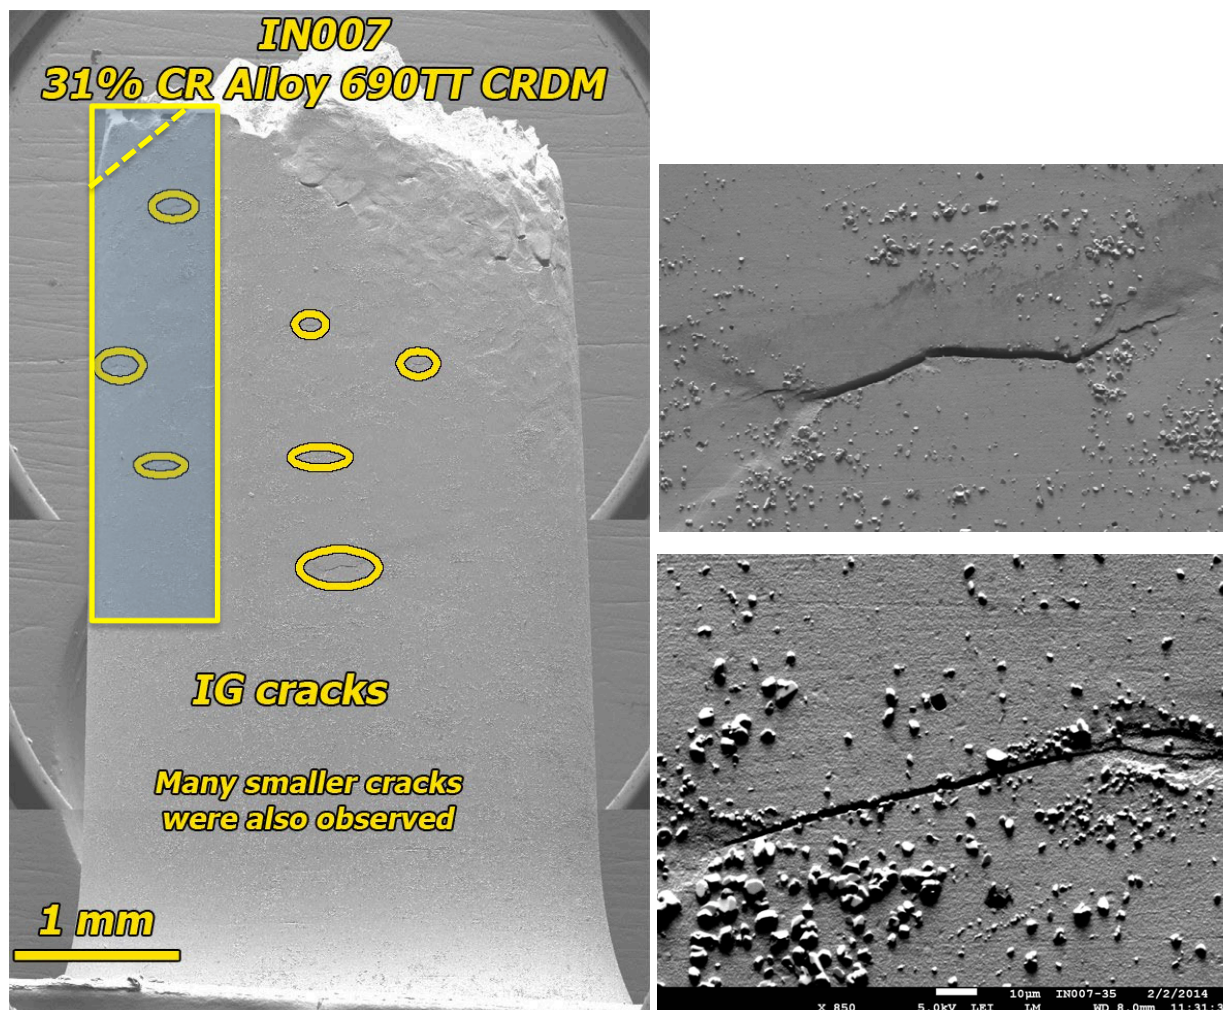
Figure 104. SEM-SE images from the gauge surface of the 31%CR CRDM specimen IN007. The yellow box indicates where a cross-section sample was prepared. The dotted line indicates a portion of the cross-section slice that was removed to due to necking damage.

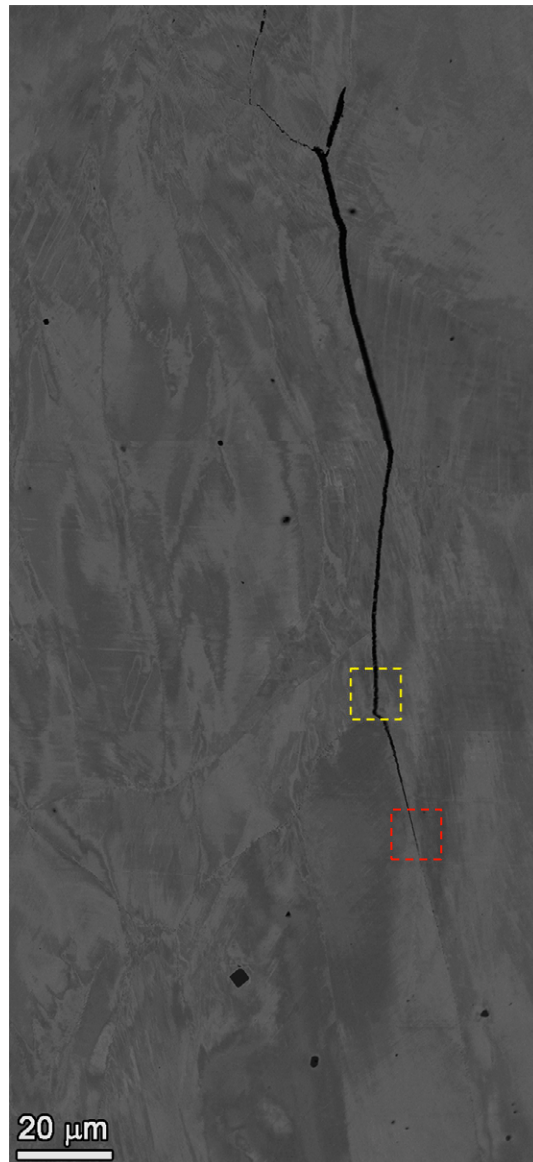
Figure 106. SEM-BSE micrograph of crack #1 in Figure 105. Note the red box near the visible crack tip and the yellow box further behind.

The first crack (IG crack #1) was observed at $\sim 500 \mu\text{m}$ deep from the gauge surface (Figure 105), and at moderate magnifications was determined to be IG (Figure 106). Our previous research on high Cr, Ni-based alloys has demonstrated that penetrative oxidation observed along crack walls can be used to not only indicate the age of an SCC crack, but determine if it was an active crack. Active SCC cracks typically will show very little penetrative oxidation near the leading tip and gradually become thicker along the crack walls farther from the growing crack. Two different regions of IG crack #1 were examined (Figure 106), one $\sim 60\text{--}80 \mu\text{m}$ behind the leading tip (yellow dashed box), and the second at the leading crack tip (red dashed box). From Figure 107, which illustrates the yellow boxed region farther behind the leading crack tip, a continuous 200 nm thick penetrative oxidation layer is apparent on either side of the crack. Closer to the leading crack tip ($\sim 4\text{--}5 \mu\text{m}$), the penetrative oxidation is shown to be $\sim 75\text{--}100 \text{ nm}$ thick (Figure 108). Finally, at the leading crack tip (also Figure 108) there appears to be very little to no penetrative oxidation at the crack tip. Hence, it was determined that crack #1 was an active SCC crack tip.

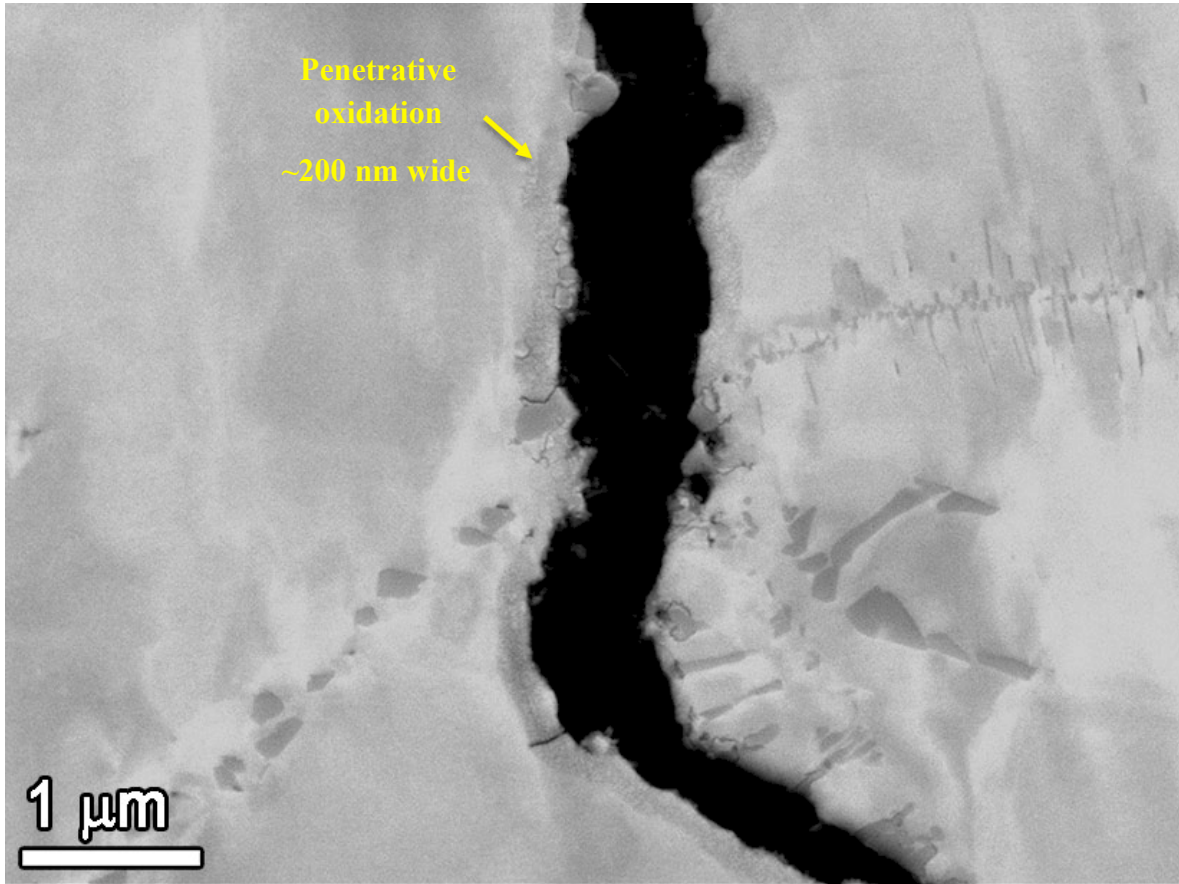
Figure 107. SEM-BSE image showing penetrative oxidation in the yellow box in Figure 106.

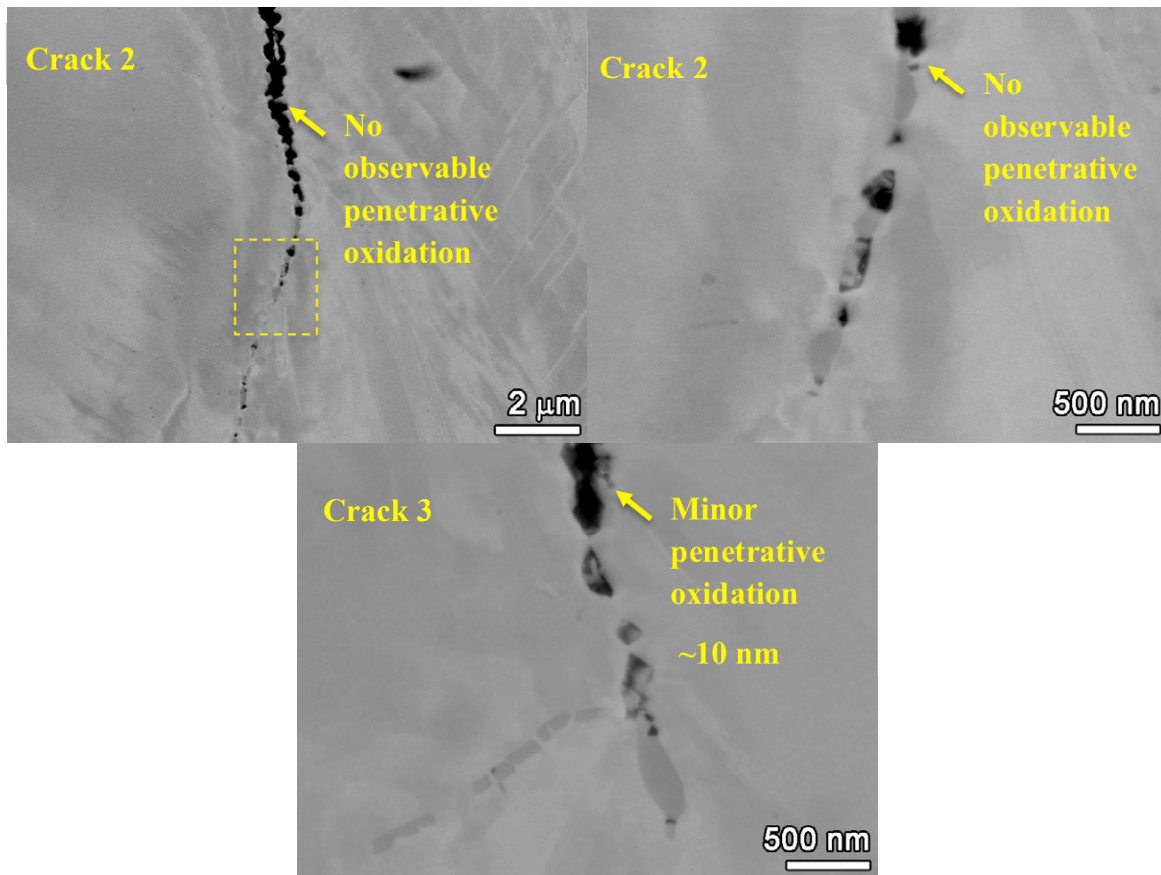
Figure 110. SEM-BSE images of crack #2 and crack #3 (see Figure 105), both of which were identified as creep cracks. No significant penetrative oxidation was observed.

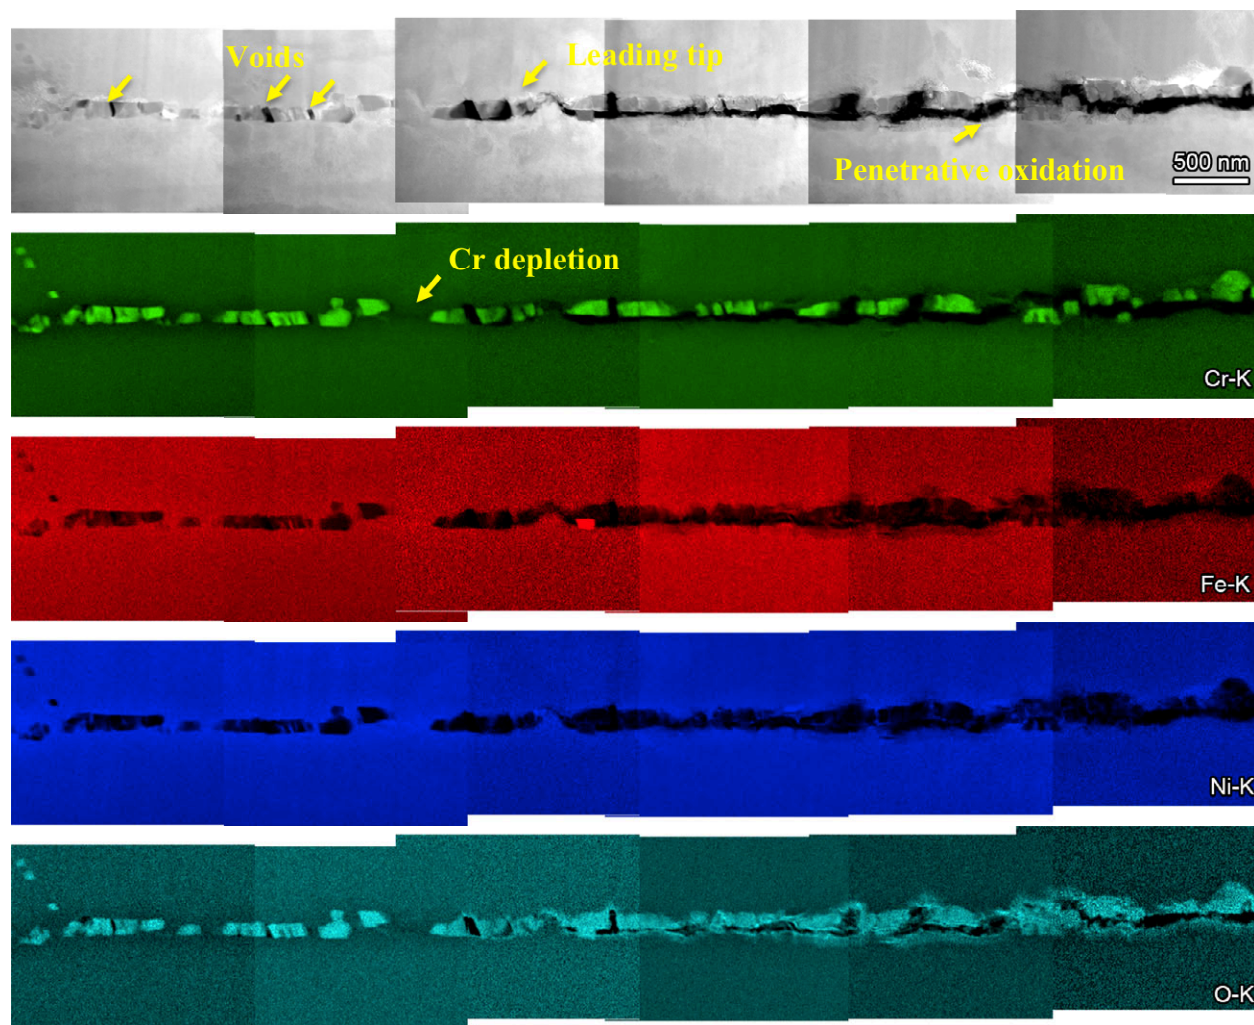
Figure 111. TEM Angular DF and EDS elemental map montages of crack #1 (see Figure 105).

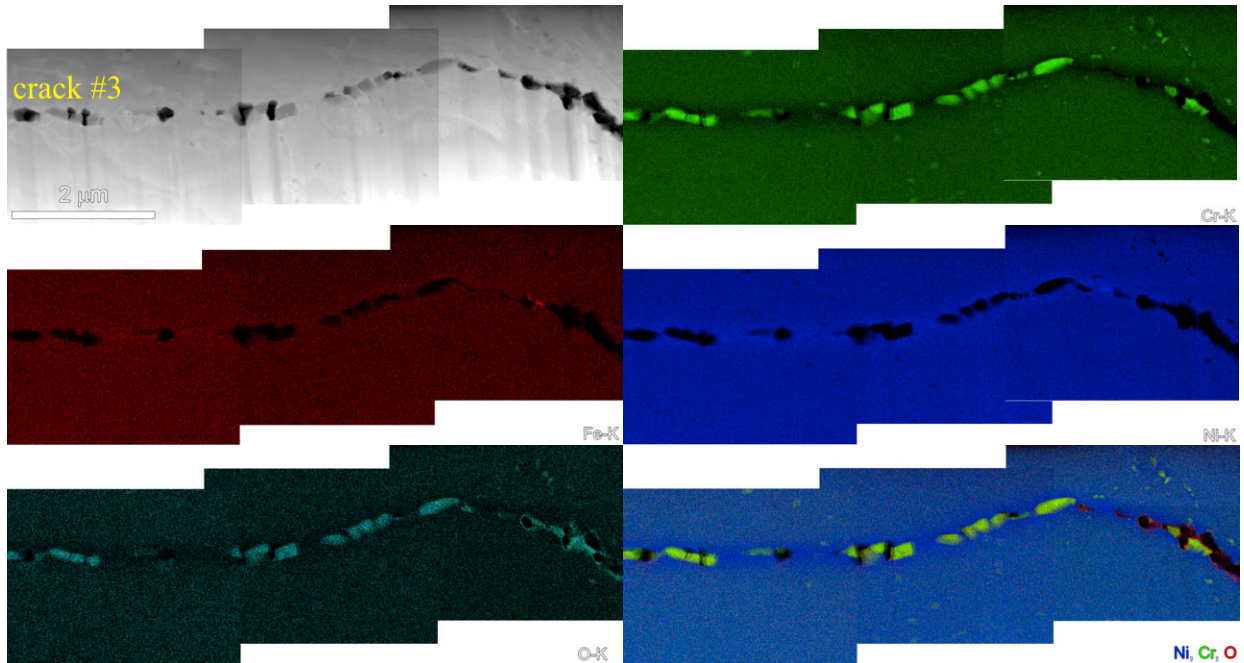
Figure 114. TEM Angular DF and EDS elemental map montages of crack #3 (see Figure 105).

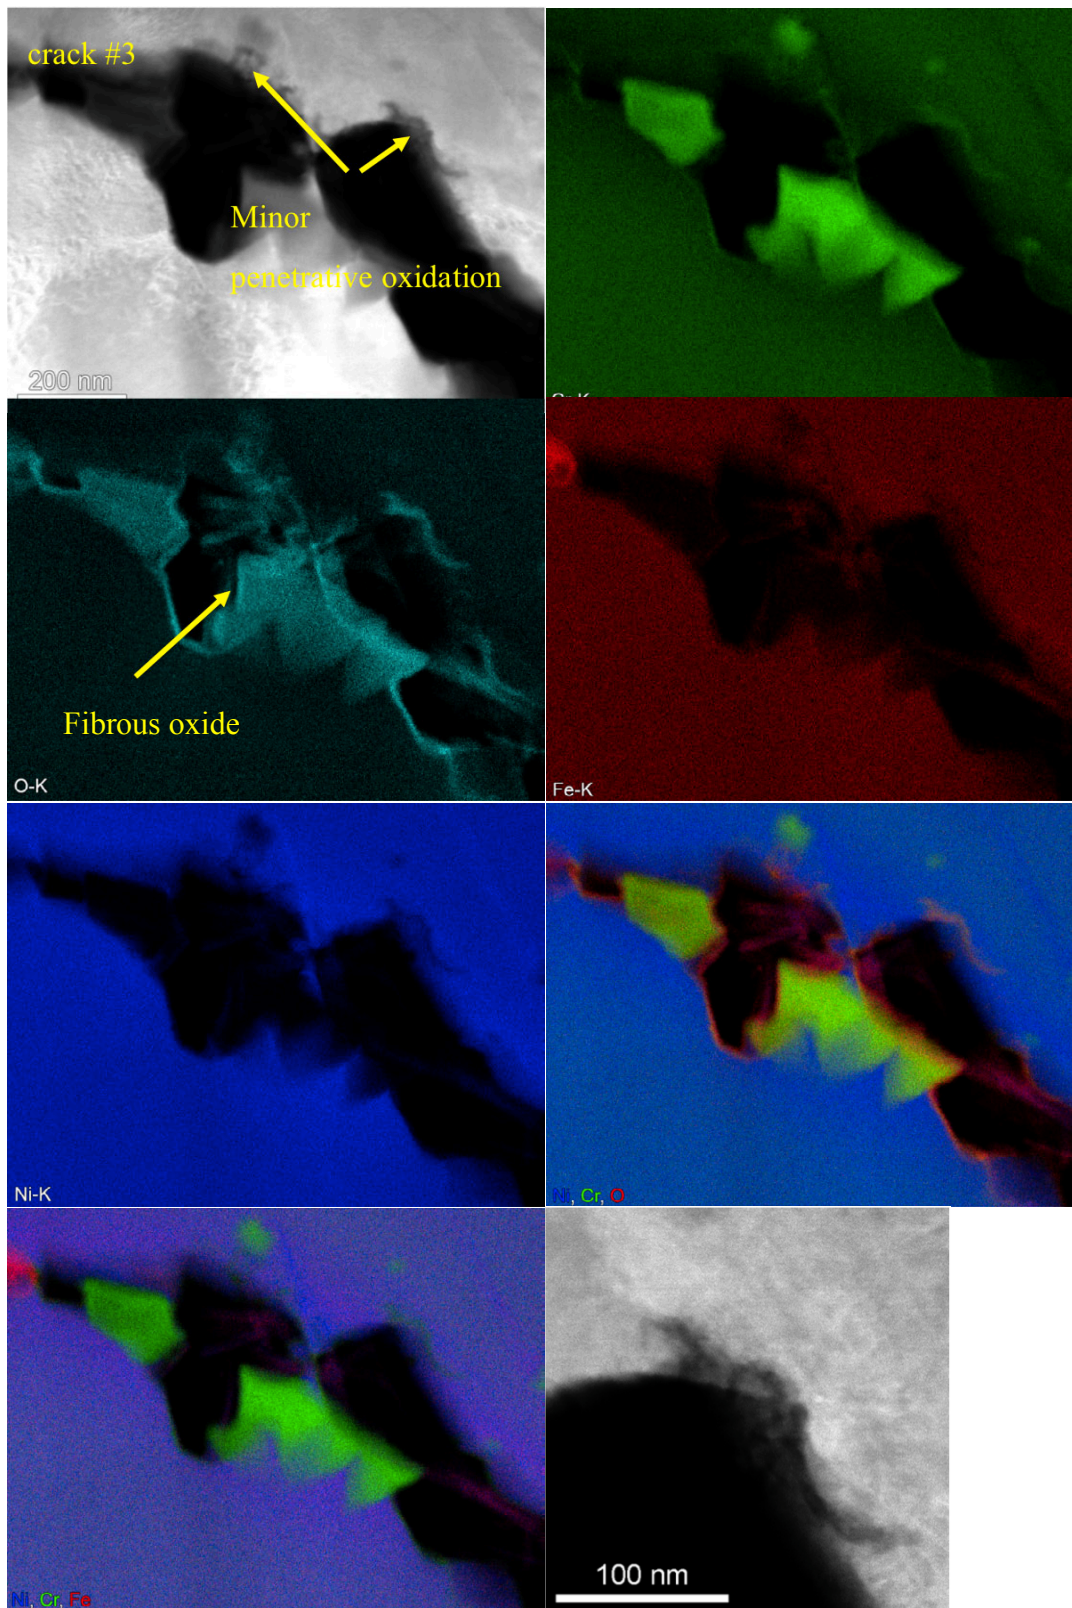
Figure 115. TEM Angular DF and EDS elemental maps of crack tip #3 (see Figure 105).

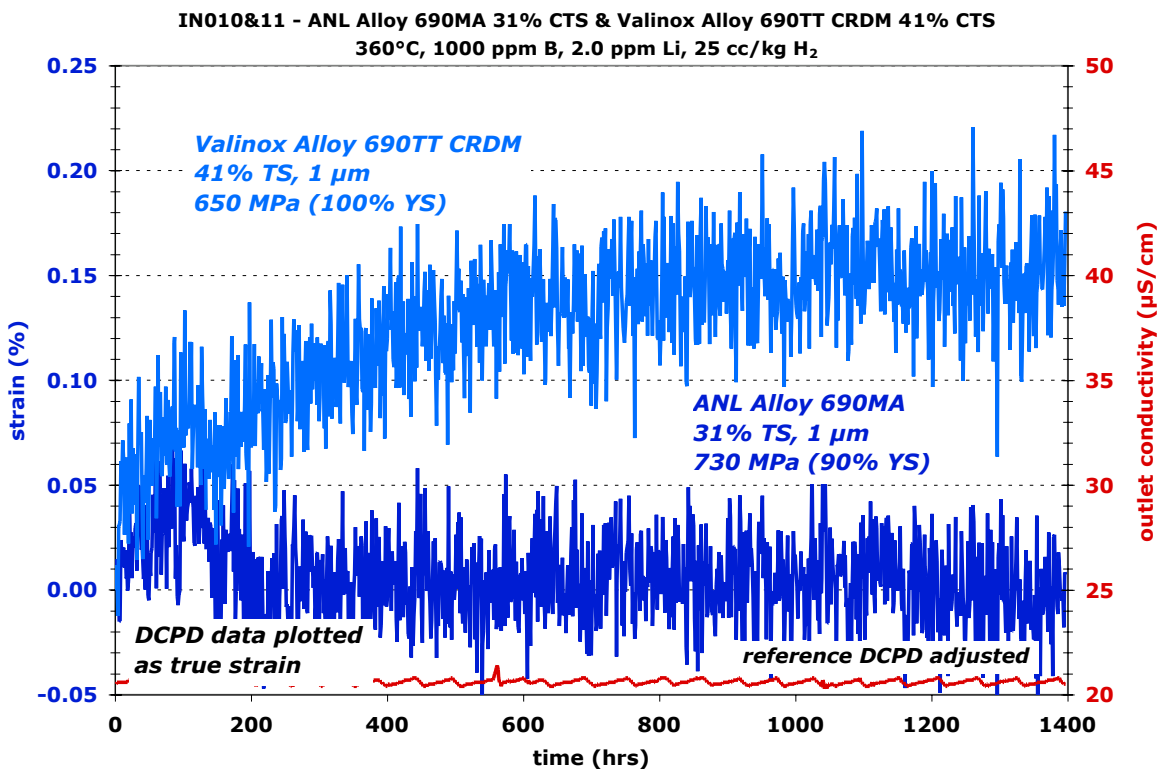
Figure 116. 31% tensile strained ANL alloy 690 plate (IN010) and 41% tensile strained alloy 690 CRDM (IN011) response during exposure in 360°C simulated PWR primary water at constant load near the yield stress.

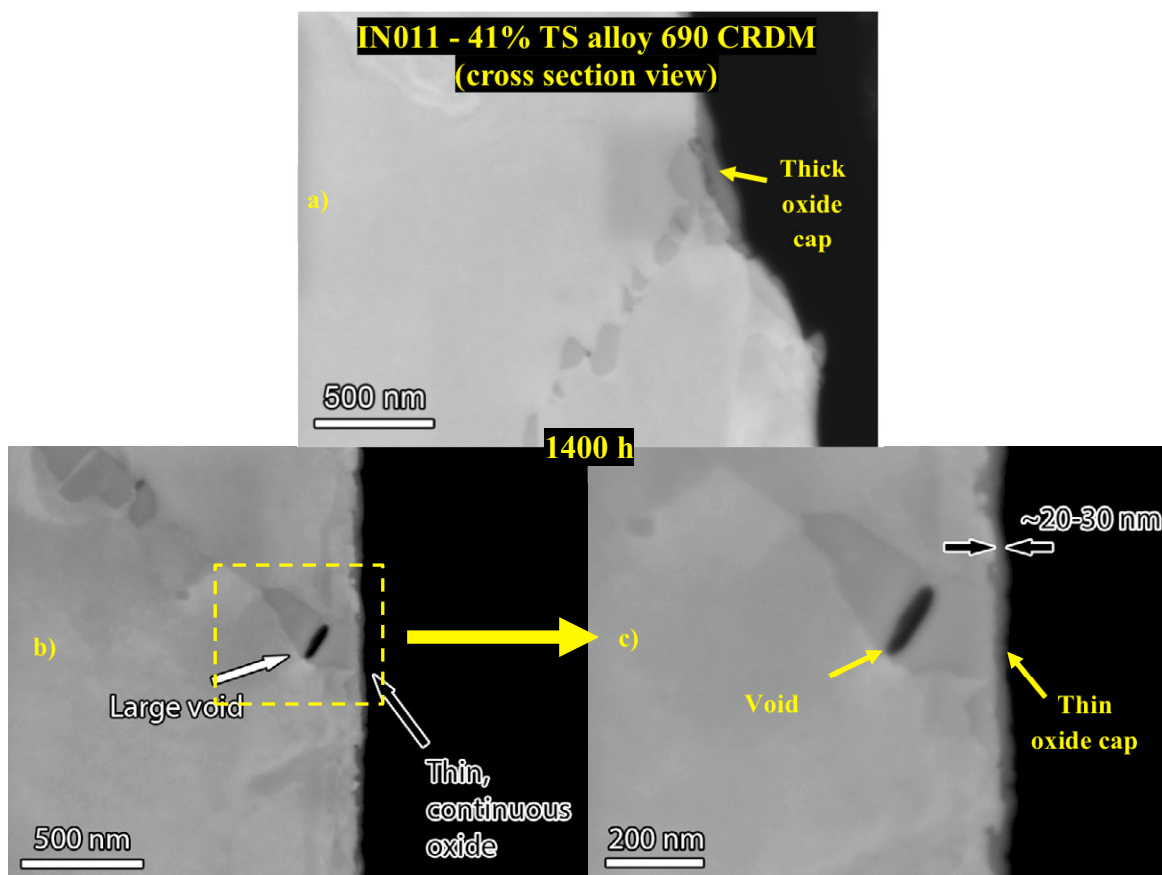
Figure 120. SEM-BSE images of the 41% tensile strained alloy 690 CRDM illustrating a thin, 20-30 nm, continuous oxide at the surface and voids between IG carbides.

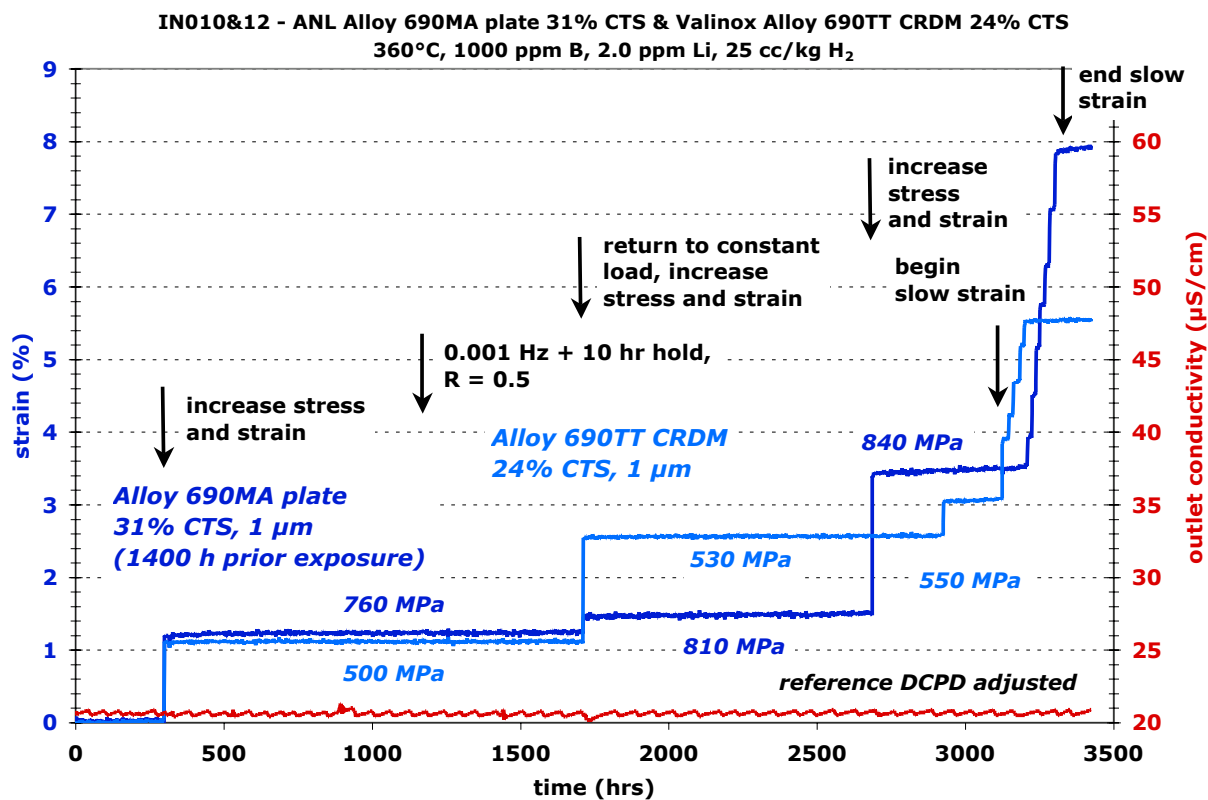
Figure 121. Overview of the entire test on the 31% tensile strained alloy 690 plate (IN010) combined with a 24% cold tensile strained alloy 690 CRDM specimen (IN012). Note that IN010 has 1400 hours of prior exposure.

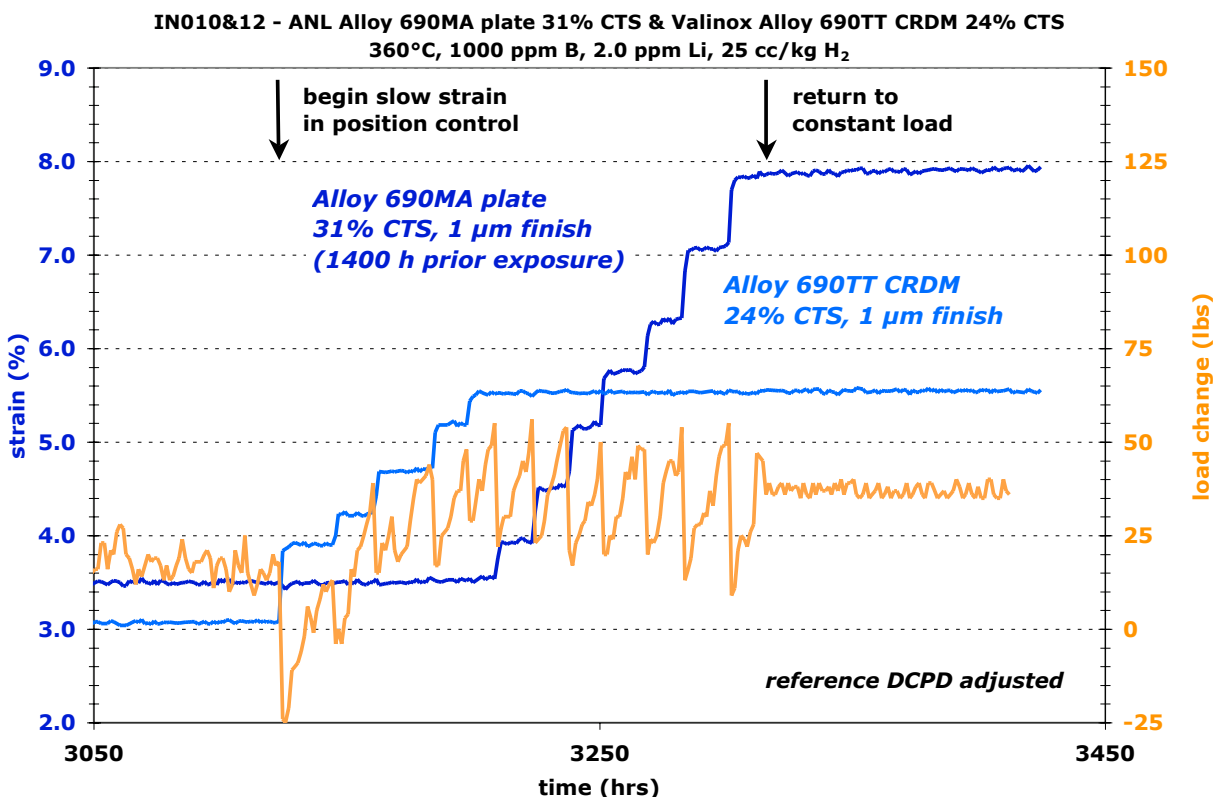
Figure 122. Slow straining response of the 31%TS alloy 690 plate (IN010) combined with a 24%TS alloy 690 CRDM specimen (IN012). Note that IN010 has 1400 hours of prior exposure.

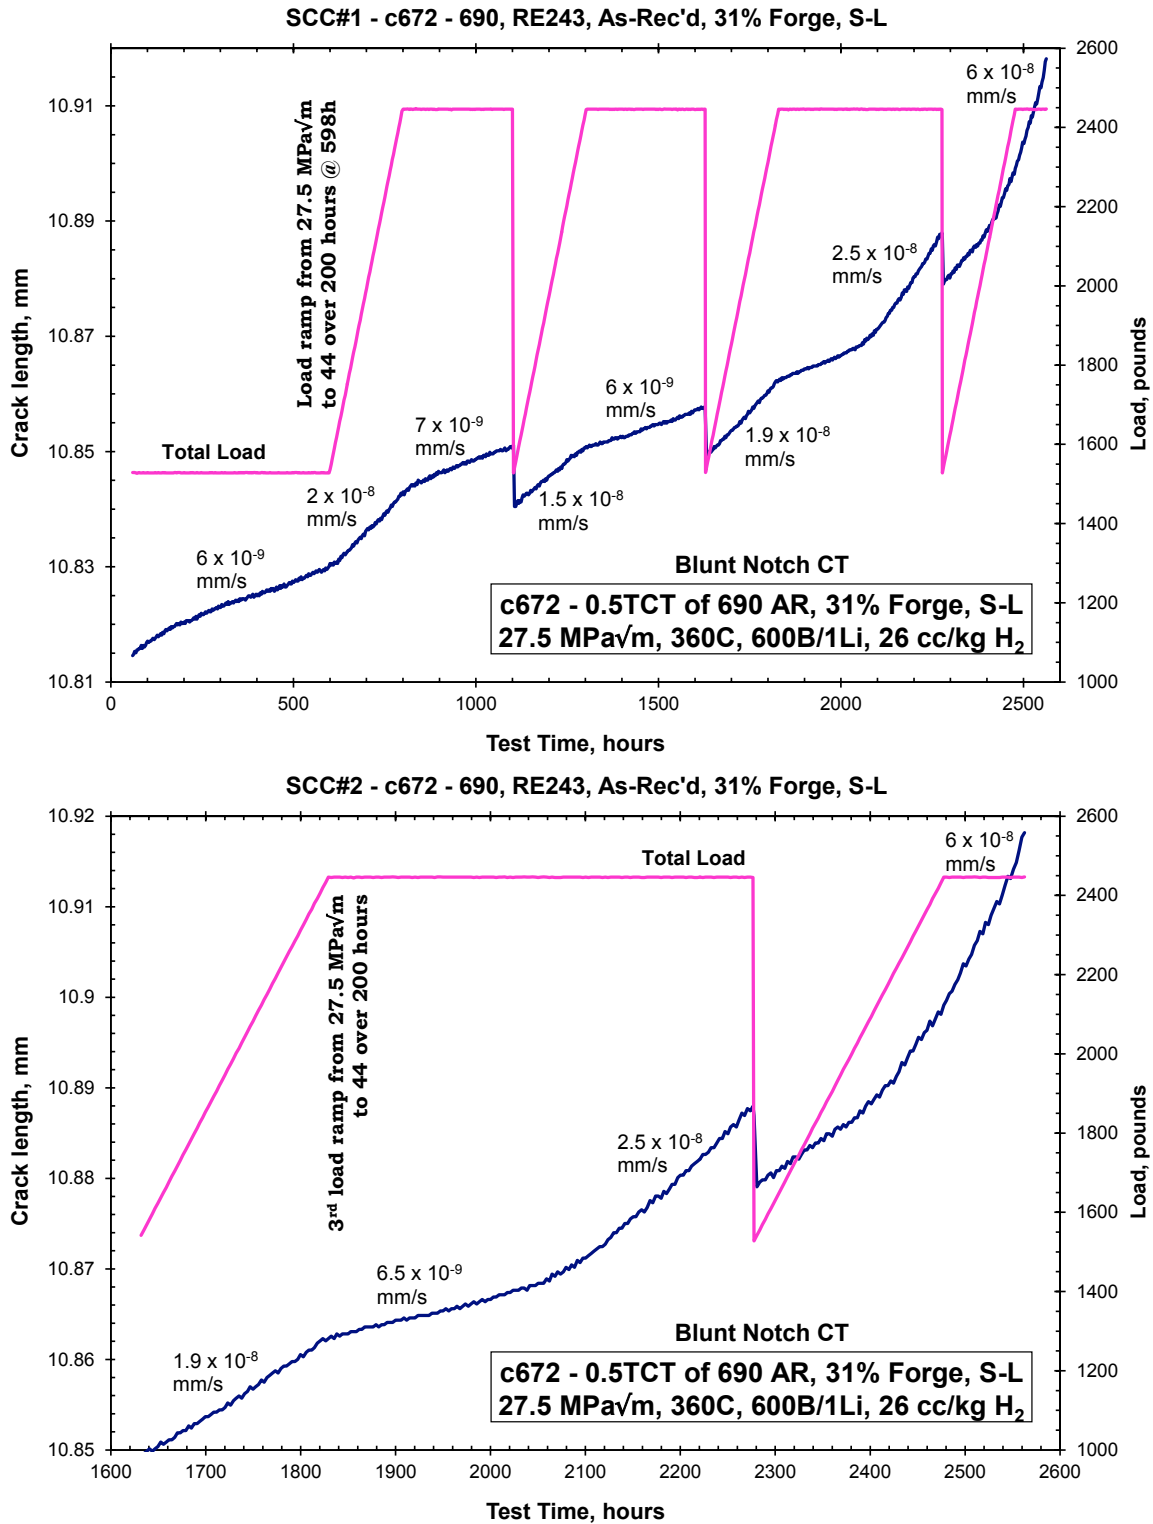
Figure 125. Crack length versus time response for the 31%CF Valinox CRDM specimen c672 blunt notch specimen.
