**STRESS CORROSION CRACK INITIATION OF COLD-WORKED
ALLOY 600 AND ALLOY 690 IN PWR PRIMARY WATER**

**Technical Milestone Report: M2LW-14OR0404023
PNNL-23712 September 2014**

Research Project:
**Stress Corrosion Crack Initiation of
Nickel-Base Alloys in LWR Environments**
Project Manager: S. M. Bruemmer
Pacific Northwest National Laboratory

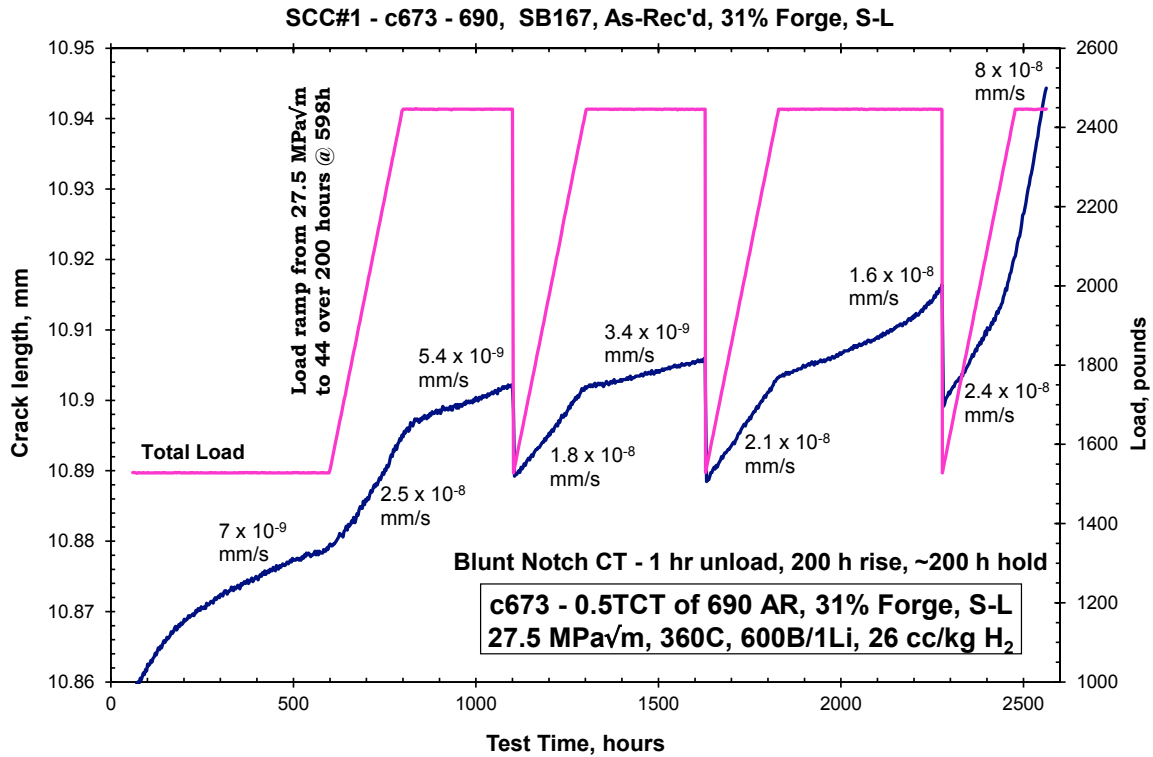
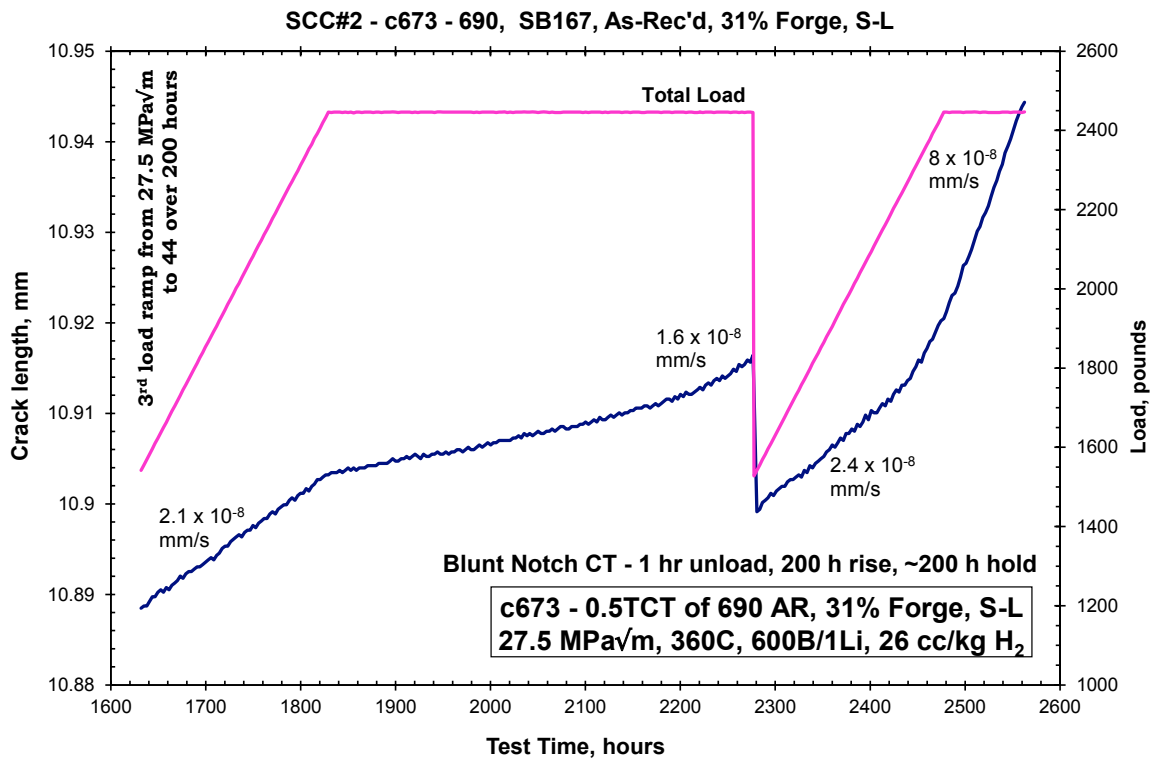
Figure 126. Crack length versus time response for the 31%CF Sumitomo CRDM specimen c673 blunt notch specimen.

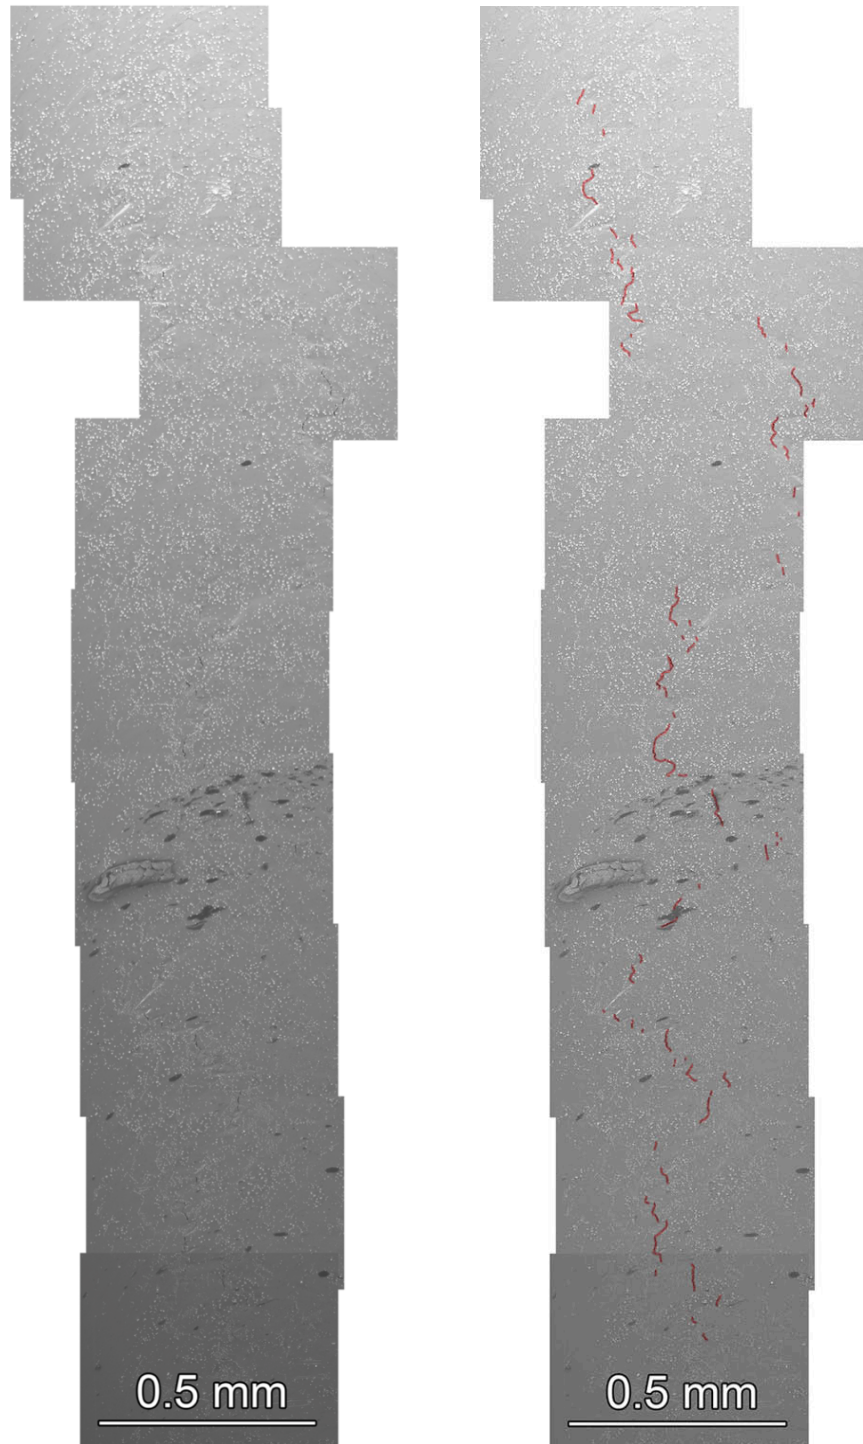
Figure 131. SEM-SE image of a portion of the 31%CF Sumitomo CRDM specimen c673 notch showing several nucleated cracks (highlighted by red marker in right image).

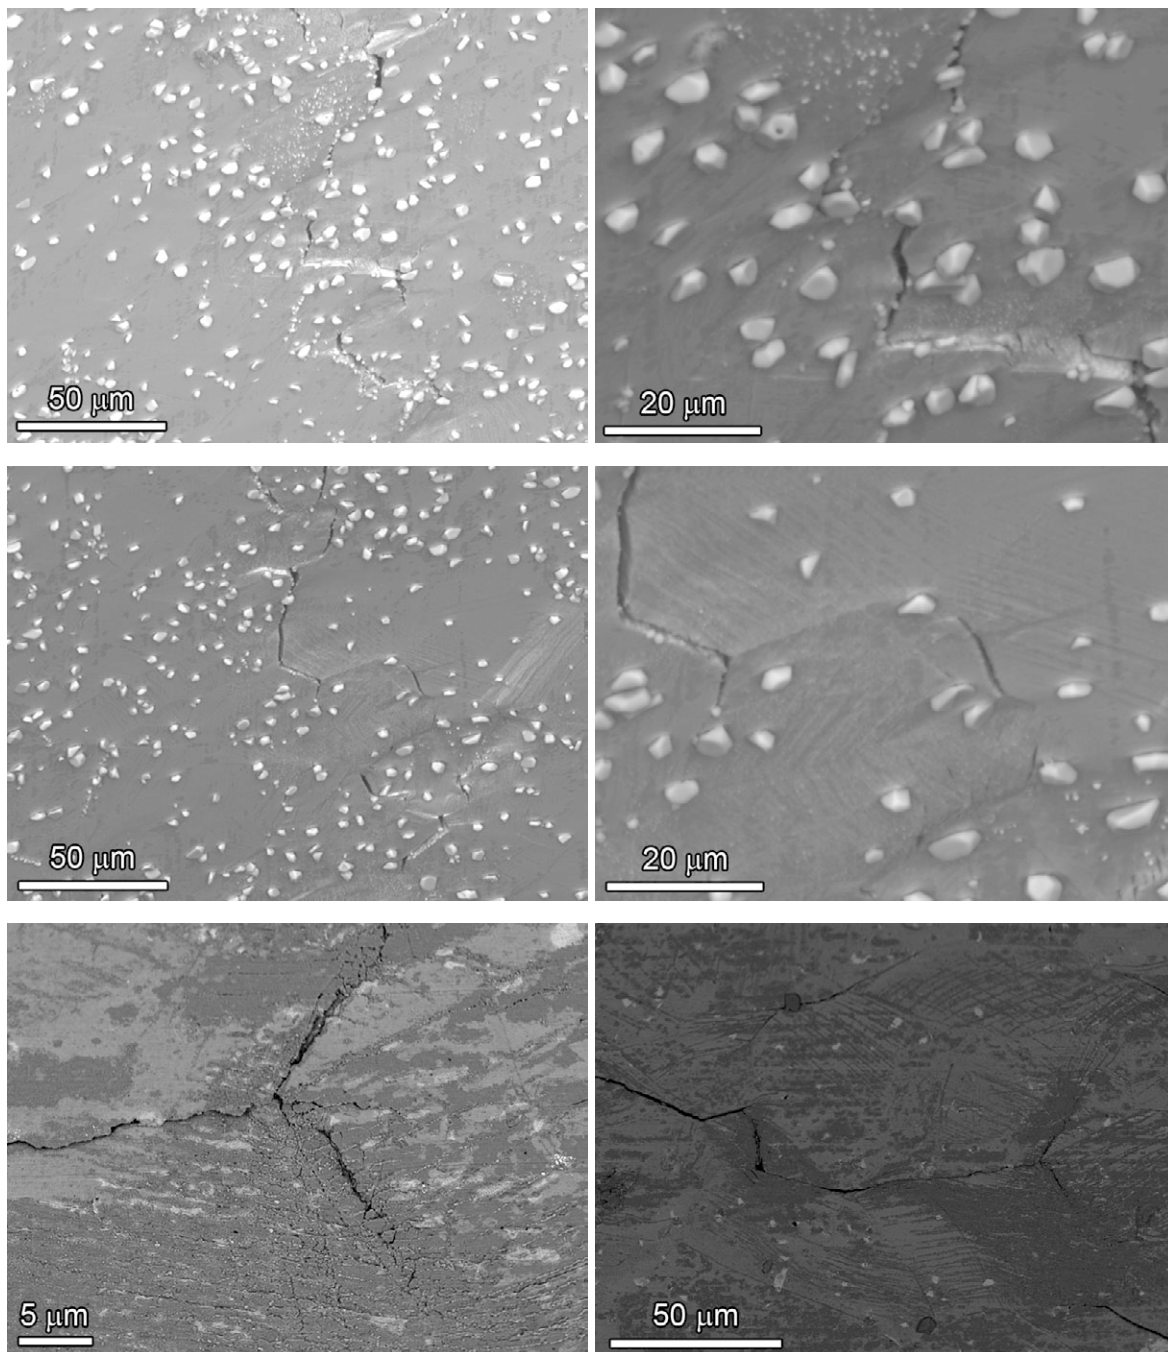
Figure 132. Higher magnification SEM images showing cracks on the notch of 31%CF Sumitomo CRDM specimen c673.

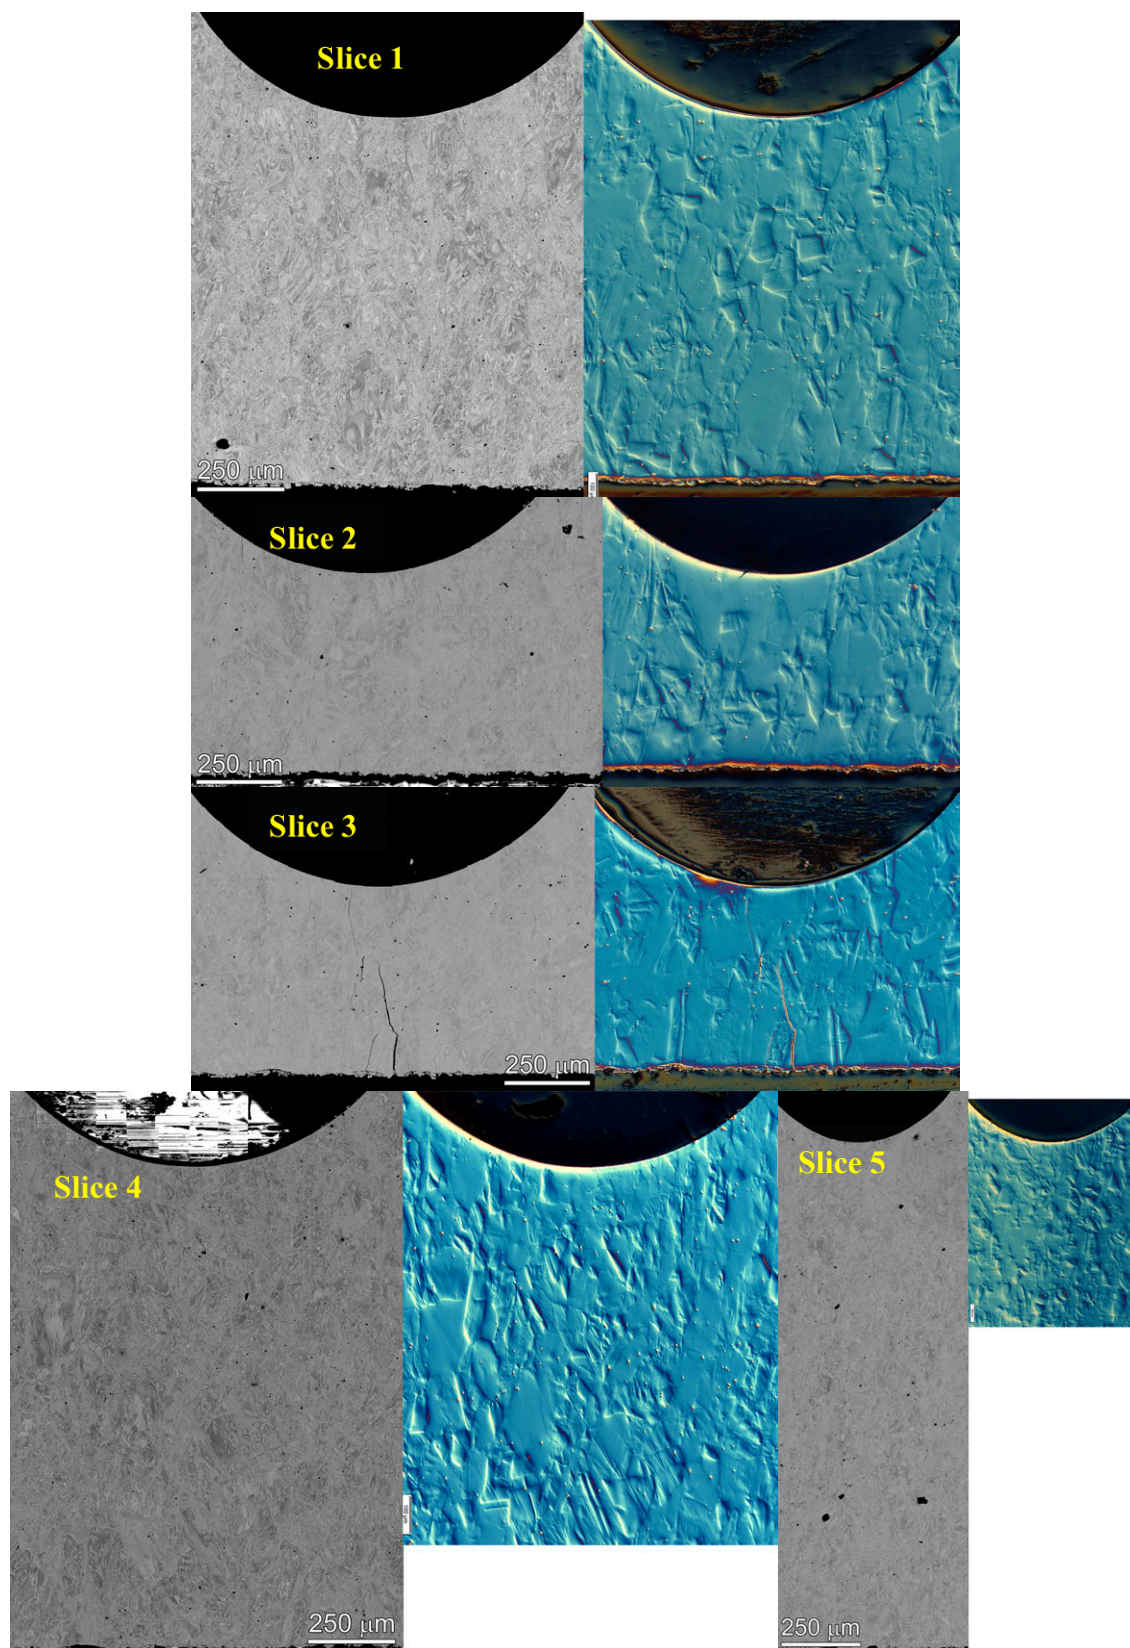
Figure 133. SEM (BSE) and optical micrographs of five slices in C672.

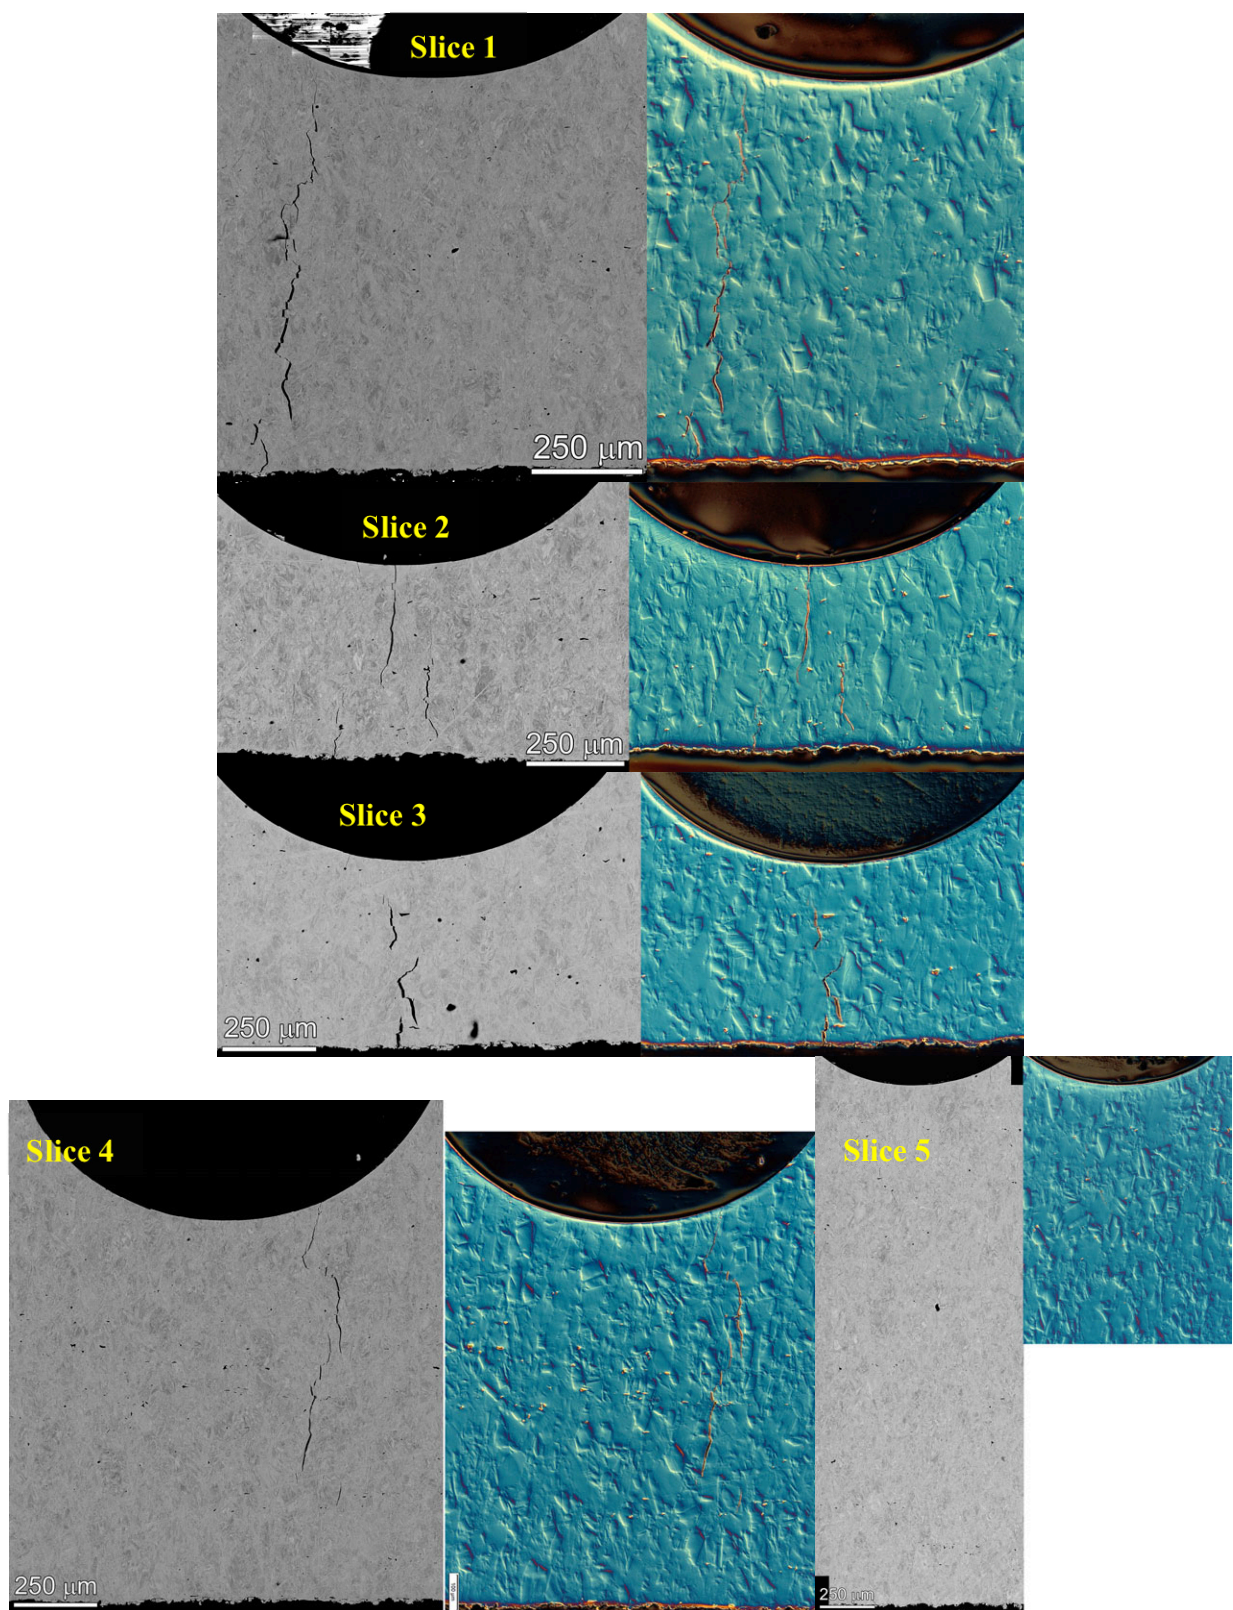
Figure 134. SEM-BSE and optical micrographs of five cross-section slices in C673.

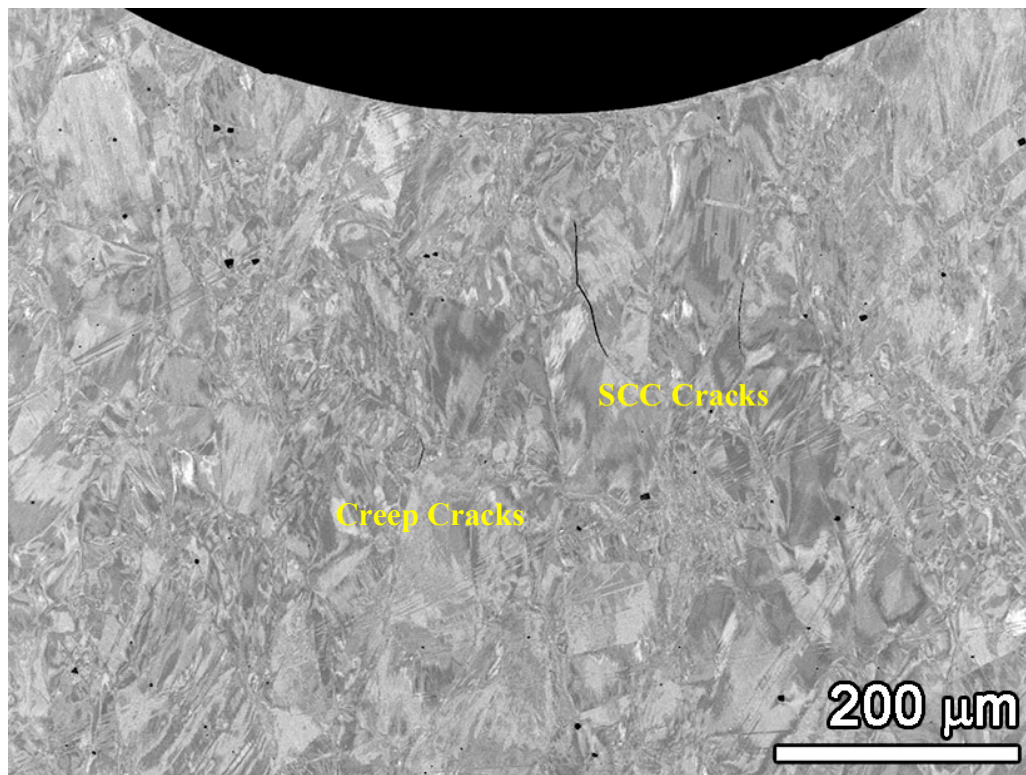
Figure 135. Blunt notch c672 cross-section slice #1 showing what are identified as SCC and creep cracks.

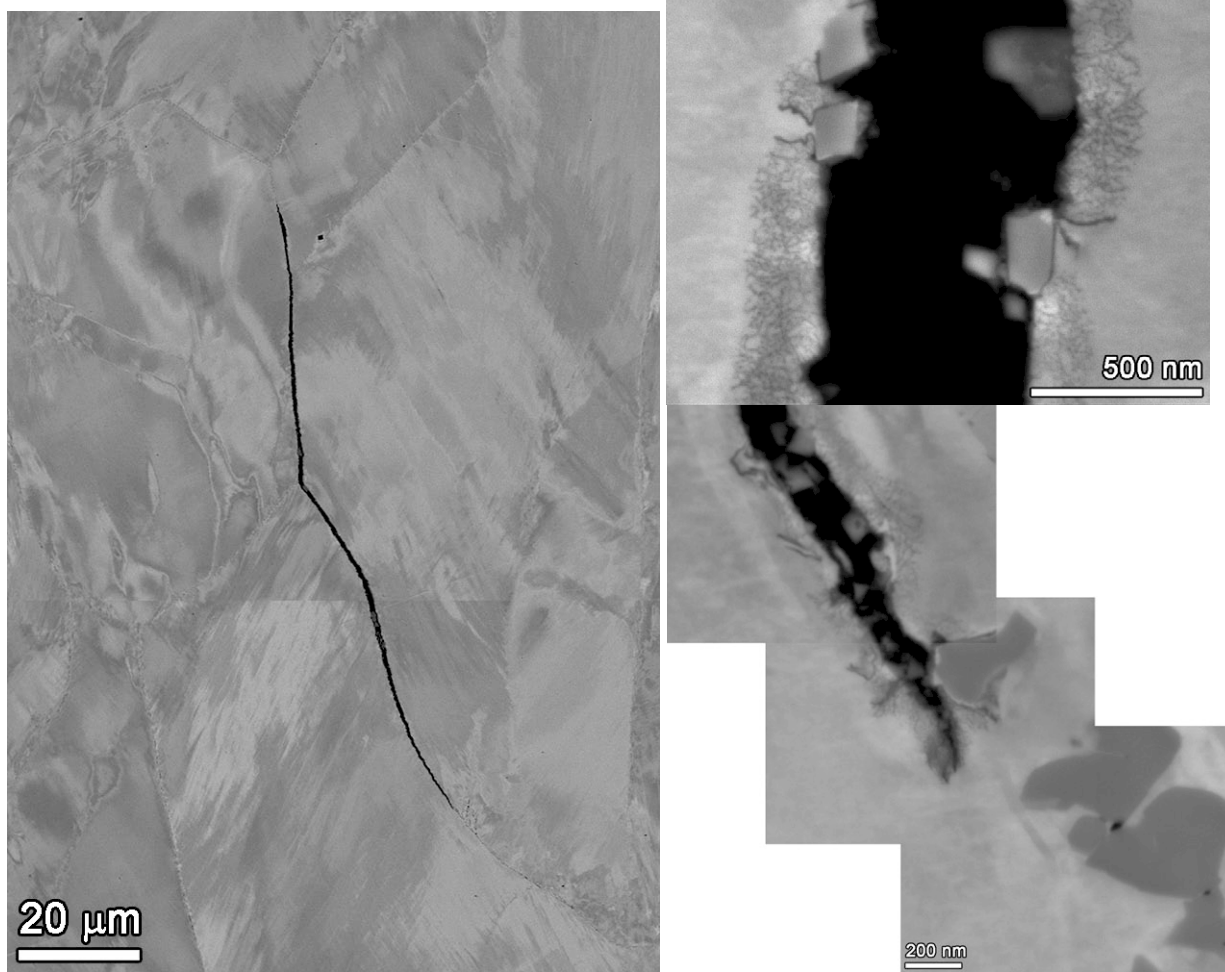
Figure 136. IGSCC crack in blunt notch specimen c672 cross-section slice #1 that clearly shows crack wall and crack tip corrosion.

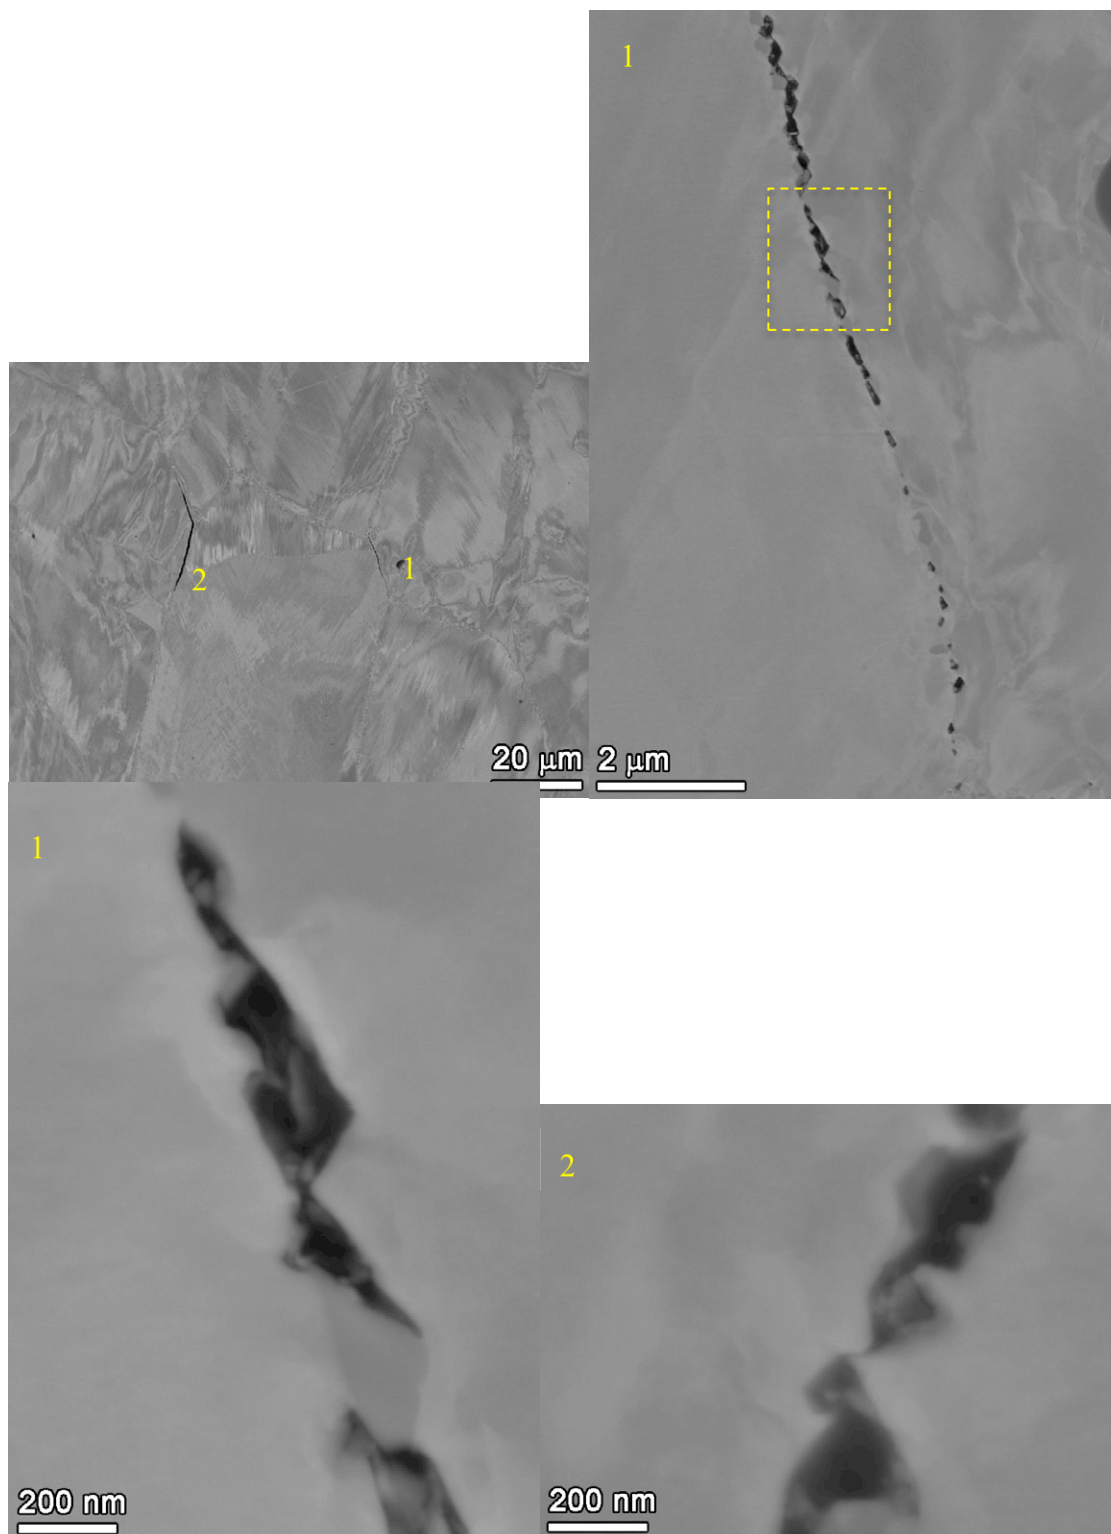
Figure 137. Apparent creep cracks in blunt notch specimen c672 cross-section slice #1 showing no evidence for corrosion or oxidation along the crack walls.

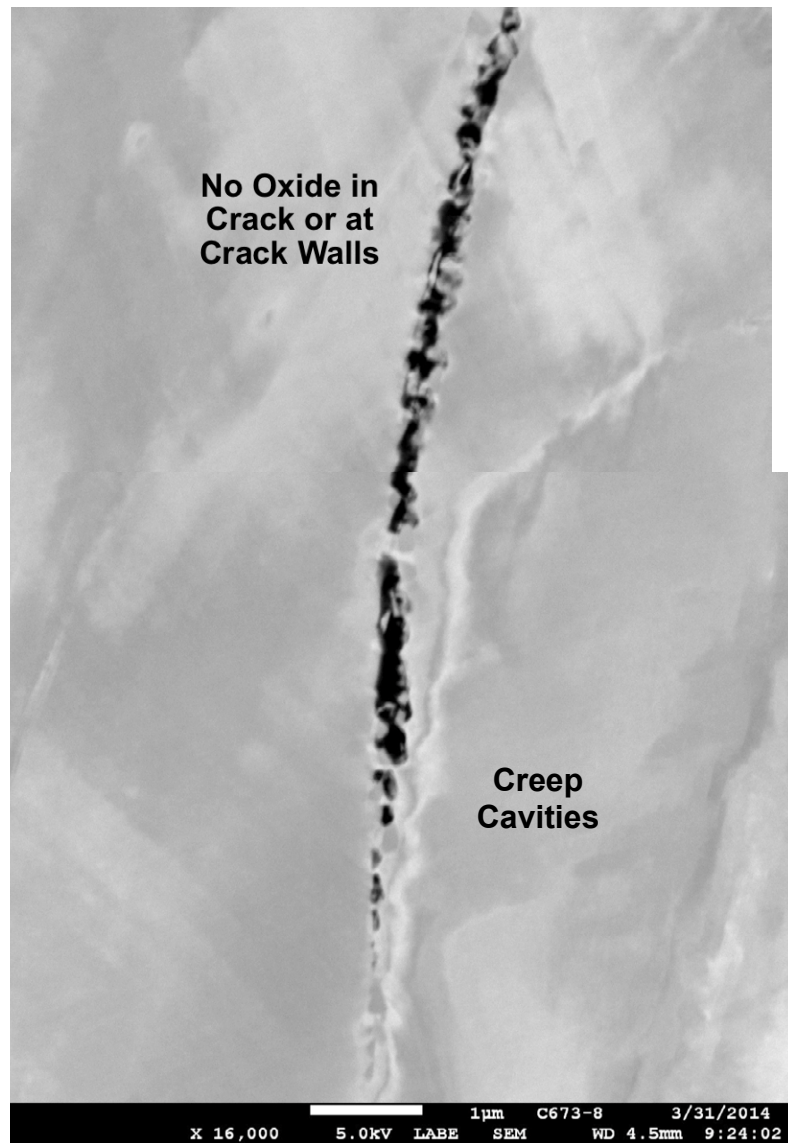
Figure 138. Example of IG creep crack and cavities in cross-section slice #2 from blunt notch specimen c672.

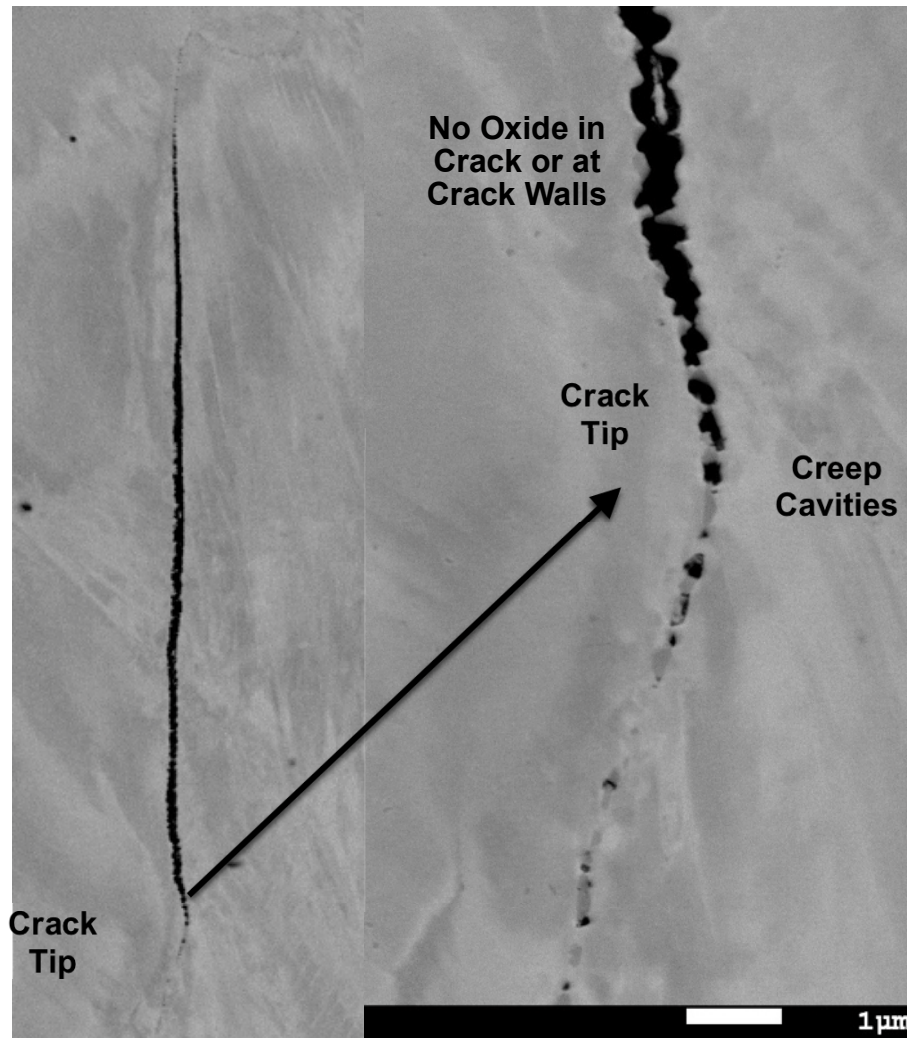
Figure 139. SEM-BSE cross-section image of c673 slice #4 showing creep crack tips. This slice had many large SCC cracks.

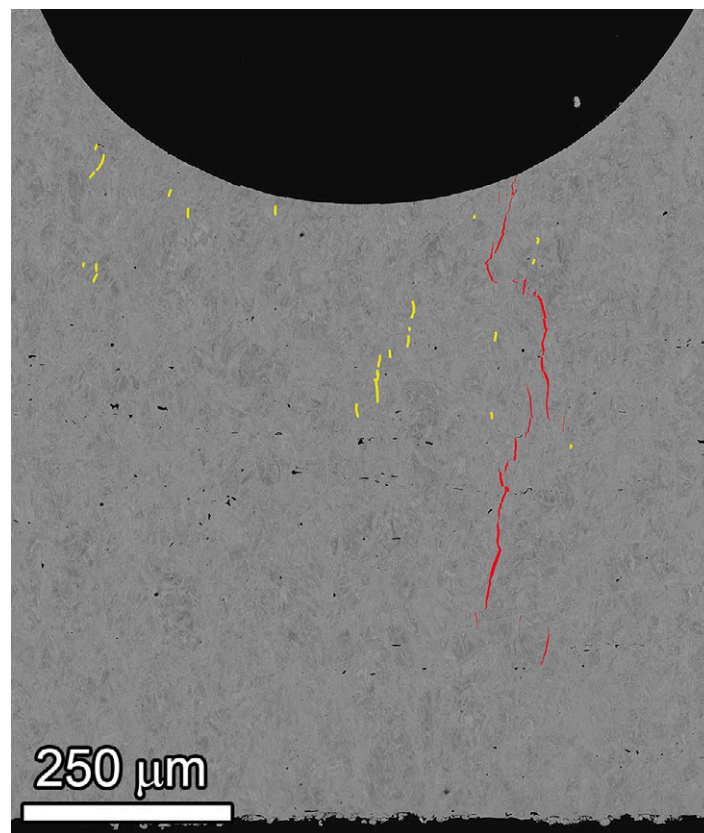
Figure 141. SEM-BSE image of C673 cross-section slice #4 showing cracks identified as SCC (red) and creep (yellow).

The main question that remains unanswered is whether creep cracking is responsible for the crack nucleation and growth observed in the blunt notch tests. To get a better assessment of the creep crack distributions, their locations were mapped on several cross-sections as presented in Figures 140 and 141 for c672 and c673, respectively. Small creep cracks are identified across the notch with a few close to the surface and most at a distance $>100\ \mu\text{m}$ below the surface. With the experiments that have been run, it has not been possible to conclude whether the creep cracks are responsible for nucleation on the surface. It seems very likely that the distribution of subsurface creep cracks promotes rapid growth of short cracks from the surface and leads to conditions for SCC growth at constant stress intensity. Much more work is needed to understand how the loading ramps employed in these blunt notch tests can produce such extensive creep cavitation and cracking. It is important to note that the same slow-strain-rate deformation was used for the IN007 tensile specimen and once again creep cracking was identified.
