# NDE Technology Development Program for Non-Visual Volumetric Inspection Technology

## Technology Screening Report

**March 2017**

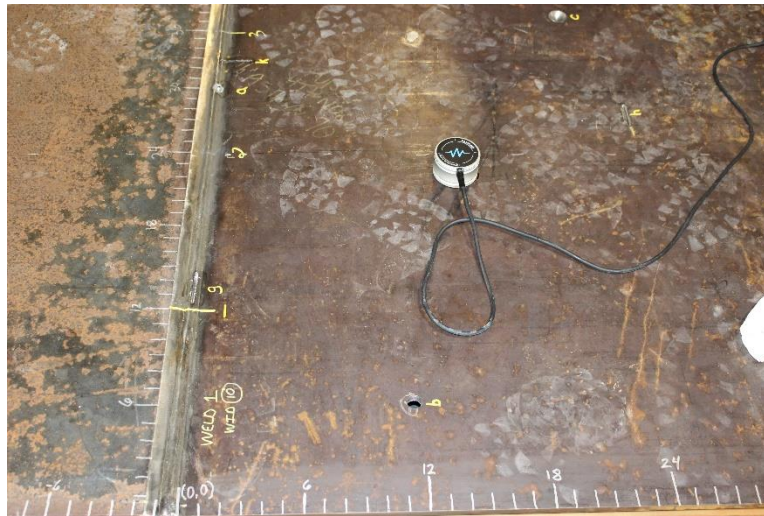
**Figure 6.1.** Guided-Wave Sensor

Guidedwave selected a 165 kHz, 30-element phased-array sensor for interrogation of the screening mockup. The active element portion of the transducer array would be small enough to fit into the air slots; however, modest re-design of the housing would be required to reduce height and to accommodate remote coupling delivery. Primarily, the sensor was used to make measurements on the 0.5-inch thick bottom plate of the mockup. Some measurements were also made on the 0.875-inch bottom plate and on the 0.5-inch wall plate above the knuckle weld. Data were acquired with the probe in a variety of locations on the mockup. Figure 6.2 shows the inspection locations for the 0.5-inch thick bottom plate not including the five locations along the simulated access channel along a diagonal on the plate used to generate composite images.

The demonstration conducted by Guidedwave consisted of a guided-wave phased-array technique where a single transducer containing several ultrasonic elements produced and steered an acoustic guided wave in the test material. This approach used specific time delays and excitation amplitudes for each element of the array to produce a guided wave in a specific direction. The data acquisition hardware controlled these delays and varied them in such a way to produce a 360° inspection around the single sensor. This approach required access to and direct contact with the bottom plate of the mockup and the use of a shear couplant to propagate the guided wave into the test material. The liquid couplant is easily removed with a minimal amount of water and wiping. The guided-wave sensor is shown in Figure 6.1, and their test report is included as Appendix A.

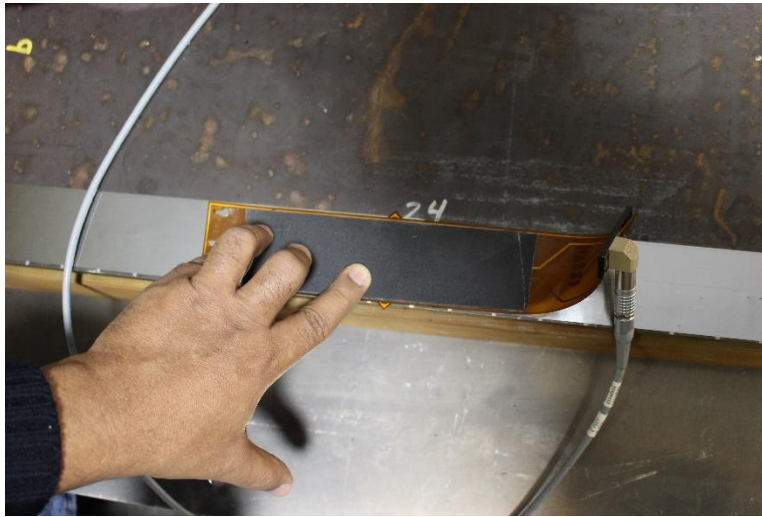
**Figure 6.3.** EMAT Technique Using Magnetostrictive Strip

Measurements performed with the magnetostrictive EMAT featured the strip placed on the top surface of the bottom plate along the long edge, perpendicular to the weld direction. An EMAT sensor consisting of a meander coil circuit in a short flexible strip was then placed over the magnetostrictive strip as shown in Figure 6.3. This configuration induced guided waves that traversed across the bottom plate of the mockup. The magnetostrictive EMAT sensor was placed at several locations along the magnetostrictive strip and manually angled at each position to control sound beam direction and detect reflections from welds and the surrogate flaws. The magnetostrictive EMATs were used as Innerspec's main technology for the DST inspections; therefore, the analysis was conducted on this technique. The flexible strip magnetostrictive EMAT would currently fit within the air slots; however, an external housing would be

required to accommodate an air bladder that would be used to pressure couple the magnetostrictive layer and flexible strip to the tank bottom.

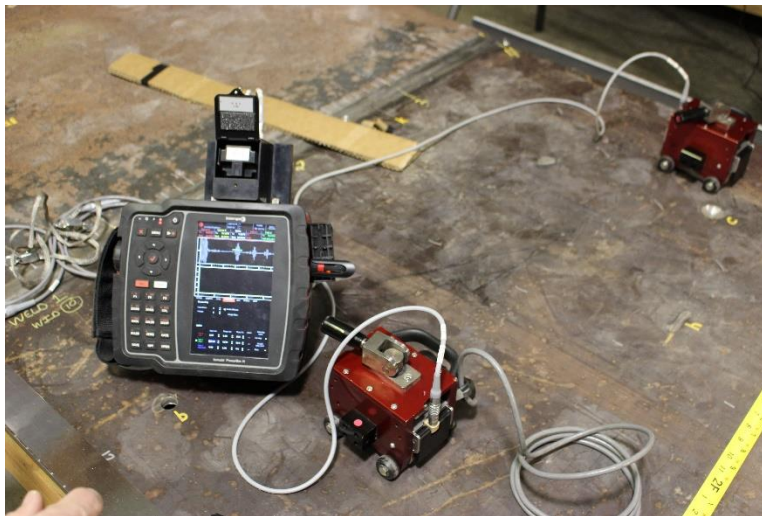
**Figure 6.4.** EMAT Pitch-Catch and Pulse-Echo Technique

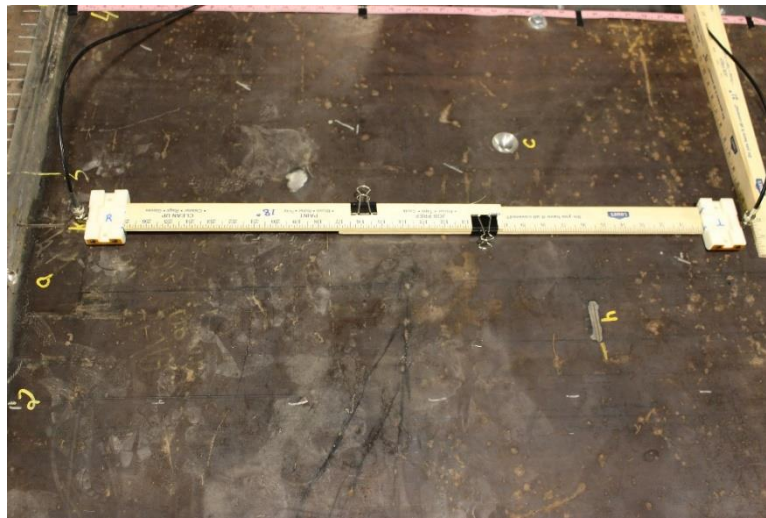
The through-transmission configuration used a transmitter and receiver separated by 29 inches, which represents the spacing between adjacent air slots. The sensor pair was kept in alignment as shown below in Figure 6.5. Data were collected by moving the EMAT sensor pair in 1-inch increments over regions of the mockup containing four surrogate flaws.

**Figure 6.5.** Through-Transmission Configuration

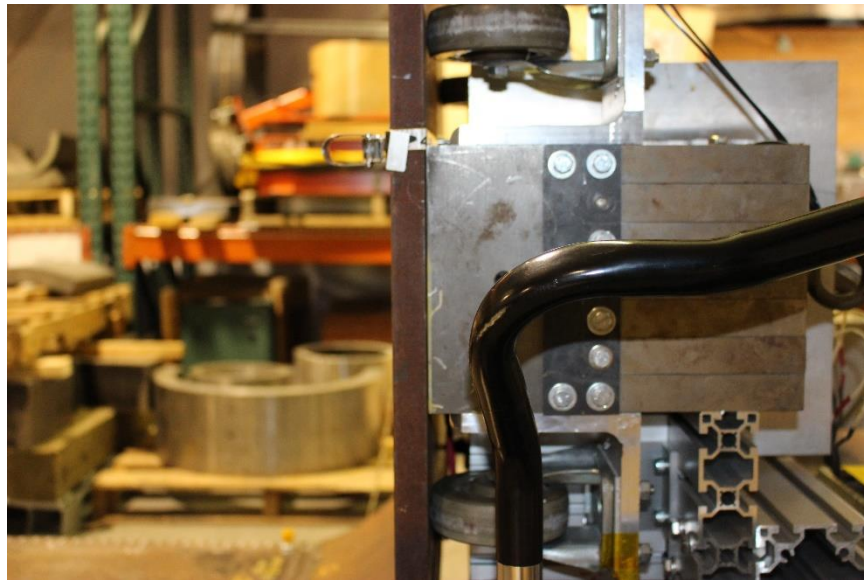
**Figure 6.8.** Side View of the Sensor in Place above the Knuckle for Examining the Surrogate Flaws Remotely

The sensor system demonstrated for the technology screening effort was specifically designed to inspect reactor containment vessels, although additional meander coil configurations, producing higher frequencies, were assembled specifically for this demonstration. The demonstrated system was rather large ( $\sim 1 \text{ ft}^3$ ) and heavy ( $> 200 \text{ lbs.}$ ) but SwRI assured that the sensor could be reduced in size and weight to accommodate deployment through a 24-inch riser into the annulus space of a DST. The system was placed on the primary wall section of the mockup just above the upper knuckle weld. The meander coils, electromagnets, and some circuitry were positioned at the inspection site, and this equipment was connected to the power supply and data acquisition equipment through a long umbilical cable. A side view of the sensor equipment at the examination site is shown in Figure 6.8.

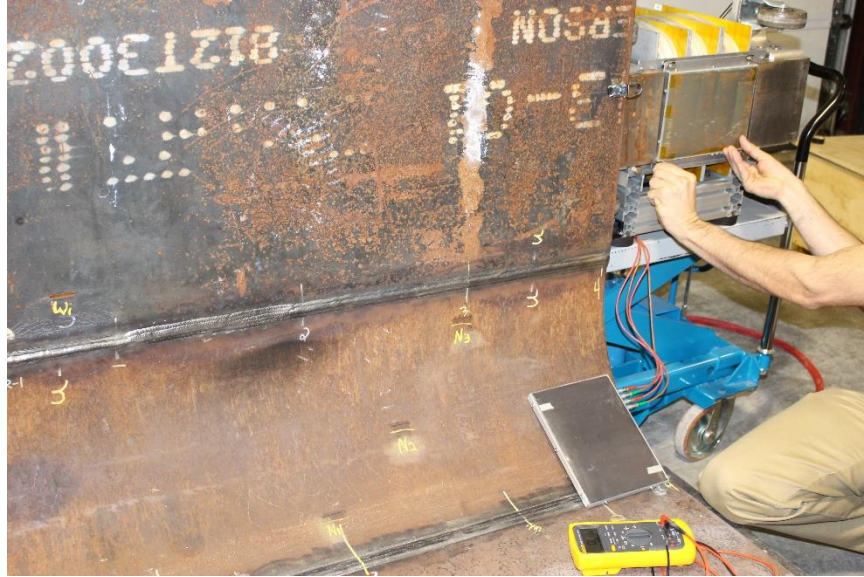
**Figure 6.10.** Meander Coil Being Replaced Between Examinations

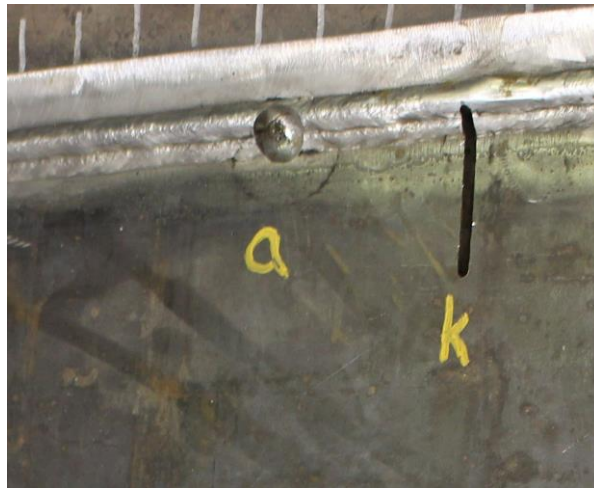
Flaw “a” is a 0.750-inch diameter pit with a height of 50% of the plate thickness (0.250 in.) located in the transition weld between the 7/8 inch and ½ inch plate. Pit “a” is in close proximity to Notch “k” as shown in Figure 7.1.

**Figure 7.1.** Photograph of Pit “a” (left) and Notch “k” (right) Located in the Transition Weld

Flaw “k” was a 2-inch long, 0.125-inch wide machined notch with a height of 50% of the plate thickness (0.250 in.). Notch “k” was located in the 7/8 to 1/2-inch transition weld and oriented perpendicular to the weld. Notch “k” was in close proximity to Pit “a” as shown in Figure 7.1 above.

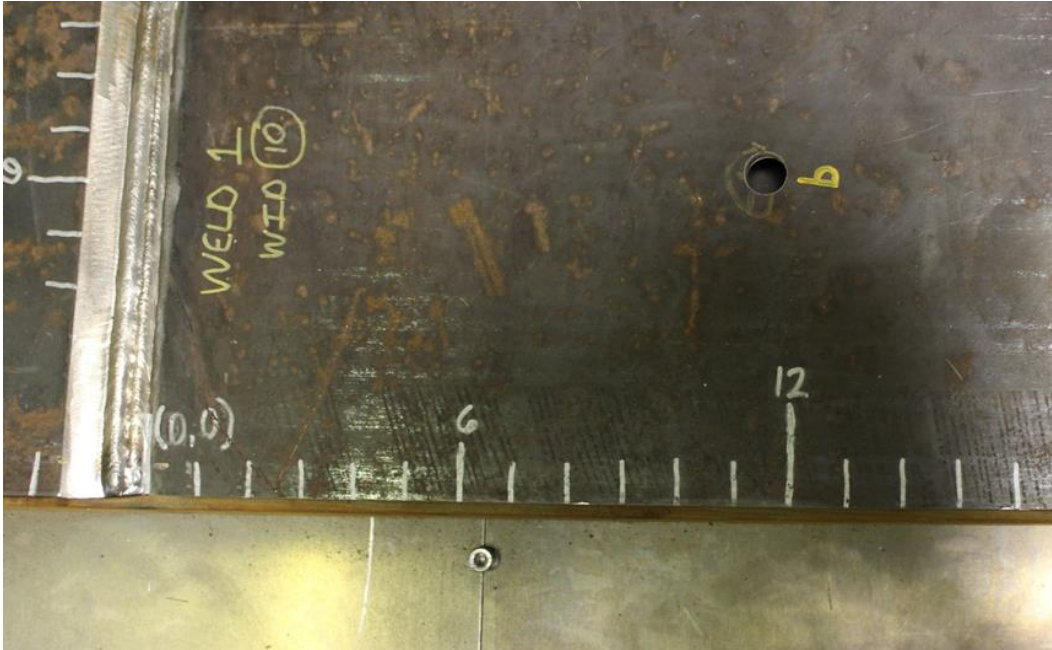
Flaw “b” was intended to be a 0.750-inch diameter pit that was 50% of the plate thickness (0.250 in.) located in the ½-inch base plate. After receiving the mockup back from the manufacturer, Flaw “b” ended up as a 0.750-inch diameter 100% through-wall hole as displayed in Figure 7.7.

**Figure 7.7.** Photograph of Hole “b”

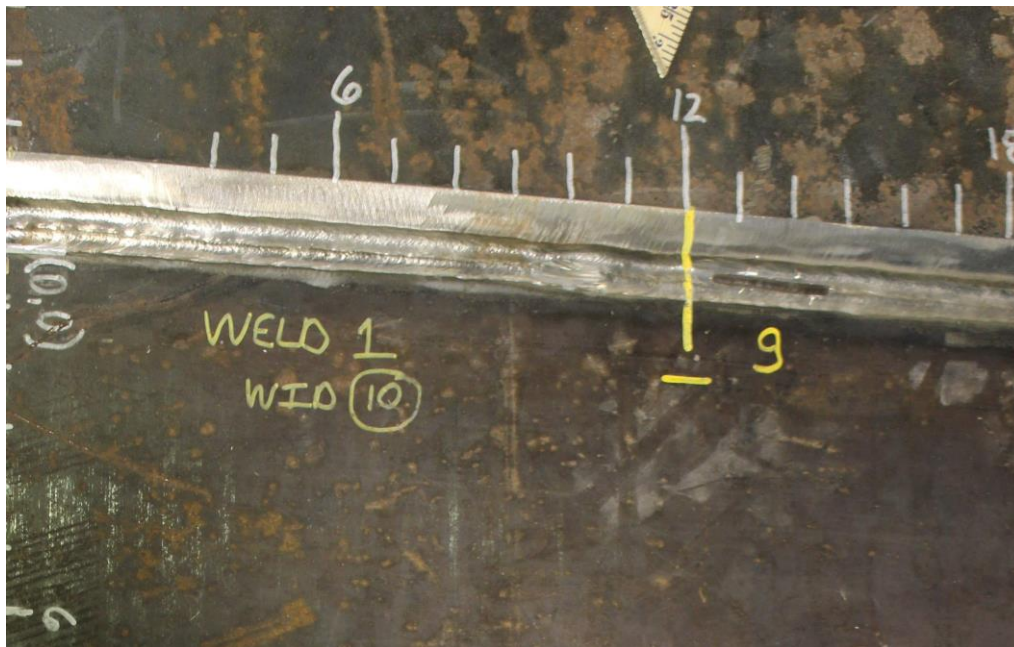
Flaw “g” was a 2-inch long, 0.125-inch wide machined notch that had a height of 50% of the plate thickness (0.250 in.). Notch “g” was located in the 7/8 to 1/2-inch transition weld and oriented parallel to the weld as shown in Figure 7.12.

**Figure 7.12.** Photograph of Notch “g” Located in the Transition Weld

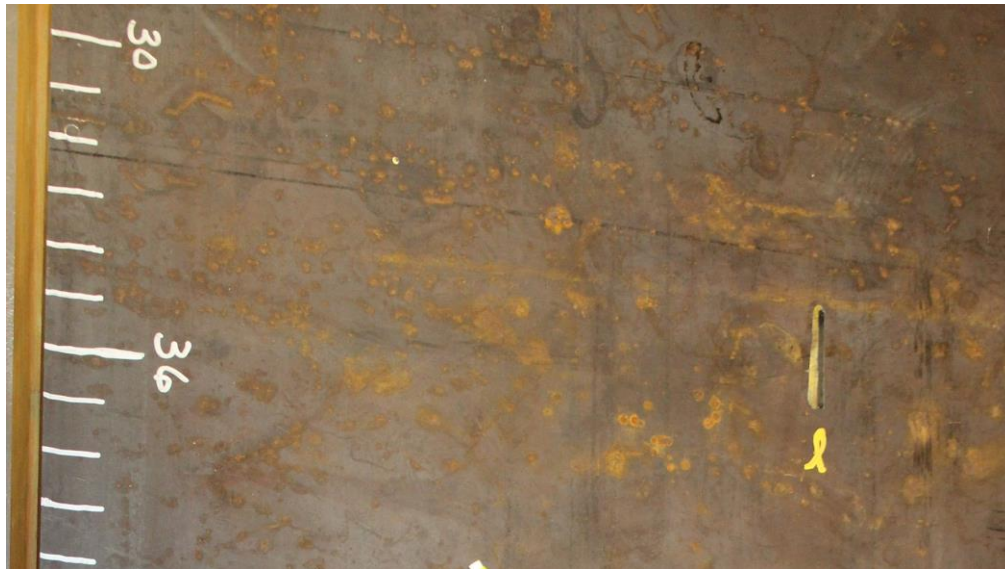
Flaw “L” was a 2-inch long, 0.125-inch wide machined notch with a height of 90% of the plate thickness (0.450 in.). Notch “L” was located near the middle of the ½-inch base plate and oriented perpendicular to the weld as shown in Figure 7.20.

**Figure 7.20.** Photograph of Notch “L”

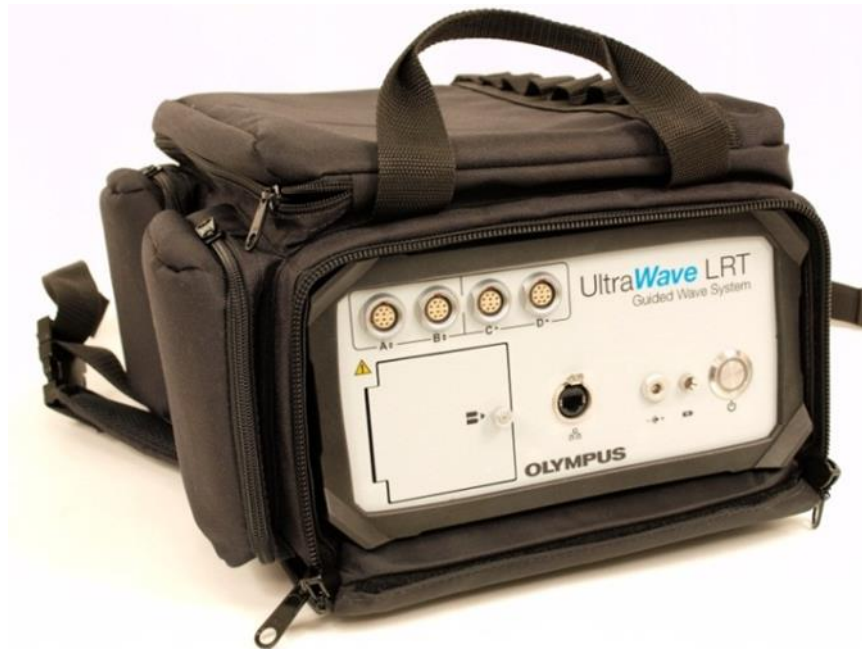
The UltraWave LRT unit, shown in Figure 4, is a multi-channel guided wave pulser-receiver platform sold and serviced through Olympus Scientific Solutions Americas (OSSA) that is currently used with the UltraWave long-range guided wave pipe inspection system, also offered by OSSA. This unit is a powerful, flexible platform for a variety of guided wave technologies, and can be utilized for GWPA applications.

**Figure 4 The UltraWave LRT guided wave pulser-receiver system sold and serviced by Olympus.**

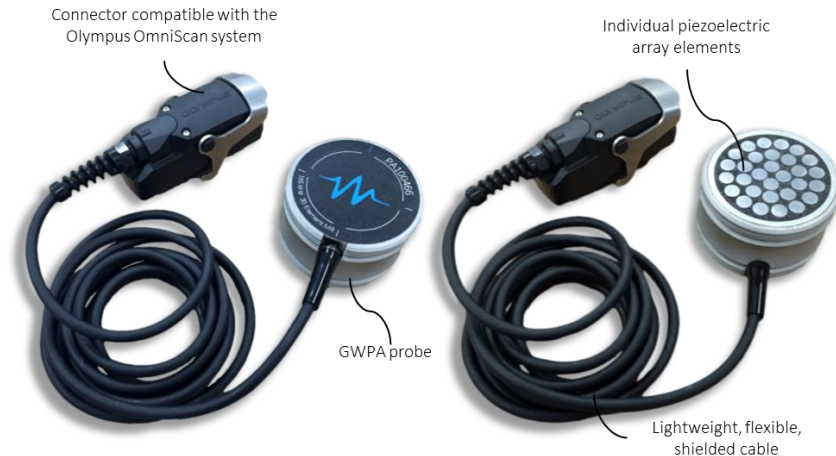
Currently, Guidedwave has designed and manufactured multiple GWPA sensors for a multitude of applications. For the primary wall mock-up, Guidedwave has selected the 165 kHz 30-element GWPA sensor PA100466 (Figure 5). This sensor offers the optimal frequency bandwidth for the given plate thickness and defect sizes expected. However, with this sensor, the resolution is slightly reduced to minimize the side lobes produced. This is necessary when there are many features in the plates or cut ends, like in a mock-up, which will produce artifacts in the final GWPA image.

**Figure 5 Photograph of a GWPA sensor that was used during the primary liner mockup inspection feasibility study**

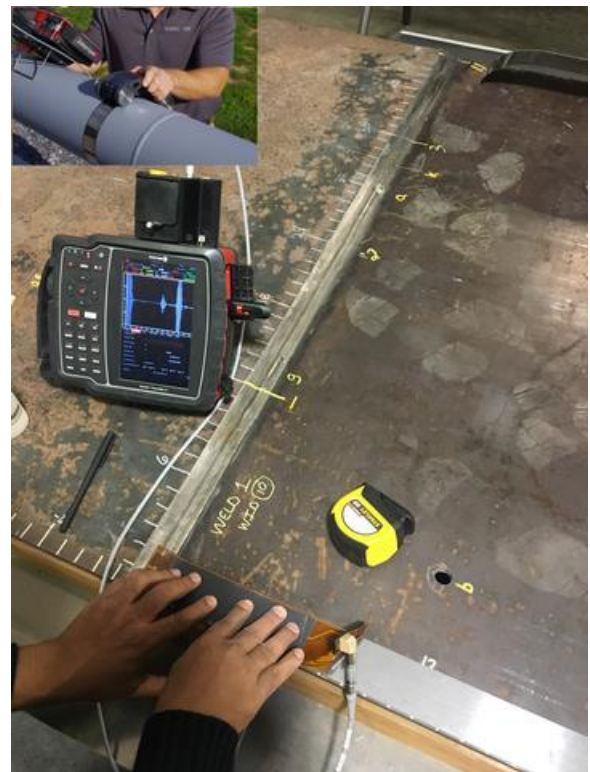
**Figure 5. Magnetostrictive Strip and EMAT Coil**

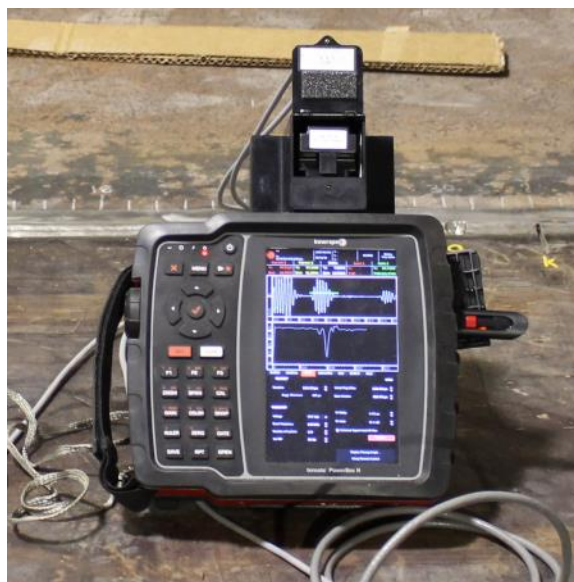
**Figure 21. Notch I Lamb wave attenuation test**

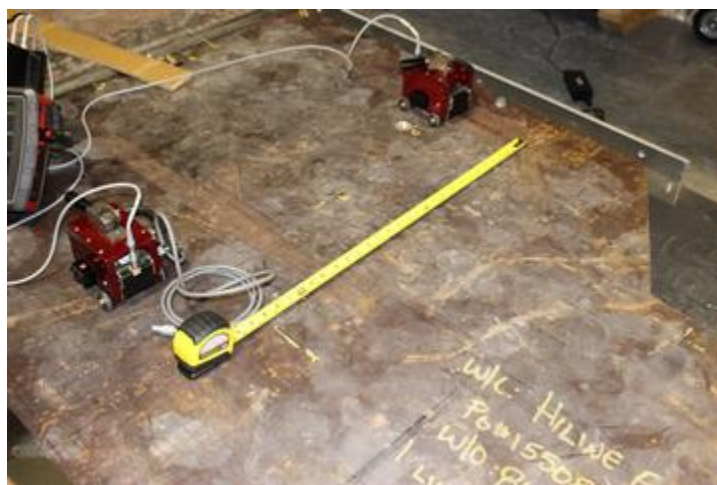
**Figure 24. Manual Lamb Wave Scanning**

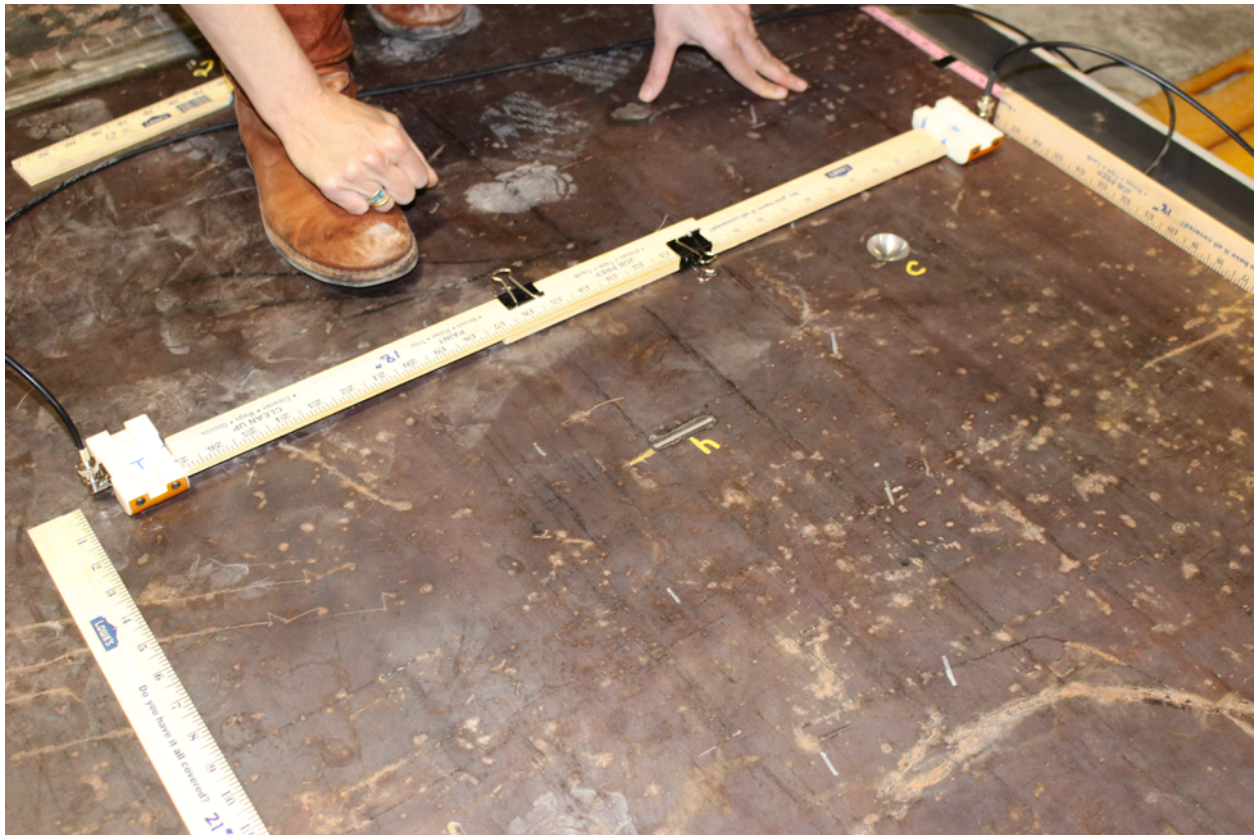
***Fig. 7. Test setup for defect c.***

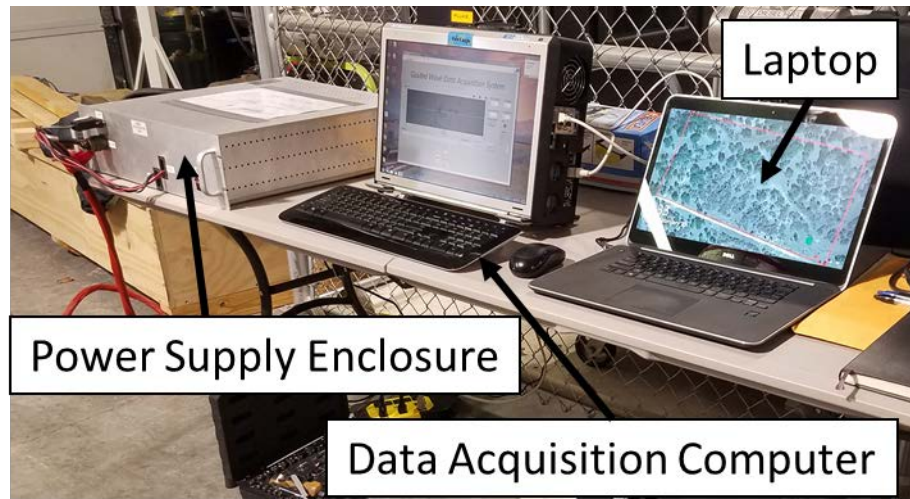
**Figure 3. Photograph of umbilical cable (red cable) connected to the power supply enclosure (left-most box) and data acquisition computer with a LabVIEW application running. The laptop on the right is used for processing the data following the data acquisition process, but the processing could occur on the data acquisition computer if necessary.**

The amplified and filtered signals are connected to an external LabVIEW-based data acquisition subsystem through an umbilical cable. This subsystem is shown in Figure 3; it is comprised of a portable computer workstation with an internal waveform digitizer and a separate power supply system. The LabVIEW data acquisition program runs on a computer to control the acquisition process. At the start of an inspection, the operator specifies the inspection parameters such as sensor height, test frequencies, inspection interval, etc. During the inspection process, the

data acquisition program prompts the operator to move the sensor cart to an incremental position. Once the operator indicates that the sensor cart has reached the desired position, the sensor electromagnet is engaged, data is acquired, and the electromagnet is disabled. This process is repeated until the scan is completed.
