Electroplating Zr on U-Mo Foils

Process Qualification Report

May 2017

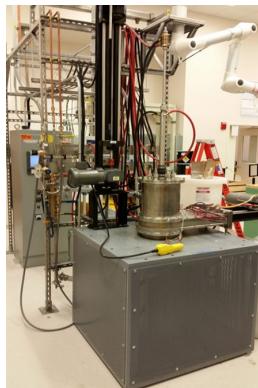
Figure 1. Electroplating Equipment

The electrolytes used to deposit Zr are mixtures of ZrF₄ and alkali fluorides. The U-Mo foil is used as the cathode and Zr electrode is inserted into the molten salt to serve as the anode. A current density is applied at a preset temperature and the ZrF₄ is disassociated, resulting in the Zr⁴⁺ ions traveling to the foil where they are deposited in a coating layer. The atmosphere (oxygen and water content) is controlled to ensure the quality of the deposited Zr coating. The detailed electroplating process to be qualified is documented in the Manufacturing and Quality Plan, 67075-MAQP-001.

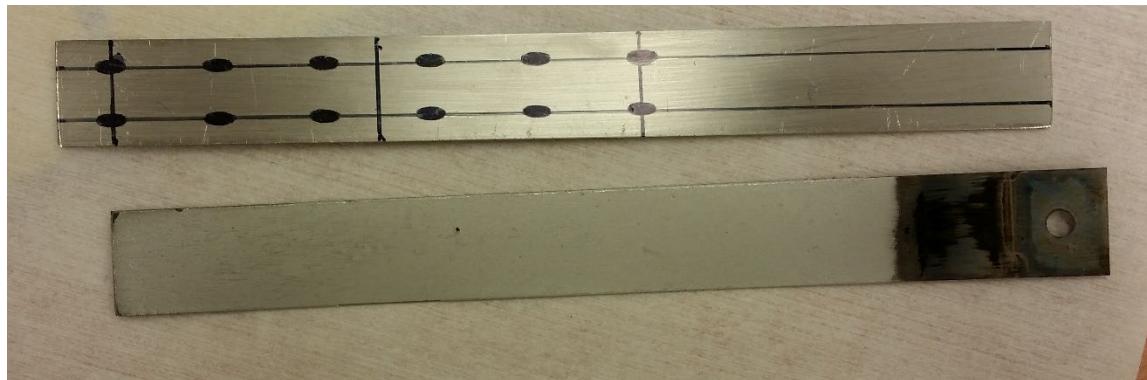
Figure 3. Measurement Locations

Figure 3 is a guide developed to help provide uniformity in measurements. The horizontal and vertical lines identify the two length and three width measurements. The 12 thickness measurement approximate locations are identified as black dots. The average length, width, and thickness measurements are provided in Table 2 along with the mass loss per foil. The average resulting mass loss was 0.2698 grams for all foils with the average thin foil losing 0.1740 and the average thick foil losing 0.3779 grams.

² Dimensional measurements are average averages per Figure 3

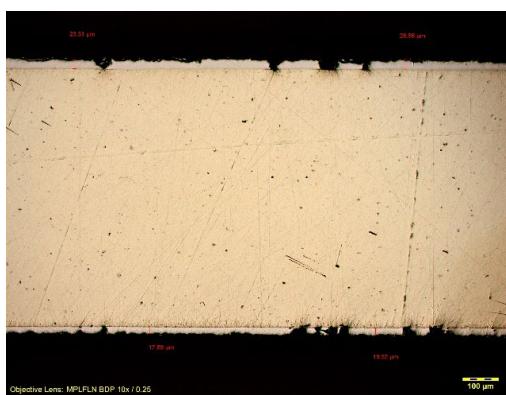
Figure 12. Center Section Q2E023

Selected optical images are provided in Figures Figure 12 through Figure 16. These were chosen to be representative of the foils. All foil images are provided in Appendix B: Optical Images. As can be seen in the images, dark occlusions and surface defects greatly affect plating quality. It is important to note the scale of these defects as many are not visible by the naked eye. Of most concern are the cracks which appeared within the foils. As can be seen in the center section (Figure 12) of Q2E023, the surface defects typically correspond with occlusions at the surface of the foil itself. These issues may be caused by cleaning issues or scratching on the foil itself.

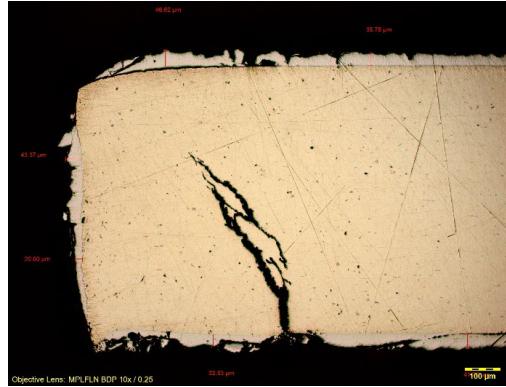
Figure 13. Cracking of Foil (Q2E020)

Another issue that was identified was internal cracking within the foil. This is illustrated in the Figure 13, the large crack leads to generally poor plating conditions. The plating typically followed the surface

conditions leading to a fairly uniform coating. The burr that was found on many of the foils resulting in plating challenges (the burr was plated but under high stress leading to bonding issues).

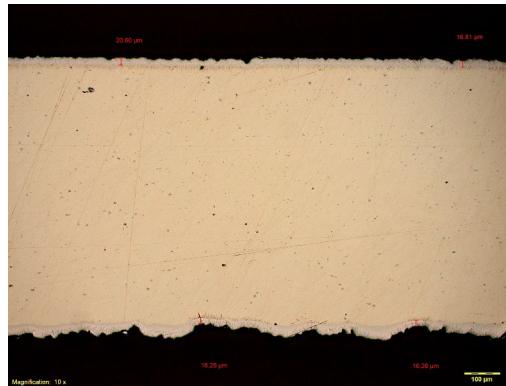
Figure 14. Q2E012 Showing Plating Tracking Surface Conditions

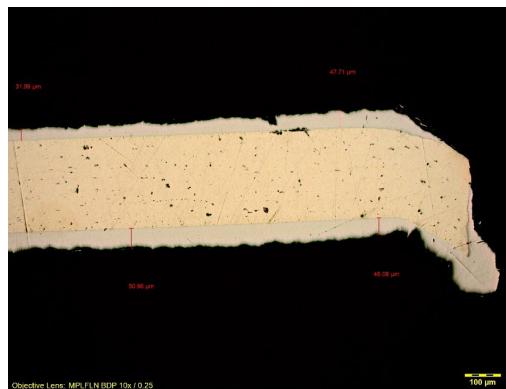
Figure 15. Q1E024 Showing Burr Effect on Plating

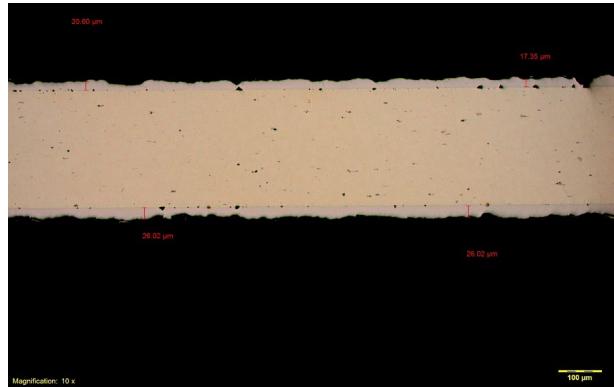
Figure 16. Optical 10x Showing Occlusions

In the optical images there are dark occlusions in both the U-Mo base metal and Zr plating. An example of such occlusions in Foil Q1E045 is provided in Figure 16. Many foils had such dark spots. SEM was performed on this foil at the locations of some of the occlusions to determine their chemical composition

for information only. SEM analysis was performed according to 67075-SOP-0010. The results are presented in Table 10 and Table 11, as well as shown in Figure 16 through Figure 19, the occlusions looked at tended to have high levels of uranium, molybdenum, with noticeable amounts of Zr, oxygen, and carbon. This indicates that the occlusions are not voids within the plating or substrate.

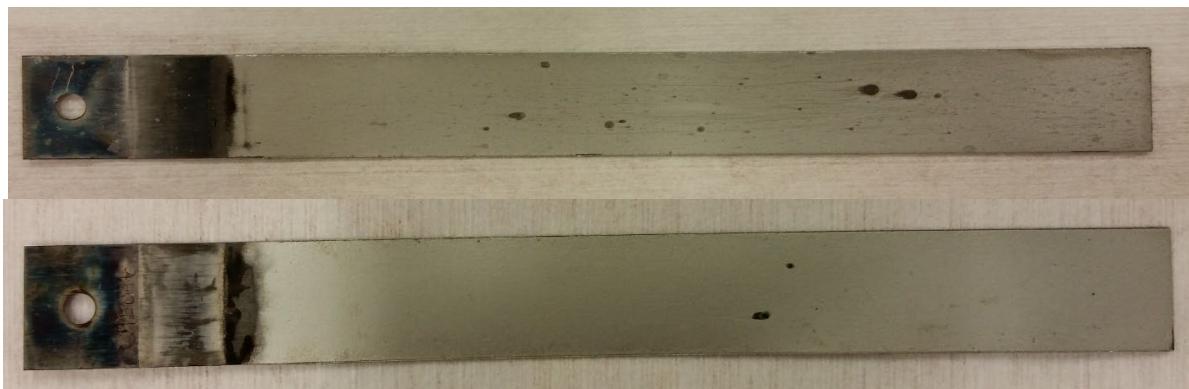
The foil shall have no surface defects (voids, cracks, scratches, inclusions) having any surface dimension larger than 0.06 inch will be confirmed via visual inspection. This was the hardest of the criteria to meet. Numerous small and large defects happened. Surface defects were the most common reason why a foil failed inspection. Often the surface defects were in the base metal and propagated through the plated metal. Examples of these defects can be seen in Figure 21 through Figure 25.

Figure 21. Failed Foil (Q1E045 (top), Q1E046 (bottom)) Post-Plating Images

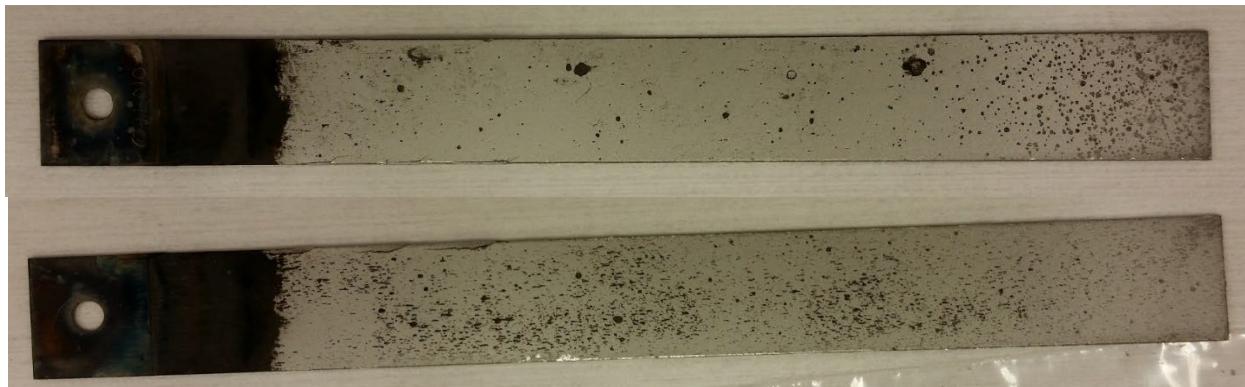
Figure 22. Failed Foil (Q2E010) Post-Plating Images

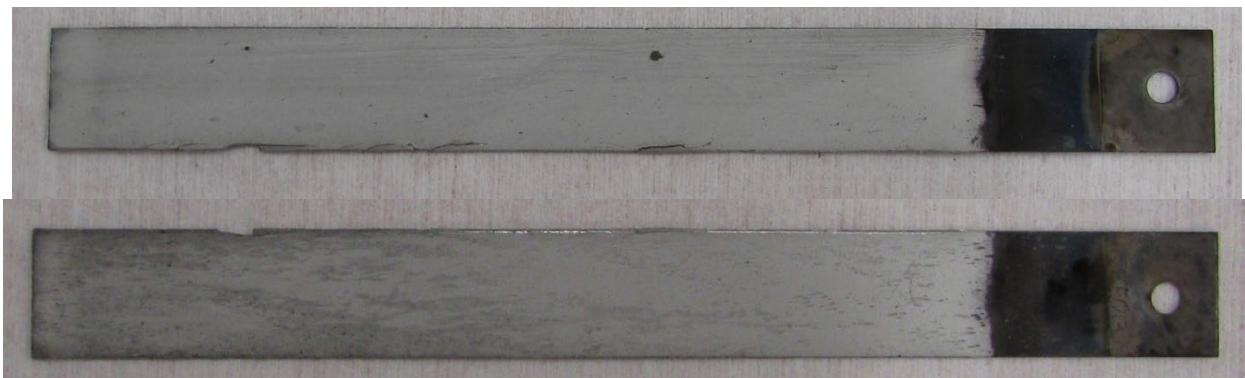
Figure 23. Foil Failed Foil (Q2E013) Post-Plating Images

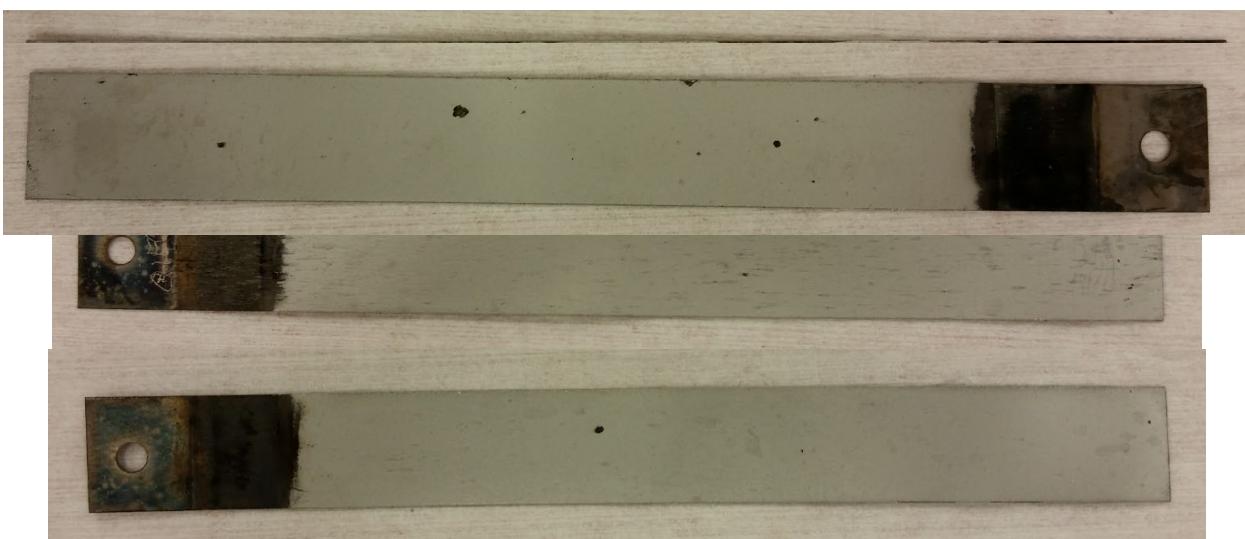
Figure 25. Foil Failed Foil (Q1E052) Post-Plating Images
