NDE Technology Development Program for Non-Visual Volumetric Inspection Technology

Phase I Summary Report

January 2018

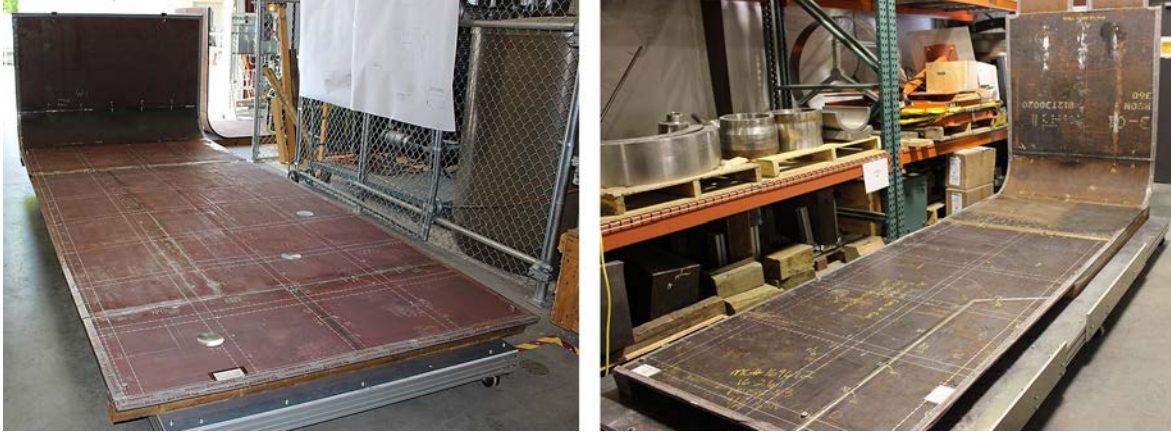
Figure 3. Photographs of the Full-scale Mock-ups of Swaths of a Primary Tank

3. Transition welds that join 7/8 in. to 1/2 in. thick bottom plates, which are present between the outer bottom plate (7/8 in. thick) and the first mid-floor bottom plate found along the entire tank bottom. The transition weld is the second most common weld in the primary tank bottom and would be the first bottom weld encountered during remote or air-slot based examinations. The transition welds are full penetration butt welds, many of which were re-worked and rendered them representative of re-worked welds in the primary tanks.

4. A tightly spaced confluence of 90-degree welds that join 1/2 in. to 1/2 in. thick bottom plates. The 90-degree weld confluence is located within a region of the 241-AY-102 tank where confirmed leak sites were located (Follett 2017).

The 90-degree weld confluence is the least common weld found in the primary tank bottoms; however, it may be a tank bottom feature that is at high risk for flaw development if weld stress relieving was not performed adequately during construction. The welds are full penetration butt welds that form a tightly spaced 90-degree weld confluence (pinwheel pattern). The 90-degree weld confluence is found in two to four different locations in the primary tank bottoms of the DSTs located in three of the six tank farms (241-AY, 241-AZ, and 241-SY). The six in-service tanks in the AY, AZ, and SY tank farms represent the oldest of the 27 in-service DSTs at 40–46 years old (Venetz and Gunter 2014).

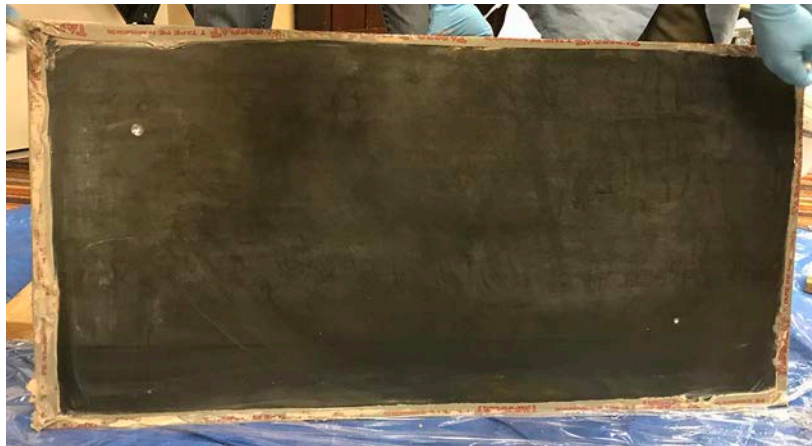
Figure 8. Bottom of the Test Plate after Removing the Slurry, Revealing the Two Locations of the Pits

Guidedwave inspected the slurry-backed test plate first and then the clean air-backed plate with both the new dry shear-wave couplant and the traditional shear-wave liquid couplant. The slurry was thoroughly cleaned from the test plate before the air-backed measurements were collected (see Figure 8). The

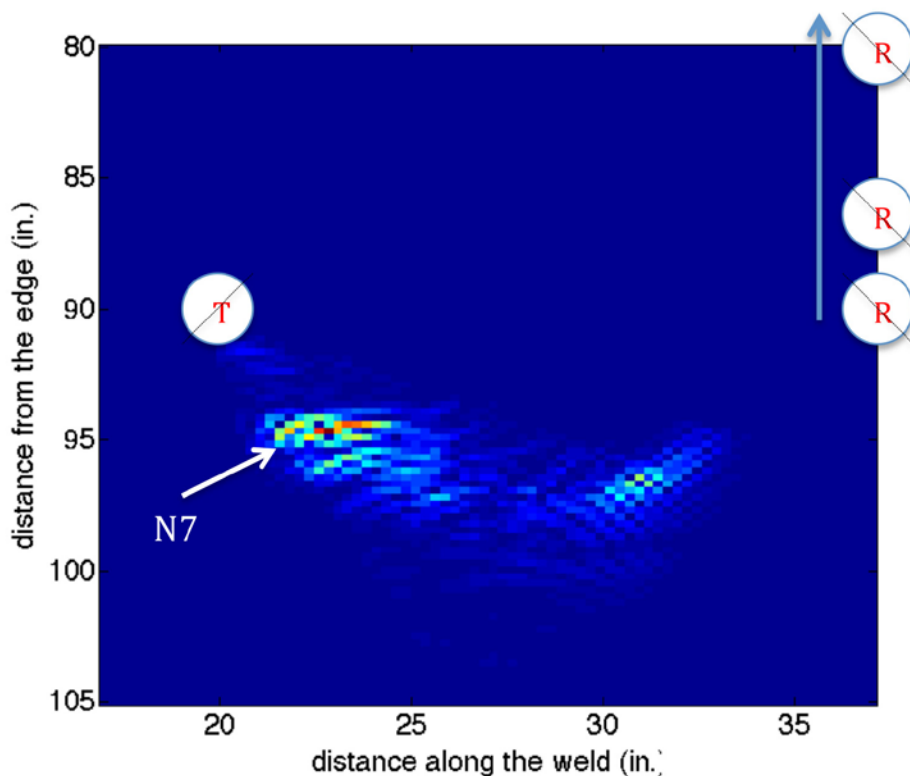
Defect coordinates and size: N7 (25, 96), 2.875" long, 0.25" deep, along weld at y=96", left edge of notch is at weld at x=24"

The photograph shows the sensor positions relative to the notch and welds. Only the receiver was moved during the scan in the marked direction.

The incident wave impinges upon the weld and flaw at an average angle of 45 degrees. However, the sound beam is diverging and so the diffracted waves travel in many different directions, making analysis with SAFT very helpful for visualization. The image below was created using SAFT and shows a clear indication of notch N7 with a SNR of 15 dB.

We noted in our SET report that during the mockup testing at PNNL a bookkeeping error kept us from collecting data on notch defect N7. We inadvertently marked N7 on the 'detected flaws' checklist, and thus thought that it had been detected, when in reality it had not. On 1 August 2017 Cliff Lissenden was at PNNL conducting an inspection of a dry storage canister mockup using the same instrumentation (except for the sensors) that was used for SET. Therefore, he had an opportunity to acquire data using the same test setup as before.

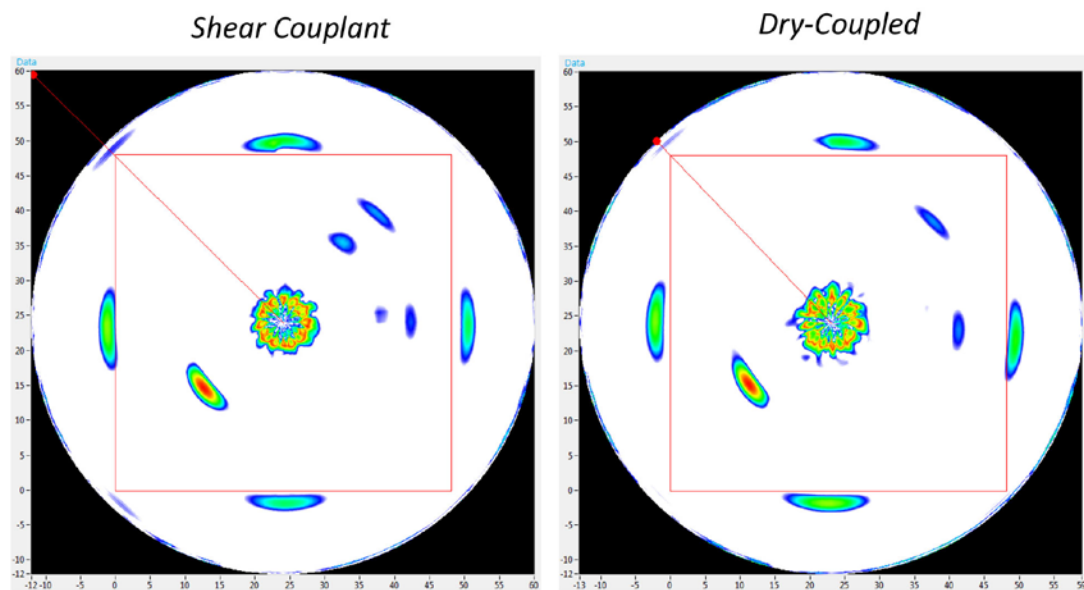
Figure 2 compares the GWPA images for both coupling methods ("shear gel" vs. "dry") normalized to 12 dB above the edge reflection amplitude. Not only is the signal quality comparable to the conventional gel coupling, but it is actually improved in some respects. The signal-to-noise ratio (SNR) of the notch is 47 dB for both scans and the SNR of the holes is 32.4 dB with shear gel vs. 33.7 with dry coupling. The dead zone radius is slightly larger with the dry coupling, at 5.5" vs. 5.2", but the sidelobe artifacts caused by the notch defect,

which appear as additional indications between the two hole defects and the probe, are reduced substantially. Figure 3 compares the same two scans with the C-filter applied.

Figure 2 Comparison of the GWPA scan using the conventional shear couplant method (left) and the new dry-coupled method (right).

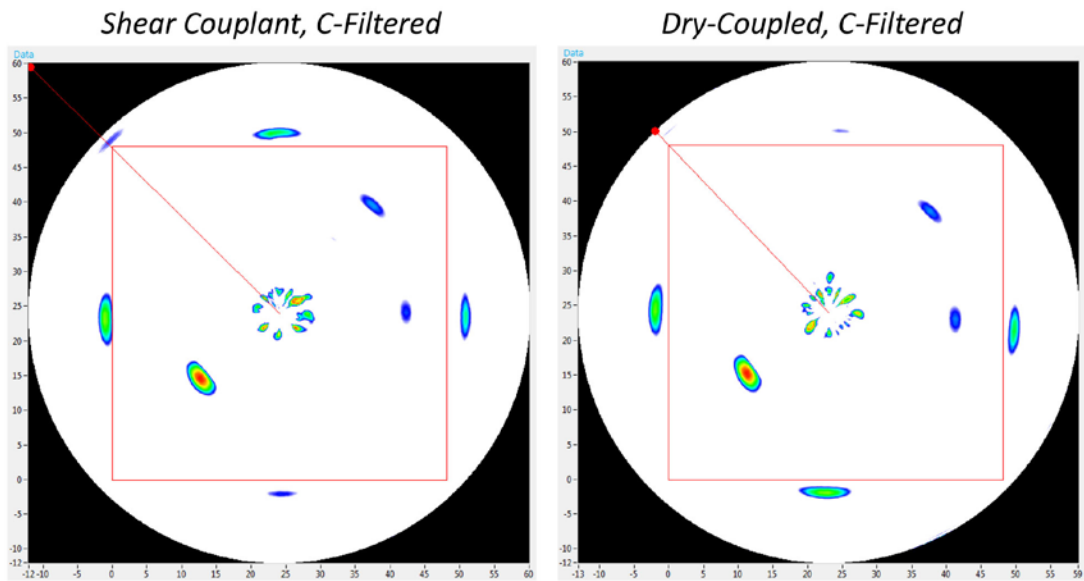
Figure 3 Comparison of the GWPA scan using the conventional shear couplant method (left) and the new dry-coupled method (right).

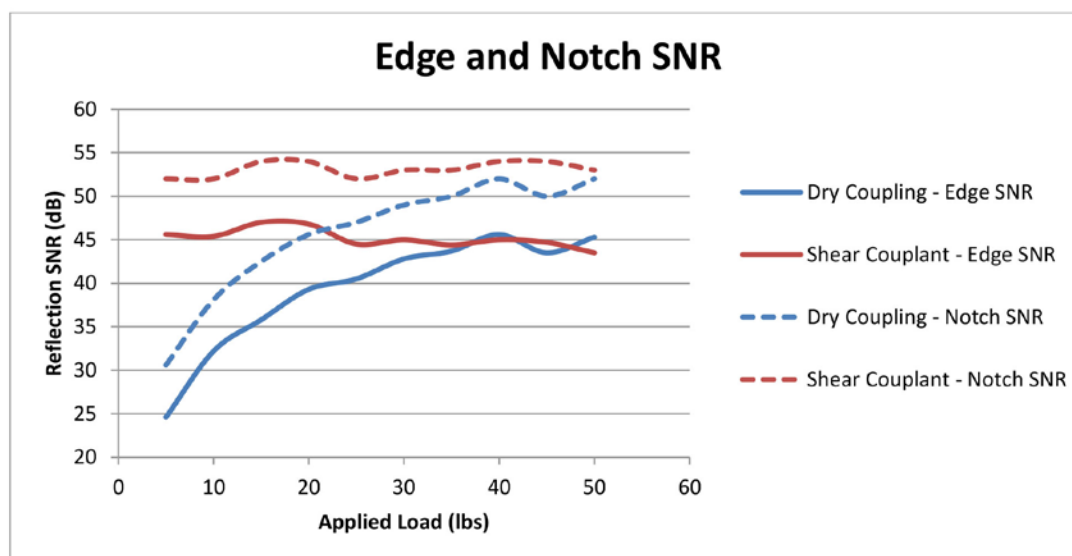
Tests were conducted with the dry-coupling mechanism using varying static loads applied to the back of the probe. Loads of from 5 to 50 lbs were applied 5 lb increments, and the signal attributes were compared to each other and those of a probe coupled directly with shear gel couplant. Figure 4 compares the plate edge and notch defect SNR for the two coupling mechanisms versus load. For this measurement, a higher value is better. The shear gel-coupled probe SNR was generally independent of applied load, while the dry-coupled probe SNR increased with load, but leveled off near the values for the gel-coupled probe near 40 lbs.

Figure 4 Edge and notch SNR values (in dB) for both coupling mechanisms versus load.

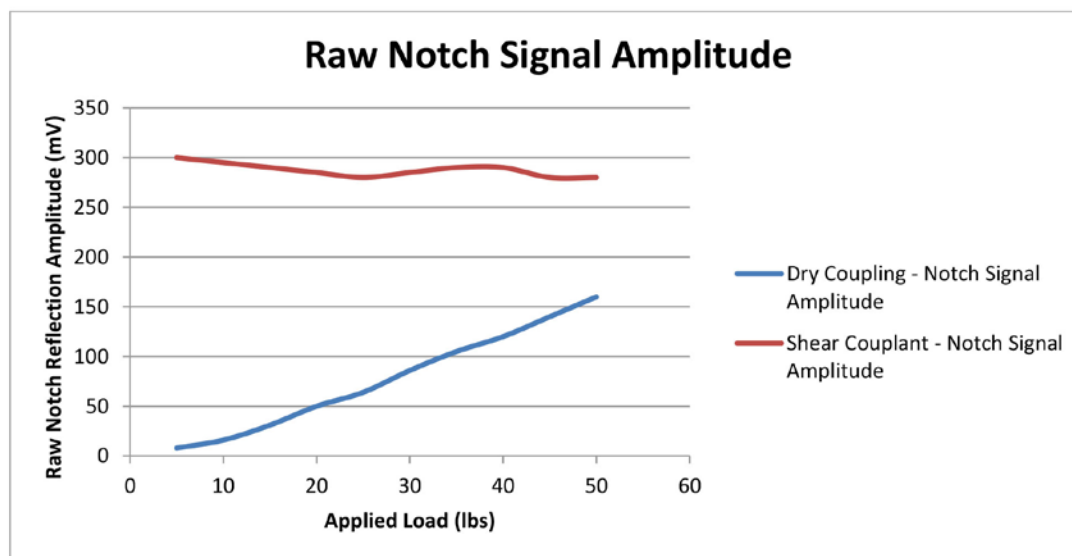
Figure 5 compares the maximum raw signal amplitude from the notch reflection (in mV), measured prior to phased array post-processing, for the two coupling mechanisms versus load. For this measurement, a higher value is better. The shear gel-coupled probe signal amplitude gradually decreased with load, but started at a high level, while the dry-coupled probe signal amplitude increased monotonically with load.

Figure 5 Max raw signal amplitude from the notch reflection for both coupling mechanisms versus load.

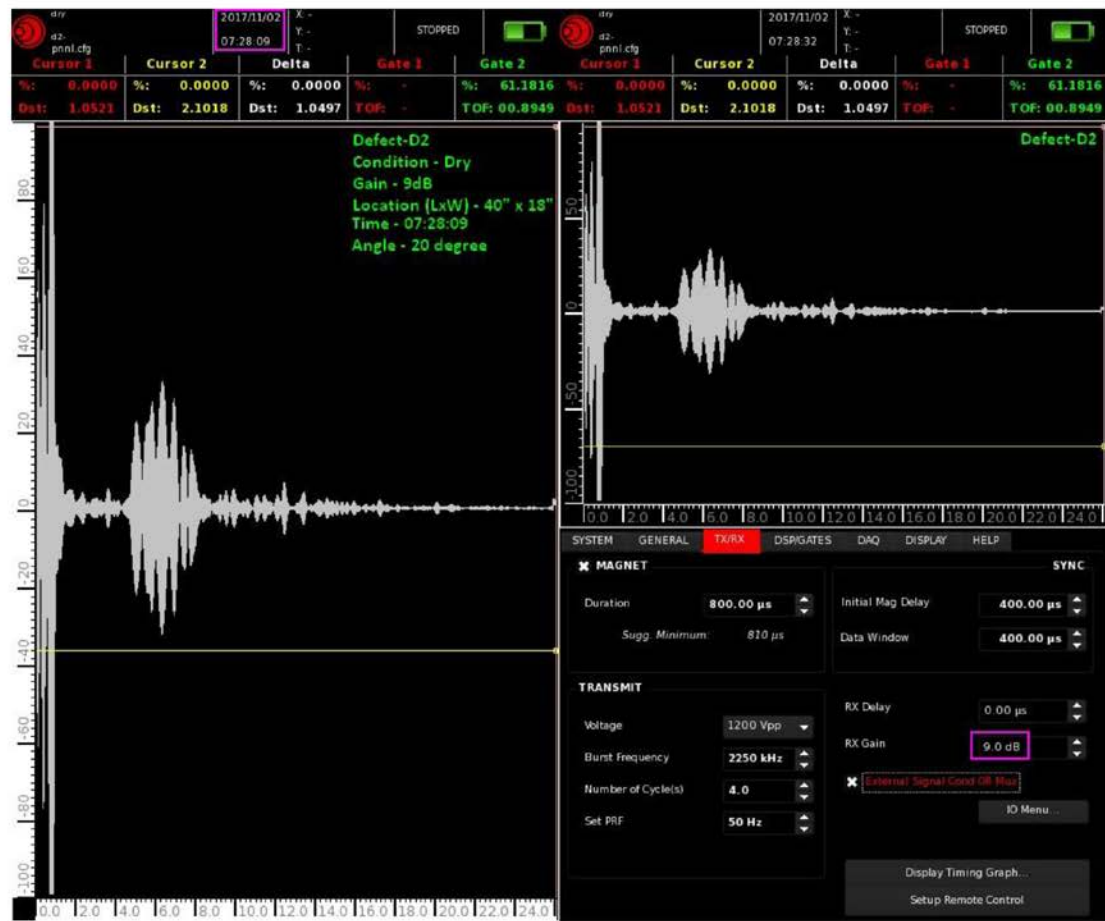
2.3. Condition Dry – Defect D2

- Amplitude of D2 – 36% (17.14 dBs)

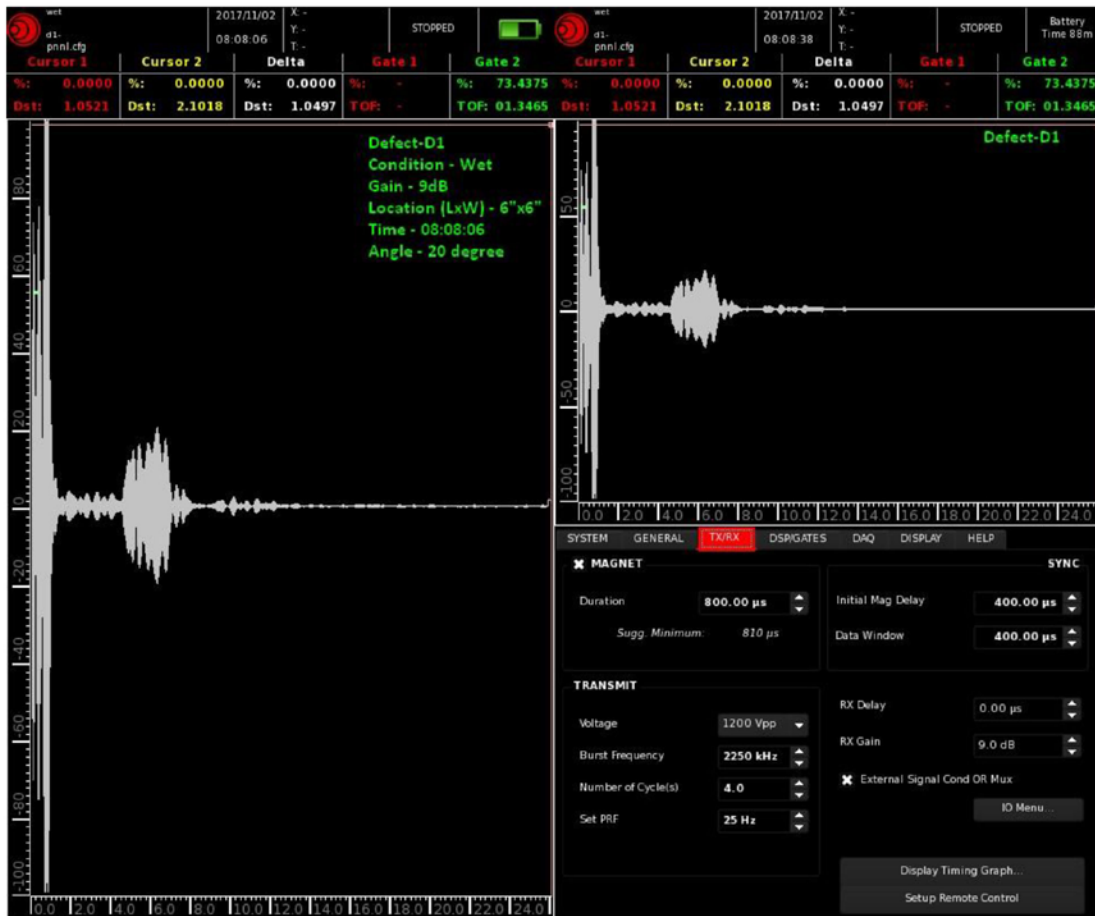
2.4. Condition Wet – Defect D1

- Amplitude of D1 – 23% (13.25 dBs)
- Attenuation due to Energy Leakage into the liquid – (22.4 dBs – 13.25 dBs = 9.15 dBs)
 - $20 \log \frac{23}{66} = -9.15 \text{ dBs}$

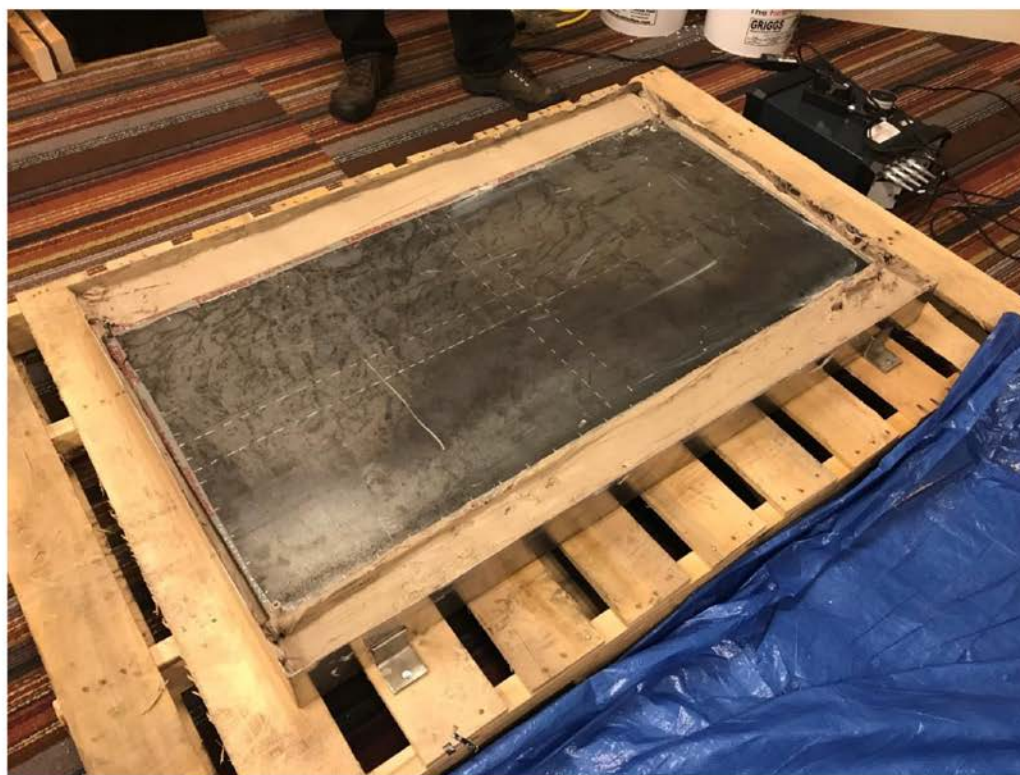
The test structure was a 24" x 48" x 0.5" steel plate with a small amount of T-tape damping material on the edges. The plate was laid atop a slurry analog for some of the tests. See Figure 1. The slurry had a high viscosity that could lead to some signal attenuation of guided and non-guided ultrasonic waves, including SH waves. Based on the results of the tests, the attenuation of the SH waves was minimal over these distances.

Figure 1 Photograph of the test plate in the slurry with the GWPA system on the left.

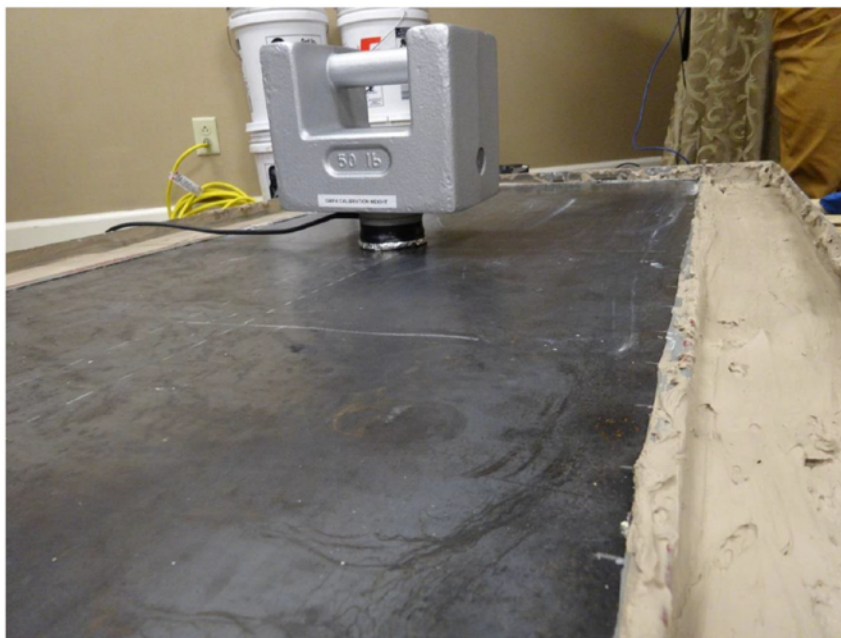
For the shear gel-coupled tests, the shear couplant was applied in a manner similar to that used during prior testing in Richland, WA. For the dry-coupled tests, a prepared membrane was applied to the face of the transducer. A 50-lb calibration weight was placed on top of the probe during scanning, as shown in Figure 2. After the weight is removed, the probe can be easily picked up and placed in the next test position.

Figure 2 Photograph of the GWPA probe under the dry-coupling configuration with the coupling membrane and the 50-lb calibration weight present.
