# NDE Technology Development Program for Hanford DST Non-Visual Volumetric Inspection Technology – Phase II

## Technical Letter Report on Air-slot NDE Sensor Maturation Testing

**August 2018**

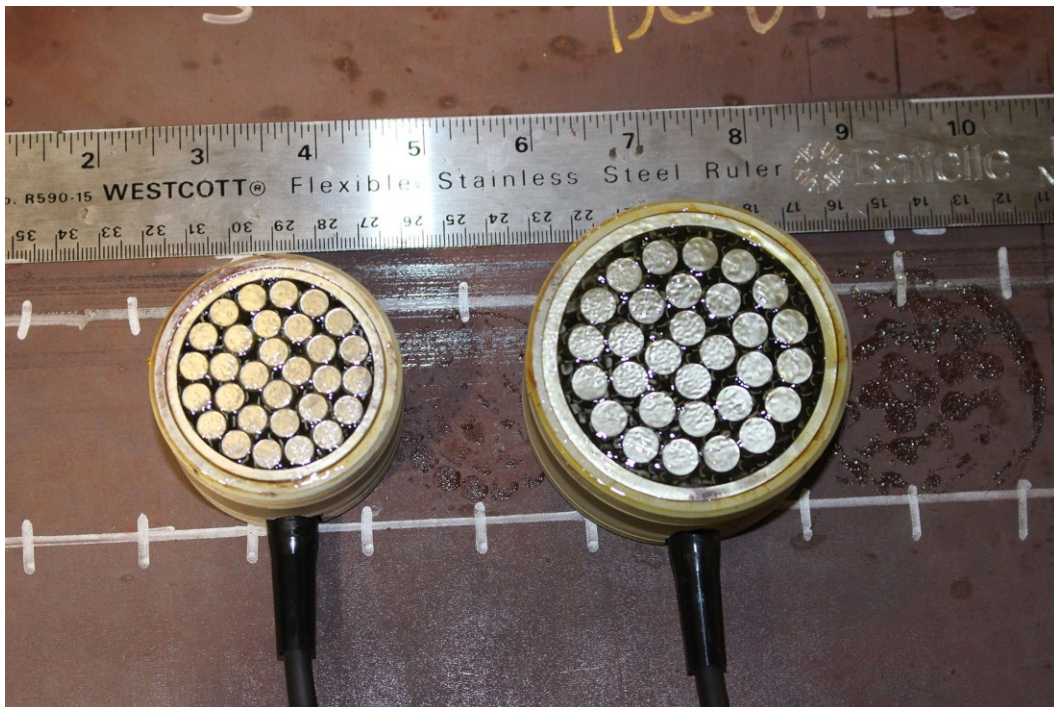
**Figure 5.** The GWPA Sensors Used during FY 2017 Phase I Testing

The GWPA sensor used during Phase I required a liquid shear couplant to be applied to the sensor faceplate to facilitate the transfer of ultrasonic energy into the test material. The amount of force applied to the sensor to couple it properly was estimated to be less than 20 lbs. The two guided-wave sensors brought for Phase I *Sensor Effectiveness Testing* are shown in Figure 5.

Guidedwave selected a 165 kHz, 30-element GWP sensor as the primary sensor with which to perform volumetric examinations of the test mock-ups. The active element portion of the transducer array, pictured on the right of Figure 5, is 2 inches in diameter and 3/8 inch in height and would be small enough to fit into the air-slots of a DST. The secondary sensor brought for testing was a 200 kHz, 30-element phased-array sensor with a diameter of 1.5 inches. The sensors were used to perform examinations of the 1/2-inch-thick bottom plate of the mock-ups. Multiple inspection locations on each plate allowed for post-processing of the data into a composite image. Figure 6 shows the Guidedwave participants and the equipment at an inspection location on the *SET* mock-up.

In Phase I, Guidedwave used the higher frequency version of the GWPA sensor design (shown on the left in Figure 5) pulsed at 225 kHz to detect T3; the flaw was not observed in any of the composite images using the lower frequency GWPA sensor. T3 was detected from two different locations on the 1/2-inch-thick base plate of the PII mock-up using the higher frequency GWPA sensor. Transducer Location II was the farthest from Wall Thinning T3 at 21 inches (Figure 17). The best SNR for T3 was 40 dB. Guidedwave detected both 50% deep wall thinning flaws, but did not detect the 10% or 20% deep wall thinning flaws with the higher frequency GWPA sensor design during Phase I testing.

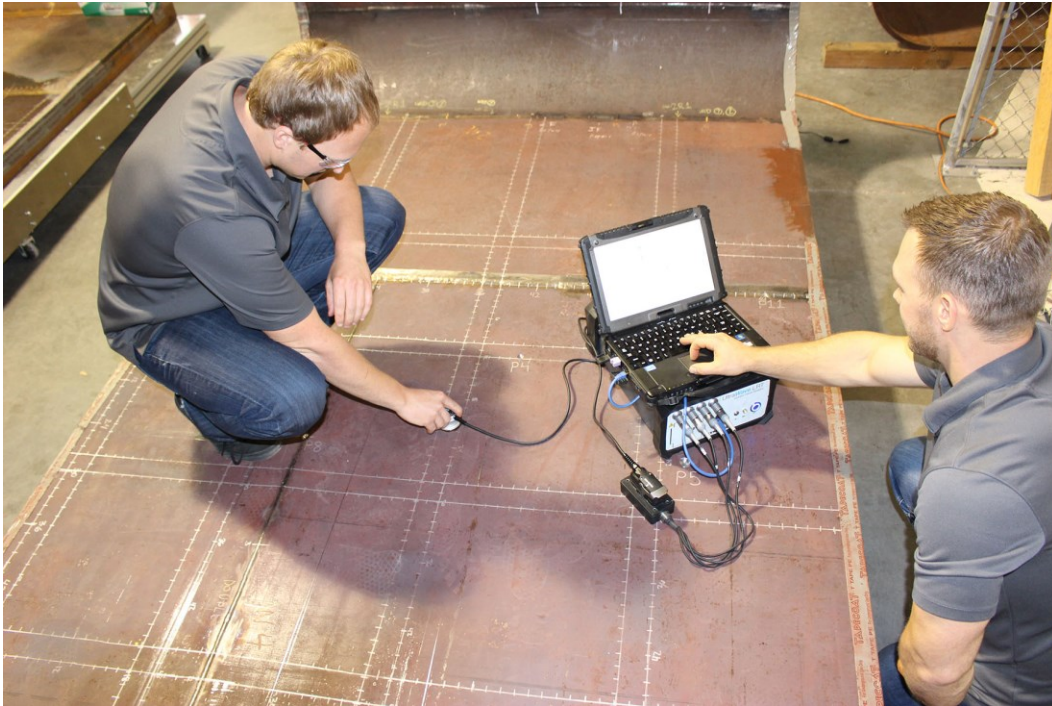
**Figure 6.** GWP Sensor Inspection Locations on the 1/2-inch-thick Bottom Plate of the *SET* Mock-up during the FY 2017 Phase I test campaign *Sensor Effectiveness Testing*
