K-3 Refractory Corrosion Test Results, HAL24M2

July 2025

Pacific Northwest National Laboratory
Richland, Washington 99354

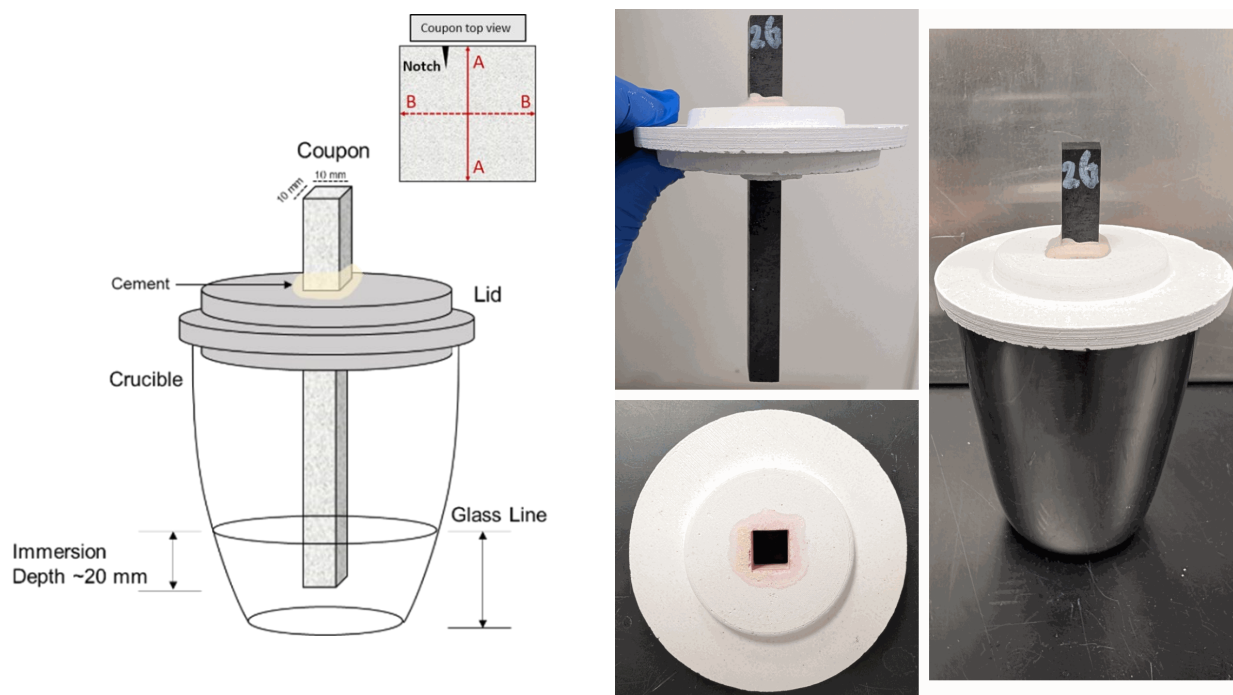
Figure 2.1. K-3 corrosion test setup in a static glass melt showing general measurements for coupon size and positioning, glass depth, and coupon immersion depth.

The refractory corrosion test was performed using a crucible-scale test method based on ASTM-C621-09 with minor modifications of crucible size and coupon size. The setup is shown in Figure 2.1. K-3 test coupons were cut from K-3 refractory slabs (Monofrax LLC, Falconer, NY) into 1-cm × 1-cm × 11-cm coupons. A notch was cut on the top end of the coupons to denote face ‘A-A’. Each coupon was mounted with the crucible lid made by castable alumina (RESCOR™ CER- CAST CERAMIC 780, Cotronics Corp., Brooklyn, NY) with a 1-cm × 1-cm slot in the center. The test coupon was inserted into a Pt crucible with crushed glass. The loaded crucible was heated in a furnace and the K-3 test coupon was submerged into a static glass melt at 1150 °C or 1200 °C for 7 days. Following the 7-day test, the coupons were removed from the glass melt for characterization.

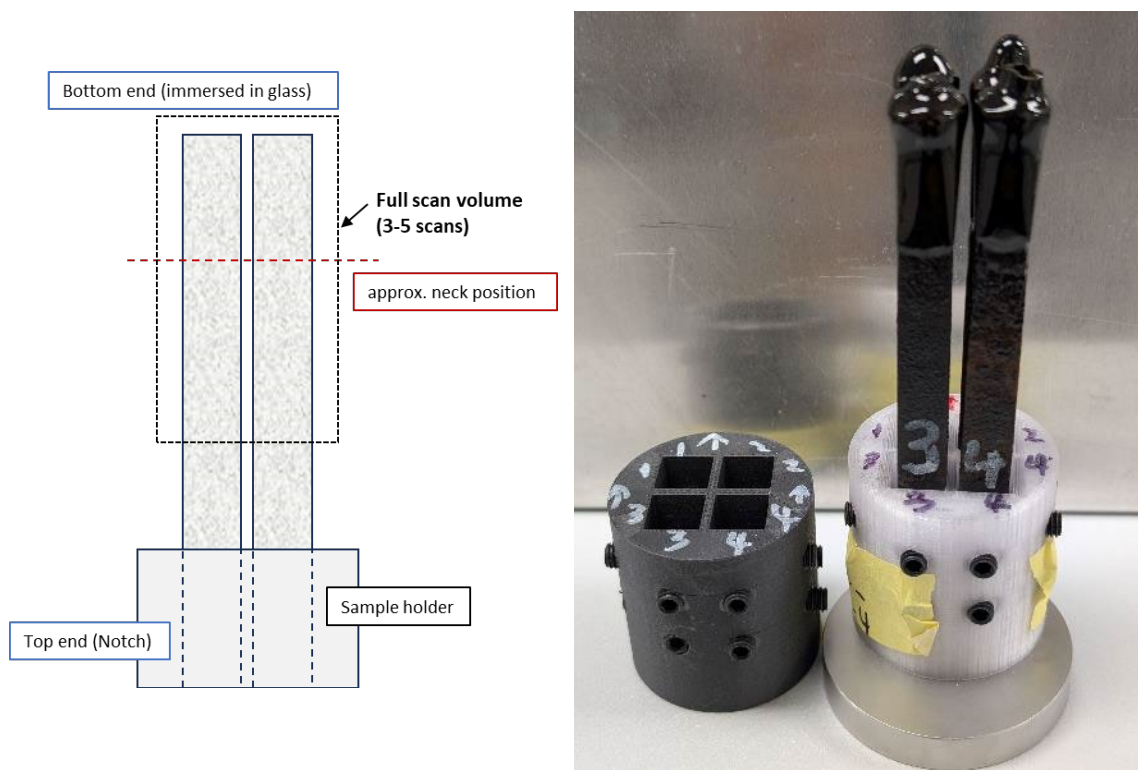
Figure 2.2. Samples for micro-CT scan.

Both pre-test and post-test coupons were scanned by Zeiss Xradia Versa 610 micro-computed tomography (micro-CT) (Carl Zeiss Microscopy GmbH, Jena, Germany). As shown in Figure 2.2, the coupons were mounted in 3D printed plastic sample holders. Up to four coupons were bundled to fit in the scanning volume. Each single scan covers a cylindrical volume ~ 4-cm tall and 4-cm in diameter; three to five scans were conducted vertically to cover a 6-10 cm length. (Single scans must be partially overlapped for stitching.) Voxel size was set to 0.04 mm. A certified volume standard steel sphere was used to verify the voxel size of the micro-CT measurement.

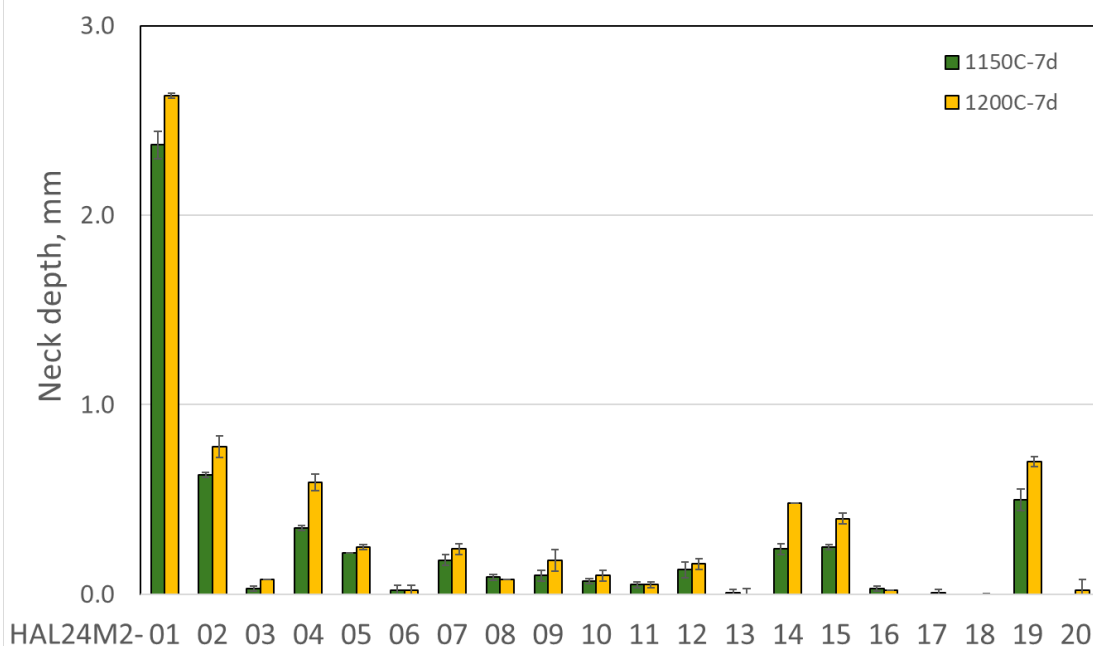
Figure 3.1. K-3 refractory corrosion neck depth.

Table 3.1 and Figure 3.1 summarize the measured neck corrosion depths of the HAL24M2 glasses. Each glass was tested under two different temperatures: 1150 °C for 7 days and 1200 °C for 7 days. Test coupon photos are shown in Appendix A and micro-CT scan images are shown in Appendix B. For each coupon, the neck corrosion depth was measured in two perpendicular directions as discussed in Section 2.2. The average values of the two measurements are reported with the standard deviation (SD).. During the micro-CT measurement, setting the threshold to outline the scanned materials can lead to a measurement uncertainty of ~1 to 3 voxels (0.04 to 0.12 mm). Therefore, a conservative estimated uncertainty is ~0.12 mm for the neck corrosion depth data. A pooled SD was used, which was calculated using duplicated data sets generated from different institutions, samples, and/or time (Vienna et al., 2022).

In this high-Al matrix, some glasses showed low corrosivity on the K-3 coupons without forming a visible neck. For one glass, HAL24M2-03, the corrosion neck was only observed on the coupons after the 1200 °C/7days test but not on the coupons after the 1150 °C/7days test. For five glasses, HAL24M2-06, -13, -17, -18, and -20, no corrosion neck was observed after tests at either of the two temperatures. (see the images in Appendix B).

The current K-3 neck corrosion upper limit is 0.04 in., which is based on a previous dataset of bubbling test data. There is an estimated offset for neck corrosion depth data from the static test in this report to be compared with those from the previous bubbling test (Vienna et al. 2025). Applying the offset of 0.5949 ln[in.] to the 1200 °C/7days measured data, only one glass, HAL24M2-01, has a neck corrosion depth on K-3 exceeding the 0.04-in. limit.

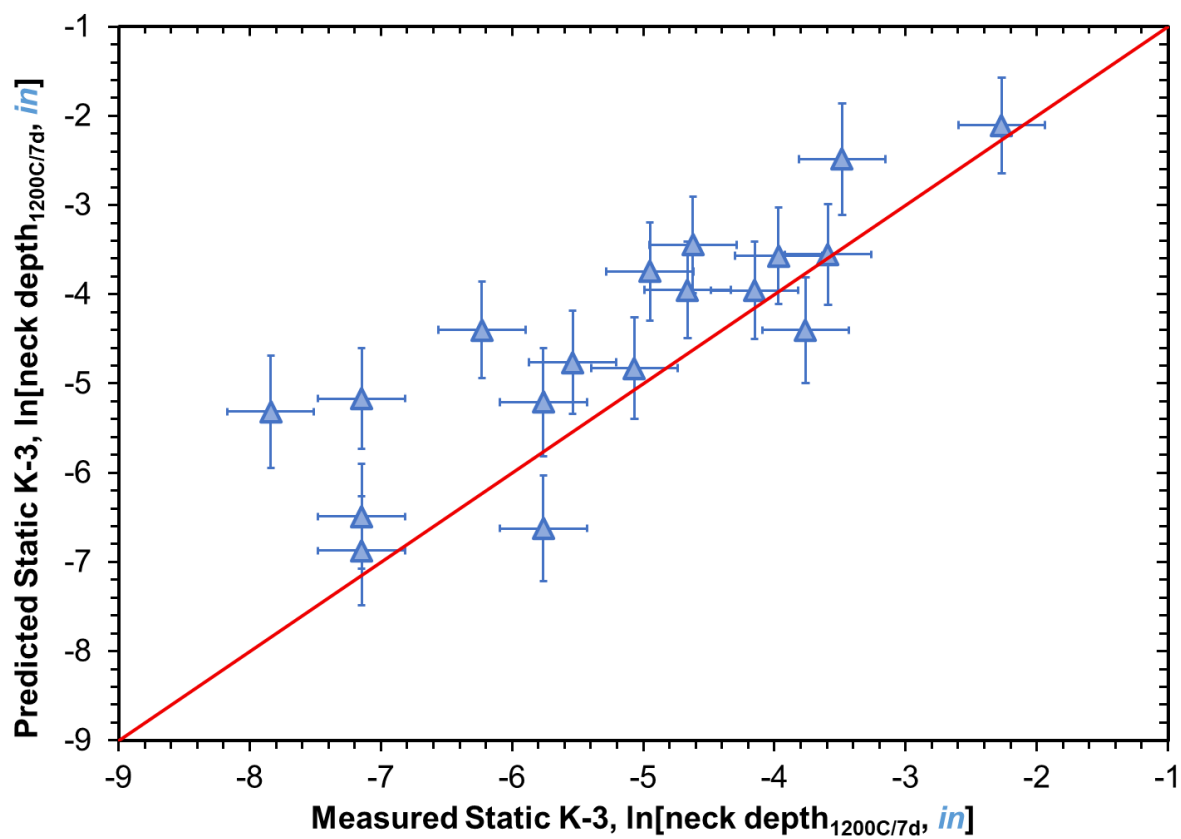
Figure 3.2. Measured and predicted (Vienna et al. 2024) K-3 refractory corrosion neck depth. Red line is the 1:1 line between the measured and predicted values. Uncertainties for measured values are represented by the pooled SD reported in Vienna et al. (2022).

Figure 3.2 shows the measured neck corrosion depth of the 1200 °C for 7 days test samples plotted against model predictions for responses obtained under this test condition from Vienna et al. (2024). The y-axis error bars are uncertainty of predicted values calculated by the model; and the x-axis error bars are applied using a fixed value of 0.3311 ln[in.] which is a pooled standard deviation reported in Vienna et al. (2022). The model slightly over-predicted the neck corrosion depth of these glasses.

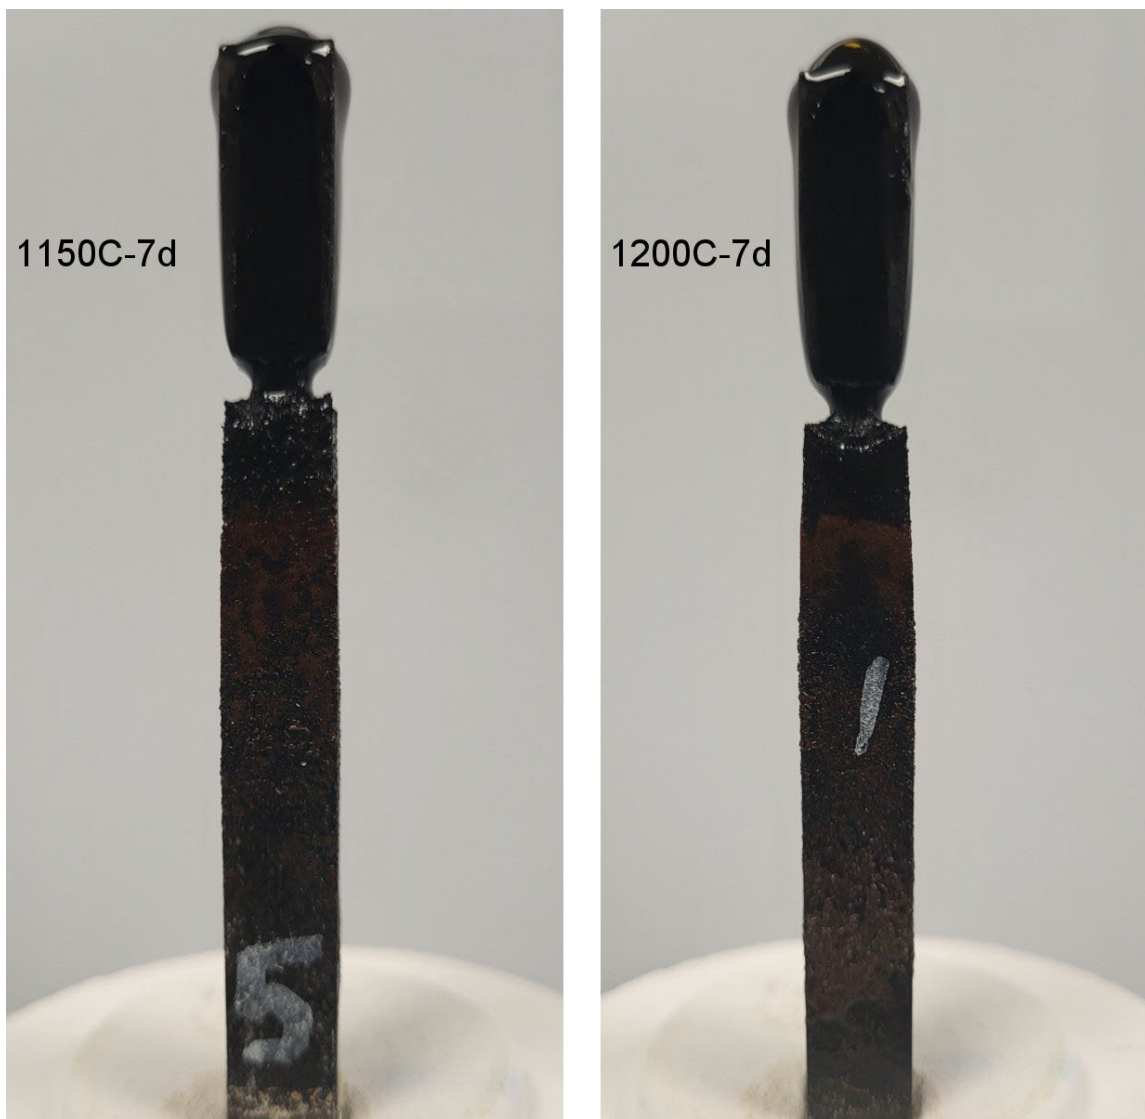
Figure A.1. K-3 coupons after refractory corrosion test, HAL24M2-01.

The photographs in this appendix show the K-3 refractory coupons after corrosion testing with HAL24M2 glasses. Note that the coupons are upside down in the photos; the top of each coupon is the section immersed in the glass melt.

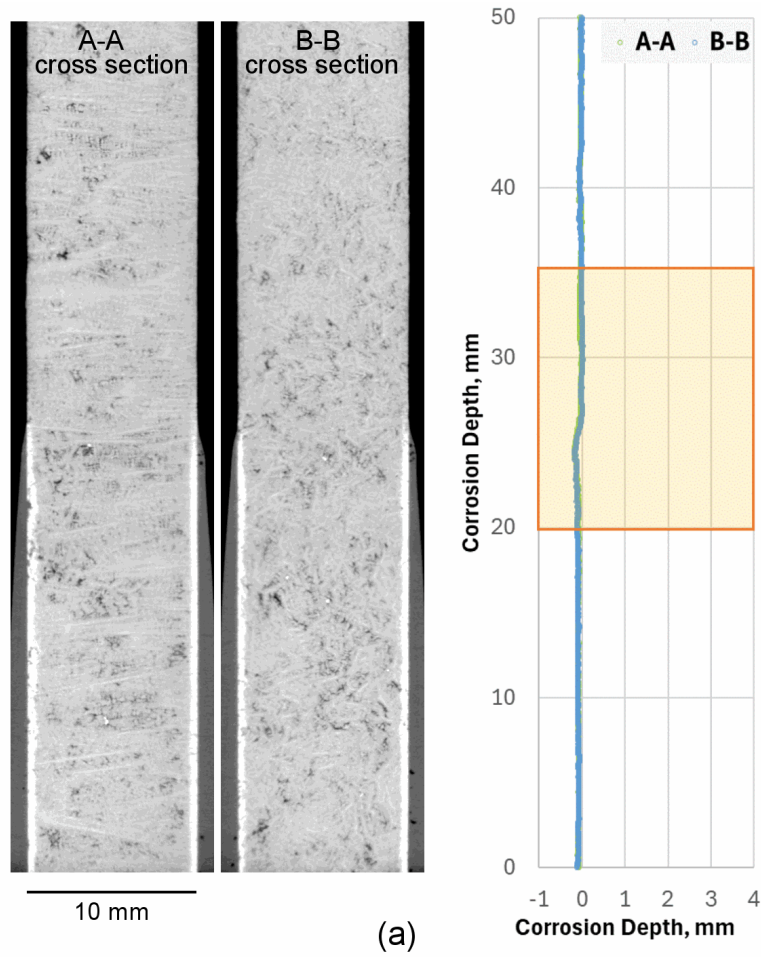
Figure B.5. Micro-CT results of K-3 refractory corrosion test, HAL24M2-03 - 1150 °C - 7day. (a) cross section at center. (b) top view slice at neck location.

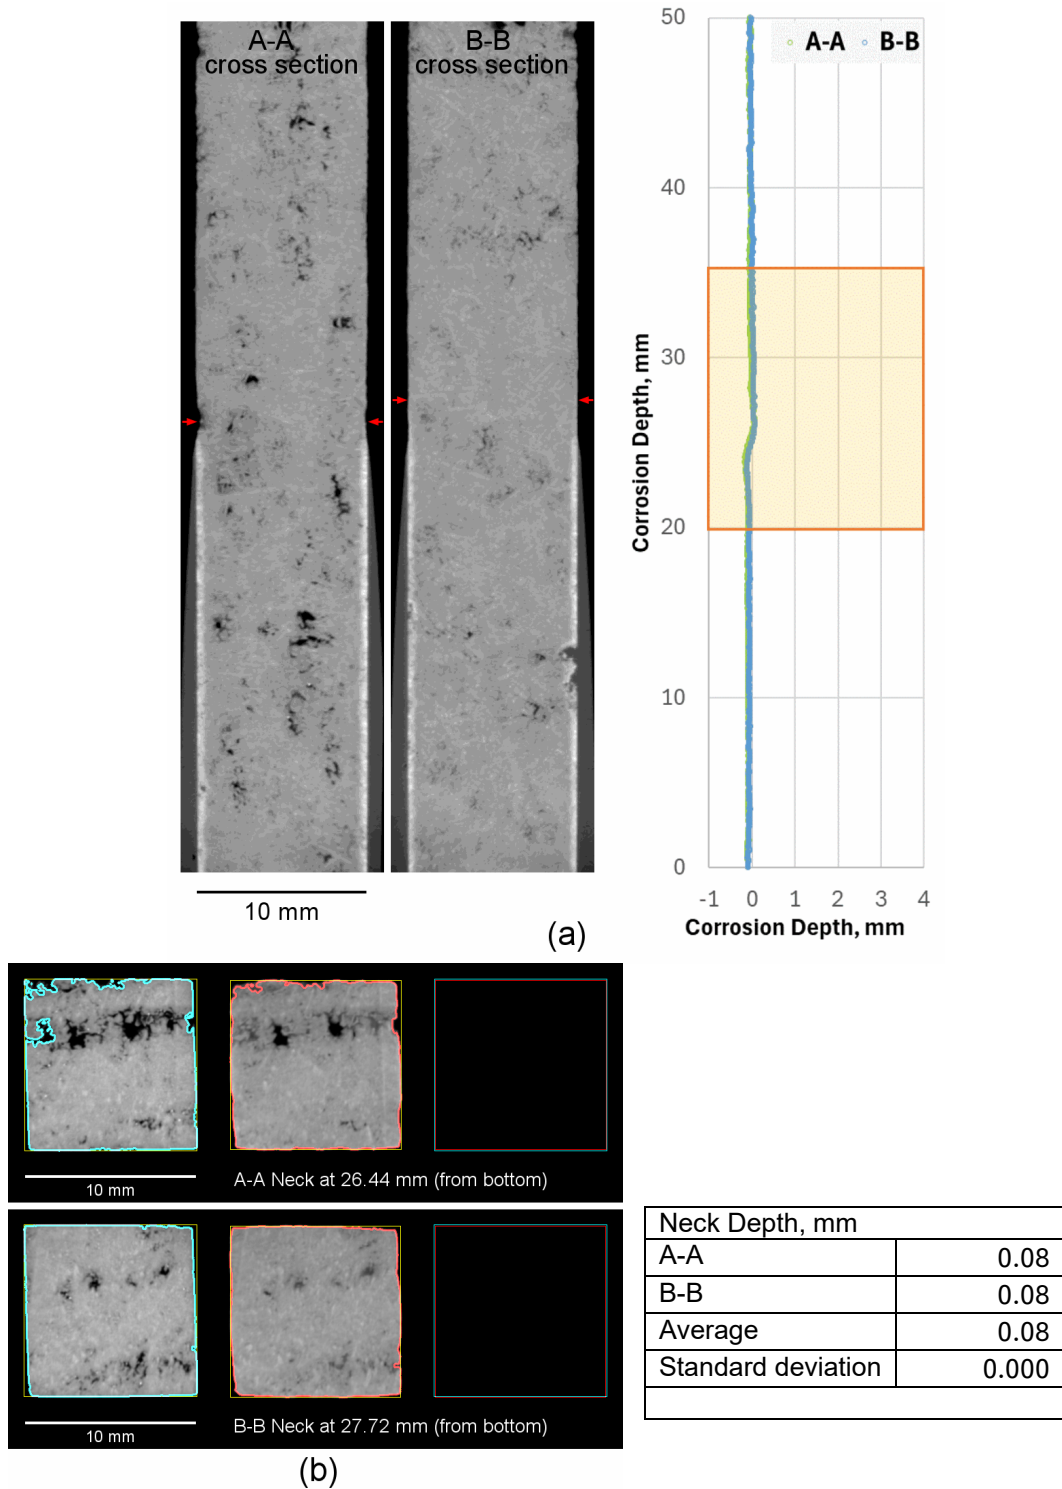
Figure B.6. Micro-CT results of K-3 refractory corrosion test, HAL24M2-03 - 1200 °C - 7day. (a) cross section at center. (b) top view slice at neck location.

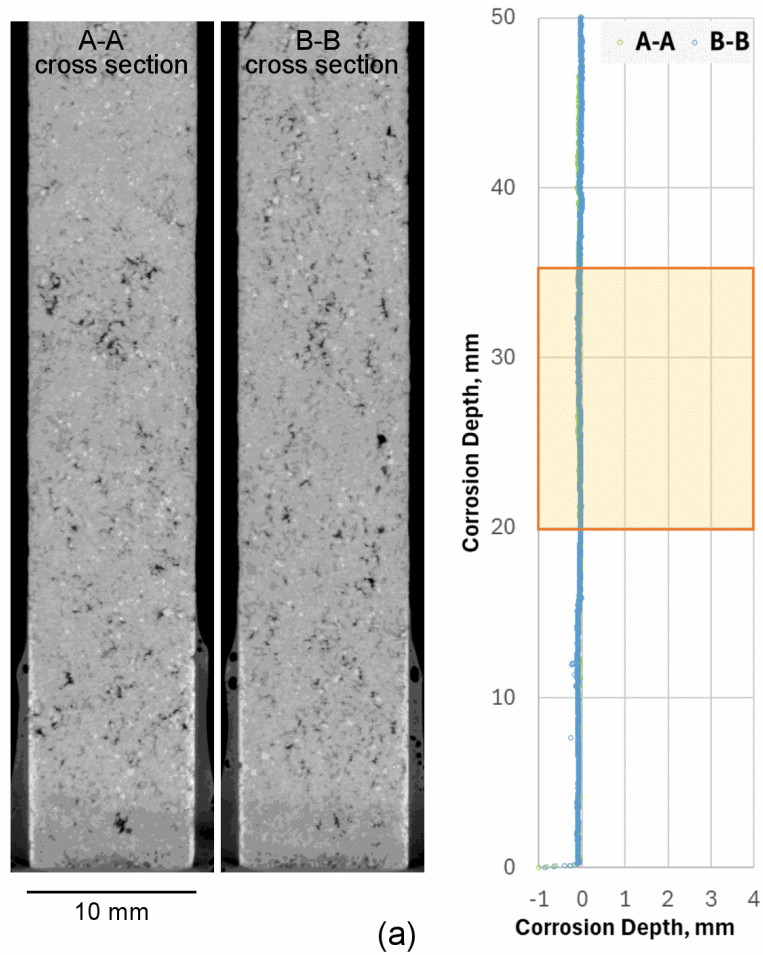
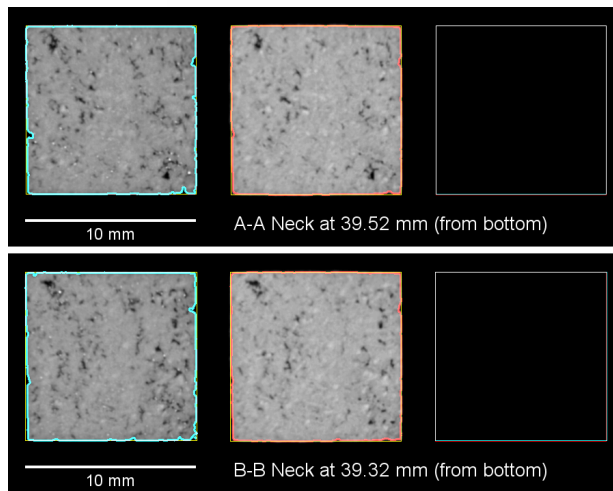
Neck Depth, mm	
A-A	-0.02
B-B	0.02
Average	0
Standard deviation	0.028
Note: no clear neck. Heights of the x-y slices in (b) are random.

Figure B.26. Micro-CT results of K-3 refractory corrosion test, HAL24M2-13 - 1200 °C - 7day. (a) cross section at center. (b) top view slice at neck location.
