# K-3 Refractory Corrosion Test Results for the HS24 Matrix

August 2026

This report summarizes the refractory corrosion data for a matrix of direct-feed high-level waste (DFHLW) glasses generated to expand glass property data into the high sulfur composition region. The design of the high sulfur glass matrix, HS24, was reported in Reiser et al. (2026). Fifty HS24 glasses were tested for the corrosion of Monofrax® K-3 refractory materials.

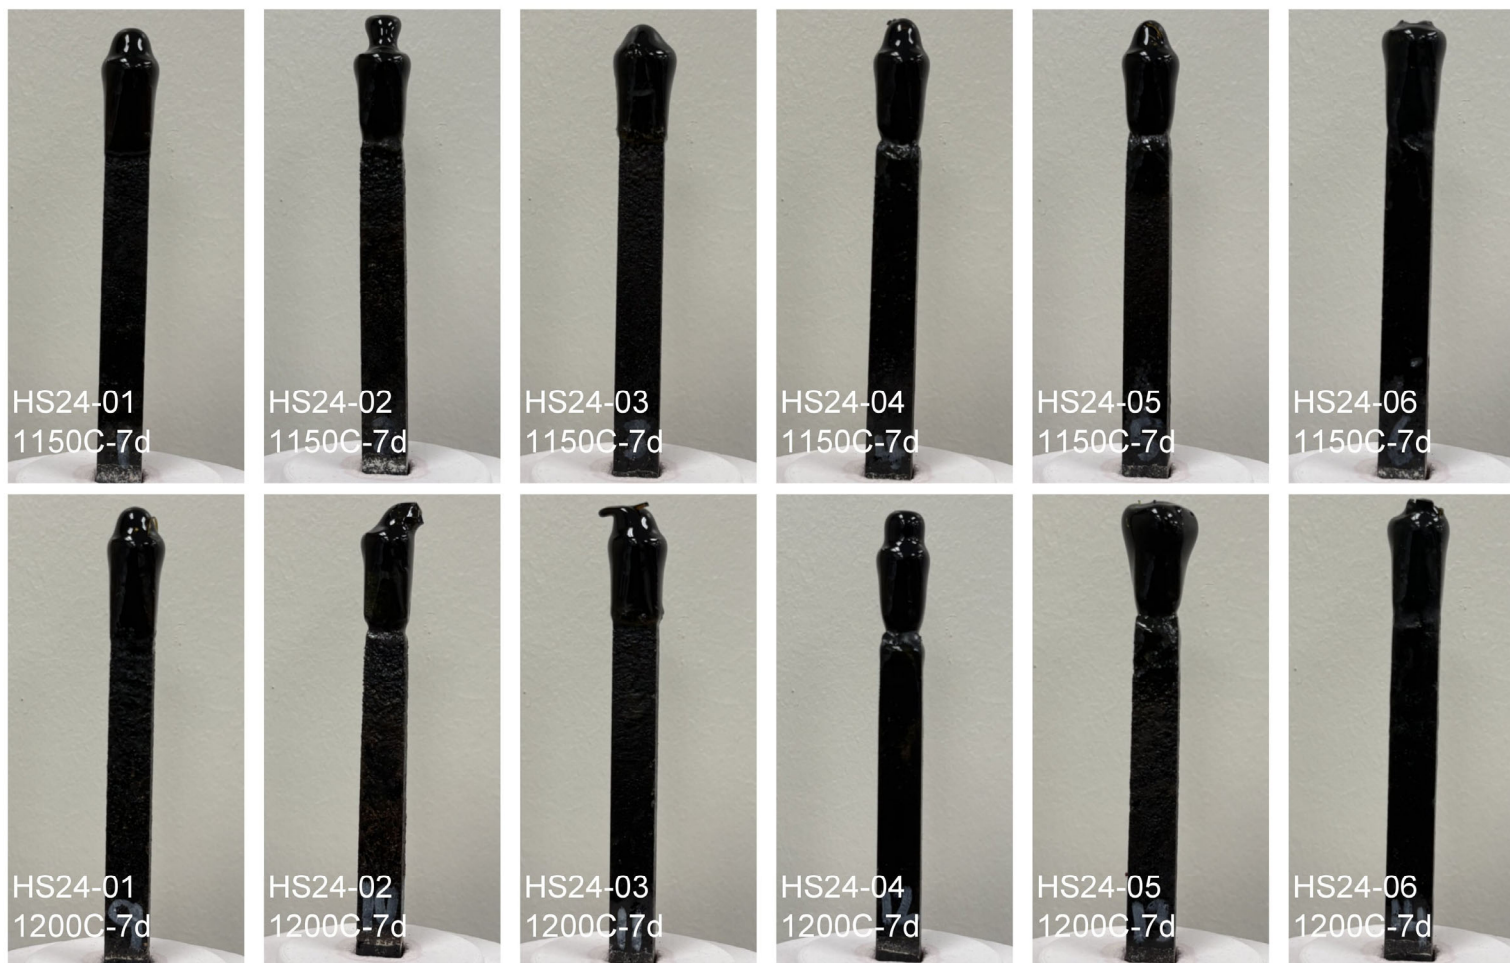
Figure A.1. K-3 coupons HS24-01 through HS24-06 after the refractory corrosion test.

The photographs in this appendix show the K-3 refractory coupons after corrosion testing with HS24 glasses. Note that the coupons are upside down in the photos; the top of each coupon is the section immersed in the glass melt.

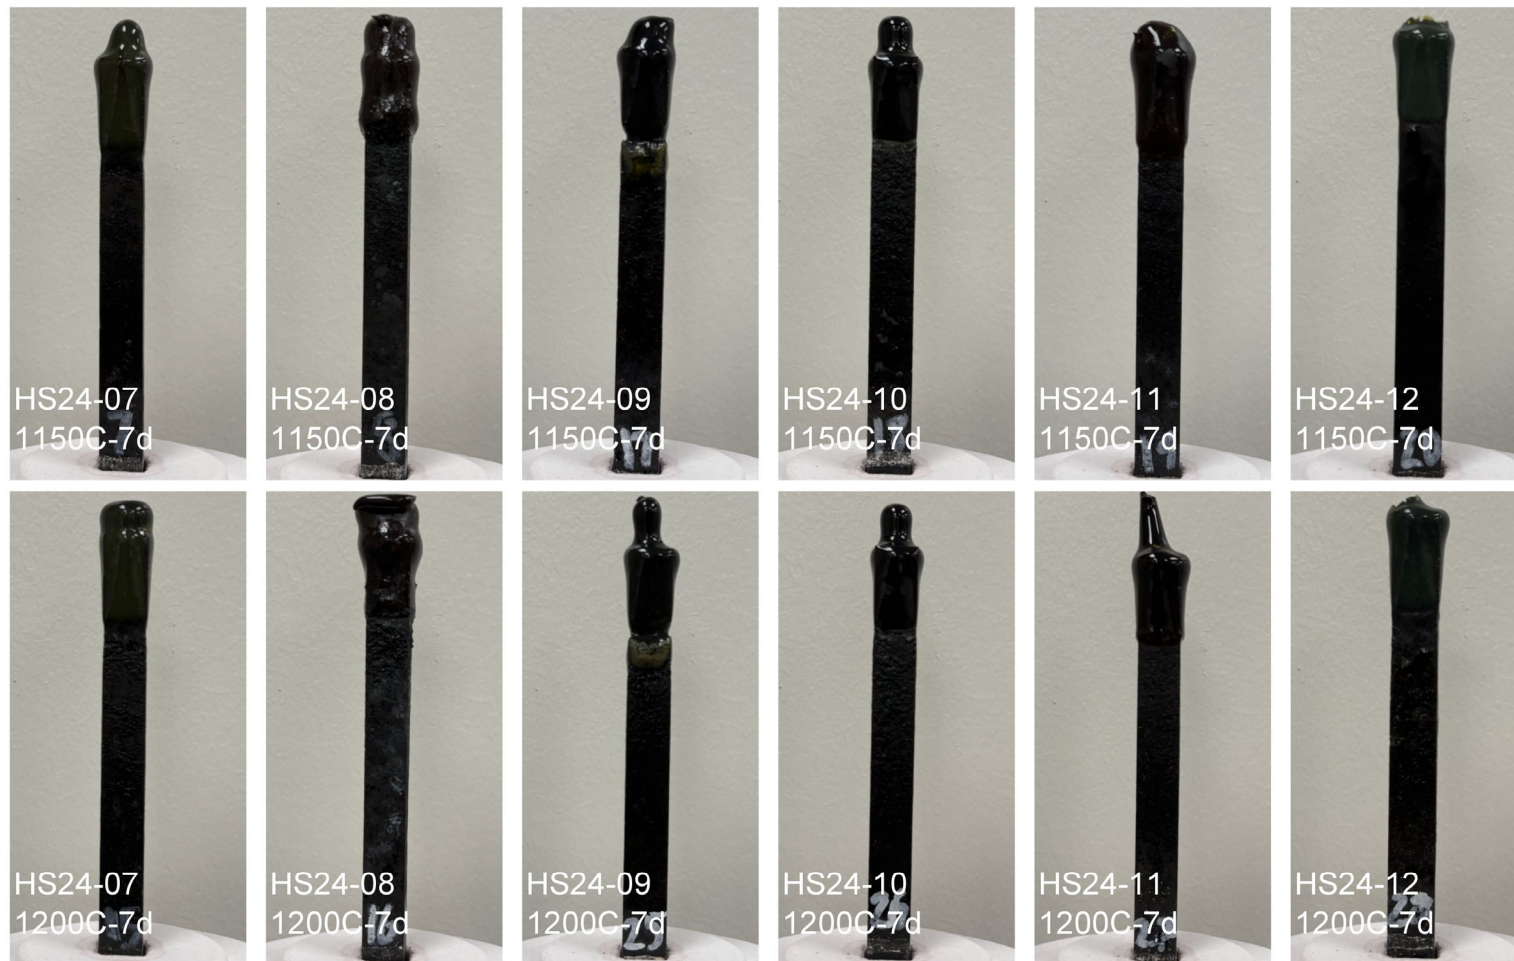
Figure A.2. K-3 coupons HS24-07 through HS24-12 after the refractory corrosion test.

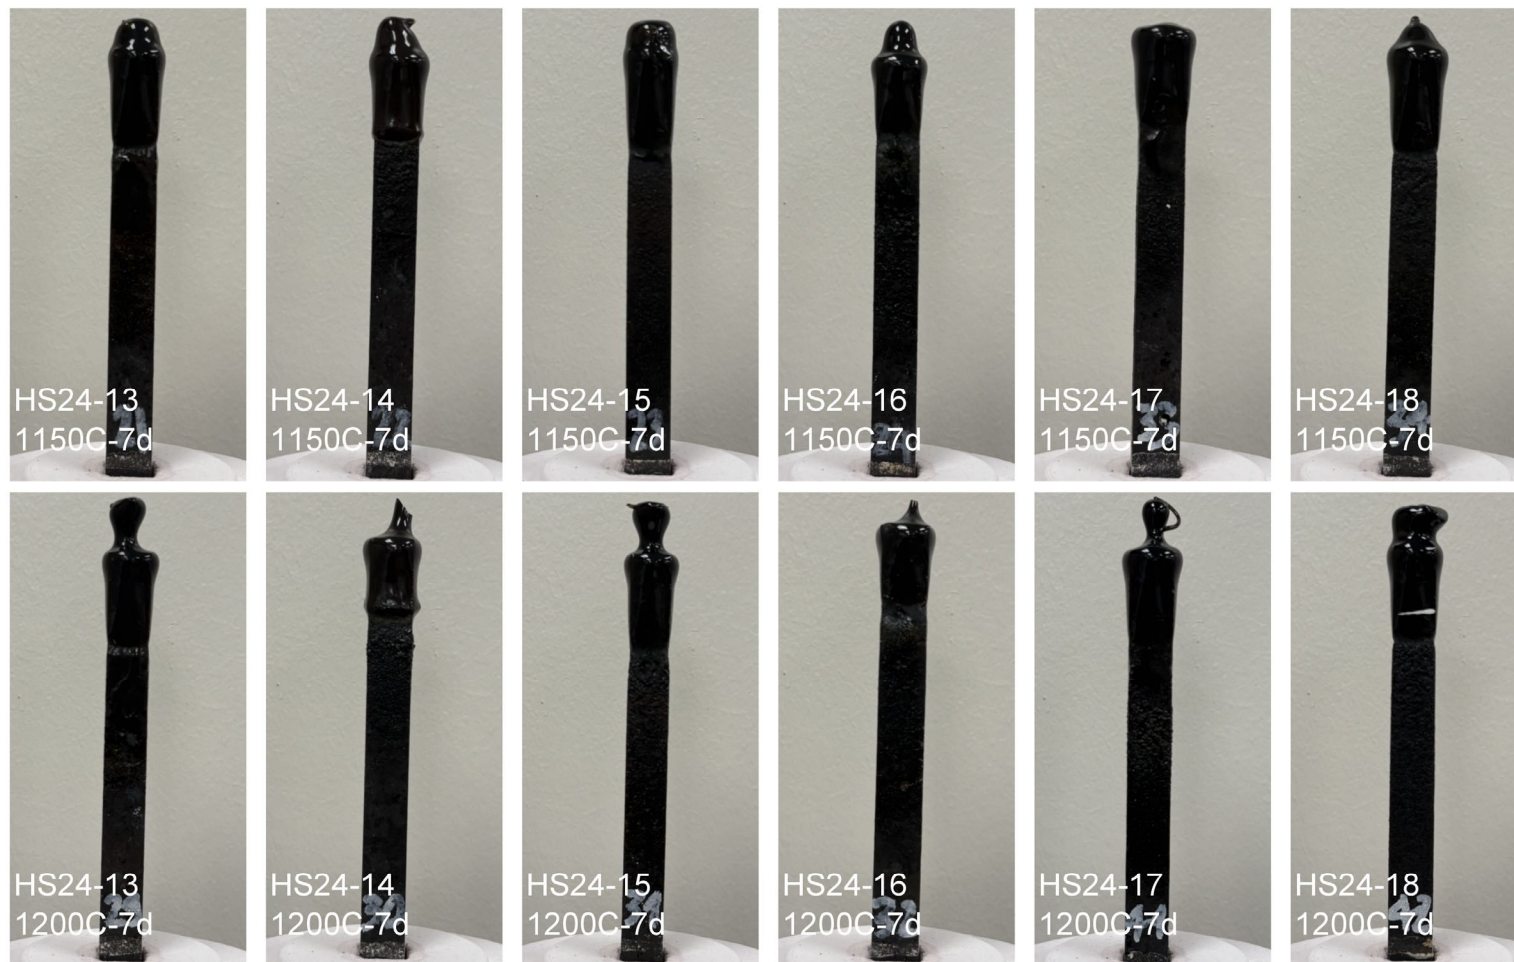
Figure A.3. K-3 coupons HS24-13 through HS24-18 after the refractory corrosion test.

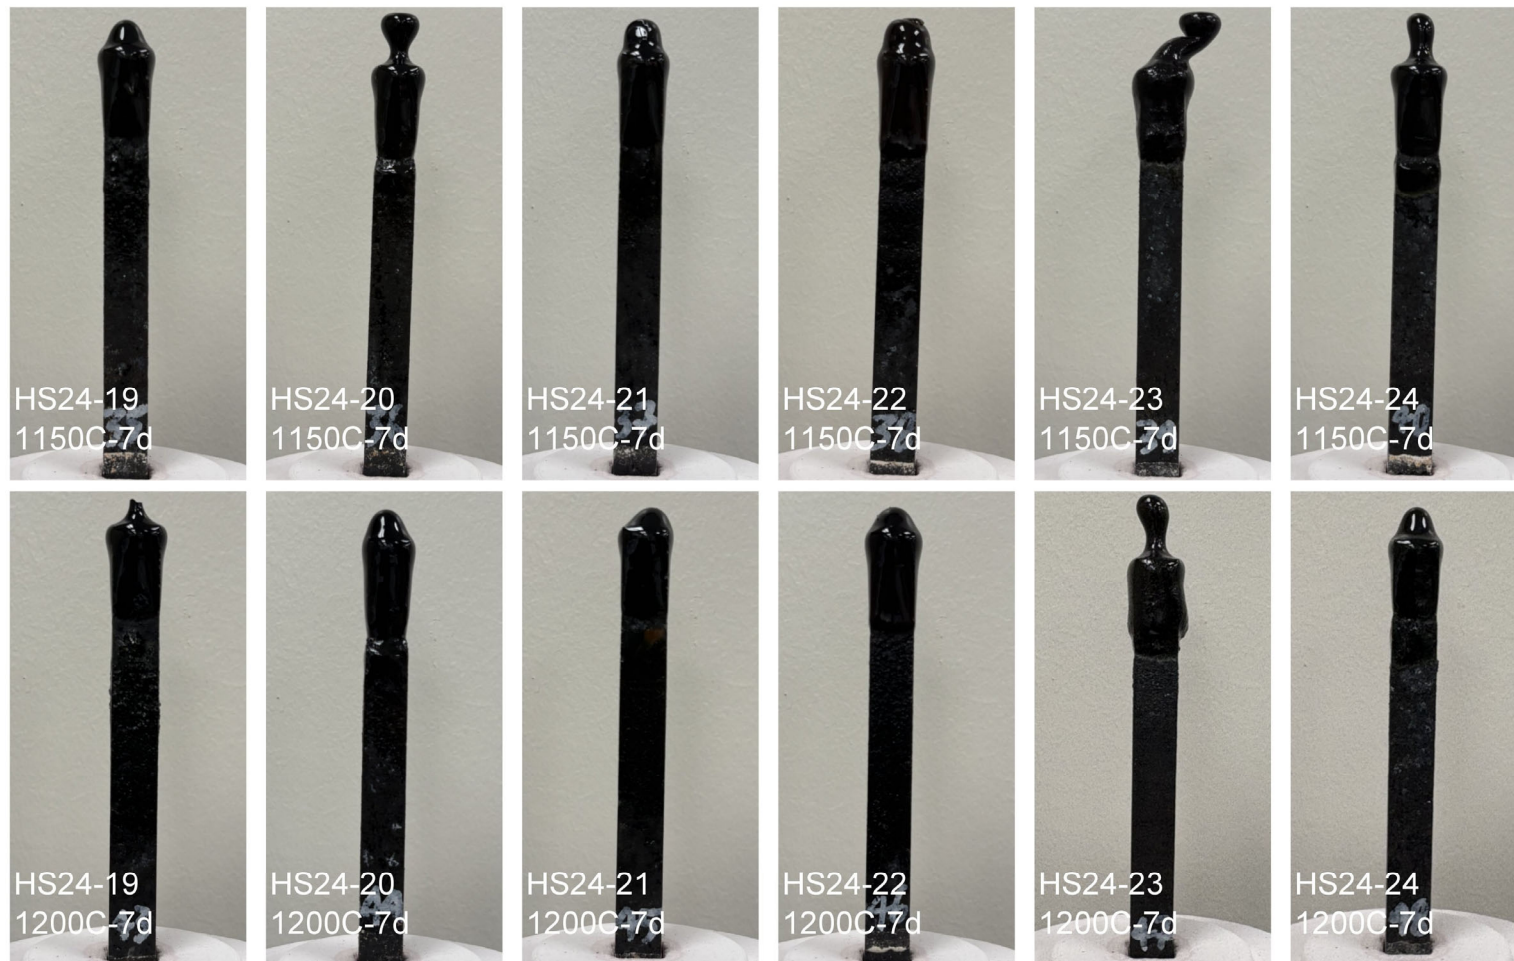
Figure A.4. K-3 coupons HS24-19 through HS24-24 after the refractory corrosion test.

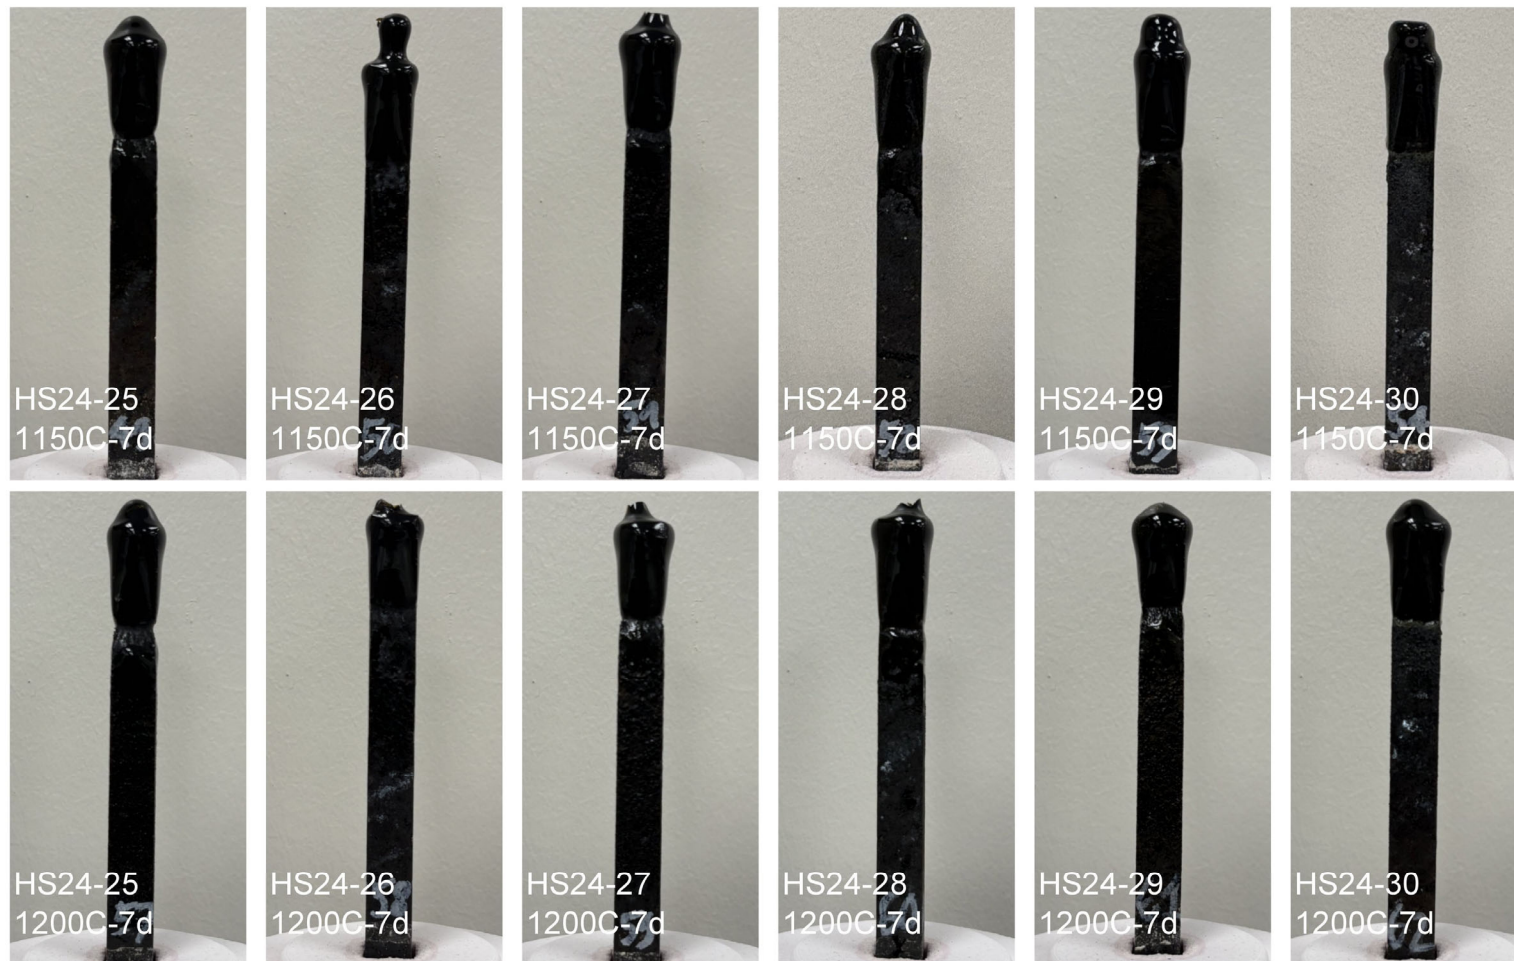
Figure A.5. K-3 coupons HS24-25 through HS24-30 after the refractory corrosion test.

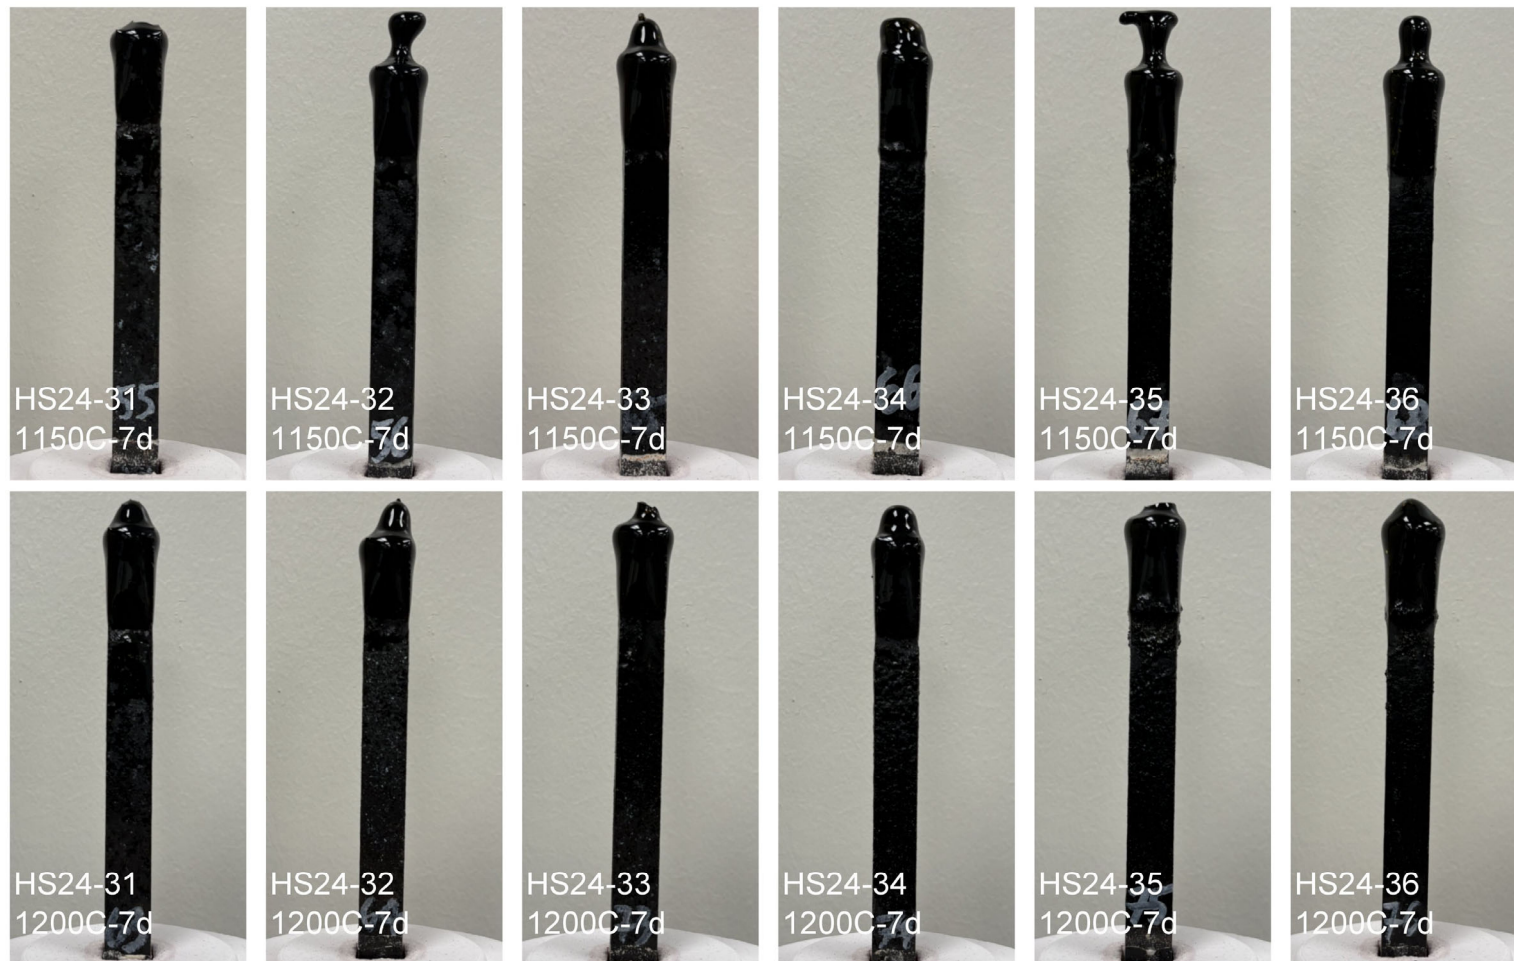
Figure A.6. K-3 coupons HS24-31 through HS24-36 after the refractory corrosion test.

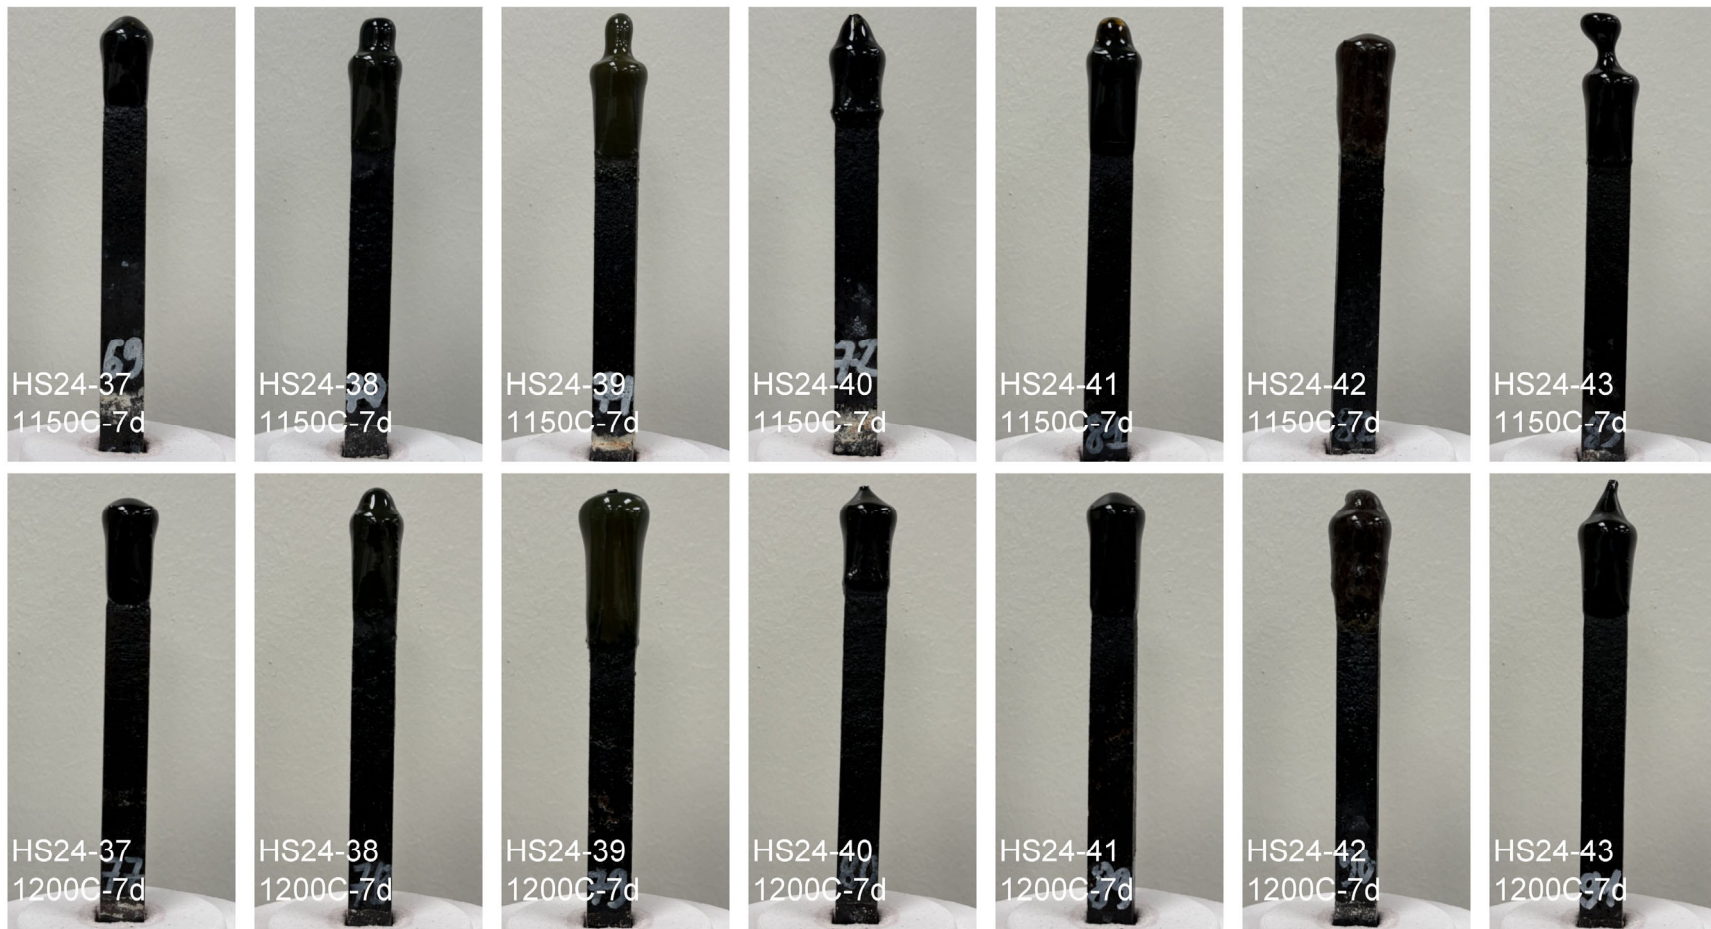
Figure A.7. K-3 coupons HS24-37 through HS24-43 after the refractory corrosion test.

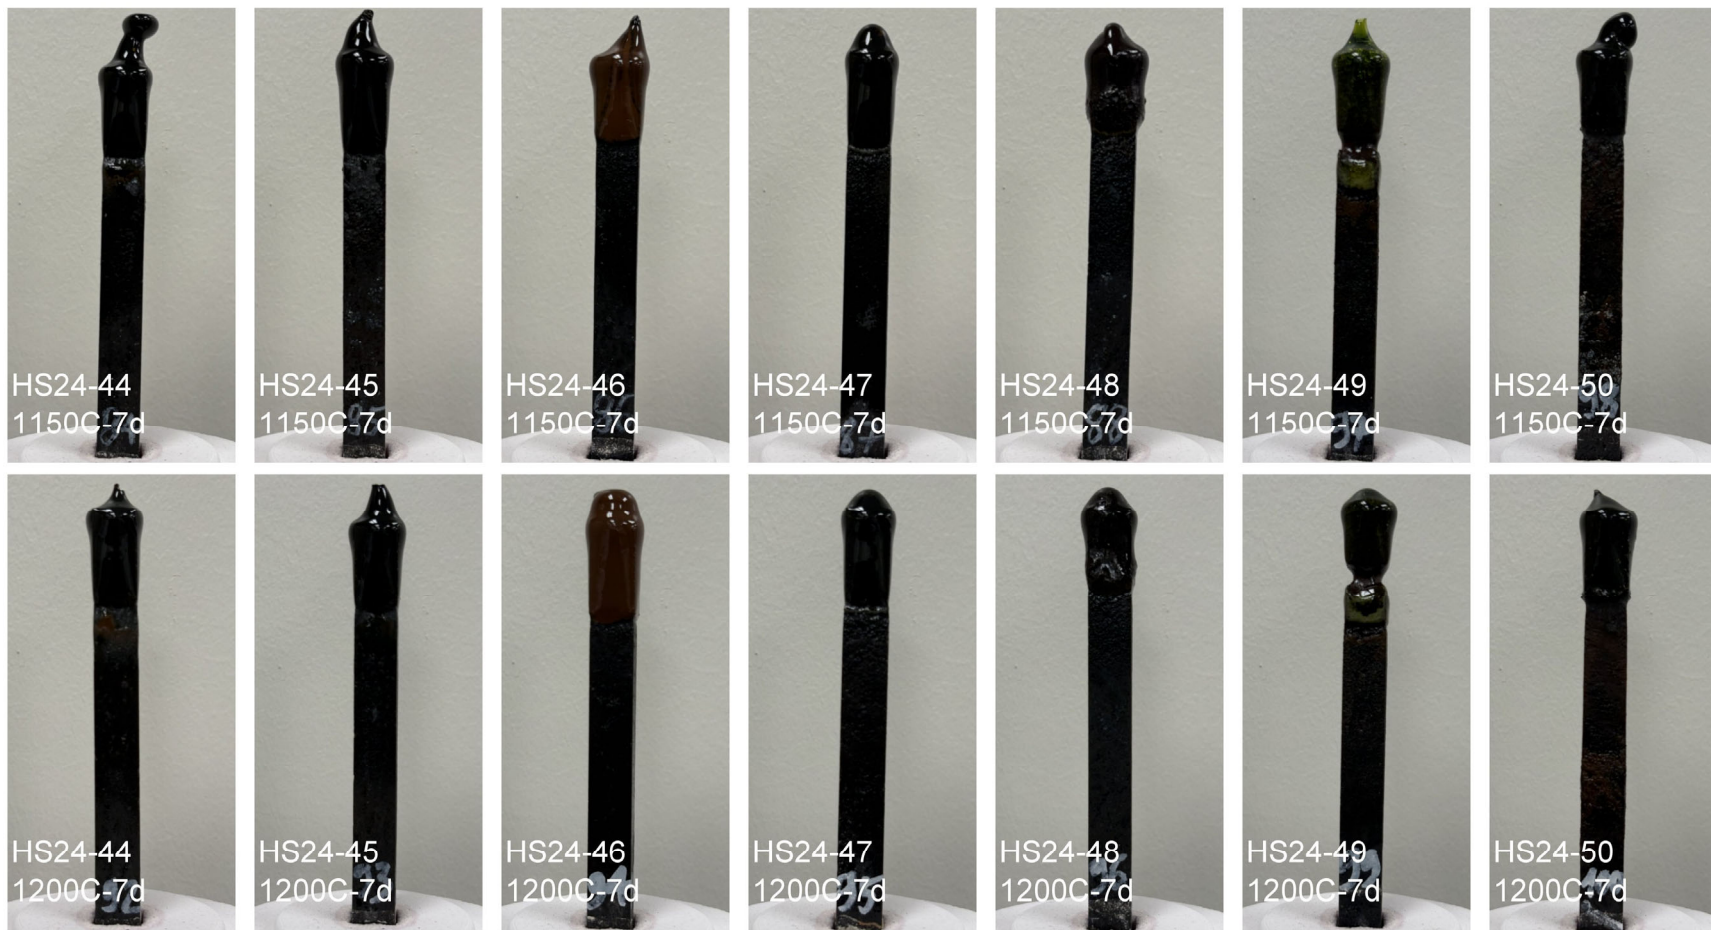
Figure A.8. K-3 coupons HS24-44 through HS24-50 after the refractory corrosion test.
