**Pacific Northwest
National Laboratory**

Final Report on Materials Characterization for the Wetted Cathodes for Low-Temperature Aluminum Smelting Program

October 2002

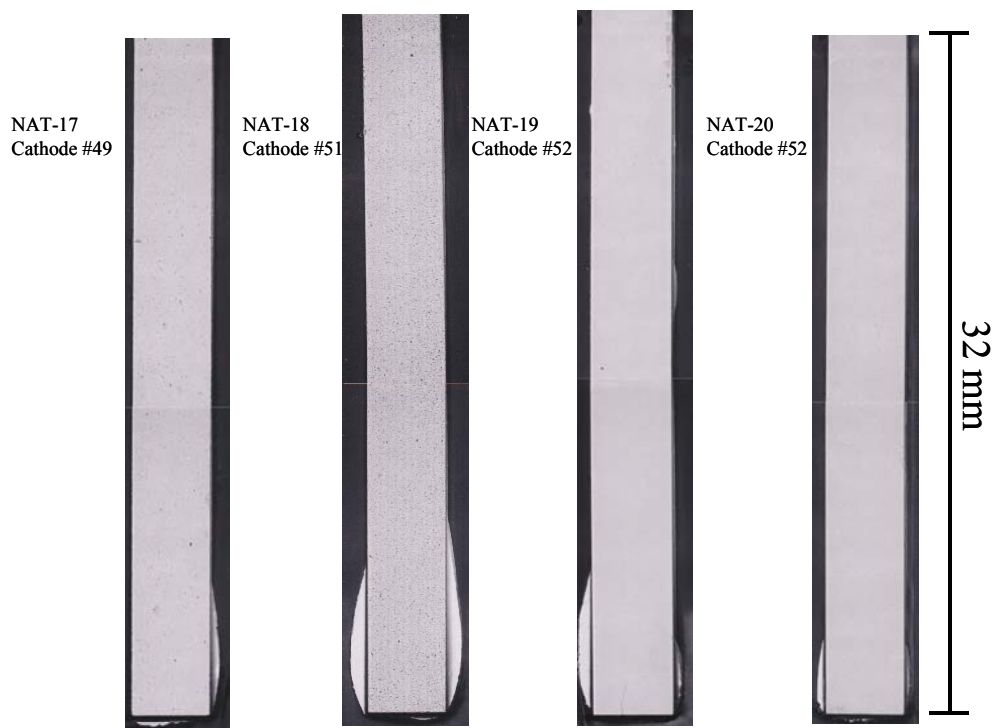
Figure A.58. Composite Optical Images of Cross Sections of NAT-17, NAT-18, NAT-19, and NAT-20

Figure A.58 shows the macro optical images of cross sections of all four cathodes. All cathodes showed minimal wear at this low magnification. Corners remained relatively sharp (compared with results for some of the other cathodes). Also, as noted before, the Al metal appeared to wet the surfaces with thin films (although the details of the wetting may be different for the different cathodes, as described below) and also tended to form a teardrop shape at the bottom of each cathode, apparently due to the liquid Al solidifying in this shape as the cathode was removed from the electrolyte. Sample NAT-19 had an approximately 1.5-mm vertical crack extending up from near the center of the sample bottom.
