**Pacific Northwest
National Laboratory**

Innovative Approach to Establish Root Causes for Cracking in Aggressive Reactor Environments

October 2003

Phase 1 Annual Report
Proposal Number 2SF020075 (NERI-2002-075)

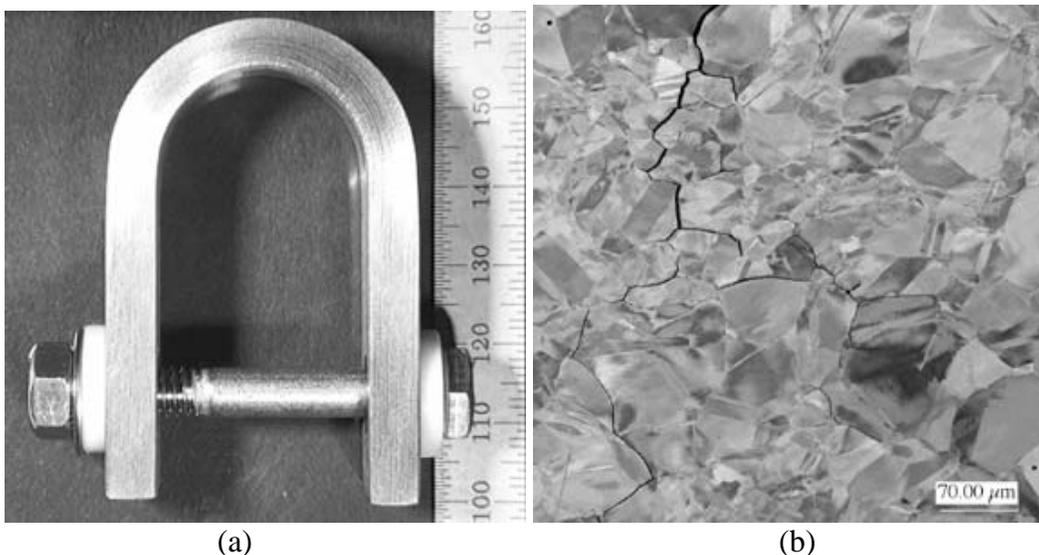
Figure 1. U-bend test sample (a) for low-temperature SCC tests in chloride, thiosulfate or fluoride environments and example of intergranular cracks produced (b).

Two approaches were taken in this subtask to generate SCC samples for crack-tip characterizations: (1) obtain and tailor specific alloys for SCC testing (primarily U-bend) at PNNL and (2) work collaboratively with outside laboratories to get SCC tests performed under critical conditions. The first base material selected for single-mechanism tests was a high-carbon 304SS. This alloy was solution annealed at 1050°C and sensitized at 650°C for 24 h before fabrication into standard U-bend samples as illustrated in Figure 1(a). SCC tests were then performed at 80°C in three high-purity water environments with an impurity addition, i.e., either NaCl, Na₂S₂O₃ or NaF as shown in Table 1. Each impurity was added at a concentration of 100 ppm, but the thiosulfate was increased to 200 ppm when cracking was not detected in 800 h.

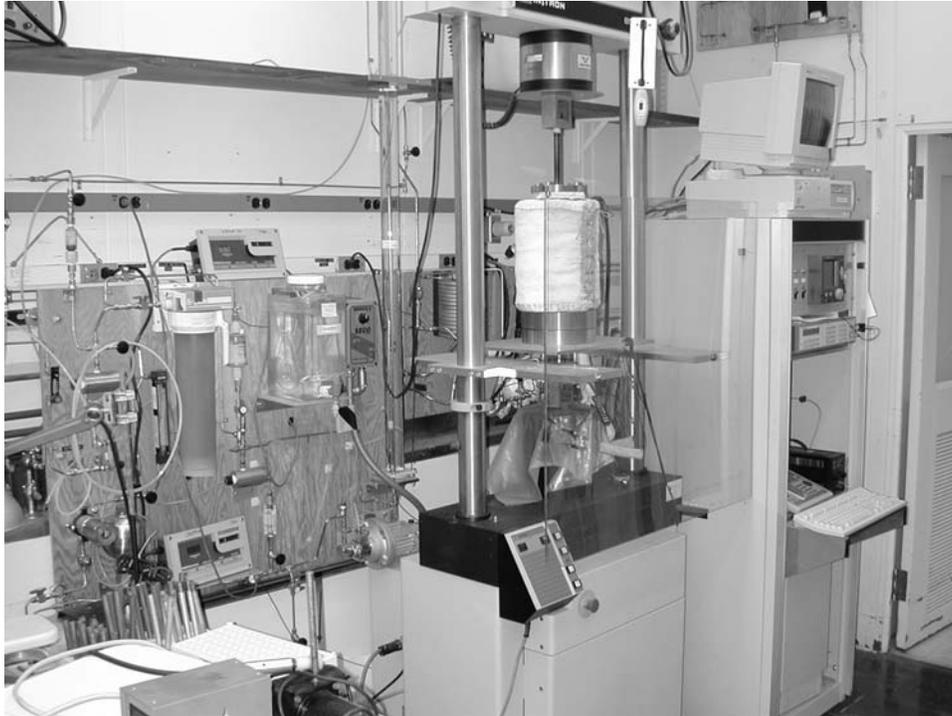
Figure 2. Photograph of a typical system for performing fatigue precracking, and corrosion fatigue and stress corrosion crack growth rate studies in high temperature water.

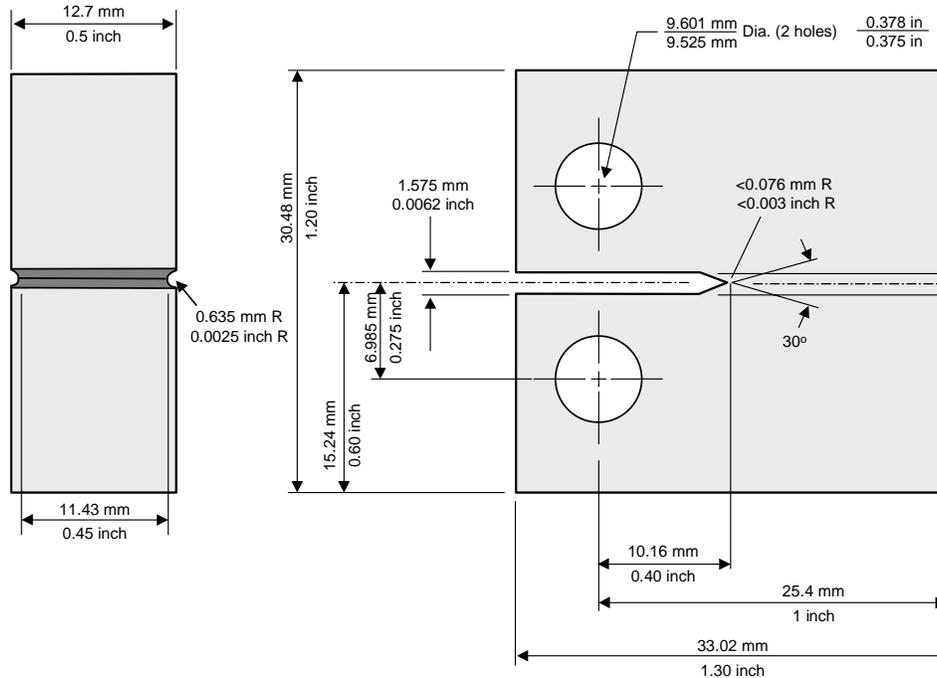
Figure 3. Schematic drawing of a 0.5TCT specimen. Oversized loading holes of about 9.5 mm diameter were used in most specimens to accommodate ceramic inserts that provided electrical isolation between the CT specimen and clevis. All dimensions for 1TCT specimens doubled.

The experimental procedures for fabrication and testing of all crack growth rate specimens in this program are summarized below. The crack growth specimens are 1-inch (1T CT) or 0.5-inch (0.5T CT) compact tension type with 5% side grooves on each side (Figure 3).

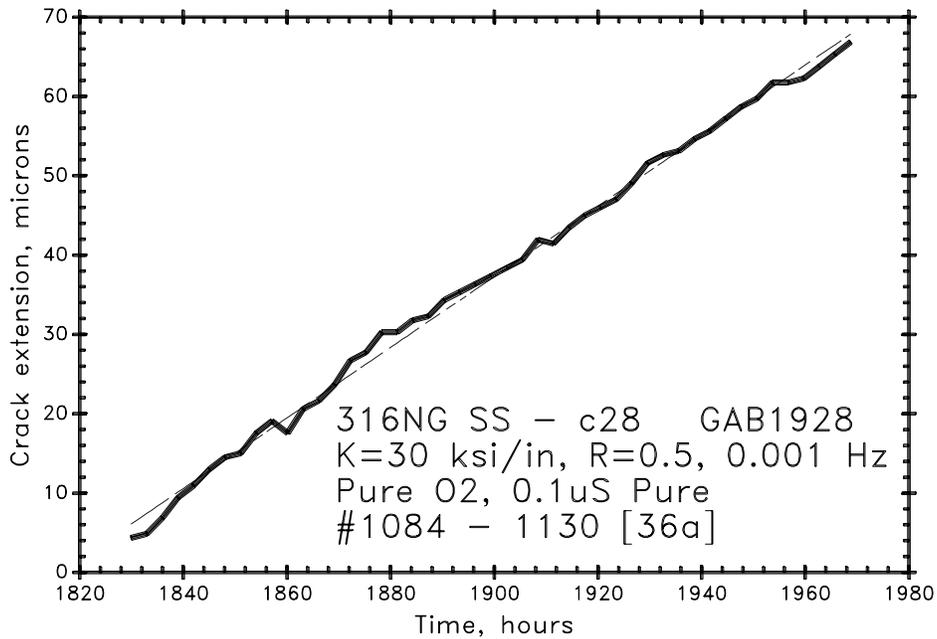
Figure 4. Crack extension vs. time for a 1TCT specimen in 288°C water showing the resolution of the reversing dc potential drop technique. Even without compensation for minor fluctuations in temperature and applied current, a resolution of ≈ 2 to 5 μm is attainable.

Optimization of the reversed DC potential drop technique has provided incremental crack length resolution on a micron scale. For example, even without compensation for minor fluctuations in temperature and applied current, Figure 4 shows the typical resolution on a 1TCT specimen in 288°C water to be, $2\text{-}5 \mu\text{m-h}$, corresponding to $\approx 1 \mu\text{m}$ resolution if data are averaged over a 5-h period. A recent analysis of the accuracy of the technique based on eleven Type 304L, 316L and 316NG stainless steel ITCT specimens tested in 288°C water revealed that the crack depth determined by potential drop was, on average, 2.2% below the actual depth (with a standard deviation, σ_n , of 5.2%) on growth increments of 4.2 to 13.6 mm from an initial (as-machined) a/W of 0.384 to 0.463. The worst case error was 11% on 20 mm of growth; the errors for 6 of 11 specimens were $<2\%$. Similar results have also been observed for sensitized Type 304 stainless steel and turbine steel specimens. Complex microstructures – esp. Ni alloy weld metals like alloy 182 – always maintain uncracked ligaments (that act as current shorting paths) in the wake of the crack. Agreement between dc potential drop and post-test fractography can show errors of $>>50\%$ in some instances, although the problems are less with the transitioning and intermittent use of periodic unloading during testing.

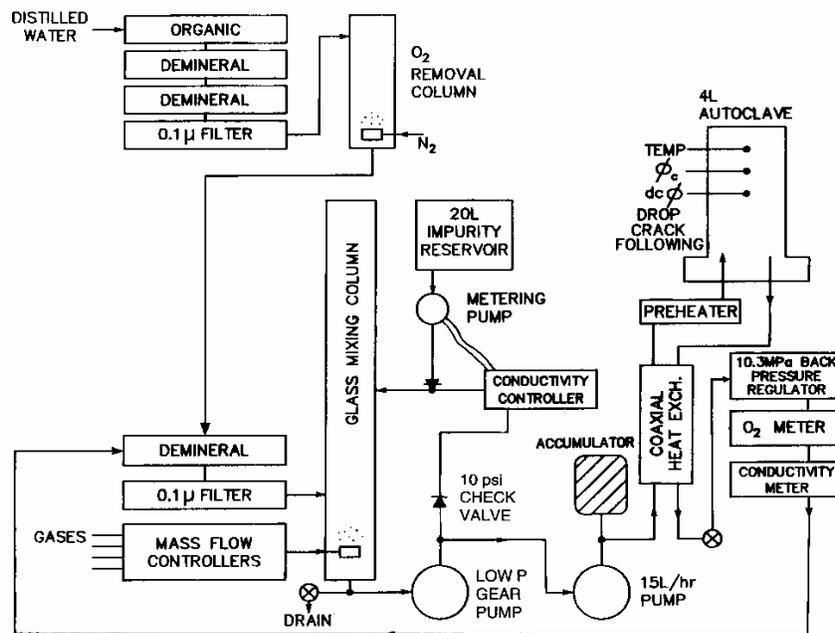
Figure 5. Schematic design of the water chemistry measurement and control, and the high-pressure pumping system.

Deaerated, demineralized water (Figure 5) is drawn through another demineralizer and submicron filter to ensure ultra-high purity ($\approx 0.055 \mu\text{S/cm}$) and then into a glass column (6.4-cm diameter by 183-cm long). A low-pressure pump provides positive pressure to the high-pressure pump, and draws water from and recirculates excess water (water that did not go into the high-pressure pump) back into the glass column. The autoclave effluent is back-pressure regulated, then measured for conductivity using a Sybron Barnstead Model PM-512 and dissolved oxygen using an Orbisphere Model 2606. The oxygen concentration is controlled by bubbling gas blended by a Tylan Model RO-20-A mass flow controller. Impurities are added to the glass column using a metering pump (Fluid Metering Model RP-G50/H1 GKC) that was controlled by the Sybron Barnstead conductivity meter.

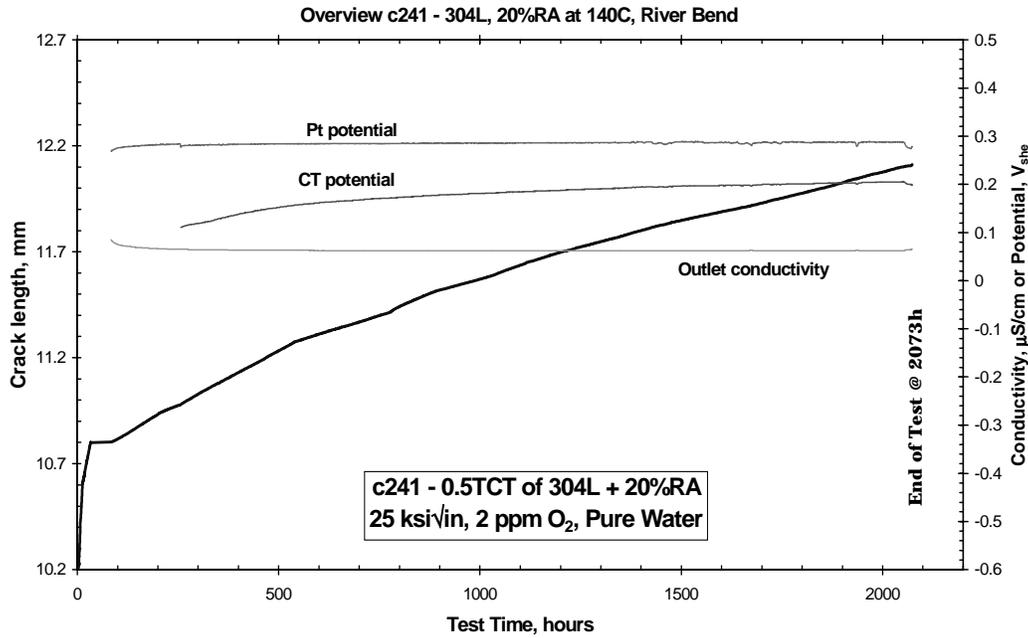
Figure 6. Overview of SCC growth rate response of warm-worked 304L stainless steel (River Bend shroud) tested in 288°C pure water.

Type 304L Stainless Steel (c241) in BWR Water. The overview and air fatigue precracking response of warm-worked (20% reduction in thickness at 140°C) stainless steel specimen c241 are shown in Figures 6 and 7. At about 83 h, the specimen was assembled into the autoclave, and the initial environmental cracking response in 288°C in water containing 2000 ppb O_2 is shown in Figure 8.

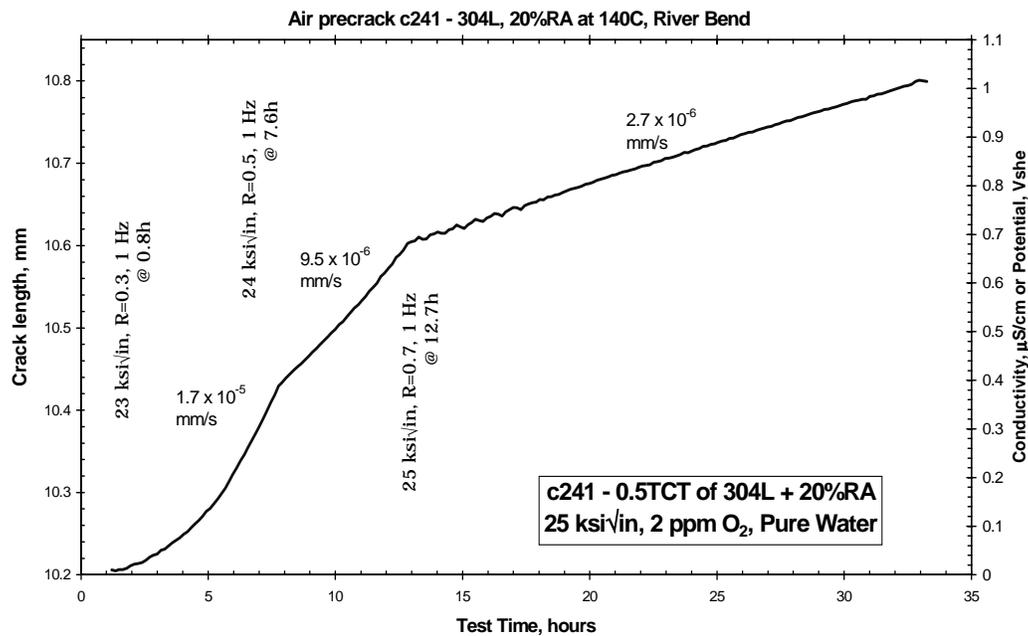
Figure 7. Air fatigue precracking response of warm-worked 304L stainless steel (River Bend shroud) and transition to test in 288°C pure water.

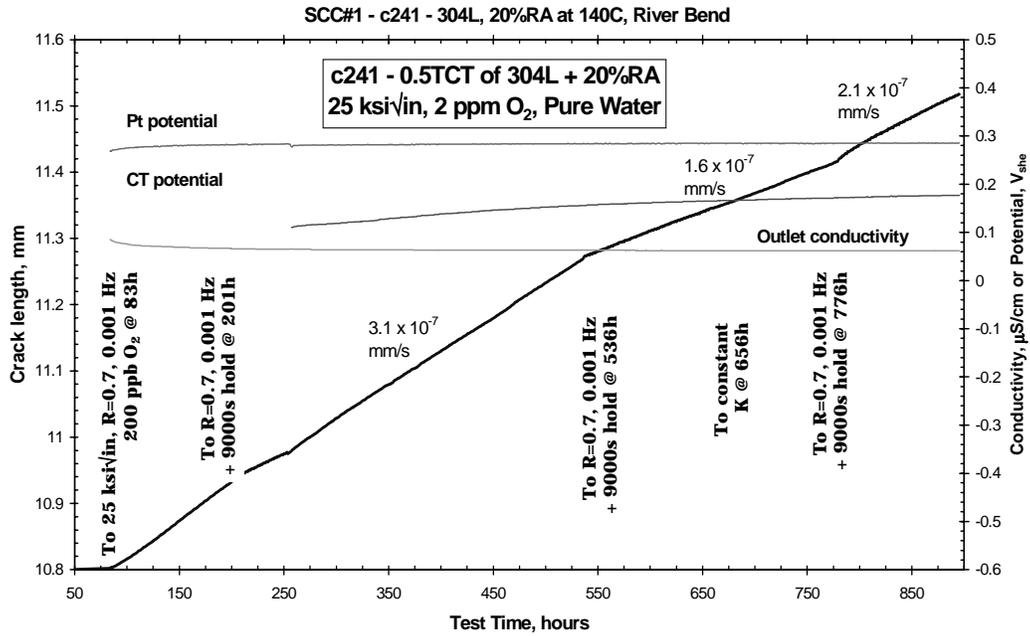
Figure 8. Transitioning and early SCC response of warm-worked 304L stainless steel (River Bend shroud) tested in 288°C pure water.

Initial testing in high temperature water involves cycling under similar conditions to encourage the entire crack front to continue to grow and transition to intergranular SCC. This is very effectively accomplished by starting with low frequency, low stress intensity amplitude (ΔK) conditions, typically a load ratio, $R = 0.7$ and 0.001 Hz. A hold time at K_{max} is then introduced (soon in this test), e.g., of 9,000 s, then if the response is well-behaved, constant K conditions are implemented, as shown in Figure 8.

To ensure that a good response is obtained, a 9,000 s hold at K_{max} is introduced at 776 h (Figures 8 and 9). This produces a slight acceleration in crack growth rate, as expected for the slightly more aggressive loading conditions. At 895 h, the loading is returned to constant K conditions, with load shedding on a regular basis (typically load is shed in ≈ 5 lb increments). The SCC response is quite well behaved, and at 2,073 h, the test was ended. The specimen was disassembled from the autoclave, put into a sealed plastic pouch, and shipped to PNNL.

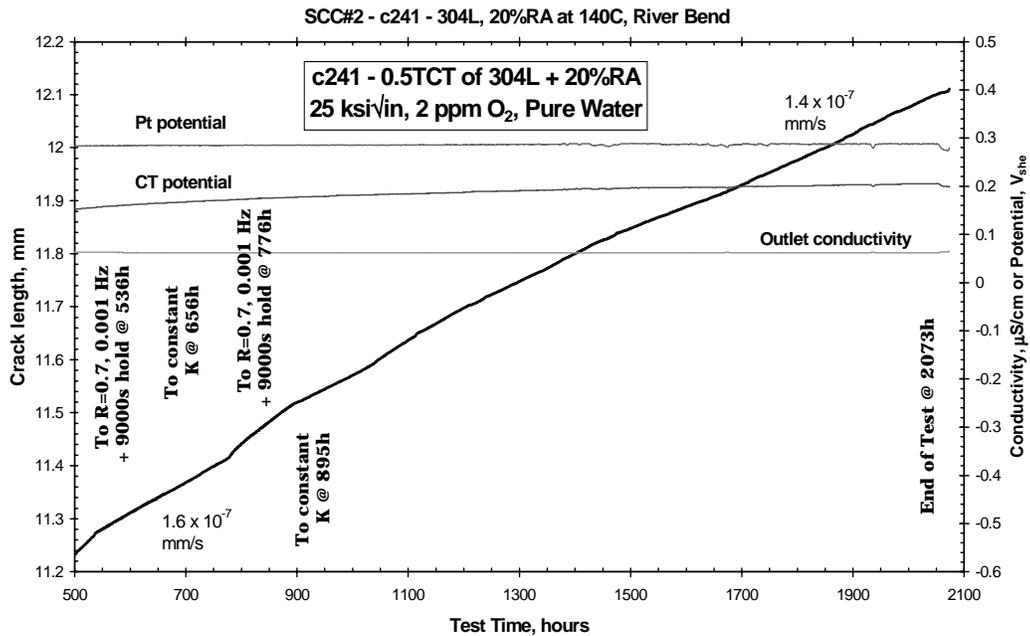
Figure 9. SCC response of warm-worked 304L stainless steel tested in 288°C pure water.

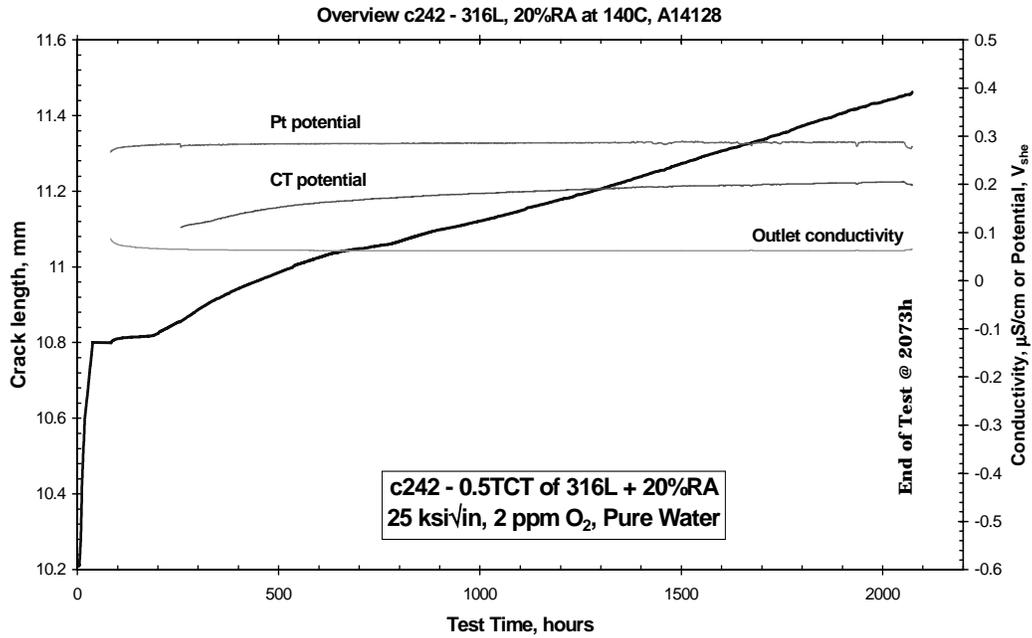
Figure 10. Overview of SCC growth rate response of warm-worked 316L stainless steel (heat A14128) tested in 288°C pure water.

Type 316L Stainless Steel (c242, heat A14128) in BWR Water. The overview and air-fatigue precracking response of warm-worked (20% reduction in thickness at 140°C) stainless steel specimen c241 are shown in Figures 10 and 11. The specimen was assembled into the autoclave at ≈ 83 h, and Figure 12 shows the initial environmental cracking response in 288°C in water containing 2000 ppb O₂.

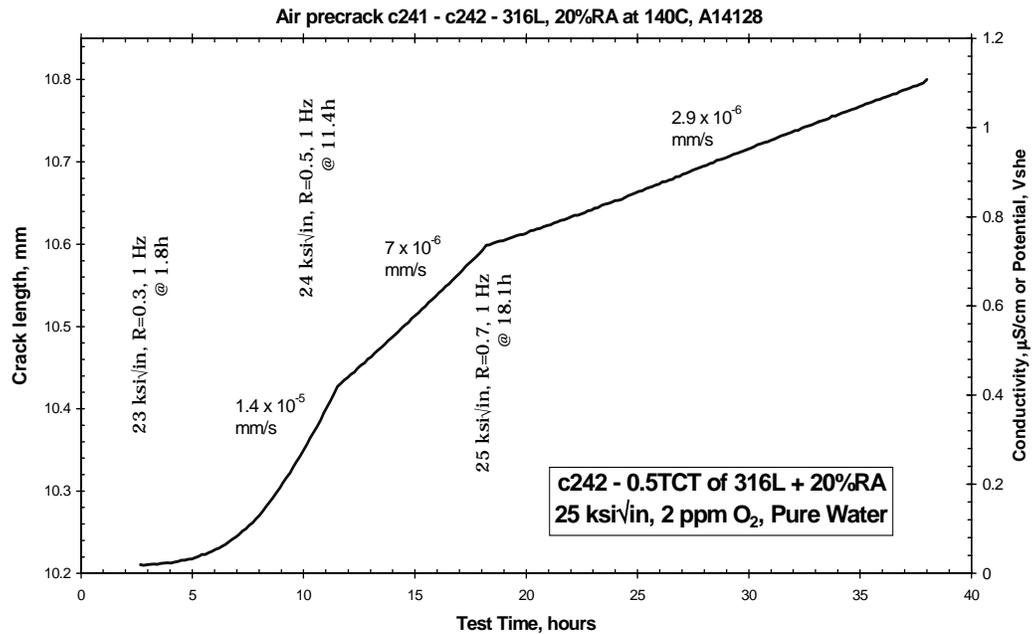
Figure 11. Air fatigue precracking response of warm-worked 316L stainless steel (heat A14128) tested in 288°C pure water.

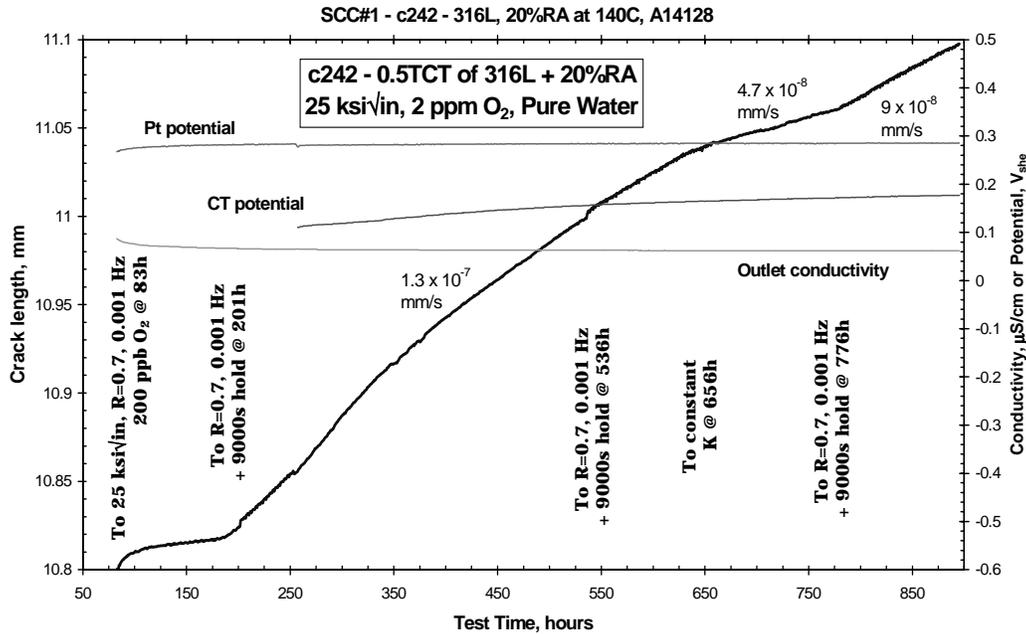
Figure 12. Transitioning and early SCC response of warm-worked 316L stainless steel (heat A14128) tested in 288°C pure water.

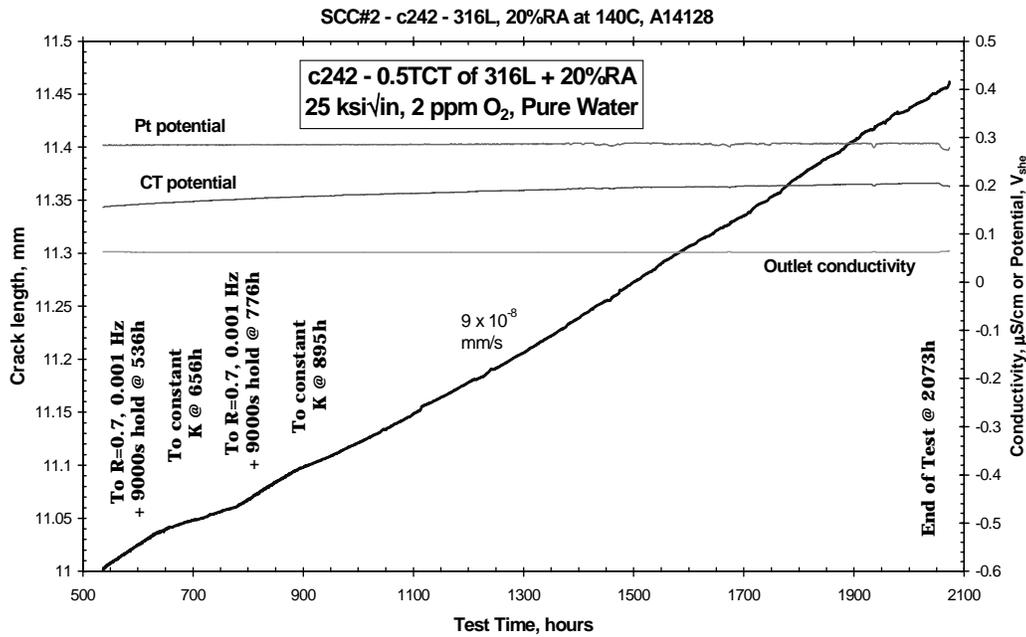
Figure 13. SCC response of warm-worked 316L stainless steel (heat A14128) tested in 288°C pure water.

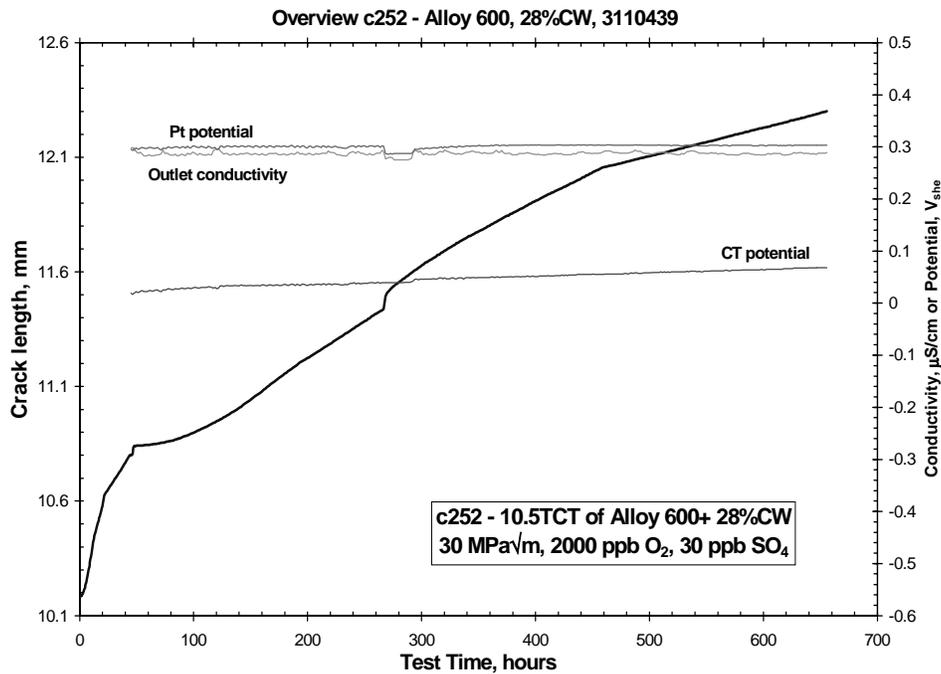
Figure 14. Overview of SCC growth rate response of cold-worked Alloy 600 (heat 3110439) tested in 288°C water with 2000 ppb O₂ and 30 ppb sulfate.

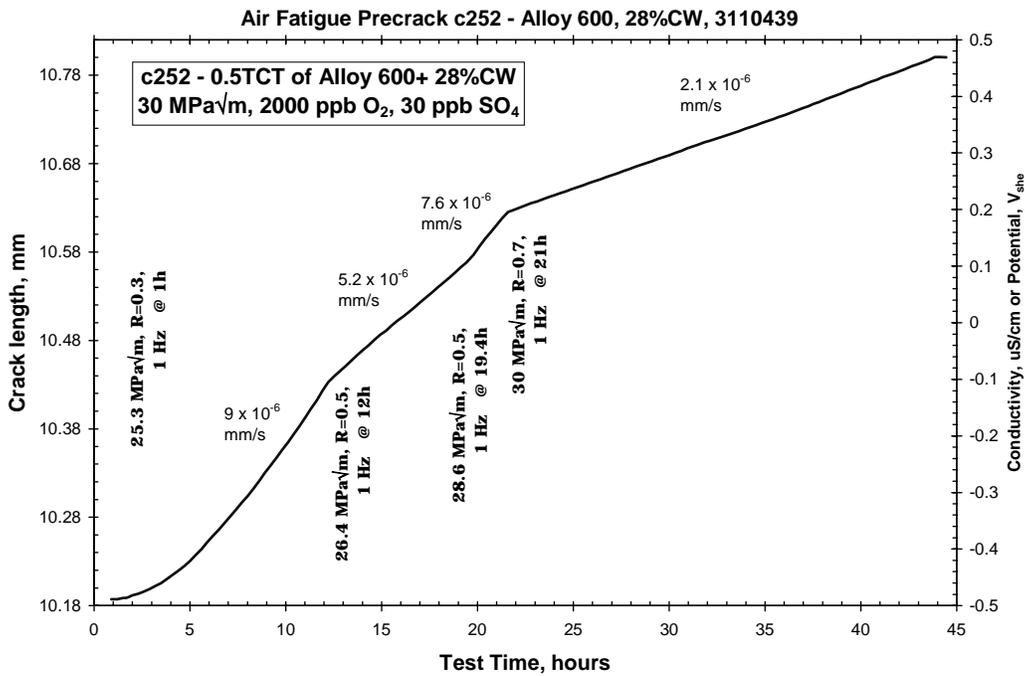
Figure 15. Air fatigue precracking response of cold-worked Alloy 600 (heat 3110439) tested in 288°C water with 2000 ppb O₂ and 30 ppb sulfate.

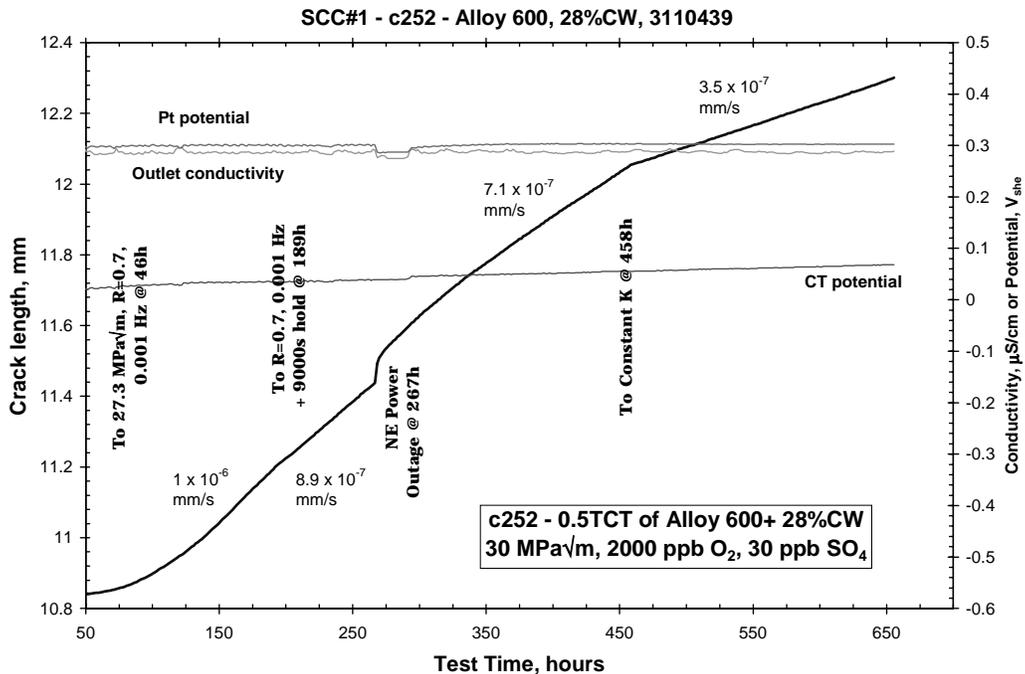
Figure 16. Transitioning and early SCC response of cold-worked Alloy 600 (heat 3110439) tested in 288°C water with 2000 ppb O₂ and 30 ppb sulfate.

After air fatigue precracking, the specimen was assembled into the autoclave at ≈ 46 h, and Figure 16 shows the initial environmental cracking response in 288°C water containing 2000 ppb

O₂ and 30 ppb sulfate as H₂SO₄. As in other tests, a transition from transgranular fatigue to intergranular SCC is achieved by loading at 30 MPa \sqrt{m} , R = 0.7, 0.001 Hz. Over the next 50 – 100 h, the initially sluggish crack growth response approaches a steady state value.

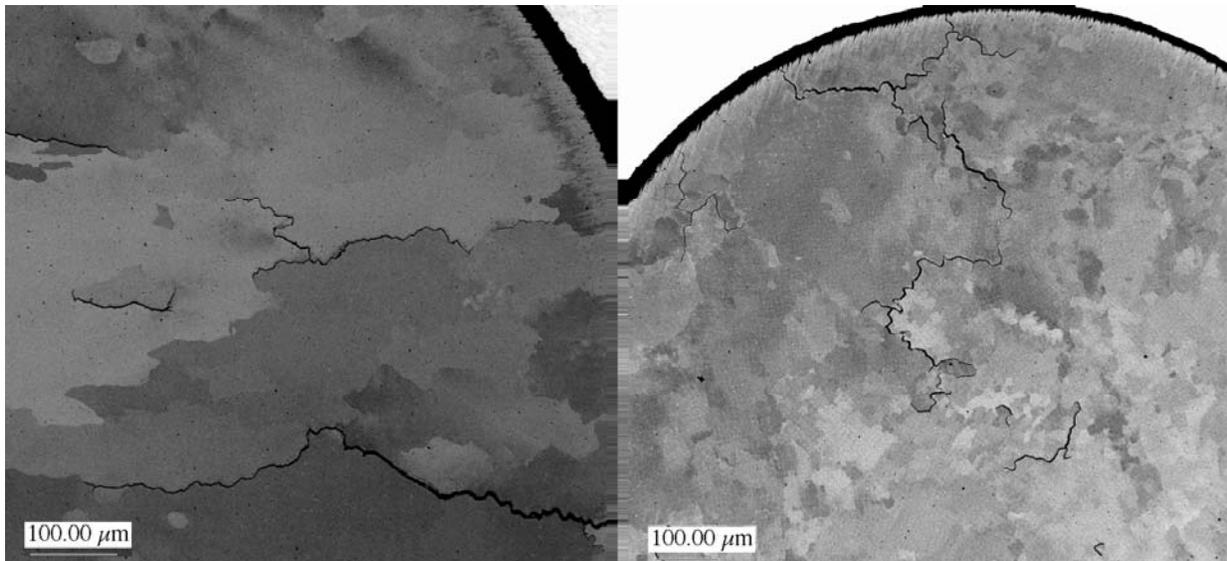
Figure 17. SEM images of two cracked alloy 182 weldments. Cracks occur along high-angle grain boundaries. The grain size of the weld on the left is much larger than the weld on the right, possibly as a result of post-weld heating.

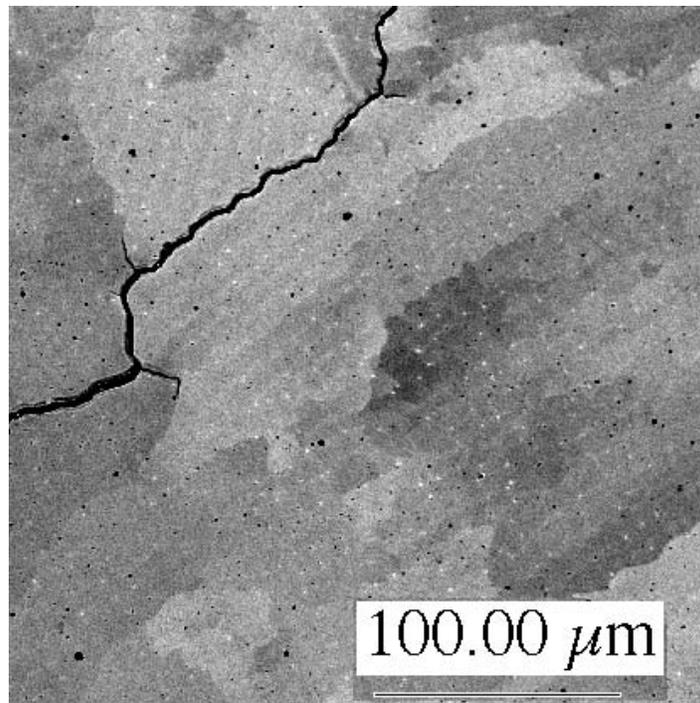
Figure 18. SEM image of a weld revealing high-angle grain boundaries, subgrain boundaries, and the regular array of NbC (white) particles and the more random Ti-based (dark) particles.

Higher magnification SEM/BSE images as shown in Figure 18 also revealed many sub- μm -size second-phase intragranular particles aligned in periodic structures related to the grain orientations. SEM/EDS analyses indicated that the particles were of mainly two types. The lighter-appearing particles were Nb carbide, and the darker ones were mostly Ti oxide or Ti-Al oxide. Initially the Nb carbides were identified as borocarbides based on EDS spectra showing a small peak at the B-K position. However, further investigation revealed that the 'boron' peak was in fact a minor Nb peak, and supplemental TEM/EELS analyses confirmed that the particles contained no significant boron. Frequent coincidences of the darker oxide particles with the centers of the lighter particles suggested that the Nb carbides had formed around some of the

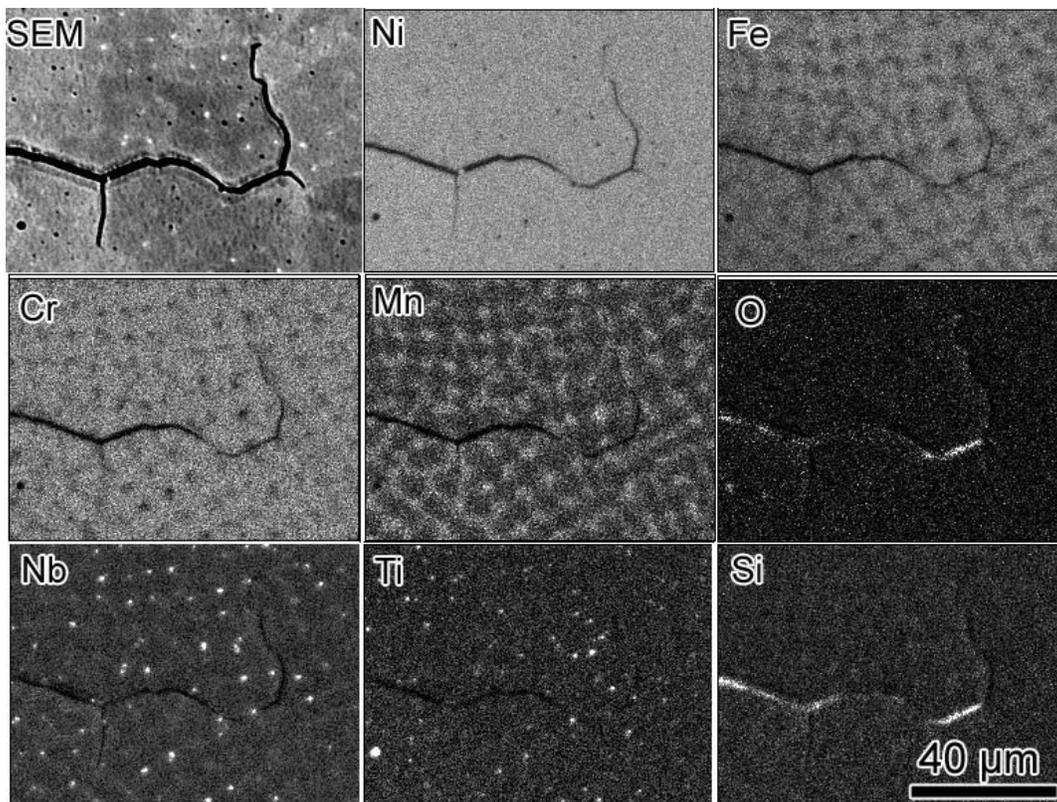
Figure 19. SEM/EDS x-ray maps of alloy 182 weld-crack region. Maps show cellular segregation and precipitation in metal matrix. Nb carbides correlate to high-Mn regions. Cracks occurred along normal grain boundaries unrelated to weld dendrites; contained oxide with high Si in places.

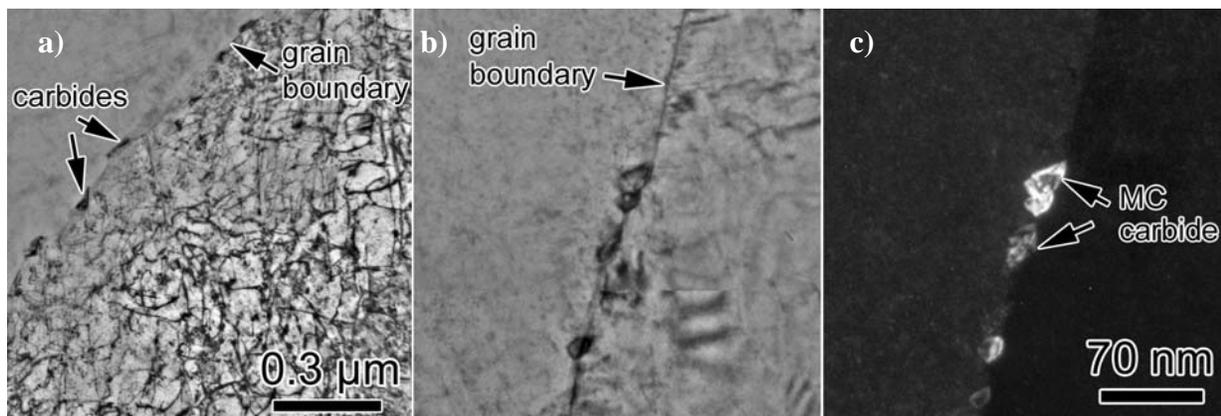
Figure 20. Base microstructure in Alloy 182 weld in the TEM. Dislocation structure on one side of grain boundary is shown on left, and boundary tilted parallel to viewing direction is shown in bright field in center (with dislocations invisible) and using precipitate darkfield image on right.

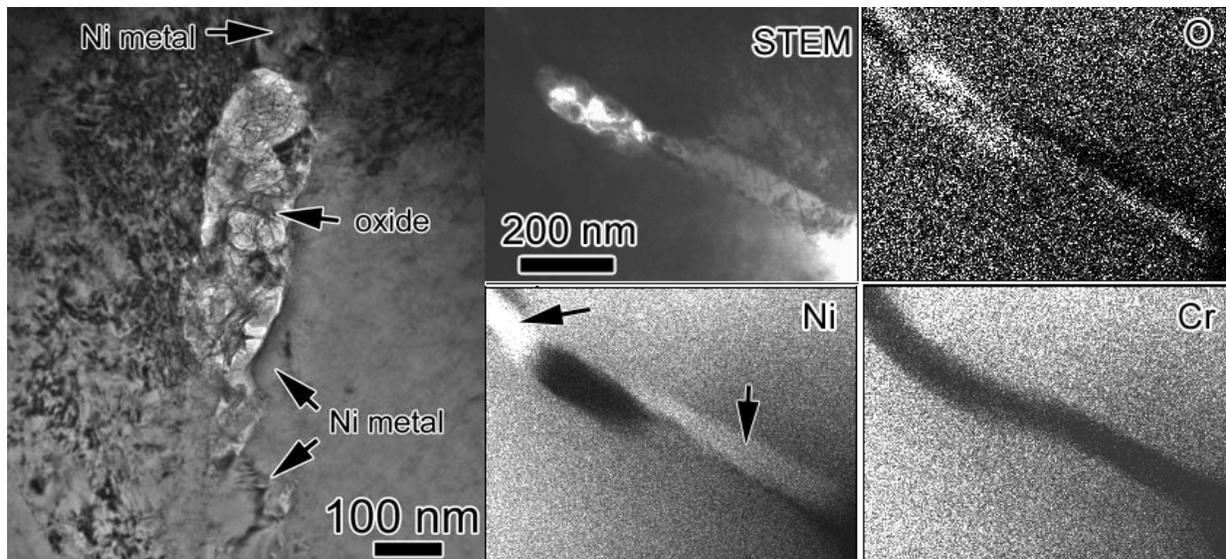
Figure 21. Attacked grain boundary with alternating regions of oxide (spinel) and Ni-metal in an Alloy 182 weld. TEM brightfield of general area is shown on left with four EDS x-ray maps on right. Arrows indicate regions of Ni-rich metal.

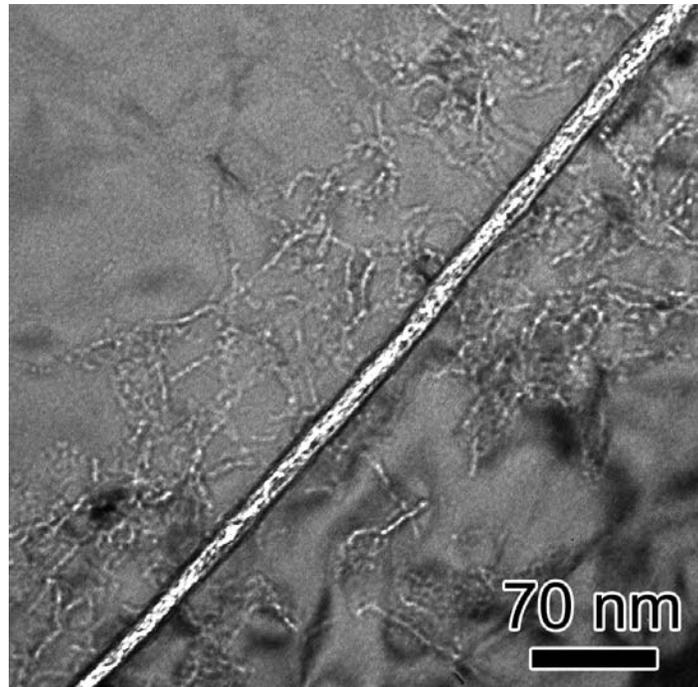
Figure 22. Underfocused TEM image showing tunnel-like structures extending into the matrix from a tight intergranular crack.

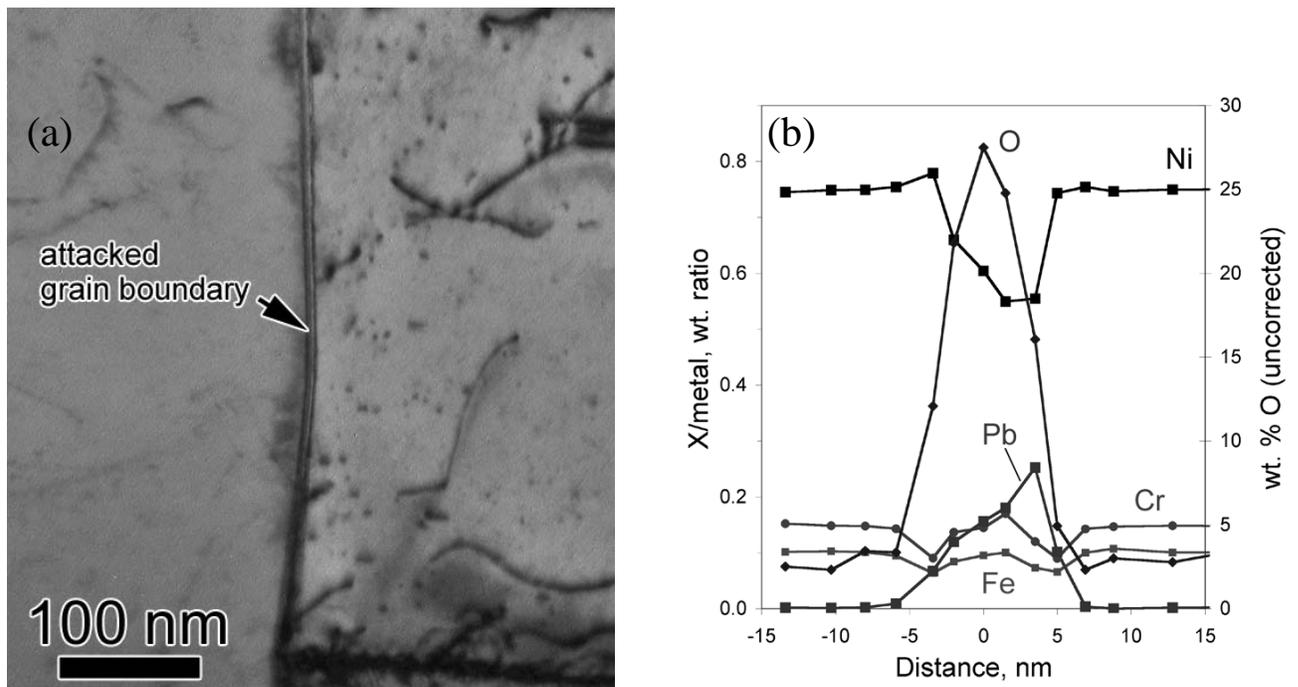
Figure 23. Characteristic IG degradation of mill-annealed alloy 600 in high-temperature water containing Pb. CIEMAT autoclave test with AVT water + 0.002M PbO at 320°C. (a) TEM brightfield image of degraded grain boundary with high Pb in nanocrystalline Ni-Cr-Fe oxide. (b) Fine-probe EDS composition profile across degraded structure.

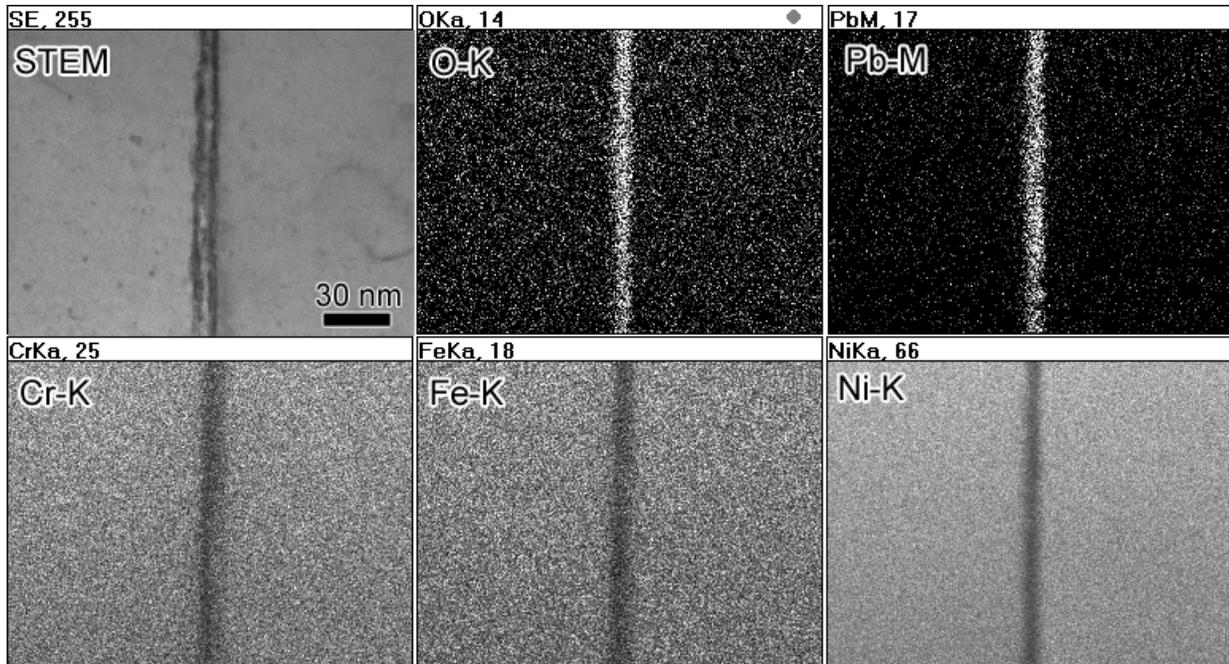
Figure 24. High-resolution EDS elemental maps showing concentrated Pb in 10-nm-wide oxidized zone along grain boundary in MA alloy 600. Autoclave test with AVT water + 0.002M PbO at 320°C.

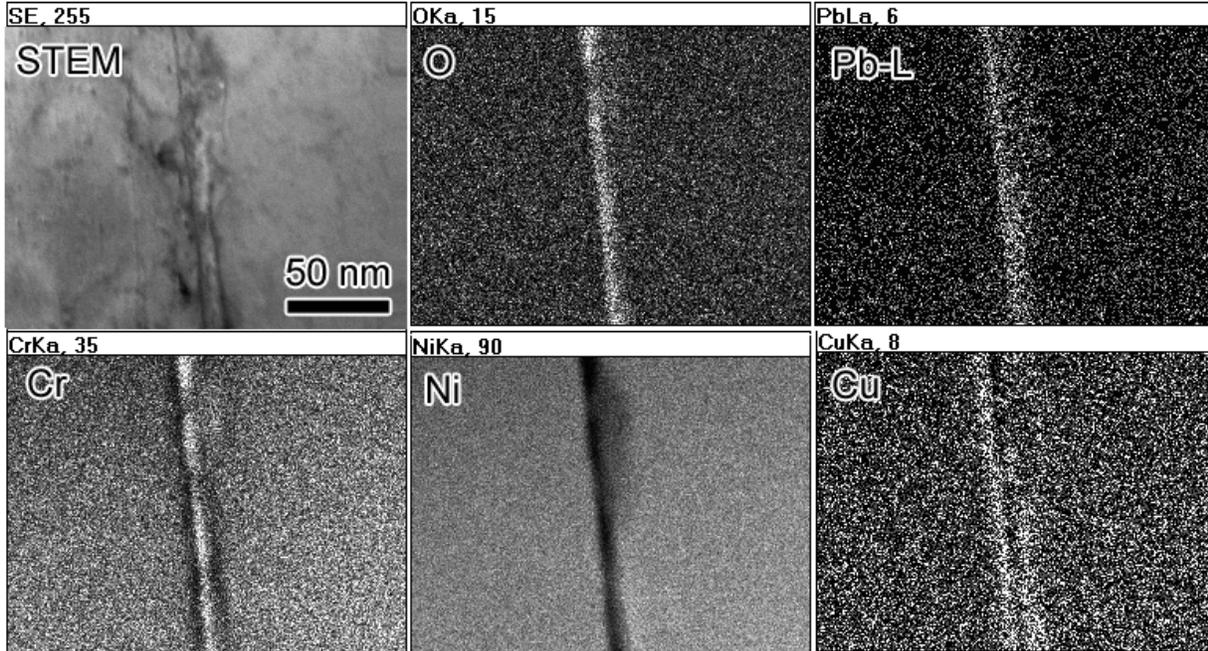
Figure 25. EDS elemental maps of attacked grain boundary in MA alloy 600 removed from PWR steam-generator service. Pb is concentrated in the crack oxide and Cu is enriched at the metal/oxide interfaces.

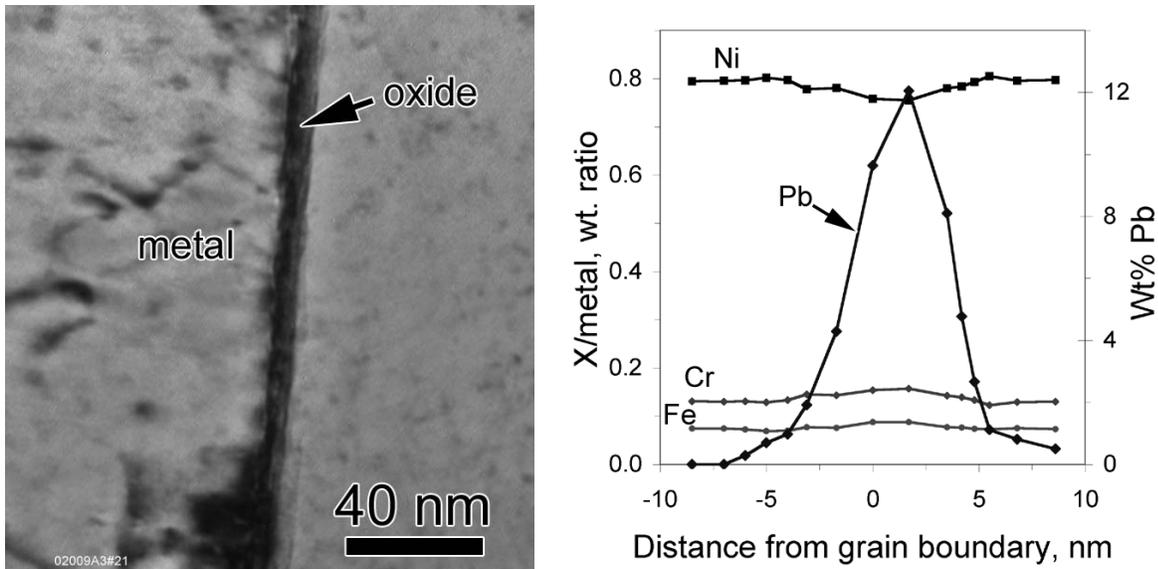
Figure 26. Pb-containing oxidized zone along grain boundary in MA alloy 600. (a) Brightfield TEM image. (b) Fine-probe composition profile across attacked and oxidized grain boundary. Width of the oxidized region corresponds to width of Pb profile.

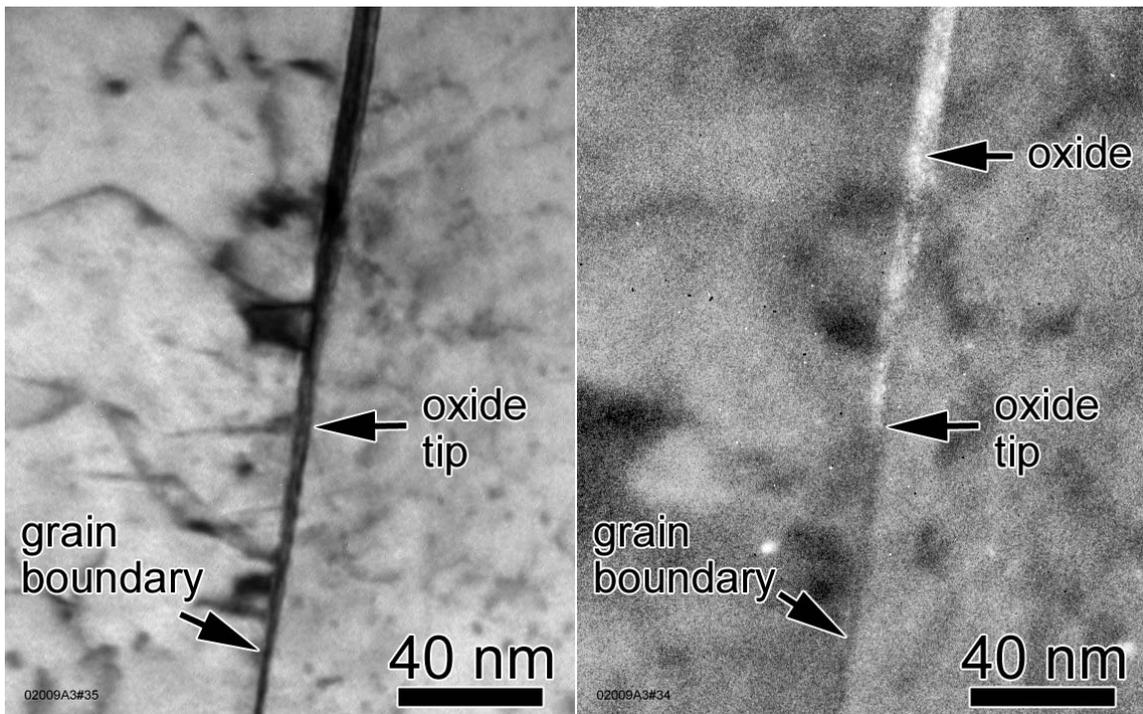
Figure 27. Tip of high-Pb oxide zone along degraded grain boundary in MA alloy 600 steam generator tubing. (a) Brightfield TEM image. (b) TEM oxide darkfield image.

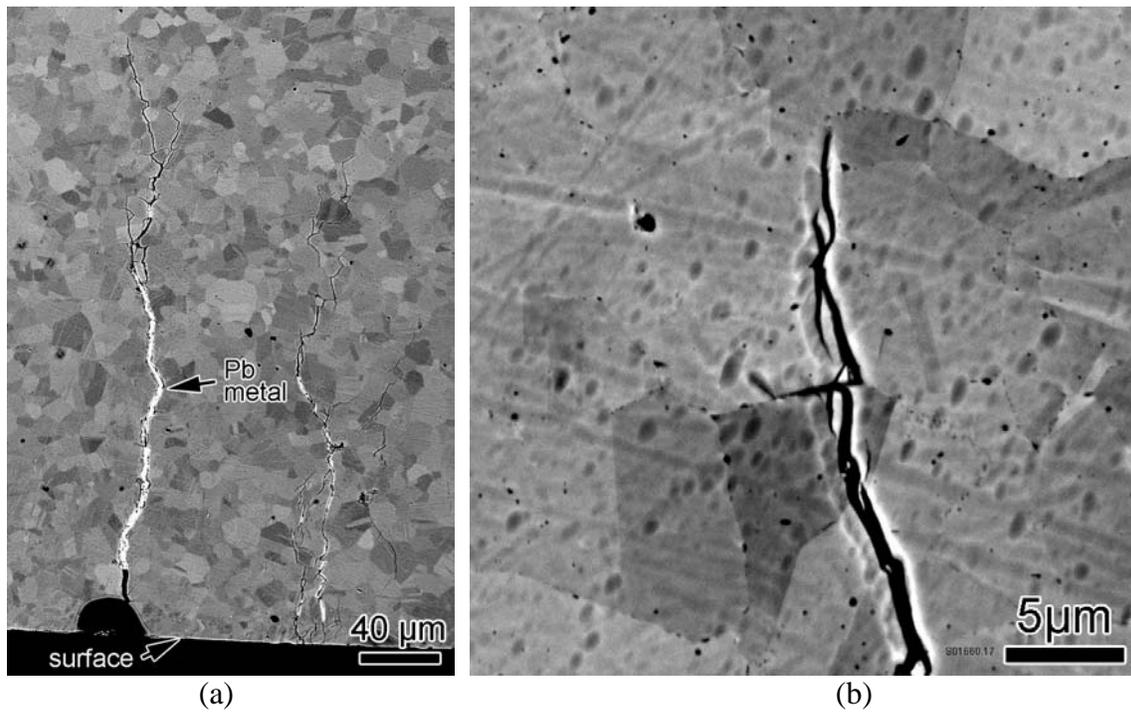
Figure 28. SEM/BSE images of mixed IG and TGSCC cracks in TT alloy 600 after tests in AVT water + 0.01M PbO at 320°C. (a) Pb metal precipitated along cracks. (b) Higher magnification view of crack-tip area.

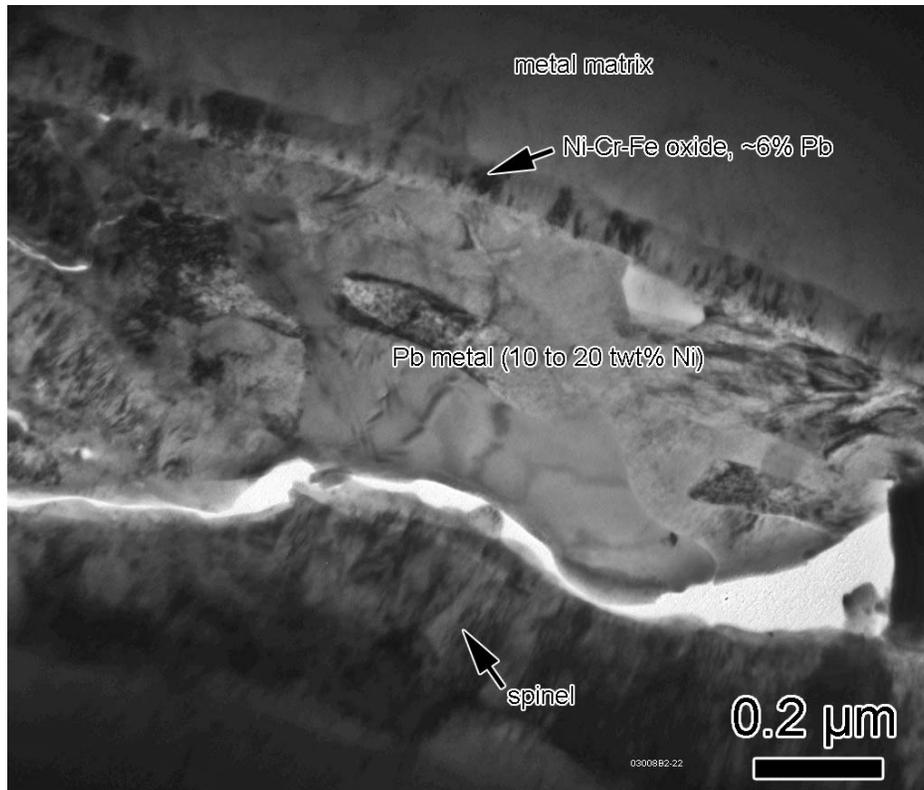
Figure 29. Metallic Pb precipitated in crack from alloy 600TT SCC test sample.
