**Pacific Northwest
National Laboratory**

Innovative Approach to Establish Root Causes for Cracking in Aggressive Reactor Environments

October 2003

Phase 1 Annual Report
Proposal Number 2SF020075 (NERI-2002-075)

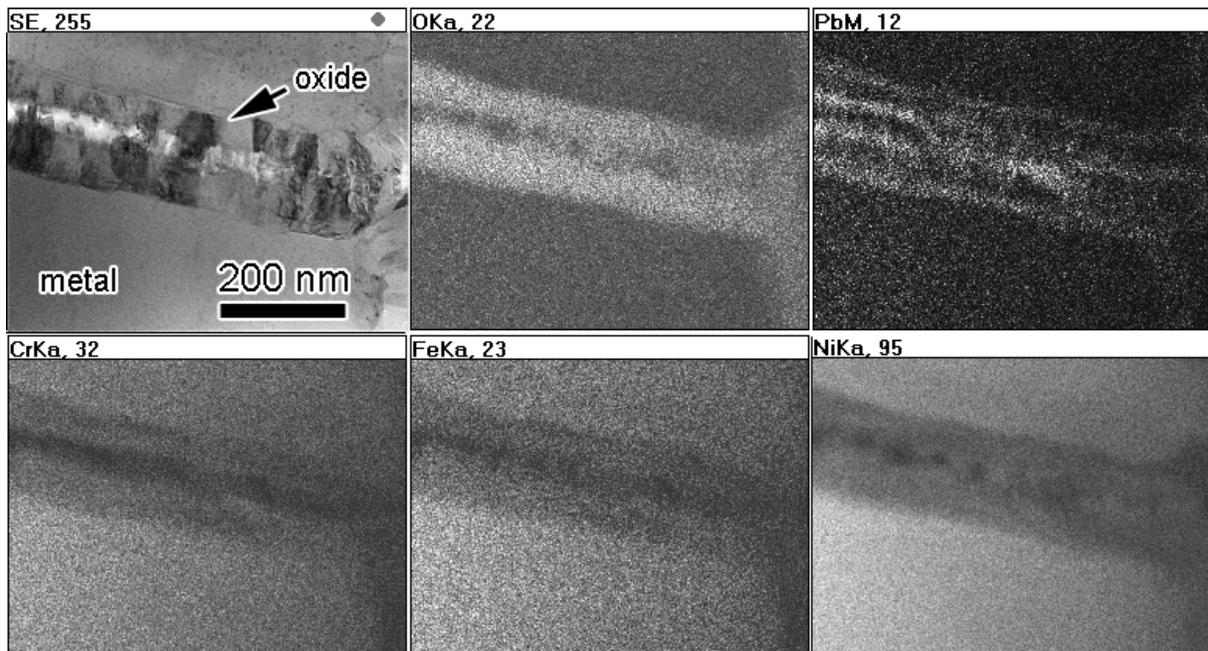
Figure 30. TEM/EDS elemental maps of cracked grain boundary in alloy 600TT after SCC test with 0.01M PbO in AVT water. EDS analyses indicated up to 6 wt% Pb in Ni-Cr-Fe oxide.

transgranular (TG) SCC. This change in cracking morphology results from the presence of a high density of grain boundary carbides and from the higher Pb concentration in solution. SEM examinations revealed that Pb had precipitated in wide parts of the cracks. This is illustrated in Figure 28. TEM examinations confirmed that the Pb seen by SEM consisted of metallic face-centered-cubic Pb-Ni alloy containing ~80 wt% Pb. The typical structure of the precipitated Pb in the SCC cracks is shown in Figure 29. No observations on service-induced SCC structures have ever revealed precipitated Pb and suggest much higher levels of this impurity in the cracks of the CIEMAT laboratory sample. The precipitated Pb does disappear as crack narrow near tips or leading edges of corrosive attack. Oxide-filled cracks and attacked grain boundaries are similar to most other Pb examples with a nanocrystalline NiCrFe oxide with very high Pb concentrations as shown in Figure 30.

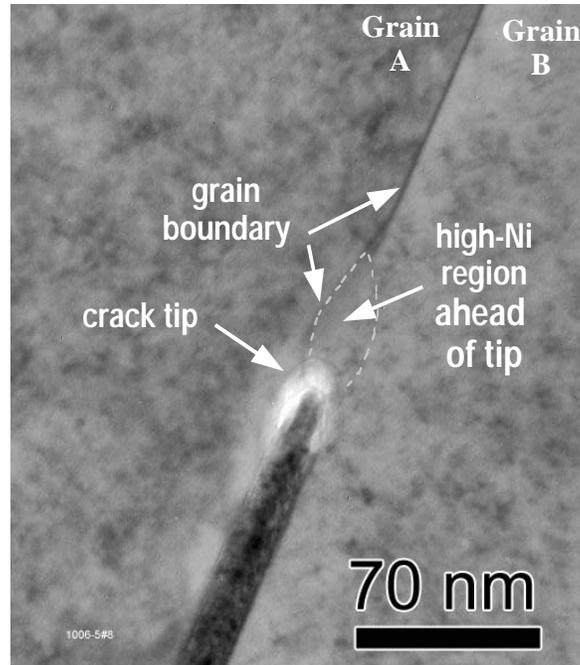
Figure 31. ATEM reveals a Cr/Fe-depleted, Ni-rich region in advance of an oxide-filled IGSCC crack tip in irradiated 304SS. [15]

The top-guide case shown in Figure 31 is expected to exhibit little Cr depletion at grain boundaries. Greater degrees of Cr depletion are predicted for lower temperatures, higher dose rates and higher doses. At the low dose rate (10^{-10} dpa/s), only 0.1 dpa can be achieved in 30 years. At this low dose, little change in grain boundary Cr concentration is predicted. At the higher dose rate (10^{-8} dpa/s), 10 dpa can be achieved and significant change in Cr grain boundary concentration is predicted. Greater segregation is predicted at lower temperatures. The large

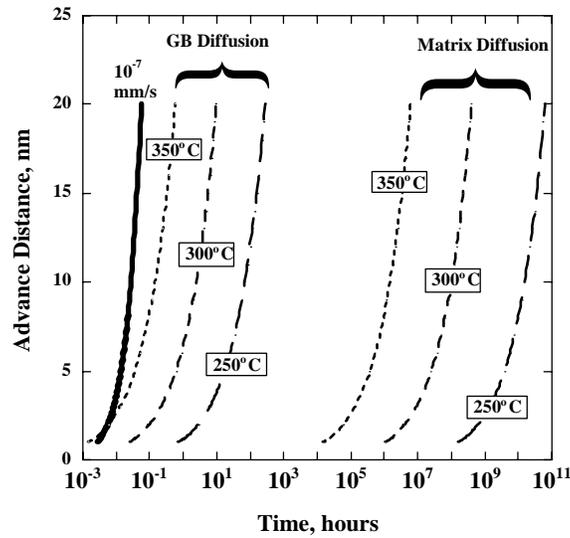
Figure 32. The rate of crack advance is compared to the times required to advance the diffusion front. Diffusion by matrix and grain boundary diffusion are shown.

Radiation Enhanced Diffusion. Calculated radiation enhanced diffusivity of Cr compared to diffusivity in the absence of irradiation is shown in Figure 33. Dose rates and temperatures relevant to LWR near-core structures are shown. A low dose rate of 10^{-10} dpa/s reflects rates experienced in components such as a top guide low dose region (0.07 dpa). A high dose rate of 10^{-8} dpa/s reflects rates experienced in near-core regions such as baffle plates and bolts. The condition of the top guide ATEM analysis is intermediate between the two rates. The effect of radiation-enhanced diffusion is greater at higher dose rates and lower temperatures. An enhancement of five orders of magnitude is predicted at 250°C and a dose rate of 10^{-8} dpa/s. In all cases, the enhancement is not large compared to enhancements that would be required to allow bulk diffusion to occur at a rate consistent with a crack advance rate as shown in Figure 32.

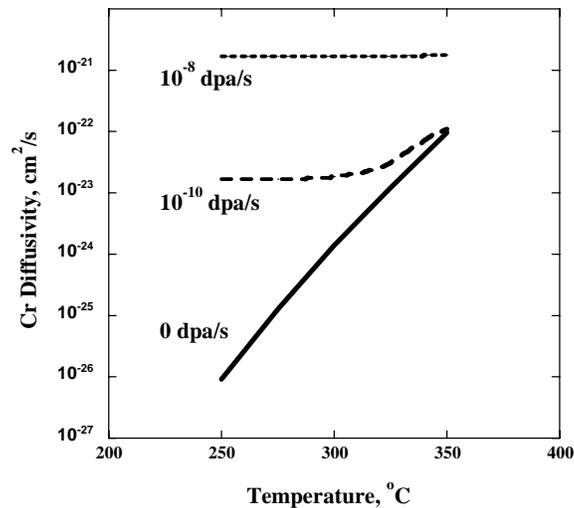
Figure 33. Radiation enhanced diffusivities are compared with thermal diffusivities (0 dpa/s). The enhancement is greater for higher damage rate and lower temperature.

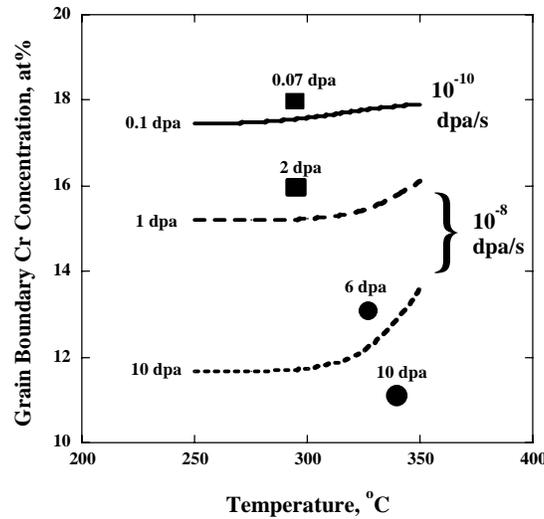
Figure 34. Radiation-induced grain boundary Cr concentration dependence on dose rate, dose and temperature. After 30 years or irradiation, 0.1 dpa is achieved at 10^{-10} dpa/s and about 10 dpa is achieved at 10^{-8} dpa/s. The dose rates corresponding to the indicated doses are 10^{-10} dpa/s at 0.07 dpa, 2×10^{-9} dpa/s at 2 dpa, 1×10^{-8} dpa/s at 6 dpa and about 2×10^{-8} dpa/s at 10 dpa.

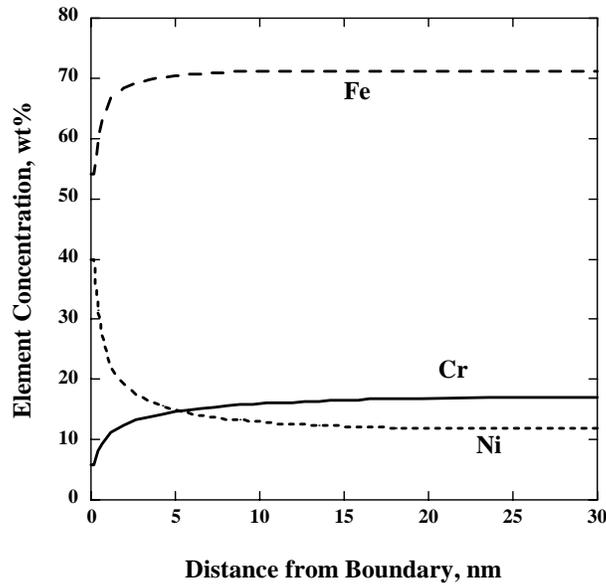
Figure 35. The effect of assuming fixed boundary concentrations is similar to measured concentrations on RIS profiles. Only minor change in the near-boundary concentrations result compared to RIS. Significant concentration gradients only develop within several nm of the boundary similar to RIS.

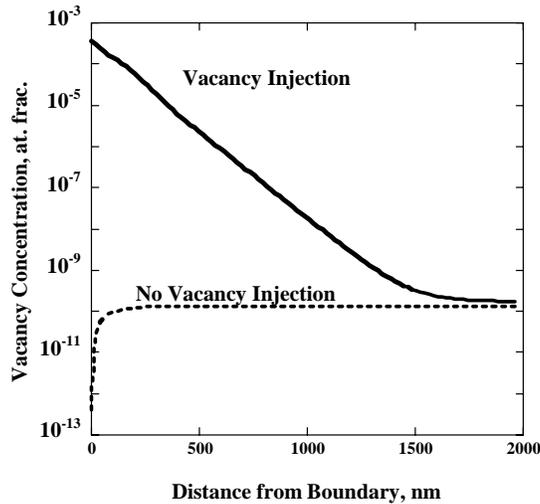
Figure 36. The effect of corrosion-induced vacancies on the vacancy concentration profile. The high vacancy concentration with injection can promote diffusion far from the boundary.

Vacancy Injection Influence The influence of corrosion-induced vacancy injection on the calculated vacancy flux is shown in Figure 36 for an intuitively high vacancy injection probability of 10%. In the absence of corrosion, the radiation-induced vacancy concentration profile induces a flux of vacancies to the boundary and vacancies are strongly depleted within about 100 nm of the boundary. Corrosion-induced vacancies reverse the net flow of vacancies to a direction away from the boundary. The near-boundary vacancy concentration is enhanced by several orders of magnitude compared to radiation alone. Furthermore, the depth of influence is large compared to the case without corrosion. In the example shown in Figure 37, the depth of enhanced vacancy concentration is about one μm . The vacancy profile has the potential of influencing the composition to significant depths in advance of the corroding surface.

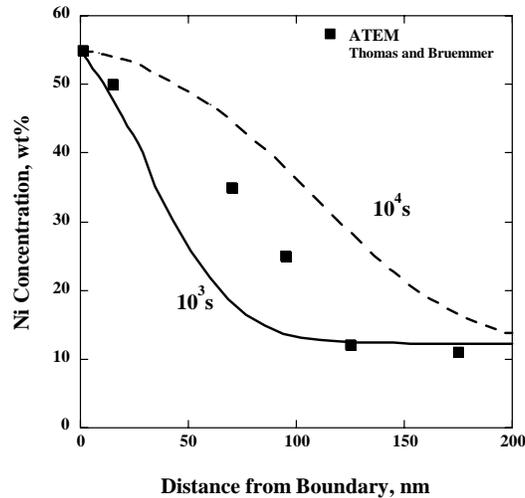
Figure 37. Solute concentration profiles affected by injected vacancies shown in Figure 36. The incremental times for corrosion are assumed to be 1,000 s or 10,000 s and the injected vacancy efficiency is assumed to be 10%.

If the crack advance times of 1,000 s and 10,000 s are assumed, the composition profile emerges as shown in Figure 37. The time of 1,000s corresponds to an advance increment of 100nm for a rate of 10^{-7} mm/s. Therefore, although vacancy injection has a potential long-range influence, the impact on composition none-the-less requires long times relative to the rate of crack advance. Note that this profile is much deeper than that shown in Figure 35 but much less than shown in Figure 36. The assumed long time and high vacancy injection efficiency (10%) suggests that corrosion occurred without significant crack advance. An arrested crack would allow these long times for deep penetration of the compositions profiles.
