**Walla Walla River Basin Fish
Screen Evaluations, 2003:
Nursery Bridge Fishway and
Garden City/Lowden II**

J. A. Vucelick
G. A. McMichael

November 2003

Prepared for the U.S. Department of Energy
Bonneville Power Administration
under Project 43868

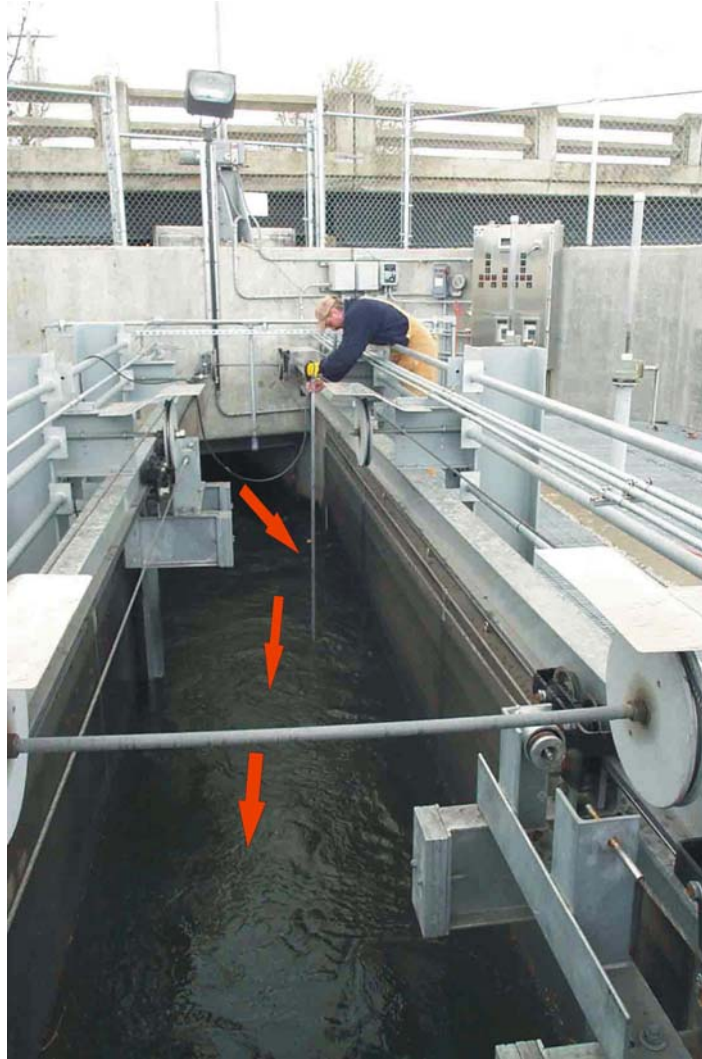
Figure 1.2. Nursery Bridge Fish Ladder Attraction Flow Screens.
The red arrows show the direction of water flow.

The evaluation of existing screen sites is important to ensure that the sites achieve the goal of protecting fish from entrainment into the irrigation systems. The screens at the Nursery Bridge Fishway were evaluated during spring 2003 to determine whether conditions at these sites were conducive to safe fish passage and whether the site was operating within criteria developed by the NOAA Fisheries. Rock weirs downstream of the dam were evaluated in summer 2003 to determine whether they might impede upstream migration of juvenile salmonids during low-flow conditions. The Nursery Bridge Fish Ladder is located on the east bank (river right) of the Walla Walla River near the town of Milton-Freewater (Figure 1.1). The fish-screen facility is located at the upstream end of the ladder and is used to draw water from upstream to increase attraction flow at the ladder entrances. This facility consists of two vertical-bar screens facing each other with a channel in between (Figure 1.2).

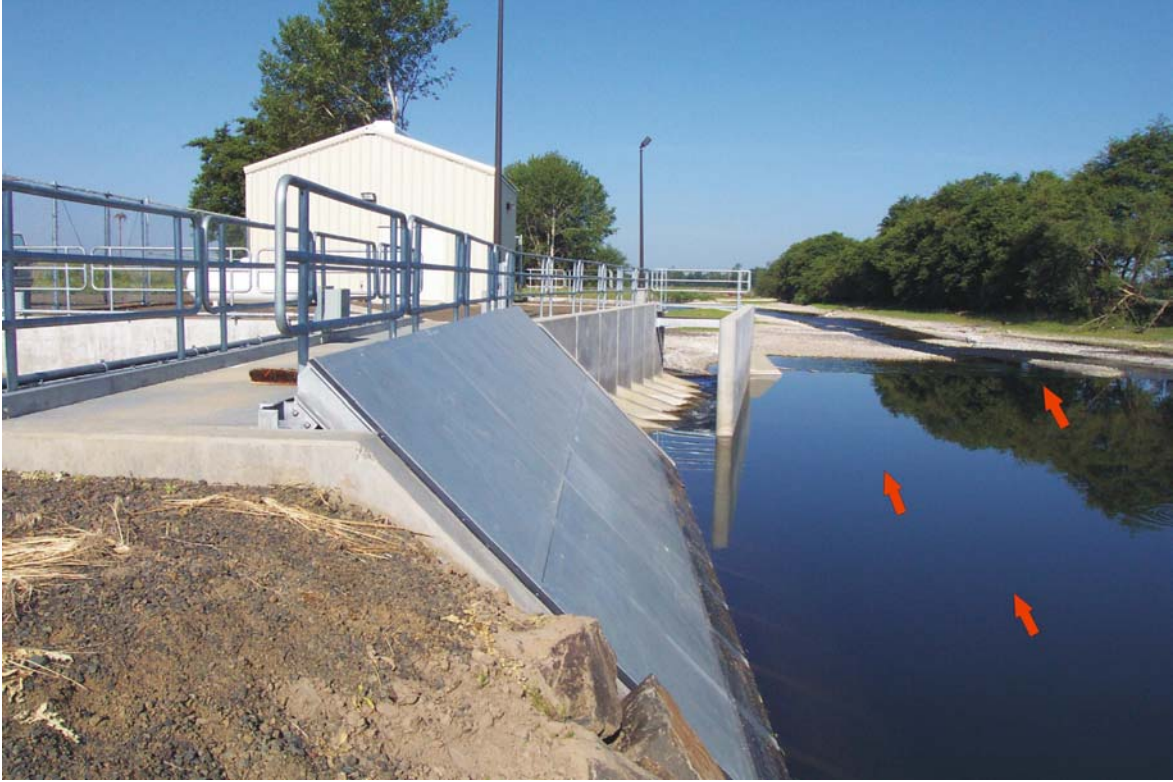
Figure 1.3. Garden City/Lowden II Fish Screens. The red arrows show the direction of water flow.

The Garden City/Lowden II site is located about 3.2 km (2 mi) east of the town of Lowden off Highway 12 (Figure 1.1). The site is an inclined plate screen with eight 1.8-m (6-ft) high \times 1.2-m (4-ft) wide screen panels (Figure 1.3). The site was evaluated in June 2003 to establish a baseline of operations and also to determine whether any changes in the baffle settings were needed, based on velocity measurements, to put the site within the NMFS criteria.

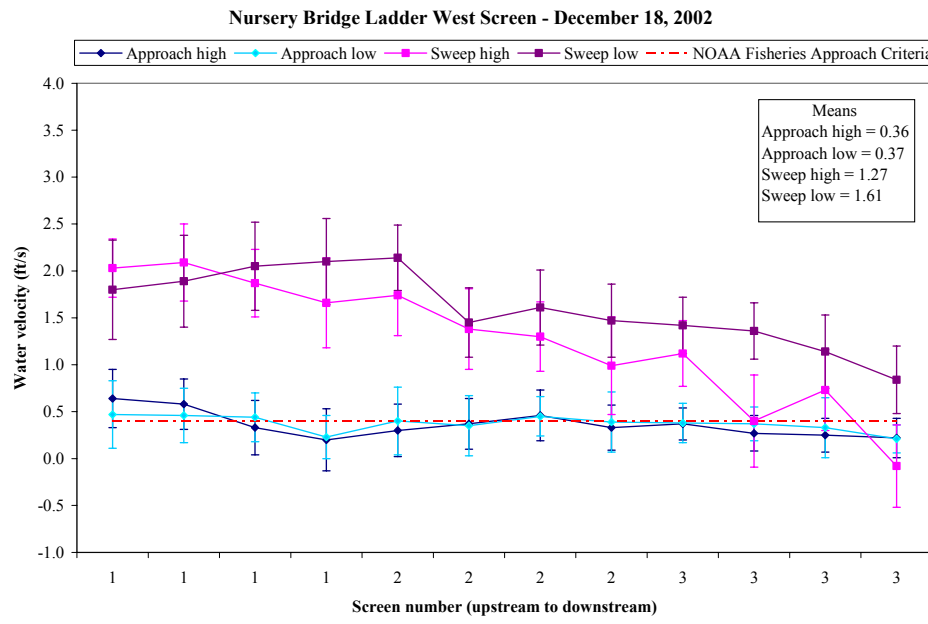
Figure 3.2. Approach and Sweep-Velocity Measurements at the Nursery Bridge Ladder West Screen on December 18, 2002. The dashed line at 0.4 ft/s represents the NOAA Fisheries criteria for approach velocities. The error bars (\pm the standard deviation) represent turbulence at each point. The text box shows the mean across all screens for the measured parameter.

The Nursery Bridge site was evaluated December 18, 2002, January 7, 2003, and March 27, 2003. Figures 3.1 through 3.4 show the results of the velocity measurements from December and January. For the west screen on December 18, 29% of the measured approach velocities exceeded the NOAA Fisheries criteria of 12.2 cm/s (0.4 ft/s), while on the east screen, none of the measured approach velocities exceeded 12.2 cm/s on the same day. On January 7, 8% of the approach velocities measured on the west screen exceeded the NOAA Fisheries criteria, while only 4% of the measured approach velocities on the east screen exceeded the criteria on the same day. The flow in the Walla Walla River was 7.99 cubic meters per second (m^3/s) (282 cubic feet per second [cfs]) on December 18, 2002, and 17.50 m^3/s (618 cfs) on January 7, 2003, as recorded by the U.S. Geological Survey gage near Touchet (approximately 30 km [19 mi] downstream from the Nursery Bridge fishway) (Figure 3.5). For the purpose of PNNL's evaluations, a site is considered to be in compliance with the NOAA Fisheries criteria if less than 10 percent of the measured approach velocities exceed 12.2 cm/s (0.4 ft/s). Thus, the conditions at the site on December 18, 2002, would be considered to exceed the criteria and require action to reduce the approach velocities, while the conditions at the site on January 7, 2003, would be considered to meet criteria and require no action.

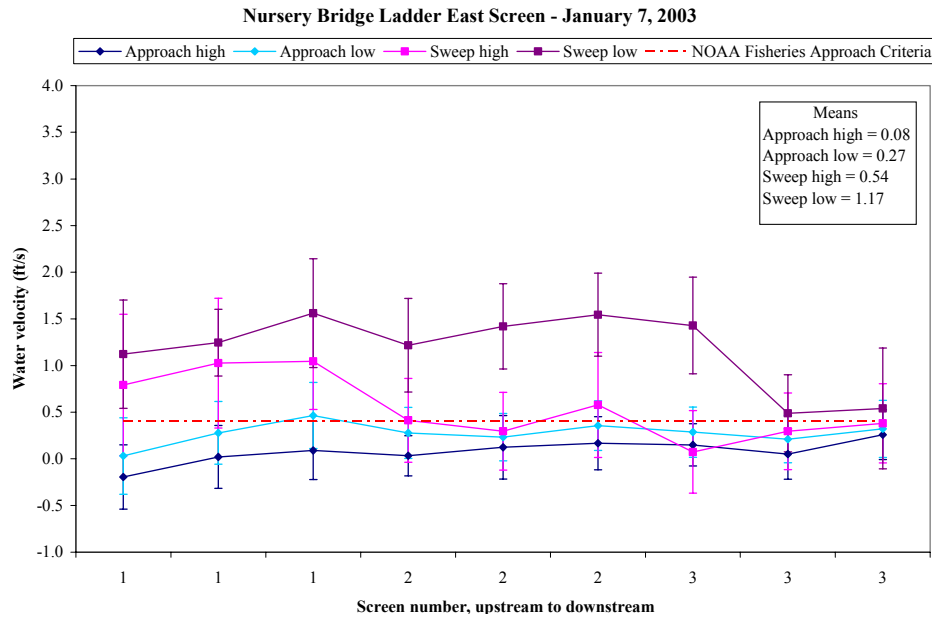
Figure 3.3. Approach and Sweep-Velocity Measurements at the Nursery Bridge Ladder East Screen on January 7, 2003. The dashed line at 0.4 ft/s represents the NOAA Fisheries criteria for approach velocities. The error bars (\pm the standard deviation) represent turbulence at each point. The text box shows the mean across all screens for the measured parameter.

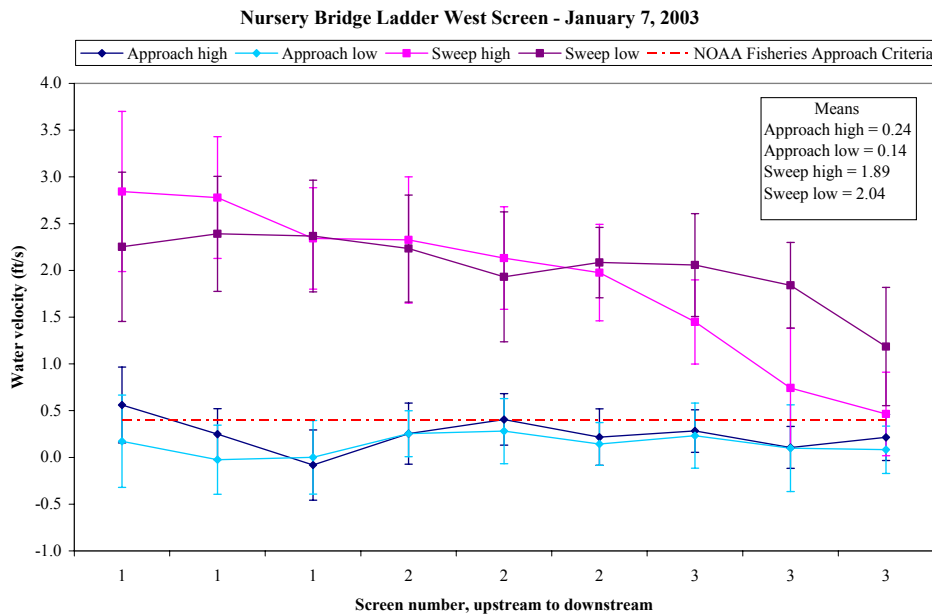
Figure 3.4. Approach and Sweep-Velocity Measurements at the Nursery Bridge Ladder West Screen on January 7, 2003. The dashed line at 0.4 ft/s represents the NOAA Fisheries criteria for approach velocities. The error bars (\pm the standard deviation) represent turbulence at each point. The text box shows the mean across all screens for the measured parameter.

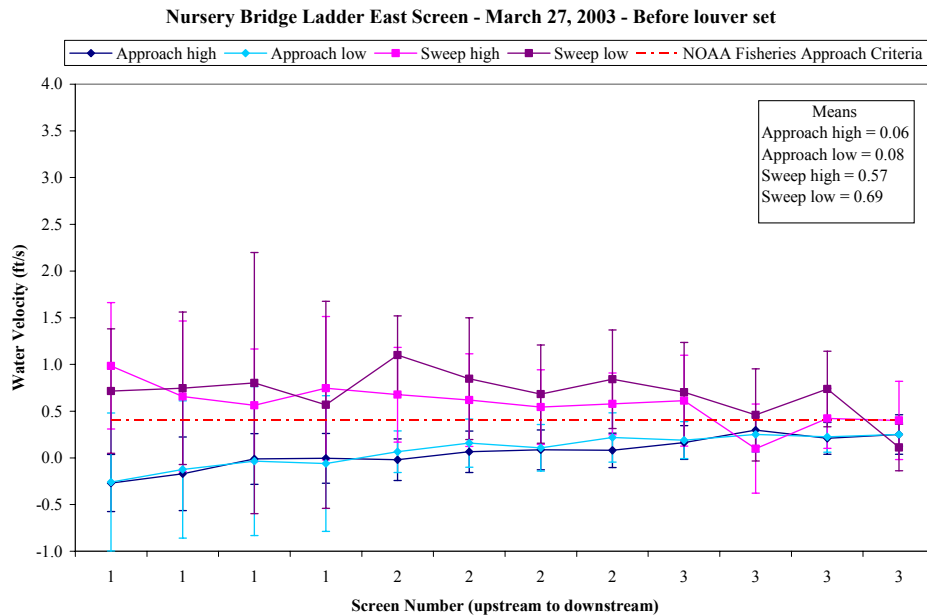
On March 27, 2003, PNNL researchers set out to evaluate the velocity conditions at the Nursery Bridge Fishway screens and, if needed, adjust the metal louvers that help to control flow from the back side of the screen. An entire set of velocity measurements at 0.2 and 0.8 of depth, in front of both sets of screens (east and west) was taken before the louvers were moved. A cursory examination of the March 7 data showed approach velocities exceeding the NOAA Fisheries criteria of 12.2 cm/s (0.4 ft/s) on the west screen at every measured location with the exception of points 3 and 4 on screen 1 (Figures 3.6 and 3.7).

Figure 3.6. Initial Approach and Sweep-Velocity Measurements at the Nursery Bridge Ladder East Screen on March 27, 2003. The dashed line at 0.4 ft/s represents the NOAA Fisheries criteria for approach velocities. The error bars (\pm the standard deviation) represent turbulence at each point. The text box shows the mean across all screens for the measured parameter.

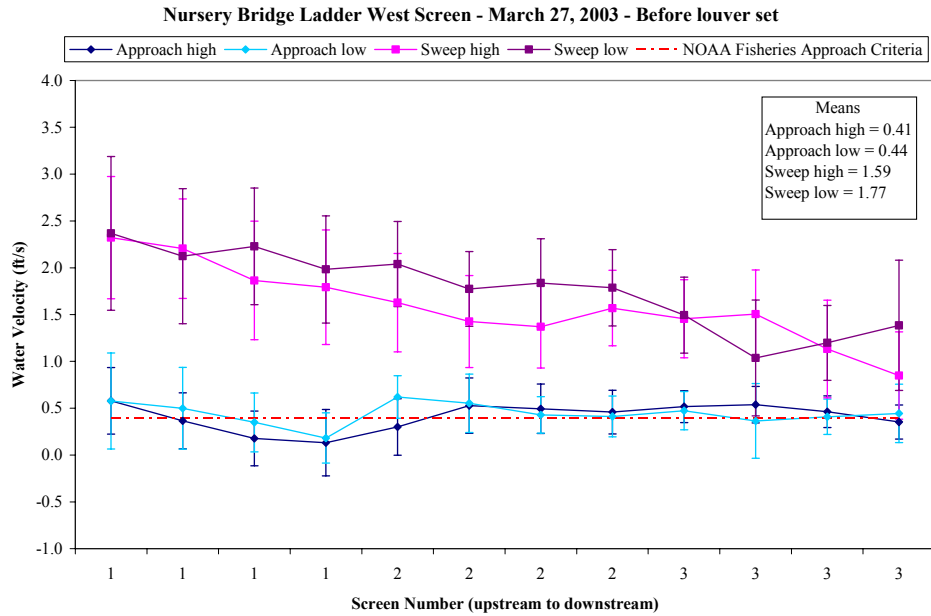
Figure 3.7. Initial Approach and Sweep-Velocity Measurements at the Nursery Bridge Ladder West Screen. The dashed line at 0.4 ft/s represents the NOAA Fisheries criteria for approach velocities. The error bars (\pm the standard deviation) represent turbulence at each point. The text box shows the mean across all screens for the measured parameter.

Based on a review of the data, researchers decided to completely close down the louvers on the two most upstream screens on the west-side screen. They also opened up the louvers to approximately 45 degrees on the most downstream screen on the east side in an attempt to draw more water further downstream into the site and towards the east-side screen.

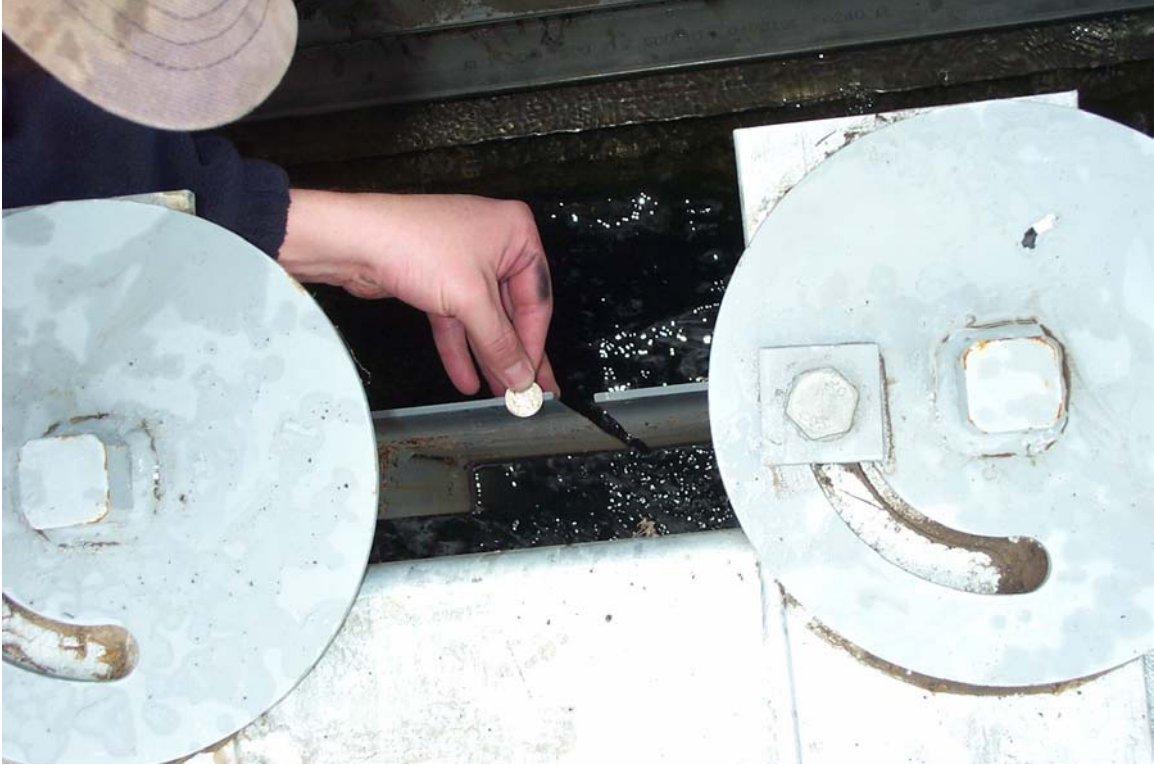
Changing the louver settings behind the screens did not change the flow patterns as much as researchers had expected, nor was it sufficient to put the site in compliance with NOAA Fisheries criteria for approach velocity, especially in front of the west screen. Two factors contribute to these problems. The first is the site design. The water enters the site at an angle toward the west screen, in essence hitting the west screen with much more force (and higher velocities) than it would if the majority of the flow were parallel to the screen face. The second problem is the louver design. Generally, louvers are designed so that when completely closed, almost no water passes through them. The edge of one meets or overlaps the edge of the next. The louvers at the Nursery Bridge Fishway do not overlap; they do not even meet. There is a gap approximately 2.2 cm (0.875 in.) wide (Figure 3.10) between the louvers when they are

completely in the “closed” position. This gap allows water to flow through the screens even when the louvers are completely closed. Therefore, the approach velocity problems at this site cannot be fixed merely by closing the louvers.

Figure 3.10. The Louvers at Nursery Bridge Fishway Attraction Water-System Screens Had a Gap the Size of a Nickle (Approximately 2.2 cm [0.875 in.]) Between Them when Fully Closed. This is a view from the top looking down at the water surface, with a quarter placed next to the gap in the louvers.

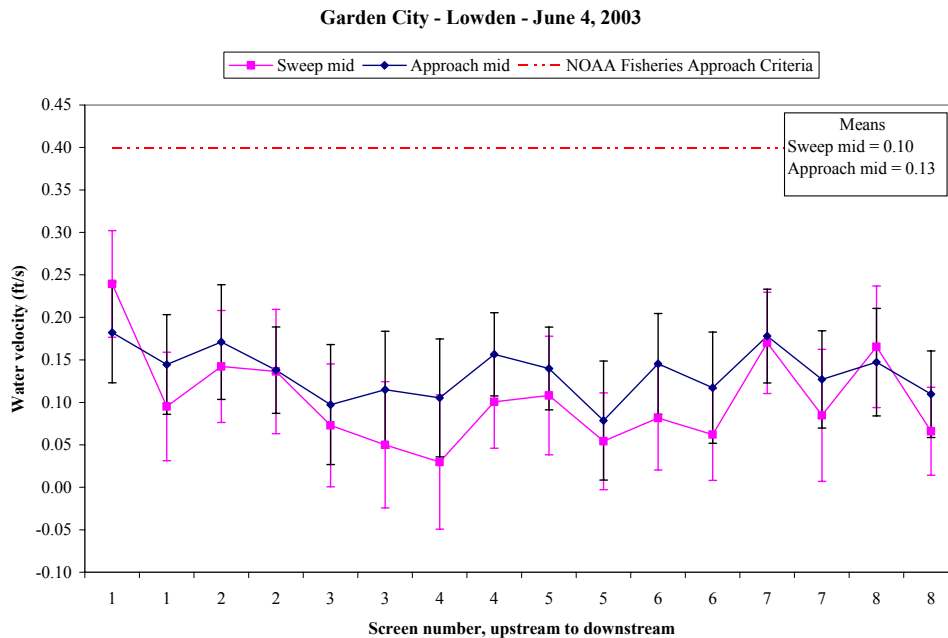
Approach velocities were well within the NOAA Fisheries approach criteria. Sweep velocities were generally lower than approach velocities (Figure 3.14). The water velocity did not increase from upstream to downstream within the site, and velocities tended to be somewhat variable from point to point. The ratio of sweep to approach was 0.77. Further testing is needed to determine whether the site would meet the NOAA Fisheries criteria when it is running closer to its capacity limit.

Figure 3.14. Approach and Sweep Velocities at Garden City/Lowden II Fish Screens June 4, 2003. The dashed line at 0.4 ft/s represents the NOAA Fisheries criteria for approach velocities. The error bars (\pm the standard deviation) represent turbulence at each point. The text box shows the mean across all screens for the measured parameter.

Based on the low approach velocities, it was determined that the louver settings did not need to be adjusted.
