# **An Assessment of Visual Testing**

**Pacific Northwest National Laboratory**

**U.S. Nuclear Regulatory Commission  
Office of Nuclear Regulatory Research  
Washington, DC 20555-0001**

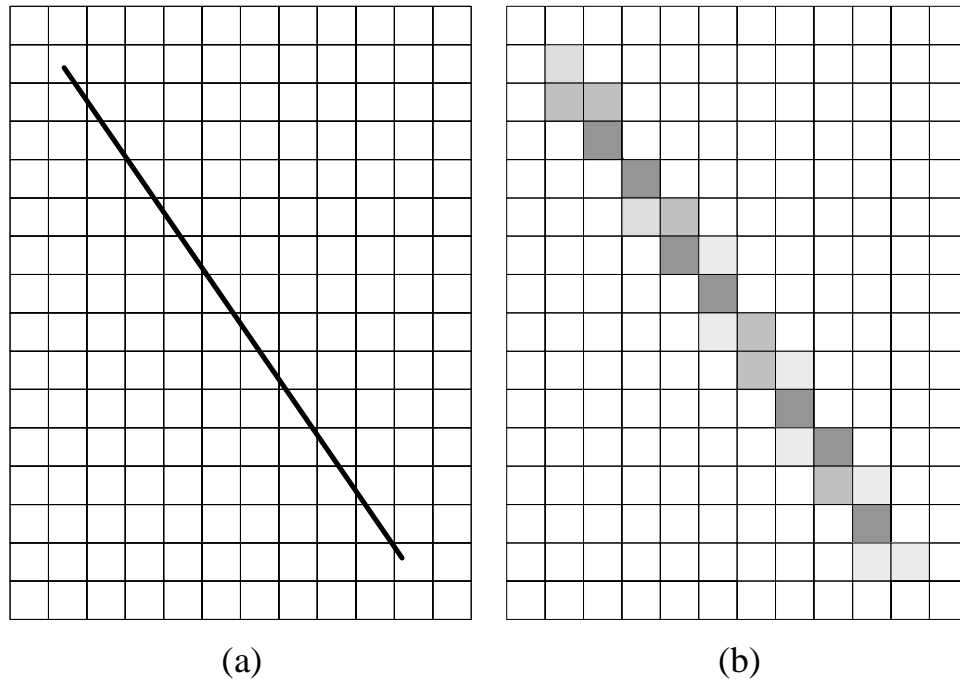
**Figure 2.1** Pixelation of line (a) into lower-contrast image (b).

The maximum possible visual acuity of a video or digital system can be described by comparing the native resolution of the system to the size of the area on which the system is focused. This measure of visual acuity assumes perfect optics and a perfect electronic capture of the image. Using this method, a 1 megapixel (1200 x 800 pixels) camera that can focus on an area 75 mm x 50 mm (3 in. x 2 in.) would have a pixel size of 0.0625 mm/pixel. Any indications that fall below this size would be pixelated and recorded as a lower-contrast shadow in the larger pixel, as the contrast from the indication is averaged with the background in the pixel. The color and shading of the pixel is dependent on the contrast between the indication and the background and on the MTF of the camera. An example of a linear indication in which the width of the line is significantly less than the pixel size is shown in Figure 2.1.

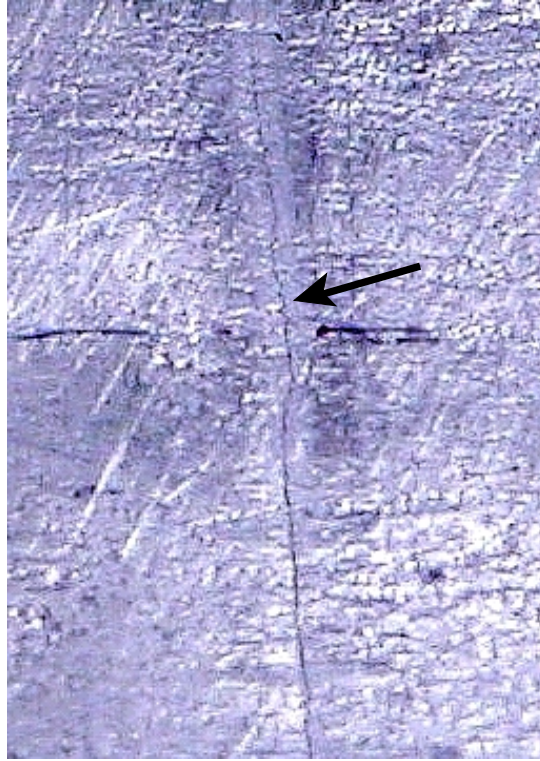
**Figure 3.1** 25- $\mu\text{m}$  (0.001-in.) COD Mechanical Fatigue Crack in Stainless Steel

Mechanical fatigue cracks are formed when a material is subjected to repeated stress cycles. Cracks formed in this way are relatively straight and typically do not branch significantly, if at all. The COD is highly dependent on the stresses in the material. The crack is widest during the phase when the tensile stresses perpendicular to the crack face are at their highest. When the stresses that form the crack are not present, the COD shrinks considerably and may close almost entirely. Often there is not much corrosion inside the crack. A typical mechanical fatigue crack is shown in Figure 3.1.

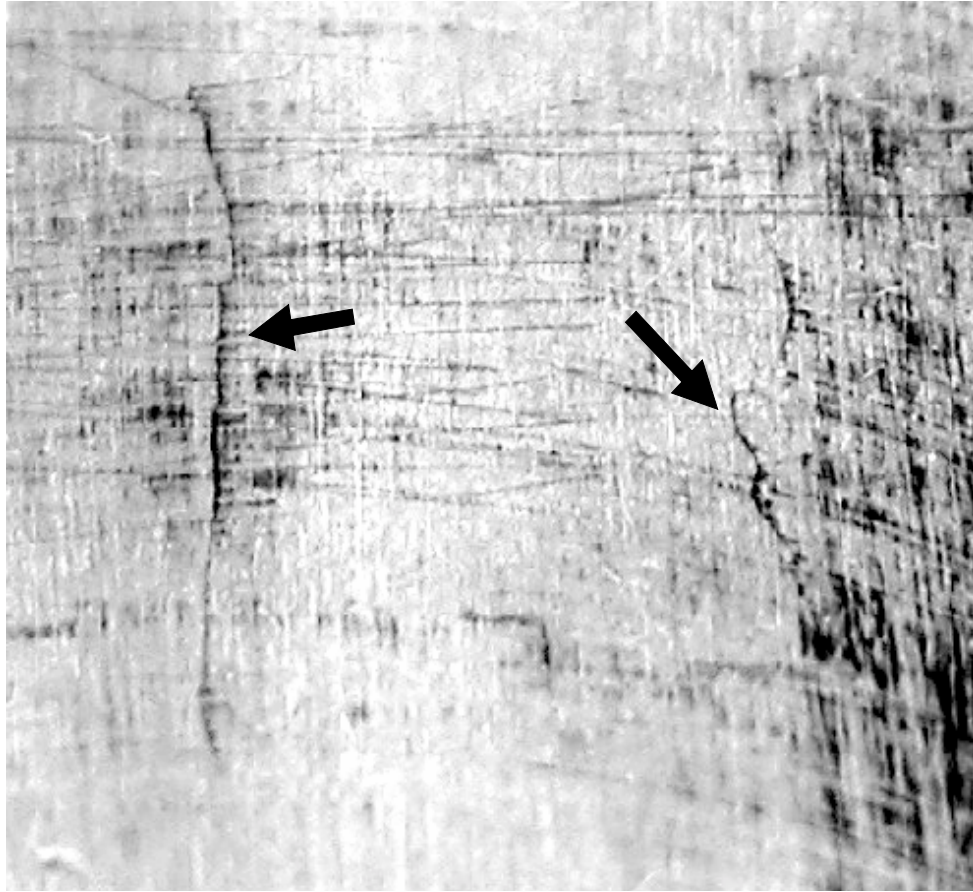
**Figure 3.2** Two 15- $\mu\text{m}$  (0.0005-in.) COD Thermal Fatigue Cracks on Machined Stainless Steel Surface. There is discoloration and chipping at the crack opening, increasing the visibility of the cracks. (Image converted to black and white and contrast-enhanced).

Thermal fatigue cracks can be manifested in regions of components with stratified hot and cold water levels that change with time. Thermal fatigue cracks will typically form in patterns. In a material without any predominant directional stresses, thermal fatigue cracks often form in a fabric-like or cobblestone pattern in the affected material. If the material in question is under a tensile stress, then multiple small thermal fatigue cracks often form with the cracks perpendicular to the direction of the stress. There may or may not be oxidation inside the crack, and thermal fatigue cracks can have a very small COD. The COD of a thermal fatigue crack is strongly dependent on the stresses perpendicular to the crack opening. A pair of thermal fatigue cracks that formed near one another is shown in Figure 3.2. Note the variation in linearity and the background noise due to machining operations.

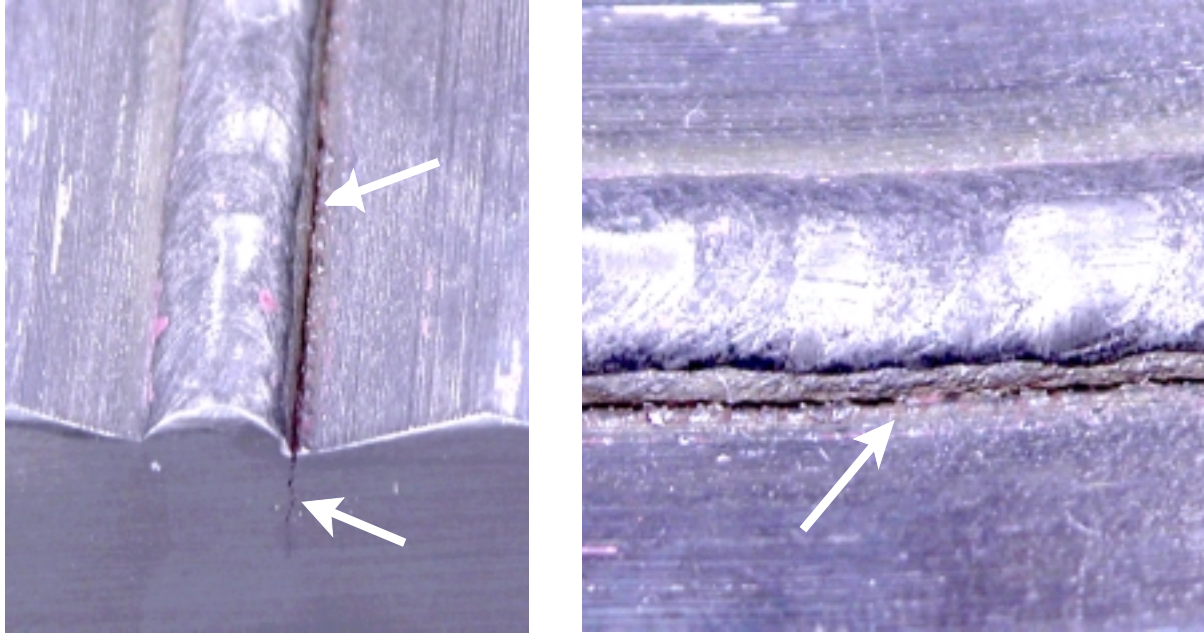
**Figure 3.3** Two Views of 125- $\mu\text{m}$  (0.005-in.) COD Stress Corrosion Crack along Weld in Stainless Steel.

Stress corrosion cracking (SCC) is caused by a combination of stress, a sensitized material, and a corrosive environment. In stainless steel, these cracks usually form along heat-affected zones near welds, as the welding process causes the heat-affected zone to become sensitized. These cracks vary in appearance, ranging from a single crack to a series of cracks lying together in a slightly feathered pattern but nearly always following the sensitized zone. Welds also have internal residual stresses created in the welding process, which provide the stress needed to propagate a SCC. Older SCCs may have some oxidation on their inside surfaces causing grains of material to dislodge from the crack face, widening the SCC. However many SCCs have a very small COD. An SCC following the heat-affected zone in a weld is shown in Figure 3.3. Note the liquid penetrant residue from a previous surface examination to enhance crack detection.

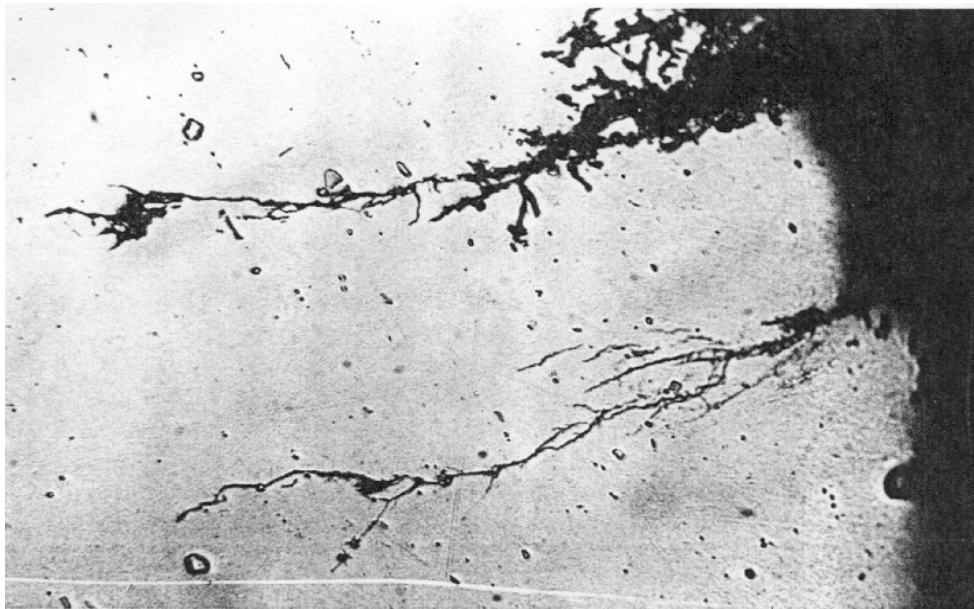
**Figure 3.4** Two Stress Corrosion Cracks in Locking Bolt (100X magnification) (Morrin et al. 1978)

The factors influencing the CODs for stress corrosion cracks are more complex than for fatigue cracks. Stress corrosion cracks form because of an interaction between a sensitized material, a corrosive environment, and stress in the material. When SCC occurs, the opening size may depend on the susceptibility of the material and the residual stresses around the crack. A stress corrosion crack can have a very small COD if one grain boundary is affected in a lightly susceptible material or a very large COD in a very susceptible material when several surface grains are dislodged from the crack (Garcia et al. 2001). A highly sensitized material can form many SCCs in the same area, which may then link up and form a crack with a large COD. A less sensitized region will have fewer and tighter SCCs. There is no reliable way to gage the depth of an SCC based on its COD. Examples of SCCs with small and large CODs are shown in Figure 3.4. It is worth noting that both cracks have penetrated to essentially the same depth.

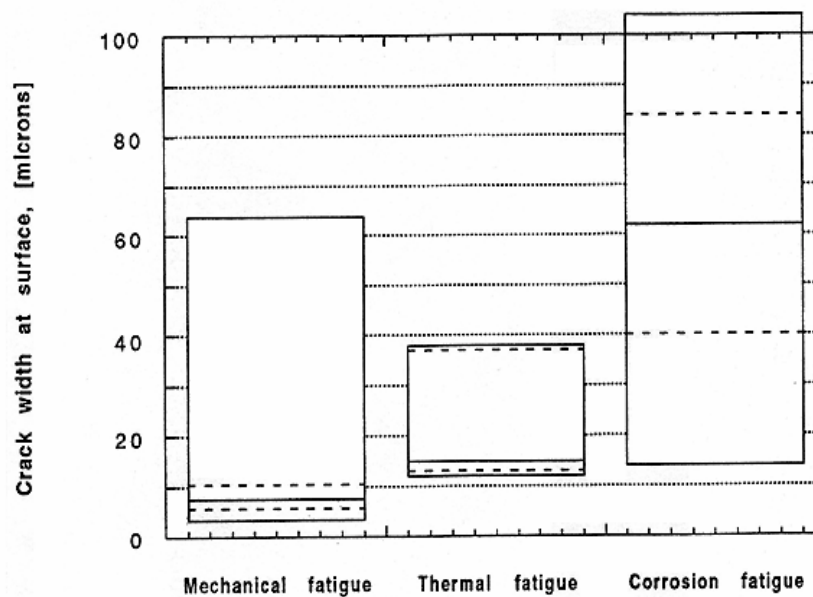
**Figure 3.5** Crack Opening Dimension Distribution for Fatigue Cracks (Ekström and Wåle 1995)

Figures 3.5 and 3.6 contain charts that show a compilation of work done by several groups who have characterized the CODs of fatigue cracks and SCCs. The middle line in each bar represents the median crack size, and the upper and lower dashed lines represent the sizes of the 75% and 25% limits. Figures 3.7 and 3.8 show the distributions of CODs to crack through-wall depth.

Figures 3.5 and 3.6 show that cracks in reactor components have a wide distribution of CODs with a significant number of cracks having a COD below  $12\text{ }\mu\text{m}$  (0.0005 in.). Figures 3.7 and 3.8 further reinforce the premise that there is a weak relationship between the COD of a crack and its through-wall penetration.

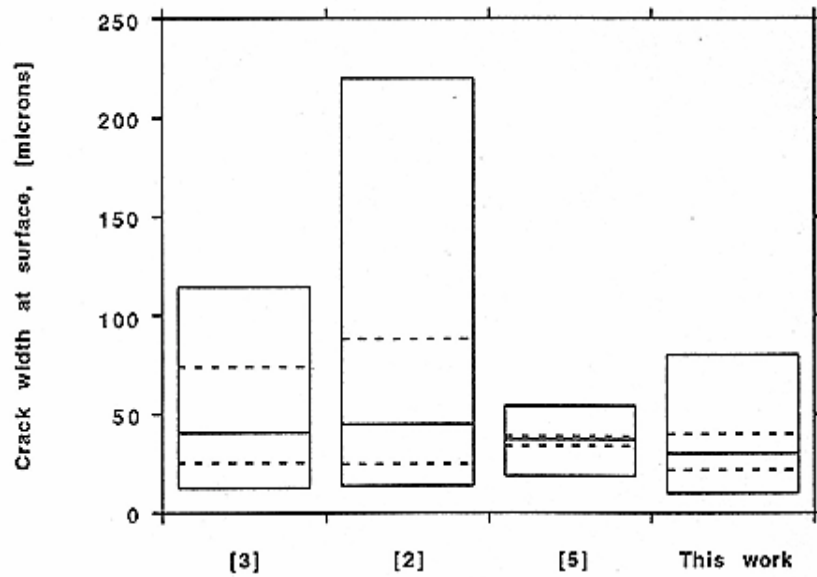
**Figure 3.6** Crack Opening Dimension Distribution for Stress Corrosion Cracks. Study 3 was conducted by MacDonald, 2 by Lapides, 5 by Stenefjall, and “This work” refers to the work of Ekström and Wåle (1995).

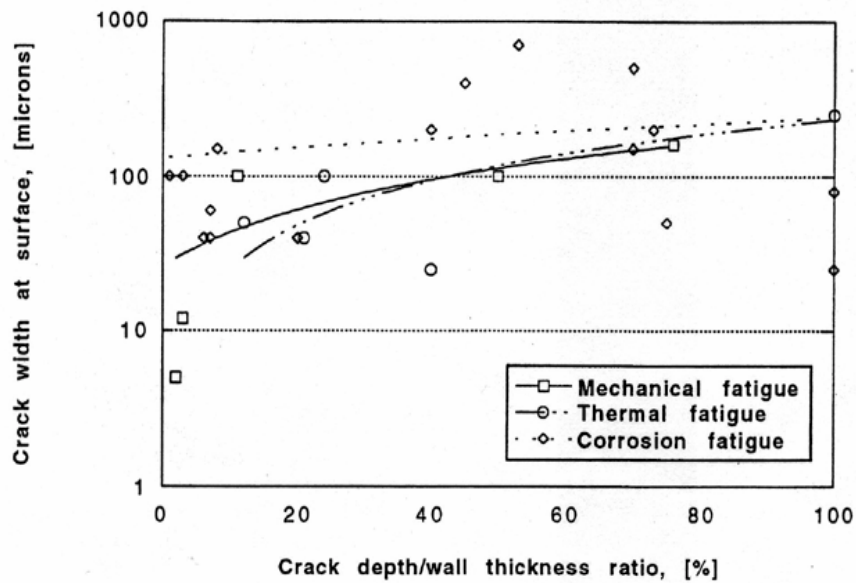
**Figure 3.7** Crack Opening Dimension Versus Crack Depth for Fatigue Cracks in Ferritic Steel (Ekström and Wåle 1995)

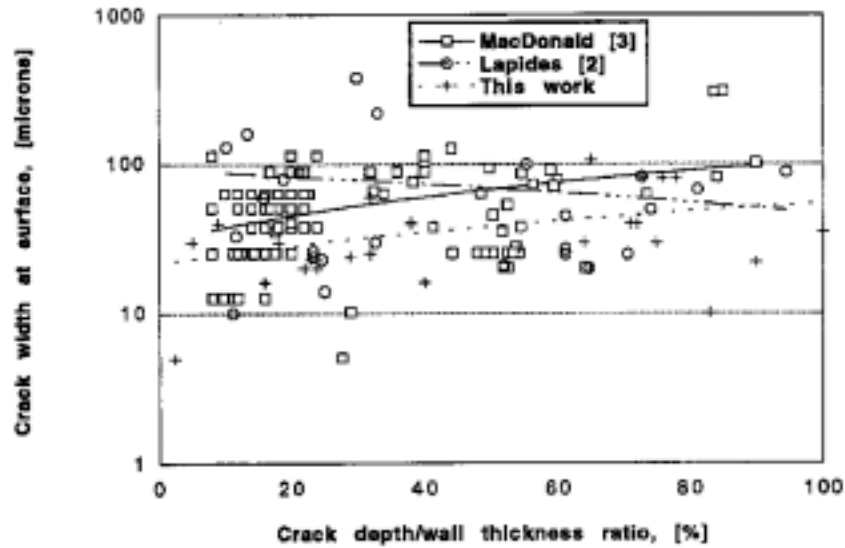
**Figure 3.8** Crack Opening Dimension Versus Crack Depth for IGSCCs in Austenitic Stainless Steel (Ekström and Wåle 1995)

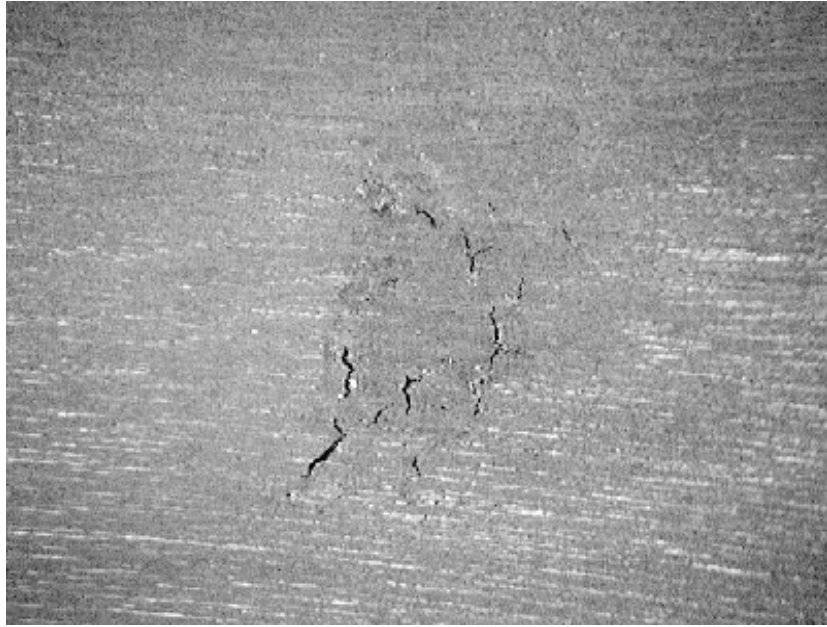
**Figure 4.1** Cracking in Reactor Pressure Vessel Cladding as Imaged by a DIAKONT Closed Circuit Video System (Vasiliev et al. 1999)

The results of a remote visual examination on the interior of the Russian Kalininskaja VVER reactor pressure vessel using a DIAKONT reactor TV inspection system are shown in Figure 4.1 (Vasilev V. G. et al 1999). The cracks are in the cladding of the pressure vessel and have CODs of between 50 to 200  $\mu\text{m}$  (0.002 to 0.008 in).

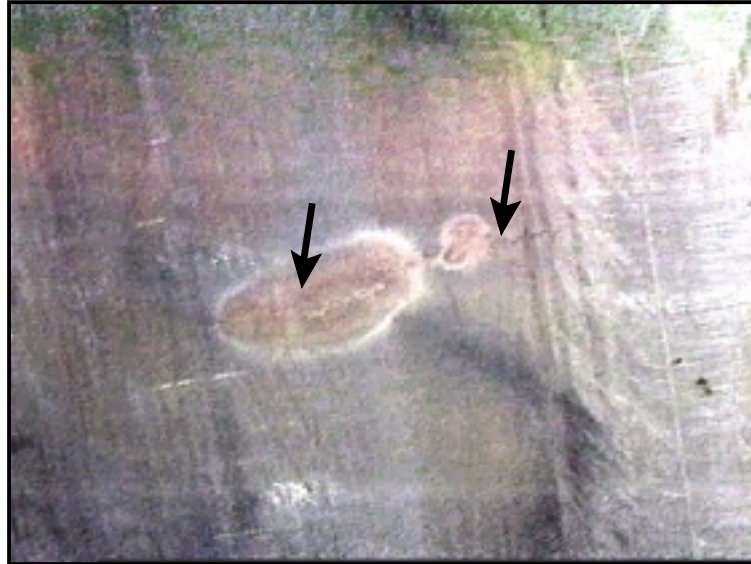
**Figure 4.2** Axial PWSCC Crack in V.C. Summer Nuclear Station Pressure Vessel Nozzle to Pipe Weld. The COD of the crack is not known.

One crack imaged using VT was a through-wall axial crack in the piping of V.C. Summer Nuclear Station. The crack was detected by indirect means; specifically, boric acid deposited from primary coolant leaking through the pipe was the first indication of a crack. The pipe was visually examined twice. The first examination used a video camera on the end of a long pole; the second used a robotic scanner. The first VT test missed the crack, while the second, performed by WesDyne, successfully detected the crack. The contrast and size of the crack image was enhanced as there was corrosion of the ferritic steel of the pressure vessel nozzle forging which bled back through the crack, lining it with reddish corrosion products. The crack is shown in Figure 4.2.

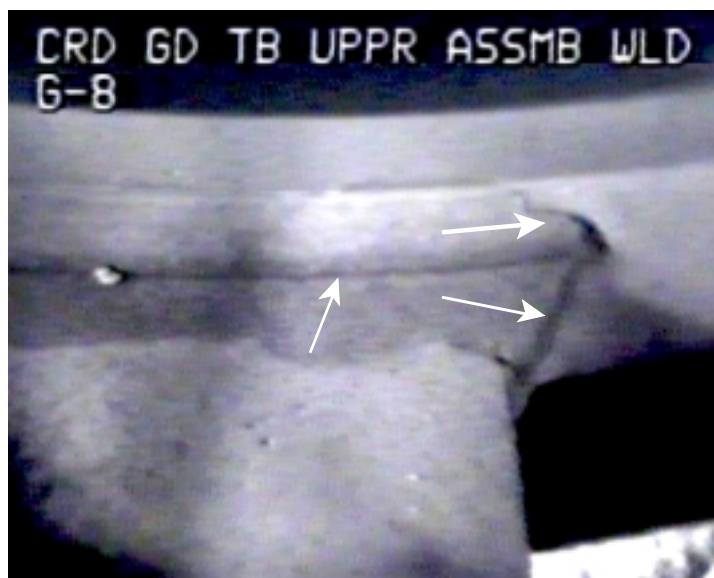
**Figure 4.3** Crud lines on the surface of the piece strongly resemble cracks and can hide real indications.

An examination of the videotaped images shows that the level and method of cleaning of the component can strongly influence the results. While it has been previously noted that any extraneous material on the surface of a component being examined with VT may mask a relevant feature on the surface, improper cleaning can result in crud lines (streaks of dirt left over from cleaning) and rub marks that can also look like cracks. The part or region to be examined needs to be cleaned of all dirt and crud while not leaving the remnants of the cleaning process. An example of a component with observable crud lines is shown in Figure 4.3.

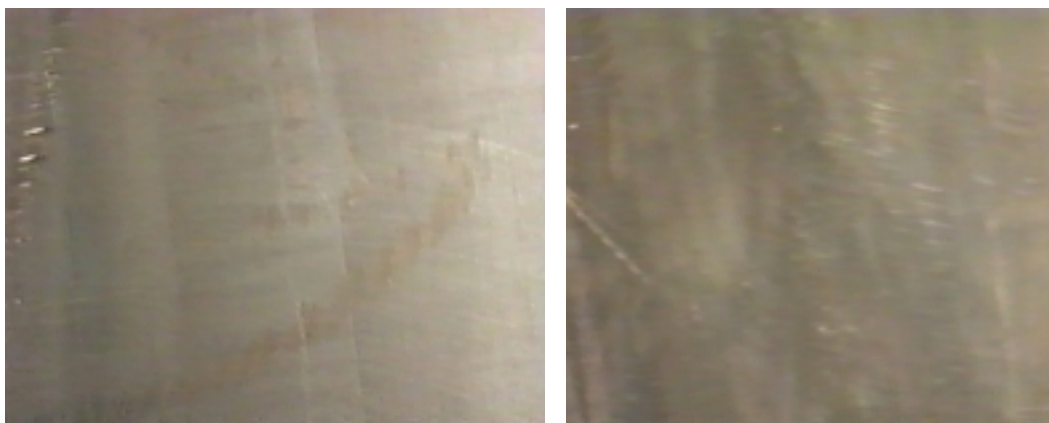
**Figure 4.4** Reduction of Visual Acuity During Scanning. Left: a screen capture from when the camera is not moving. The vertical lines are sharp and the picture is relatively clear. Right: a screen capture of different area when the camera is moving. The vertical lines are blurred, as is the rest of the picture.

An example of the loss of visual acuity when a camera is scanning is shown in Figure 4.4. The picture is significantly sharper when the camera is stationary (system normal visual acuity) over a zone as opposed to scanning (system kinetic visual acuity). This lower kinetic visual acuity demonstrates that a system capable of passing a resolution test when not moving can possibly fail when the camera is being scanned.

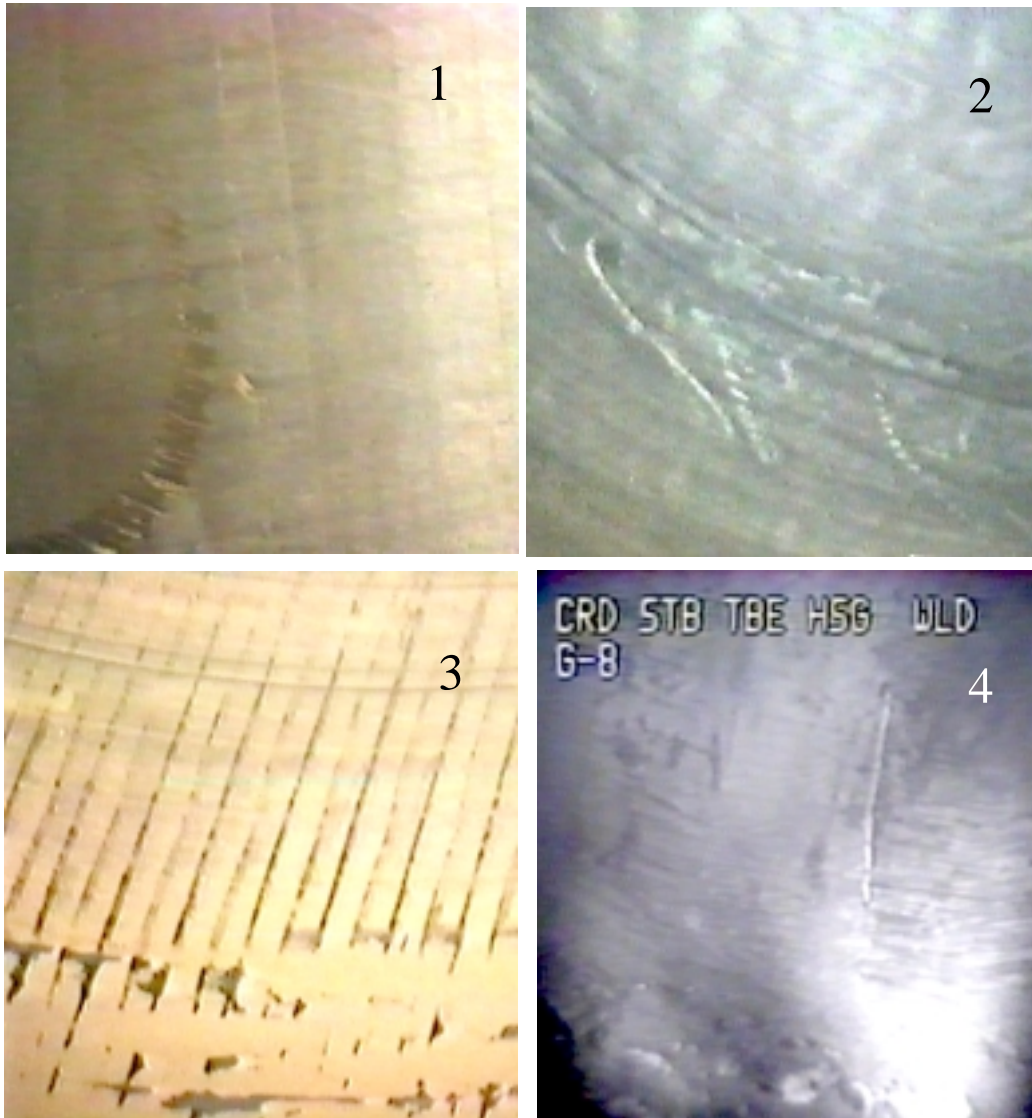
**Figure 4.5** Four Images from Visual Inspections of Pressure Vessels and Piping. 1. Close-up of the metal near a weld showing scratches and markings. 2. Close-up of a pipe interior showing scratches and marks. 3. Manufacturing axial and circumferential markings on the interior of a PWR pipe. 4. Scratches and a vertical rubbing mark on a control-rod drive stub tube housing.

U.S. reactor pressure vessels (RPVs). The interiors of the RPVs have machining and grinding marks over most surfaces. Some areas are discolored and possibly slightly oxidized. These scratches and machining marks provide a lot of visual “noise” that may mask cracking. Four examples of the interior conditions of pressure vessel internals and piping are shown in Figure 4.5.

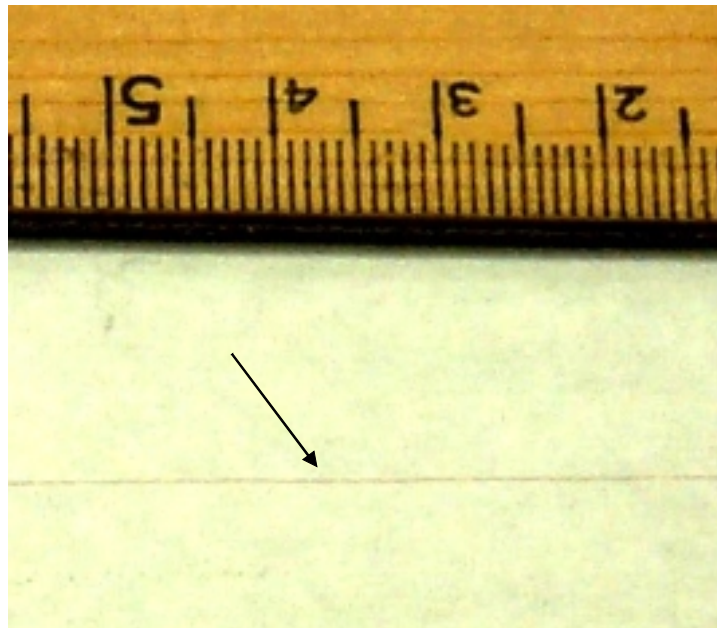
**Figure 4.6** Resolution Demonstration with 25- $\mu\text{m}$  (0.001-in.) Diameter Wire Image Taken using 1-megapixel Camera

Figure 4.6 shows that a 1-megapixel, 3X zoom digital camera used to study crack openings can easily image a 25- $\mu\text{m}$  (0.001-in.) Diameter wire. Photographs of selected cracks are shown in Figures 4.7 through 4.9. These photos were taken under laboratory conditions, using a tripod and careful lighting. Figure 4.7 shows a thermal fatigue crack with a COD of  $12\text{ }\mu\text{m}$  (0.0005 in.). This thermal fatigue crack is not difficult to image, as it has some discoloration around the crack opening that has turned black and contrasts strongly with the steel. This crack has propagated 50% through-wall. Figure 4.8 shows a thermal fatigue crack that also has a COD of  $12\text{ }\mu\text{m}$  (0.0005 in.). The material has been sanded down to a smooth surface, making the crack difficult to detect from most angles. It is also difficult to photograph clearly, as the crack is shown as a barely perceptible line. This crack also has a 50% through-wall depth. Figure 4.9 shows an 80% through-wall mechanical fatigue crack with a COD of  $125\text{ }\mu\text{m}$  (0.005 in.) and a 50% through-wall mechanical fatigue crack with a COD of  $25\text{ }\mu\text{m}$  (0.001 in.) on a smooth surface. The 80% through-wall crack is very easy to detect from nearly any angle. The 50% crack can be seen only on close inspection. As some of the cracks are on the edge of the camera detection ability, printouts and photocopies of these pages may not show all of the details even though the contrast had been digitally enhanced

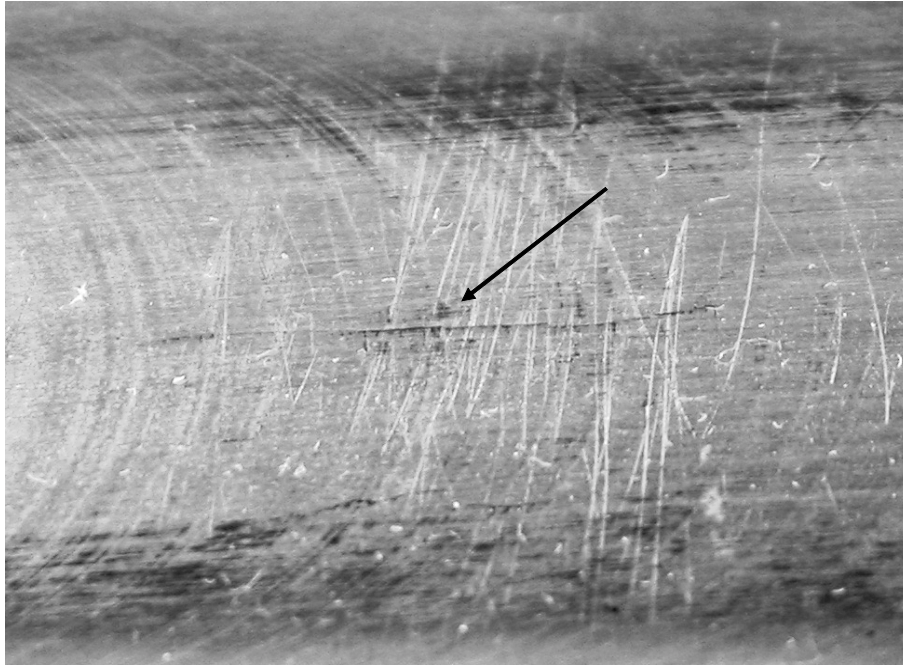
**Figure 4.7** 12- $\mu\text{m}$  (0.0005-in) COD Thermal Fatigue Crack on Machined Surface. The crack is clearly visible despite its small COD, as there is discoloration around the crack opening

The photography of the cracks demonstrates that a digital camera able to detect a 25- $\mu\text{m}$  (0.001-in.) wire may not be able to resolve similarly-sized cracks. In several cases a very close visual inspection could find cracks that were invisible to the digital camera. During the direct visual inspections we were able to examine the specimens at a much shorter distance than with the digital camera, allowing for better detection.

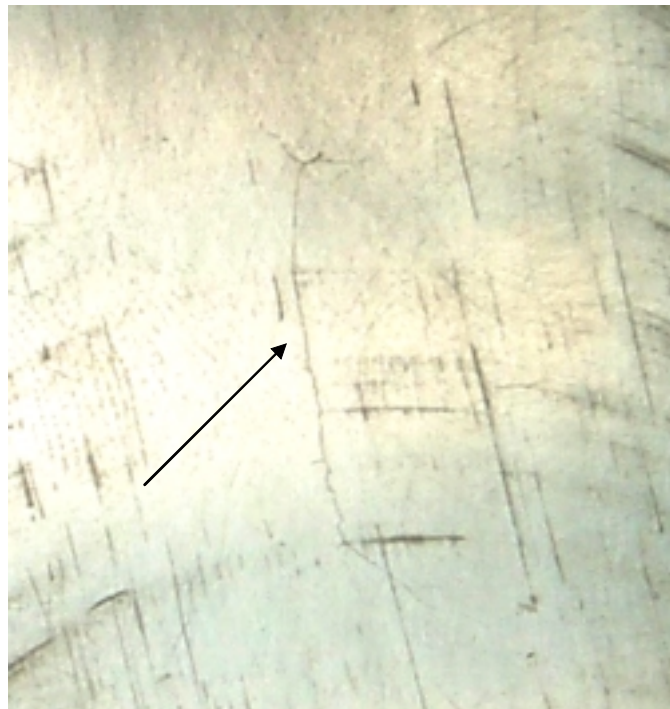
**Figure 4.8** 12- $\mu\text{m}$  (0.0005-in.) Thermal Fatigue Crack on Smooth Surface

**Figure A.3** Sample B118 Showing difficulty in Detecting a Thermal Fatigue Crack. With higher magnification, the crack is detectable, as shown in Figure 4.8

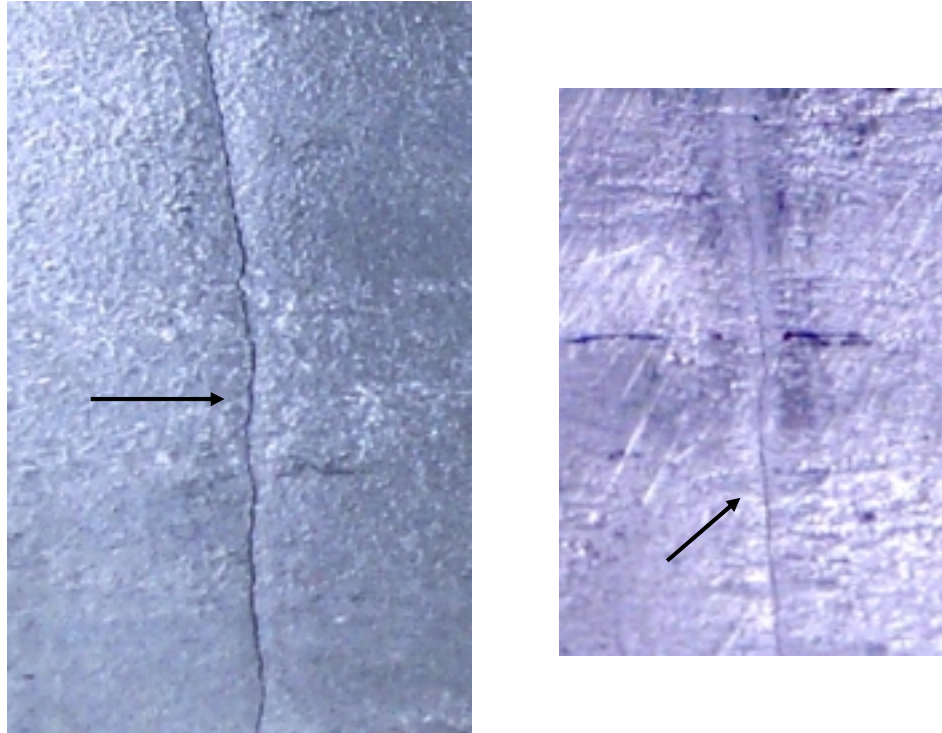
**Figure 4.9** 125- $\mu\text{m}$  (0.005-in) COD and a 25- $\mu\text{m}$  (0.001-in.) COD Mechanical Fatigue Crack on Smooth Surfaces. The 125- $\mu\text{m}$  COD crack is clearly visible, while the 25- $\mu\text{m}$  COD crack is visible only on close inspection.

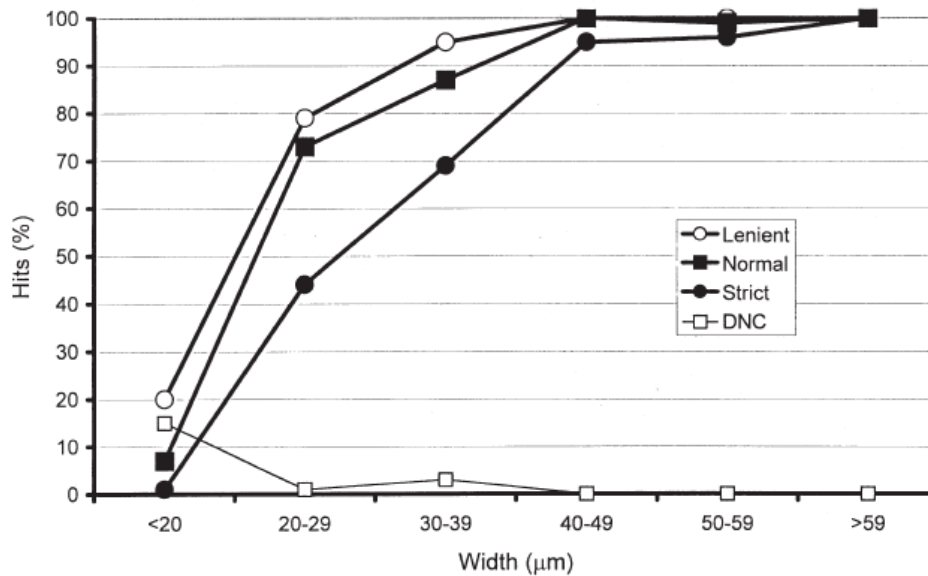
**Figure 4.10** Crack Detectability Versus Crack Opening Dimension (Enkvist J. 2002)

counted all but DNCs as hits. The results are shown in Figure 4.10. Cracks above 40  $\mu\text{m}$  COD were easily detected, while cracks below 20  $\mu\text{m}$  COD had, at best, a 20% probability of detection using the “Lenient” grading scale.

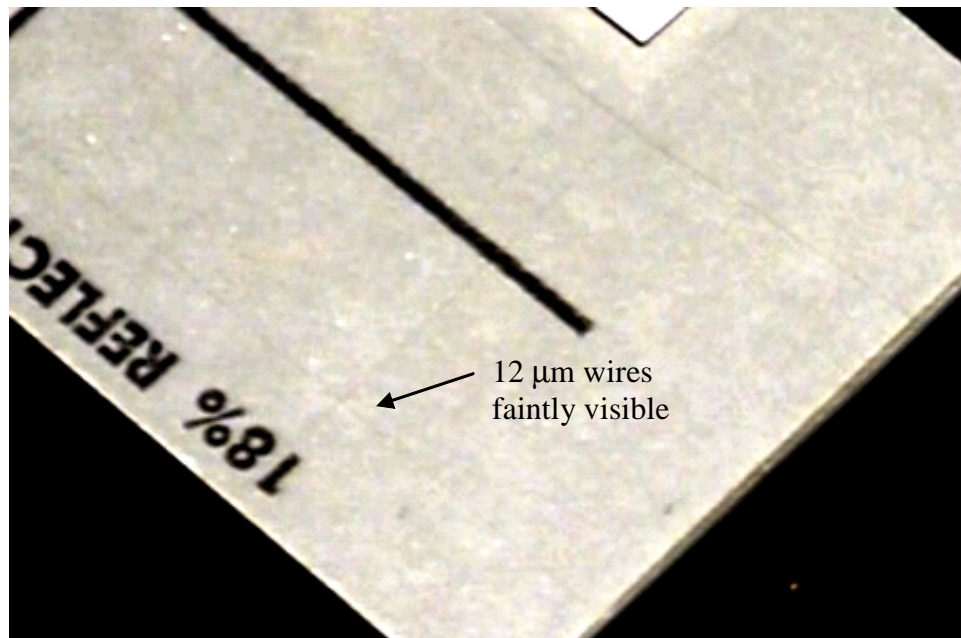
**Figure 5.1** Example of Current Performance Demonstration Standard Showing two 12  $\mu\text{m}$  (0.0005 in.) Crossed Wires Against an 18% Neutral Grey Card

An example of a camera system using a 12- $\mu\text{m}$  (0.0005-in.) wire detection test is shown in Figure 5.1. It should be noted that the resolution target also contained a series of letters for use as a reading chart. For ease of viewing and printing, contrast in the Figure 5.1 has been digitally enhanced. The wires are detectable as low-contrast fuzzy linear indications against the 18% neutral grey card. The video camera used in this example has a pixel size of 7.5 pixels/mm (190 pixels/in.) or 125  $\mu\text{m}$  (0.005 in.), this being measured in a different frame which included an image of a ruler. The 12- $\mu\text{m}$  wire is one tenth of the width of each of the pixels and is well below the resolution of the system at this magnification. Had the contrast between the wire and the background been weaker, or if any visual noise were near the wires, the wires would probably not be detectable.

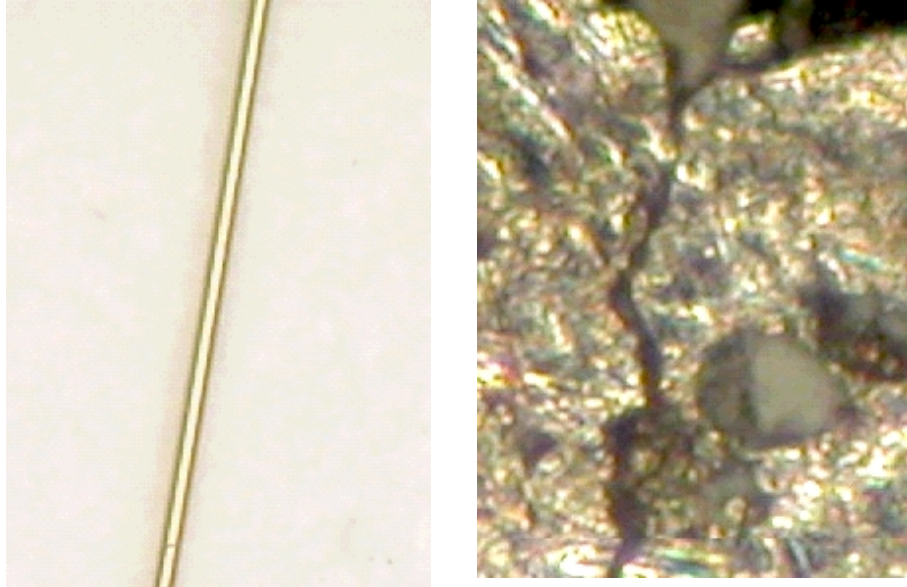
**Figure 5.3** Micrographs of 25- $\mu\text{m}$  (0.001 in.) Wire and Crack with a 25  $\mu\text{m}$  (0.001 in.) COD

In addition to the issues related to testing the camera resolution, the wire standard is also problematic on the issue of illumination angle. There are important differences between visually detecting a stretched wire and detecting a crack. A wire sitting on the surface of a piece has a very different geometry than does an inset crack, and a wire has a very different response to light than does a crack. Lighting angles that make a wire very visible may not be effective for crack detection. One difference between a wire and a crack is that a round wire surface is very good at reflecting light, while cracks do not produce strong reflections and often are detectable only as a dark line. Another issue is that a wire will cast a relatively long shadow when a light source is placed near the surface of the piece, while a crack can never look larger than it actually is, based on shadowing effects. Figures 5.3 through 5.5 show the differences between cracks and wires. Figure 5.3 shows the different appearance of a wire and crack of the same width. Figure 5.4 is a

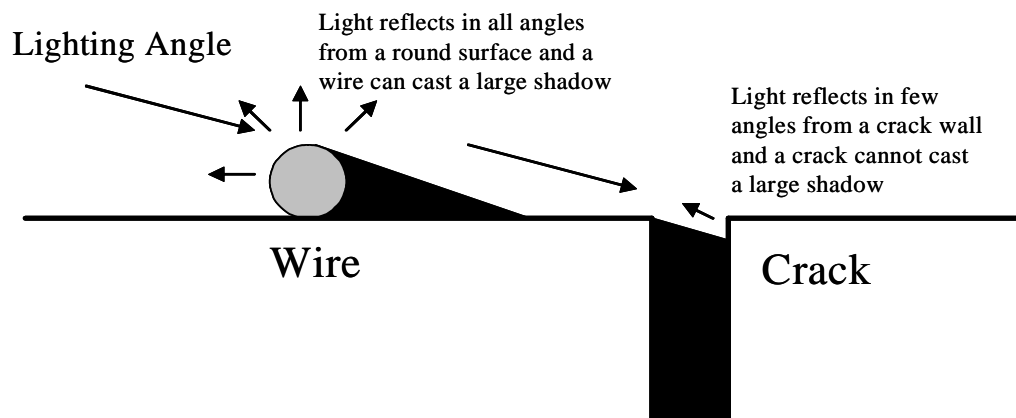
**Figure 5.4** Differences in Appearances of Cracks and Wires when Lighted from the Side

schematic demonstrating how wires and cracks differ with side lighting. Figure 5.5 shows a 25- $\mu\text{m}$  (0.001-in.) wire next to a 125- $\mu\text{m}$  (0.005-in.) crack when lighted from the side and when lighted directly.

As Figure 5.5 shows, the side-lighted wire shows up much better than does the much larger crack. This effect is caused by a combination of the effects shown in Figure 5.4. Also interesting is that the crack also appears bright in places and dark in others, as the light is reflecting from some of the facets in the crack. When the specimen lighting is directly overhead, the crack and wire appear as dark lines, with the crack correctly appearing to be larger than the wire. As with the performance standard, a more representative standard for determining the optimum lighting could be a block with an EDM notch or crack with an appropriate width. The use of a notch or crack to arrange the lighting would provide far more accurate feedback as to which lighting setup is best for finding a crack.

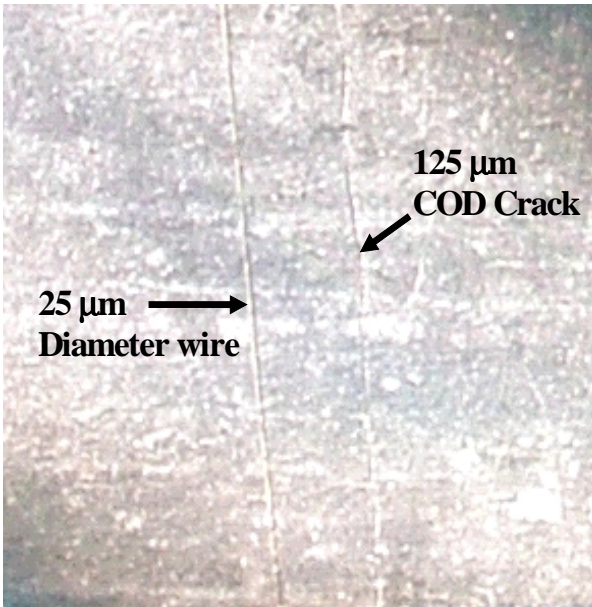
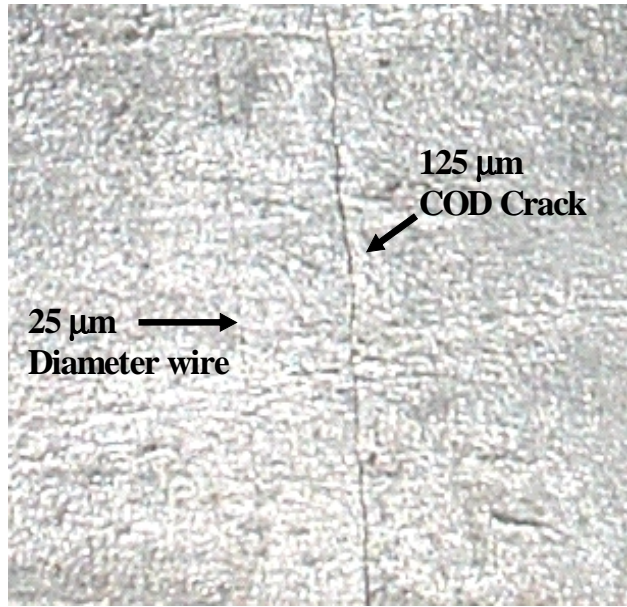
**Figure 5.5** Effects of Lighting Angle on 25-μm Wire and 125-μm Mechanical Fatigue Crack

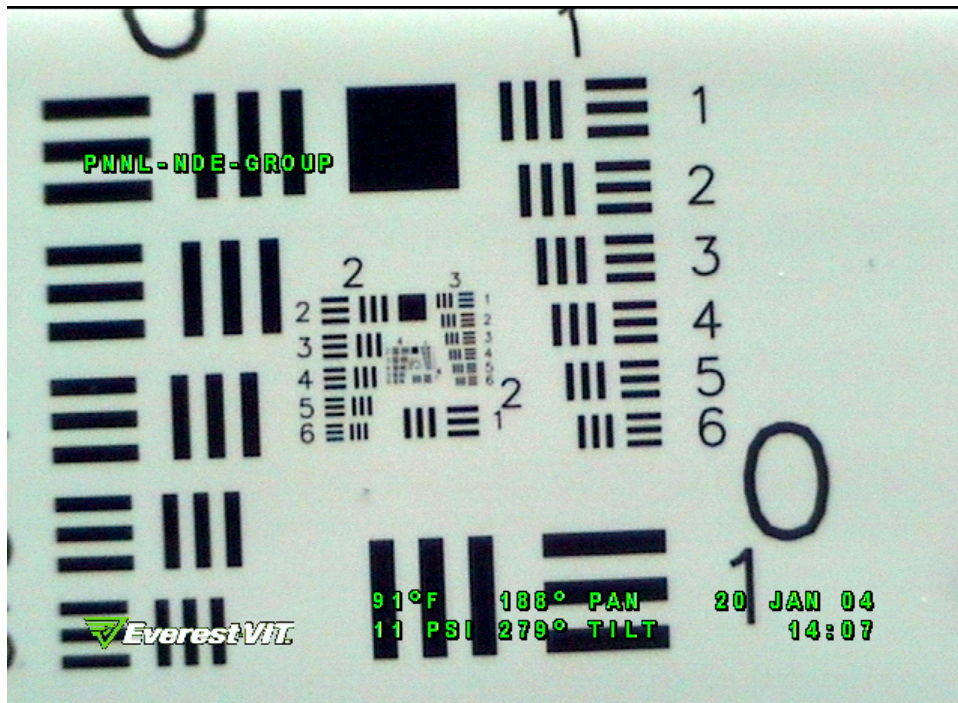
**Figure 5.6** 1951 USAF Resolution Target Imaged by CaZoom PTZ System

An example of a resolution test is shown in Figure 5.6. This resolution test was conducted using a 1951 USAF Resolving Power Target. The highest resolution was measured under laboratory conditions in air at approximately 4 cm (1.6 in.) from the resolution target. Using this target, researchers determined the system resolution to be 11.31 line pairs per millimeter, meaning that the system could discern a gap as small as  $44\text{ }\mu\text{m}$  (0.0017 in.) between two black lines. The inspected area was 2 cm x 1.5 cm (0.78 in. x 0.59 in.) indicating there were 32 pixels/mm (812 pixels/in.) for a pixel size of  $33\text{ }\mu\text{m}$  (0.0013 in.). If this test had been performed in water (correcting for the refractive index of water as compared to air) the pixel size would have been  $25\text{ }\mu\text{m}$  (0.001 mil).

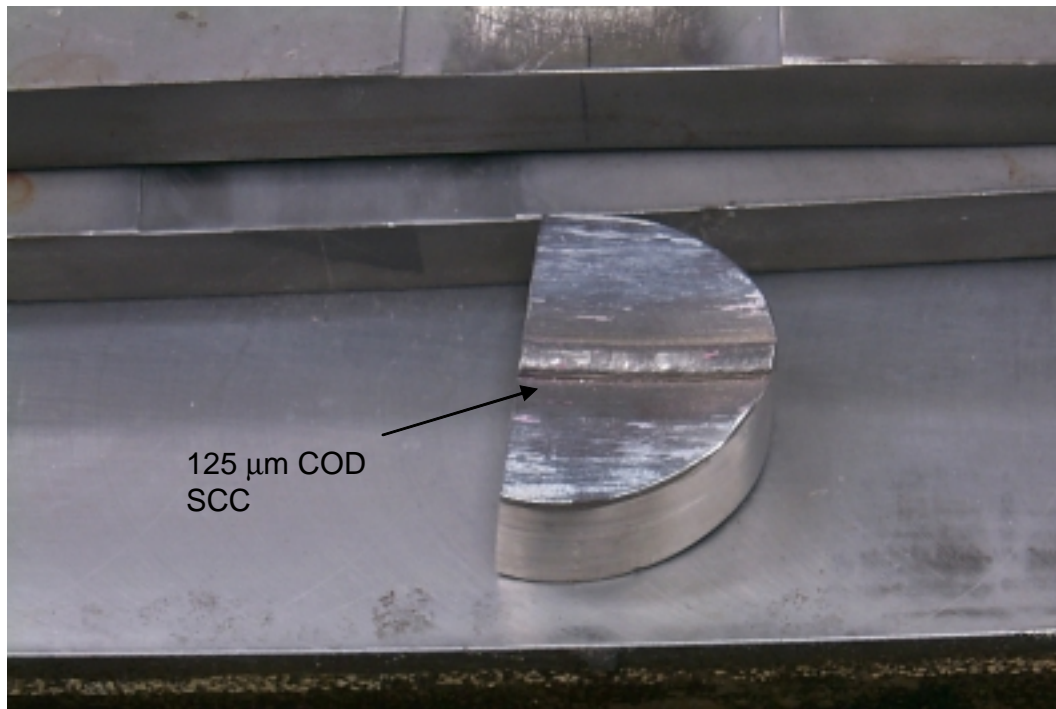
**Figure A.1** Sample d32a with a 125- $\mu\text{m}$  COD Stress Corrosion Crack Along the Weld Root.

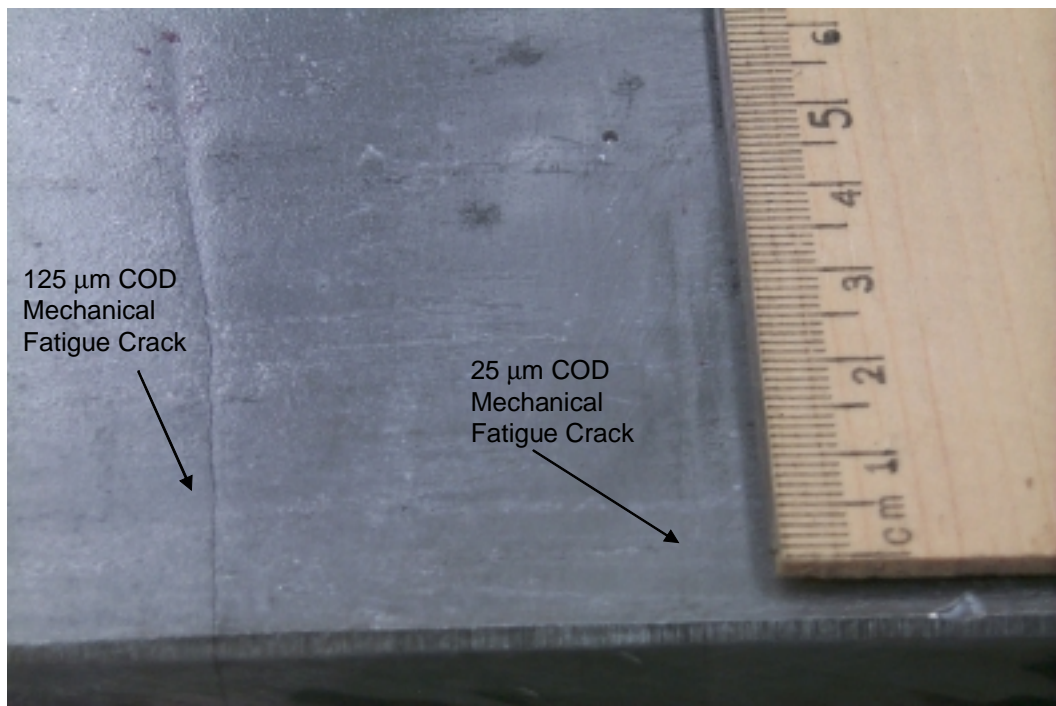
**Figure A2** Two Mechanical Fatigue Cracks in Sample 4

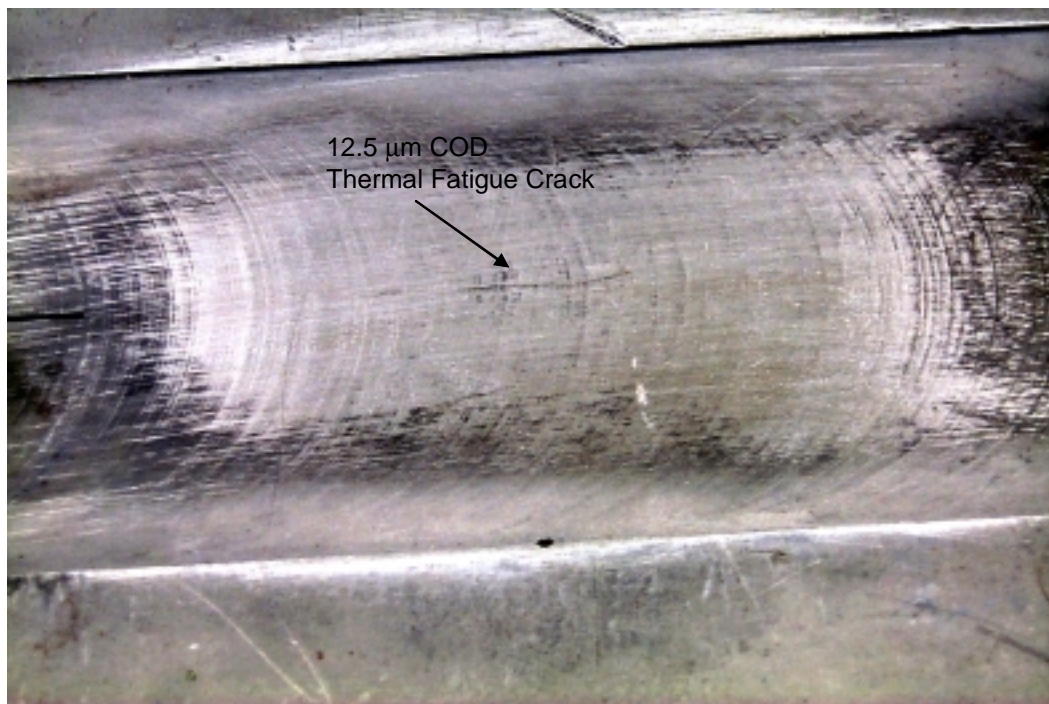
**Figure A.4** Sample B117 Showing a 12- $\mu\text{m}$  COD Thermal Fatigue Crack. This crack has a much higher contrast than the crack in sample B118, as the edge of the crack is chipped and discolored.

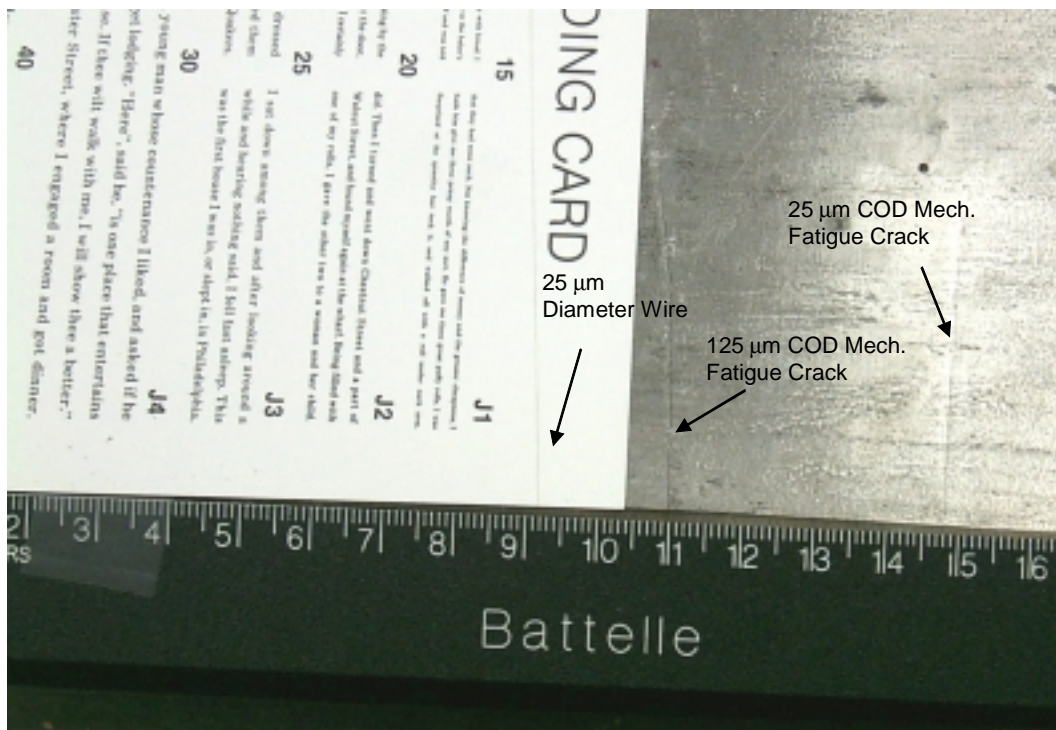
**Figure A.6** Sample 4 with Jeager Reading Chart and a 25-µm Diameter Wire

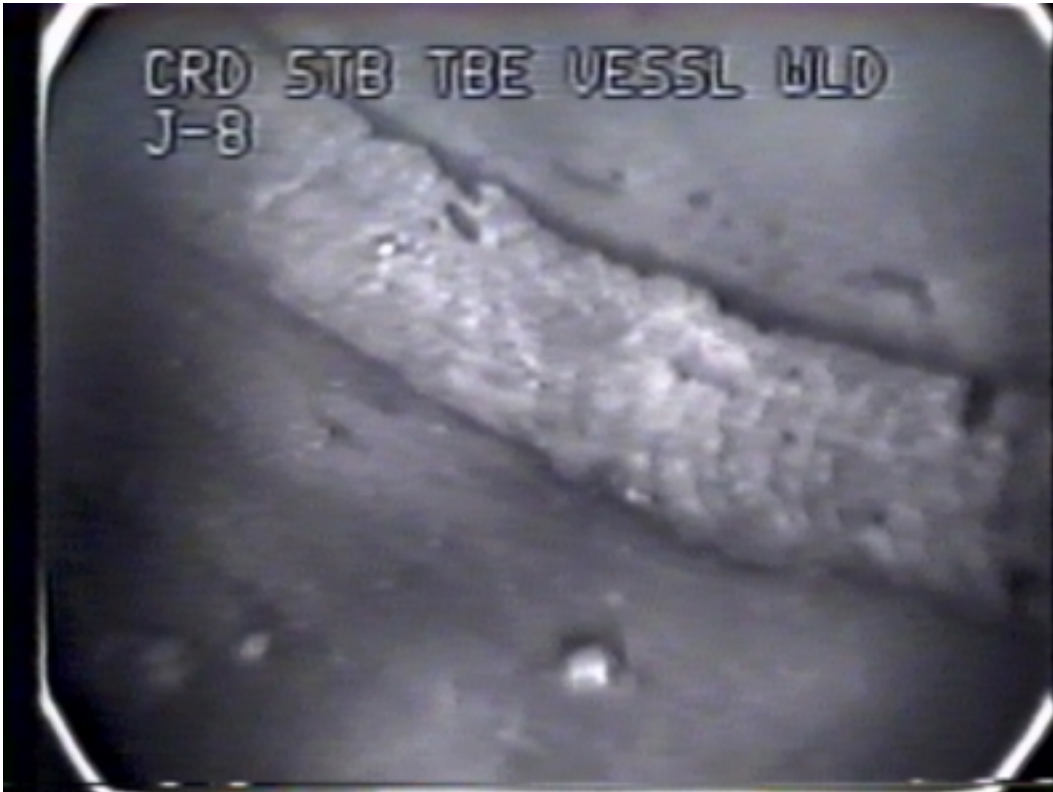
**Figure A.7** Frame Capture from Videotaped Visual Inspection of a Control Rod Drive Stub Tube Weld. Note the relatively soft focus.
