# **An Assessment of Visual Testing**

**Pacific Northwest National Laboratory**

**U.S. Nuclear Regulatory Commission  
Office of Nuclear Regulatory Research  
Washington, DC 20555-0001**

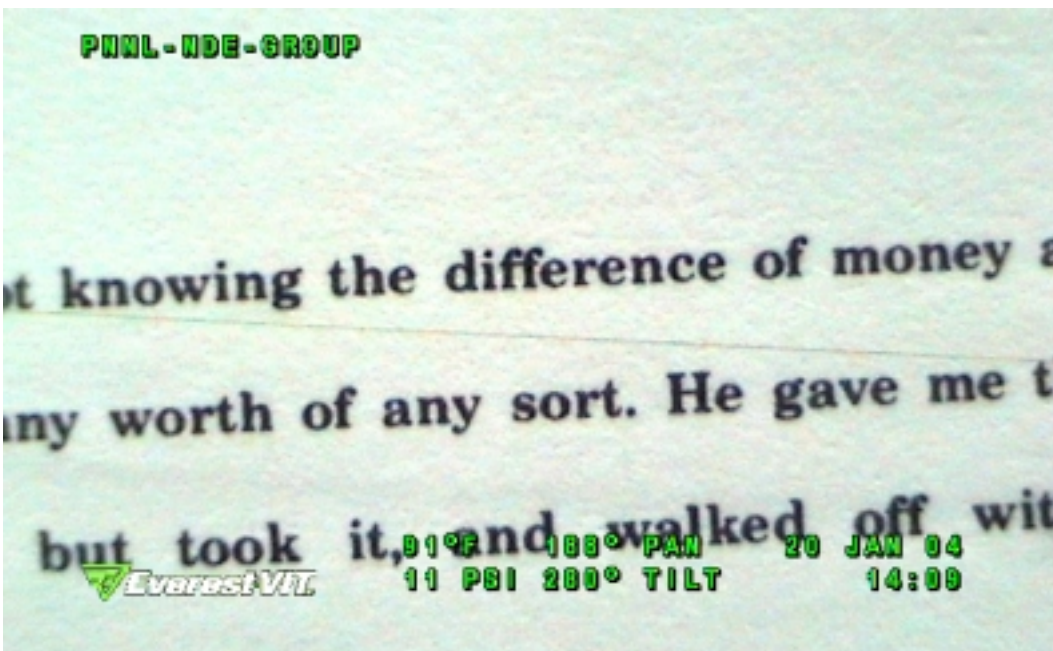
**Figure A.8** Closeup of a Jeager Reading Chart and 25- $\mu$ m Diameter Wire using CaZoom PTZ Camera. The wire is still less than 1 pixel wide.
