PNNL-15678-5

Fifth Annual Report: 2008 Pre- Construction Eelgrass Monitoring and Propagation for King County Outfall Mitigation

Prepared for
King County Department of Natural Resources and Parks
Wastewater Treatment Division, Brightwater Project
Under a Related Services Agreement
With the U.S. Department of Energy
Contract DE-AC05-76RL01830

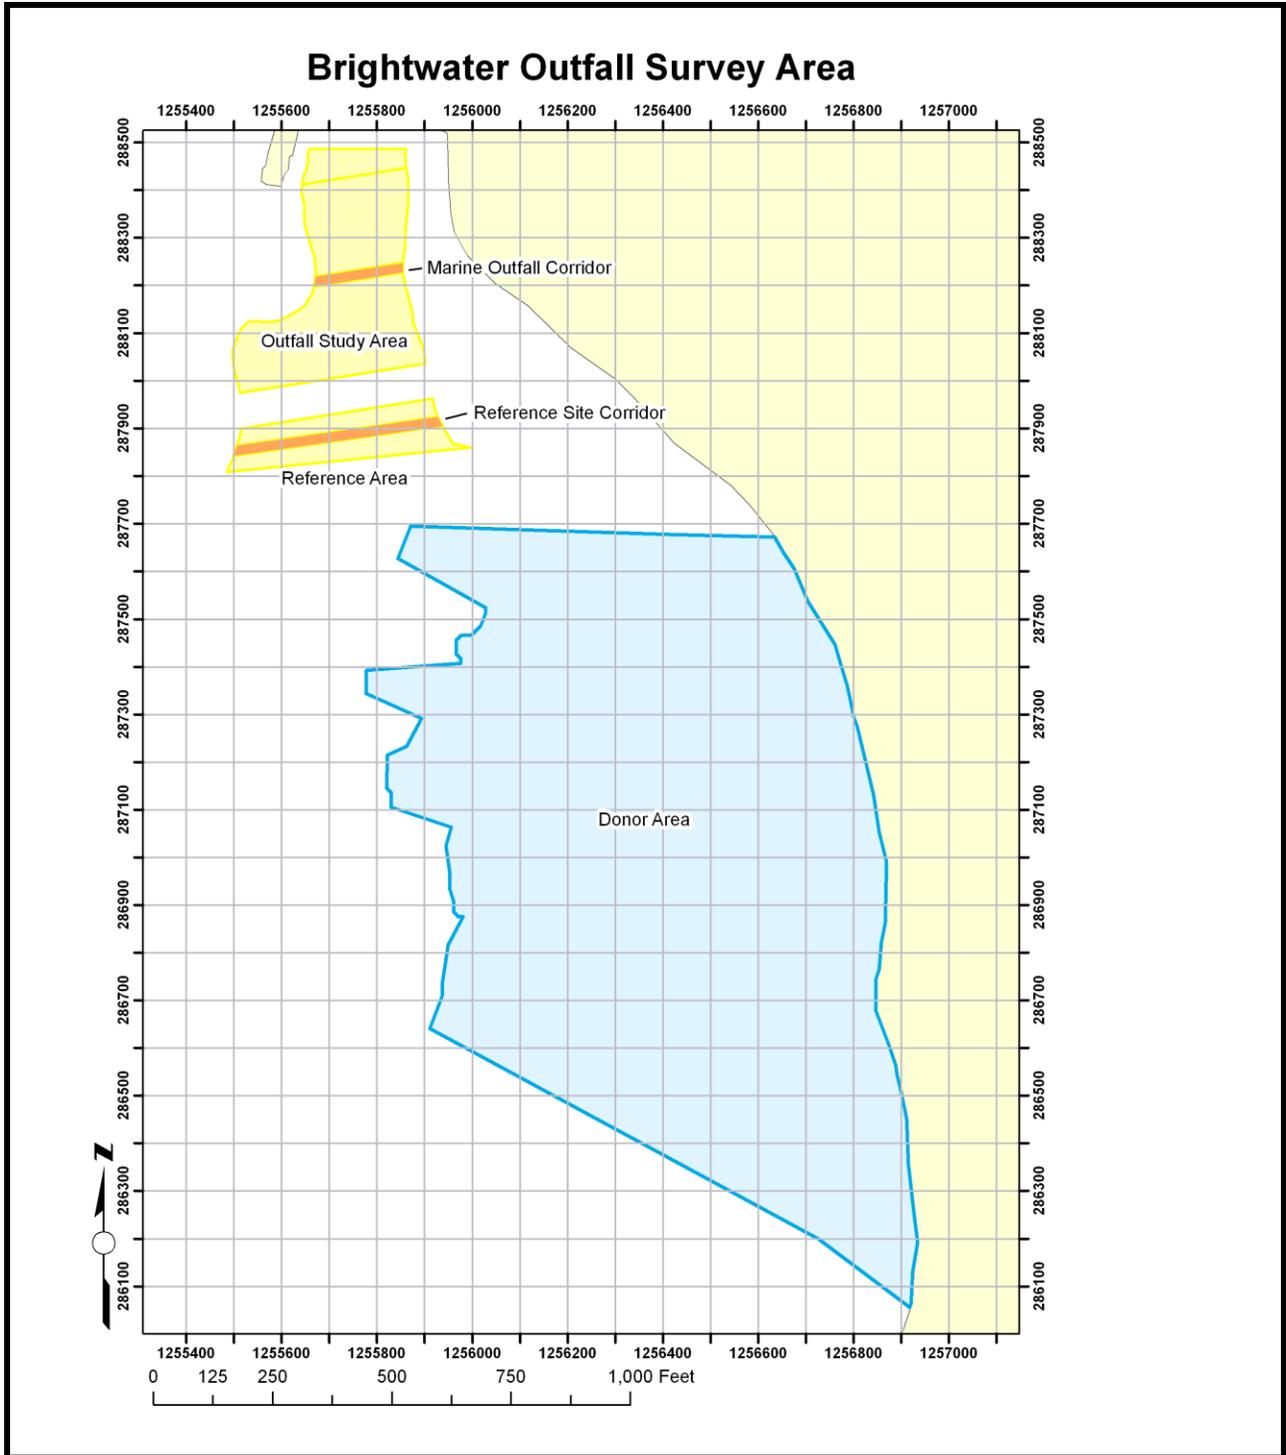
Figure 1. Location of Brightwater Outfall Survey Area Including Outfall Study Area, Reference Area, and Donor Area

The Brightwater outfall survey area encompasses the Outfall (Eelgrass) Study Area, Marine Outfall Corridor, Eelgrass Reference Area, and the Eelgrass Reference Corridor (Figure 1). An Eelgrass Donor Site has been identified as a contingency in the event the harvest and propagation effort described below fails to provide sufficient eelgrass for transplanting. The Outfall Study Area extends 210 feet both north and south of the outfall pipeline alignment centerline, between 0 ft mean lower low water (MLLW) and -25 ft MLLW, a zone in which eelgrass and associated macroalgae grow. Within the Outfall Study Area is the Marine Outfall Corridor, a narrow zone (20 ft wide) centered on the outfall pipeline alignment that includes 4 ft on either side of the 12-ft-wide sheeted trench.

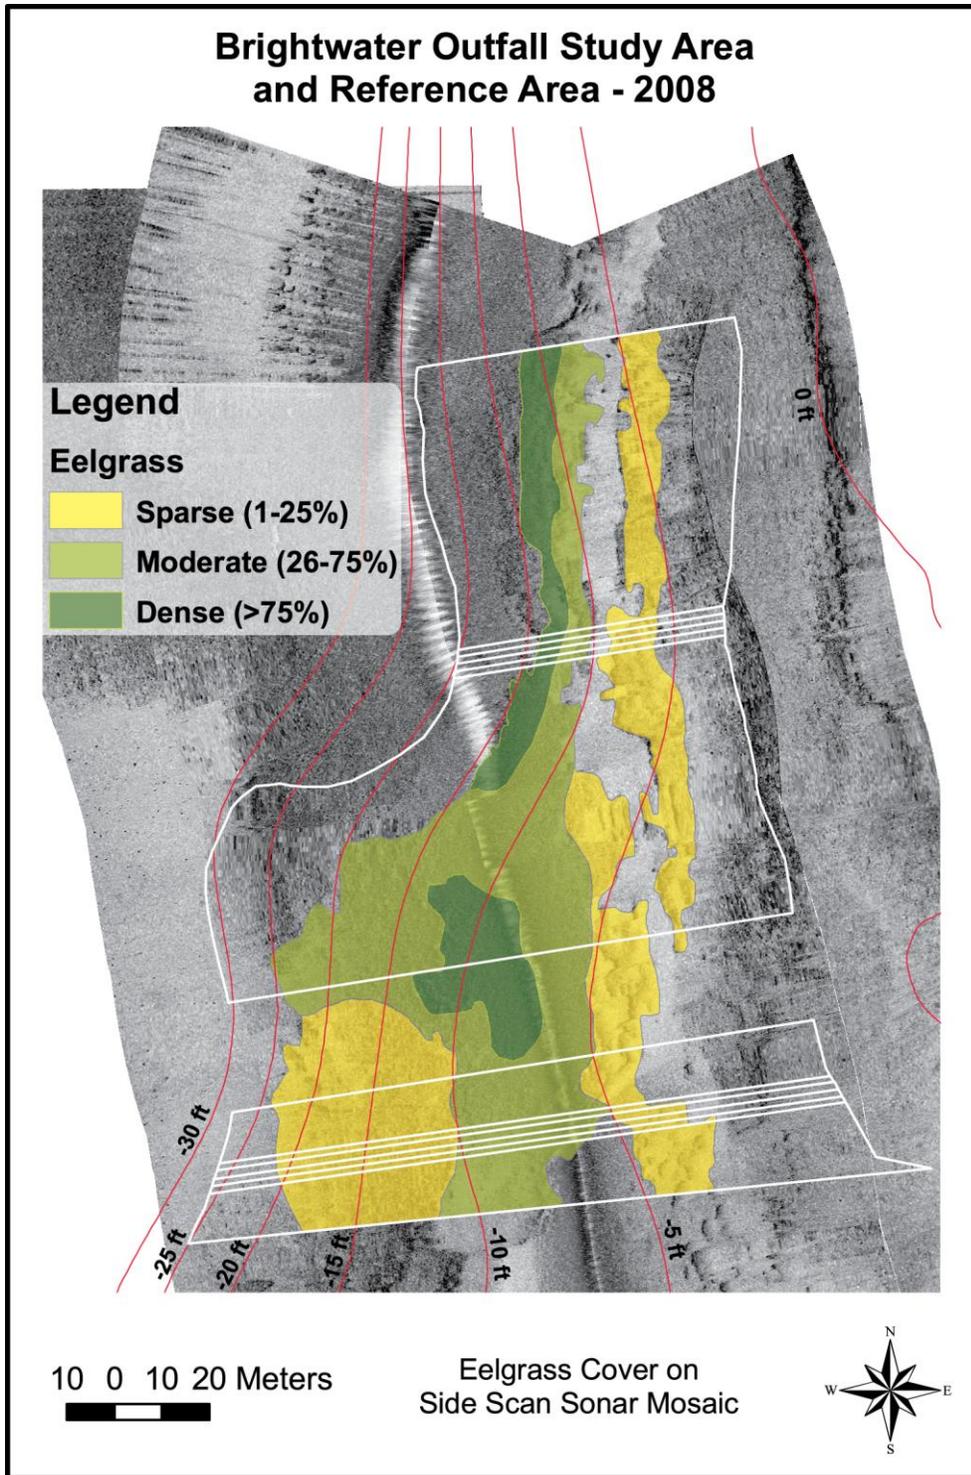
Figure 2. Final Side Scan Sonar Mosaic Used to Delineate Eelgrass Cover

The side-scan sonar and underwater video data were collected in the Outfall Study Area and the Reference Area (Figure 1), from approximately 65 m (213 ft) north of the Marine Outfall Corridor, to approximately 10 m (33 ft) south of the Eelgrass Reference Area, and offshore to a depth of at least -25 ft MLLW. The methods used are described in greater detail in the Implementation Workplan (King County 2008). A GeoAcoustics Ltd. side scan sonar system was towed by boat in overlapping swaths at high tide to include all areas where eelgrass was present. Data were collected along transects (tracklines) parallel to shore, and spaced approximately 60 m apart to provide the best resolution of data with an approximate 50% overlap of swaths. Each transect provided a unique “view angle” (upslope or downslope) of the eelgrass. An on-board differential global positioning system (dGPS) and computer imaging system provided real-time output of sonar images on a computer monitor. Each pass of the sonar was examined for signatures of eelgrass edges and patches; the information from the passes with the strongest eelgrass signal returns were merged, creating the final mosaic (Figure 2) used to delineate the eelgrass polygons.

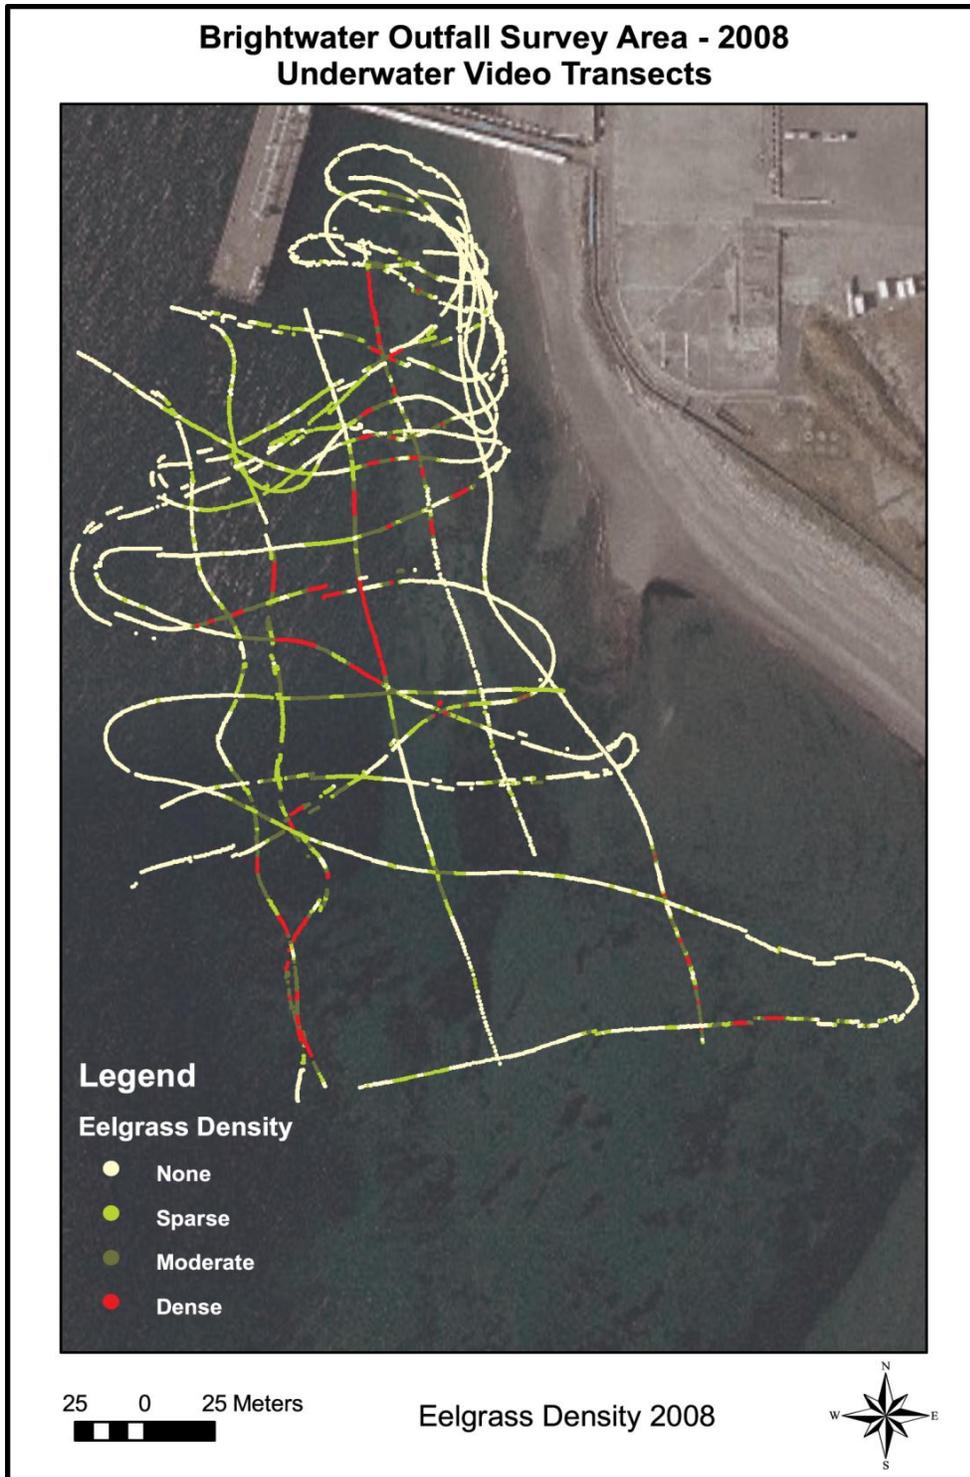
Figure 3. Georeferenced Underwater Video Transects and Eelgrass Cover Class Located in the outfall Study Area and Reference Area.

Underwater video transects were collected in the area of the Outfall Study Area and Reference Area: five transects were collected parallel to shore approximately 10-20 m apart, several transects were collected perpendicular to shore in the corridor areas, and several transects were collected diagonally in an onshore to offshore “zig zag” pattern encompassing the entire survey area. Additional transects were collected at the north end of the survey area inside the Paramount Petroleum pier to provide additional coverage (Figure 3). Video data was collected at a high tide to ensure the fullest possible coverage close to shore. Copies of all video data have been provided to King County.

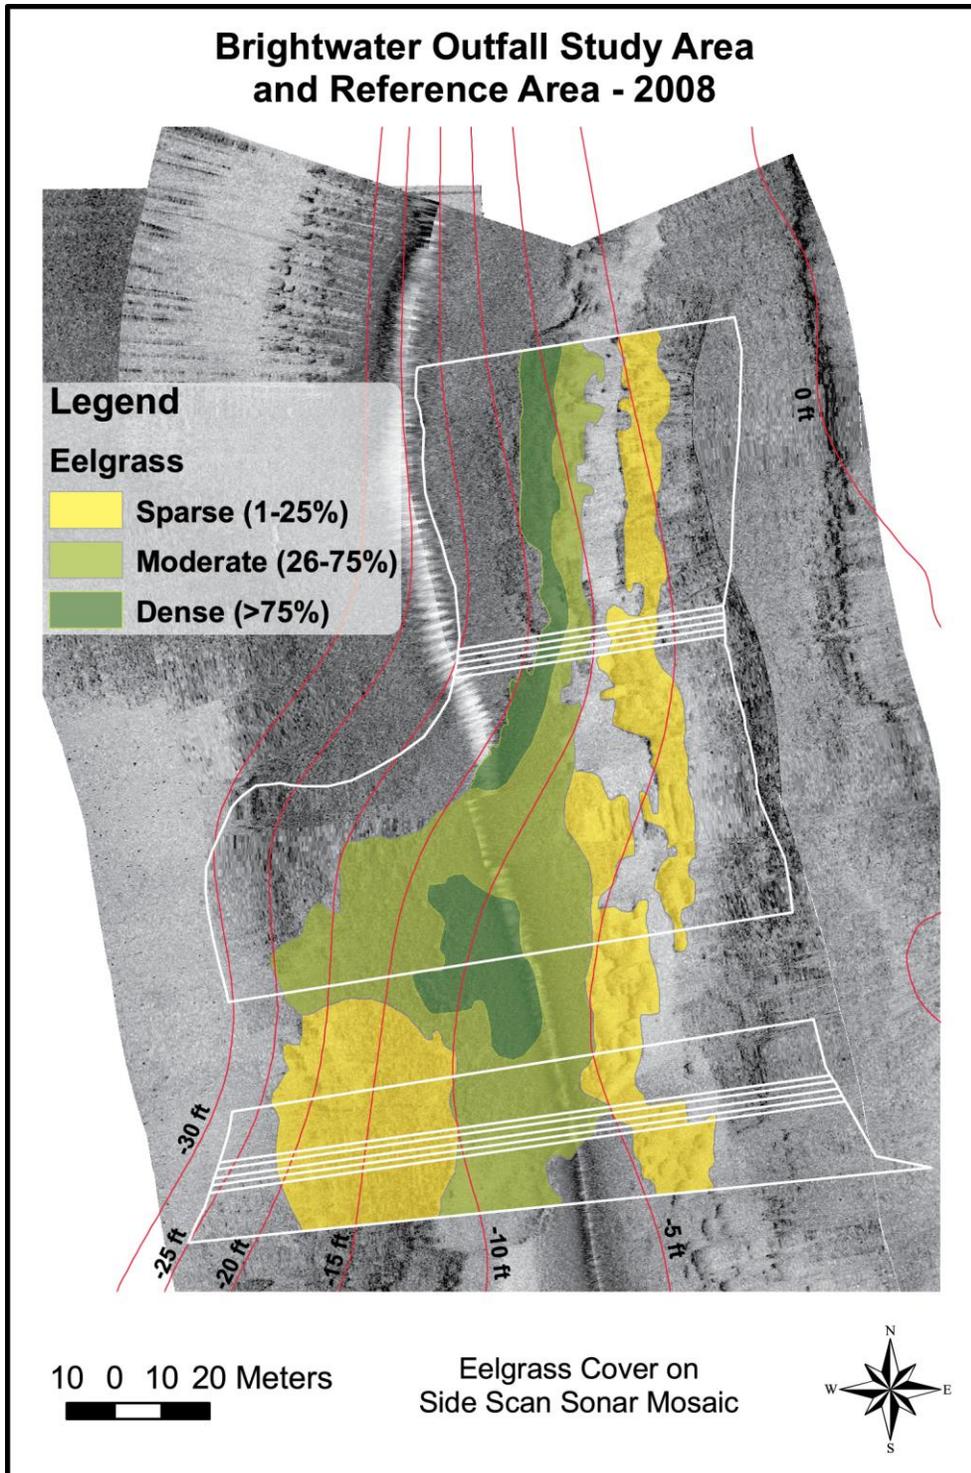
Figure 4. Eelgrass Cover Classes as an Overlay on Side Scan Sonar Mosaic in the Brightwater study Area.

Side-scan sonar and underwater video imagery were formatted in ArcView 9.3 to create preliminary data layers for further delineation of eelgrass distribution. Eelgrass cover was delineated in the Outfall Study Area, the Marine Outfall Corridor, the Reference Area, Reference Site Corridor and the areas between the Outfall and Reference Study areas. In the Corridor Areas (Outfall and Reference), Grette Associates (2008) dive-survey information was also incorporated into the final delineation, providing higher resolution of eelgrass distribution within the Outfall and Reference corridors. The overall process involved an initial evaluation of the side-scan sonar data to determine the spatial extent of the eelgrass (boundaries), then overlaying the underwater video data to verify spatial cover and patchiness, and determination of final cover classes, shown in Figure 4 as an overlay on side scan sonar imagery.

The underwater video data was used as an overlay on the mosaic of the side-scan sonar image. Additional polygons were delineated or refined based on the information from the underwater video data. Finally, the survey data from Grette Associates (2008) was reviewed for the Corridors and final polygon determinations made based on all available data. Each polygon was assigned a cover class as shown in Table 1.

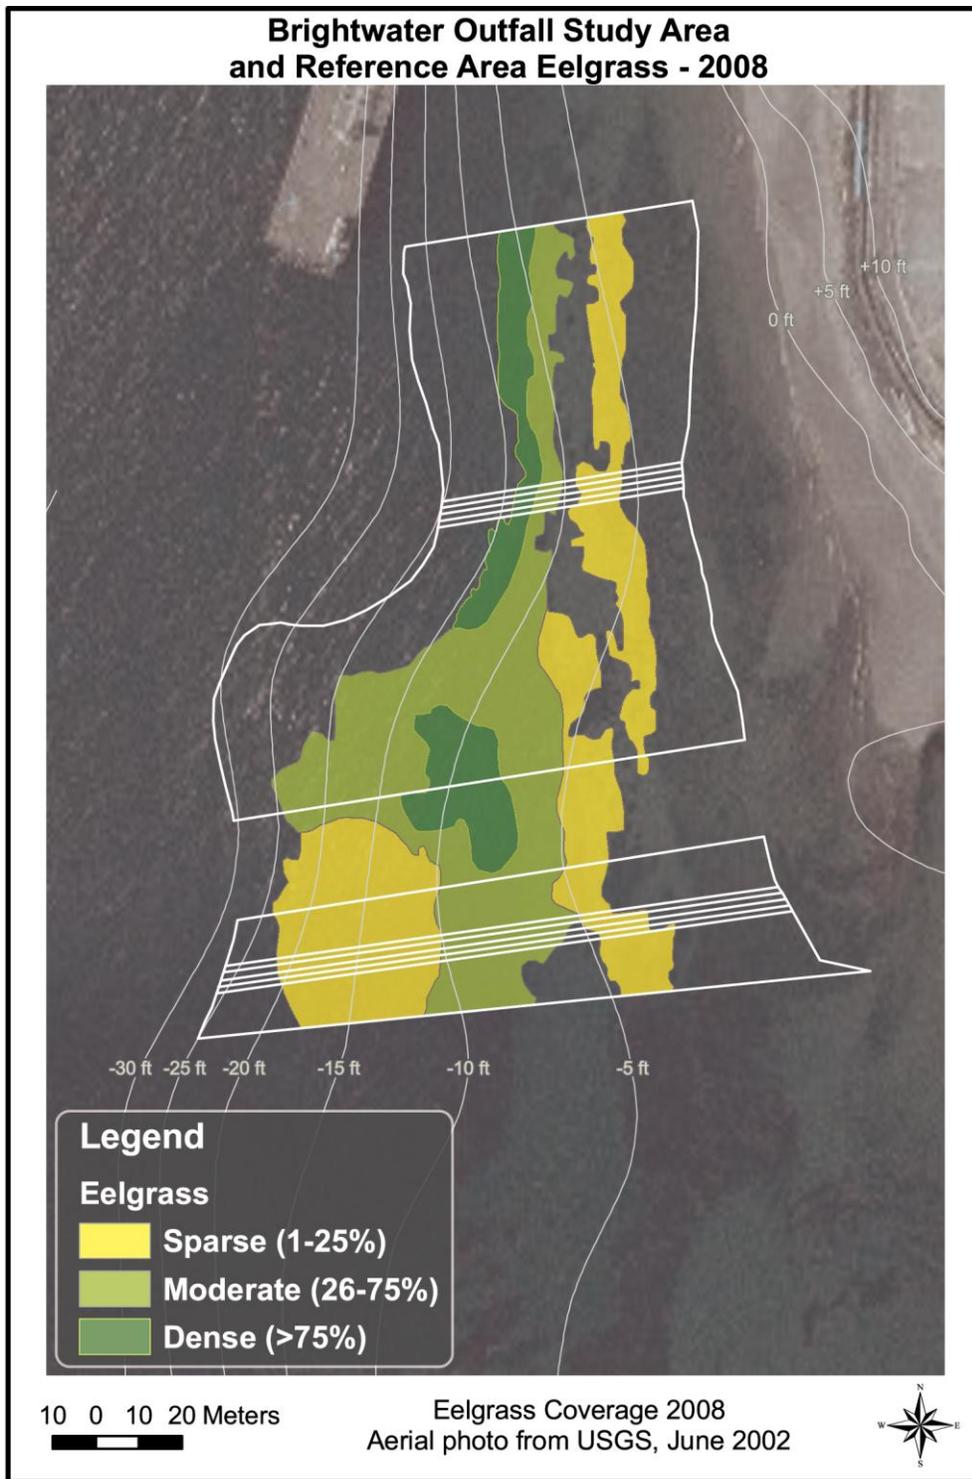
Figure 5. Eelgrass Cover Classes and Area (m²) Determined in 2008 in Brightwater Survey Area.

The distribution of eelgrass, *Z. marina*, in the Brightwater outfall study area is shown as polygon overlays on aerial imagery in Figure 5. On a broad scale, the location and pattern of eelgrass presence in the study area is similar to that mapped in 2004, shown in Figure 6. However there has been an increase in overall coverage and density between 2004 and 2008, noted in Figures 5 and 6, and Table 2. The overall area of coverage of eelgrass in the general area of study was 8486 m² in 2008, compare to 6701 m² in 2004. A similar trend was also observed by Grette Associates (2008) in diver surveys of the corridors. Table 2 shows the eelgrass cover class distribution (m²) for each density classification and area for 2004 and 2008. The eelgrass cover increase in the Marine Outfall Corridor between 2004 and 2008 was 127 percent, (63 to 143 m²) compared to a 29% increase in the Reference Corridor (412 to 533 m²). A similar trend was shown in the corridors by Grette Associates based on the average eelgrass shoot density. The average shoot density in the Marine Outfall Corridor increased from 23 shoots/m² in 2004 to 80 shoots/m² in 2008, and 30 shoots/m² in 2004 to 38 shoots/m² in 2008 in the Reference Area Corridor.

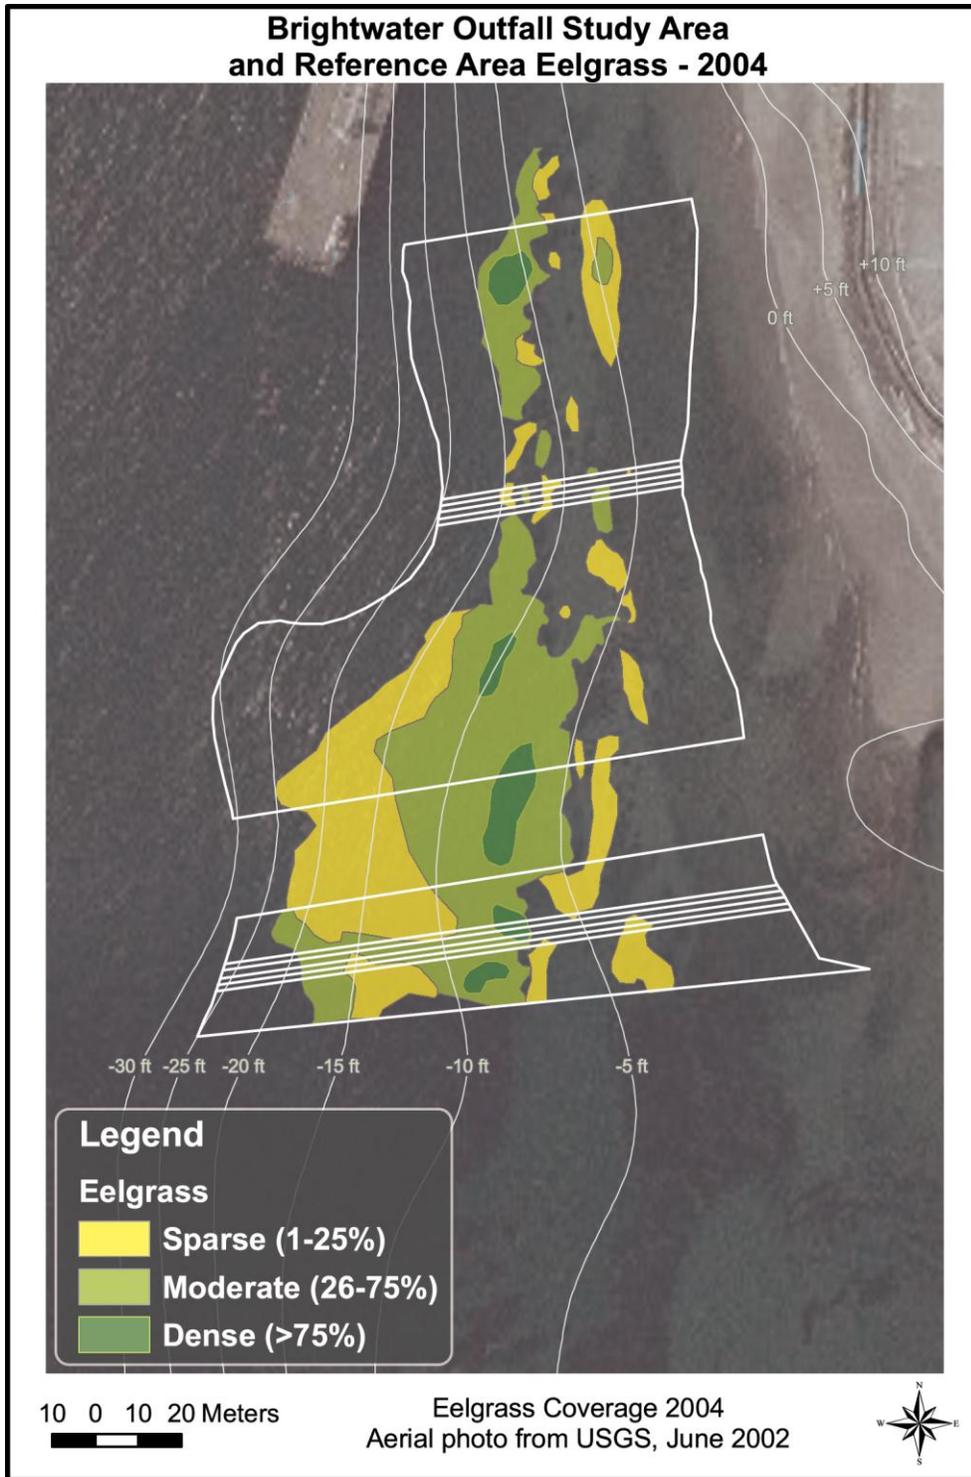
Figure 6. Eelgrass Cover Classes and Area (m²) Determined in 2004 for the Outfall Study and Reference Areas.

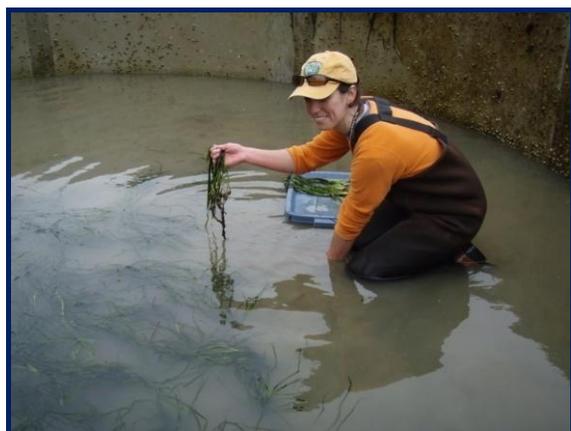
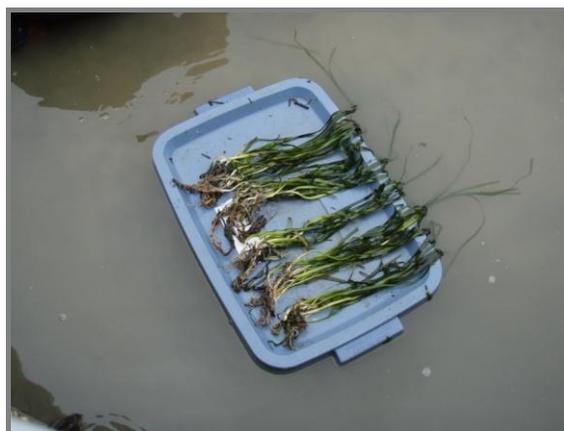
Figure 7. Transplanting eelgrass into MSL propagation tanks in May 2008 (left), and bundled eelgrass shoots ready for transplanting (right).

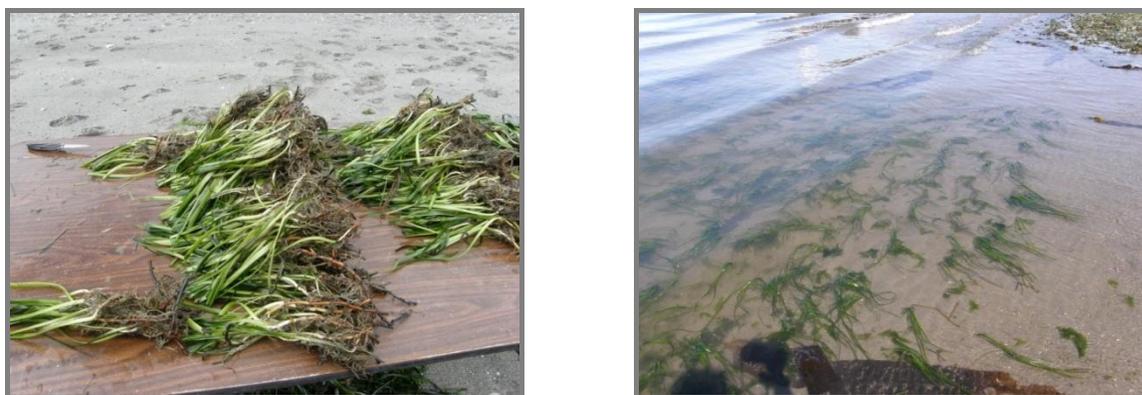
Figure 8. Eelgrass ready for transplant at Marine Outfall Corridor, May 2009 (left), and recently transplanted in the Outfall Corridor, June 2009 (right).

Between July 2008 and mid-October 2008, construction activities below mean high water in the Marine Outfall Corridor, included the following components; shoring, trenching, placing the outfall pipes, backfilling the trenched area, and removal of shoring. To replicate pre-construction habitat conditions as closely as possible, the uppermost layer of substrate in the corridor was stockpiled separately during construction and returned after construction to the site. Eelgrass plants were returned to the site approximately seven months after construction early in the growing season to allow establishment of a healthy root system and to store energy for the following winter. On May 18th, 2009, approximately 16,000 eelgrass shoots were harvested using the bare-root method described above from the MSL propagation tanks. The leaves were trimmed to approximately 30 cm to facilitate handling and planting (Figure 8). Shoots were packed in coolers filled with seawater and transported to the outfall site where they were transplanted by Grette Associates divers. A portion of the shoots will remain at the MSL in reserve during the first year, and used as needed to fulfill the restoration guidelines outlined in the *Implementation Plan* (King County, 2008).
