# Evaluating Cumulative Ecosystem Response to Restoration Projects in the Columbia River Estuary, Annual Report 2006

FINAL REPORT  
December 10, 2007

Prepared for:  
U.S. Army Corps of Engineers, Portland District  
Under a Related Services Agreement with  
The U.S. Department of Energy  
Contract DE-AC05-76RLO 1830

Prepared by:  
Pacific Northwest National Laboratory, Marine Sciences Laboratory  
NOAA Fisheries, Pt. Adams Biological Field Station  
Columbia River Estuary Study Taskforce

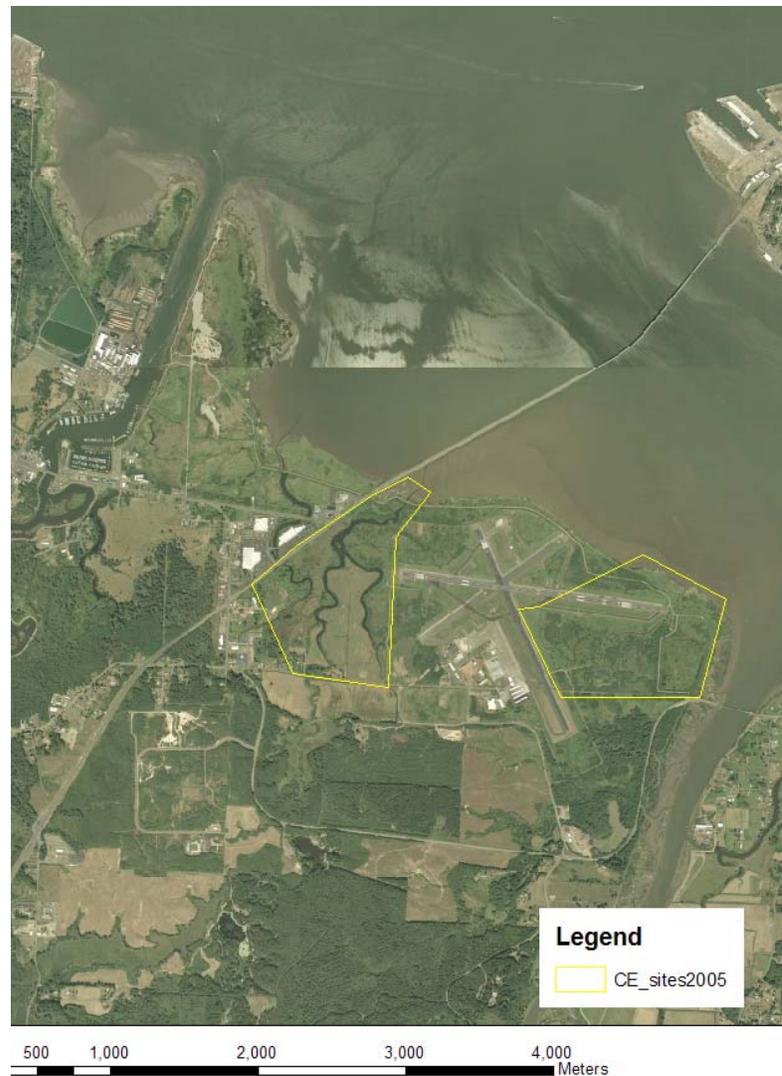
**Figure 1.2.** Vera Slough Tide Gate Replacement Site (left polygon) and Reference Site (right polygon) Separated by the Astoria Regional Airport on Youngs Bay, Oregon

Vera Slough on Youngs Bay in Oregon, with low salinities, was selected to represent the brackish marsh restoration (Figure 1.2). The property, which is near Warrenton, Oregon, is owned by the Port of Astoria and restoration is being planned and managed by the Columbia River Estuary Study Taskforce (CREST). Following baseline data collection in the spring and summer of 2005, in October of 2005 the two top-hinged tide gates restricting flow into the slough were replaced (Figure 1.3) by two 5-ft x 5-ft square tide gates of different models (one side-hinge and one top-hinge, both with lighter lids and fish-passable doors). These models are currently experimental allowing managers to manipulate the amount of tidal intrusion onto the site. Several manipulations occurred on both gates during the field season to increase the level of tidal influence, thereby affecting the tidal flood elevations. Objectives of the project included the following: increase fish access to backwater slough habitat; lower temperatures; improve dissolved oxygen (DO) conditions; increase salinity intrusion; develop estuarine plant communities; and increase food-web productivity.

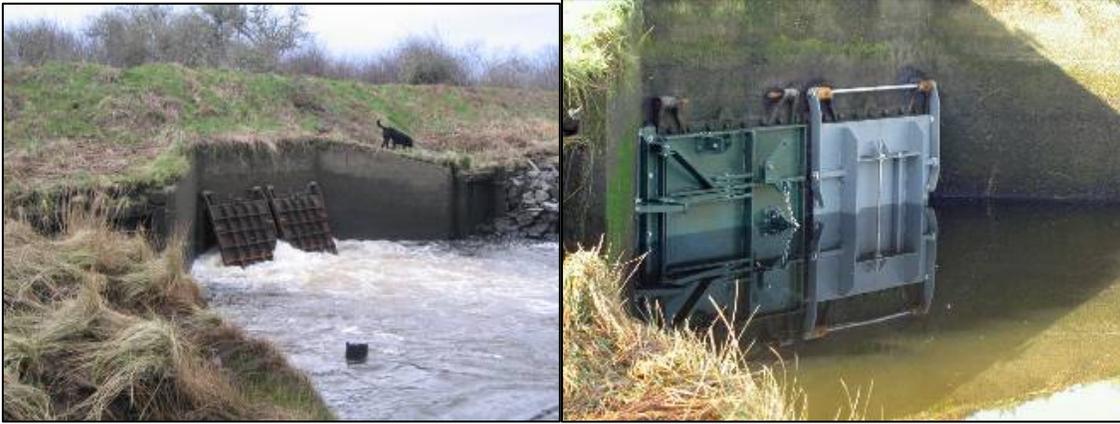
**Figure 1.3.** Tide Gates at Vera Slough Before (left; open) and After (right; closed) Replacement (photos courtesy of CREST)

The Vera Slough project entailed the replacement of two tide gates designed to increase connectivity with Youngs Bay and the Columbia River, while maintaining a certain degree of flood protection. The tide gates were replaced on 12 October 2005. Measurements were initiated in May 2005 and are ongoing. Tide gate replacement resulted in an increase in tidal amplitude from 0.50 m to about 0.75 m inside Vera Slough. The truncated vertical amplitudes indicate the effectiveness of the tide gates at limiting full tidal connection, while providing flood control and improved circulation and access to wetland habitats for juvenile salmonids in the area. During the post-replacement period, mean daily water temperature deviation between reference and restoration sample sites was generally < 1 °C, whereas prior to the restoration action the deviation was as high as 4 °C.

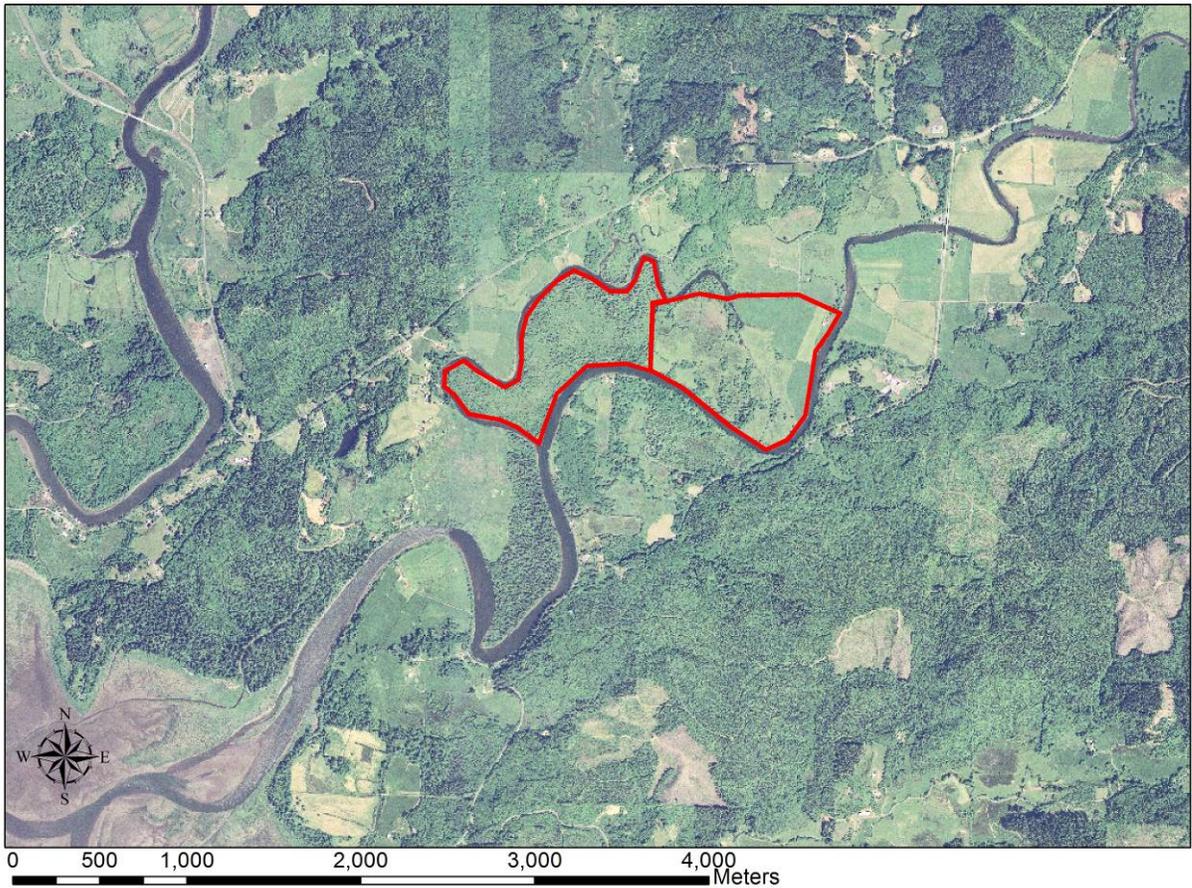
**Figure 1.4.** Kandoll Farm Dike Breach and Culvert Replacement Site (right side of polygon) and Reference Site (left side of polygon), between Seal Slough and the Grays River in Washington

Kandoll Farm on the Grays River in Washington was selected to represent the tidal freshwater swamp restoration (Figure 1.4). The property is owned by the Columbia Land Trust (CLT) and restoration was being planned and managed by CLT with engineering by Ducks Unlimited. Following baseline data collection in the spring and summer of 2005, the two small tide gates restricting flow into the slough were replaced with 13-ft-diameter culverts (Figure 1.5), and the dike along the Grays River was breached in three places in September 2005. Objectives of the project included permanently protecting and restoring 163 acres of diked tideland and approximately 1 mile of shoreline in order to increase access to swamp habitat, lower water temperatures, raise dissolved oxygen levels, and increase food web productivity. Kandoll Farm is part of the Grays River complex, which includes 927 acres of permanently protected habitat lands - spruce forested wetlands (swamps), floodplain channels, and emergent/scrub-shrub wetlands. The CLT has restored salmonid access to 400 acres of formerly diked floodplain habitat and enhanced 116 acres within the Seal Slough-Grays River parcel (reference site) through the removal of logging road crossings of tidal channels (Ian Sinks, pers. comm.).

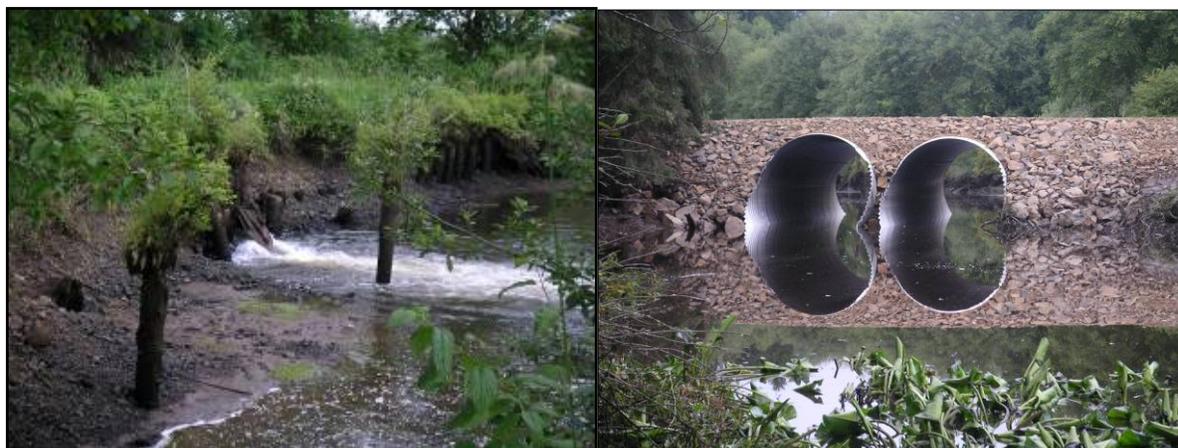
**Figure 1.5.** Tide Gate at Kandoll Farm before (left) and Culverts after (right) Replacement

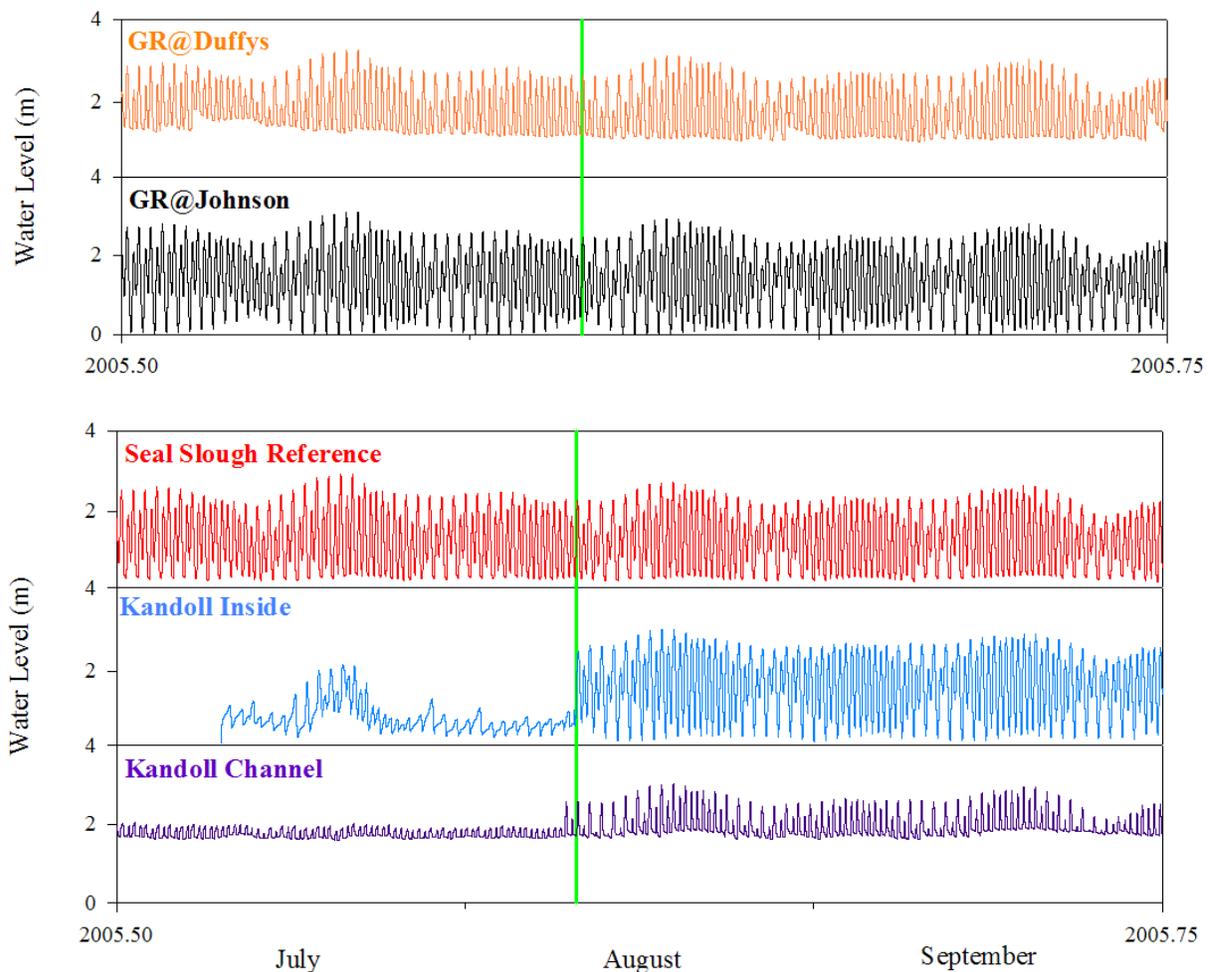
**Figure 2.1.** Time Series of Water-Level at Hydrographic Stations within the Grays River System before and after the Tide Gate Removal (green vertical line)

Tide gate removal and dike breaching activity had an immediate effect on water-level fluctuations within the Kandoll Farm site (Figure 2.1). At the Kandoll Inside station, pre-breach fluctuations changed from a weak tidal signal to a fully semidiurnal pattern. Maximum amplitudes increased from ~1.0 m to ~3.0 m. The Kandoll Channel station, which was located at a higher elevation than the Kandoll Inside station, also had a ~3x change in mean amplitude albeit at a lower level. Spectral analysis confirms a change in tidal properties (Figure 2.2) as the tidal prism, inundation levels, and flux of water through the system were greatly increased.

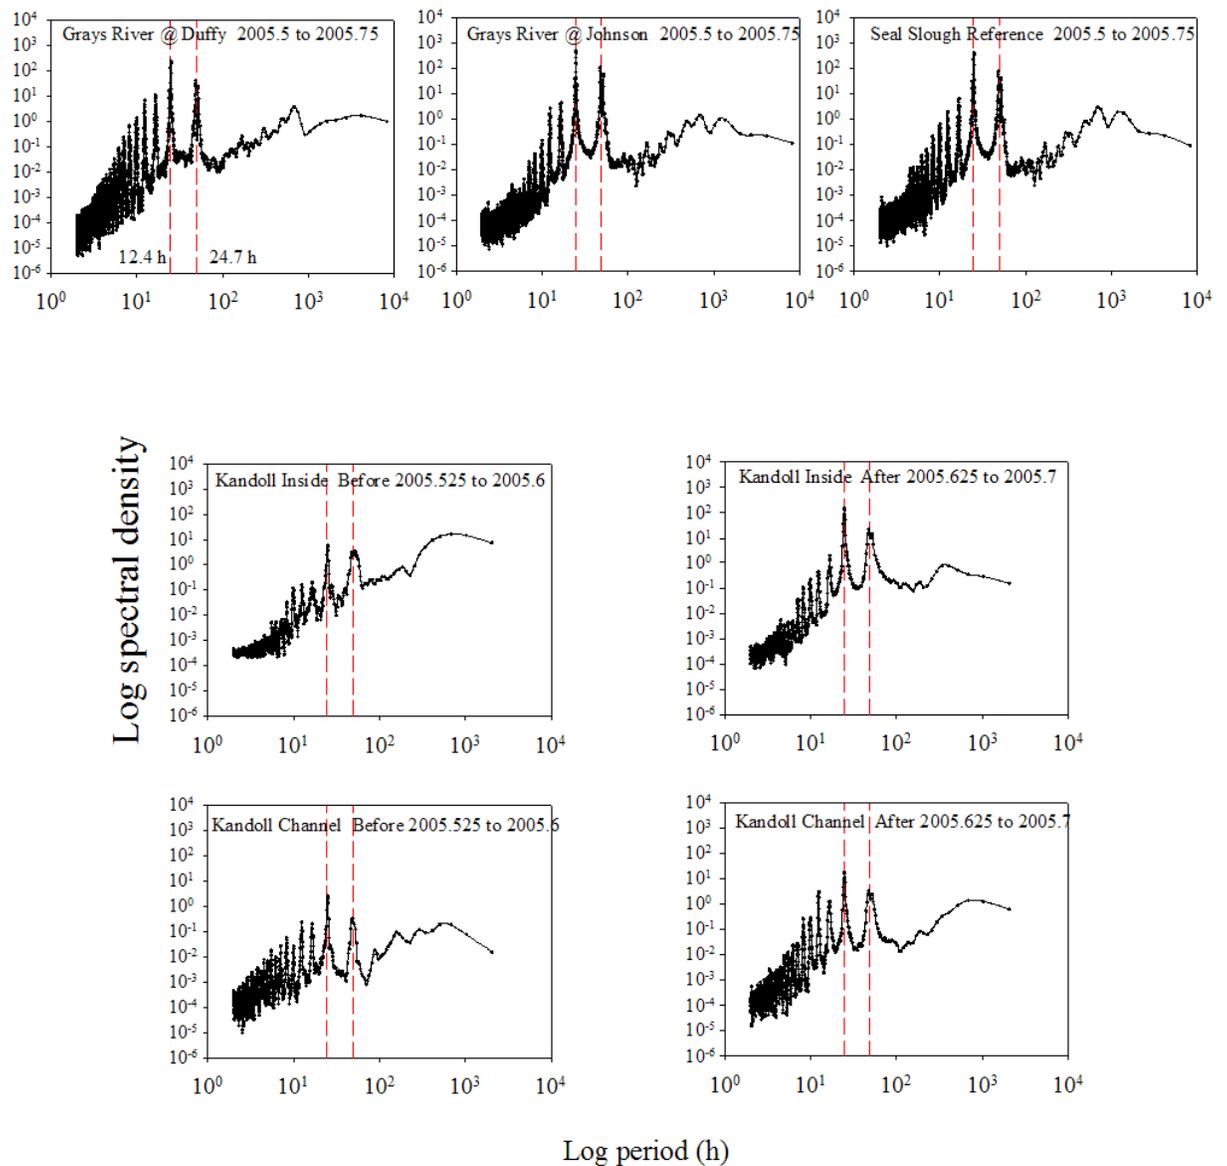
**Figure 2.2.** Spectral Density (square of the variance) Plots of Water-Level Data Measured at Hydrographic Stations in the Grays River System. Water-level variance was concentrated at semidiurnal periods at all stations. Top row -- reference stations outside of restoration area. Middle row -- before and after tidal gate removal at the Kandoll Inside station, respectively. Bottom row -- before and after tidal gate removal at the Kandoll Channel station, respectively.

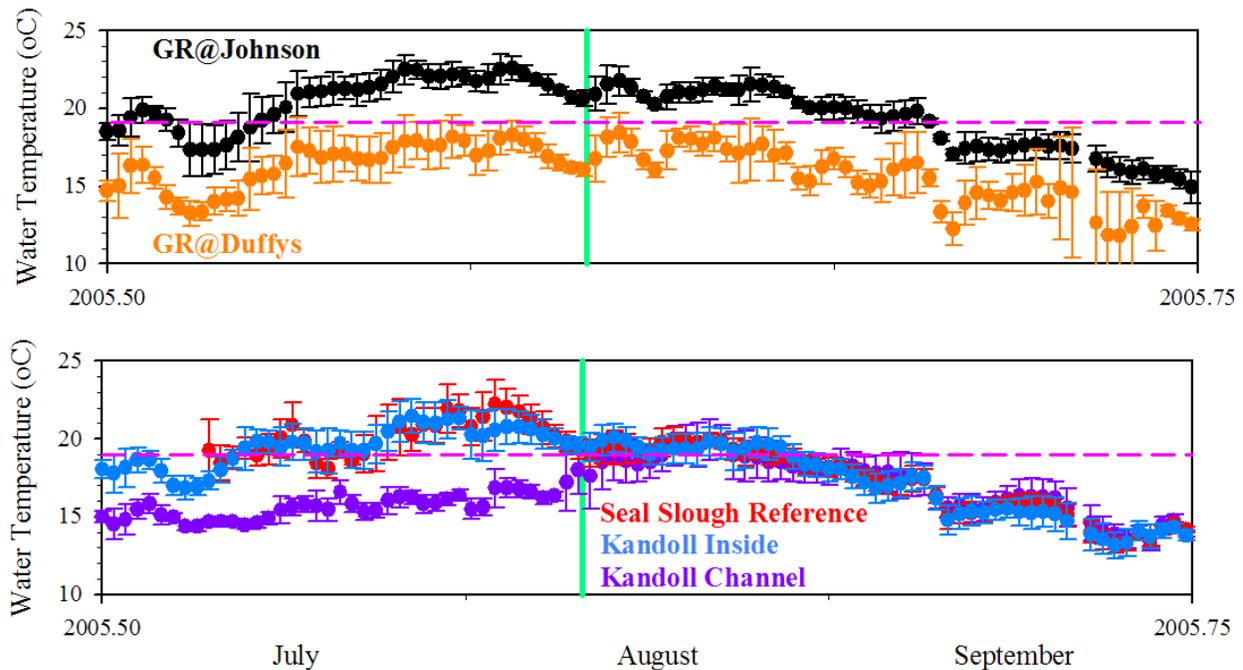
**Figure 2.3.** Mean Daily Temperature (+ sd) at Hydrographic Stations within the Grays River System before and after the tide gate removal (green vertical line)

sensor, temperatures during the July-August period reached or exceeded the 19 °C threshold used to delimit conditions for salmonids (Bottom et al. 2005). Most salmonids had probably moved through the system by this date (Roegner et al. 2006). Considering the Grays River stations, mean daily temperatures in summer were as much as 4 °C cooler in the Grays River at Duffy's compared with Grays River at Johnson, which may be caused by intrusion of Columbia River water to the Johnson site.

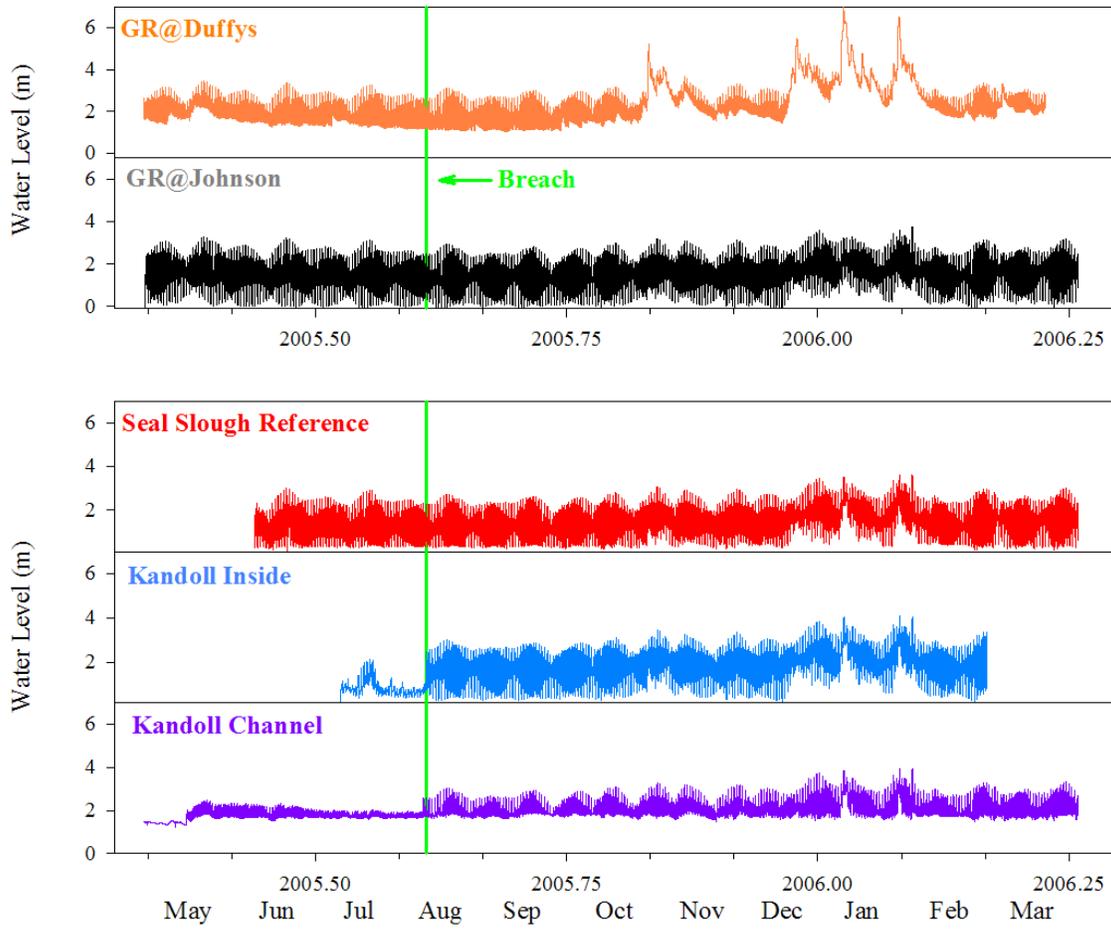
**Figure 2.4.** Time Series of Water-level at Hydrographic Stations within the Grays River System for the May 2005 through March 2006 period. Note flood conditions in Nov. 2005 and winter 2005-2006.

Long time series of water-level and temperature data are useful for evaluating system-wide impacts, especially episodic events (storms), which can impart lasting structural changes to topography and biota and are a source of uncertainty regarding restoration trajectories (Diefenderfer et al. 2005). The storm events of winter 2005-2006 were clearly recorded in the Grays River system hydrography. The GR@Duffys station measured several flood events that raised water levels ~3 m above mean high water, with peak levels approaching 7 m above NAVD88 datum (Figure 2.4). Interestingly, all other instrument stations measured more modest 1-2 m flood events. It appears the river flow was constrained within dikes at Duffy's causing a rapid surge that was dissipated within the flood plain further downstream. Note the temperature signal of the flood events, a ~9 °C increase from December 2005 to Feb 2006 (Figure 2.5).

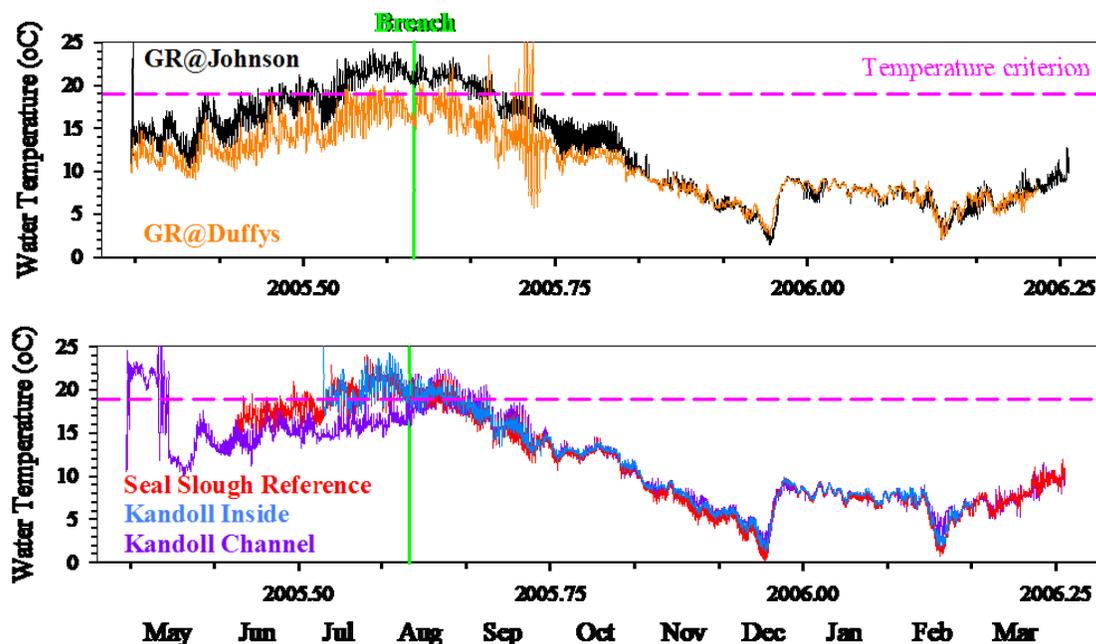
**Figure 2.5.** Time Series of Temperature at Hydrographic Stations within the Grays River System for the May 2005 through March 2006 Period

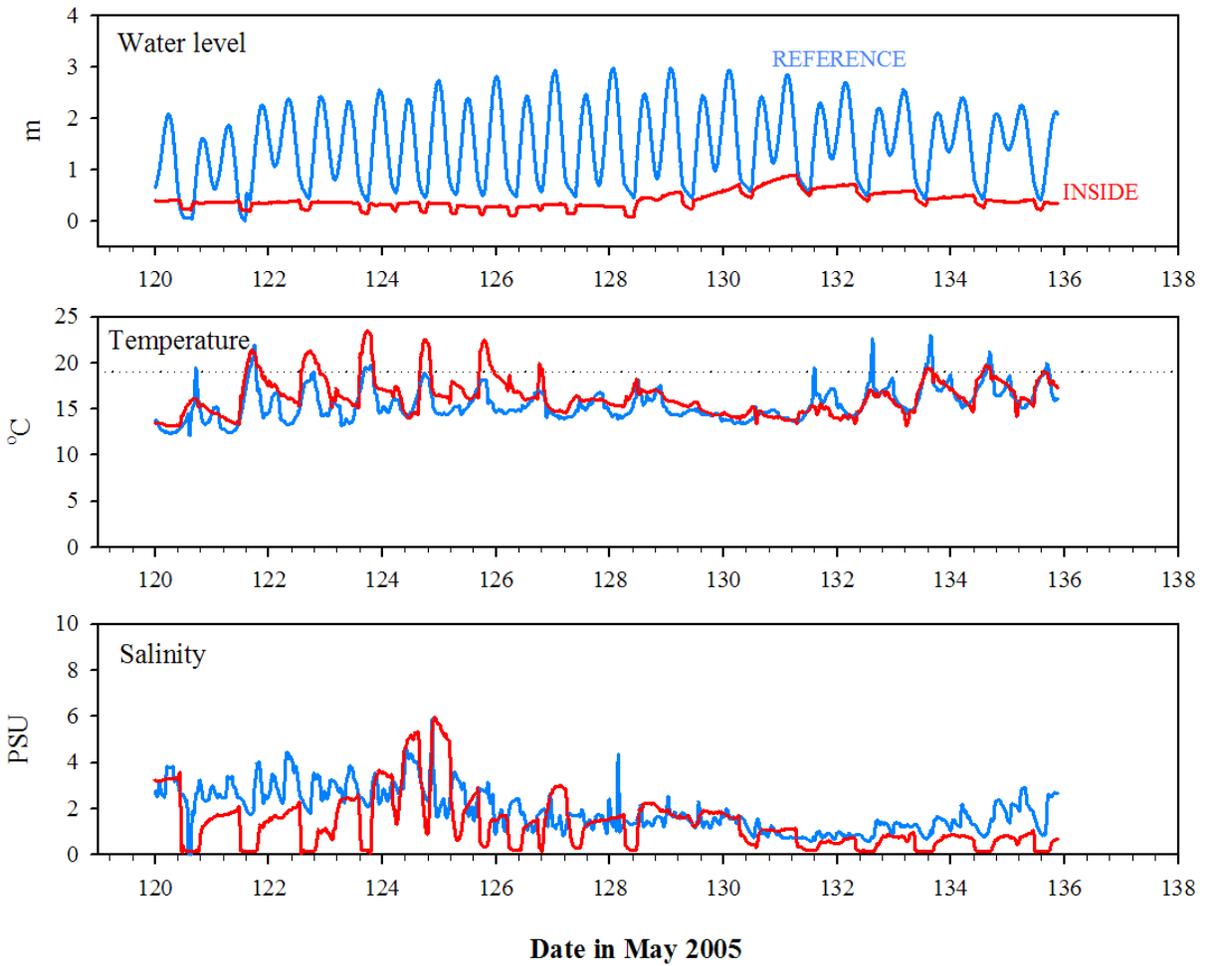
**Figure 2.6.** Vera Slough Pre-Tide Gate Replacement Conditions during May 2005. Time series of water-level, temperature, and salinity at Vera Inside (red) and Vera Reference (blue) hydrographic stations.

In the pre-replacement condition, tidal fluctuations at the inside station were about 0.10 m, while outside the tide gate and in the reference slough, a full semidiurnal tidal range of amplitude between 1 and 3 m occurred (Figure 2.6). Tide gate replacement resulted in an increase in tidal amplitude to about 0.5 m at the Vera Slough Inside station (Figure 2.7), which increased to about 0.75 m after tide gate adjustment (Figure 2.8). The truncated vertical amplitudes exhibited in both pre- and post-replacement time series indicate the effectiveness of the tide gates at limiting full tidal connection.

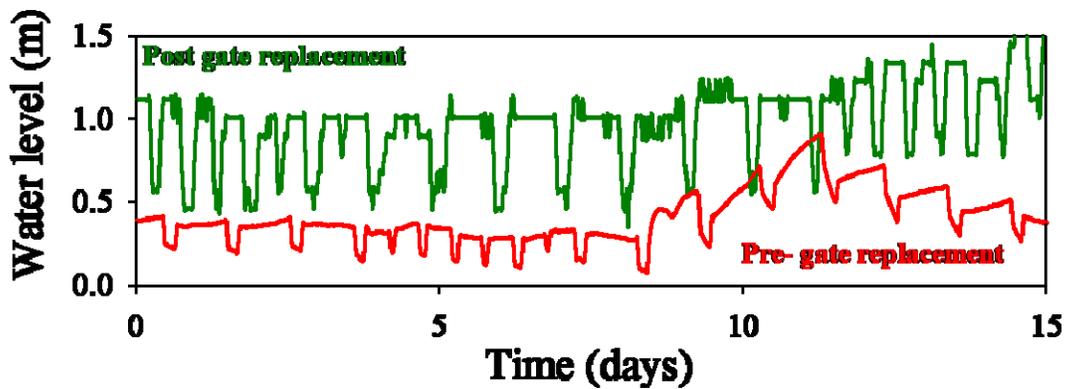
**Figure 2.7.** Vera Slough Pre- and Post-Tide Gate Replacement Conditions during September 2005. Time series of water-level Vera Inside (red) and Vera Outside (green) hydrographic stations.

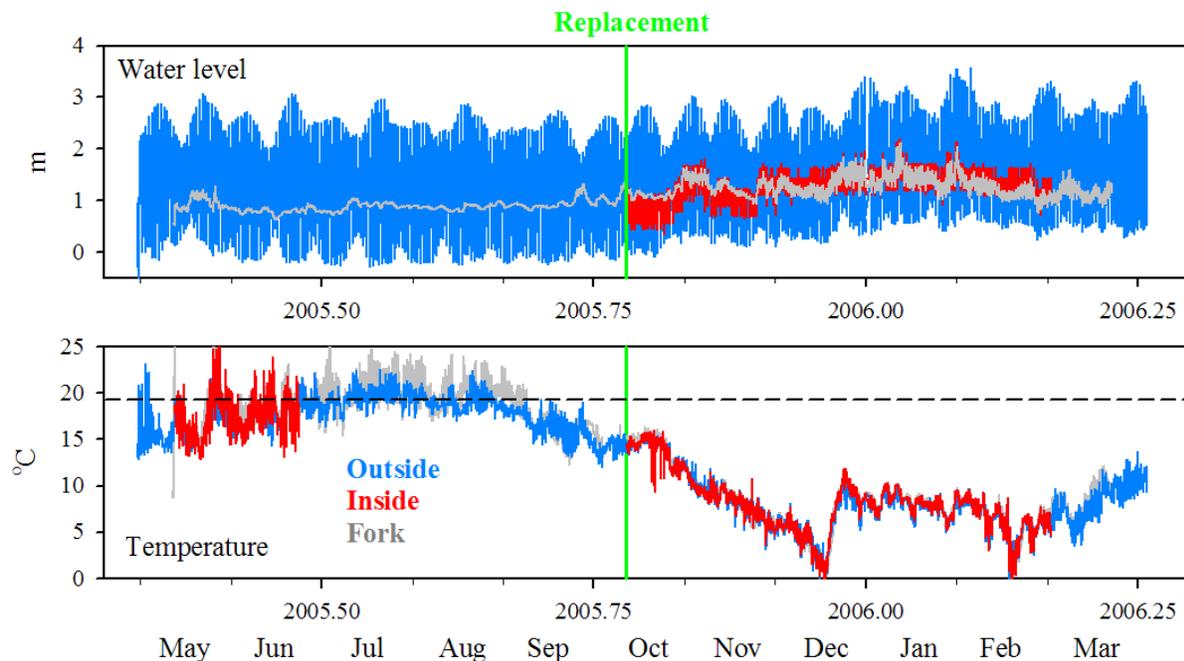
**Figure 2.8.** Time Series of Water-Level and Temperature at Hydrographic Stations within the Vera Slough System for the May 2005 through September 2006 Period. Vera Outside, blue; Vera Inside, red, Vera Forks, grey. Tide gate replacement, green vertical line. Dashed horizontal line designates 19 °C temperature threshold.

Analysis of water levels at the Vera Forks station illustrates the effect of increased tidal reconnection on larger spatial and temporal scales (Figure 2.8). During the pre-replacement period of May to October 2005, mean water level at Vera Forks was  $0.89 + 0.11$  m, and daily fluctuations were generally  $< 0.05$  m. Spectral analysis of the time series detected a weak semi-diurnal peak but a lack of a diurnal peak in variance (Figure 2.9). In contrast, during the post-replacement period after October, mean water level increased to  $1.27 + 0.20$  m, and daily water-level fluctuations increased to a maximum of 0.60 m. Some of this overall increase in water level was likely due to seasonal factors. However, a semidiurnal tidal period was evident in the water-level spectrum post-replacement (Figure 2.9), indicating tidal fluctuations had increased upstream of the tide gate.

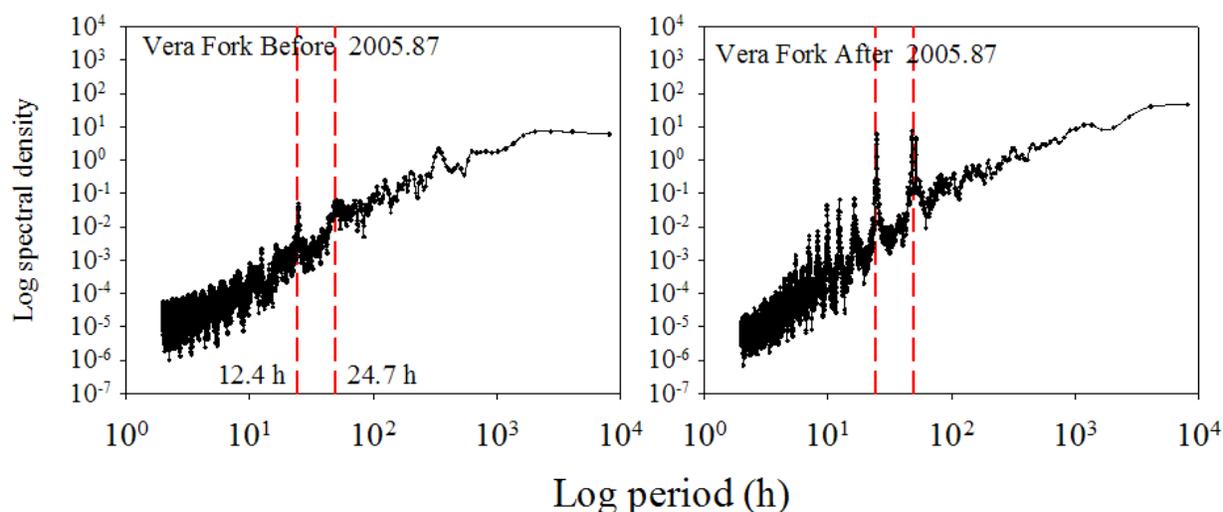
**Figure 2.9.** Spectral Density (square of the variance) Plots of Water-Level Data Measured at Vera Forks Before and After Tide Gate Replacement. Tidal constituents increased in the post-replacement period.

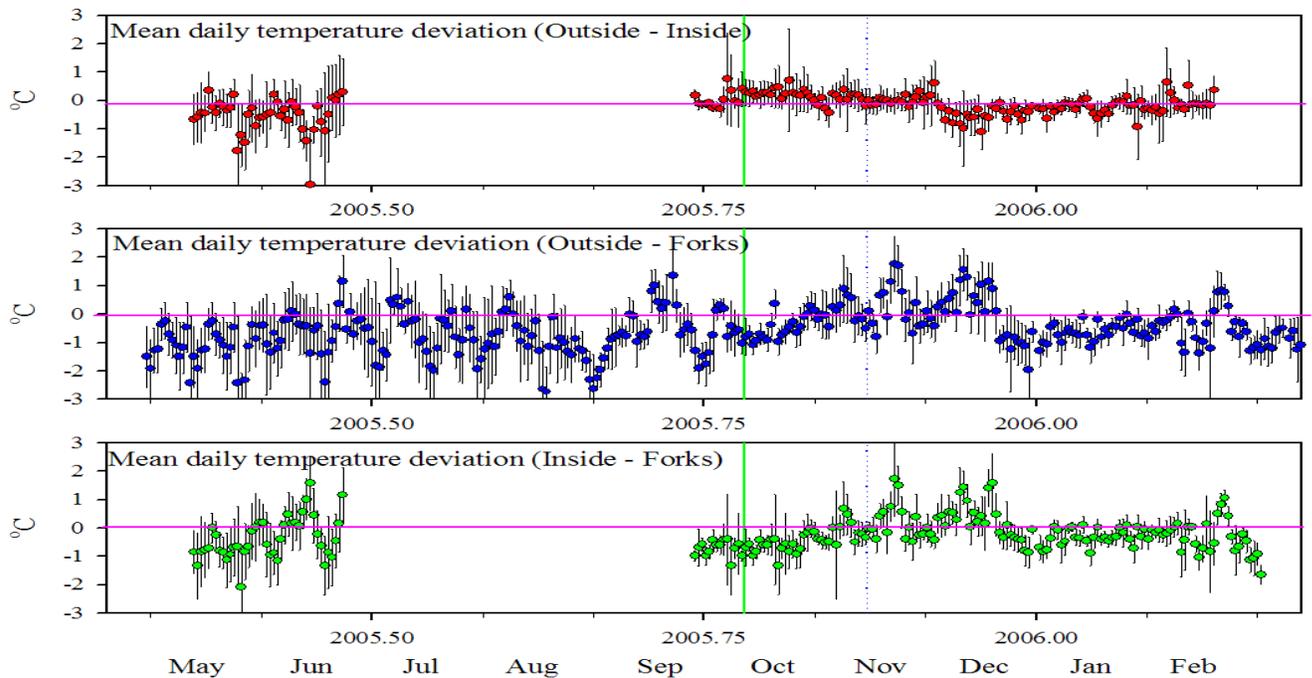
**Figure 2.10.** Mean Daily Temperature Deviation Time Series for Vera Outside – Vera Forks, Vera Outside – Vera Inside, and Vera Inside – Vera Forks Tide gate replacement, green vertical line.

During the post-replacement period, mean daily water temperature deviations between Vera Slough Inside and Outside and Vera Slough Inside and Forks were all generally < 1 °C (Figure 2.10). Temperature gradients will be assessed more fully when new data are available. Limited salinity data are shown in Figure 2.11 for the October-September 2006 post-replacement period. Salinity measurements inside ranged from ~5 to 10 psu and exhibited a spring-neap periodicity. Daily fluctuations were 1 to 4 psu. The data loggers recorded higher overall salinities in the late summer-early fall than had been previously measured (Figure 2.6). Salinities of this range can control floral and faunal distributions.

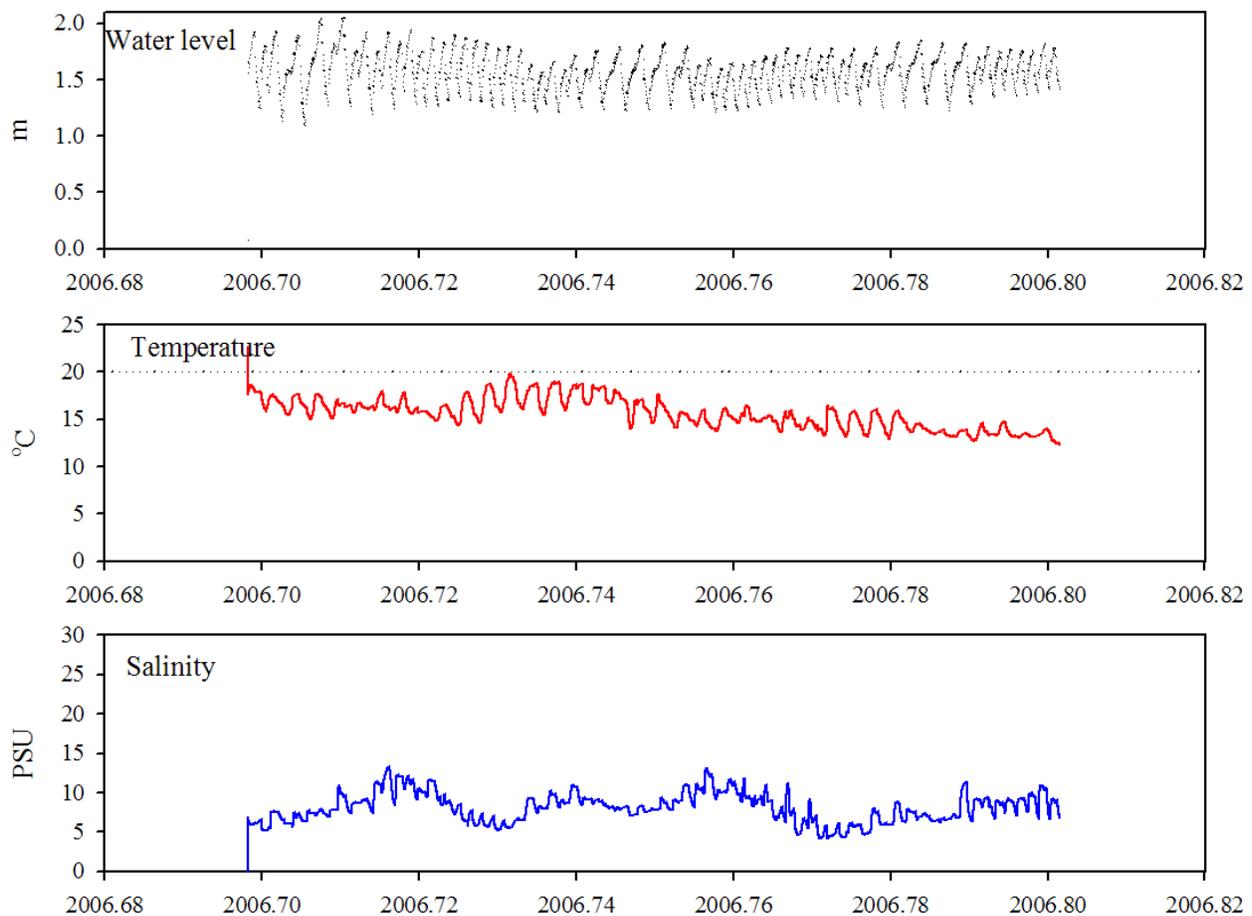
**Figure 2.11.** Time Series of Water Level, Temperature, and Salinity at Vera Inside during Post-Tide Gate Replacement Conditions in September and October 2006

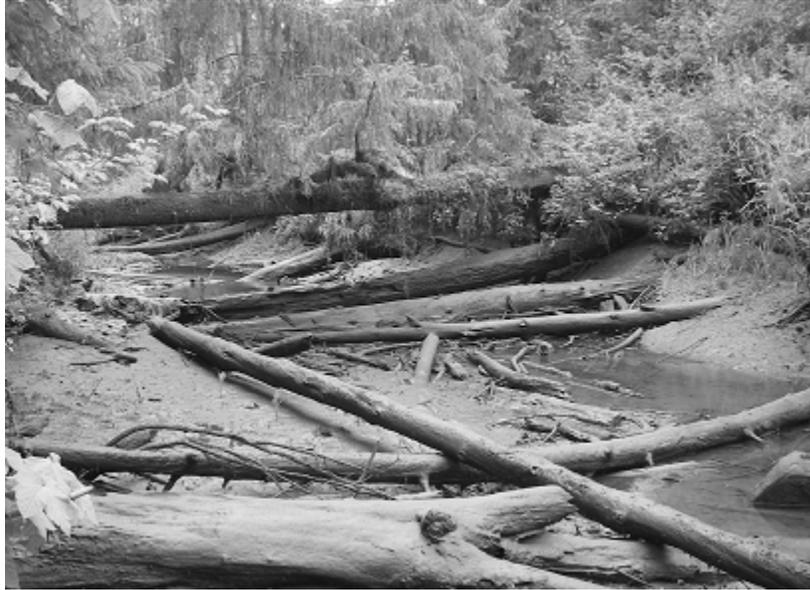
**Figure 3.2.** Wood in Seal Slough Side Channel. Exposed by a minus tide, looking upstream at the tailout of one pool (right) and the deepest portion of another (left). Elevated nurse log across channel supports *Picea sitchensis* saplings.

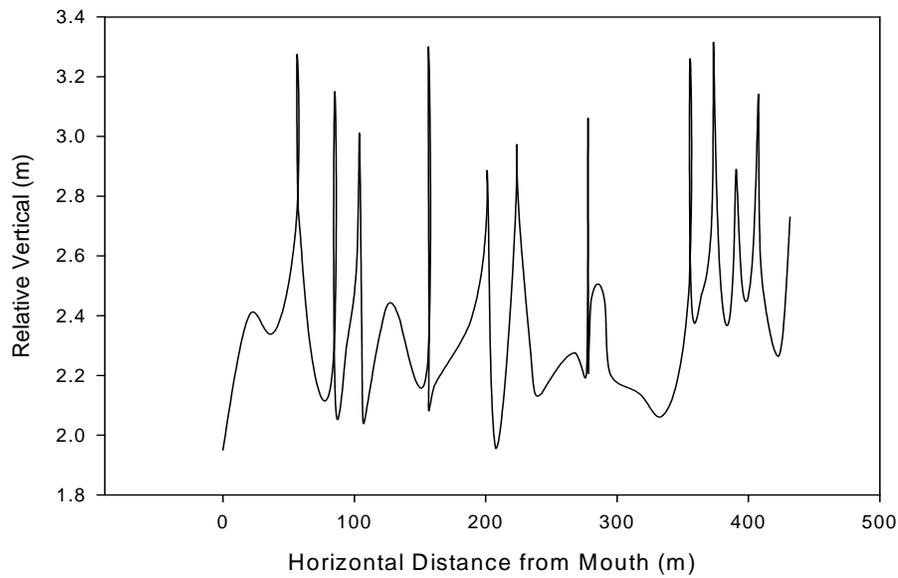
**Figure 3.3.** Longitudinal Surveys of Forested Wetland Channels in Seal Slough, Secret River, and Crooked Creek. Bold lines represent substrate elevation immediately downstream and upstream of log jams. Peaks are log jams or beaver dams, and troughs are pools.

Two features of the tidal channels in *Picea sitchensis*-dominated wetlands in the vicinity of the Grays River evidence a forced step-pool morphology (Montgomery et al. 1995; Montgomery and Buffington 1998). First, the average number of channel widths per pool (1.7) falls within the characteristic range. Second, the observed sequence of log jams (steps) with pools between them is typical of forced step-pools. These tidal channels, however, are different from others to which this classification has previously been applied in that the tidal channels have bidirectional flow and very low gradients whereas the riverine channels typically do not. In fact, the tidal pool structure is reversed from that of typical mountain streams. In the tidal channels, pools most frequently are located immediately upstream of log jams, with tails located upstream of the pool just downstream of the next obstruction. This suggests that the incoming flood tide, in plunging over the log jams and beaver dams once the water-level exceeds their elevation, plays a larger role in structuring channels longitudinally than does the ebb tide.

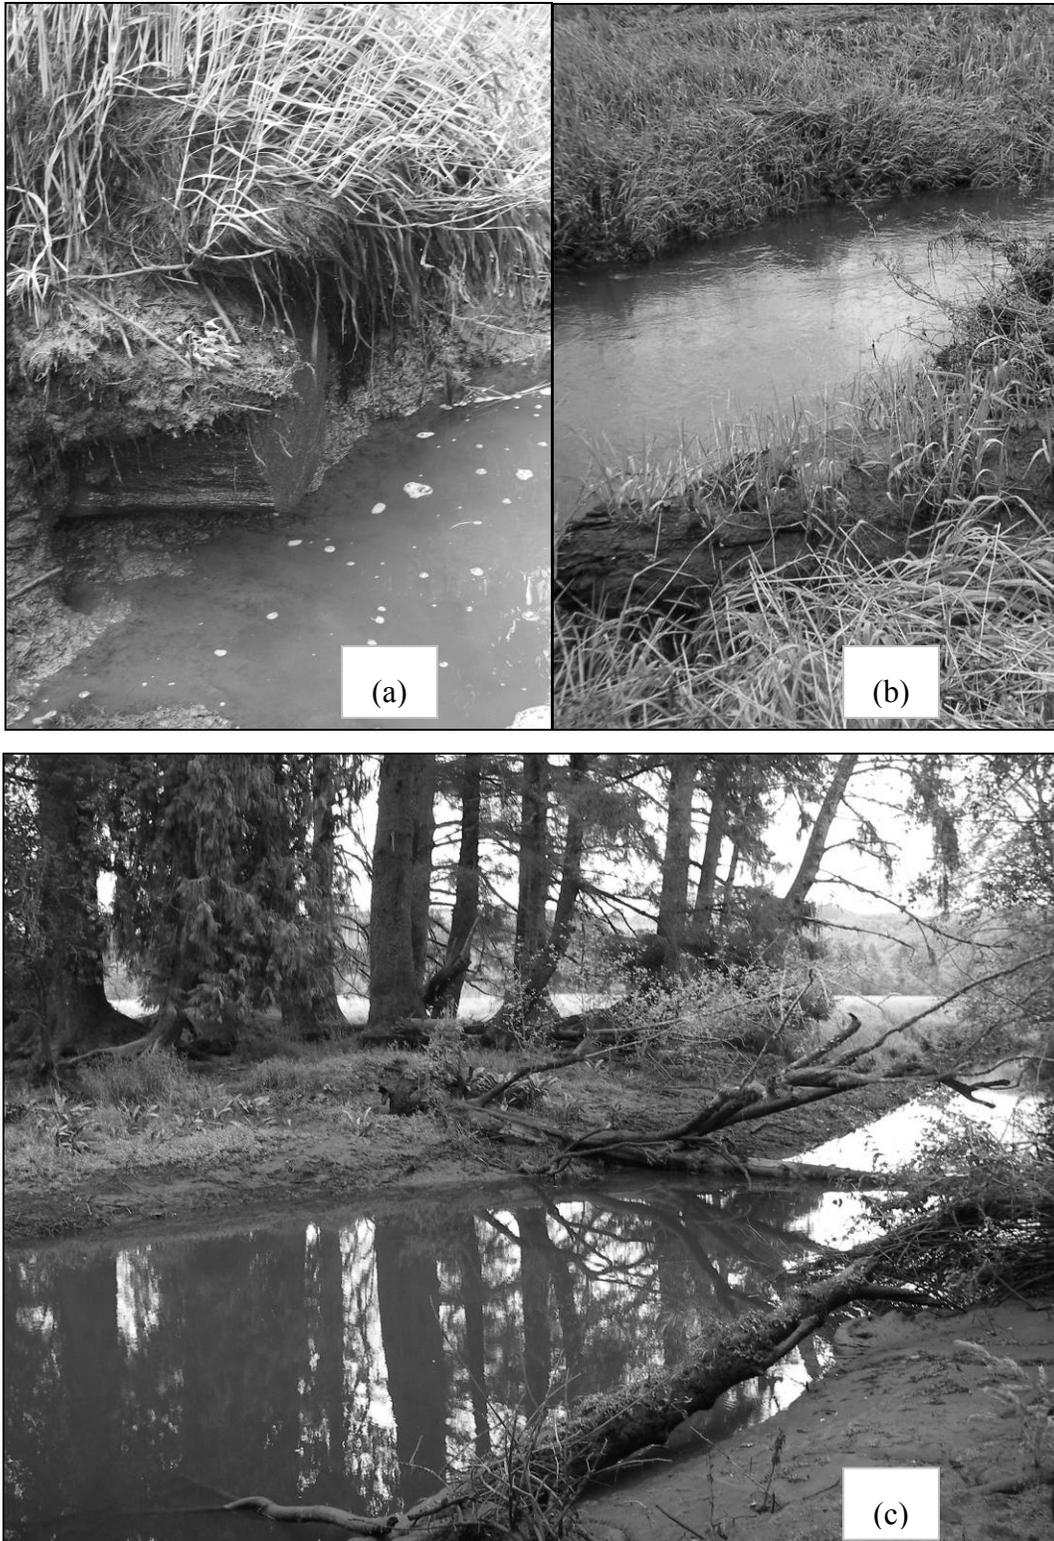
**Figure 3.4.** Logs Exposed by Channel Network Development following Dike Breaching at two Grays River Restoration Sites: (a) see Figure 3.1, (b) see Figure 3.1, (c) large woody debris (LWD) recruitment following culvert replacement in Seal Slough (see Figure 3.1).

Since culvert replacement at Kandoll in 2005, the developing channel network in the non-forested restoration area has exposed previously buried logs (Figure 3.4). In addition, many of the remaining trees on the restoration site succumbed in the first winter after increased inundation and some remain in or near the channels (Figure 3.4). Anecdotal observations showed that large wood located below the tide gates on Seal Slough moved out of the Seal Slough system following replacement with culverts and increased flow velocities and levels of inundation on the farm. Beaver dams mapped prior to culvert replacement were broken apart by the summer of 2006.

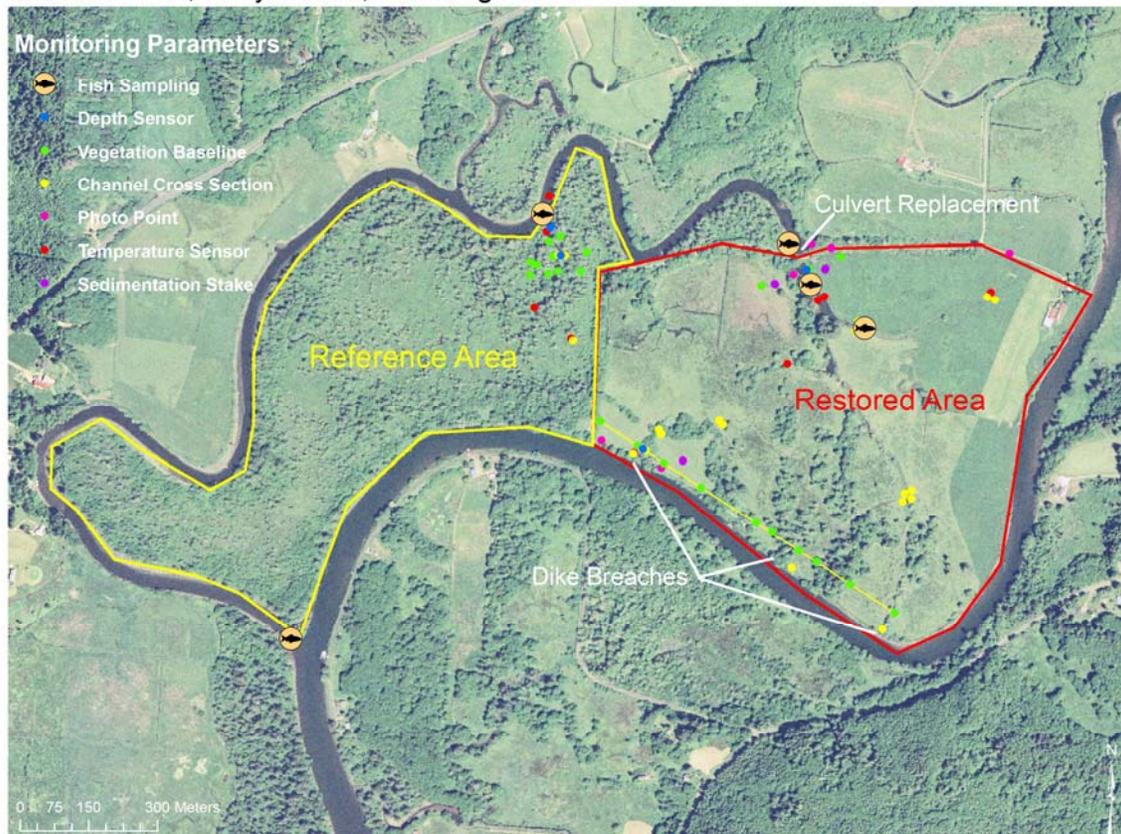
**Figure 4.2a.** Sampling Schematic for Kandoll

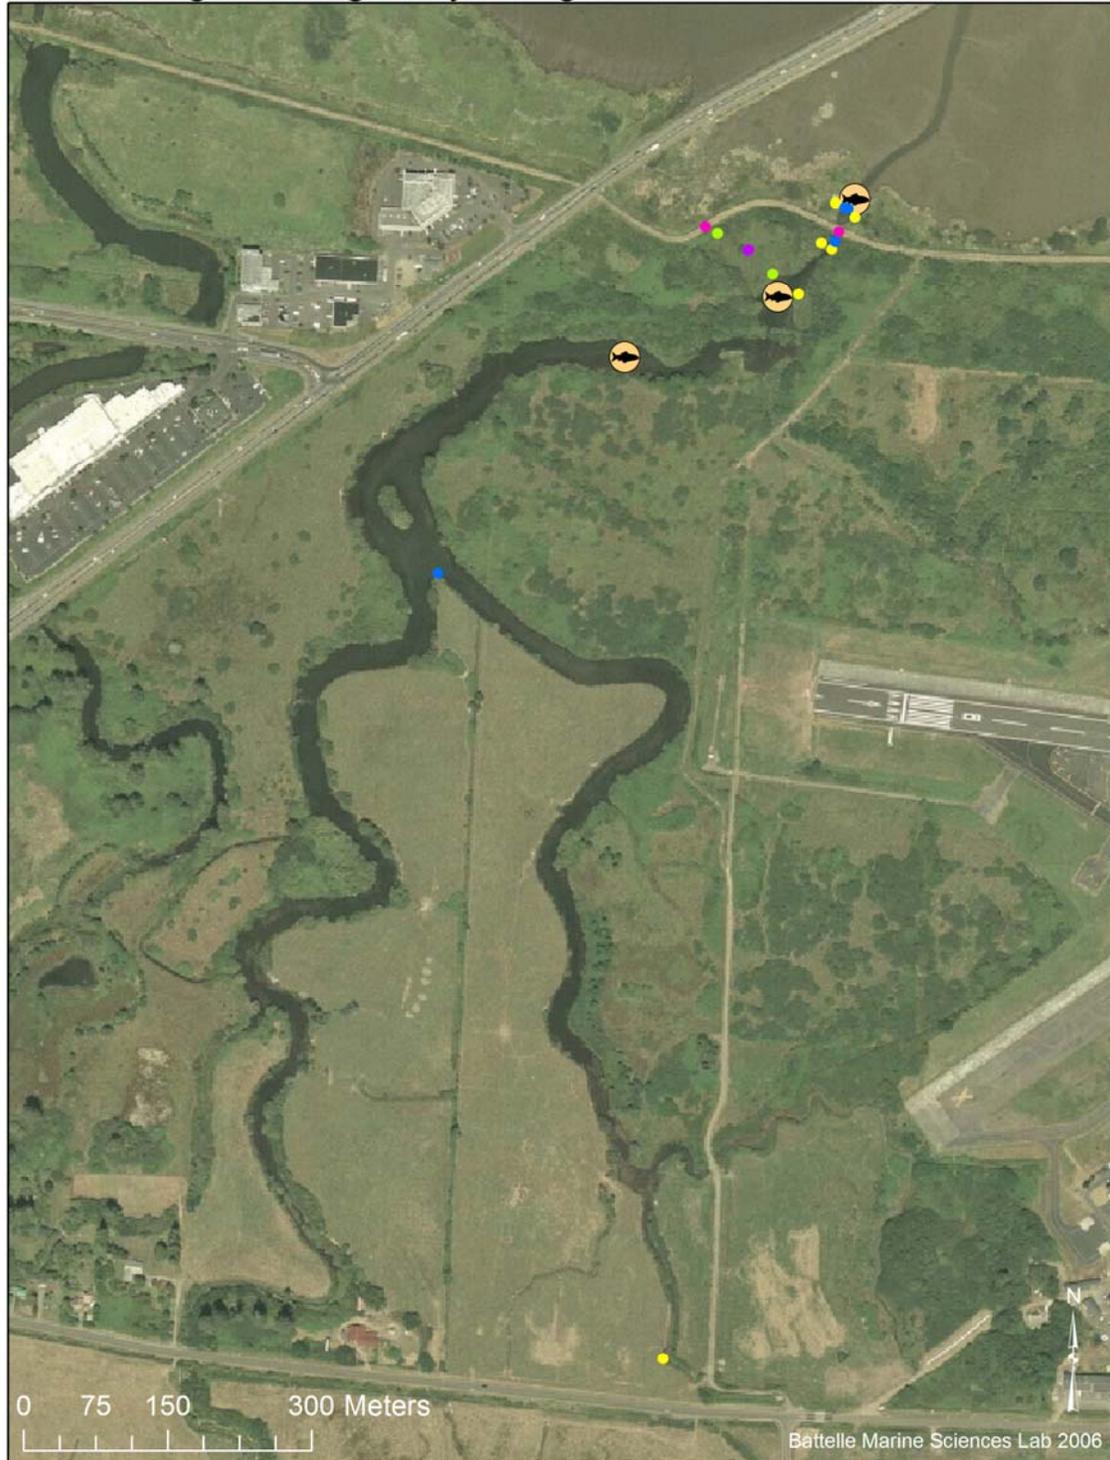
**Figure 4.2b.** Sampling Schematic for Vera
