# Evaluating Cumulative Ecosystem Response to Restoration Projects in the Columbia River Estuary, Annual Report 2006

FINAL REPORT  
December 10, 2007

Prepared for:  
U.S. Army Corps of Engineers, Portland District  
Under a Related Services Agreement with  
The U.S. Department of Energy  
Contract DE-AC05-76RLO 1830

Prepared by:  
Pacific Northwest National Laboratory, Marine Sciences Laboratory  
NOAA Fisheries, Pt. Adams Biological Field Station  
Columbia River Estuary Study Taskforce

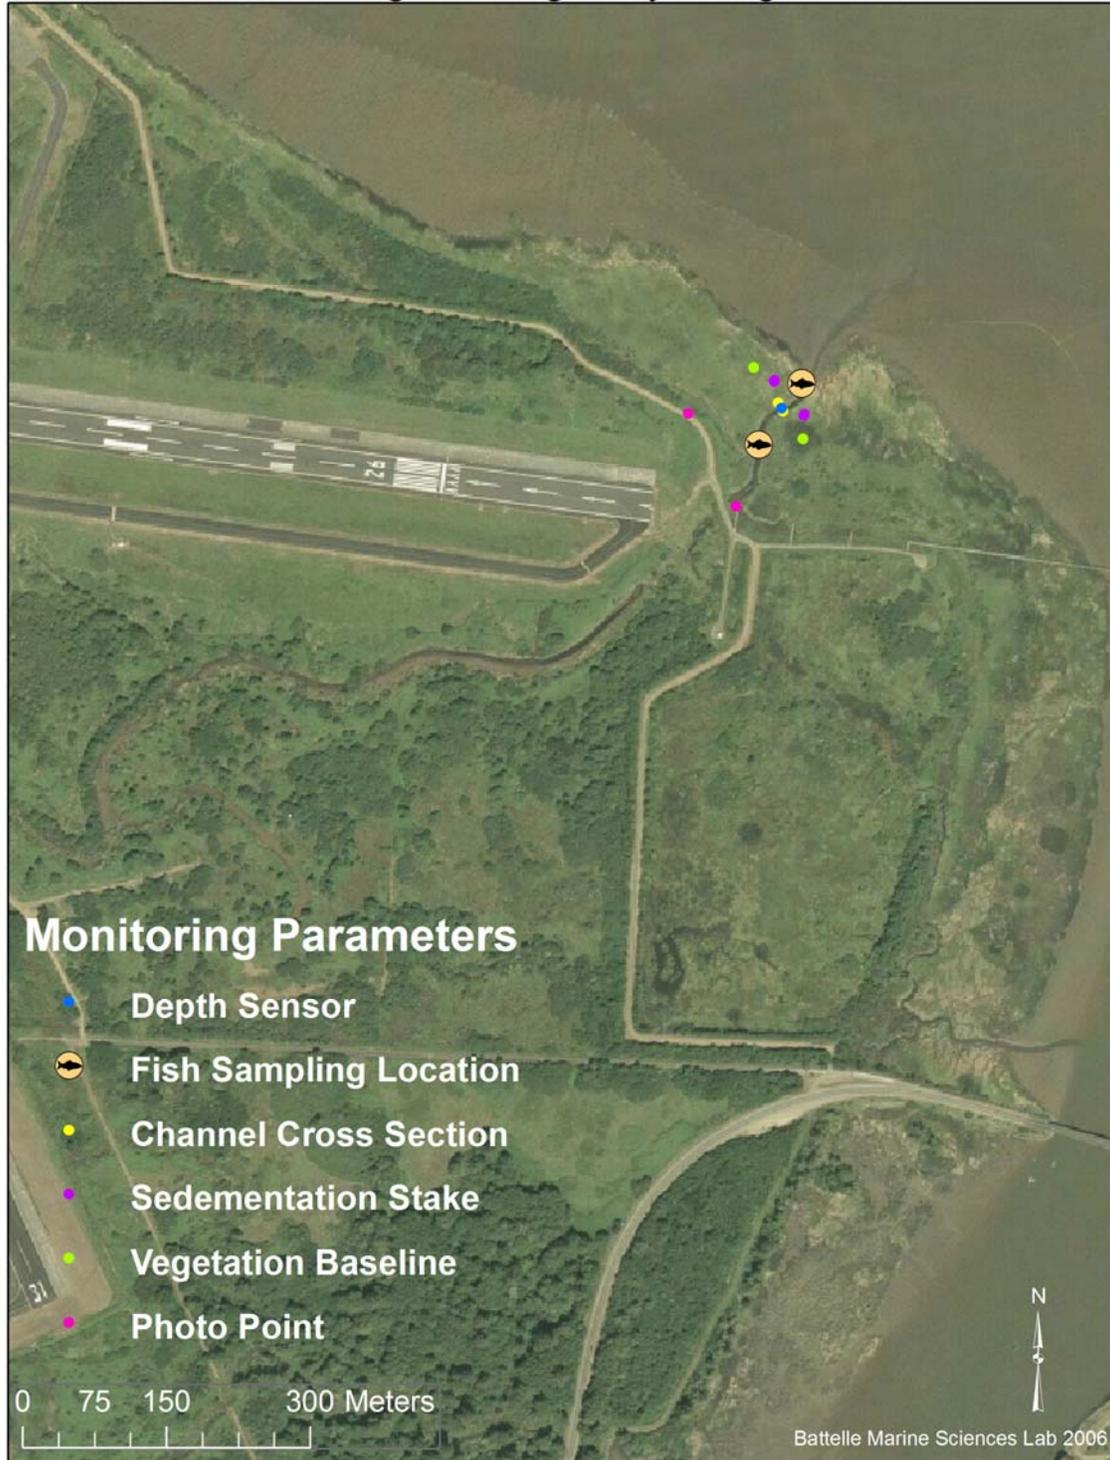
**Figure 4.2c.** Sampling Schematic for Vera Reference

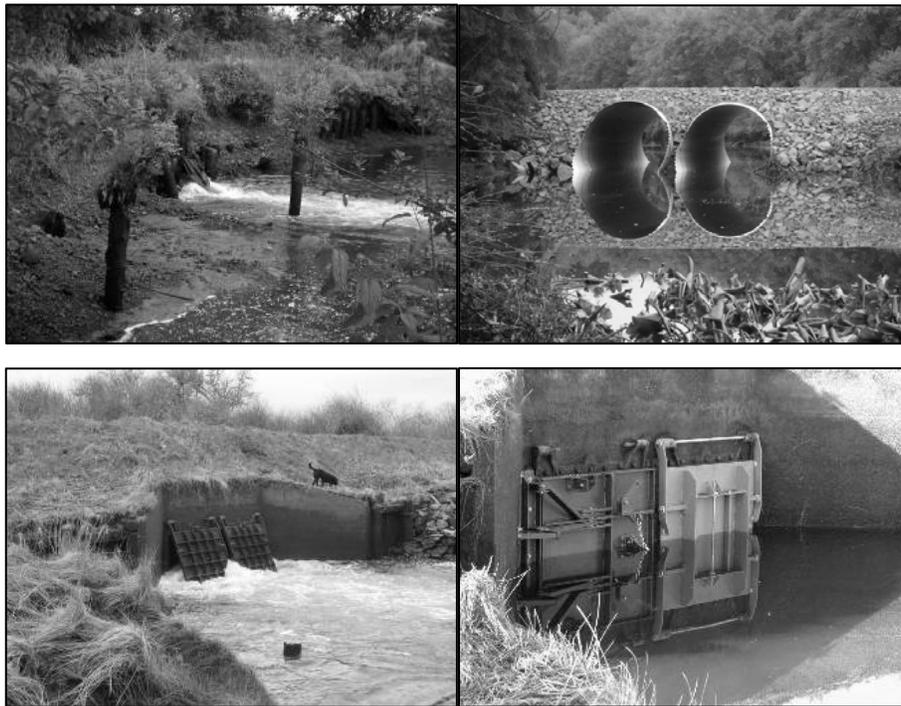
**Figure 4.3.** Tide Gate with 48-in Culvert on Seal Slough at Kandoll Road (left) Prior to Replacement with Twin, 13-ft Diameter Culverts (right) in 2005 (top) and Tide Gates at Vera Slough before (left) and after (right) Replacement in 2005 (bottom).

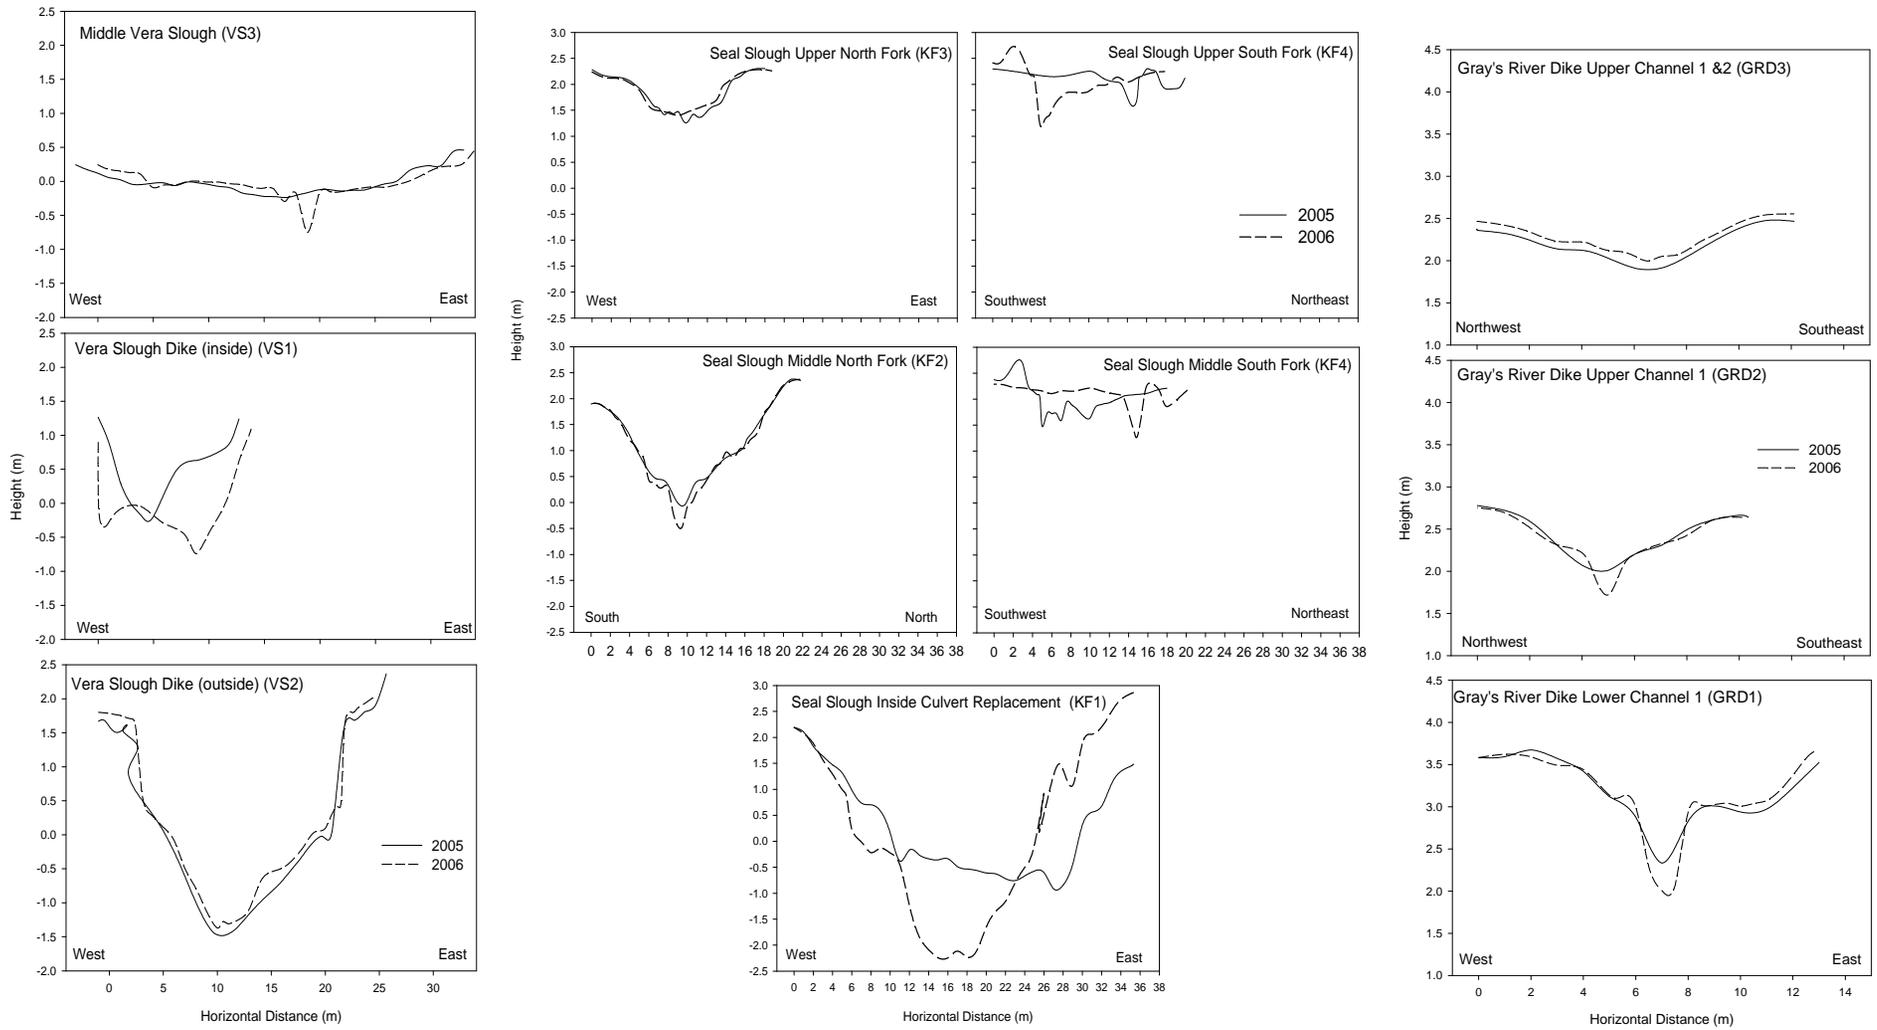
**Figure 4.4.** Channel Cross Sections before and after (a) Tide Gate Replacement (b) Culvert Replacement and (c) Dike Breaching

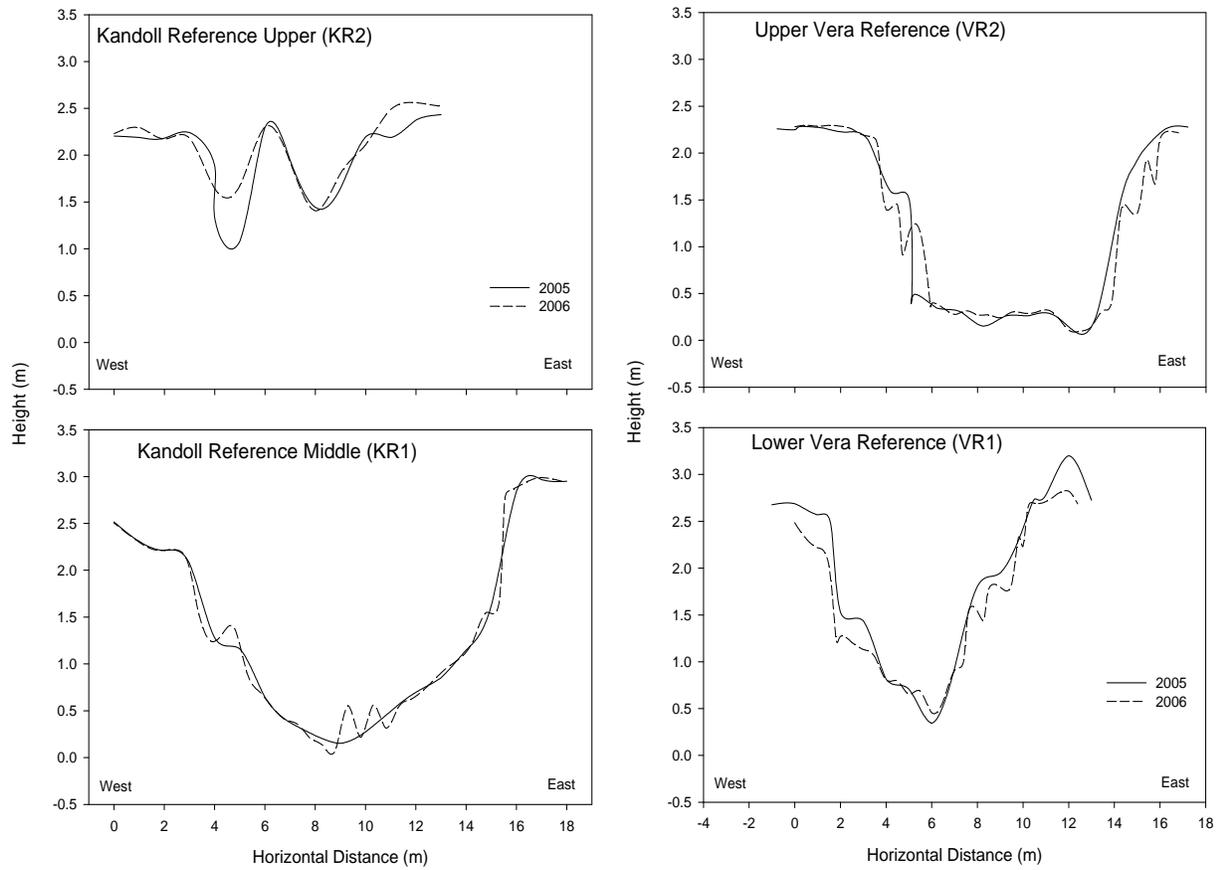
**Figure 4.5.** Cross Sections at Reference Channels before and after Nearby Restoration and Enhancement Actions

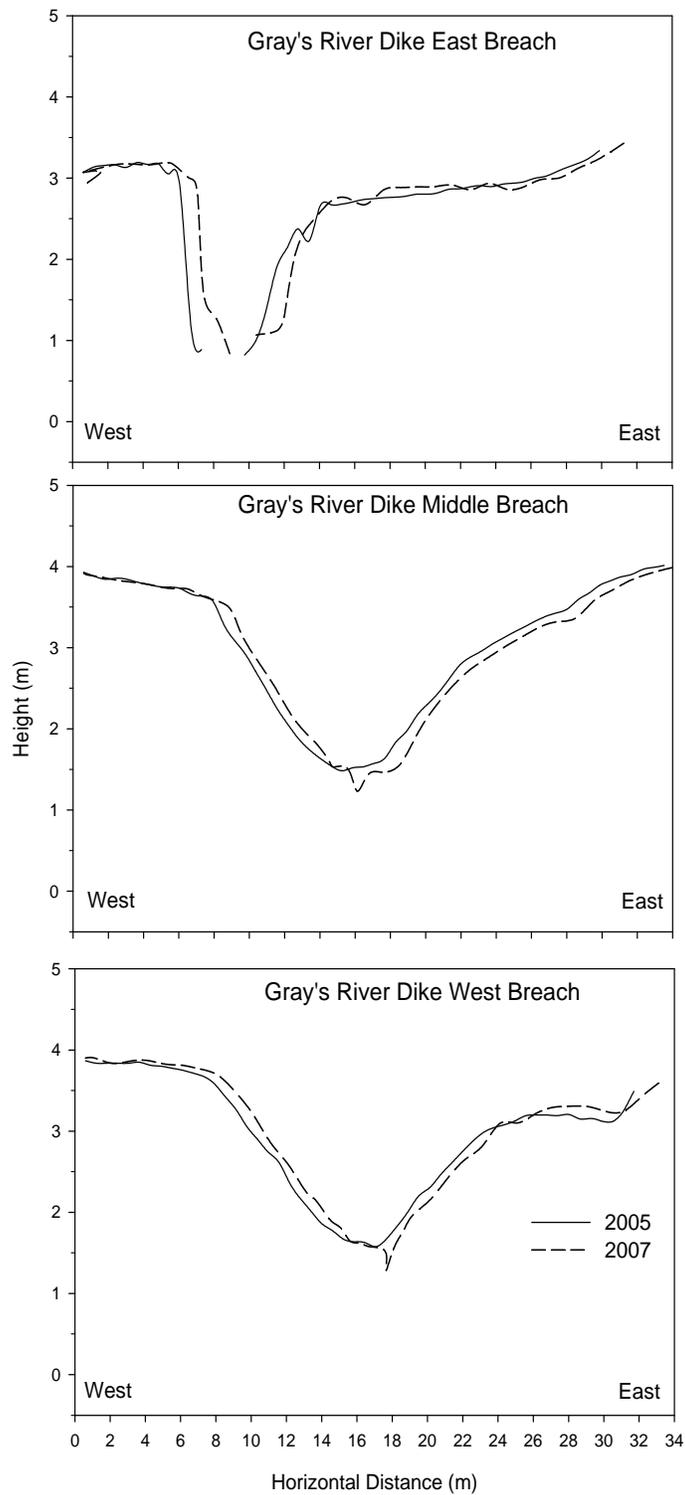
**Figure 4.6.** Three Dike Breaches on the Grays River: 2005. Data are from as-built surveys after excavation of the breaches.

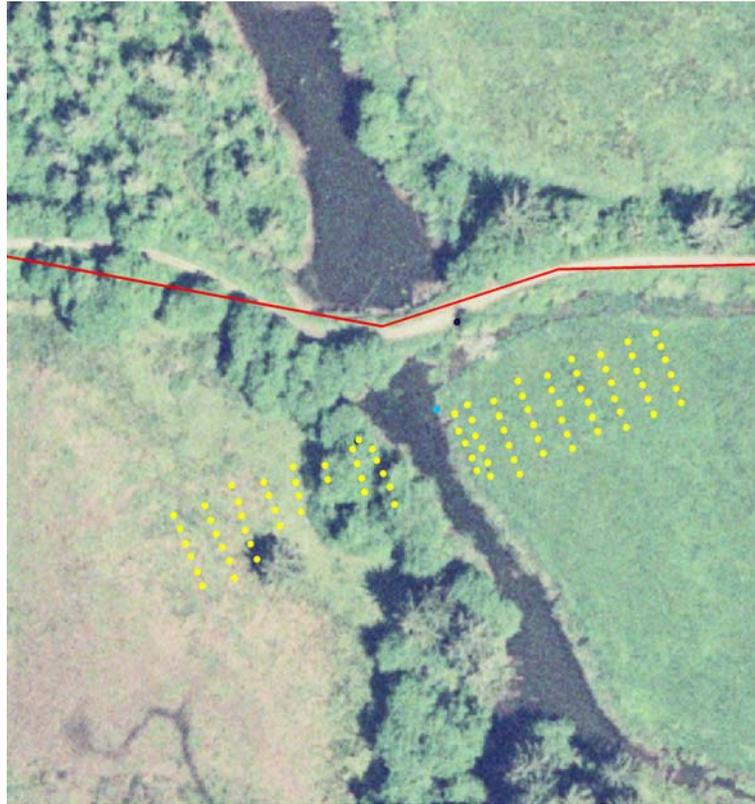
**Figure 5.1.** Vegetation Sampling Grid at Seal Slough in the Kandoll Farm Restoration Site

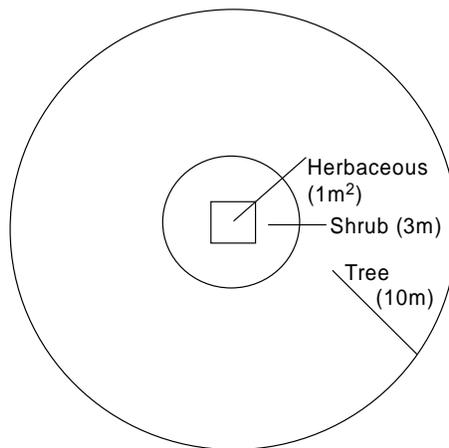
**Figure 5.2.** Vegetation Plot Design for Forested Wetlands

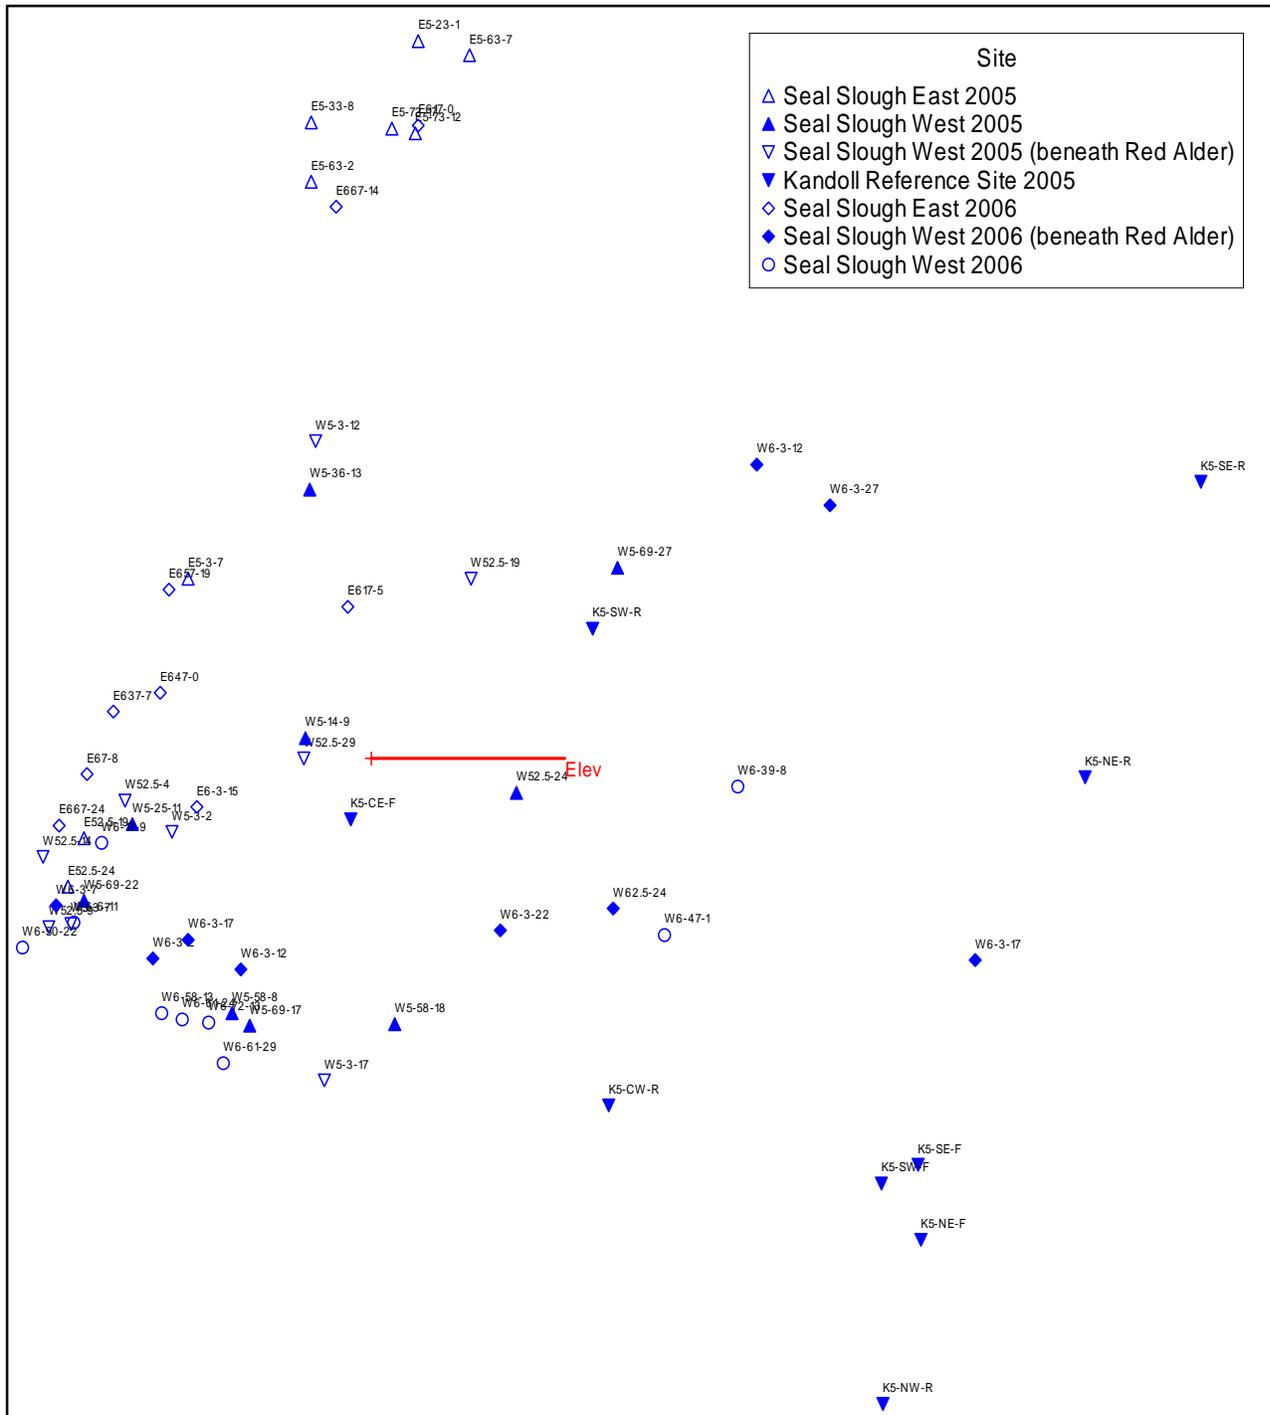
Figure 5.3. Non-Metric Multidimensional Scaling of 2005 and 2006 Species Composition Data

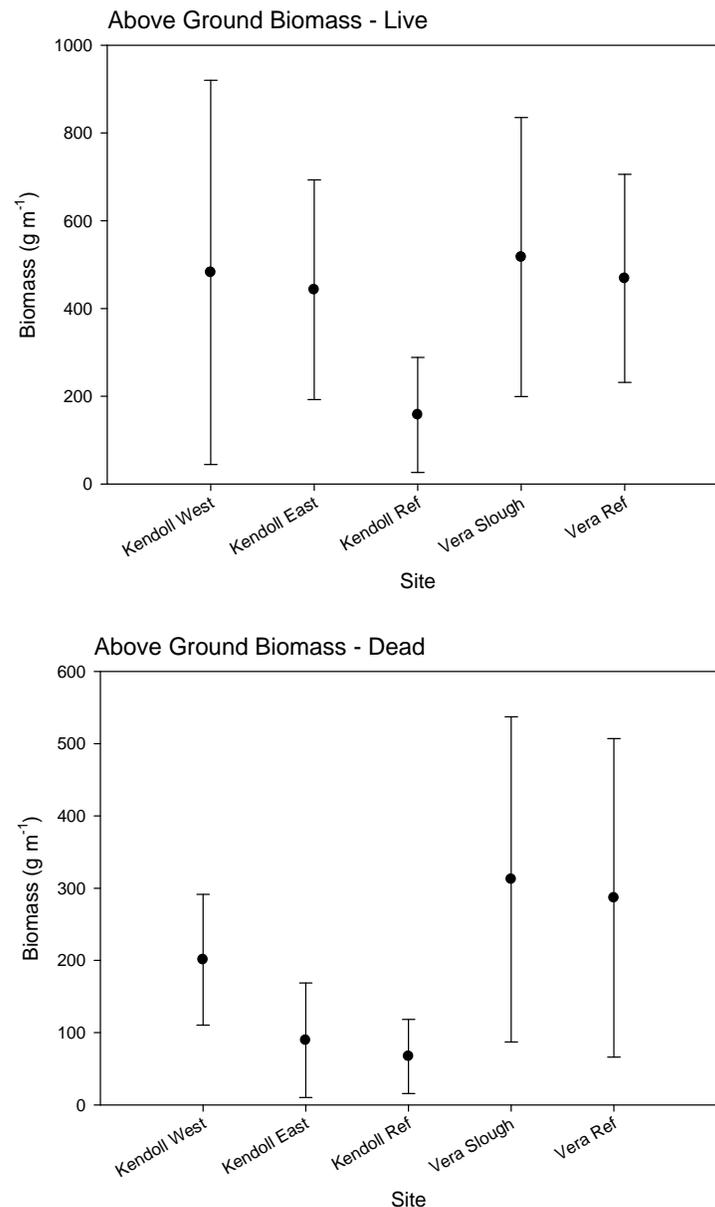
**Figure 5.4.** Amounts of Above-Ground Biomass, Live and Dead, Measured at Each Site

Above-ground standing live and dead macrophytic vegetation biomass was sampled along with below-ground organic matter. Above-ground biomass (AGOM) averaged nearly 500 g/m<sup>2</sup> at all sites except Kandoll reference (Figure 5.4). This tidal forested wetland site had a very low standing biomass of herbaceous plant species. Above-ground biomass showed high variance at all sites. Kandoll reference site had the highest ratio of dead to live biomass (Figure 5.5). Below-ground organic matter (BGOM) at Kandoll reference site was between 5% and 35% of soils (Figure 5.6). There appears to be no correspondence between below-ground organic matter and above-ground biomass. Vera Slough and Reference sites had similar AGOM levels, whereas BGOM was much greater in Vera Slough. This may reflect the restricted flushing of this site.

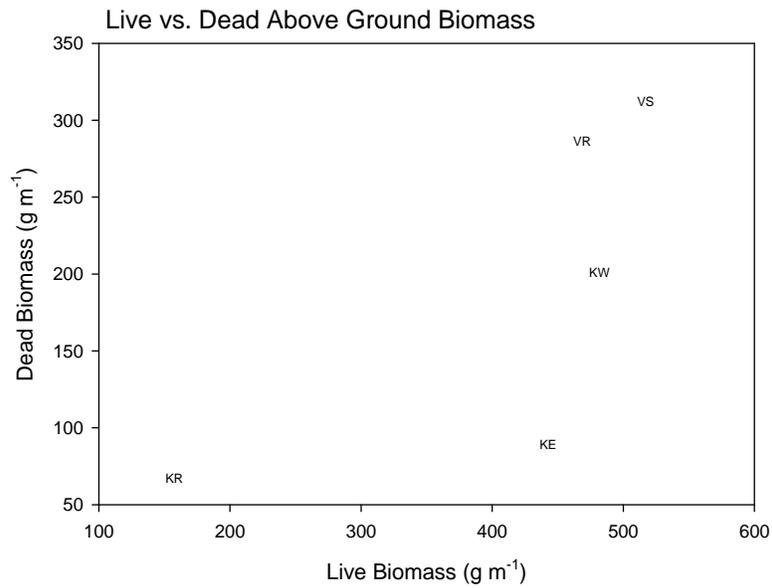
**Figure 5.5.** Comparison of Live to Dead Biomass at each Site

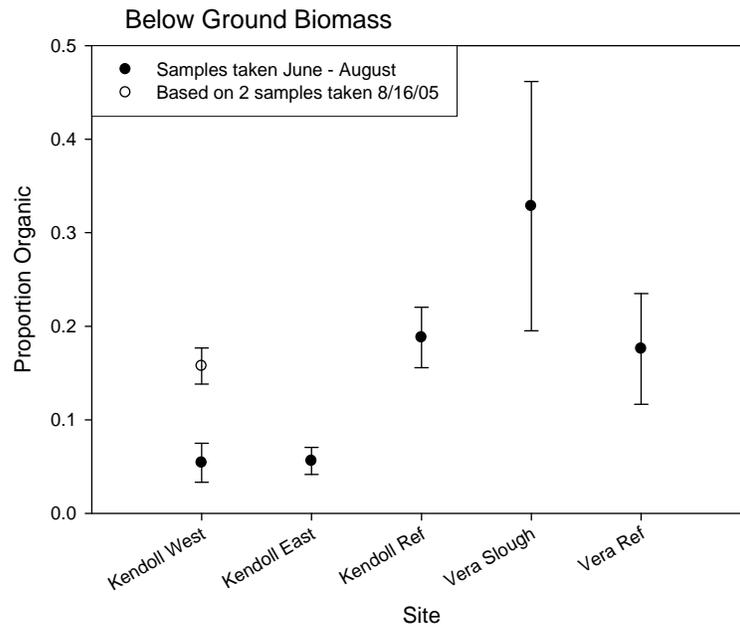
**Figure 5.6.** Amounts of Below-Ground Organic Matter Measured at each Site

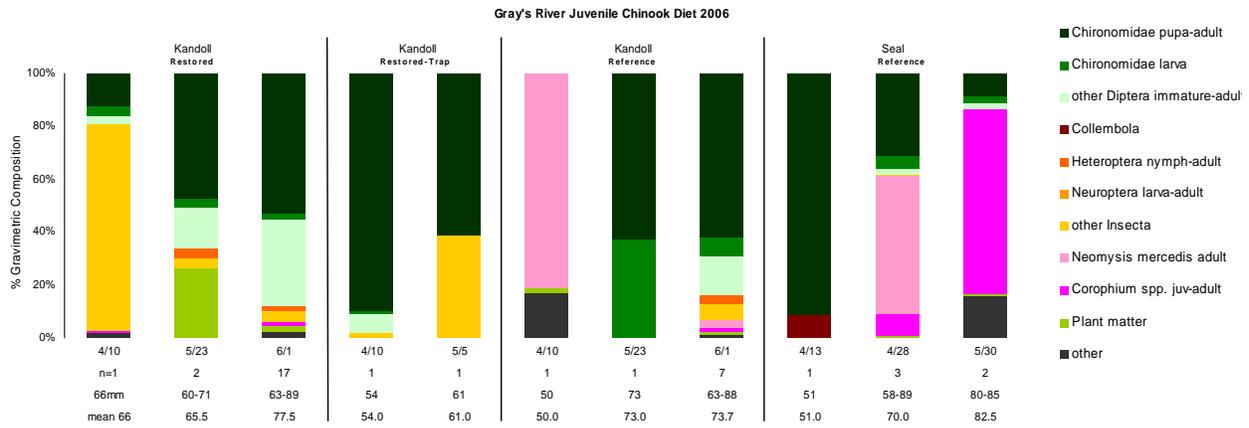
**Figure 6.1.** Juvenile Chinook Salmon Diets at Restoration and Reference Sites on Seven Sampling Days April-June, 2006

A total of 9 Chinook, 1 chum and 15 coho salmon stomachs were collected over the course of three sampling days (4/10, 5/23, and 6/1) in 2006. At the Kandoll restored and reference sites, Chinook salmon were eating Chironomidae (Figure 6.1). At Seal, two of the Chinook salmon were eating *Corophium* (Figure 6.1). Chum and coho diets included Chironomidae, Heteroptera, and other insects (Figure 6.2).

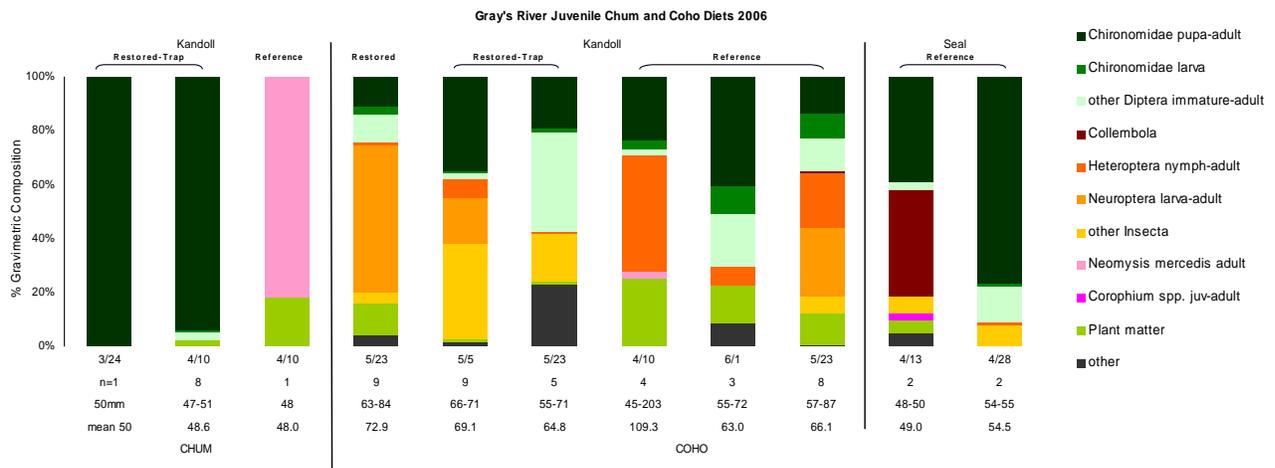
**Figure 6.2.** Juvenile Chum and Coho Salmon Diets at Restoration and Reference Sites on Seven Sampling Days April-June, 2006

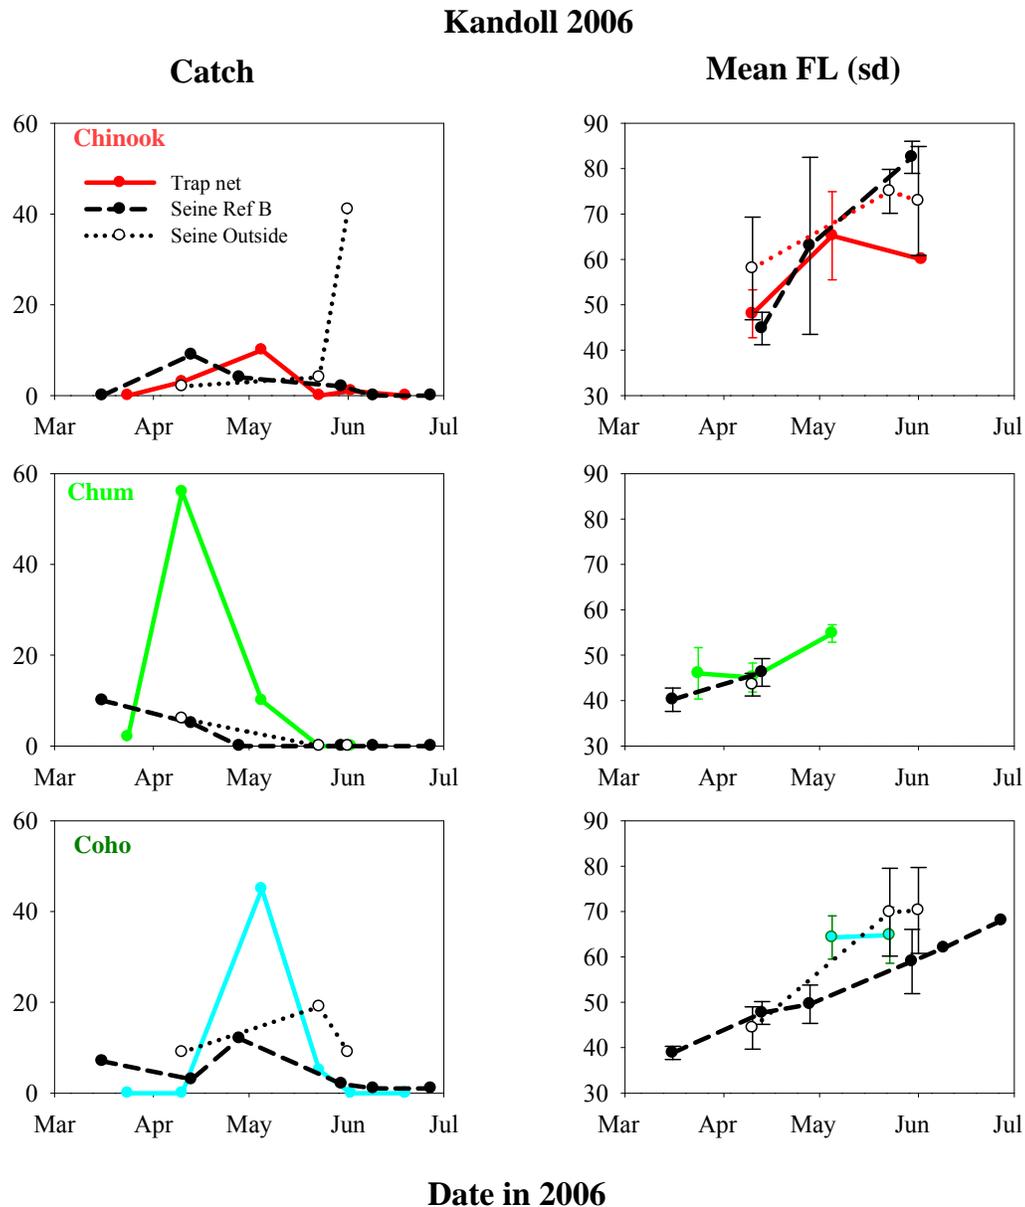
**Figure 7.1.** Salmonid Catch and Mean Size ( $\pm$  s.d.) at Kandoll Farm Restoration and Reference Sites in 2006. (FL = fork length)

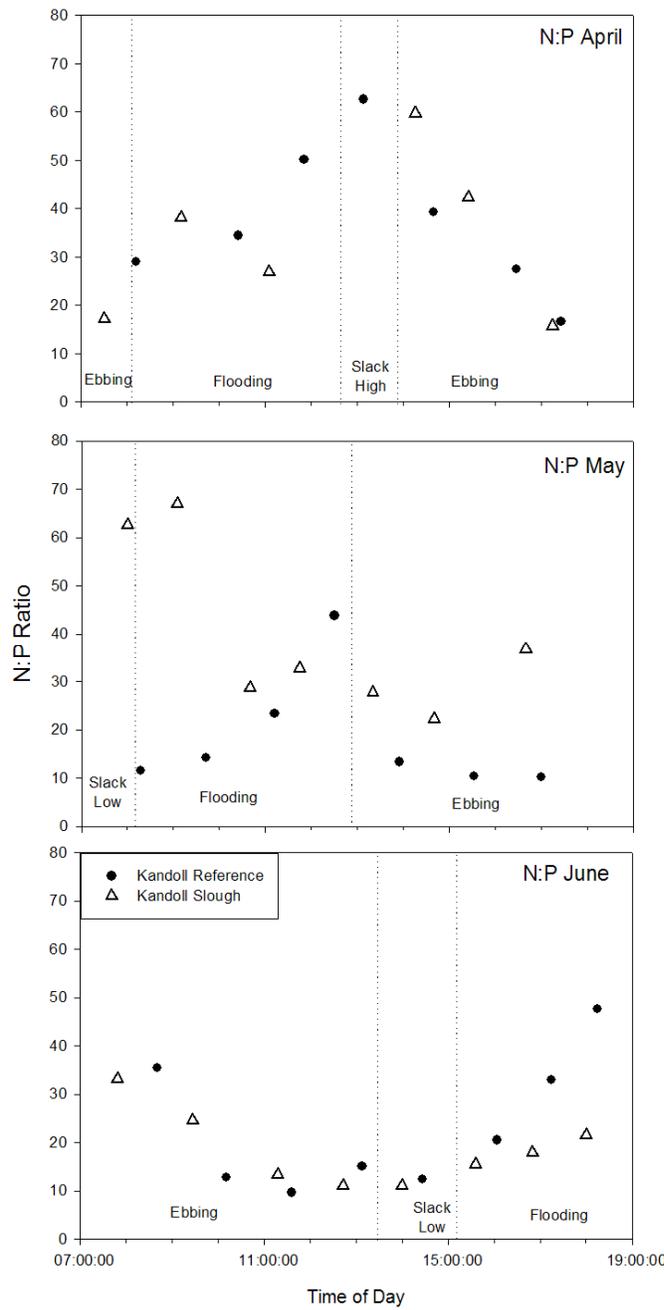
**Figure 8.1.** Nitrogen:Phosphorus Ratios for the Kandoll Sites in Three Sampling Periods in 2006

Nitrogen to Phosphorous Ratio (N:P): Changes in the N:P ratio are plotted in Figures 8.1 and 8.2. Vera sites track fairly well with each other, especially in April and June, and have ratios well over 16. The ratios at the Kandoll sites indicate a more complicated pattern that may have a seasonal component. Kandoll Farm is generally more stable throughout the tidal cycle in any month although mean values change between months (moderate in April, high in May, low in June). In contrast, the ratio at Kandoll Reference is always low except for a few peaks in April.

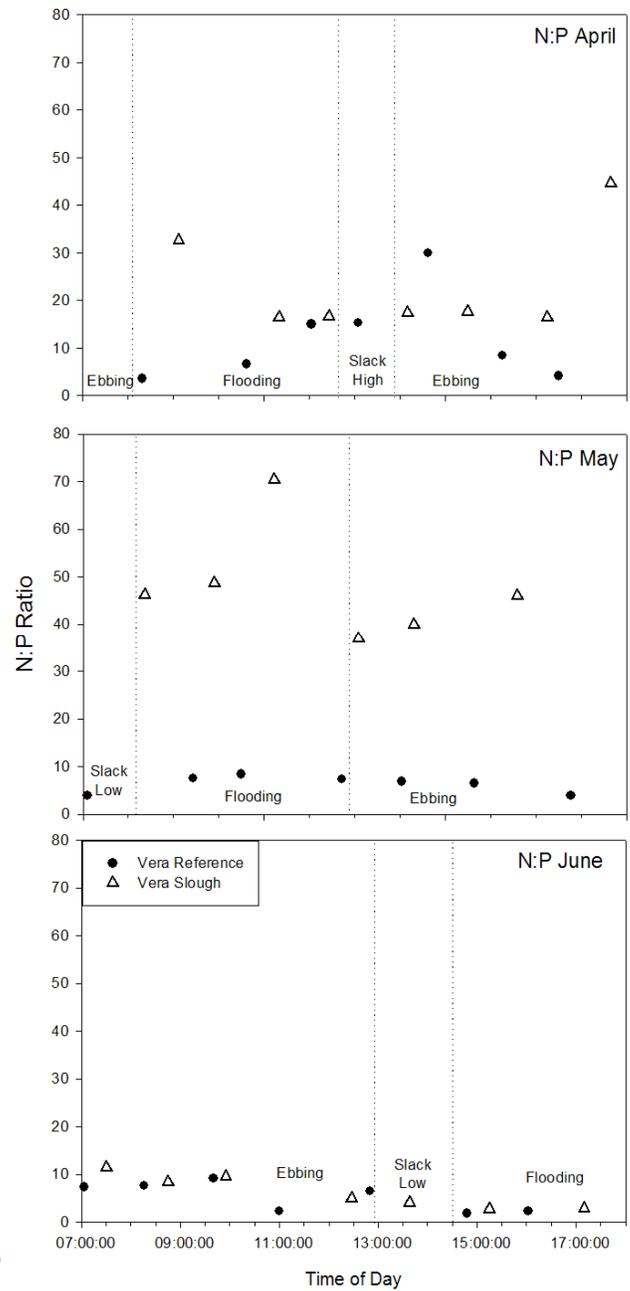
**Figure 8.2.** Nitrogen:Phosphorus Ratios for the Vera Sites in Three Sampling Periods in 2006

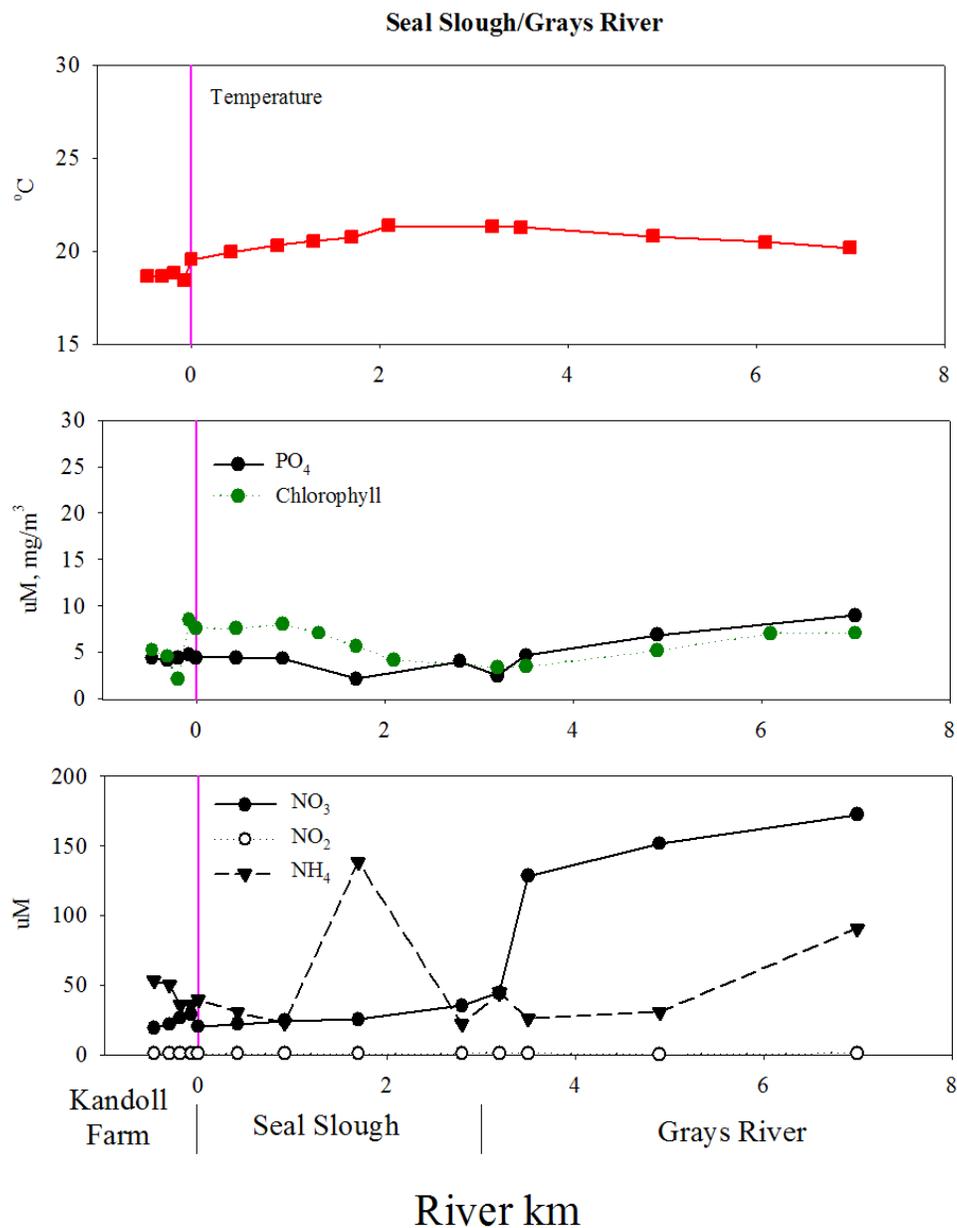
**Figure 8.3.** Transect of the Seal Slough/Grays River System: Temperature (top); PO<sub>4</sub> and chlorophyll a concentration (middle); and NO<sub>3</sub>, NO<sub>4</sub>, and NH<sub>4</sub> concentration (bottom). Pink vertical line denotes breach site.

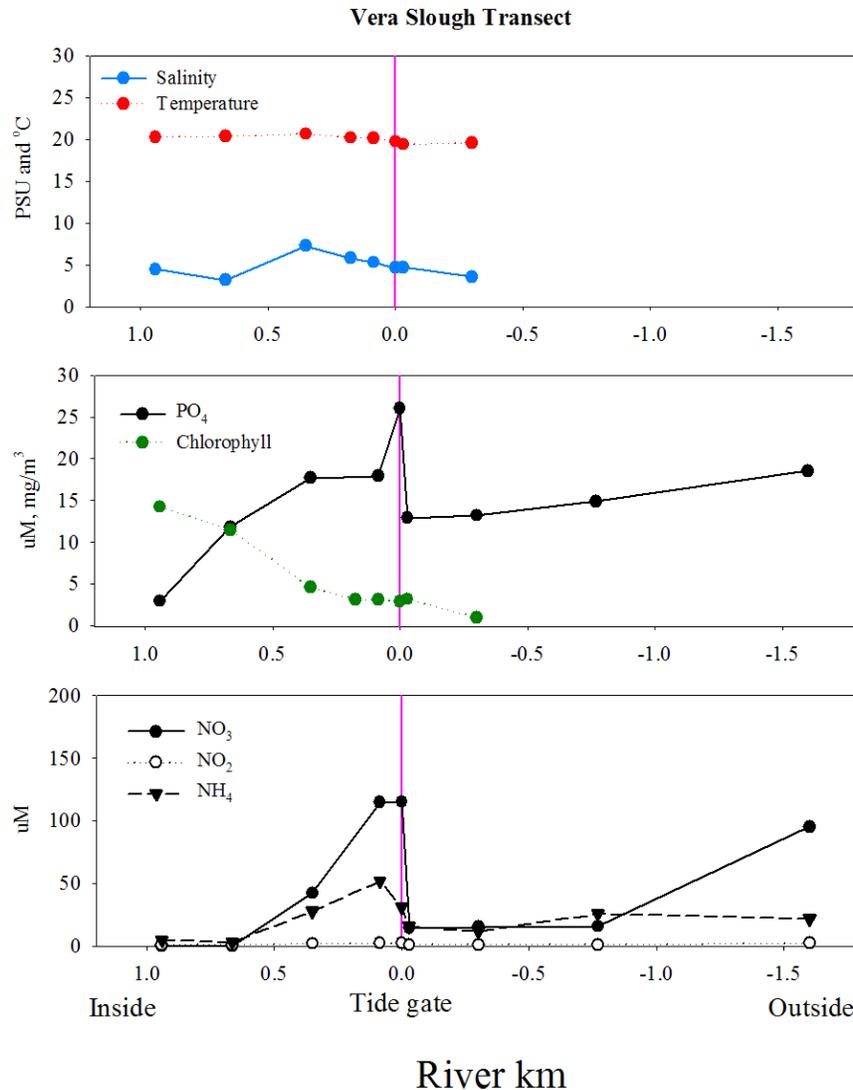
**Figure 8.4.** Transect of the Vera Slough System. Temperature (top); PO<sub>4</sub> and chlorophyll a concentration (middle); and NO<sub>3</sub>, NO<sub>4</sub>, and NH<sub>4</sub> concentration (bottom). Pink vertical denotes tide gate.

The Vera Slough transect was composed of ten stations over a 2.5-km transect, but not all stations were sampled for both water properties and dissolved constituents (Figure 8.4). There was strong horizontal heterogeneity in dissolved and particulate constituents due to the presence of the tide gate, while surface-0.5 m water properties were fairly uniform and indicated brackish conditions to the furthest station sampled. All dissolved constituents had maxima within 0.25 km inside the tide gate, and nitrogen species were at low concentrations within the system. In contrast, chlorophyll maxima were located at the furthest stations within Vera Slough; chlorophyll and nutrients were negatively correlated. These data suggest Vera was a source for remineralized nutrients and that phytoplankton dynamics may be influencing nutrient concentrations.
