200-BP-1 Prototype Hanford Barrier Annual Monitoring Report for Fiscal Years 2005 Through 2007

A. L. Ward
S.O. Link
C.E. Strickland
K.E. Draper
R.E. Clayton

December 2007

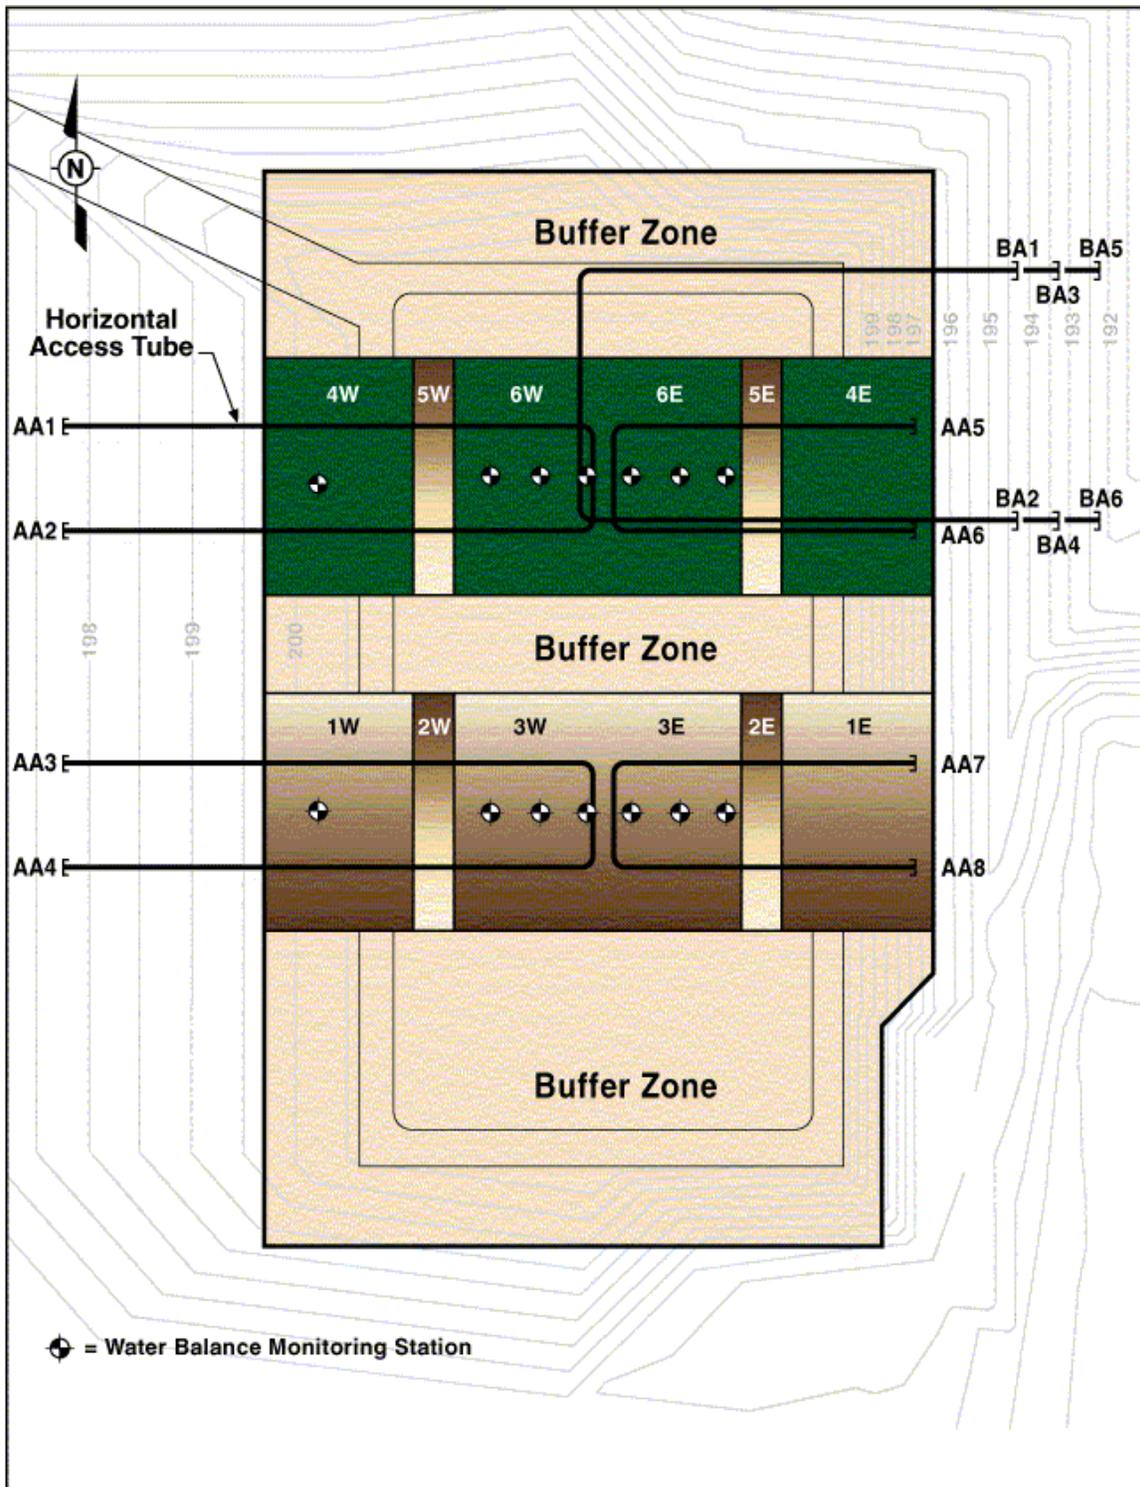
Figure 2.2. Plan View of the Prototype Hanford Barrier Showing the Layout of the 12 Surface Soil Plots (1W to 6W and 1E to 6E) and Horizontal Neutron Access Tubes (AA Above Asphalt; BA Below Asphalt)

Although not specifically used to assess water storage, neutron logging in horizontal access tubes is used to monitor several zones of the barrier for changes in the soil-moisture content. At the west side of the prototype surface barrier, two pairs of U-shaped horizontal access tubes were installed at 1.95 m below the surface, near the capillary break (silt-loam-sand filter interface) (AA1, AA2, AA3, AA4; Figure 2.2). A similar set of tubes (AA5, AA6, AA7, AA8) was installed at 1.95 m on the east side. Three additional sets of tubes were installed under the northeast section of the barrier below the asphalt layer. Tubes BA1 and BA2 were installed at a depth of 1 m below the asphalt, tubes BA3 and BA4 at 2 m, and tubes BA5

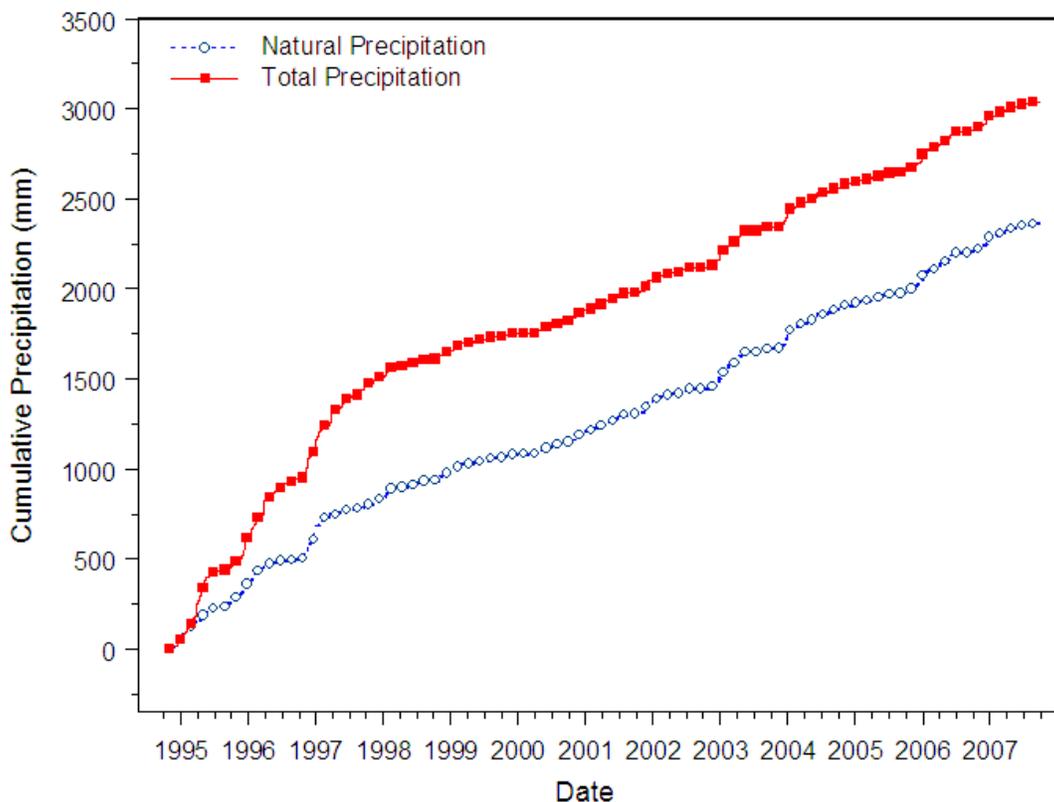
Figure 2.3. Natural and Total Precipitation (Natural plus Irrigation) at the Prototype Hanford Barrier From October 1, 1994, Through September 30, 2007

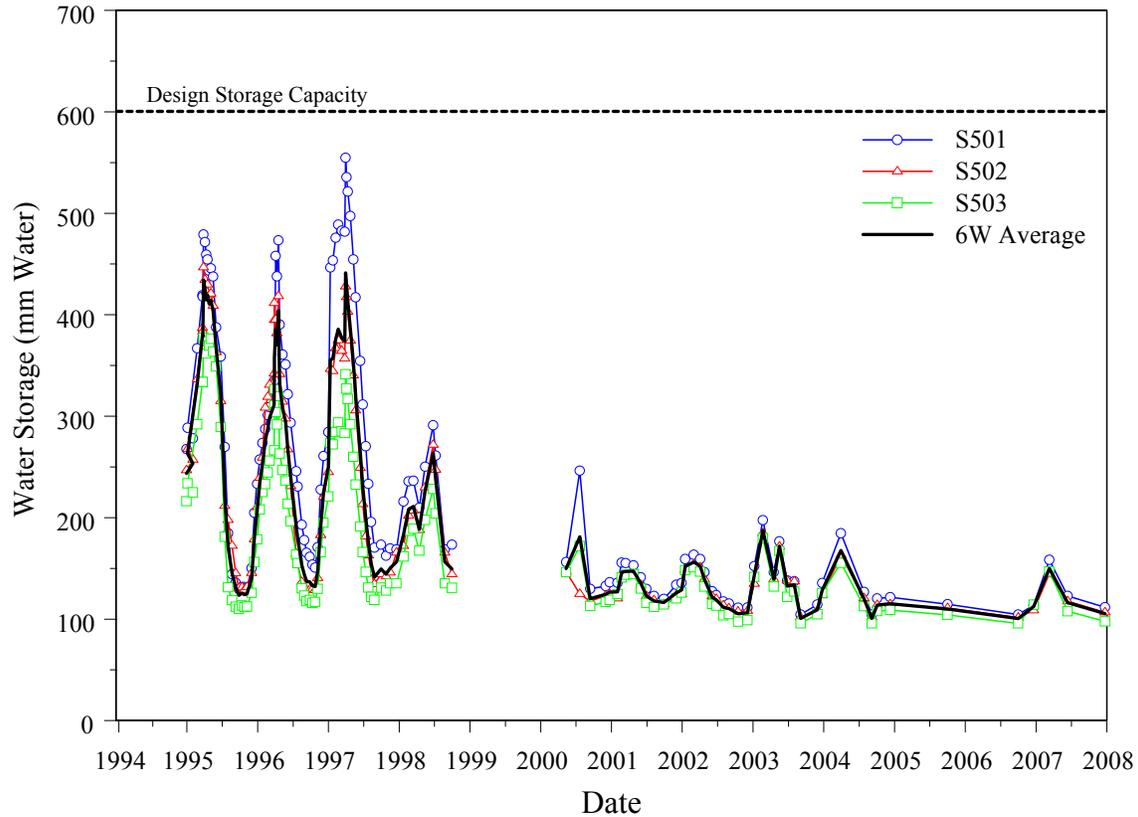
Figure 2.4. Temporal Variation in Soil-Water Storage in Northwest Plot 6W at the Prototype Hanford Barrier, October 1994 Through September 2007 (design water storage capacity is 600 mm)

Figure 2.4 through Figure 2.7 show distributions of $W(t)$ on the silt-loam plots from September 30, 1994, through September 22, 2007, derived from neutron-probe measurements. Figure 2.4 and Figure 2.5 summarize measurements made on the northern half of the barrier whereas Figure 2.6 and Figure 2.7 summarize measurements made on the southern half of the barrier. The northern half of the barrier was irrigated from FY 1995 through FY 1997 as part of the treatability test whereas the southern half was maintained under ambient precipitation conditions. No storage data were collected in FY 1999; hence, the break in the record. Another break in the record occurred from mid FY 2005 through FY 2006, and no neutron-probe measurements of storage were made.

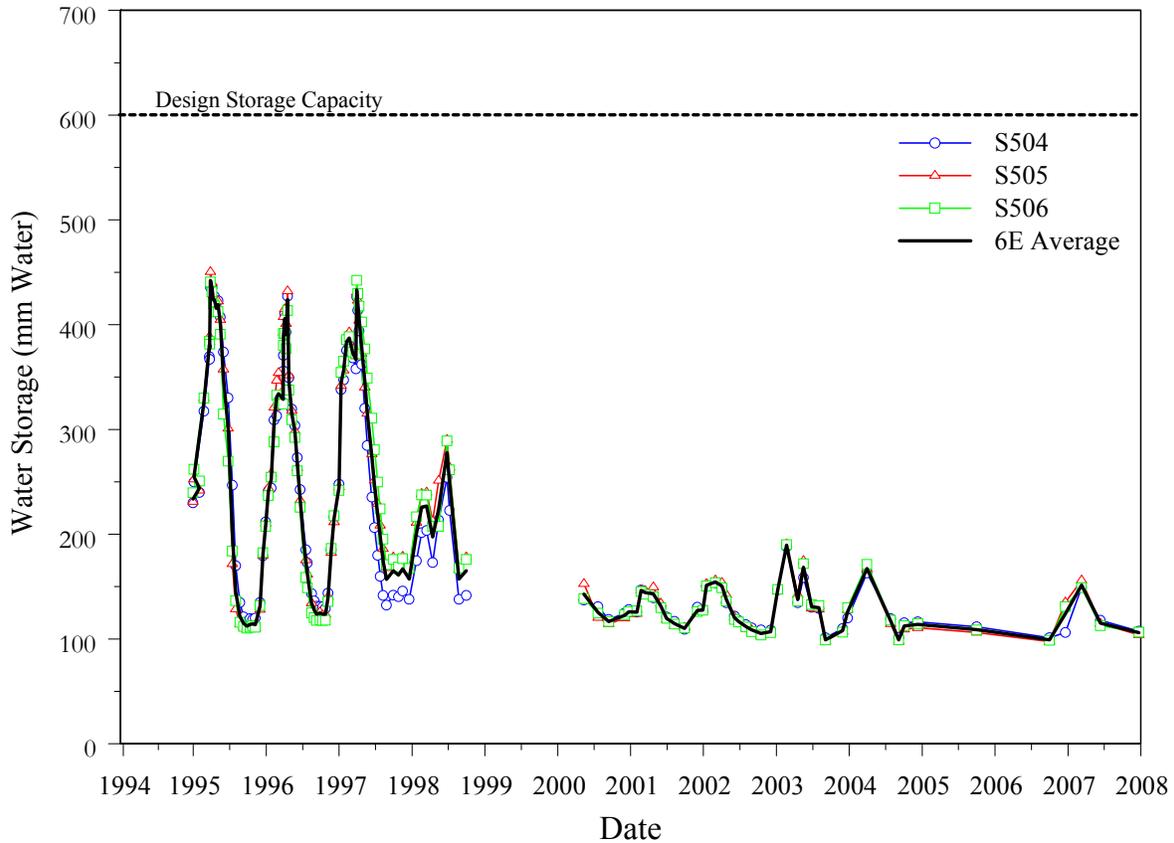
Figure 2.5. Temporal Variation in Soil-Water Storage in Northwest Plot 6E at the Prototype Hanford Barrier, October 1994 Through September 2007 (design water storage capacity is 600 mm)

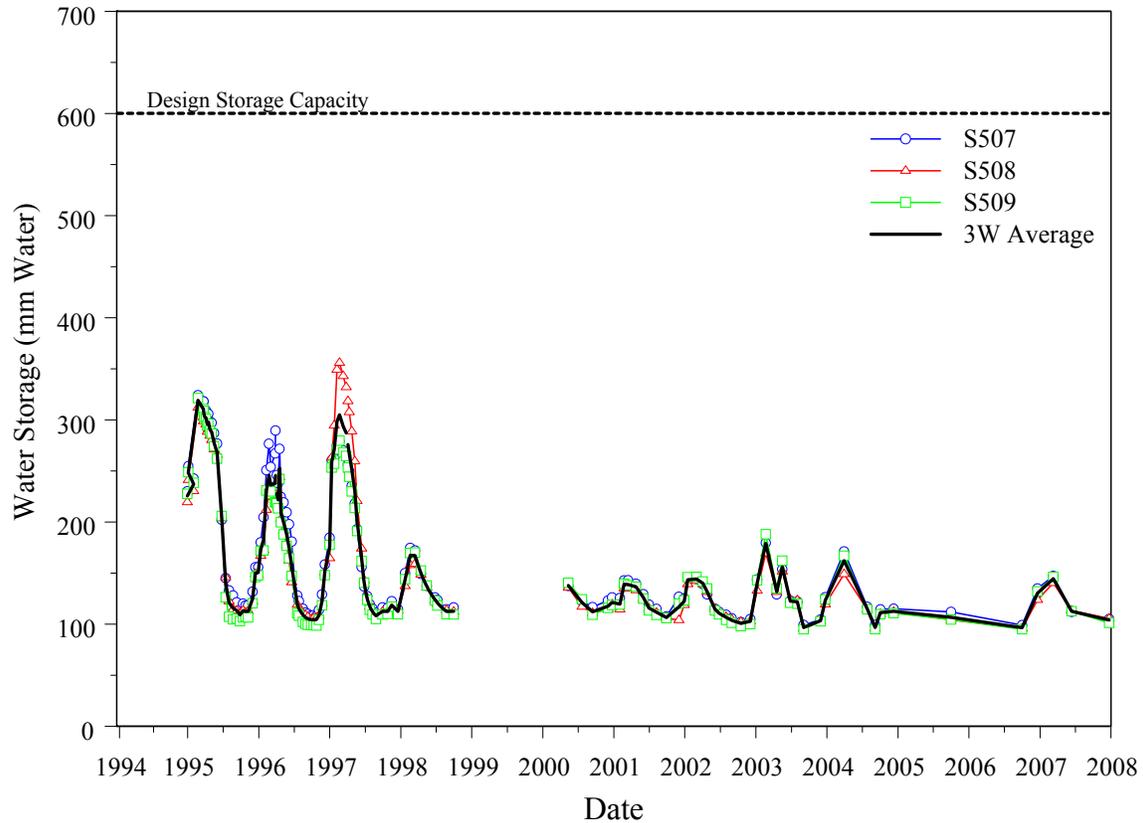
Figure 2.6. Temporal Variation in Soil-Water Storage in Northwest Plot 3W at the Prototype Hanford Barrier, October 1994 Through September 2007 (design water storage capacity is 600 mm)

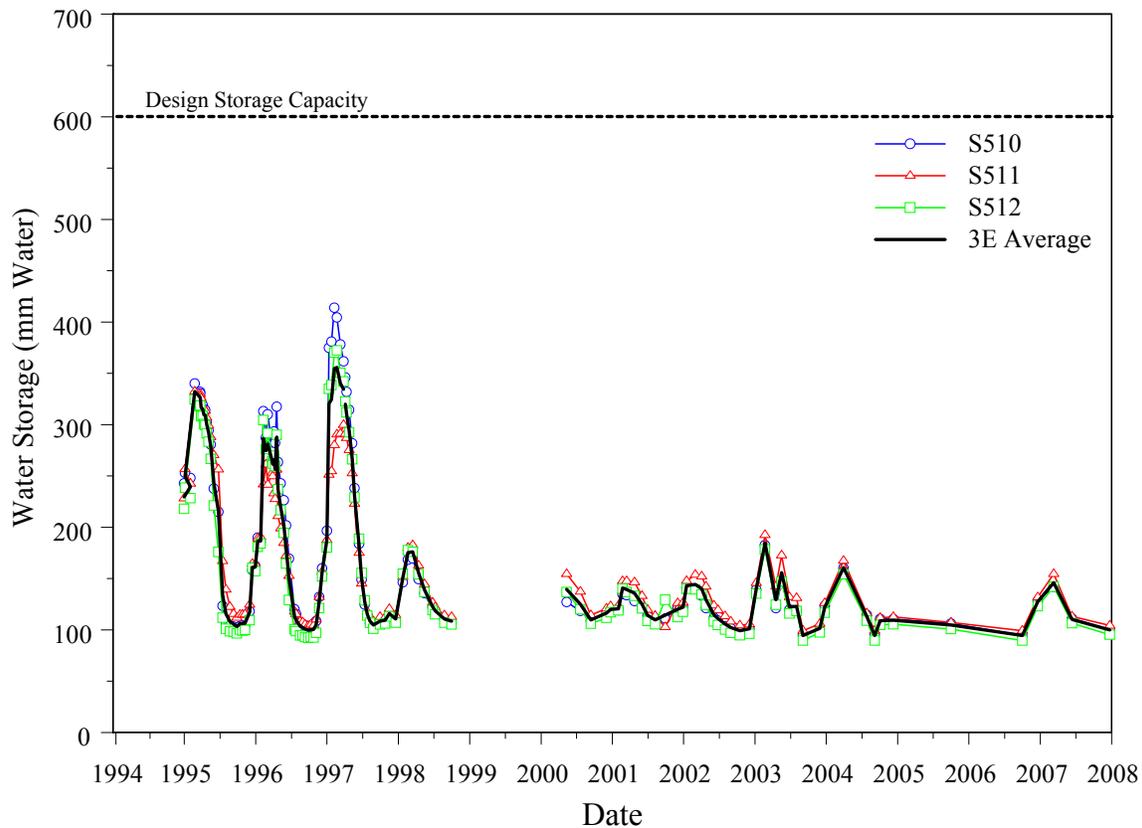
Figure 2.7. Temporal Variation in Soil-Water Storage in Northwest Plot 3E at the Prototype Hanford Barrier, October 1994 Through September 2007 (design water storage capacity is 600 mm)

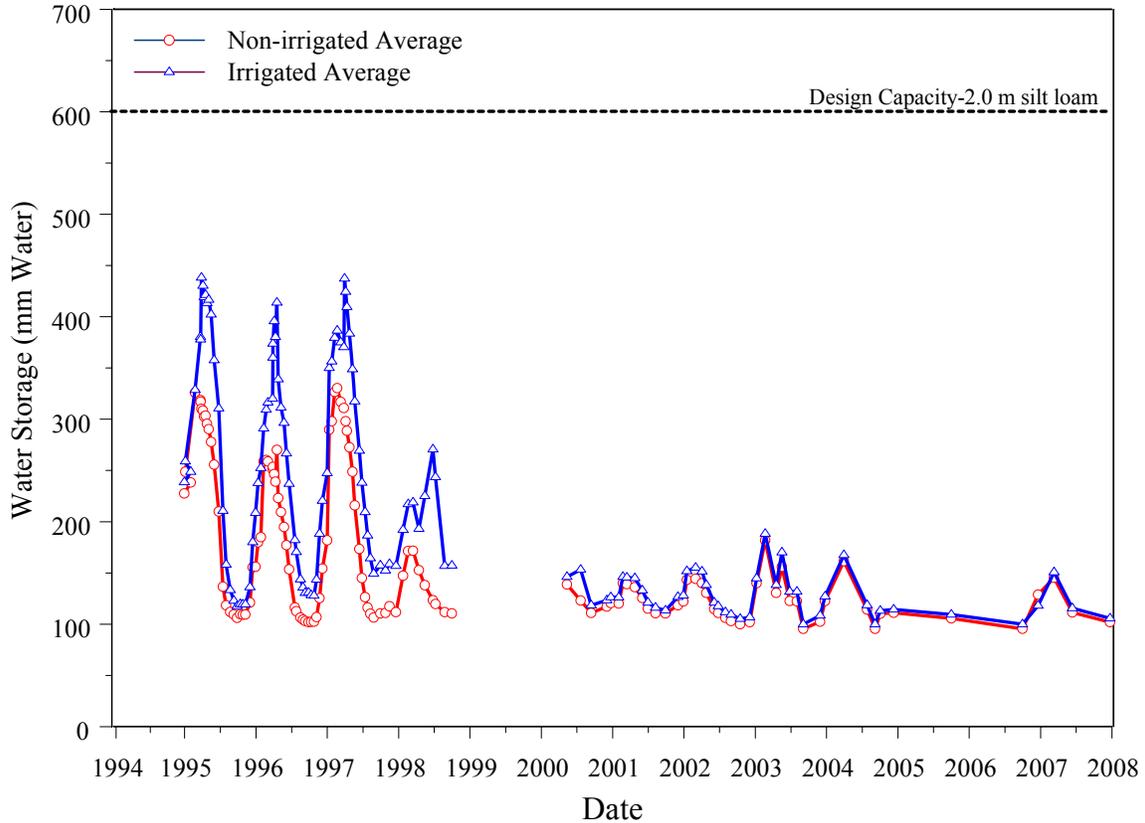
Figure 2.8. Temporal Variation in Mean Soil-Water Storage on the North and South Plots at the Prototype Hanford Barrier, October 1994 Through September 2007 (design water storage capacity is 600 mm)

Figure 2.8 compares the mean storage on the northern and southern sections of the barrier. The mean storage for the north was calculated as the temporal average of $W(t)$ measured at S1 through S6. The mean storage for the south was calculated as the temporal average of $W(t)$ measured at S7 through S12. As of September 21, 2007, the mean storage was 105.39 mm on Plot 6W and 105.98 mm on Plot 6E, compared to 103.91 mm on Plot 3W and 99.90 mm on Plot 3E. In comparing water storage between plots for FY 2007, the distribution is quite similar to that observed around the same time in FY 2006. At the end of FY 2006, the mean storage was 100.56 mm on Plot 6W and 99.17 mm on Plot 6E, compared to 96.54 mm on Plot 3W and 94.40 mm on Plot 3E. Although there are small differences between plots, differences in mean storage between plots at the end of monitoring in FY 2007 are not statistically significant.

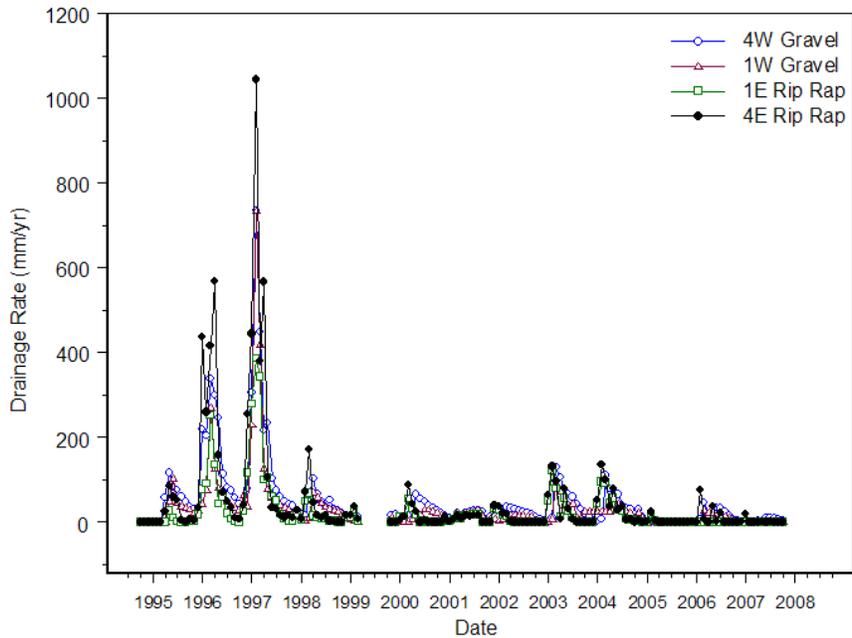
Figure 2.9. Rate of Drainage from the Side-Slope Plots at the Prototype Hanford Barrier for the Period September 1994 Through September 2007. (Note: A 3-month reporting hiatus occurred from March 1999 through May 1999.)

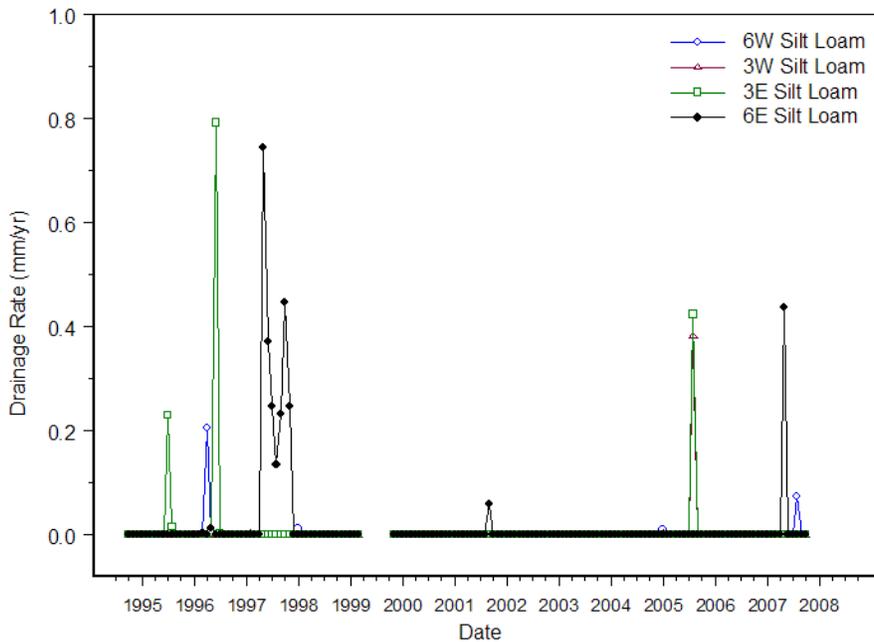
Figure 2.10. Rate of Drainage from the Silt-Loam Plots at the Prototype Hanford Barrier for the Period September 1994 Through September 2007. (Note: A 3-month reporting hiatus occurred from March 1999 through May 1999.)

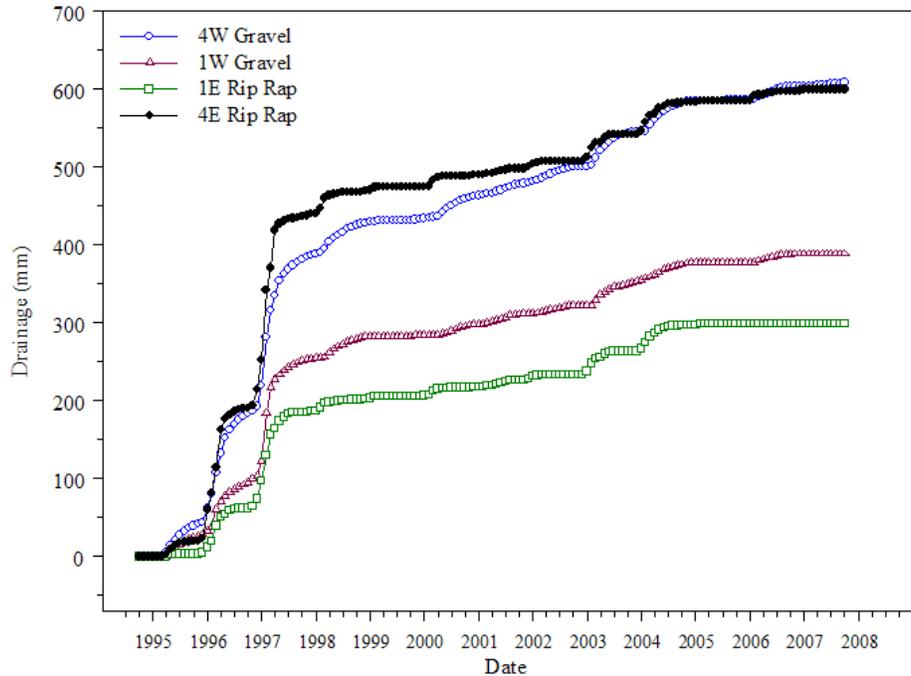
Figure 2.11. Cumulative Amounts of Water Diverted by the Asphalt Pad (Drainage) from the Side-Slope Plots at the Prototype Hanford Barrier in September 1994 Through September 2007. (Note: A 3-month reporting hiatus occurred from March 1999 through May 1999.)

Figure 2.11 shows the cumulative drainage from the side-slope plots for the period from October 1994, through September 2007. Figure 2.12 shows a similar plot for the soil-covered plots. Since the start of testing, drainage from the barrier has shown seasonal dependence. Of the side-slope plots, the irrigated riprap treatments typically showed lower drainage rates than the gravel except in the winter months. Despite the low rates in the summer, cumulative drainage from the riprap generally exceeded that from the gravel for the duration of the treatability test. This is because drainage rates from the riprap were usually much higher than from the gravel in the winter months. Differences between the gravel and riprap on the north plots started to decline after reaching a maximum in the winter of FY 1997, becoming almost identical by the end of FY 2002.

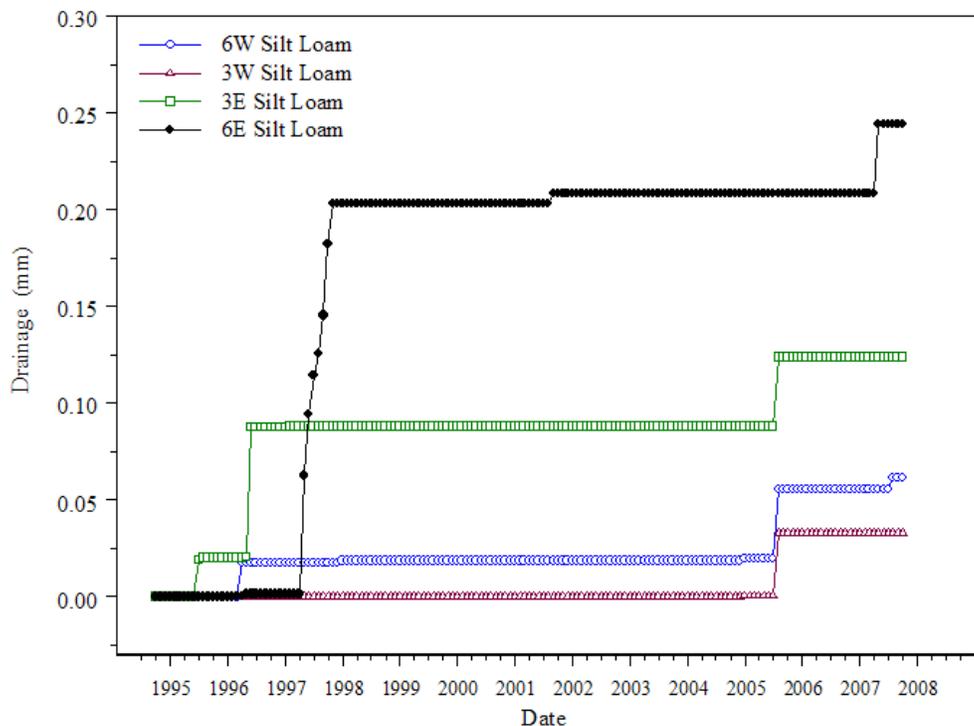
Figure 2.12. Cumulative Amounts of Water Diverted by the Asphalt Pad (Drainage) from the Silt-Loam Plots at the Prototype Hanford Barrier in September 1994 Through September 2007. (Note: A 3-month reporting hiatus occurred from March 1999 through May 1999.)

These results also show that through FY 2007, cumulative drainage from each of the soil-covered plots remained significantly less than the 0.5 mm yr^{-1} drainage criterion (Figure 2.12). Plots 6W, 3W, 3E, and 6E generated totals of 0.06 mm, 0.03 mm, 0.12 mm, and 0.24 mm of drainage, respectively, over the 13-yr period. There is some uncertainty about the nature of the higher amounts from plot 6E. Verification studies in FY 1997 showed no significant differences in soil physical properties. However, visual inspection and vegetation surveys suggest a thicker grass cover and smaller than average shrubs (Section 4).

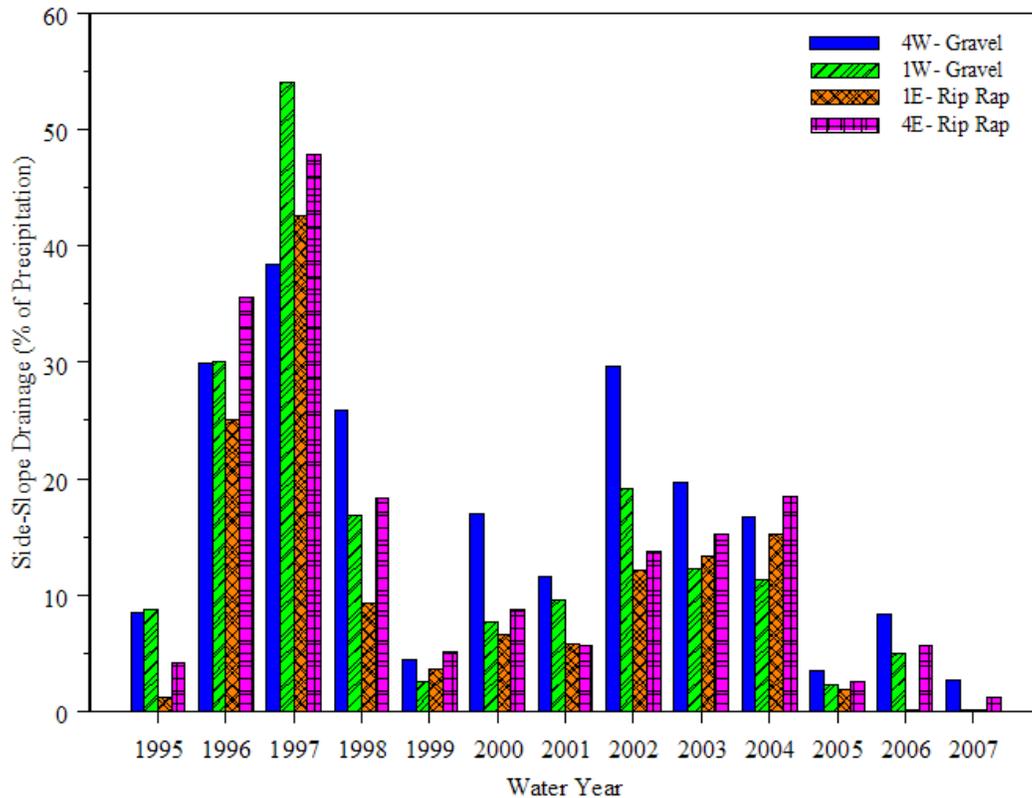
Figure 2.13. Cumulative Amounts of Water by Water Year Diverted by the Asphalt Pad (Drainage) From the Side-Slope Plots at the Prototype Hanford Barrier in September 1994 Through September 2007 as a Percentage of Precipitation

Figure 2.13 shows a grouped bar graph plot of cumulative drainage for FY 1995 through FY 2007. This plot shows that apart from FY 1995 and FY 1997, the wettest year on record for the barrier, plot 4W has consistently drained a larger fraction of precipitation than any of the other plots. Apparent drainage rates (e.g., Figure 2.9 and Figure 2.10) show a strong correlation between drainage rates and winter precipitation. The higher rates observed from plot 4W remain unexplained. It was initially hypothesized that the larger drainage was due to a leak in the irrigation supply system. Such a leak was found and fixed in the FY 2002 and since then, the water supply to the barrier has been shut off.

If the higher drainage had been caused by a water-line leak, then differences between 4W and other plots with a similar configuration (e.g., 1W) would have been eliminated after FY 2002. As shown in Figure 2.13, these differences continued through FY 2007. One possible explanation is a difference in the hydraulic properties of the northern section of the gravel slope. Such differences could result from minor differences in the particle-size distribution between 4W and on 1W and the impact on the water-holding capacity. Another explanation could be differences in plant cover between the two gravel plots. A lower plant density on the northwestern plot could result in lower drainage amounts compared to the southwestern plot. A lower plant density on 4W would result in less water loss by ET and an increase in drainage relative to 1W. However, the FY 2007 plant survey found that percent cover on the northern and western side slopes was relatively uniform, so the data were combined. Nonetheless, drainage from 4W as a percentage of precipitation has shown a steady decline since FY 2002 compared to 4E. Although this observation lends some support to the hypothesis of a leaking water line, differences between 4E and other plots persists.

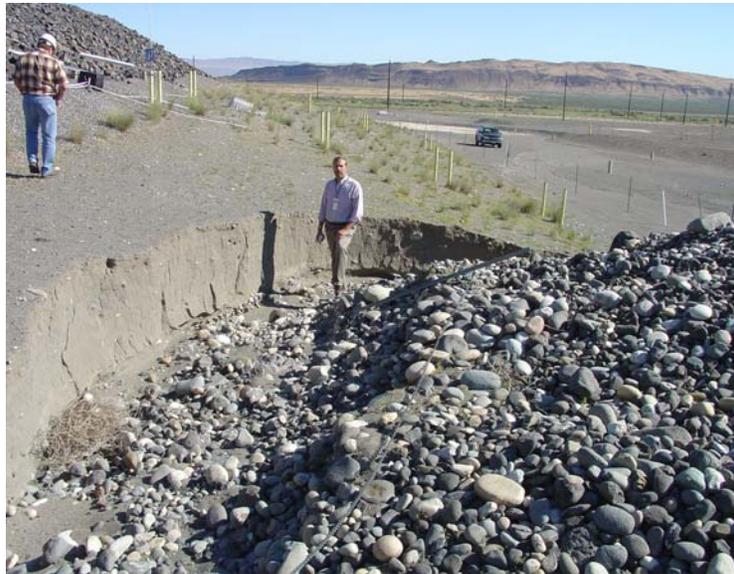
In May 2004, after severe thunderstorms, water collecting near the BY Farm eroded a berm and flowed down the northwestern slope of the tank farm, eroding gravel armor in its path. The runoff water from the elevated BY-BX Tank Farm surface flowed down-gradient to the region between the tank farm and the prototype barrier, damaging the west fence and eroding a channel over 40-inches deep at the base of the barrier side slope. Figure 2.14 is a photograph taken on June 16, 2004 (looking to the north from the BY tank farm) during an inspection by Kirk Christensen and Curt Wittreich of CH2M Hill.

Figure 2.14. North-Facing Photograph Taken on June 16, 2004, from the BY Tank Farm During an Inspection by Kirk Christensen and Curt Wittreich (standing in channel). The light-colored area behind the vehicle is the fine-textured sediment remaining after the ponded runoff water infiltrated and evaporated adjacent to the BY Cribs.

This photograph shows the eroded channel between the east side slope of the 200-BP-1 Prototype Hanford Barrier (left side of photo) and the west side slope of the BY Tank Farm (right side with cobbles). The channel, with depths of over 45 inches in places, extended into the sandy structural fill layer of the riprap toe slope. The light-colored area (fine soil deposit) behind the vehicle at the top of the photo indicates an area of ponding. All repairs were completed in FY 2005. Figure 2.15 shows the toe region shortly after the erosion event with Figure 2.15a). A work order was subsequently issued to repair this and other damage resulting from the erosion event. Figure 2.15b shows the current state as of September 2007 following a successful repair in FY 2005. Since this episode no other further runoff or erosion events have been observed.

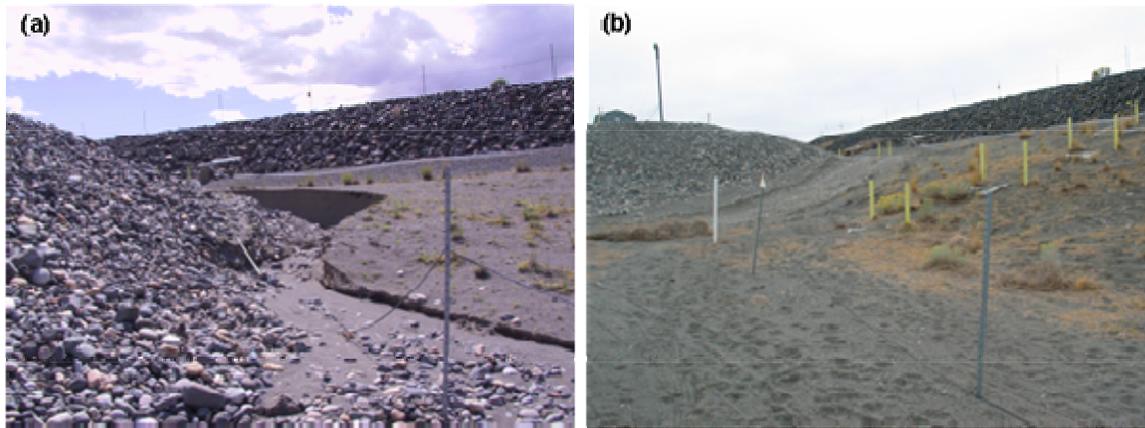
Figure 2.15. Evidence of Erosion Near the Prototype Barrier Resulting from a Thunderstorm in May 2004: (a) damaged fence and erosion channel formed between BY Farm and the prototype barrier, (b) repaired toe of the side slope in September 2007. Photographs by Chris Strickland of PNNL.

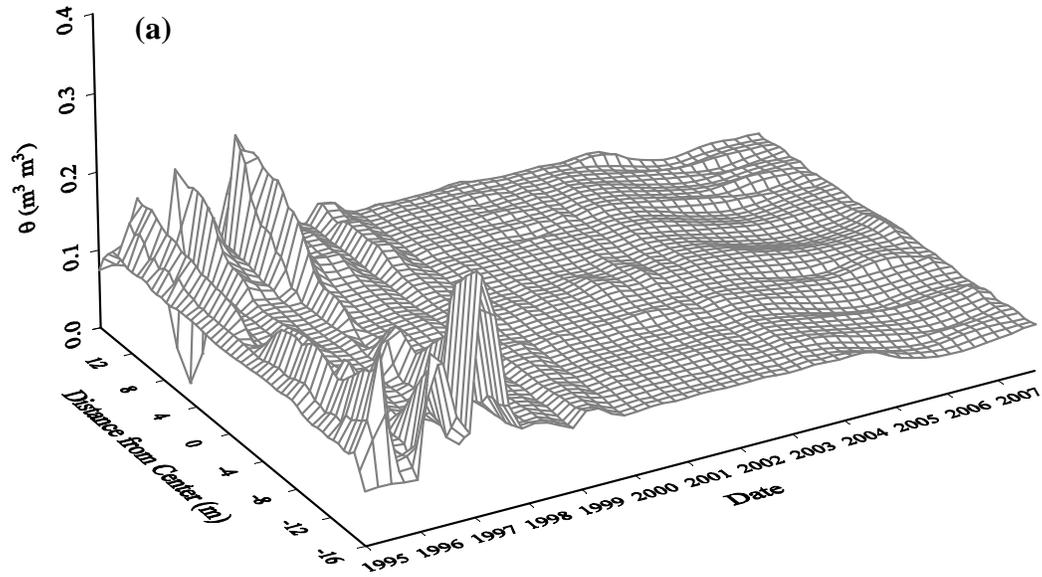
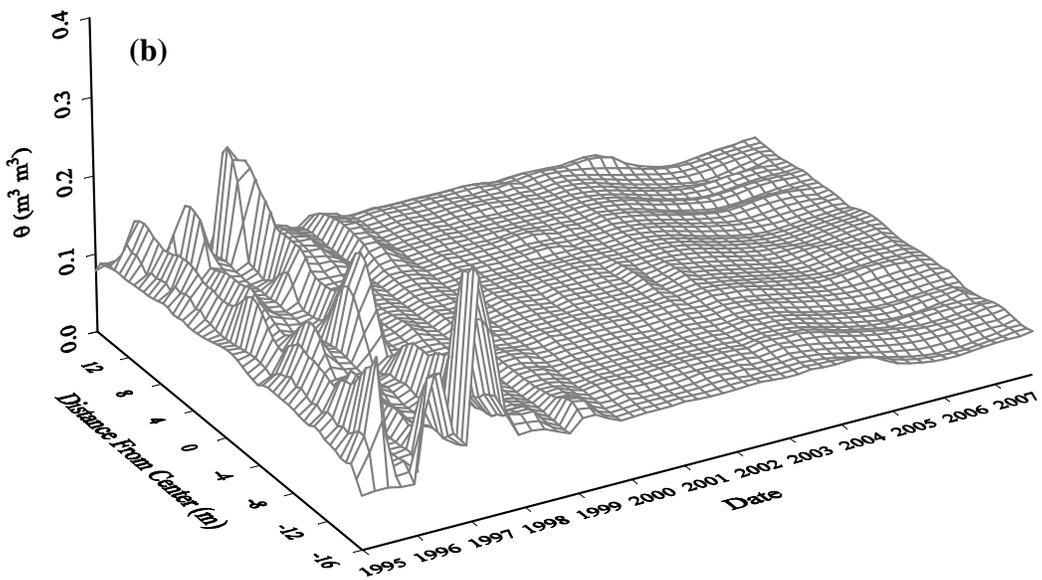
Figure 2.16. Spatiotemporal Variations in Soil-Water Content at the Bottom of the Silt-Loam Layer of the Irrigated Treatment of the Barrier: (a) Northern End of Treatment, Tube AA1 + AA5, and (b) Southern End of Treatment, Tube AA2 + AA6

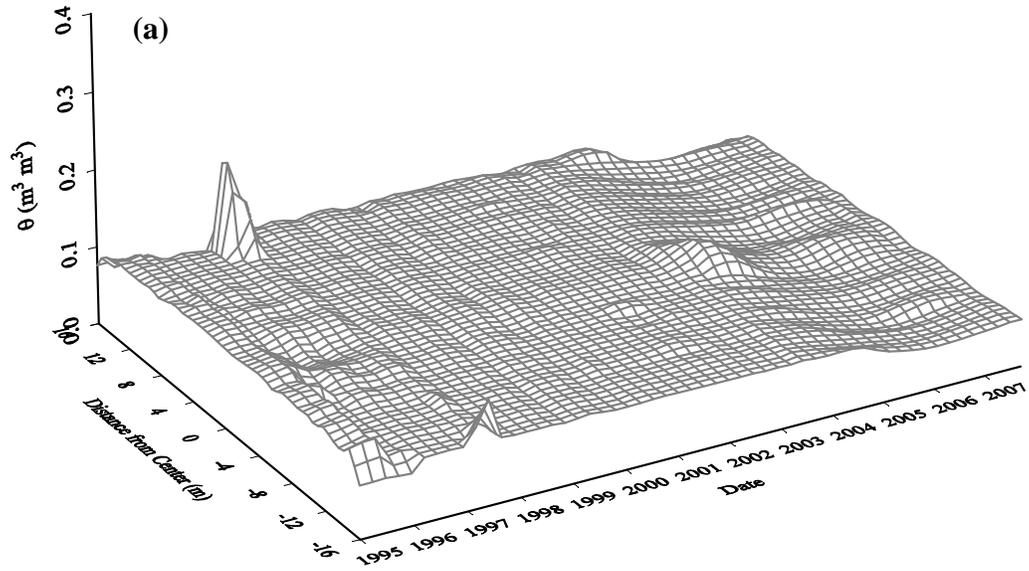
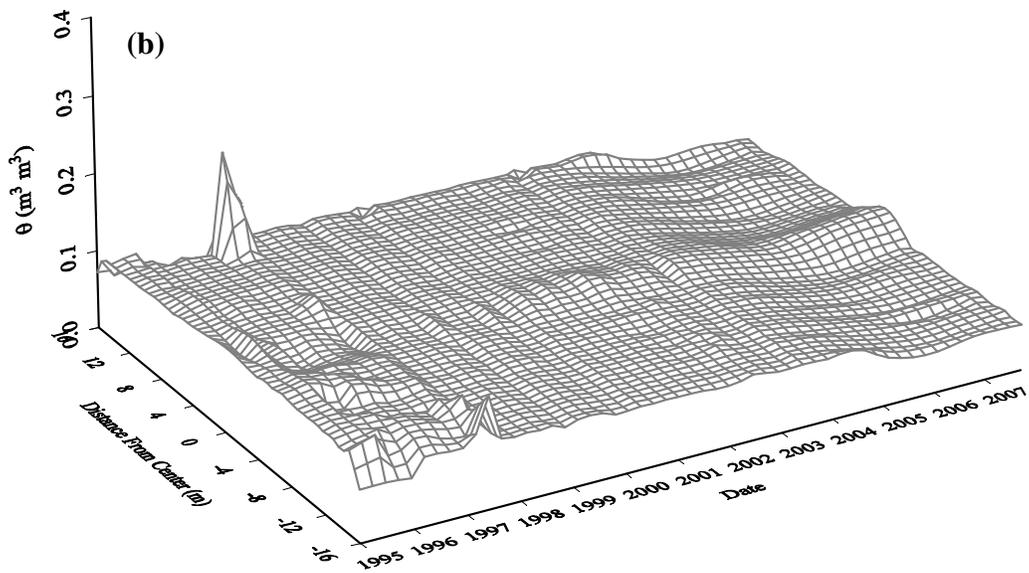
Figure 2.17. Spatiotemporal Variations in Soil-Water Content at the Bottom of the Silt-Loam Layer of the Nonirrigated Treatment of the Barrier: (a) Northern End of Treatment, Tube AA3 + AA7, and (b) Southern End of Treatment, Tube AA4 + AA8

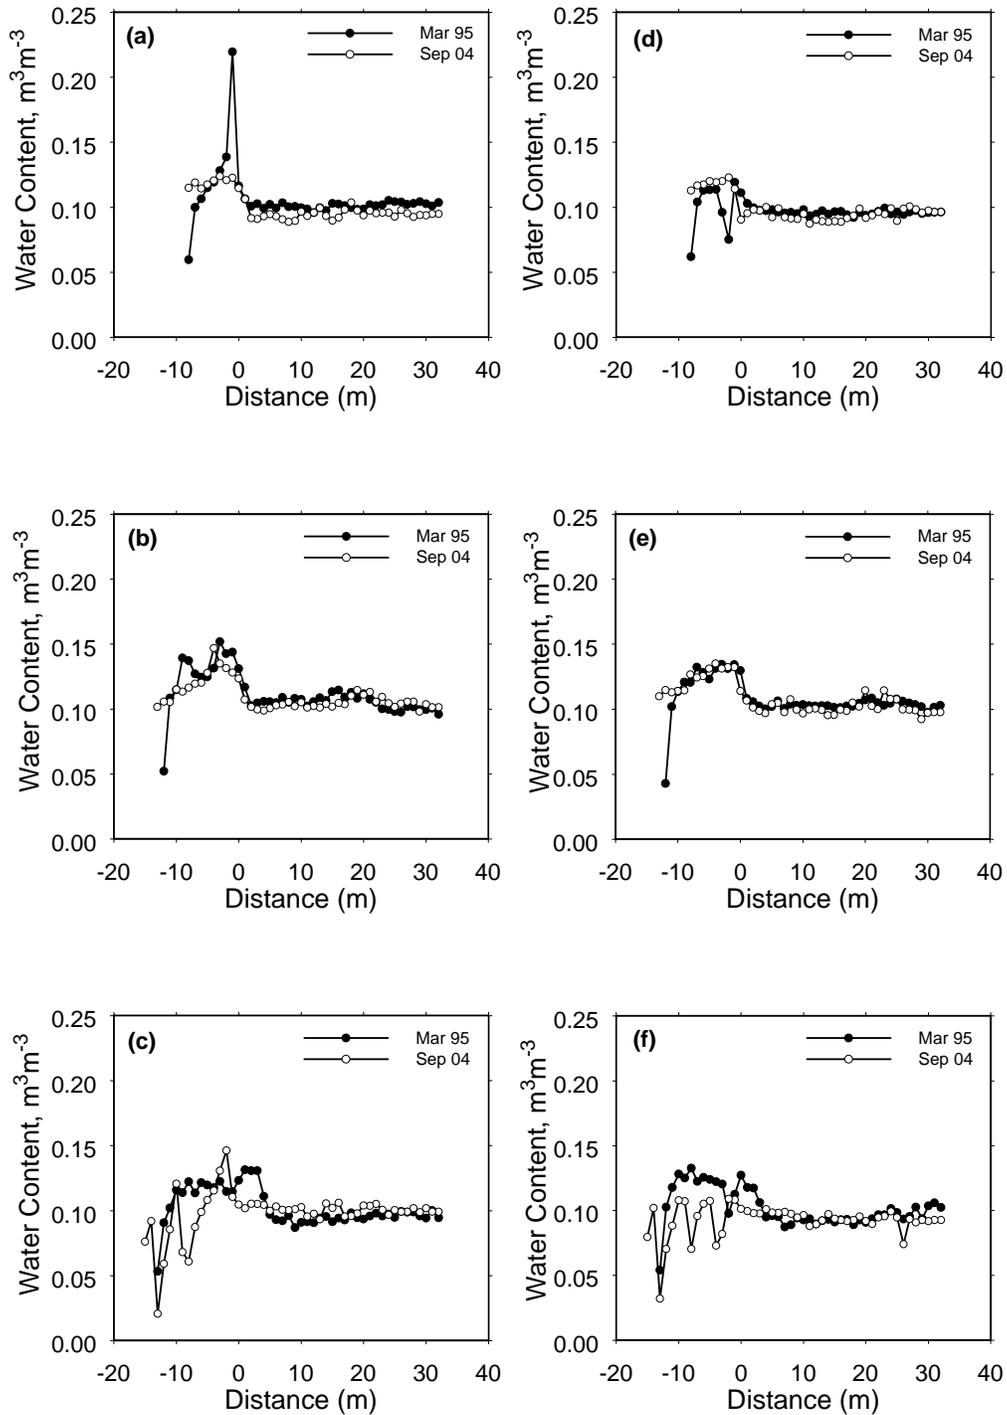
Figure 2.18. Spatial Variation in Soil-Water Content Under the Asphalt Layer (Uncurbed Section) on March 28, 1995, and September 04, 2004: Horizontal Neutron Tubes (a) BA 1 at 1 m, (b) BA 3 at 2 m, (c) BA 5 at 3 m, (d) BA 2 at 1 m, (e) BA 4 at 2 m, and (f) BA 6 at 3 m

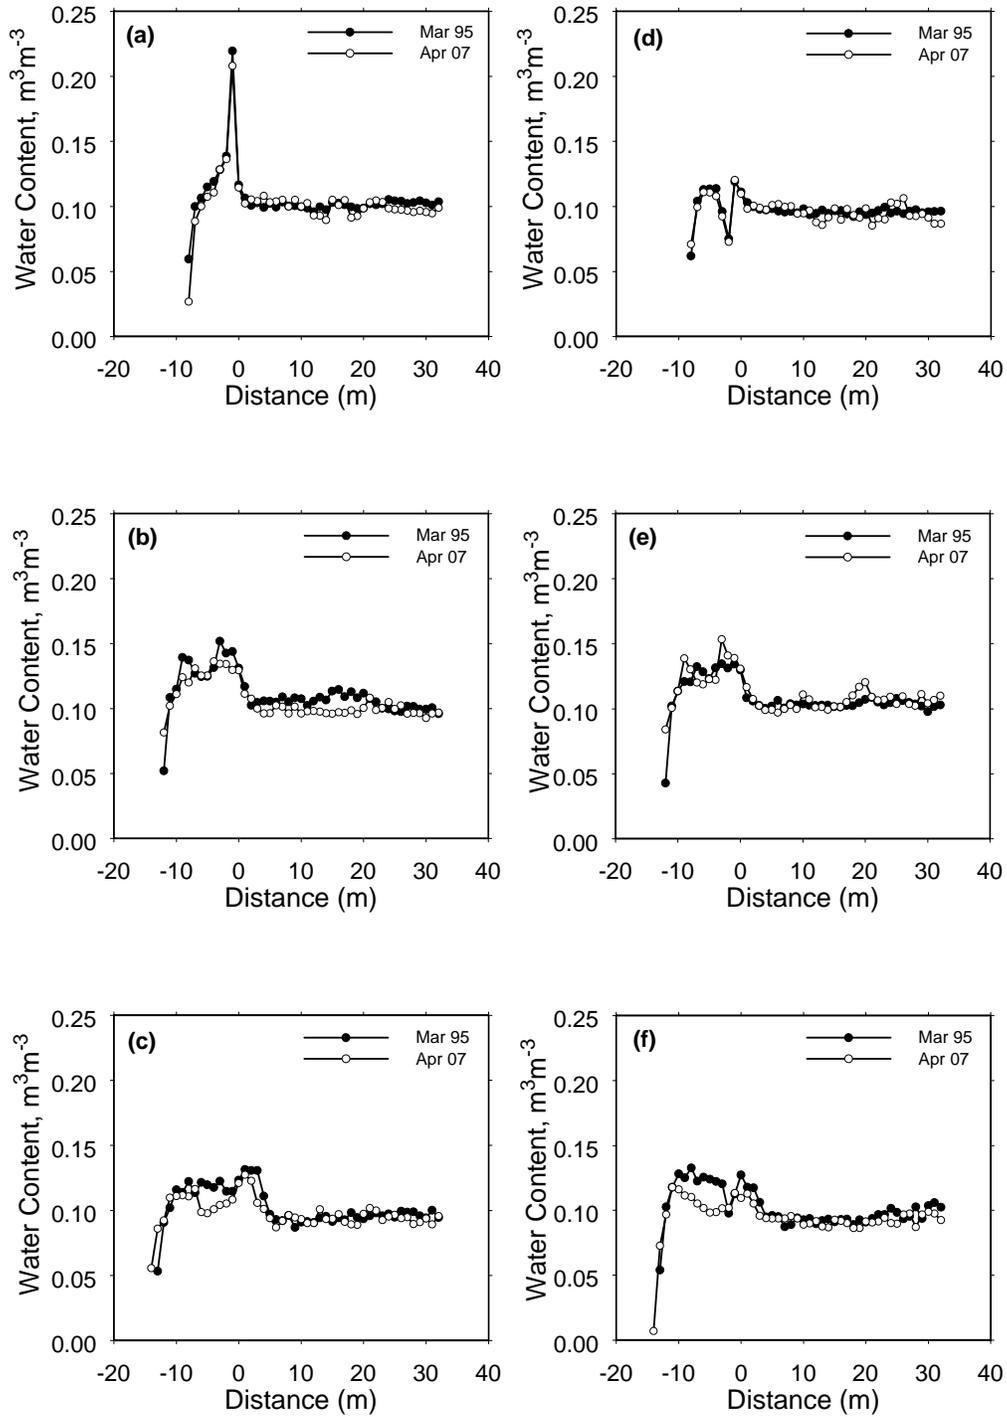
Figure 2.19. Spatial Variation in Soil-Water Content Under the Asphalt Layer (Uncurbed Section) on March 28, 1995, and April 05, 2007: Horizontal Neutron Tubes (a) BA 1 at 1m, (b) BA 3 at 2 m, (c) BA 5 at 3 m, (d) BA 2 at 1 m, (e) BA 4 at 2 m, and (f) BA 6 at 3 m

Figure 2.19 compares the spatial distribution of volumetric water content, θ , measured horizontally under the asphalt layer shortly after construction on March 28, 1995, compared to its distribution in September 2004, and more recently in April 2007 (see Appendix A, Table A.1, for the data set). After 13 years, the spatial trends in θ remain quite similar with only small increases in moisture near the edge of the asphalt layer in the winter. During the course of a year, the wetting front will penetrate a maximum distance of about 1 m under the asphalt. While the extent of the annual migration of the wetting front appears small, underflow remains a major factor for consideration in the design of final covers. Except for a small section near the northeastern corner, the asphalt layer is almost totally curbed to prevent the discharge of water along the edge. These data show that a potential exists for underflow along the edges, although the true extent cannot be determined from the data because of the presence of curbs on the asphalt layer to allow measurement of percolation. The extent, however, could be easily simulated with a calibrated multidimensional numerical model such as the STOMP simulator (Ward et al. 2005b).

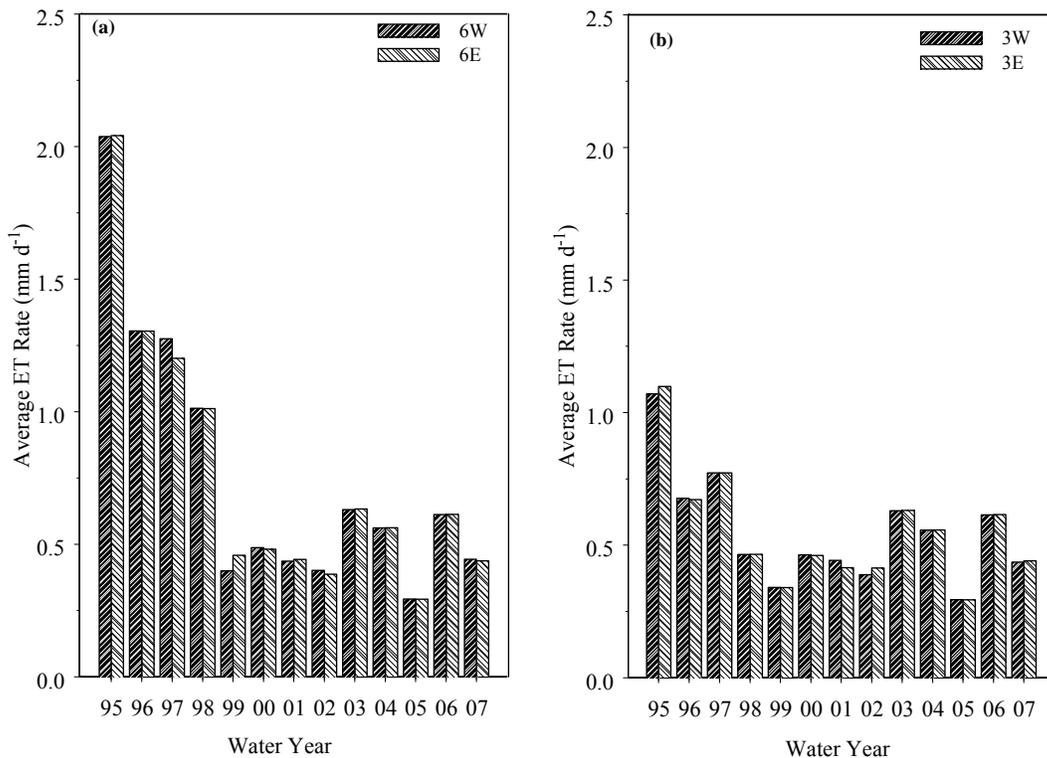
Figure 2.20. Comparison of Average ET Rate at the Prototype Hanford Barrier: (a) North Plots, 6W and 6E, and (b) South Plots, 3W and 3E

This hypothesis is supported by the observation that, while the ET rate continued to decline through FY 1997 on the north plot (Figure 2.20a), the ET rate increased slightly on the southern plots (Figure 2.20b). The exception to the general decline is FY 1997 when the southern plots showed a slight increase, perhaps in response to the wetter-than-normal conditions that occurred that year. FY 1997 was one of the wettest years on record for the barrier. Following the cessation of irrigation at the end of FY 1997, the difference in ET rates on the north and south treatments started to decline. By the end of FY 2000, the difference in average rates was only 0.02 mm d^{-1} ; by the end of FY 2002, the rates were essentially equal. The convergence of rates suggests that the shrubs on the north section may have finally recovered from the stresses caused by over 3 years of elevated precipitation. All of the plots then showed an increase in the ET rate for the first time since FY 1997. During the last reporting period, FY 2004, the rate had shown a slight decrease, although it remained above the rates observed in FY 1997. These

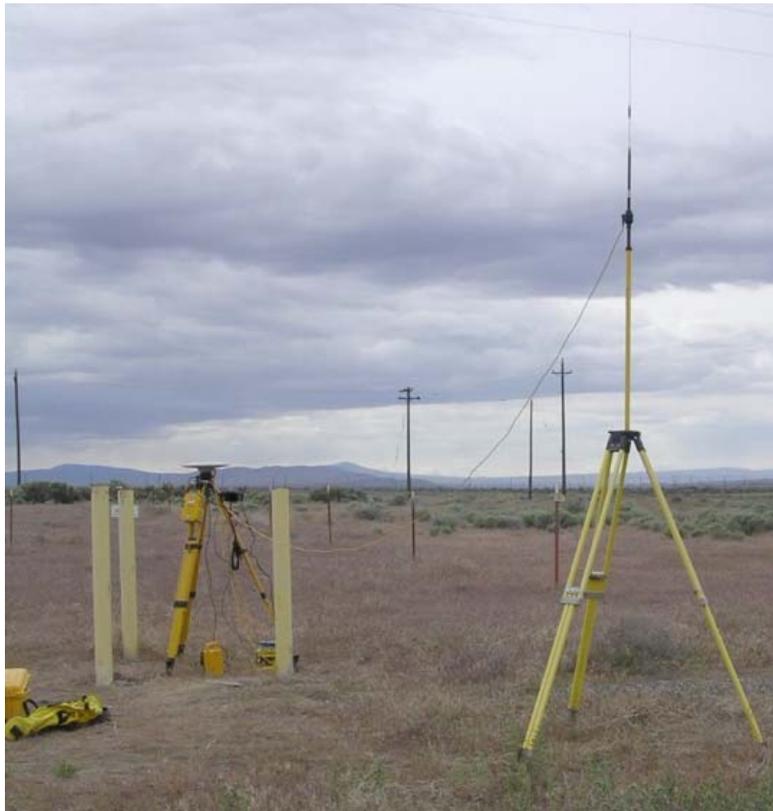
Figure 3.1. RTK GPS Surveying System with a 5700 Receiver and Trimmark 3 Base Station Radio with Whip Antenna

A complete survey of the prototype barrier was performed using GPS. The GPS surveying equipment consisted of a Trimble RTK 5700 base station with a RTK 5800 rover (Figure 3.1) and a Trimmark 3 Base Station Radio with a 6-ft whip antenna, all manufactured by Trimble Navigation Limited (Sunnyvale, CA).

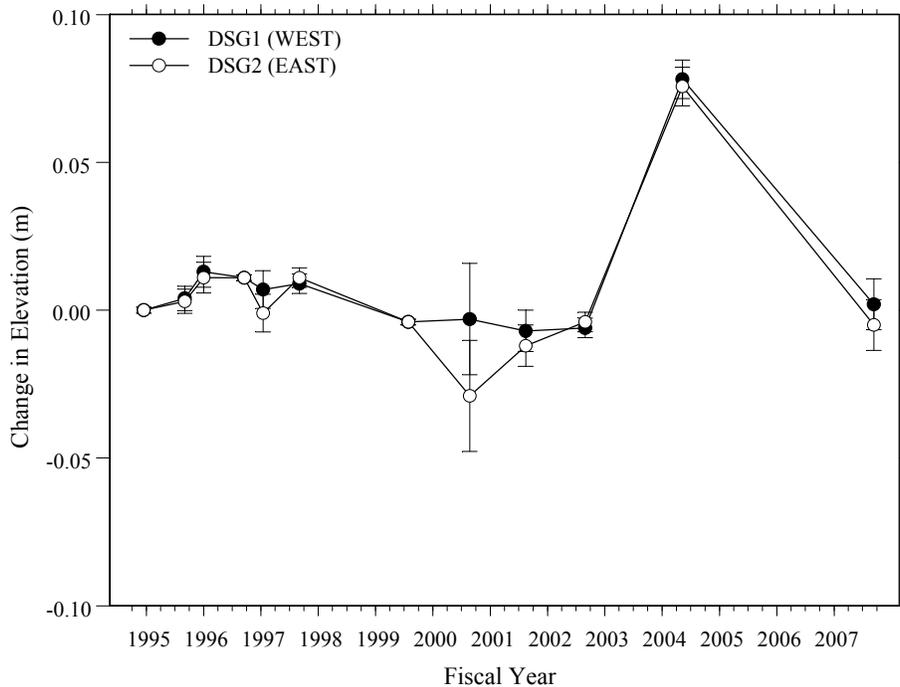
Figure 3.2. Summary of Changes in Settlement Gauge Elevation Between November 1, 1994, and September 14, 2007. (Error bars represent the total measurement error; DSG2 is located 14 m east of DSG1.)
