200-BP-1 Prototype Hanford Barrier Annual Monitoring Report for Fiscal Years 2005 Through 2007

A. L. Ward
S.O. Link
C.E. Strickland
K.E. Draper
R.E. Clayton

December 2007

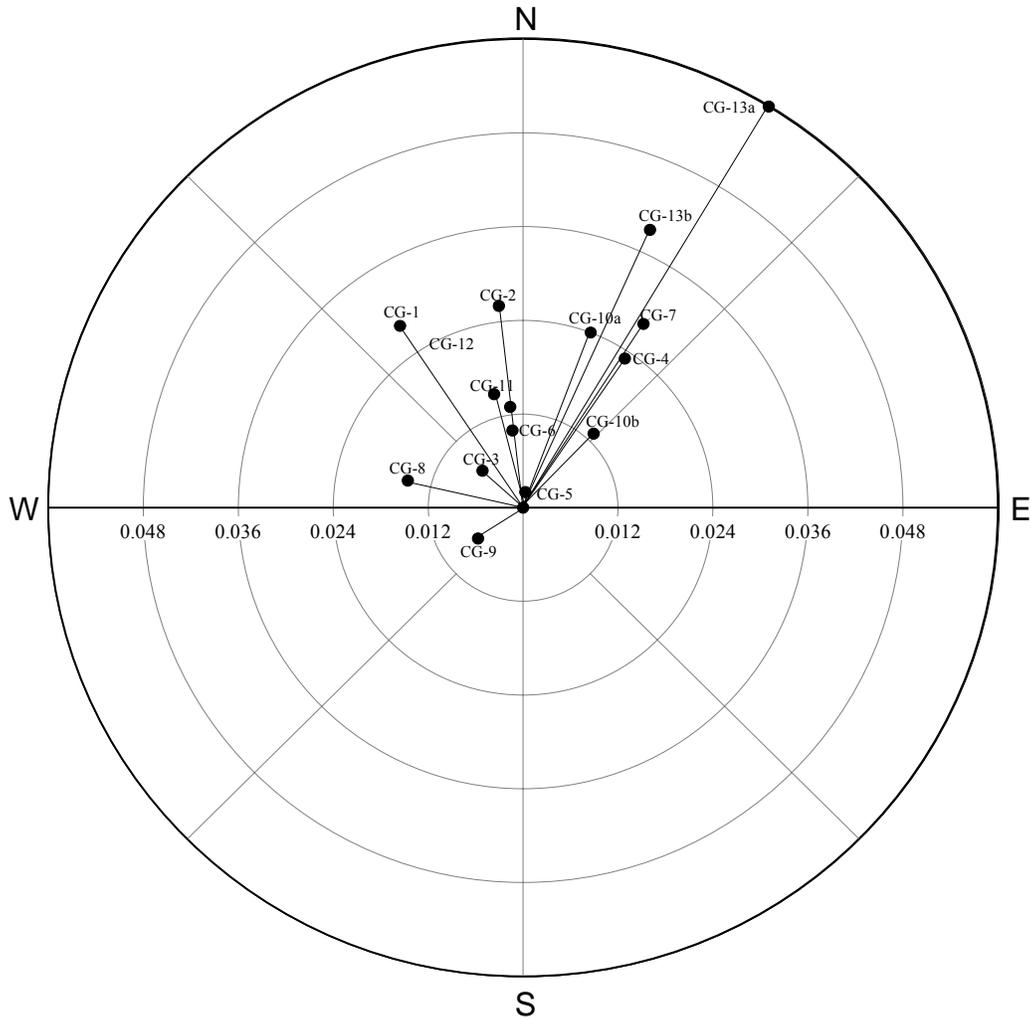
Figure 3.3. Net Creep Gauge Movement Between May 2004 and September 2007. (Elevation measured by EDM until FY 2003, subsequent measurements by GPS; the resultant [horizontal component] is in meters).

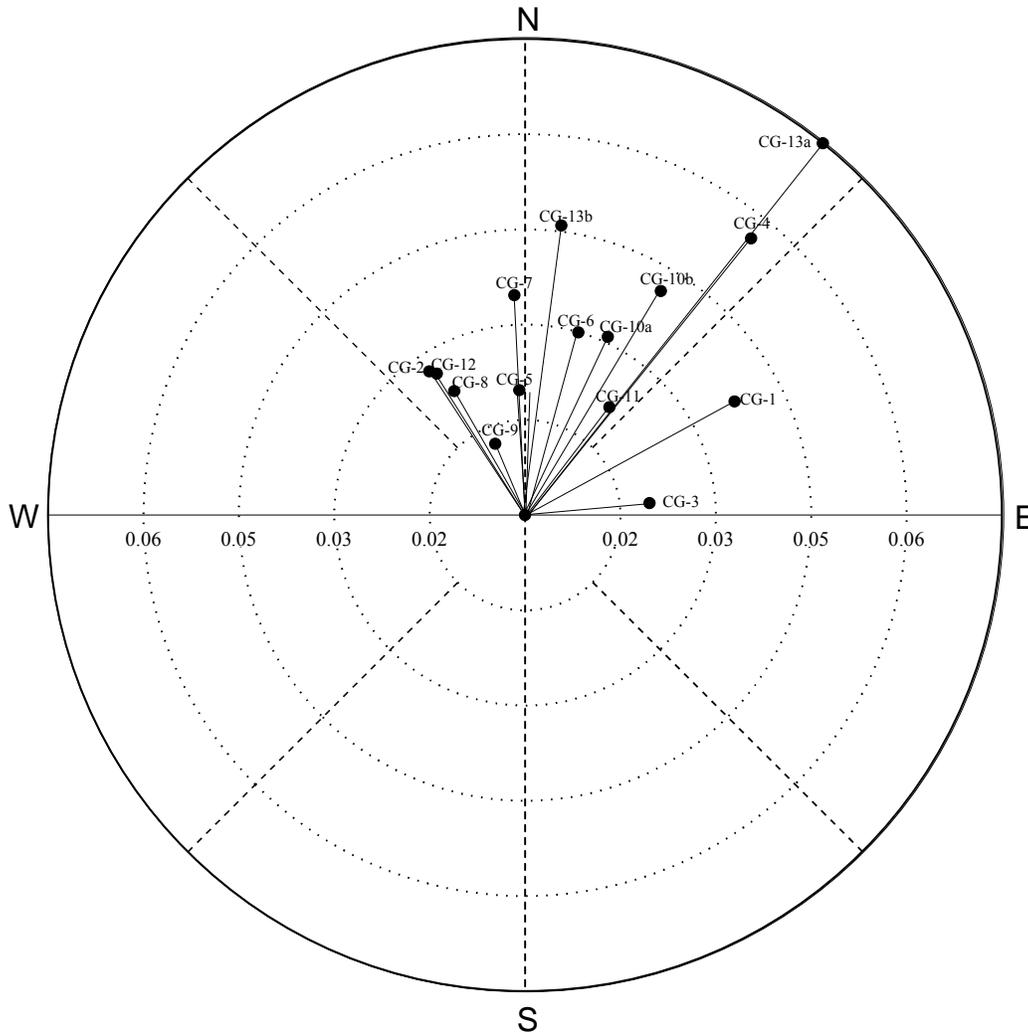
Figure 3.4. Net Creep Gauge Movement Between May December 1994 and September 2007. (Elevation measured by EDM until FY 2003, subsequent measurements by GPS; the resultant [horizontal component] is in meters).

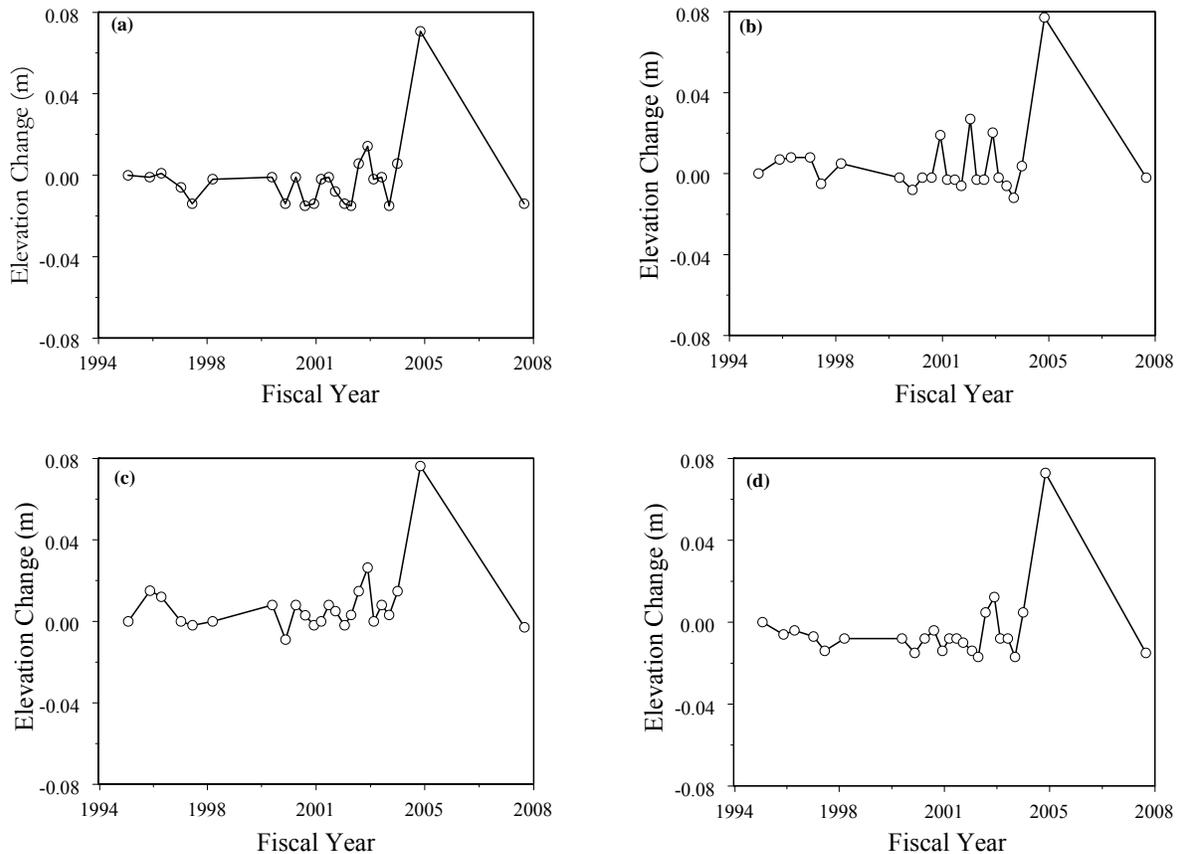
Figure 3.5. Creep Gauge Elevation Changes Between December 1994 and May 2004: (a) CG1, (b) CG2, (c) CG3, and (d) CG4. (Elevation Measurements by EDM until FY 2003; subsequent measurements made using GPS.)

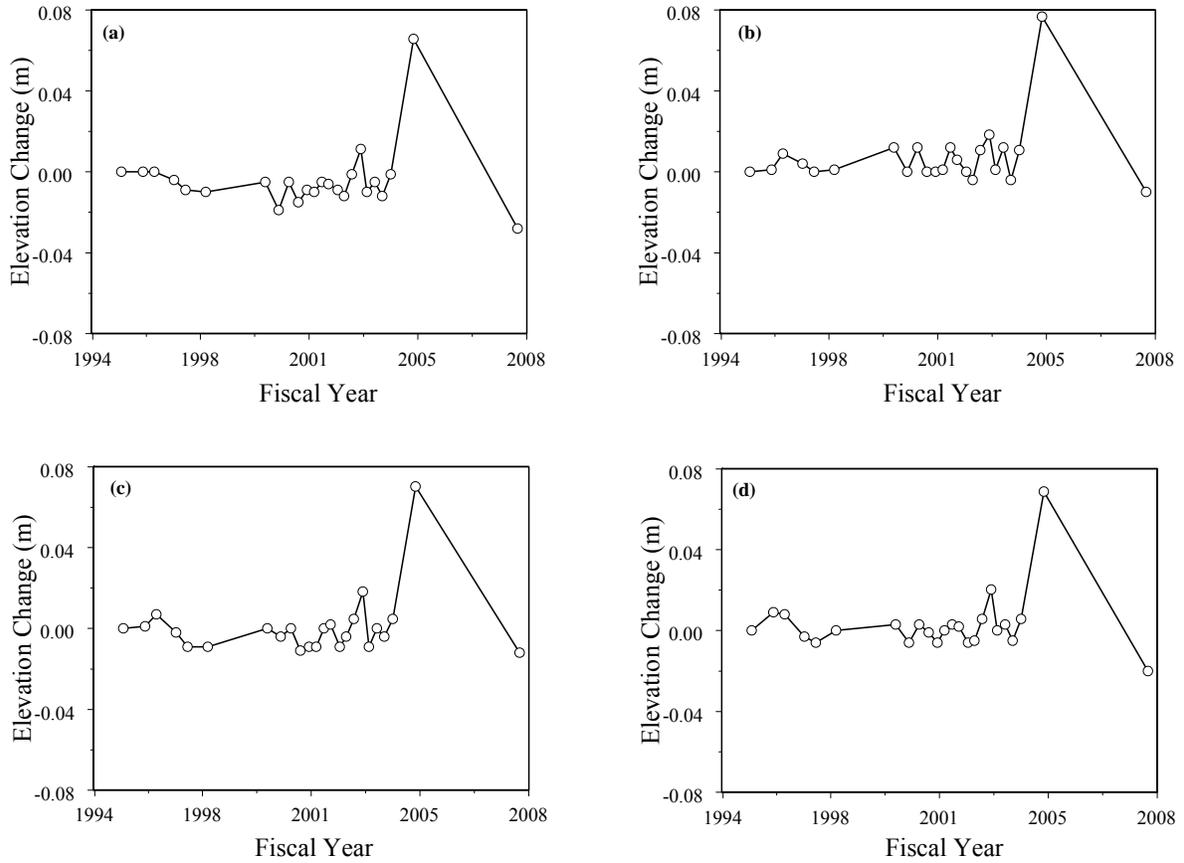
Figure 3.6. Creep Gauge Elevation Changes Between December 1994 and September 2007: (a) CG5, (b) CG6, (c) CG7, and (d) CG8. (Elevation Measurements by EDM until FY 2003; subsequent measurements made using GPS.)

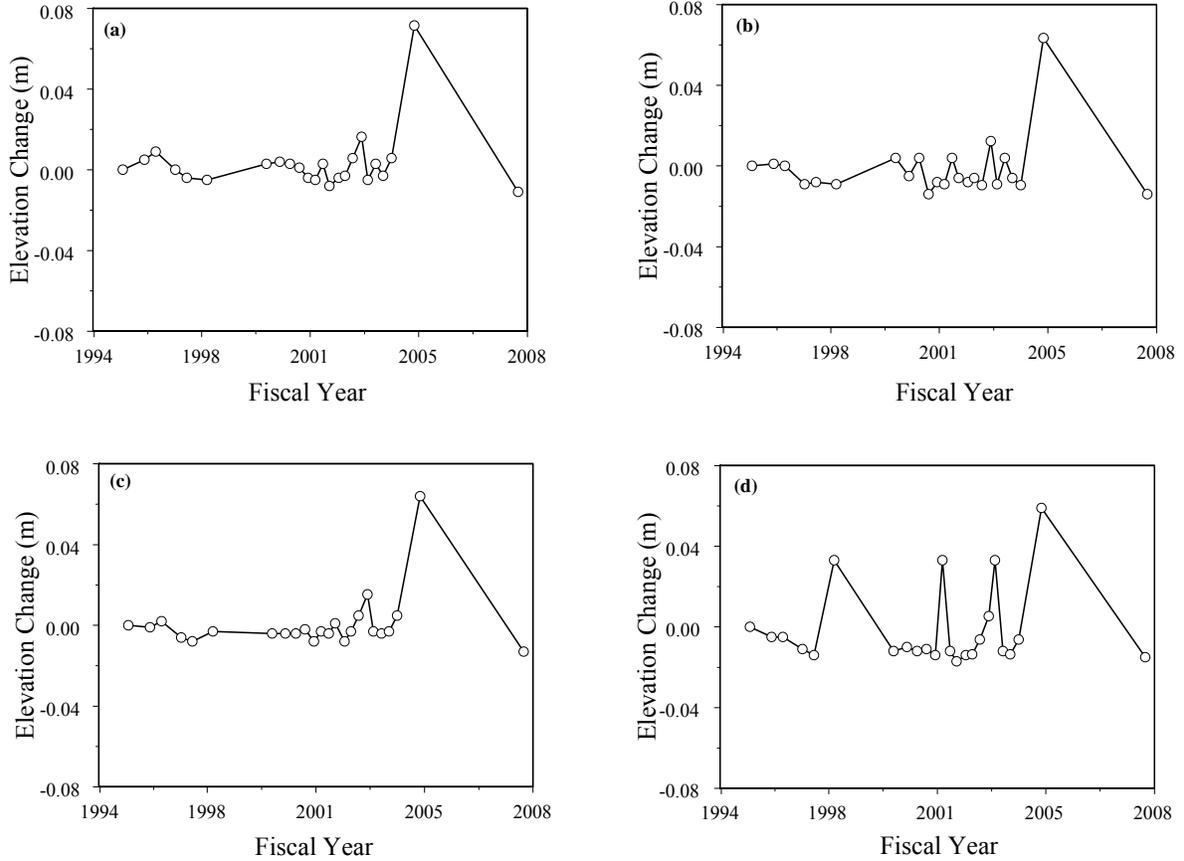
Figure 3.7. Creep Gauge Elevation Changes Between December 1994 and May 2004: (a) CG9, (b) CG10a, (c) CG10b, and (d) CG11. (Elevation Measurements by EDM until FY 2003, subsequent measurements made using GPS.)

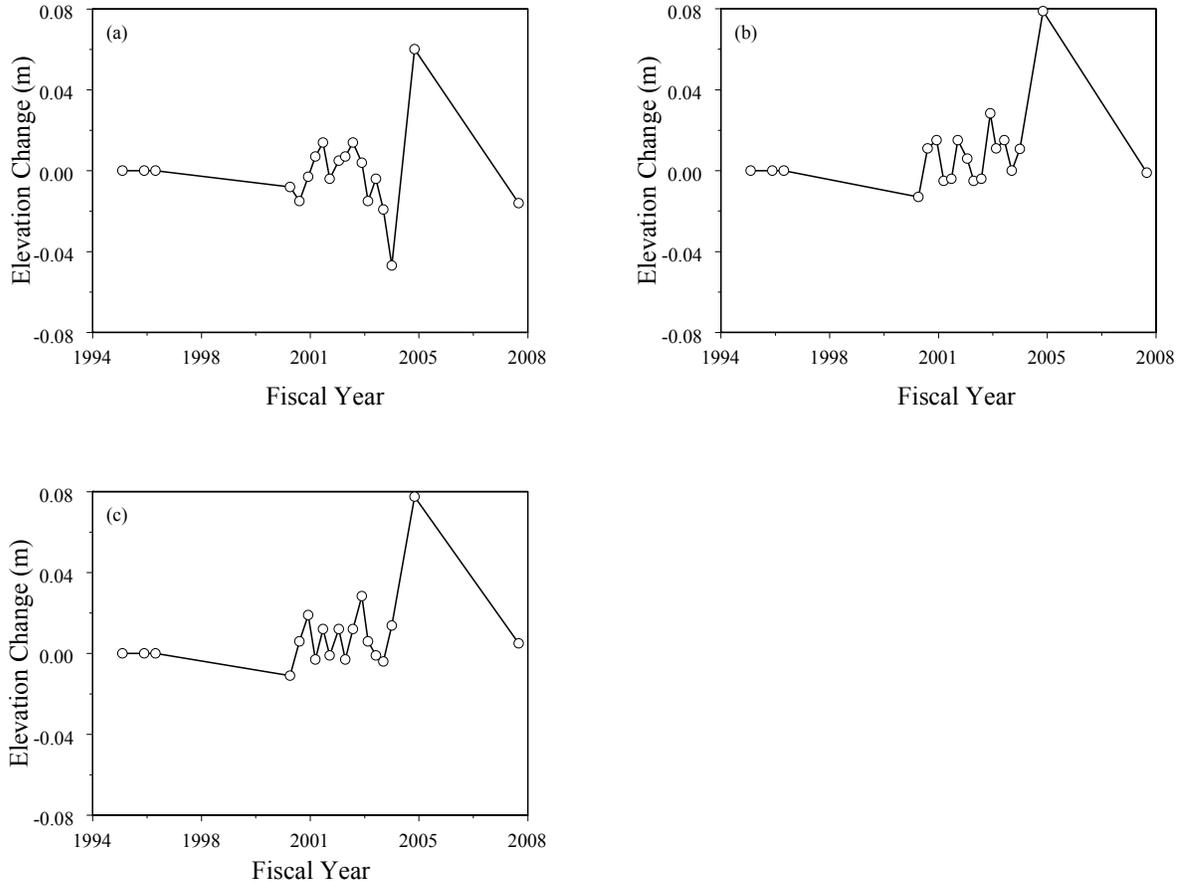
Figure 3.8. Creep Gauge Elevation Changes Between December 2004 and September 2007: for Gauges (a) CG12, (b) CG13a, and (c) CG13b. (Elevation Measurements by EDM until FY 2003; subsequent measurements made using GPS.)

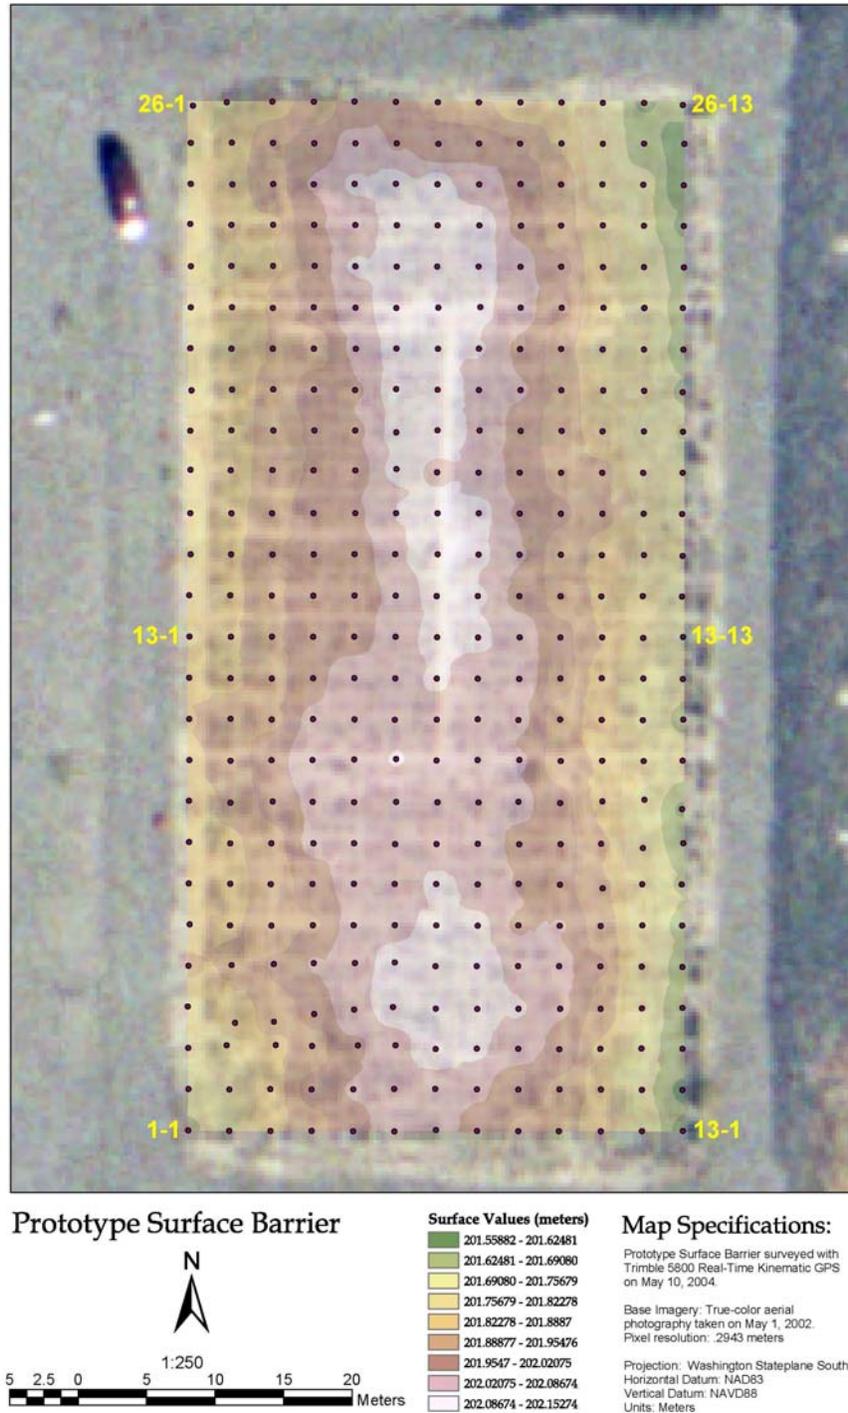
Figure 3.9. Contour Map of Surface Elevation Measured with Trimble 5800 RTK GPS on May 10, 2004. Contours are overlain of a True-color Aerial Photograph Taken on May 1, 2002 with a Pixel Resolution of 0.2943 m. Dark points are measurement Locations, numbers represent stake coordinates of the 3×3 m grid shown in Figure 2.1.

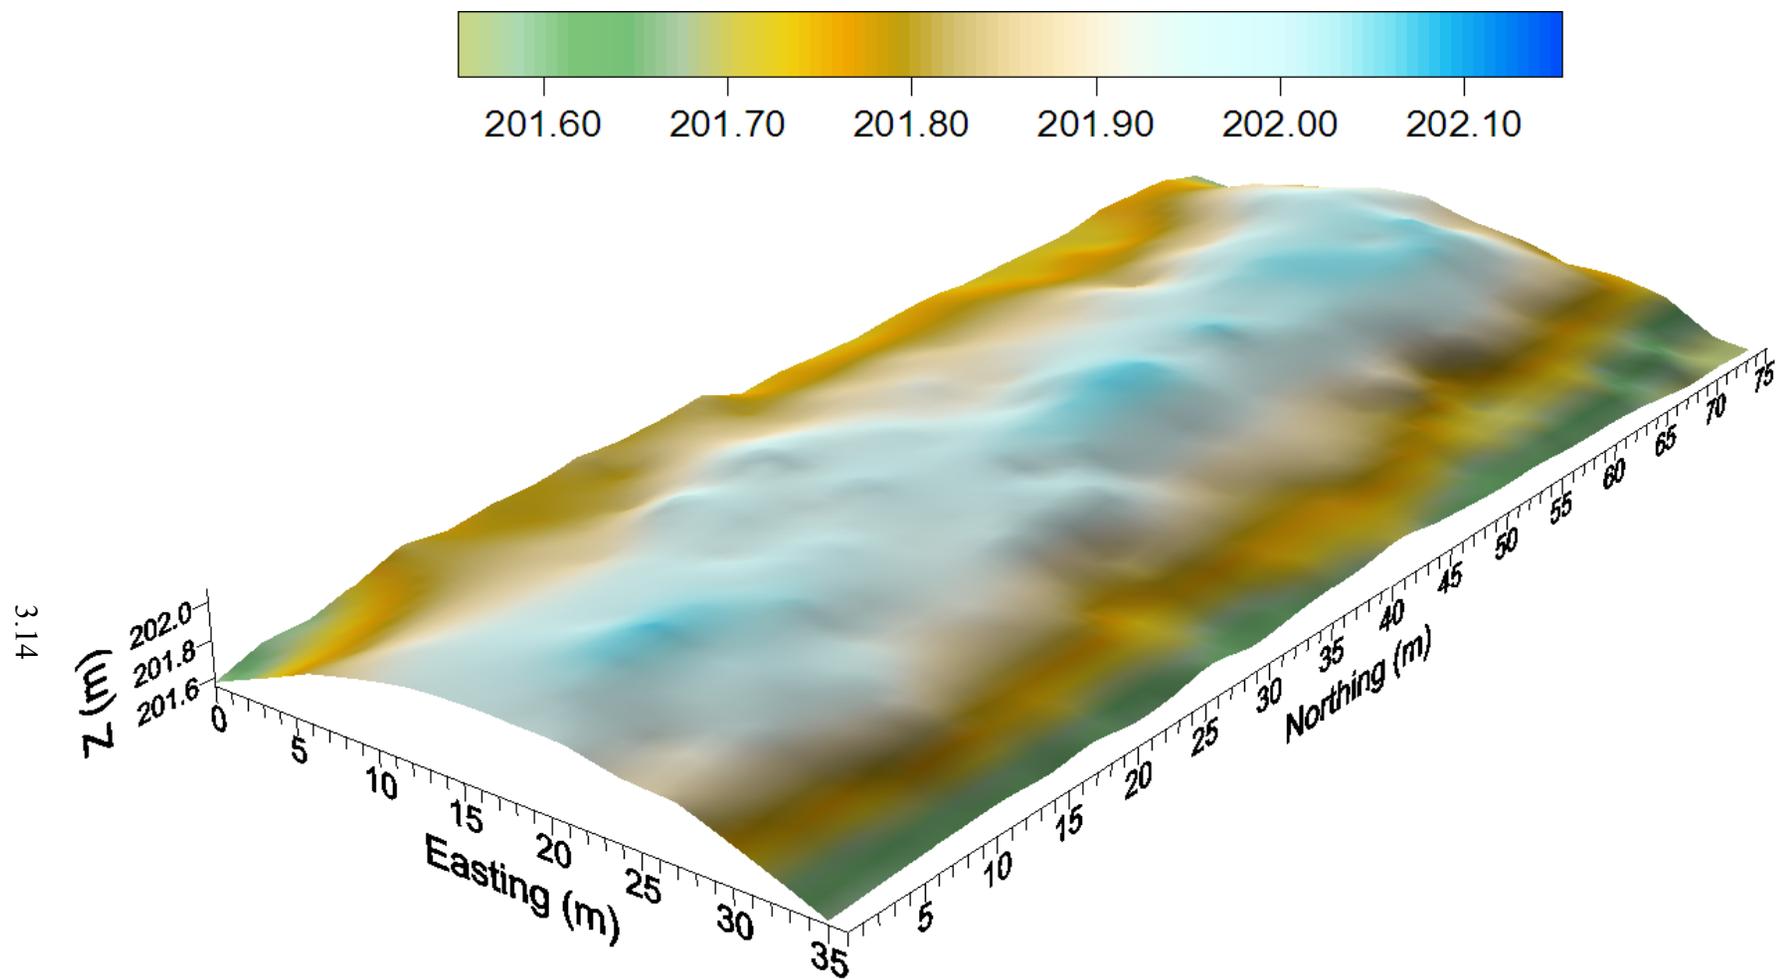
Figure 3.11. Surface Elevation (10× Vertical Exaggeration) at the Prototype Hanford Barrier as of September 12, 2007, Measured Using an RTK GPS

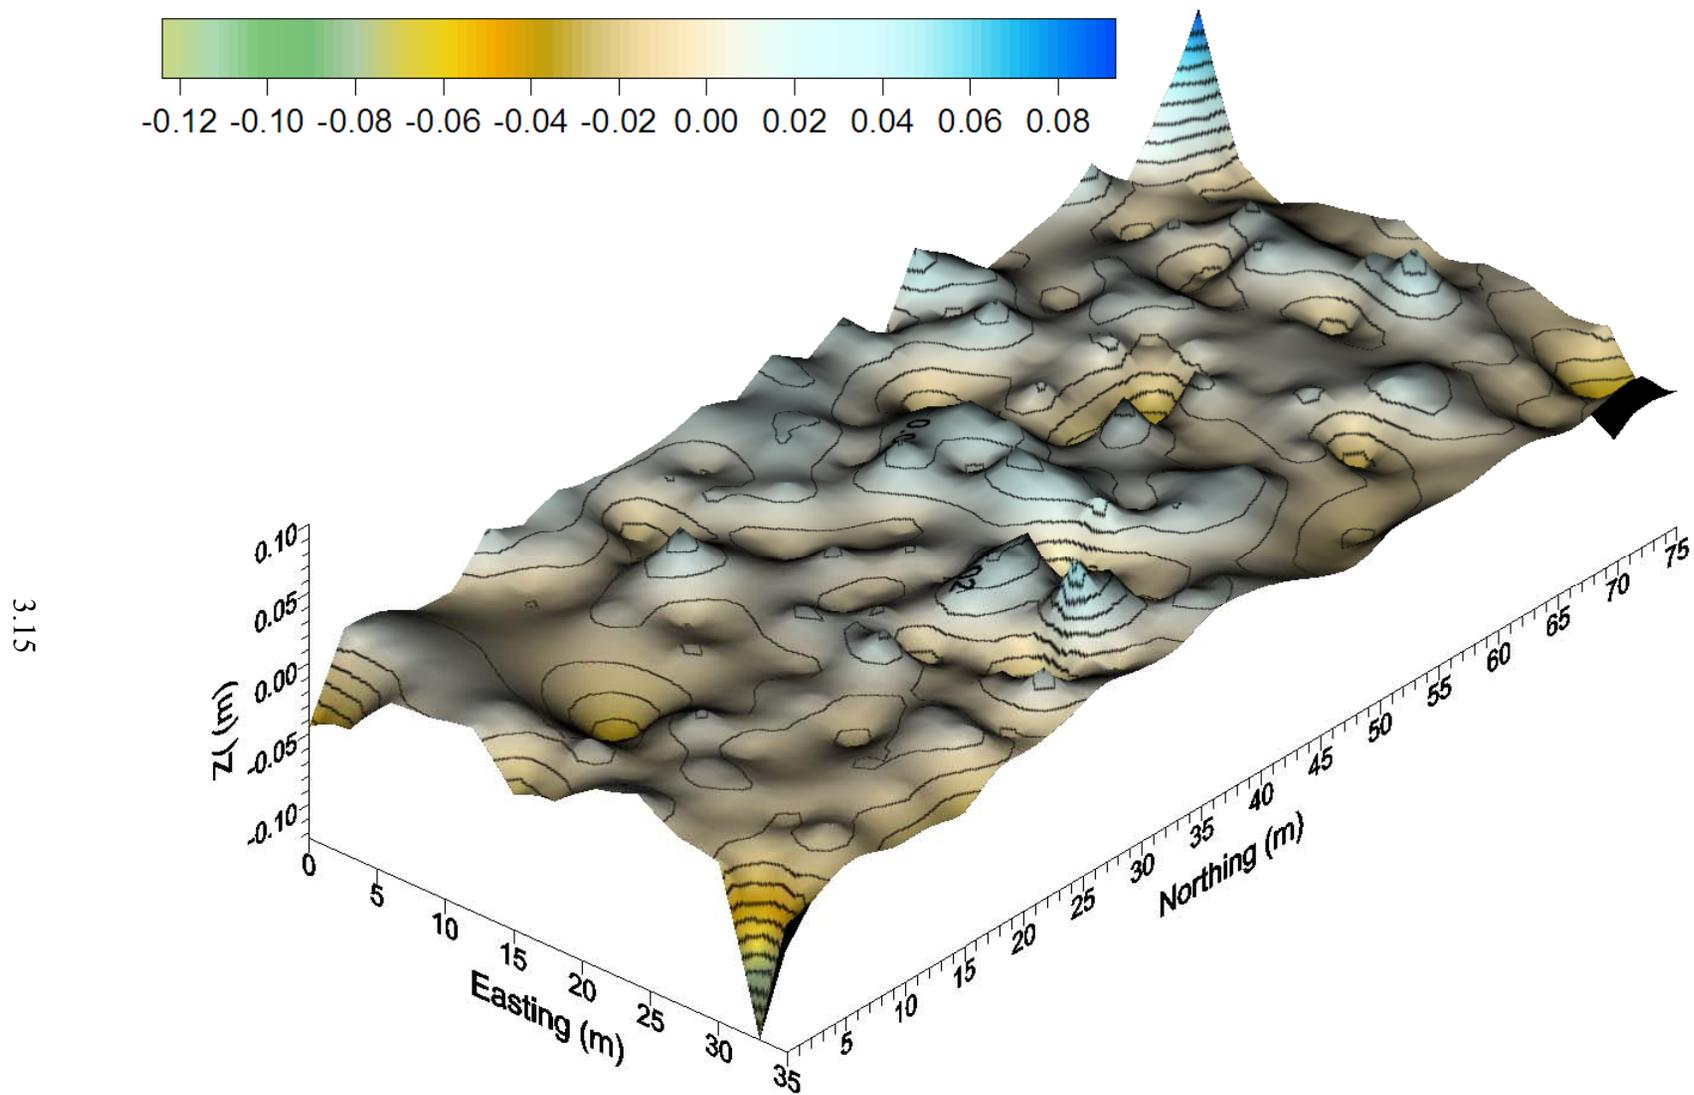
Figure 3.12. Change in Surface Elevation ($66 \times$ Vertical Exaggeration) at the Prototype Hanford Barrier as of September 12, 2007, Measured Using an RTK GPS

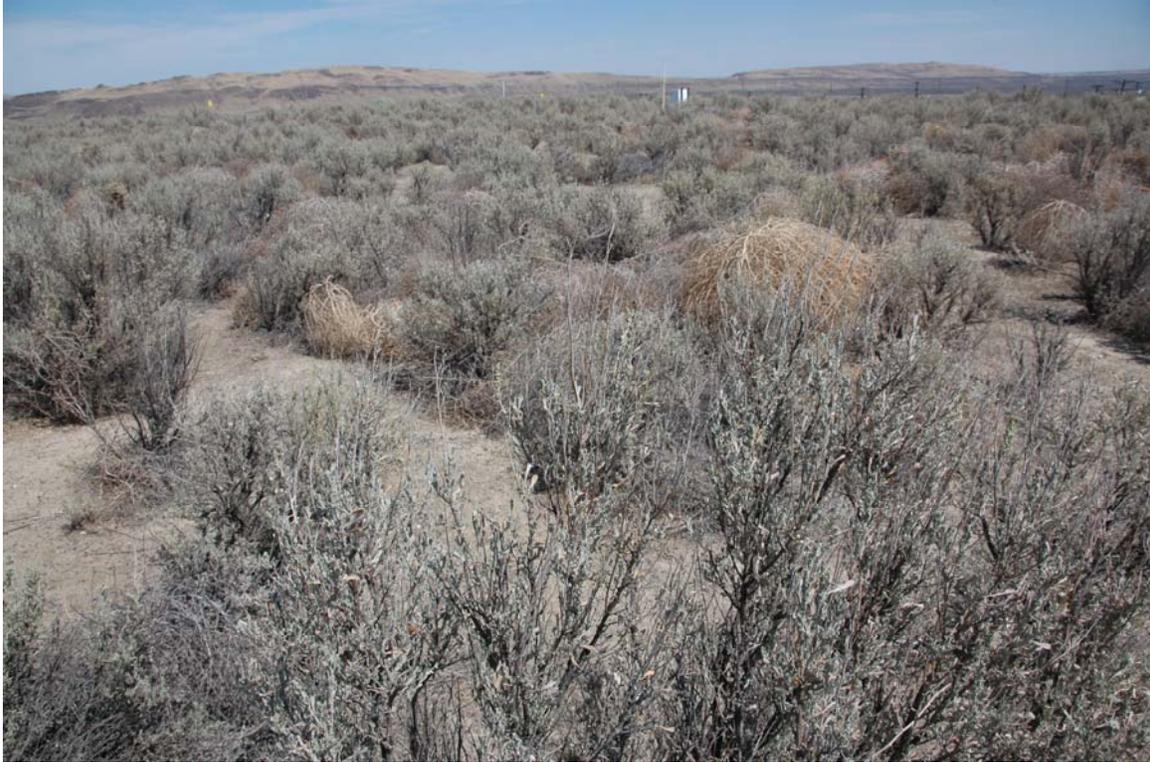
Figure 4.1. Prototype Hanford Barrier Cover Dominated by *Artemisia tridentata* in 2007, 13 Years After Establishment

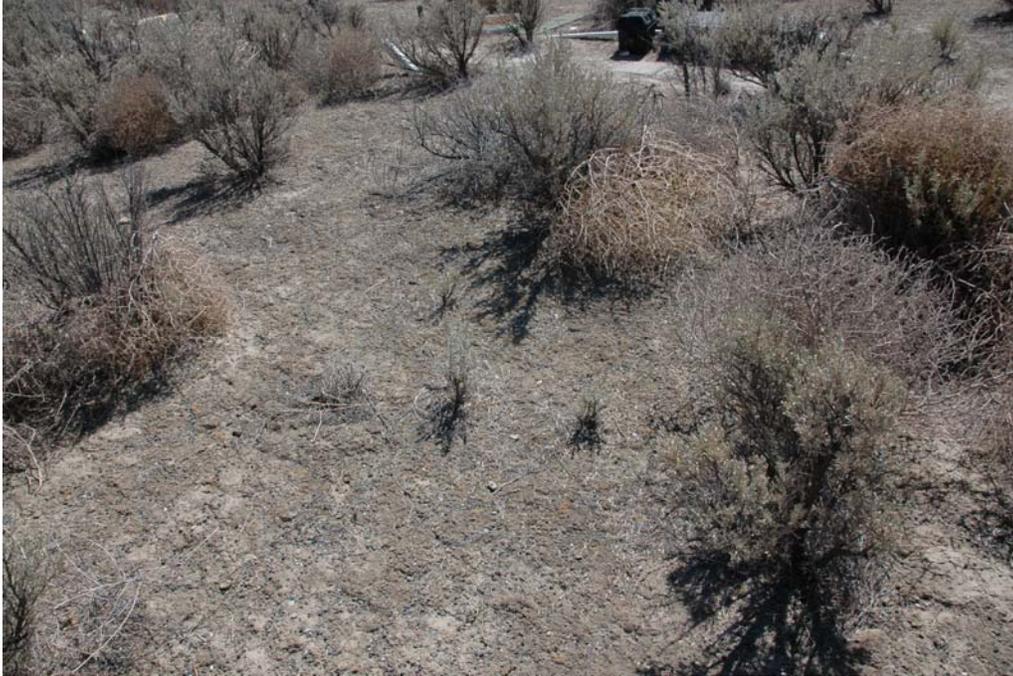
Figure 4.2. Cryptogamic Crust Covering Most of the Soil Surface. Bright Patches on the Surface are Bare Soil.

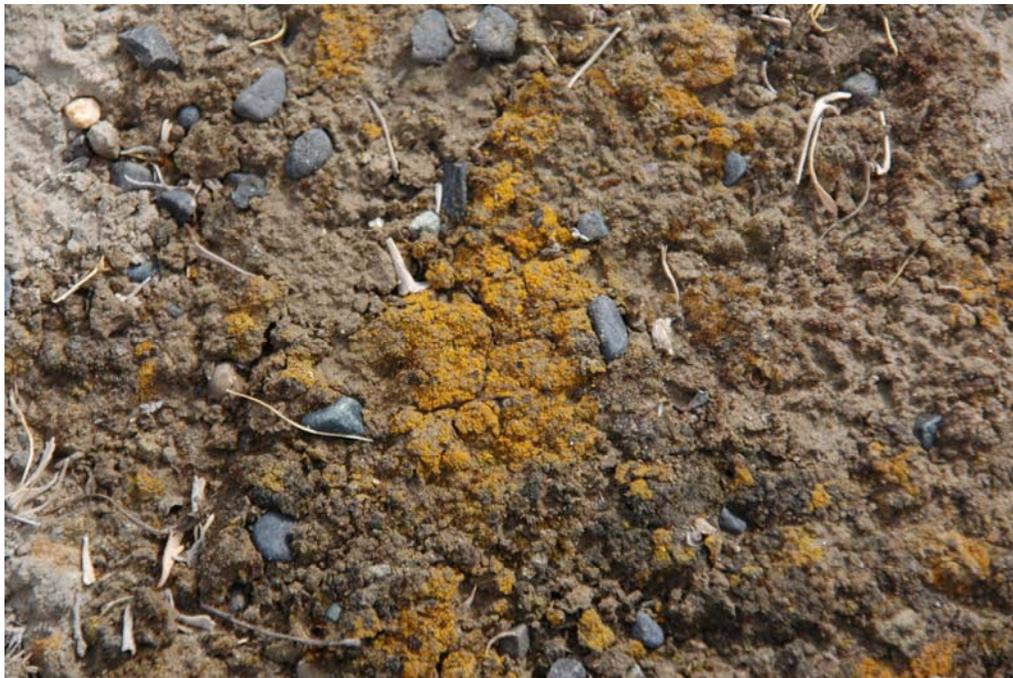
Figure 4.3. Soil Cryptogams. The orange lichen is *Caloplaca tominii* and the moss is *Bryum cf. caespiticium* (Link et al. 2000).

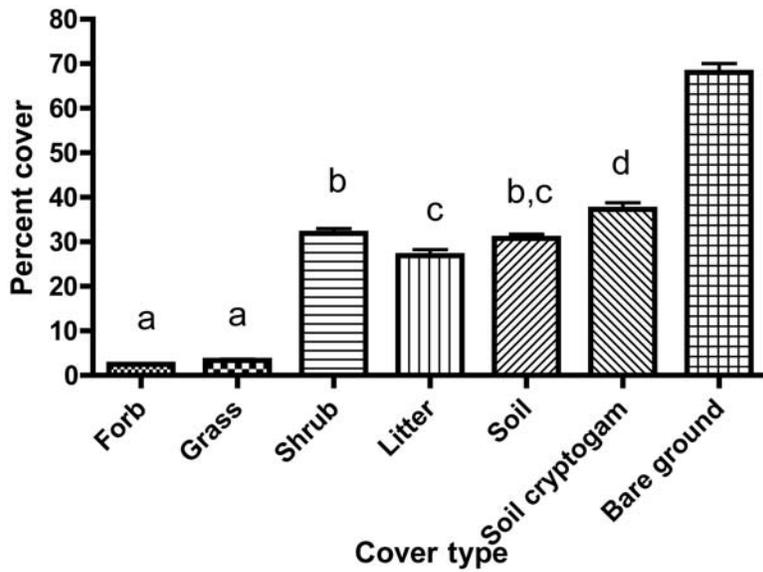
Figure 4.4. Mean Cover on Non-Irrigated Half of the Barrier. Error bars of one standard error of the mean. Different letters indicate significant differences.

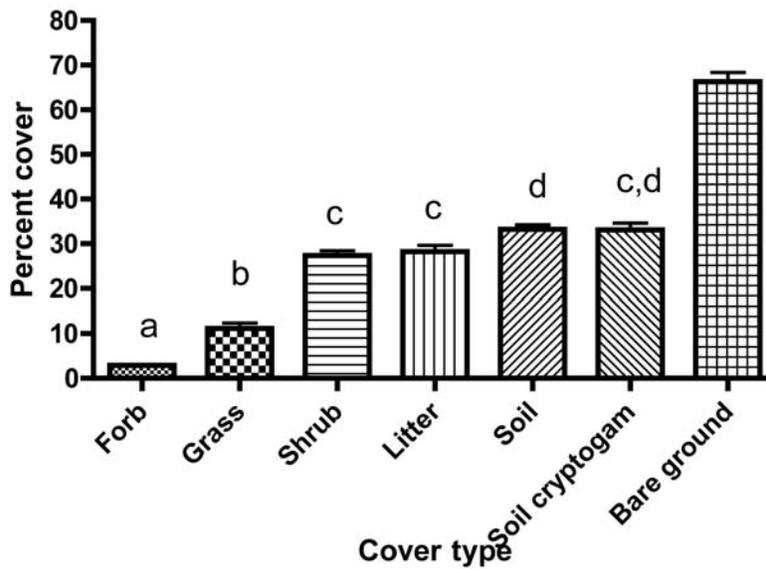
Figure 4.5. Mean Cover on Formerly Irrigated (North) Half of the Barrier. Error bars of one standard error of the mean. Different letters indicate significant differences.

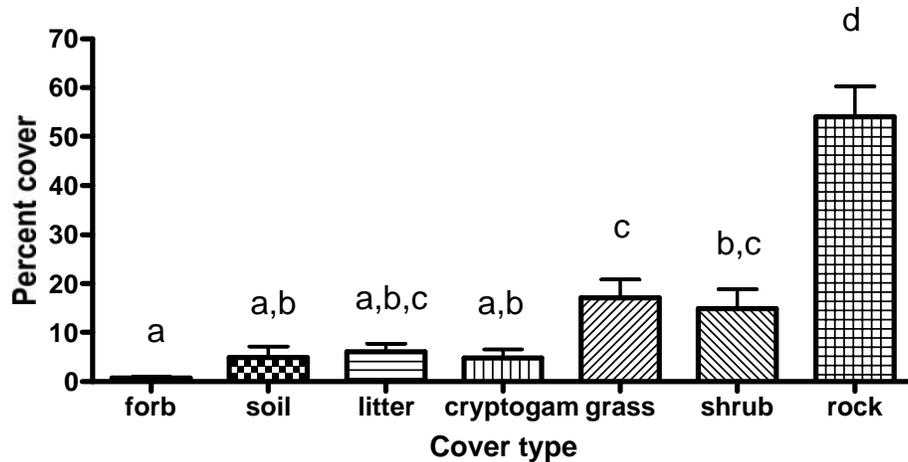
Figure 4.6. Mean Cover on the North and West Side Slopes of the Barrier. Error bars of one standard error of the mean. Different letters indicate significant differences.

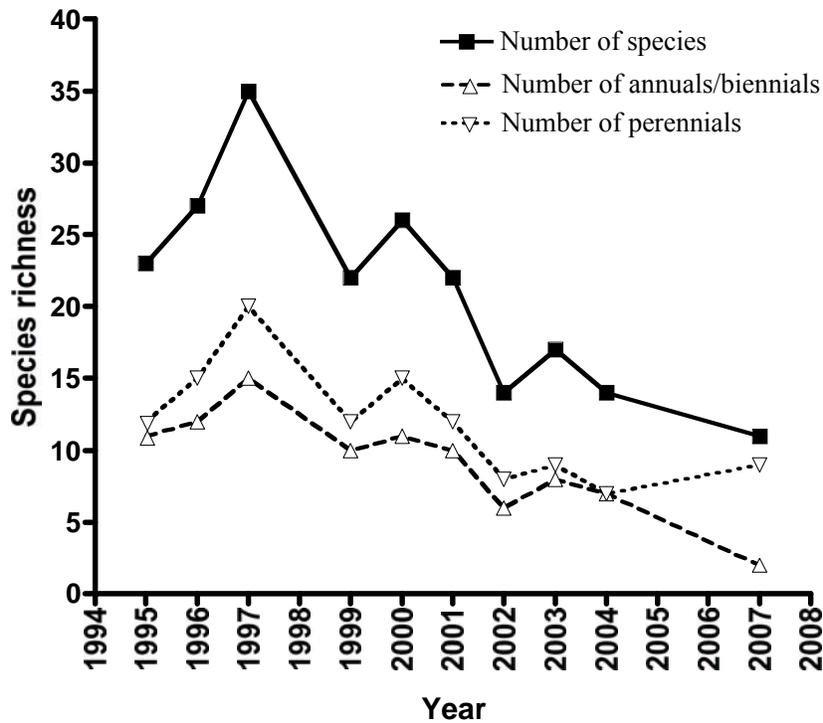
Figure 4.7. Temporal Variation in the Number of Annual/Biennials and Perennial Species Including Total Species on the Prototype Hanford Barrier

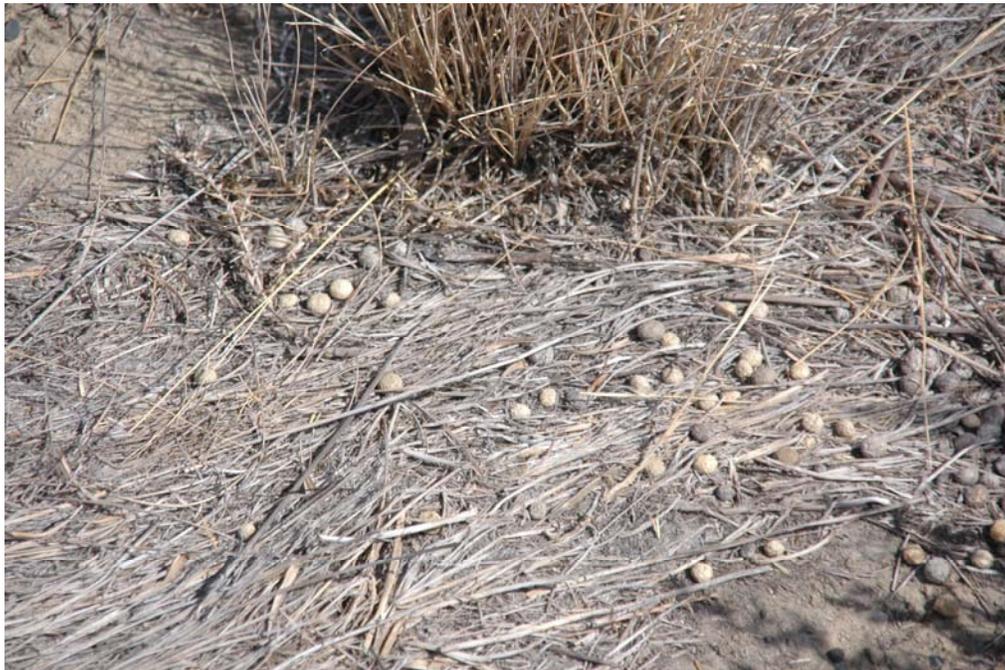
Figure 5.1. Rabbit Droppings in Association with High Grass Cover in the Northeast Corner of the Barrier Surface

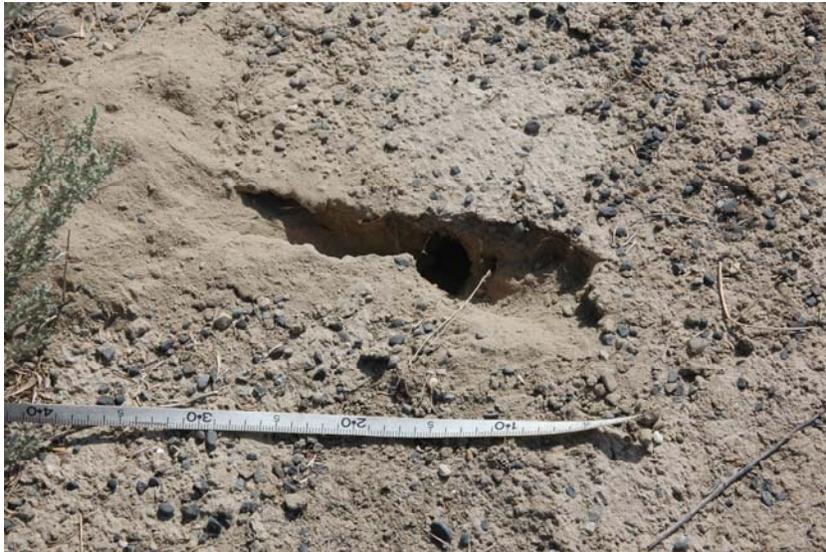
Figure 5.2. A Small Mammal Hole on the Barrier Surface. Note recent digging activity in the upper left hand corner.

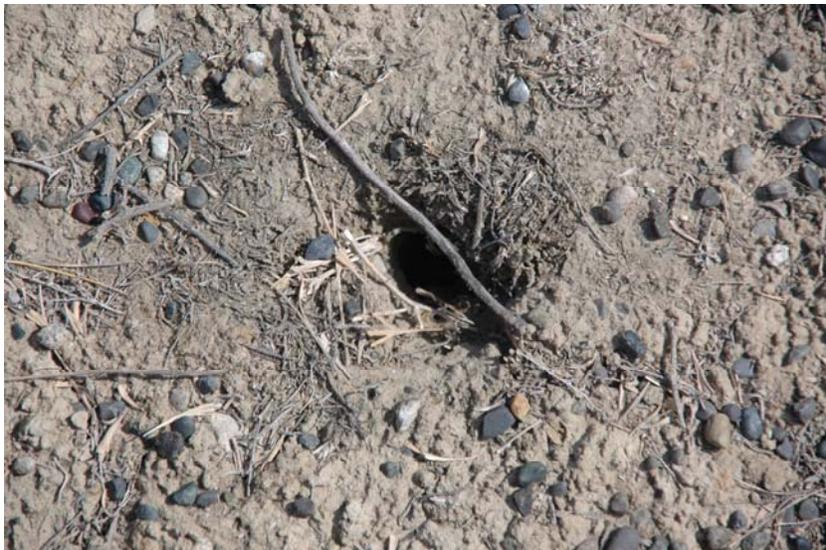
Figure 5.3. Typical Animal Hole on the Surface of the Barrier
