PNNL-17272

## **2006 Status Report**

# **Characterization and Monitoring Data for Evaluating Constructed Emergent Sandbar Habitat in the Missouri River Mainstem**

November 2008

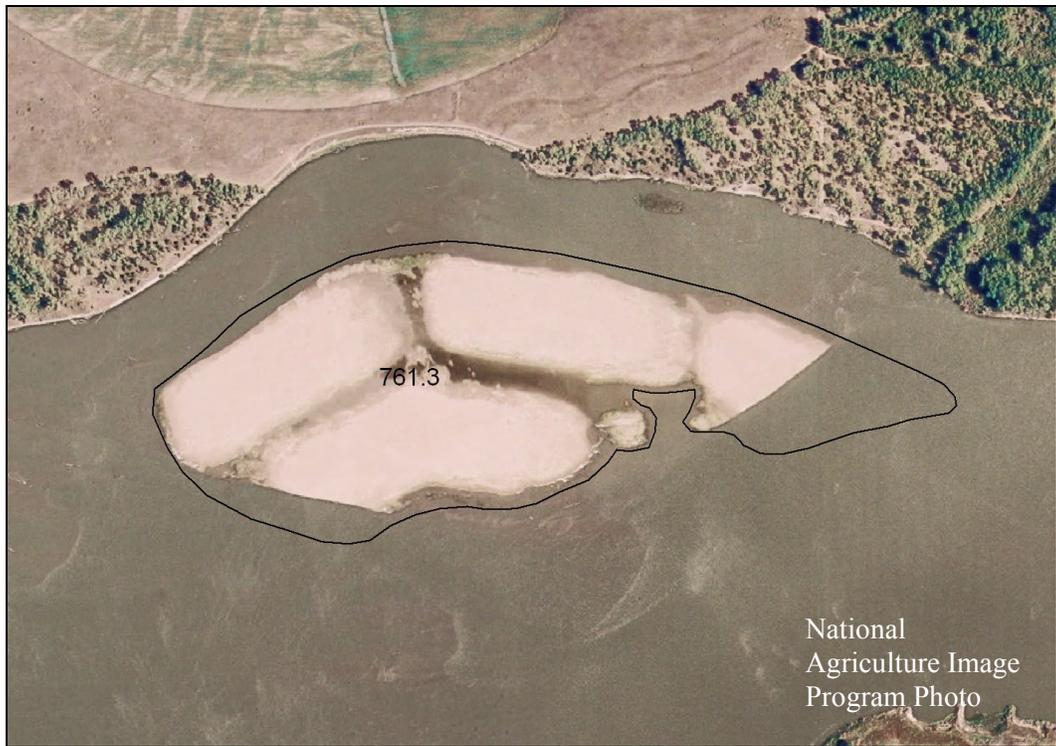
**Figure 2.3a.** Infra-Red Aerial Photograph of Emergent Sandbar Complex at RM 761 taken June 2005 (river flows ~21,500 cfs)

The complex at RM 761.3, which was constructed to provide approximately 38 acres at 30,000 cfs, also suffered some post-construction erosion losses, particularly at the downstream end (Figure 2.3). On August 19, 2005, the size of the complex was estimated at 45.4 acres at 23,500 cfs flow. Erosion rates have declined and numerous snags have appeared at the upstream end of the sandbar complex. This sandbar was colonized by cottonwood trees during spring/summer 2005, and the majority of the trees appeared in a 20- to 100-foot-wide fringe around the perimeter of the sandbar complex (Jons 2006).

**Figure 2.3b.** Aerial Photograph of Emergent Sandbar Complex at RM 761 taken July 2006 (river flows ~25,000 cfs)

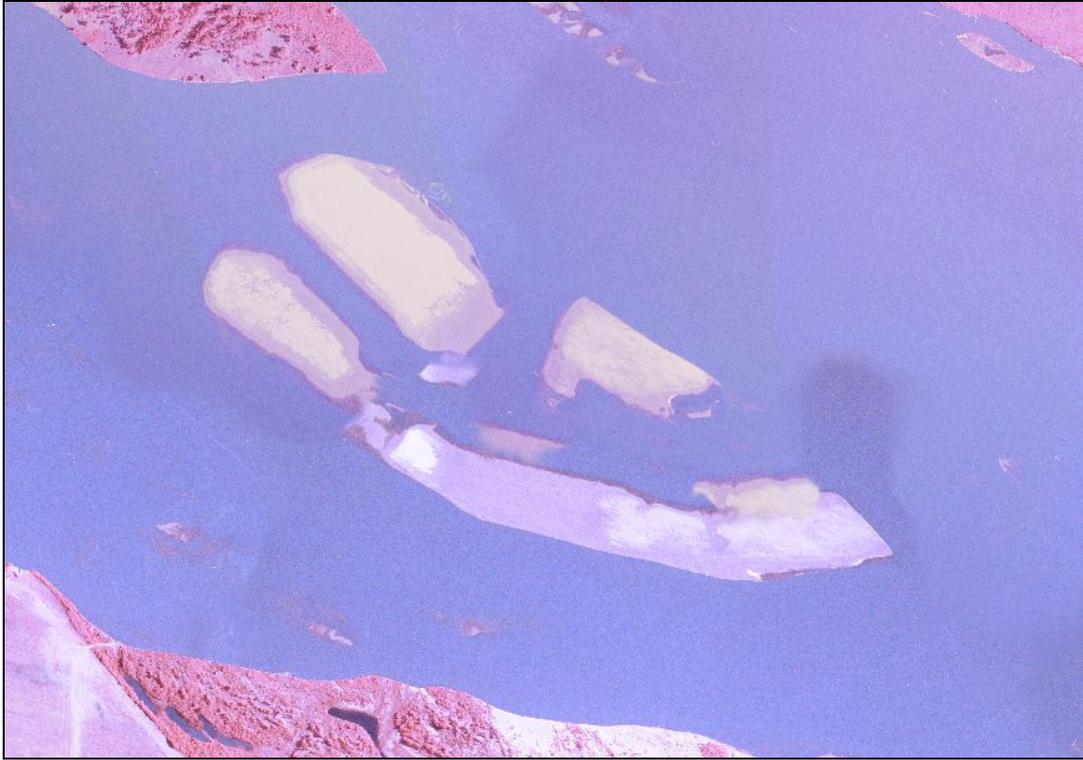
**Figure 2.4a.** Infra-Red Aerial Photograph of Emergent Sandbar Complex at RM 770 taken June 2005 (river flows ~21,500 cfs)

The complex at RM 770 was constructed to provide four sandbars, resulting in a total of approximately 50 acres at 30,000 cfs (Figure 2.4). Some erosion occurred on this sandbar complex, particularly at the downstream end on the South Dakota side, but the exposed sandbar complex still provided approximately 52.9 acres at a lower flow of 23,500 cfs in August 2005 (Jons 2006). Portions of the sandbar perimeters of this complex were also colonized by cottonwood trees and herbaceous vegetation, but the central portions of the sandbars remained free of vegetation. In the winter of 2007, a significant scouring event again changed this complex.

**Figure 2.4b.** Aerial Photograph of Emergent Sandbar Complex at RM 770 taken July 2006 (river flows ~25,000 cfs)

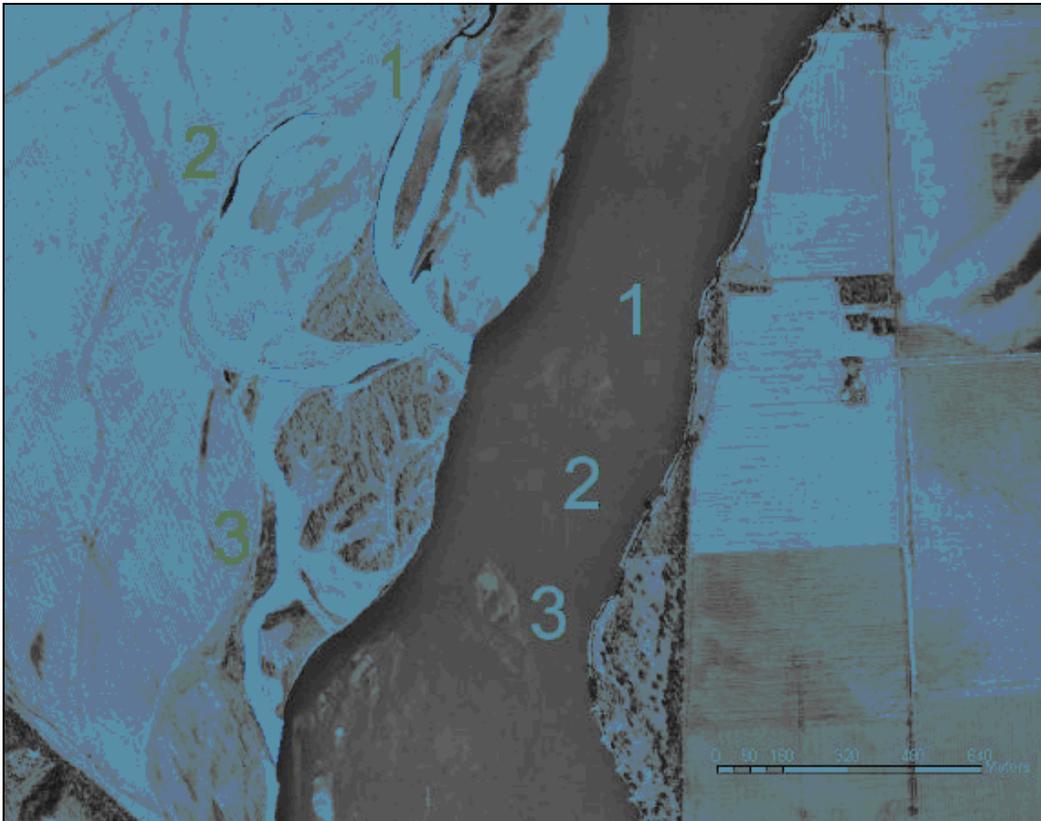
**Figure 2.6.** Aerial Photograph of Created Shallow Water Habitats near Ponca State Park (Figure 2 from Mestl 2004)

When the ESH complex was constructed near Ponca State Park (RM 754.4), the methods used to create ESH also allowed enhancement of shallow water habitats. Material was removed from in-river borrow areas to build up the sandbars, resulting in the expansion of three shallow water areas that provided approximately 30.9 acres of post-construction slack water that serves as spawning, rearing, and foraging habitats for native riverine fish (Figure 2.6). To document results of these management actions on fish populations, pre- and post-construction sampling was conducted (Wallace 2000; Mestl 2004). Fish sampling with beach seines and gill nets was initiated in 2000 to develop a pre-construction baseline for fish communities in backwater habitats. Post-construction sampling utilized seines, mini-fyke nets, frame nets, and barrel nets during July and August 2004. Limited nighttime electrofishing was also utilized for sampling in backwater habitats in 2004. Multiple samples were gathered both in the backwater areas as well as in shallow water near adjacent constructed sandbar habitats.
